TETON DAM FLOOD, SOUTHEASTERN IDAHO, JUNE 1976

TETON DAM FLOOD OF JUNE 1976, WOODVILLE QUADRANGLE, IDAHO

By Howard F. Matthai and Herman A. Ray

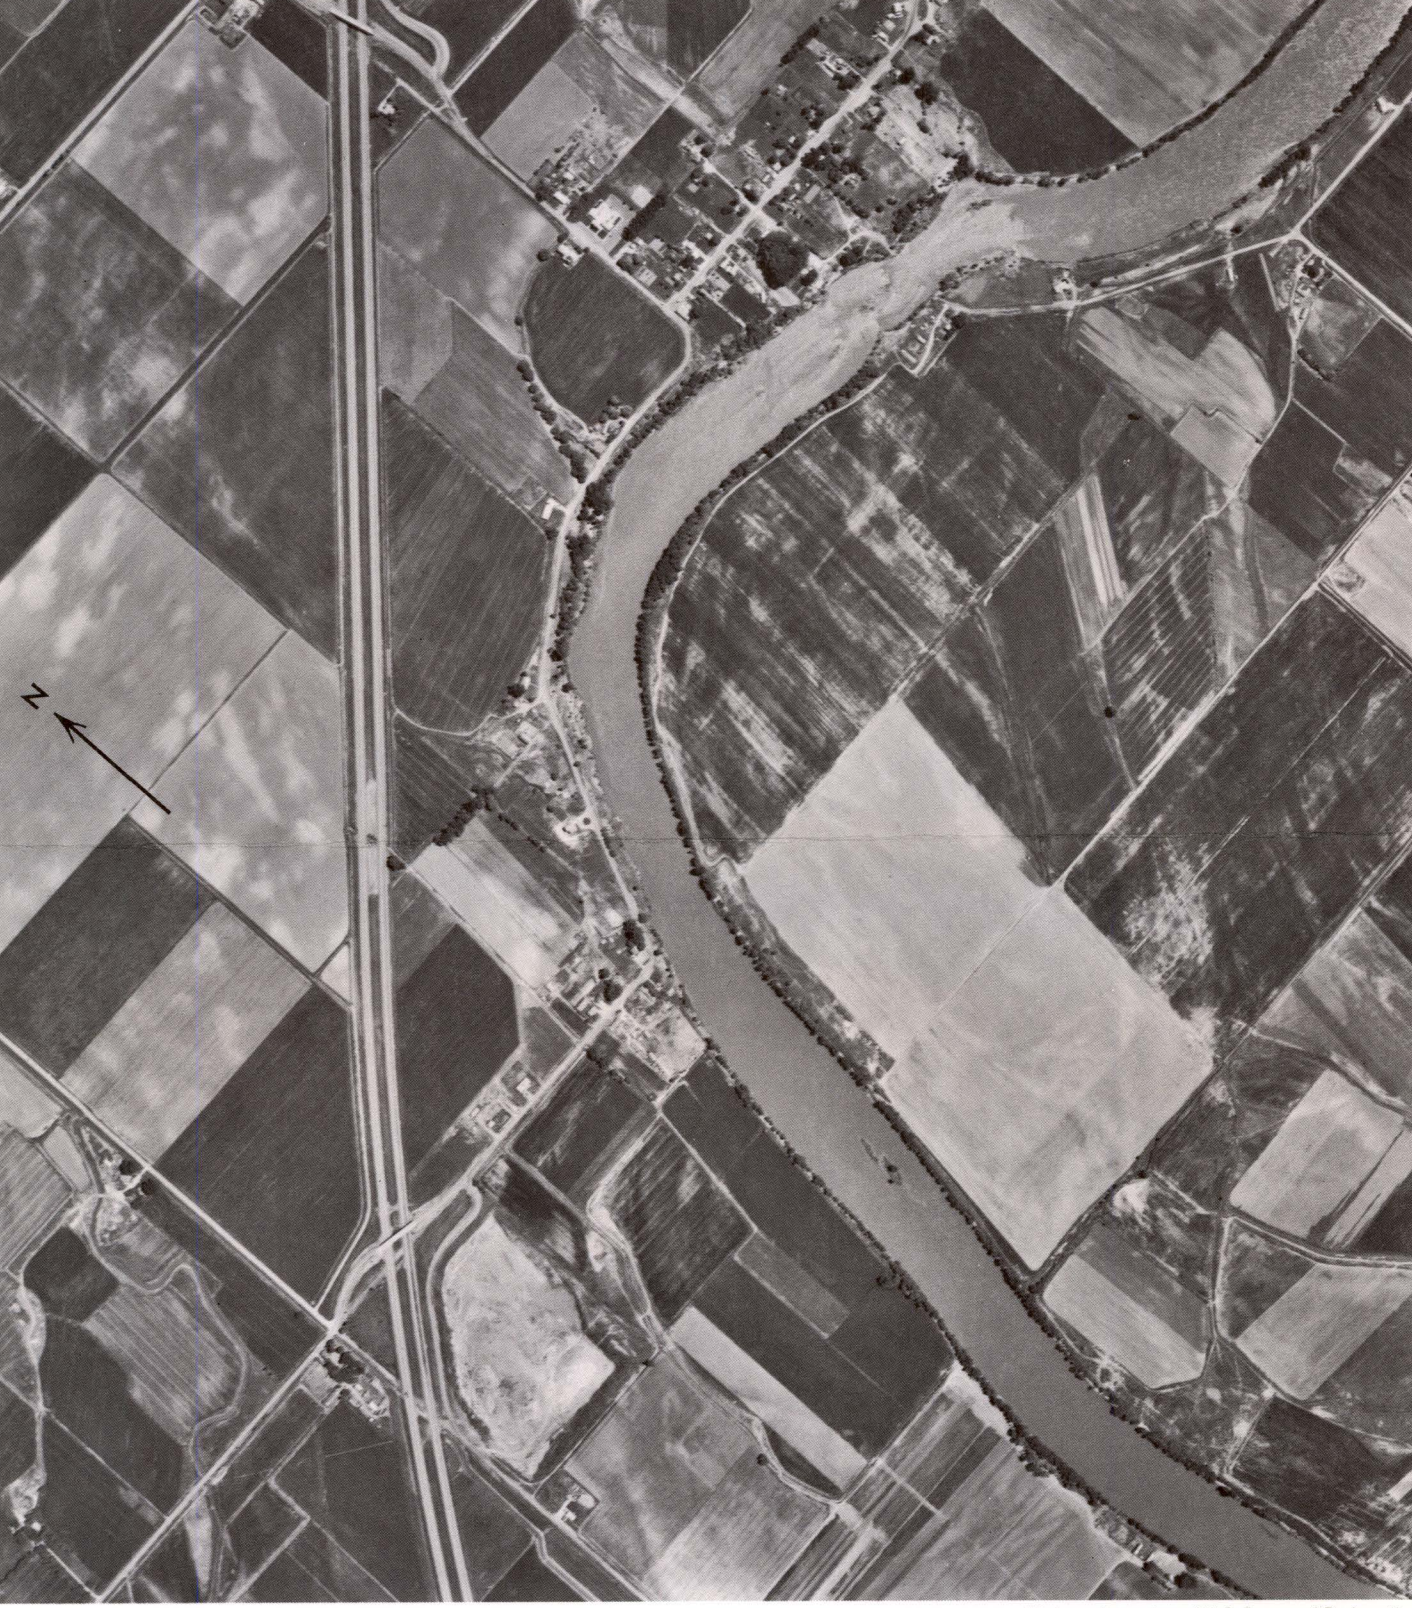
Snake River flowing within banks near Woodville, Idaho, June 10, 1976.
