TETON DAM FLOOD, SOUTHEASTERN IDAHO, JUNE 1976

TETON DAM FLOOD OF JUNE 1976, BLACKFOOT QUADRANGLE, IDAHO

By John H. Bartells and Larry L. Hubbard

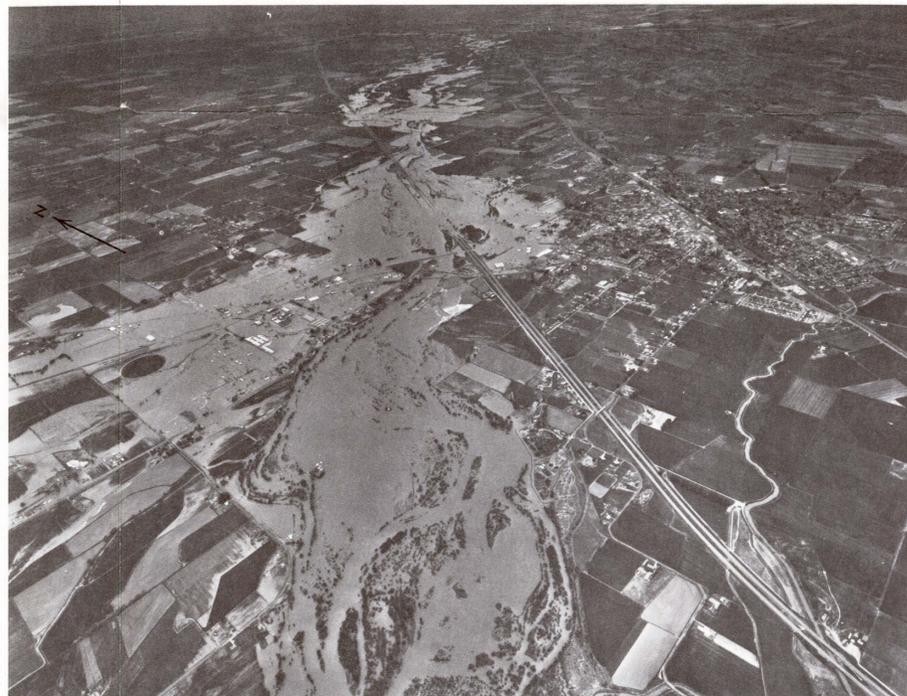
Area inundated by Snake River in the vicinity of Blackfoot, Idaho, June 7, 1976. Photograph courtesy of U.S. Army Corps of Engineers.
