INTRODUCTION

KELLY BARNES DAM FLOOD OF NOVEMBER 6, 1977, NEAR TOCCOA, GEORGIA

By
C. L. Sanders, Jr., and V. B. Sauer
1979

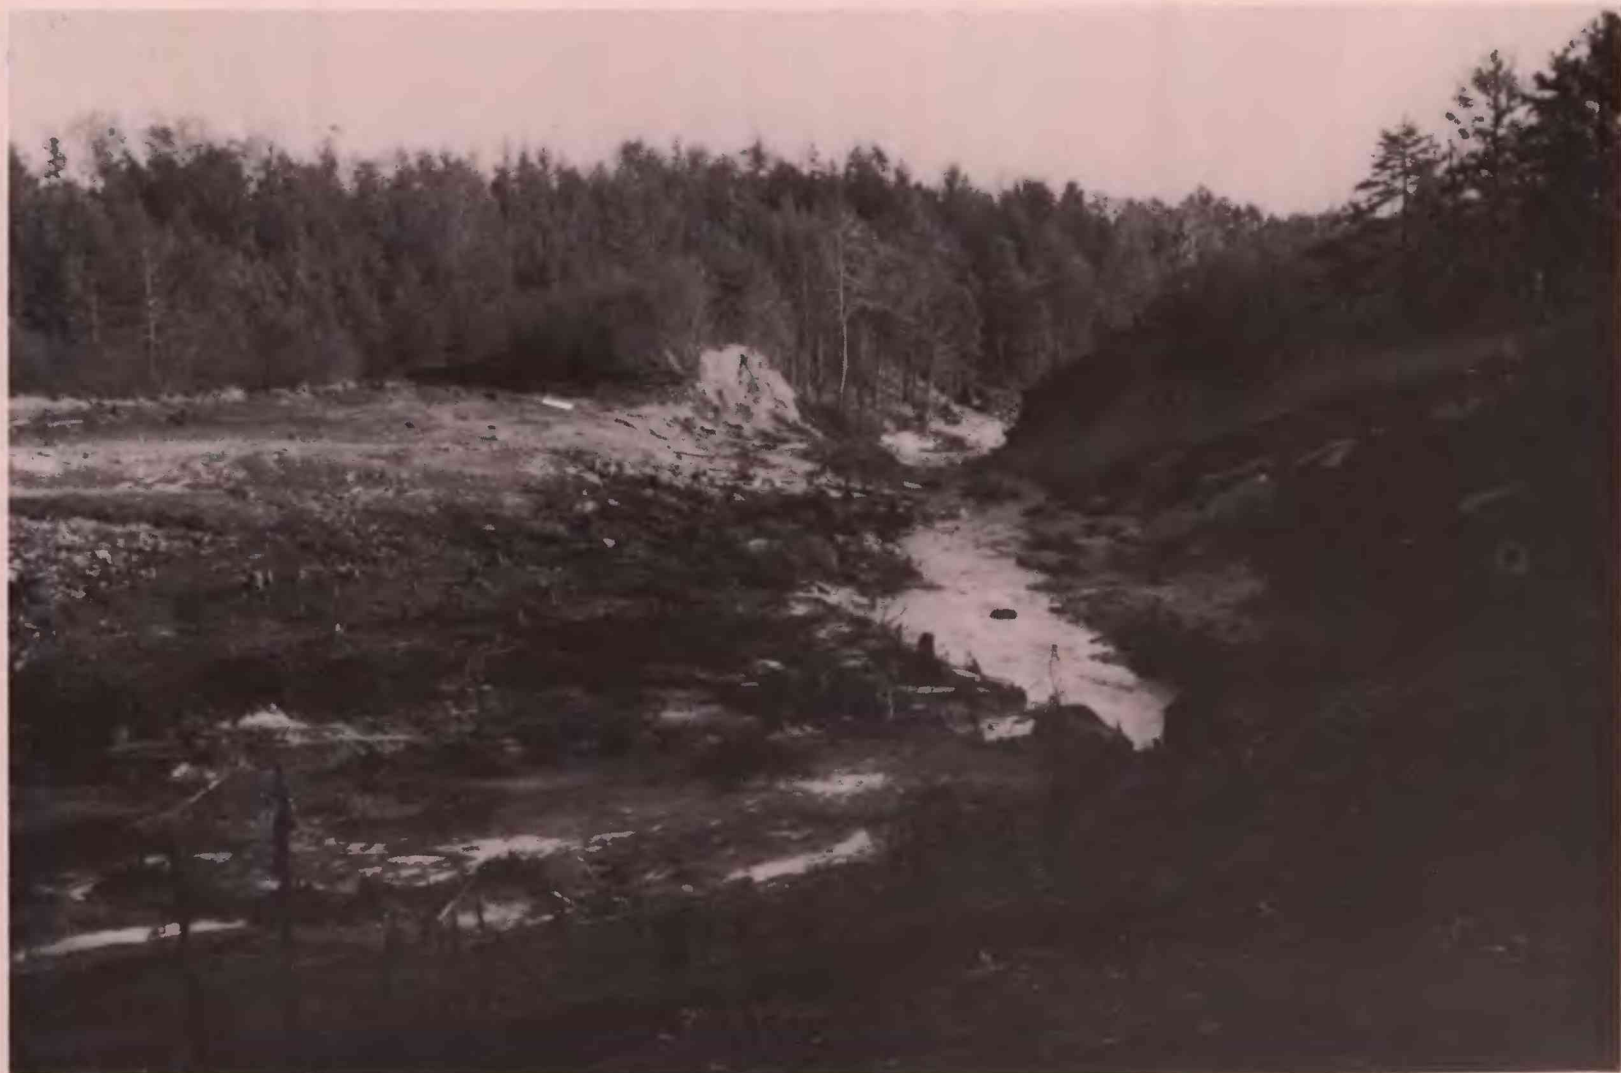
FIGURE 2. - Lakebed and remains of Kelly Barnes Dam. (View downstream)

Kelly Barnes Dam and Lake. Kelly Barnes Dam was about 400 feet long, 20 feet wide at the crest, and 40 feet high at the maximum section. The dam was concave upstream. Figure 2 shows the lakebed and the broken dam.

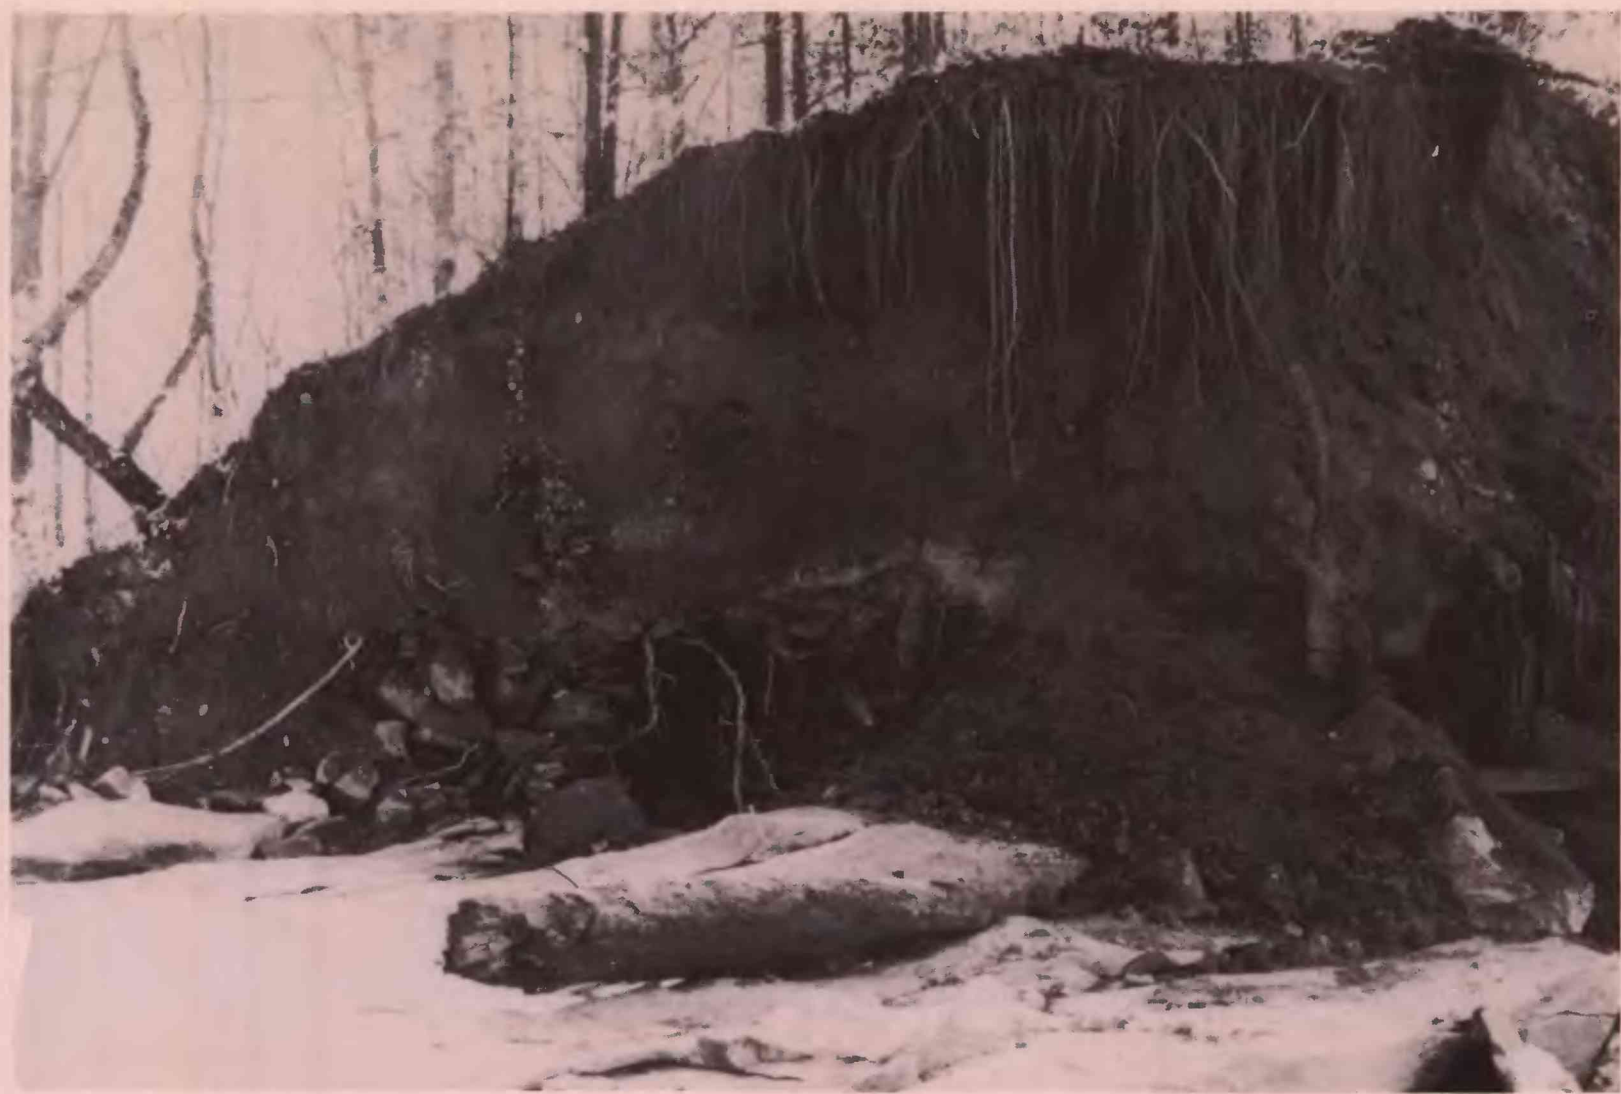
FIGURE 3. - Remains of rock crib dam and penstock pipe exposed by breach in Kelly Barnes Dam. Log in foreground was part of rock crib dam

The history of the dam as determined by the Federal Investigative Board (1977) is summarized as follows: The dam went through various stages of development, first as a rock crib dam and then with subsequent stages as an earth dam. The rock crib dam was completed about 1899 to impound water for a small hydroelectric plant located near the foot of the falls. About 1937, the Toccoa Falls Bible Institute, which later became Toccoa Falls College, was interested in developing a more dependable power source and decided to build an earth dam over the rock crib dam with equipment provided by a local manufacturer. Figure 3 shows part of the rock crib dam and the penstock pipe to the powerplant that was incorporated in the new dam.

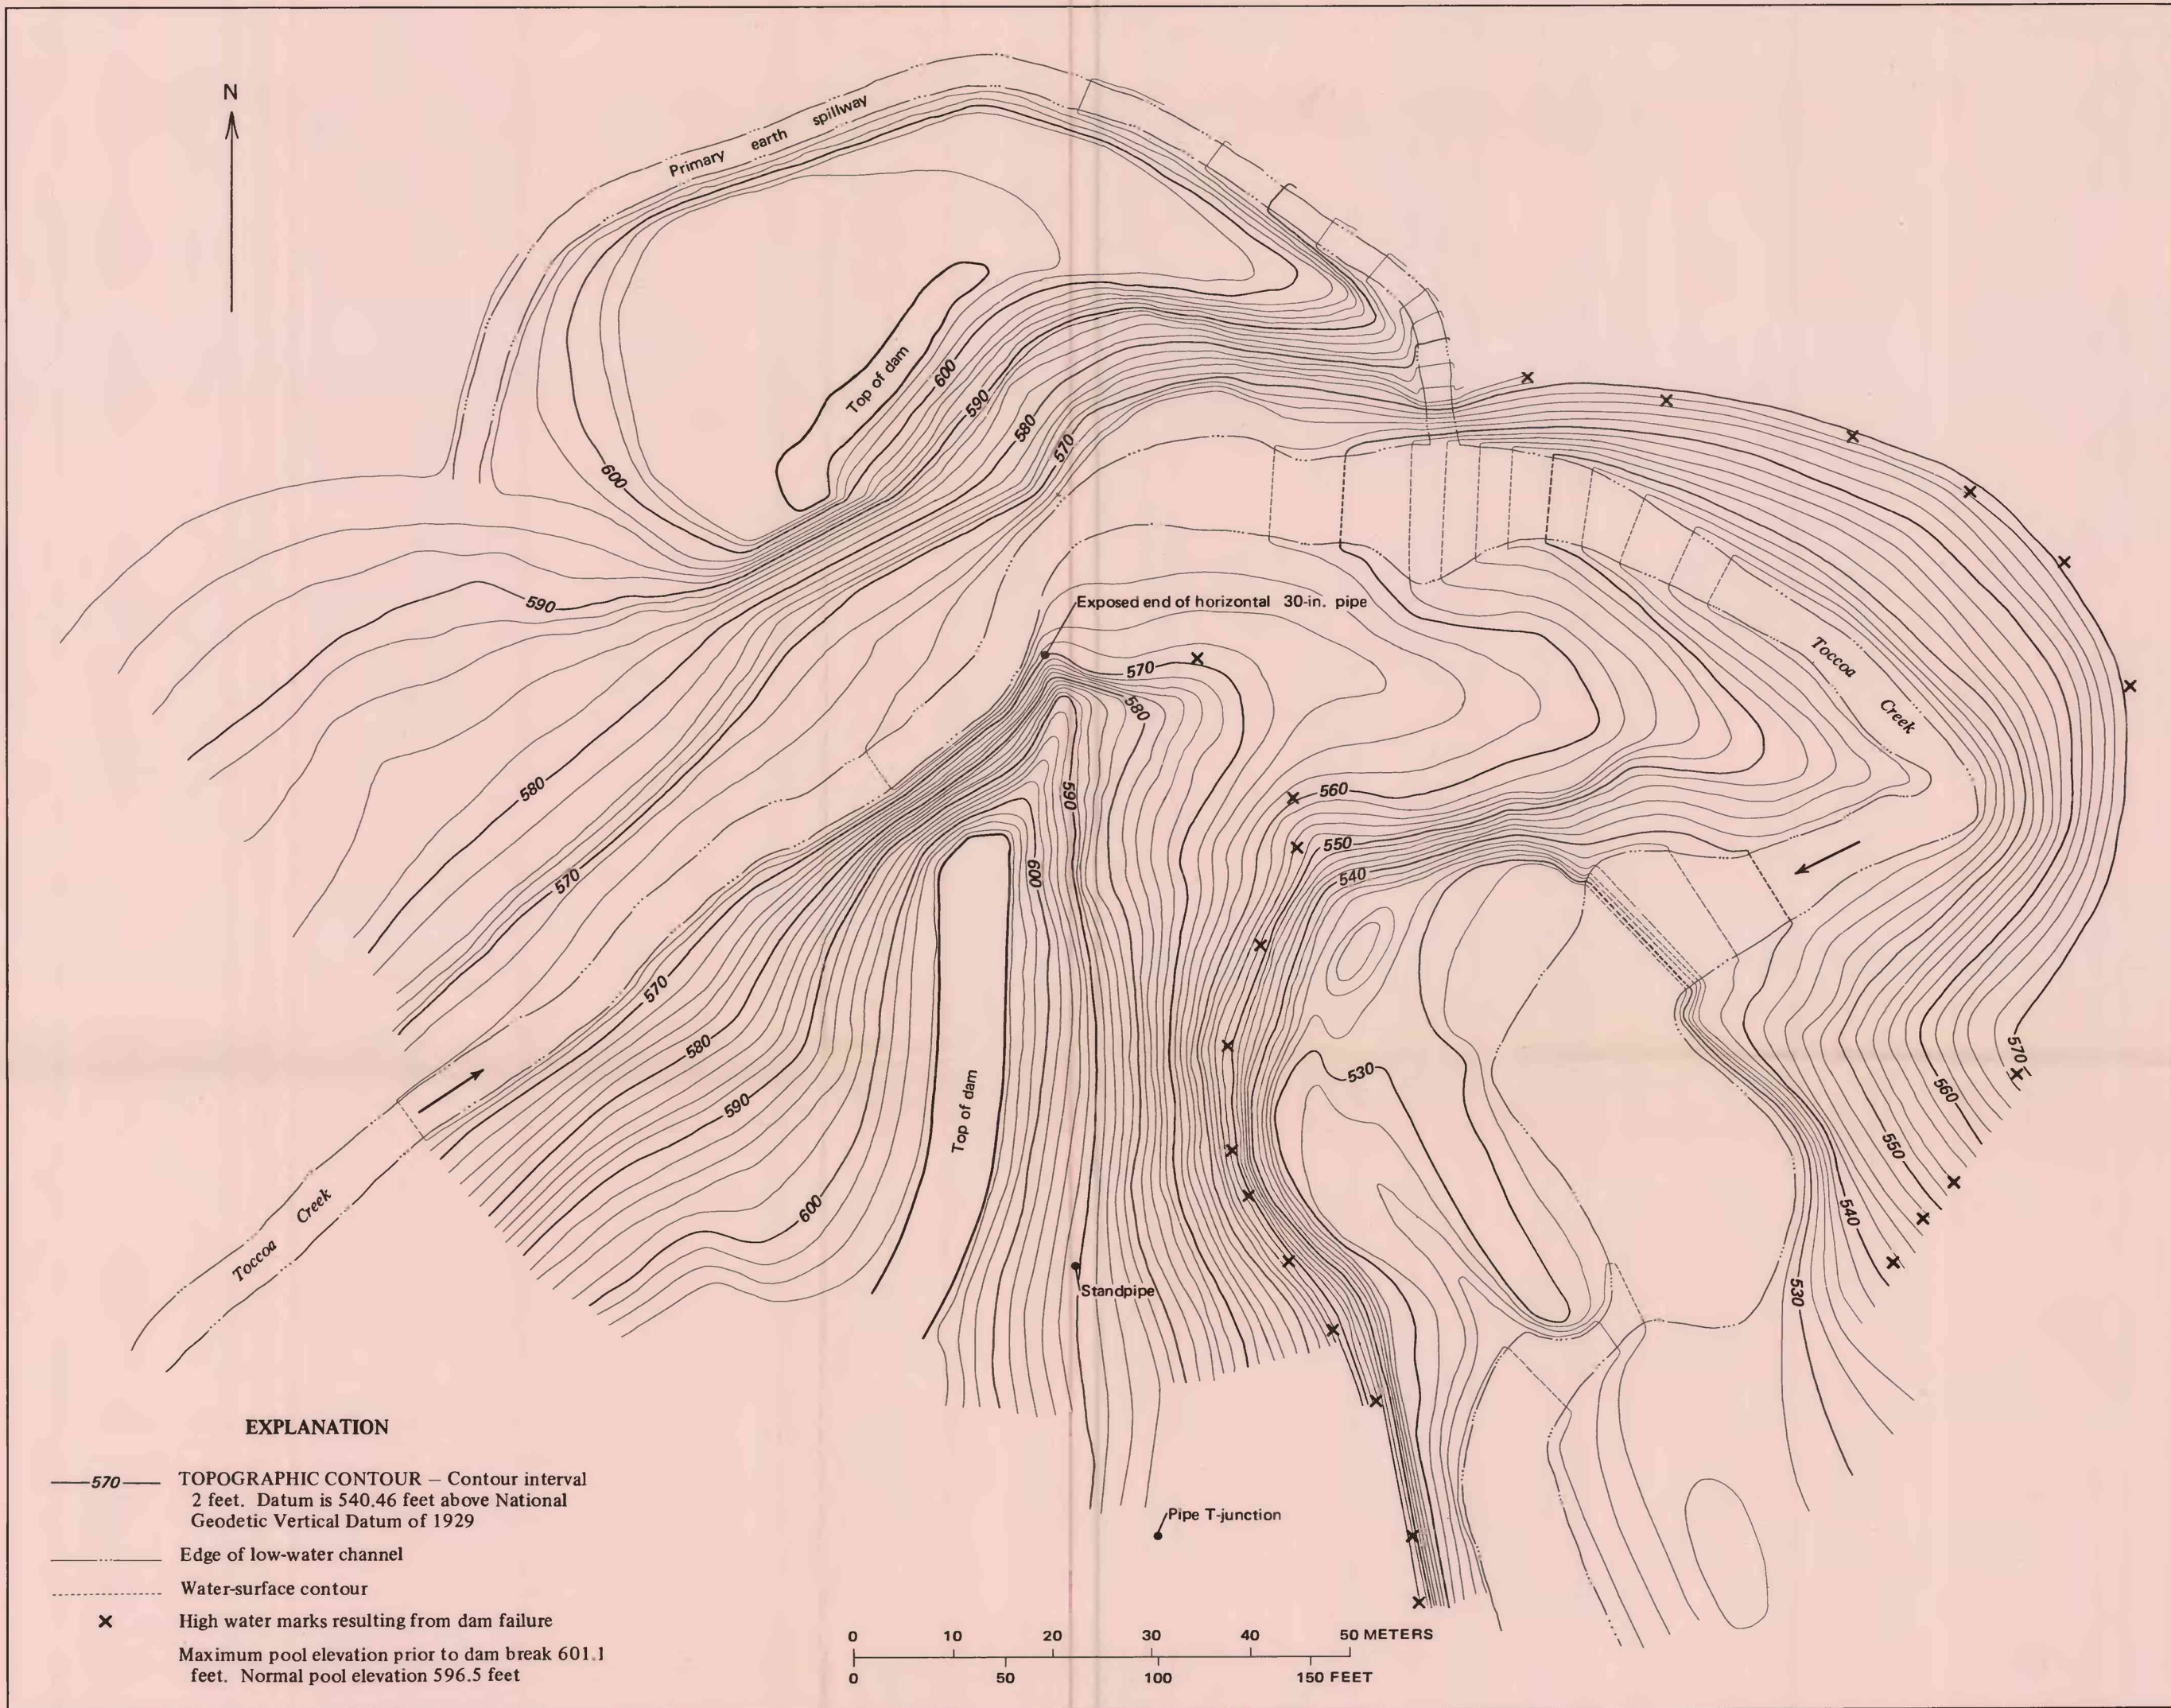
Topographic maps of the lakebed and the dam were prepared immediately after the break by the U.S. Geological Survey (figs. 5 and 6). The earth spillway at the left end of the dam (facing downstream) apparently carried all normal lake overflow. The crest of the spillway was 1,136.7 feet above NGVD (596.2 feet above datum). A low area, minimum elevation 1,139.8 feet (599.3 feet above datum), in the approach road about 1,100 feet upstream on the right rim, served as a secondary spillway.

The Board also stated, "The rock type at the site is a biotite gneiss of the Carolina gneiss series. * * * A layer of soft alluvium, from two to five feet thick (overlying solid bedrock) was observed in both faces of the breach of the dam. This material extends from the proximity of the old crib dam upstream - an undetermined distance. The layer appears to be quite extensive in the foundation of the earth dam. The lower six inches of the layer of the alluvium contains an extensive root mat. The alluvium appears to be composed principally of soft, plastic clay and (or) silt with some layers of fine silty sand."

FIGURE 6. - Kelly Barnes Dam after failure

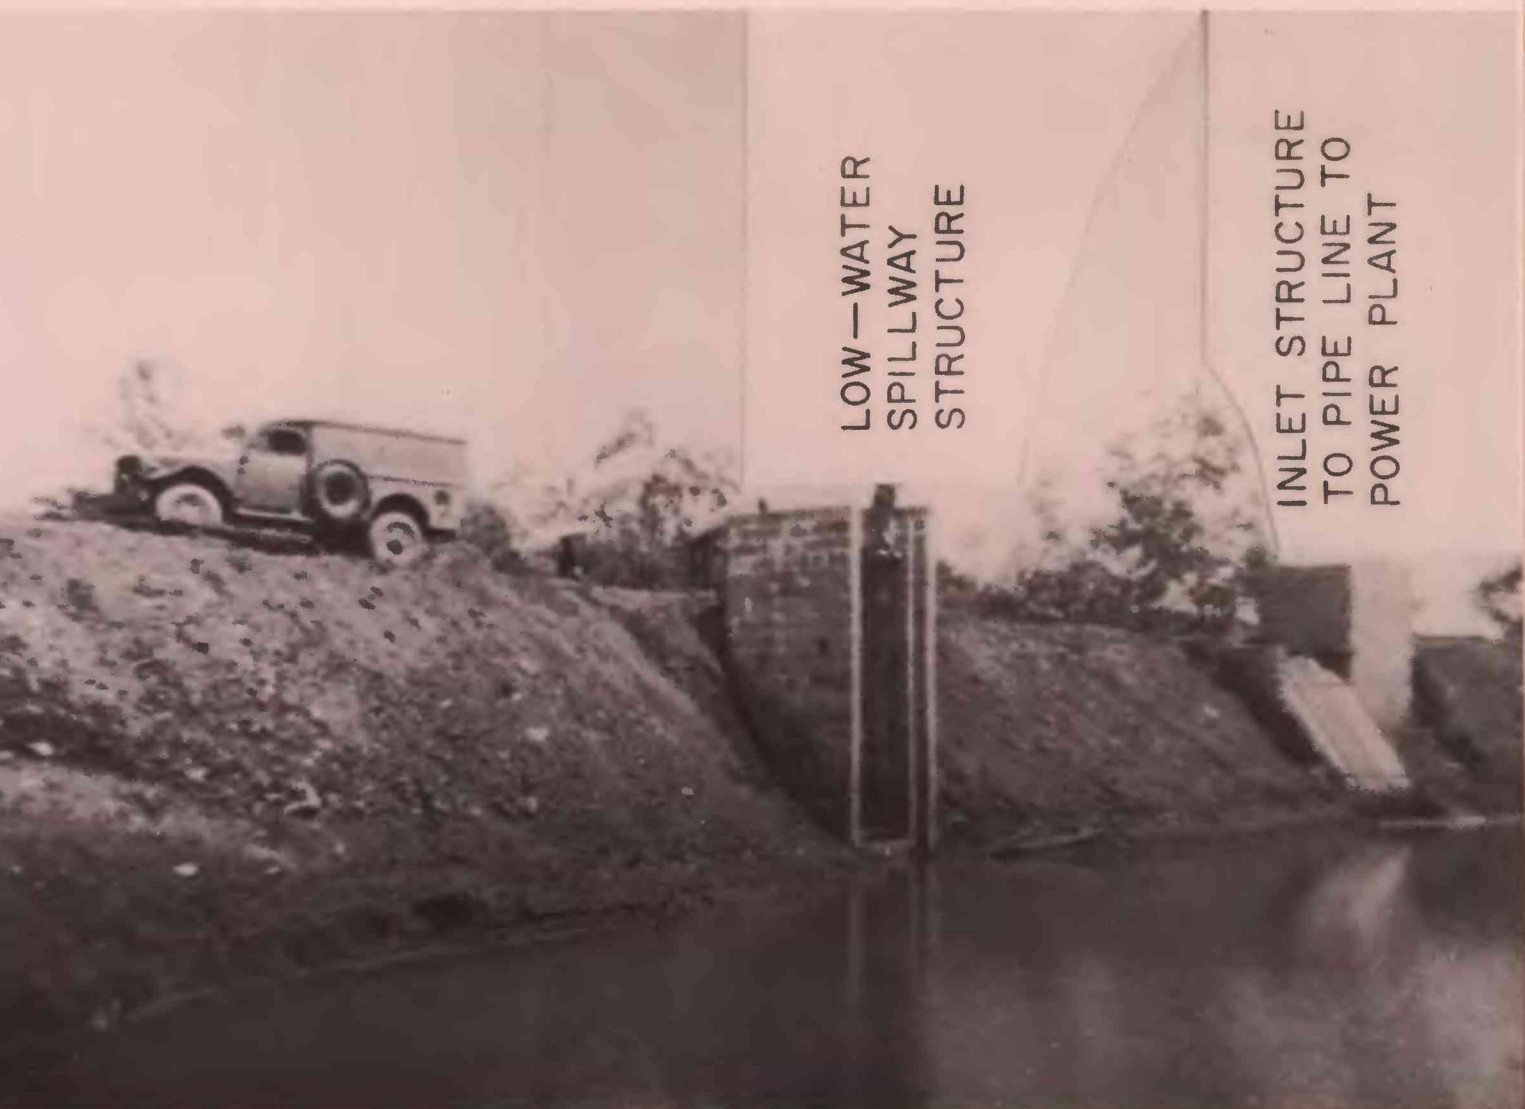
The Federal Investigative Board (1977) concluded that separate inlets for a low-water spillway and a welded steel penstock to the powerplant existed at the time of the dam failure (fig. 7). These facilities were described by the Board as follows: The low-level spillway had a rectangular shaped masonry inlet which could be shut off with stop logs or flashboards. The inlet for the welded steel penstock was also masonry and controlled with a slide gate at the upstream toe of the dam. *

Some historical witnesses remember the penstock slide gate but do not recall the masonry structure. After the failure, this gate was retrieved from below the damsite and found to be closed. The conduits for the spillway outlet and new penstock were both welded plate pipes approximately 30 inches in diameter. A historical witness stated that during placement of fill over the spillway conduit, the pipe began to cave in and had to be reinforced with metal struts. *

FIGURE 7. - Separate inlets for low-water spillway and welded steel penstock to power plant, photographed in 1949. (Photograph courtesy of Federal Investigative Board, Kelly Barnes Dam)
