**GROUND DEFORMATION IN GRANADA HILLS AND  
MISSION HILLS RESULTING FROM THE  
JANUARY 17, 1994, NORTHRIDGE, CALIFORNIA,  
EARTHQUAKE**

**U.S. GEOLOGICAL SURVEY  
OPEN-FILE REPORT 95-62**

**GROUND DEFORMATION IN GRANADA HILLS AND MISSION HILLS  
RESULTING FROM THE JANUARY 17, 1994, NORTHRIDGE, CALIFORNIA,  
EARTHQUAKE**

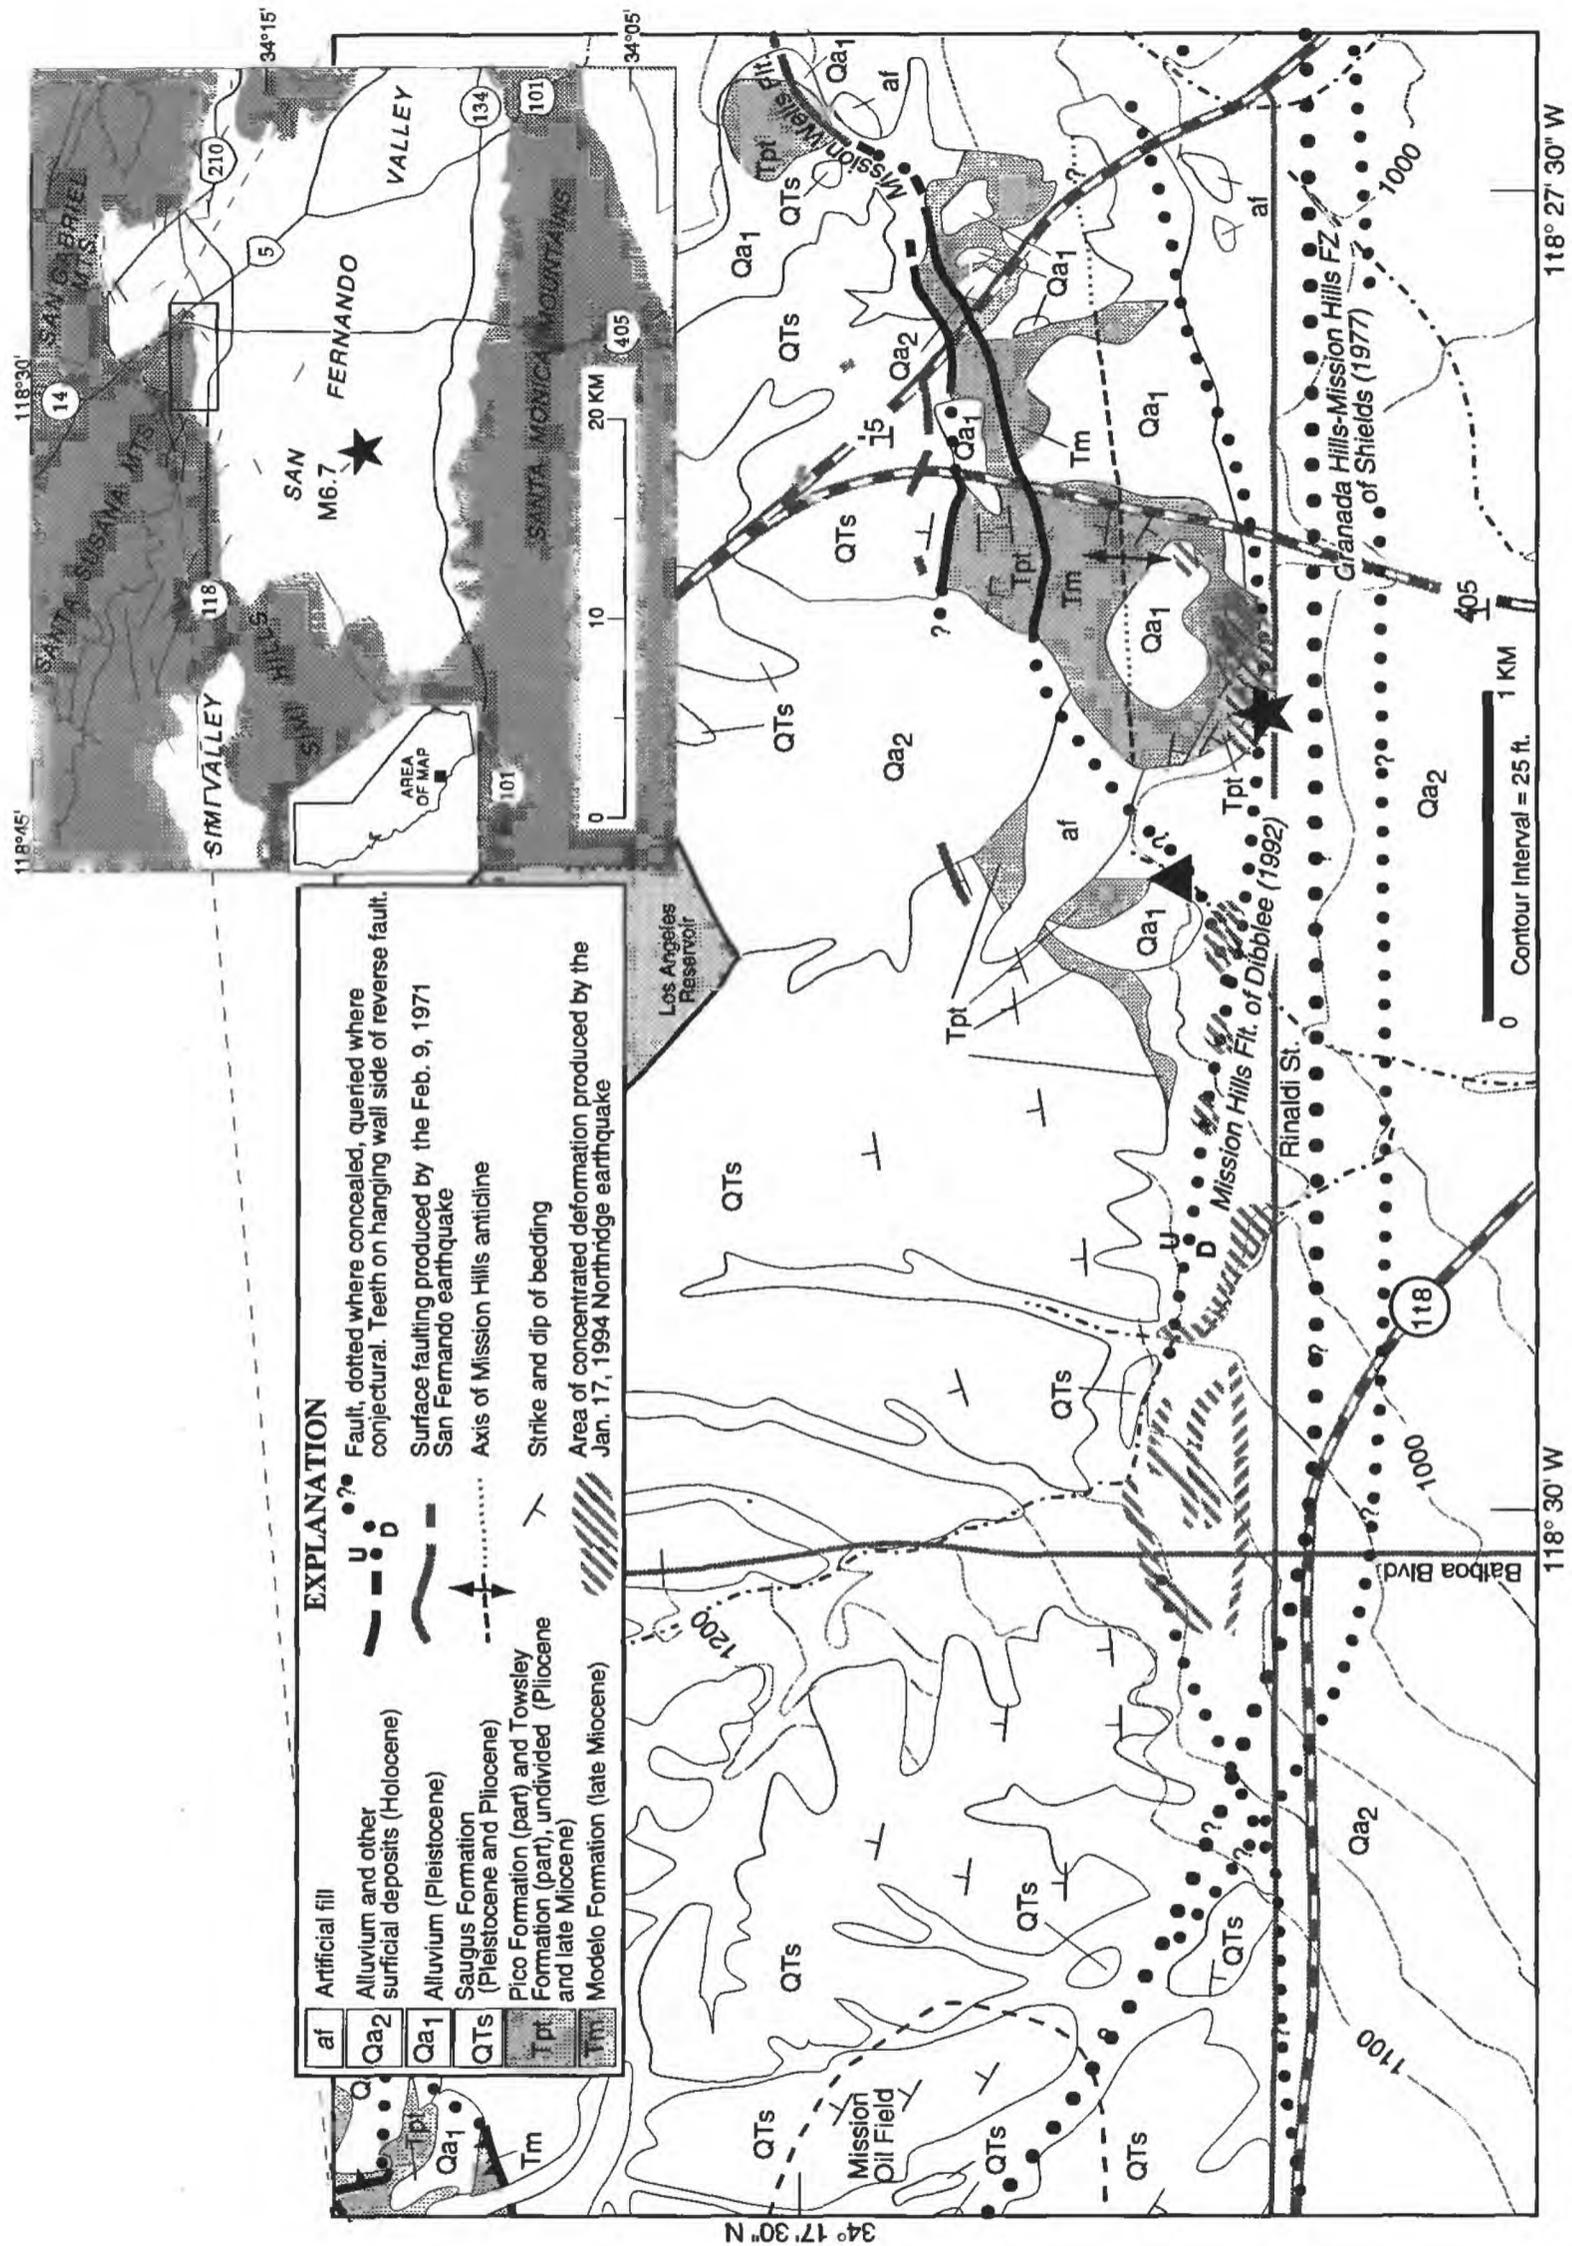
Figure 1. Simplified geologic map of the Granada Hills-Mission Hills area, showing the relation between concentrated zones of cracks produced by the January 17, 1994, Northridge earthquake and geologic structure. Also shown are the approximate locations of the strong motion site at the Rinaldi Receiving Station (triangle) and the epicenter of the ML 5.9 aftershock that occurred about 1 minute following the main shock (star). Geology modified from Dibblee and Ehrenspeck (1991, 1992), Shields (1977), and Barrows, Kahle, and others (1975a). Topography from USGS Oat Mountain and San Fernando 7.5' quadrangles.

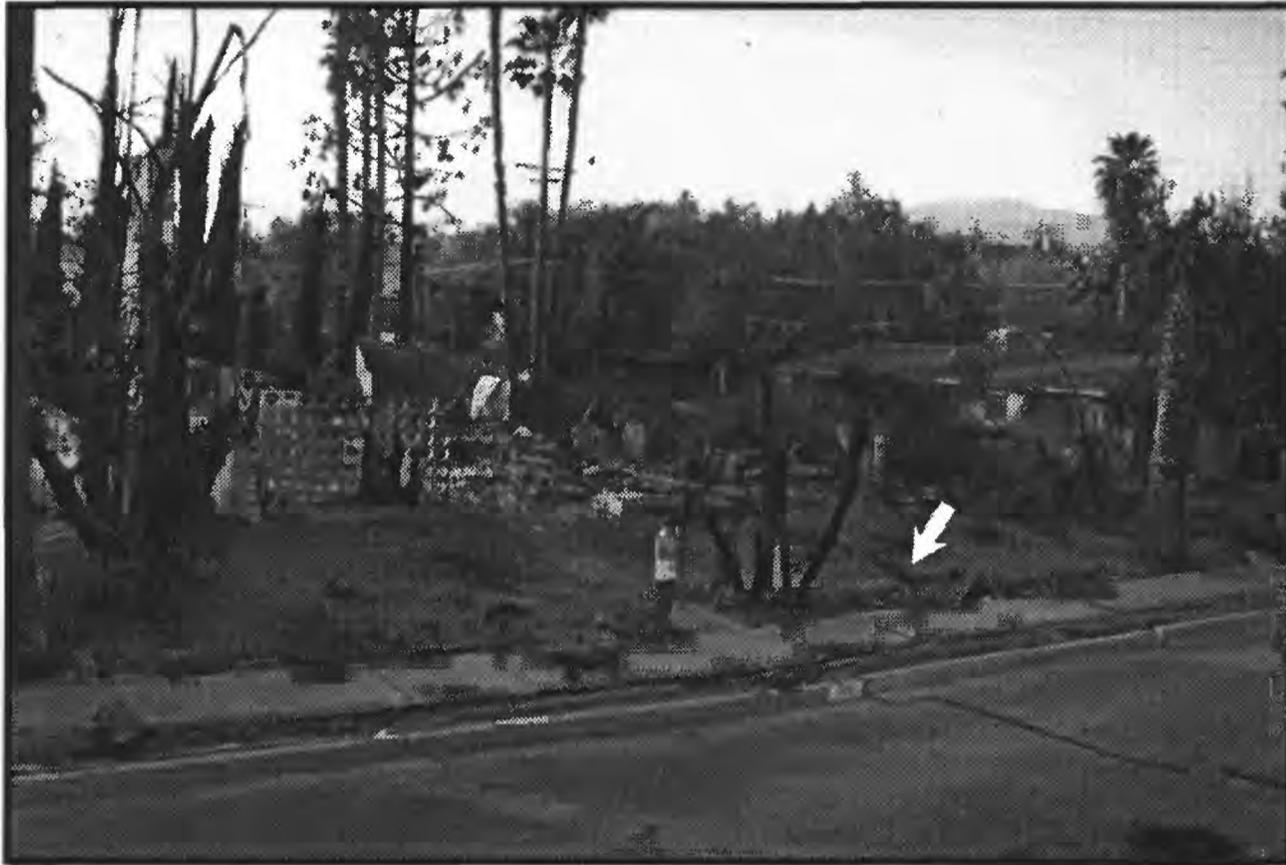
distribution pipeline, and two water trunk lines (124 cm (49") and 173 cm (68") diameter) (O'Rourke, 1994; O'Rourke and Palmer, 1994). Leaking gas ignited, and the ensuing fire destroyed five nearby houses and partially damaged a sixth (see plate 2, locality 1a; fig. 2).

Figure 2. View to northwest of principal zone of tension cracks and one of five houses destroyed by fire on Balboa Blvd. (west of locality 1a, plate 2). Tensile failure of gas lines beneath the street (to the right of view) led to the fire. Note large ground crack (arrow; see fig. 3), with southeast-side-down vertical separation. Photo by M.J. Rymer.

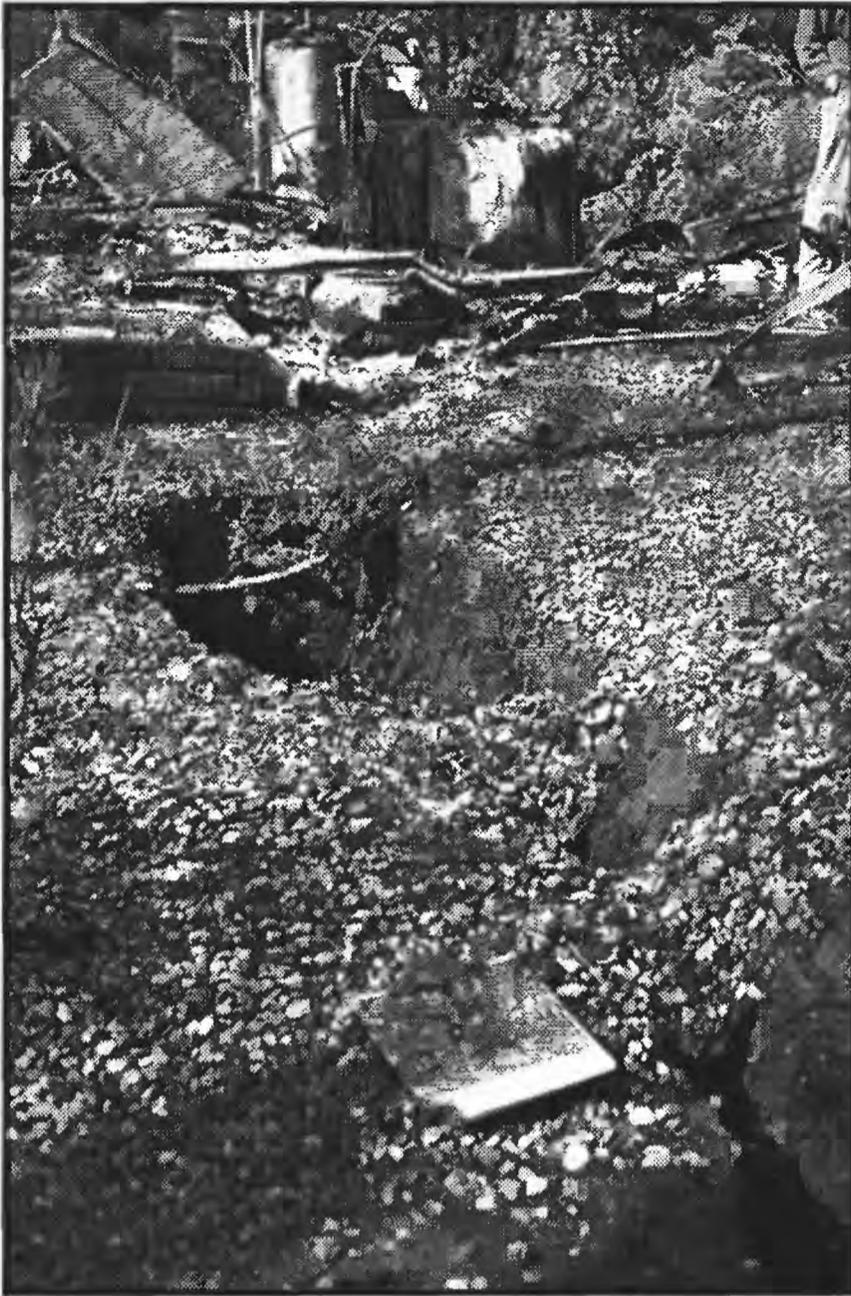
Figure 3. Close up view (to northwest) of large ground crack where it disappears beneath remnants of burned house at 11661 Balboa Blvd. (fig. 2). Measurements at this site document 22 cm of southeast-side-down vertical separation at the ground surface. The crack was widened considerably by caving owing to the surface flooding that followed rupture of nearby water mains. Photo by S. Hecker.

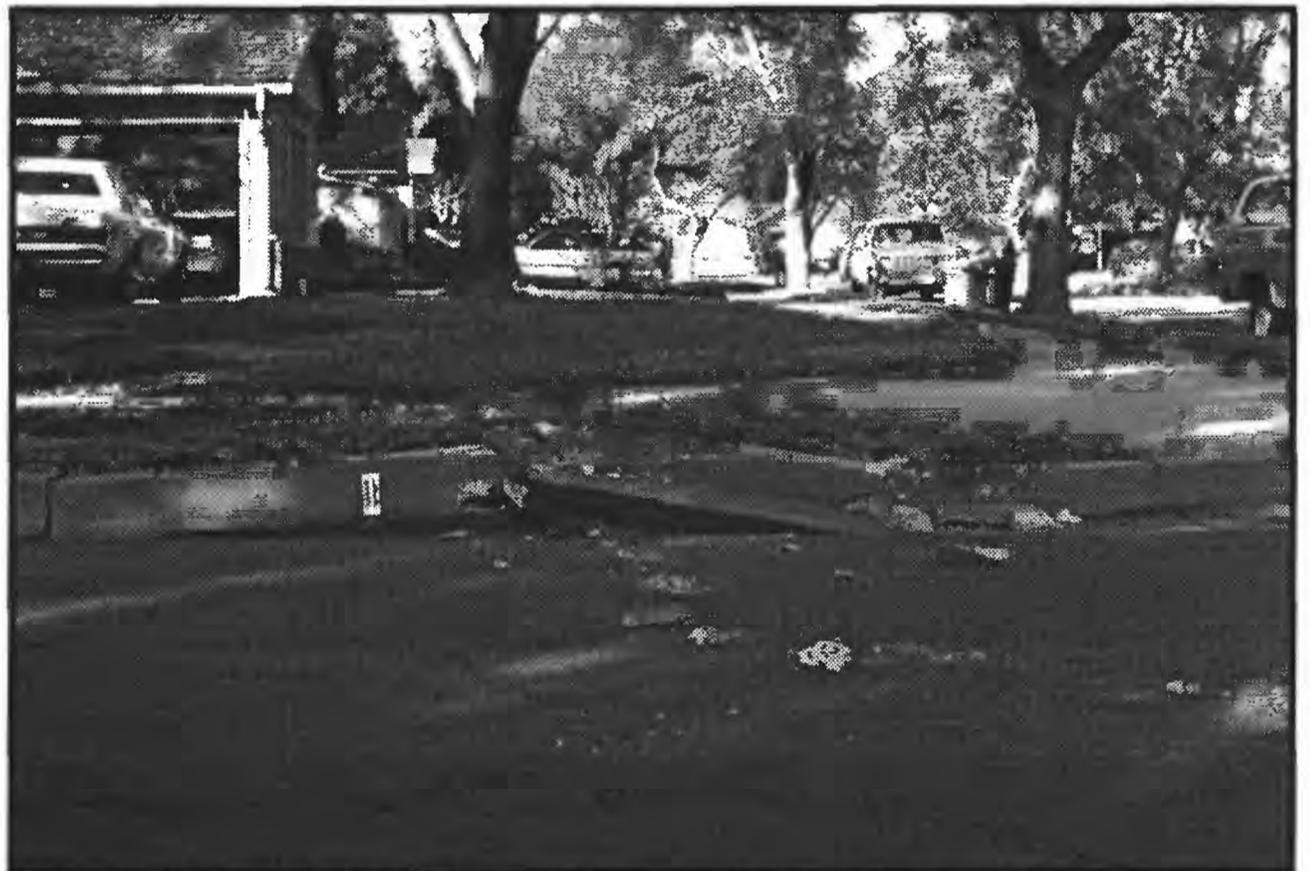
Figure 4. Spalled and thrust-shortened curb at northwest corner of Halsey St. and Ruffner Ave. This type of feature is common in the zone of compression near Flanders St. Photo by M.J. Rymer.

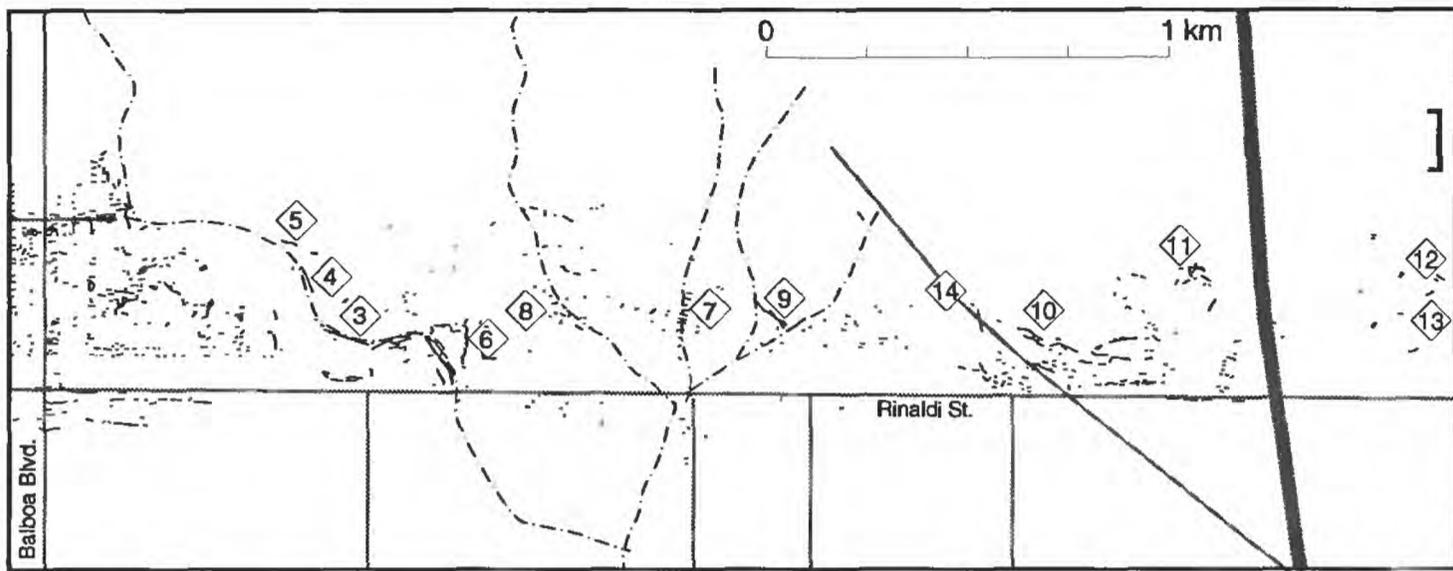
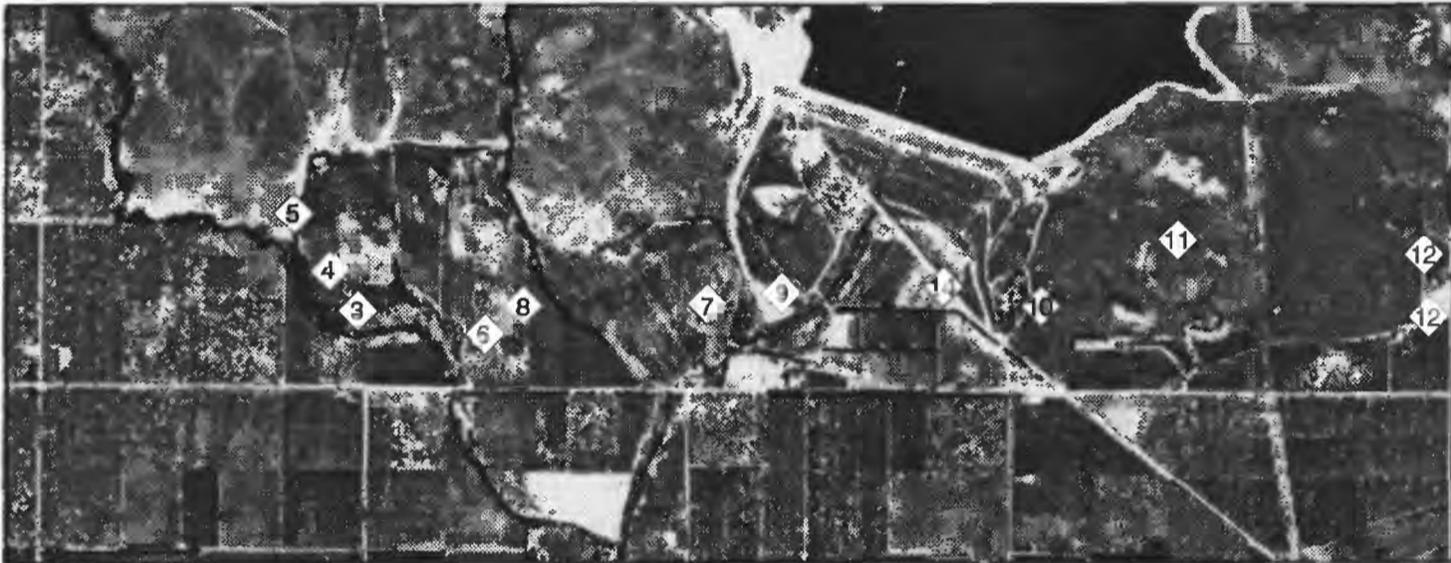
Figure 5. 1947 aerial photograph (U.S. Geological Survey, number GS-EM 5-46) of the Granada Hills–Mission Hills area showing location of drainage channels prior to urbanization. Many of the ground cracks that formed in 1994 (shown in line drawing) are adjacent to or overlie these old channels (localities 3-9). Note particularly the geometry of the ground cracks at locality 6 and the existence of an abandoned meander bend at the same location.

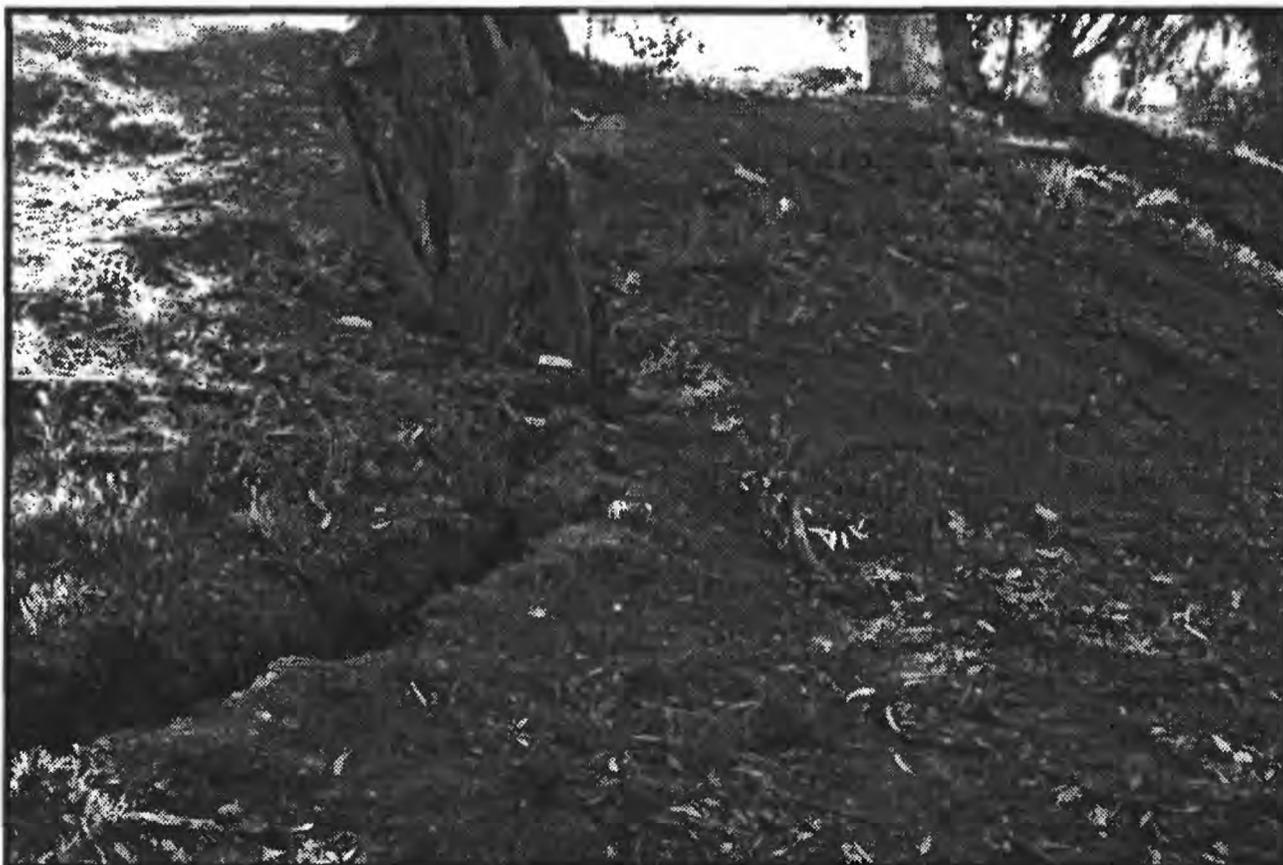
A 150-meter-long zone of cracks developed along the storm-drain alignment, on and at the base of the southwest wall of the present channel cut (plate 2, locality 3). Individual cracks are as long as 50 m, have a decimeter or more of opening, and form vertical scarps that face toward the channel (fig. 6). Liquefaction may have contributed to ground failure here, as evidenced by a small area of vented sand on the channel floor near the downstream end of the zone.

Figure 6. Tension crack on the southwest wall of the Bull Creek channel (view to the west; near locality 3, plate 2). Photo by T. E. Fumal.

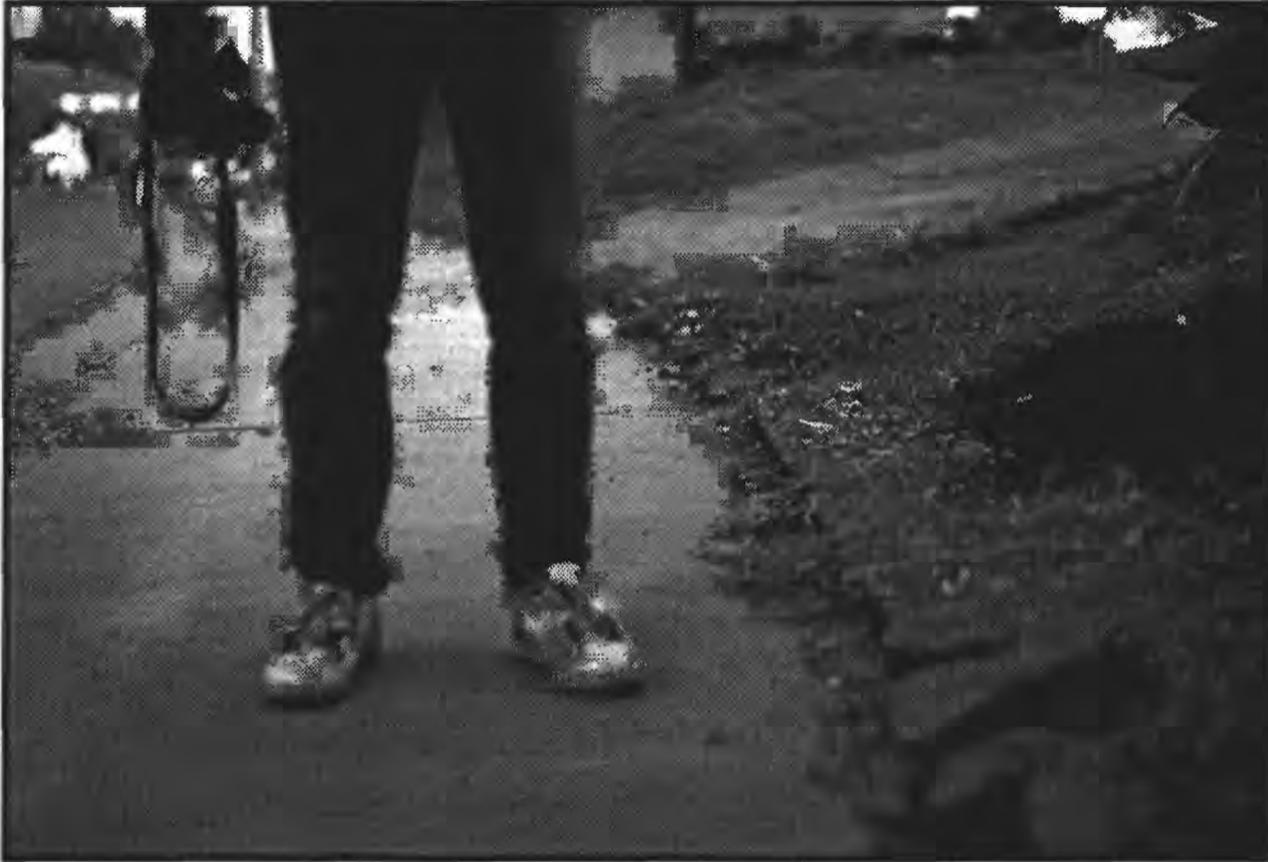
mounded against the sidewalk on the south and west sides, respectively, of Halsey St. and Odessa St. (fig. 7) and pavement compressed against concrete curbs on the other sides of these roads are evidence for compression orthogonal to both Halsey and Odessa Streets. Tension cracks formed parallel to the compressional features, but they are less extensive and record less movement (typically ~1-2 cm opening versus ~5 cm shortening). A series of closely spaced tension cracks also developed transverse to Odessa Ave. (plate 2). Another zone of tension cracks takes a path through several houses and lots east of Odessa Ave. (plate 2, locality 6). As shown in fig. 5, these cracks follow an abandoned meander bend along the old incised channel of Bull Creek.

Figure 7. Topsoil and turf thrust over sidewalk along the west side of Odessa Ave. View to the south. Photo by D.P. Schwartz.

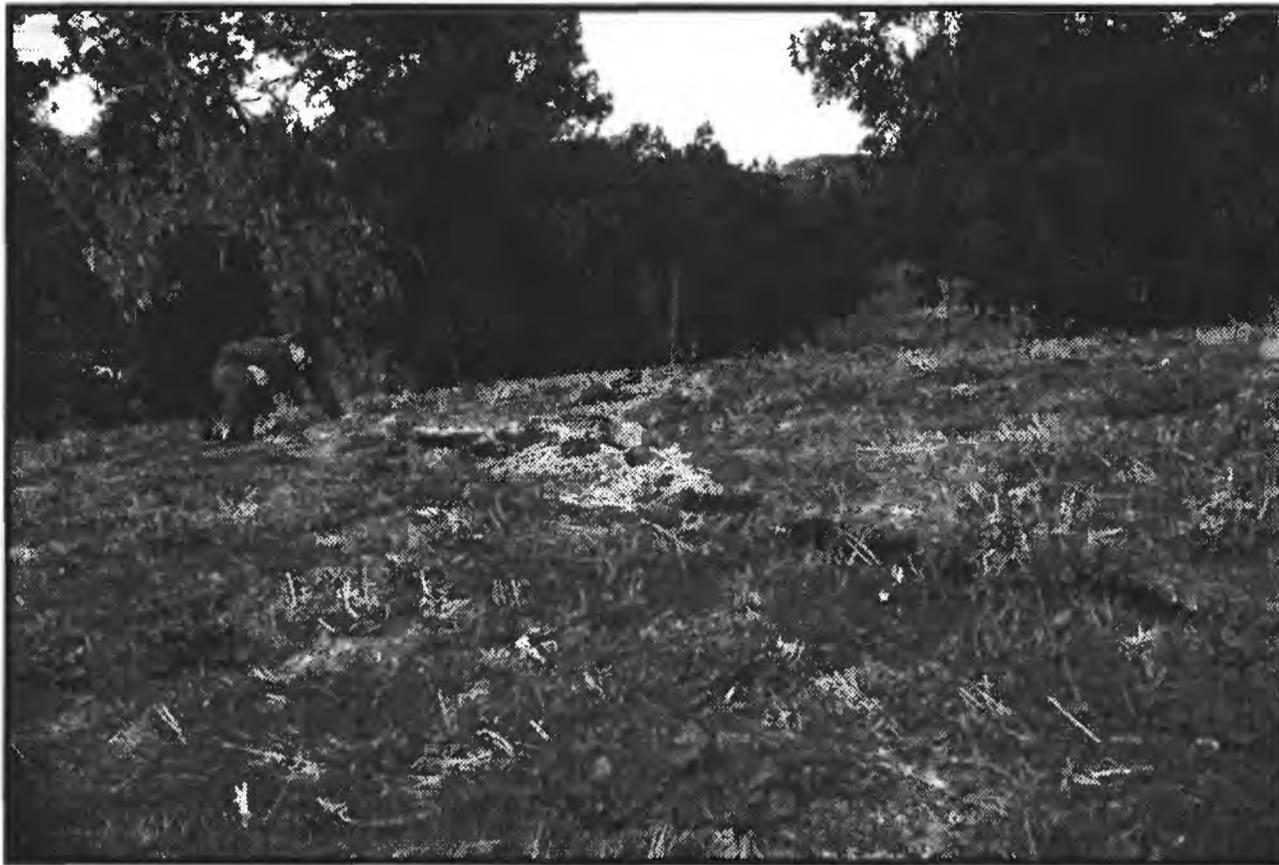
Two subzones dominated by tension cracks and small normal-fault scarps developed low on the south flank of the Mission Hills anticline west of Interstate 405 (fig. 8). The subzones are each about 350 m long, approximately parallel, and cross from open ground into a densely developed housing complex (plate 1, locality 10). The cracks follow the general contour of the moderately steep (~15% gradient) hillside and appear also to follow bedding planes in the upper Miocene Modelo Formation and the upper Miocene and lower Pliocene Towsley Formation, which dip in the downslope direction (~60-70° to the south; Dibblee and

Figure 8. Tension crack and small scarp on south flank of the Mission Hills anticline (near locality 10, plate 1). View to the northwest. Photo by C.D. Garvin.

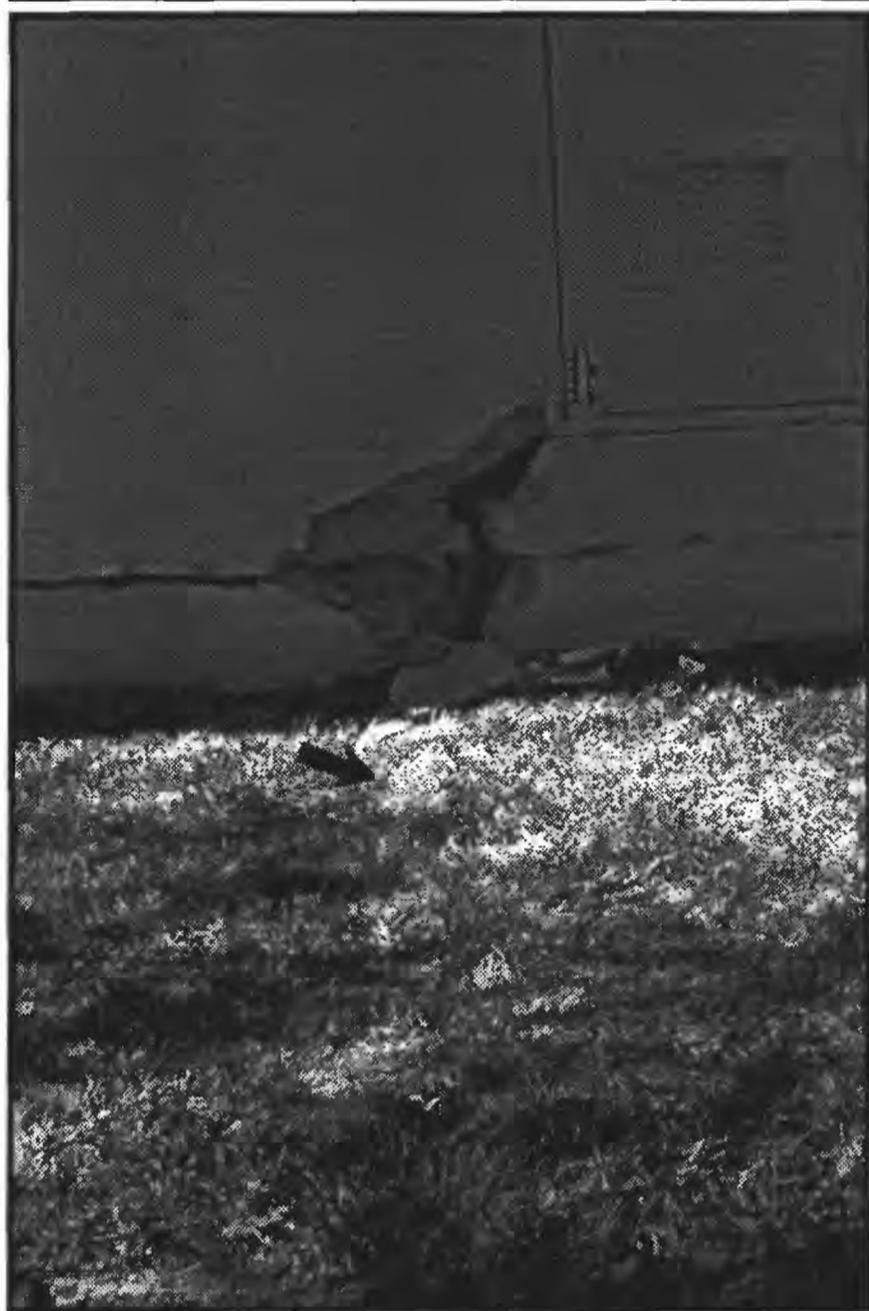
Figure 9. Foundation slab of a house broken by a ground crack (arrow), south side of Armstead St. The house was one of two on the street that were substantially damaged and assigned "red" inspection tags (plate 2). Photo by M.J. Rymer.
