**RECONNAISSANCE REPORT OF GEOLOGY OF
EKLUTNA LAKE DAM SITE AND CONDUIT ROUTE
NEAR ANCHORAGE, ALASKA**

By
**A. F. Bateman, Jr.
U. S. Geological Survey**

Great Falls, Montana August, 1947

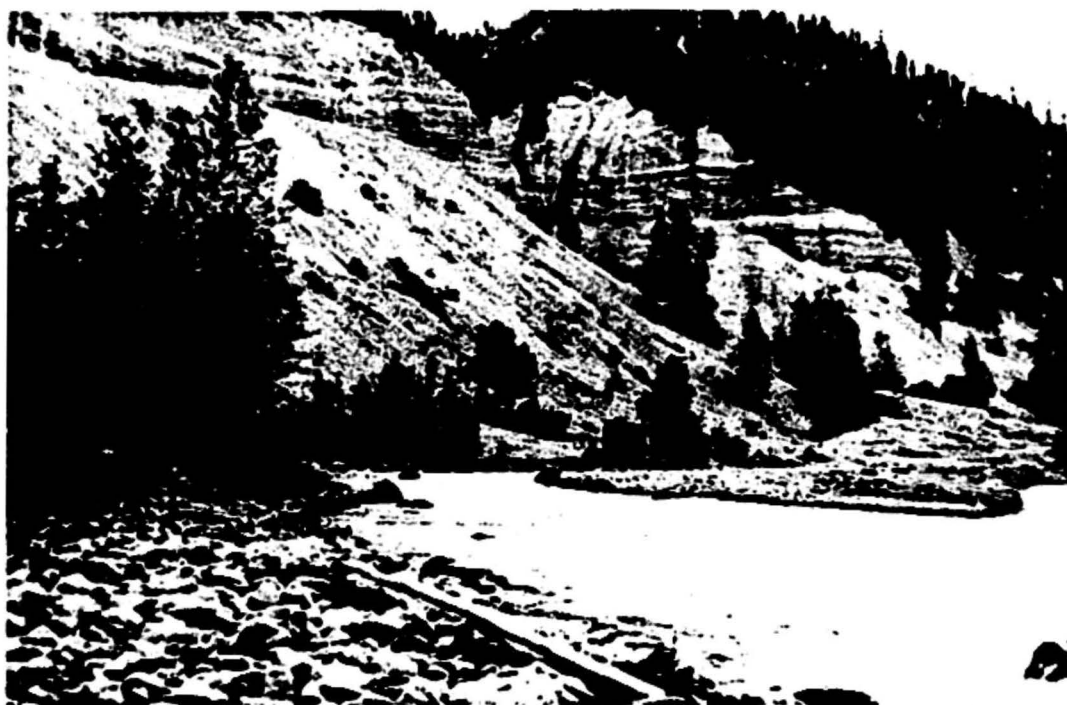
Plate V. Horizontally stratified deposits
of gravel exposed in lower part
of measured section No. 16.

4. Horizontally stratified gravels. - Overlying the till in section No. 19 is a thick deposit of gravels that is remarkably uniform in composition and appearance, although it is made up of lenticular beds of the following materials: (1) light yellowish-gray, well-graded, slightly silty gravel and sand; (2) medium brownish-gray, well-graded, clean gravel and sand; (3) medium yellowish-gray, poorly graded, silty to clean sand that varies from fine to coarse. The gravels are coarse with occasional boulders up to 10 inches in diameter. On figure No. 6, a grain size distribution curve shows the gradation of the most common material listed above as (1). The entire series is very permeable, compact, resistant to erosion, and tends to stand in vertical cliffs which occur throughout the lower valley from section 10 to section 22. Stratification is well-developed and is either horizontal or dipping downvalley at angles from 1 to 5 degrees. The greatest observed thickness is 233 feet in section No. 19, the only locality where the base of the series was seen. Cobbles and pebbles of greenstone in these gravels show the effects of weathering in thin, discolored rinds from 1/8-to 5/16-inches thick. (See pls. V, VI, and VII.)

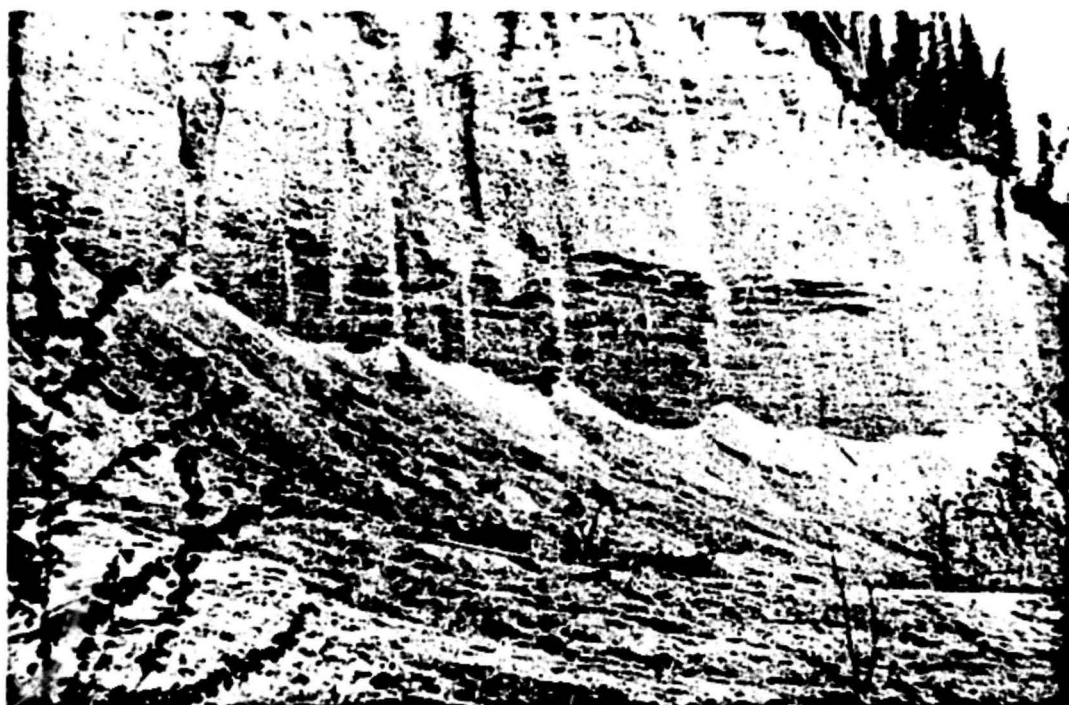
Plate VI. Horizontally stratified gravel deposits about two miles down Eklutna Creek from the lake outlet.

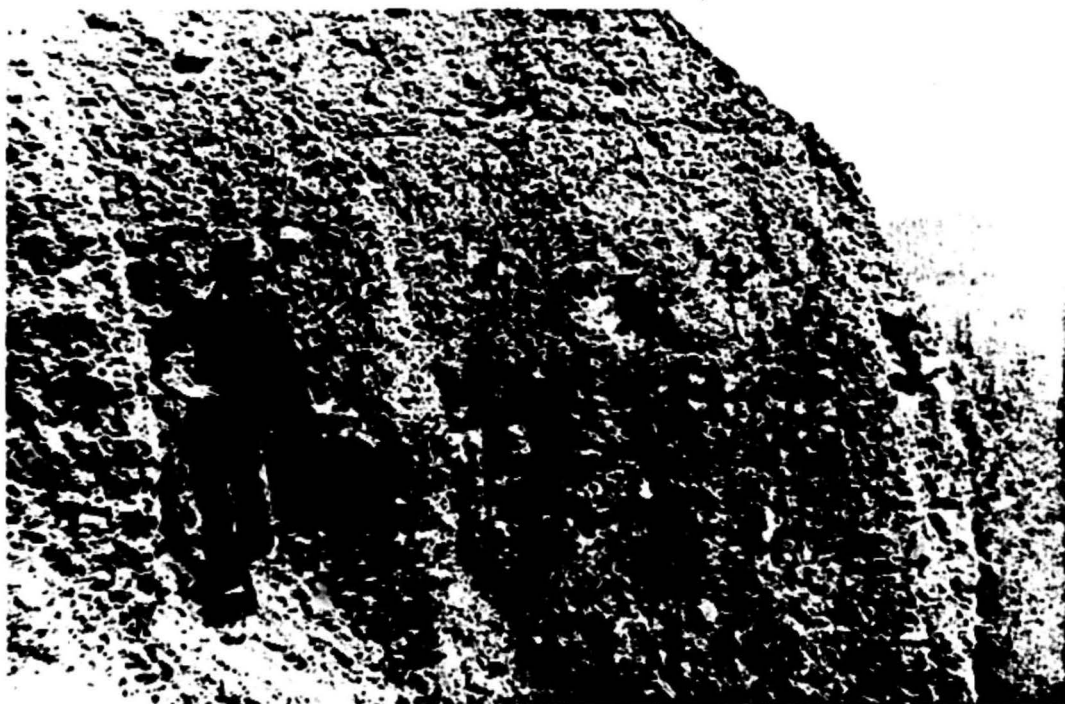
Plate VII. Contact between light yellowish-brown, horizontally stratified gravel and overlying bluish-gray till. Man's hand rests on boulder just below contact. Picture taken at measured section No. 13, altitude 884.

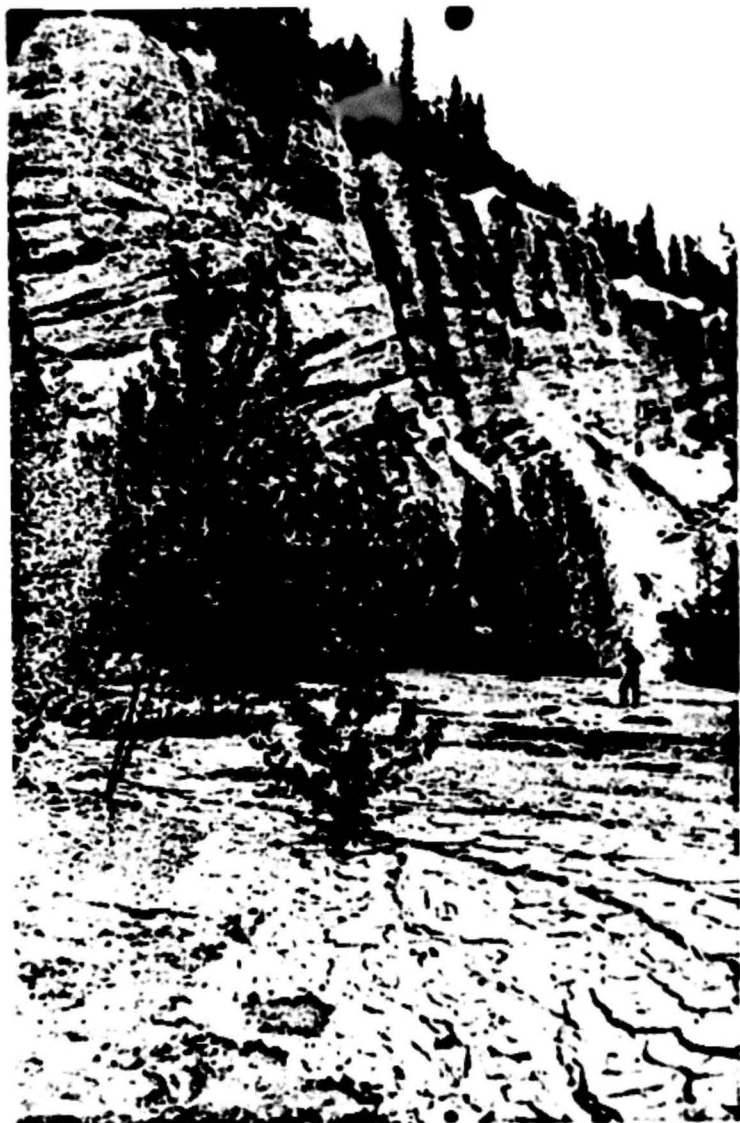
Plate VIII. Gravel deposits showing foreset cross-bedding dipping downstream at angle of about 20 degrees. Picture taken half a mile downstream from measured section No. 16.

clean, even-grained sand, and small lenses of silt. These beds are permeable, fairly resistant to erosion, and tend to stand in vertical cliffs. The foreset beds dip downstream at an angle of about 20 degrees. As is shown in figure 4, these beds first appear between sections 15 and 16, thicken to 144 feet in section No. 17, and then thin to 74 feet in section 14. In section 20, they are replaced by a series of normally dipping, interbedded coarse gravels, sands, and silts about 35 feet thick and an overlying light yellowish-brown, horizontally stratified gravel 56 feet thick.

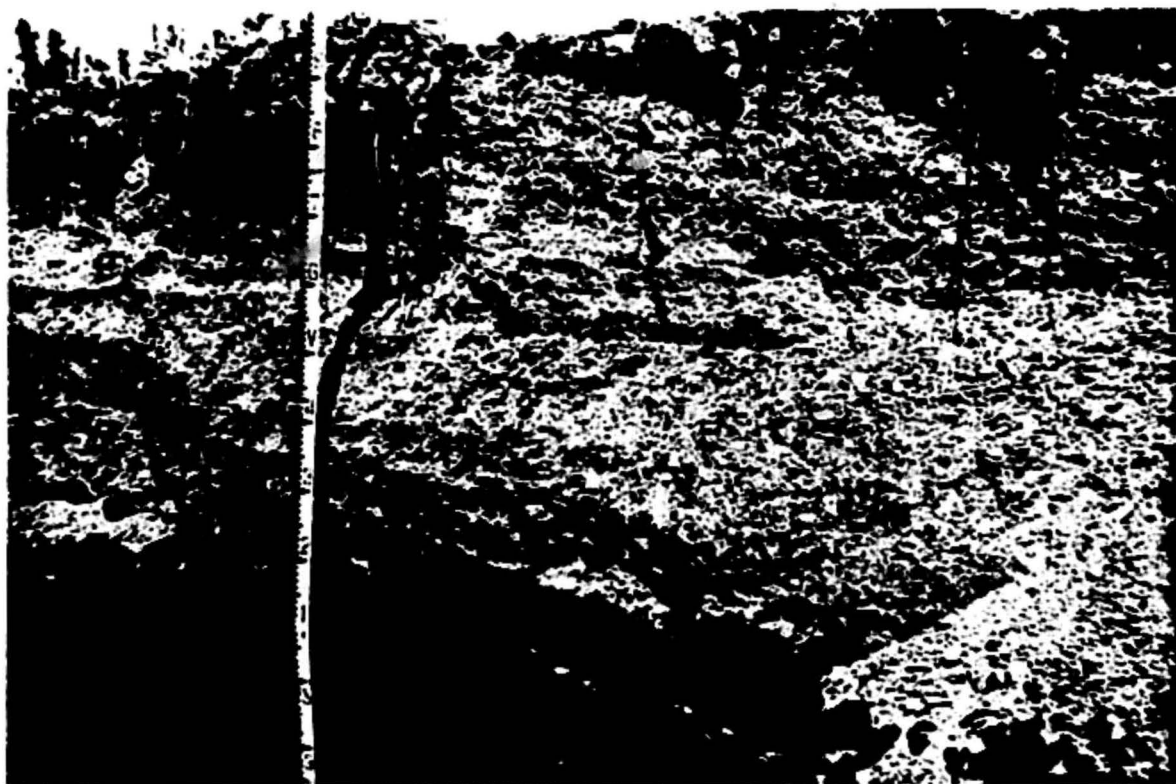
Plate XII. View of gravel deposits exposed in test pit No. 5.

The bed of the river and probably the left abutment are underlain by an unknown thickness of compact stony till. This till was also found in drill hole No. 1 below altitude 848. Further exploration will be required to determine whether or not it extends under the right abutment to the north wall of the valley. In the center of the dam site area between drill hole No. 1 and measured section No. 4, the till is overlain by 18 to 20 feet of lean, silty clay that in the vicinity of section No. 4 contains many fragments of carbonized wood. Overlying the clay are from 3 to 7 feet of fine-to-medium, poorly sorted to even-grained, clean sand; then 3.5 to 6.5 feet of loose, clean, coarse gravel; and finally, 3 to 7 feet of the lake shore gravels. (See pl. XII.)

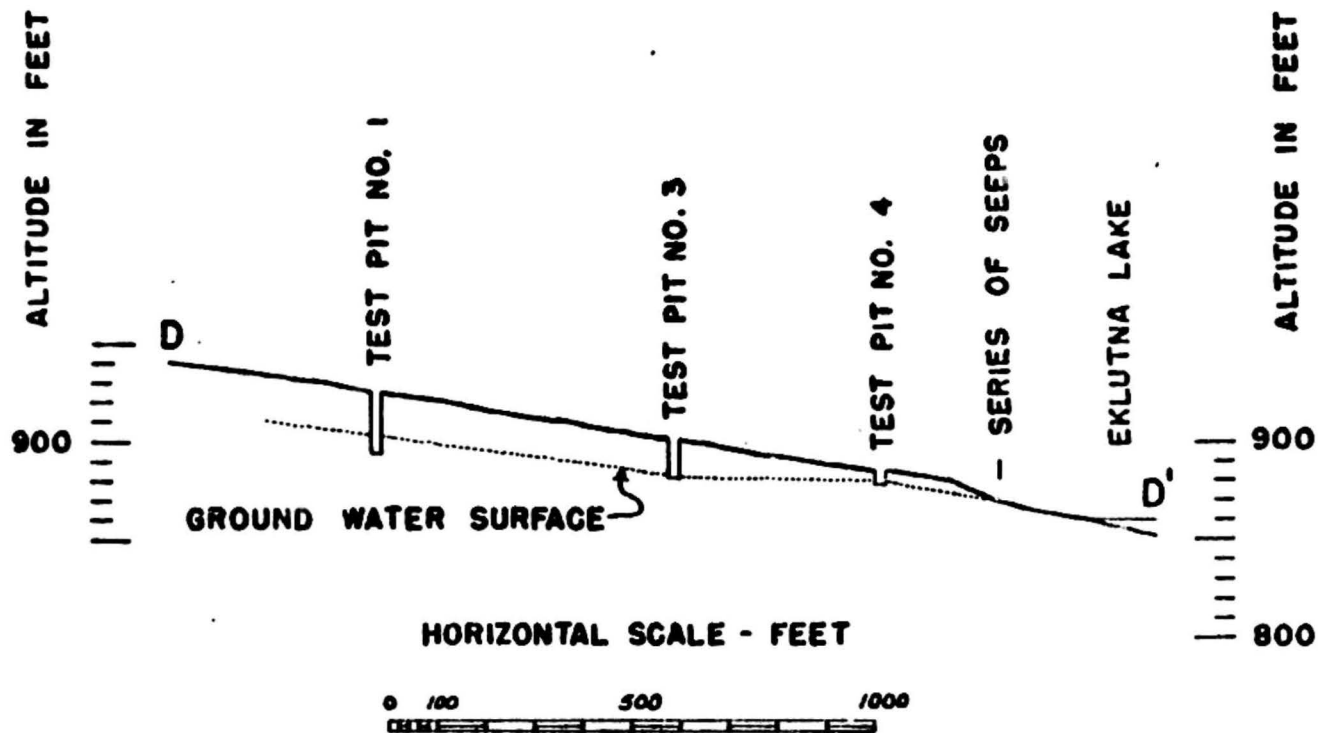
GROUND WATER PROFILE ALONG LINE D-D'

Ground water conditions: The ground-water level within the dam site appears to be related directly to an intake area about half a mile north where the discharge of a small tributary stream is absorbed by the gravels of the alluvial fan. The water then percolates on a fairly uniform gradient toward Eklutna Creek and Eklutna Lake. Along the lake shore it appears as a series of small seeps at an altitude of about 868. Profiles of the ground water surface in the dam site area to the right of Eklutna Creek are shown on figures 7 and 8. In drill hole No. 2, the till underlying the river bed was sufficiently impermeable so that no ground water was encountered.
