Preliminary Report on Ground Movements at
Helper, Carbon County, Utah

D. J. Varnes

Abstract

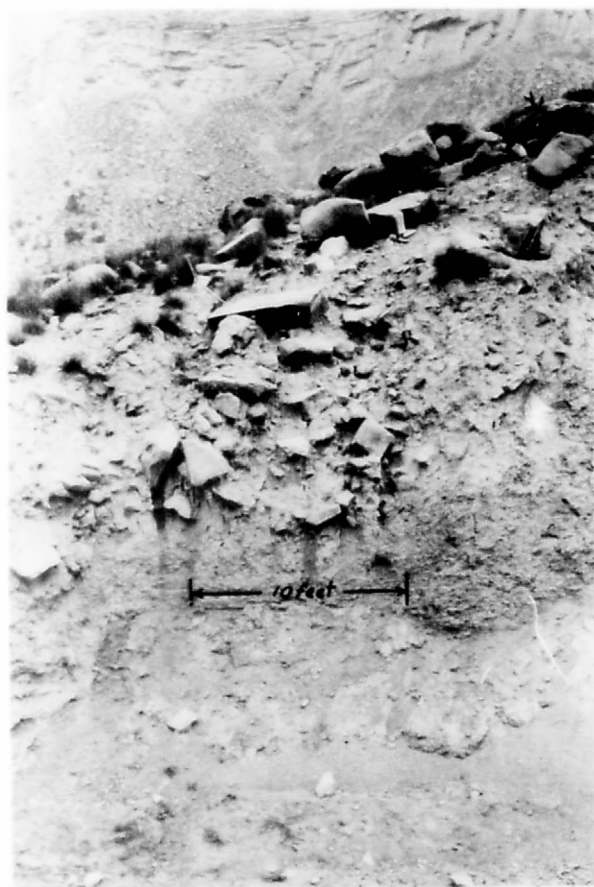
Fig. 2. Fan material overlying shale,
as exposed in railroad cut.

So far as we know, shale bedrock has not been reached in excavations for foundations in this vicinity. We estimate that the fan is probably several tens of feet thick where the houses rest upon it, although there is no direct evidence from wells or borings. The contour of the shale surface beneath the fan cover is also unknown, but it is probably irregular. The fan heads to the north in tongues separated by ridges of shale, and it is likely that these ridges project southward beneath the cover of alluvial debris. The slope of the fan surface between D and E Streets is 8 to 10 feet per hundred feet.

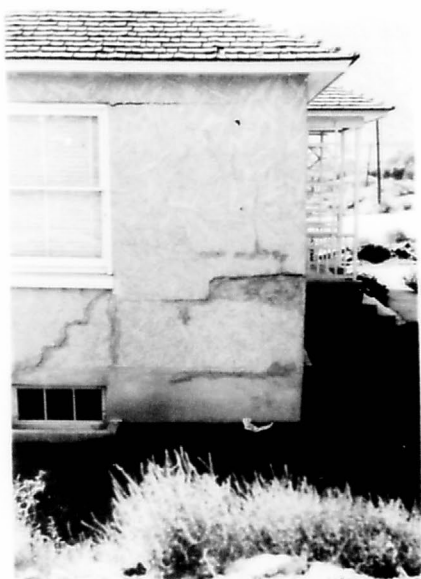
Houses:- Most of the damaged houses are along the north side of D street. Typical cracks in exterior walls and foundations of the houses may be seen in the photographs (figs. 3-6) and sketches (fig. 7).

Fig. 3. Cracks in the
northeast corner of 110 E Street

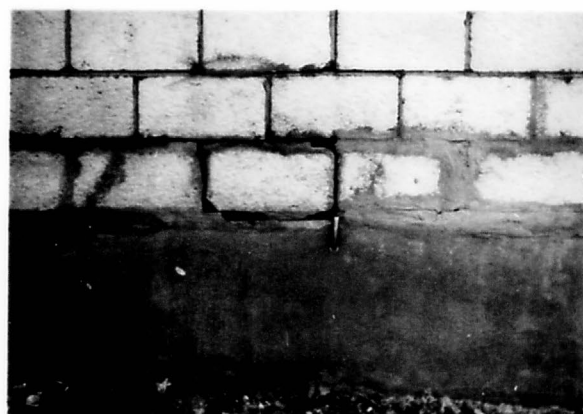
Fig. 4. Cracks in the northwest corner
of 154 D Street

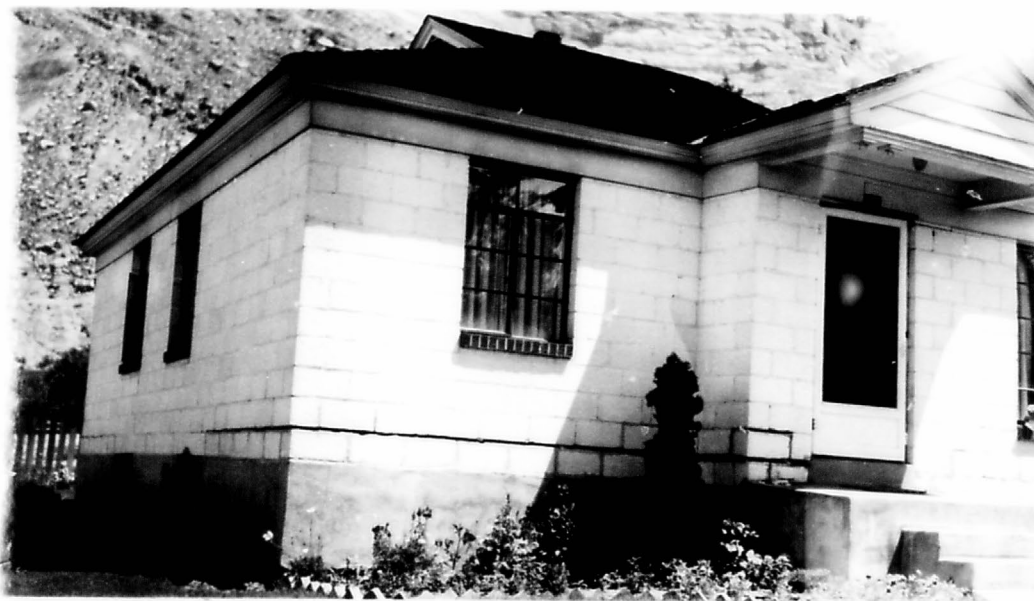
The most severely damaged house is 103 D Street, a single block structure occupied by Mr. Cliff Mennott. The interior of this house also shows numerous cracks, door frames are skewed, and part of the basement floor is said to have sunk. Two tie bars between the east and west foundation walls, presumably tight when put in, were slack in July, 1948. A procedure of repair followed in July was to jack up the superstructure, support it on 6" x 6" uprights to the basement floor, and fill in the horizontal crack above the foundation with cement. This operation must be repeated as the foundation walls sink deeper. The foundation itself has cracked in two places in the west wall.

Fig. 5. View of southwest corner of 103 D Street

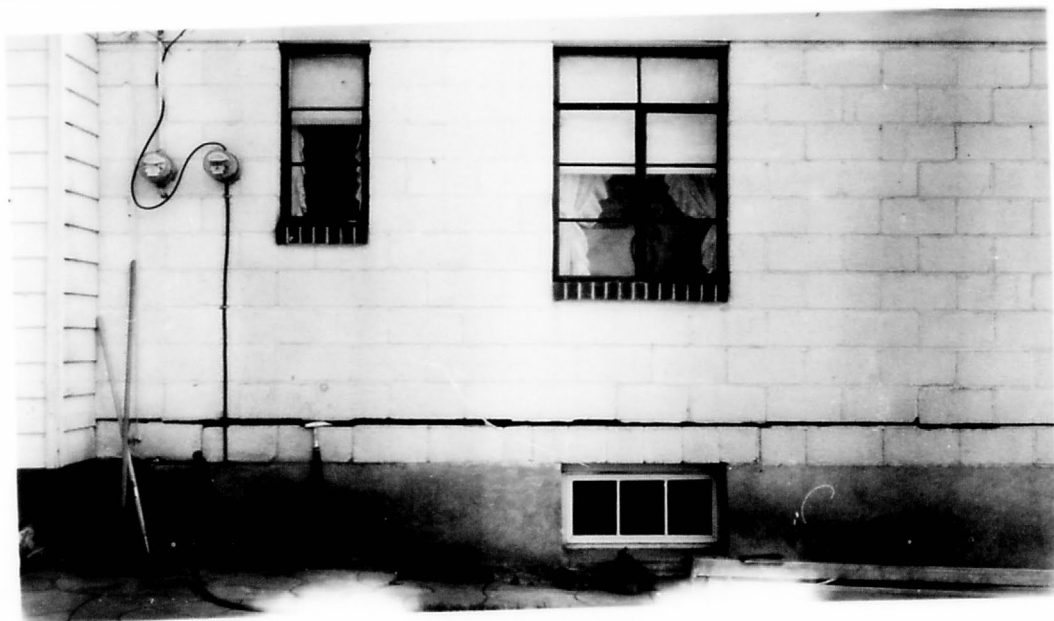
Fig. 6. View of north side of 103 D Street

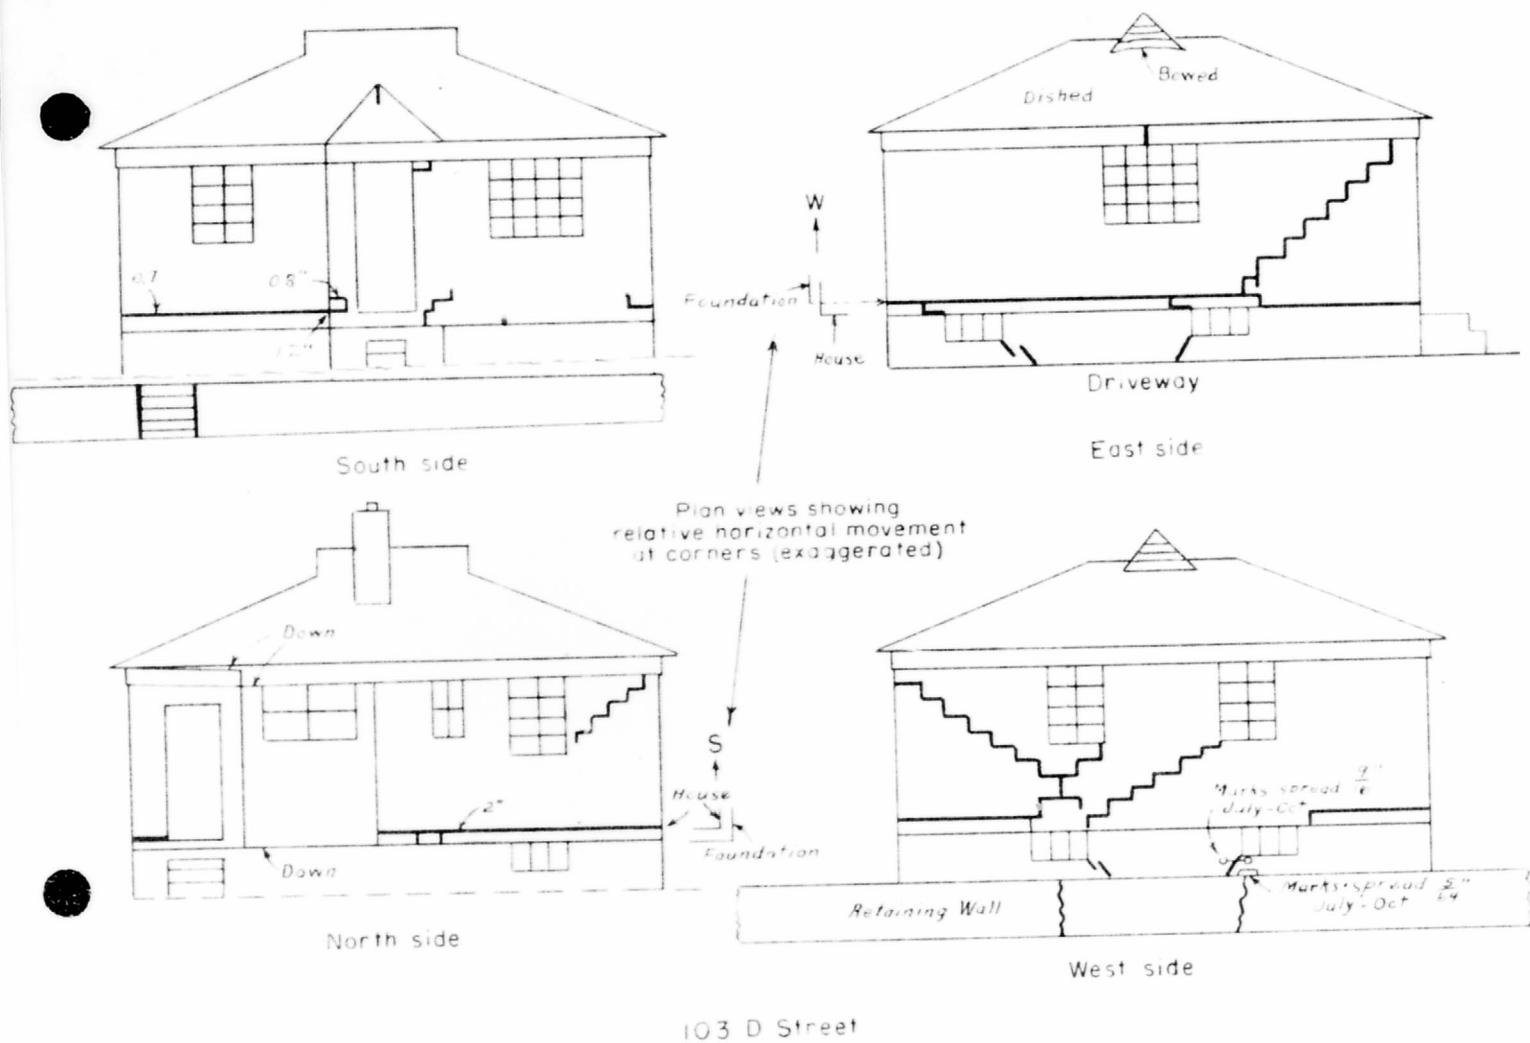
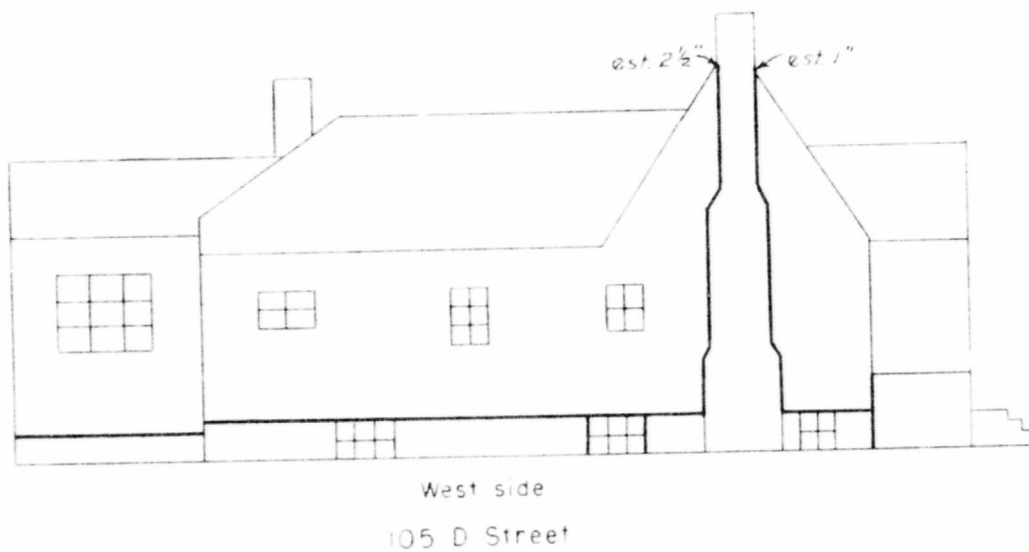
Figure 7. SKETCHES OF CRACKED HOUSES

Cracks shown in heavy lines

The houses at 101 D and 105 D are also conspicuously cracked above the foundations (see fig. 7). At 105 D the most prominent cracks are those along either side of the chimney where it adjoins the house. Many other houses in the immediate neighborhood show slight to severe damage.

Measurements were made at two places between stakes on either side of the crack in the ground, and between several sets of points on either side of cracks in the foundations and retaining walls of the houses. The location of the two lines across the crack in the ground and the changes in the lengths of these lines are also shown on fig. 9. The widths of some of the cracks in the houses, and changes in widths of some of these cracks between July and October, are shown on the sketches of the houses (fig. 7).

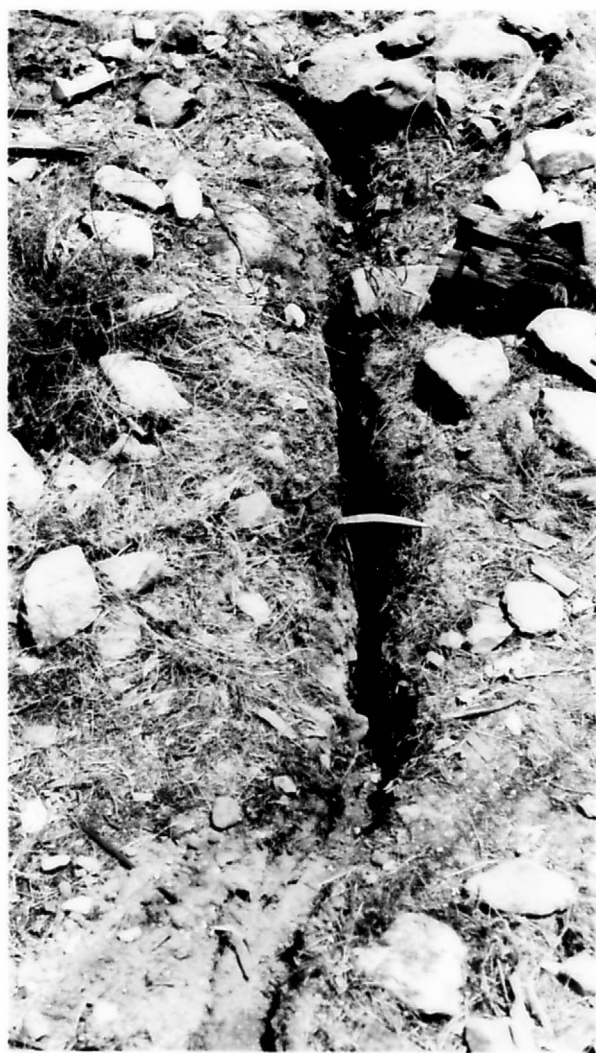
This crack is 1 inch to 6 inches wide (see fig. 8) and appears to be at least 5 feet deep, although the bouldery ground would not allow complete probing. The sides of the crack show no noticeable vertical offset. The age of the crack is unknown; Mrs. Hatch believed it to be 8 or 9 years old; Mr. Young reported it opened or reopened after heavy rains in August or September 1947.

Fig. 8. View of crack in ground
