Investigation of the deep well in Mesa Verde  
National Park, Colorado

December 6-15, 1948

By Penn Livingston and William Hale

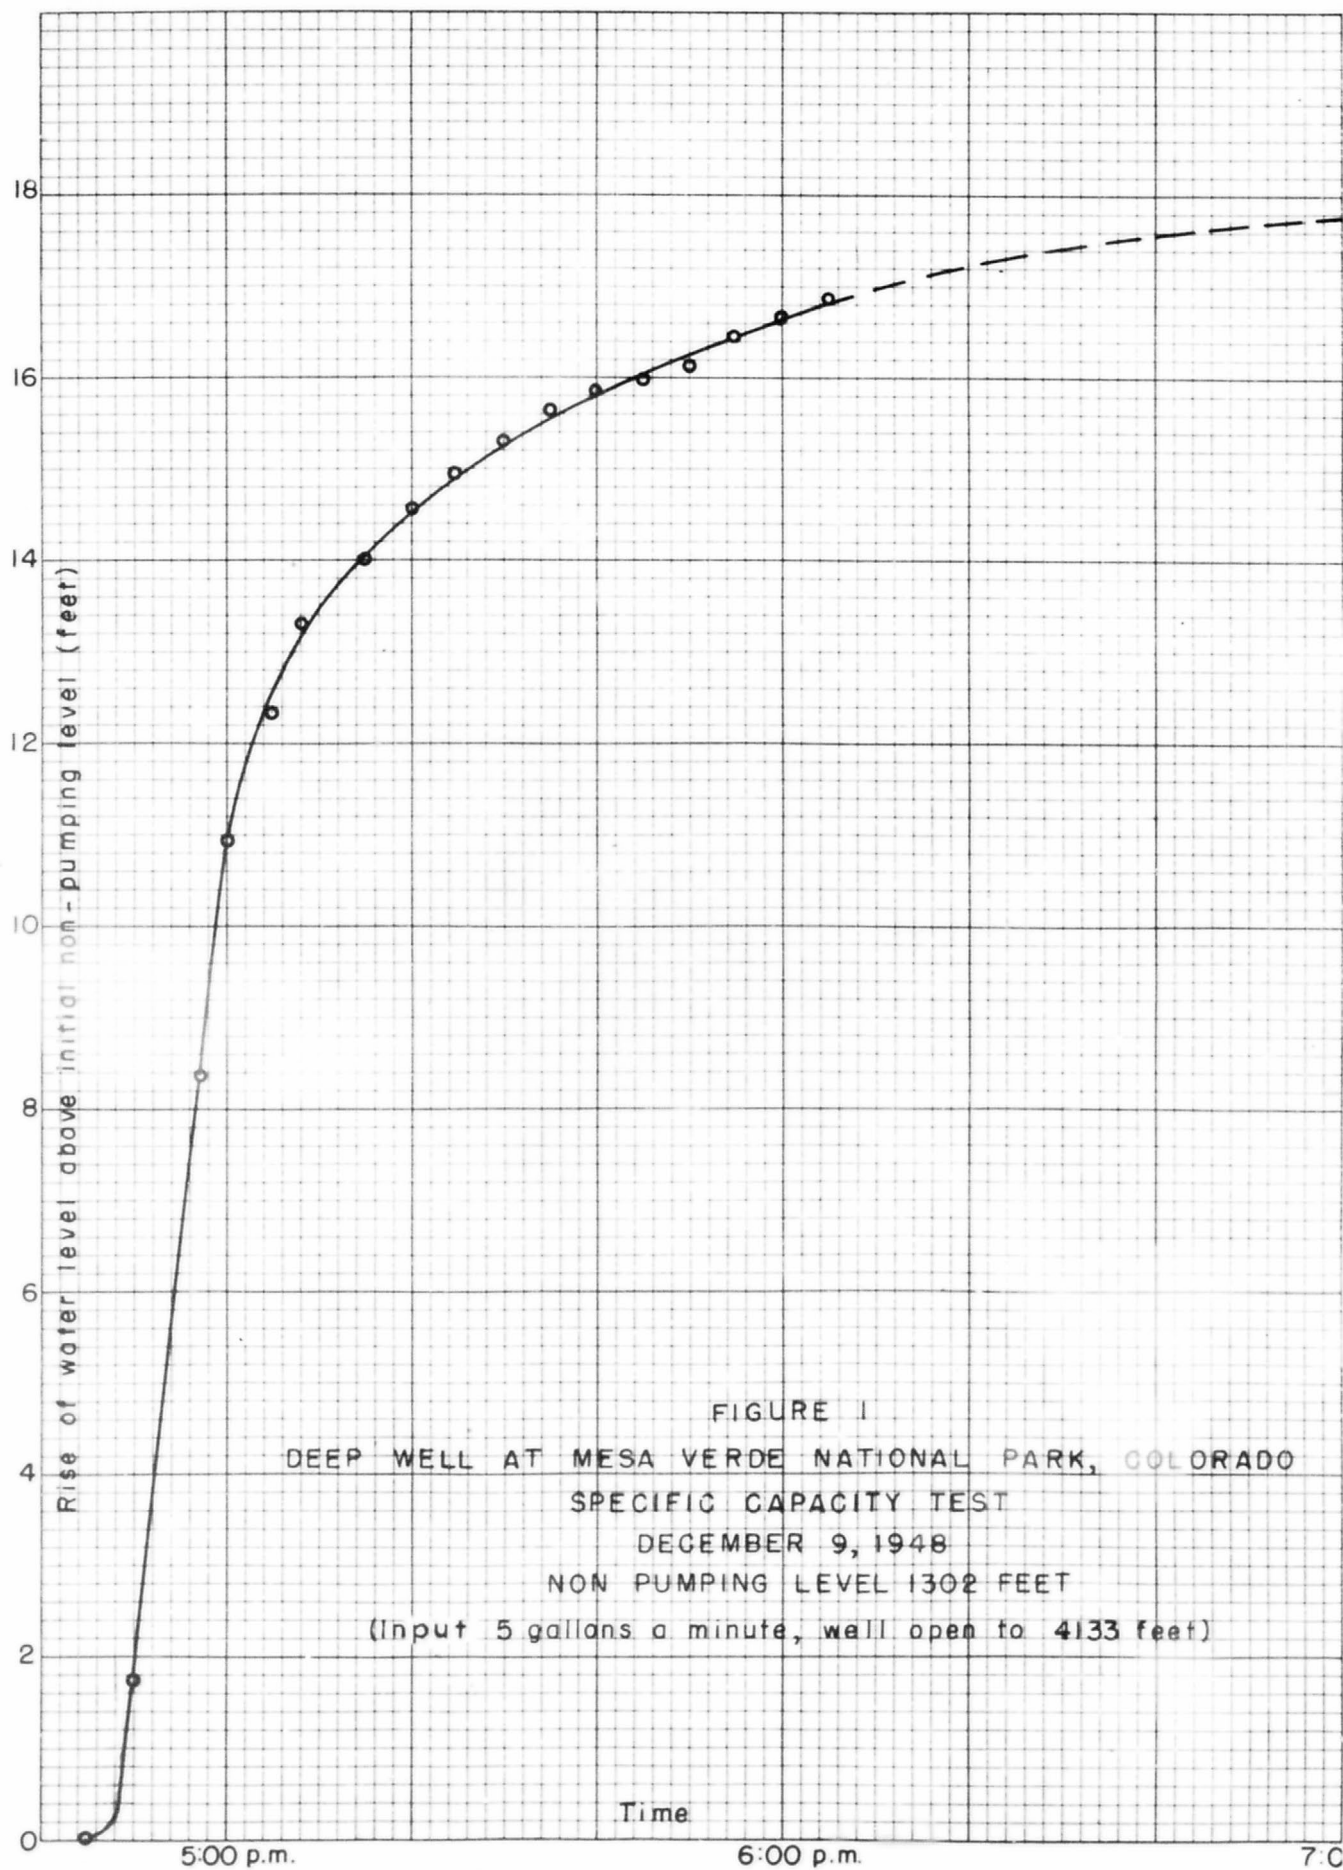
With the well open to a depth of about 4,133 feet, exposing between 60 and 70 feet of screen, a test was made to determine the present specific capacity of the well. This test was made to determine if the screen were open above 4,133 feet and if it were imperative to open the screen below that depth to obtain a supply of 30 gallons a minute. Water was introduced into the well at the surface at a rate of 5 gallons a minute starting at 4:45 p.m. on December 9 and ending at 6:07 p.m. The water level rose about 17 feet

during the test and had an estimated ultimate rise of 18 feet or more, indicating a rise of about 3.5 feet for each gallon a minute of recharge (fig. 1).
