UNITED STATES
DEPARTMENT OF THE INTERIOR
U.S. GEOLOGICAL SURVEY

Landslides in shale at Rapid City, South Dakota

Dwight R. ^{Raymond} Grandell

Washington
1951

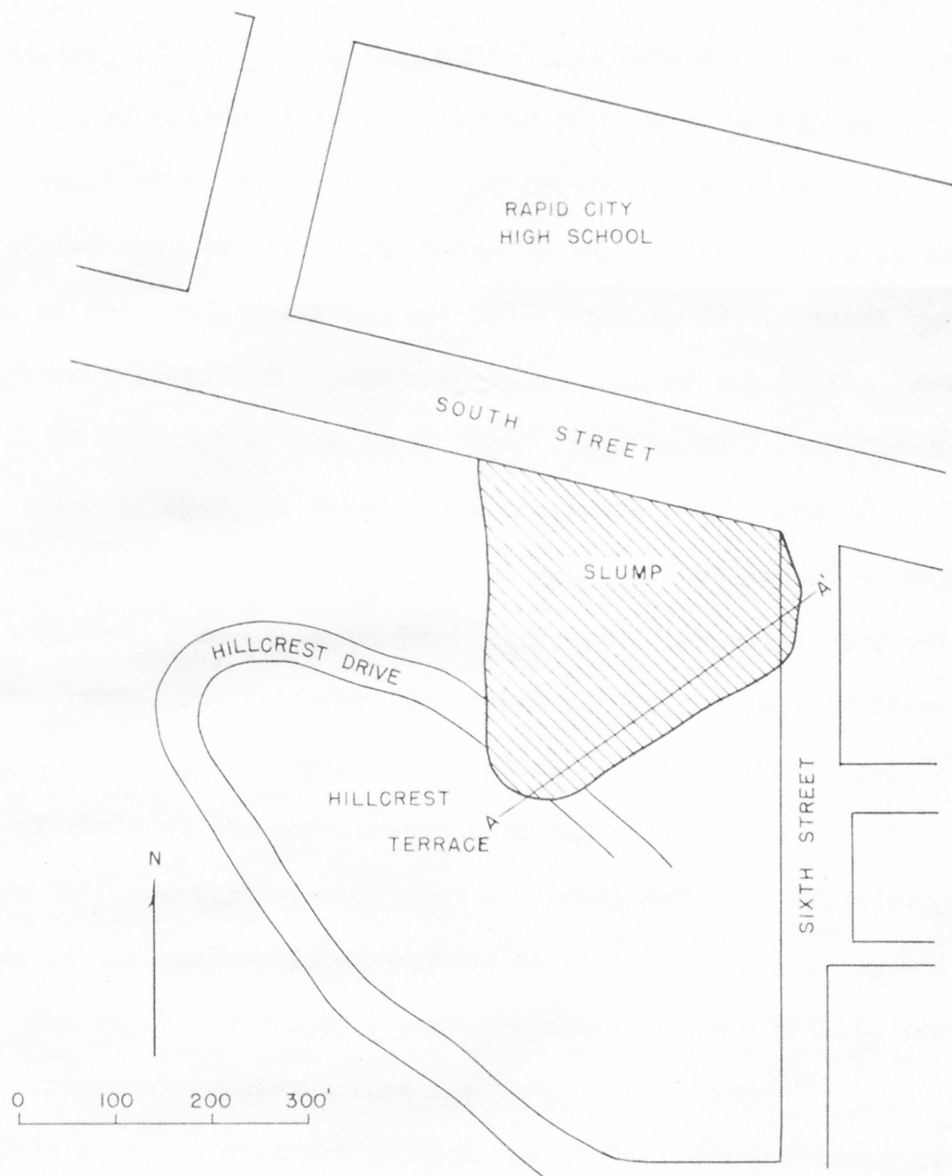
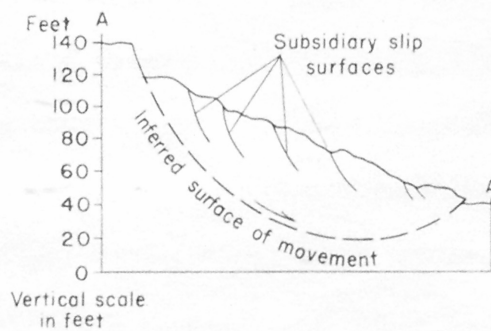
Figure 3. Location map and inferred cross section of Hillcrest slump.
Map taken from unpublished report by E. D. Dake, dated November 1947.

History of slump.- The landslide that caused destruction in 1946 and the years following is believed to represent renewal of movement in a dormant slump that probably had previously attained equilibrium. Dake stated that two distinct basins on the northeast side of the hill served as catchment areas for rainfall prior to 1946. These basins are a common feature in landslide areas. One of the initial causes of renewal of movement on the slump block seems to have been the construction, prior to 1940, of several houses on the south side of South Street. This necessitated the excavation of a considerable amount of material from the north side of the shale hill. Retaining walls were built at the lot fronts, but near-vertical banks of shale were left standing back of the houses. Subsequently, excavation for Sixth Street left steep banks of shale at the northeast toe of the hill.

When the Hillcrest slump was visited in June 1951, it consisted of a great mass of individual slump blocks, each bounded by a deep crack and in some places by a shallow depression (fig. 3). The main slump scarp at the rear of the slide ranged in height from several feet to about 20 feet.

Causes of the slump.- Excavation of the toe of what evidently was a dormant landslide probably was the most important cause of renewal of large-scale movement. The trigger that started the movement appears to have been an addition of a large amount of water to the landslide in the spring, summer, and fall of 1946, both by natural and artificial means. Once movement began, cracks in the surface of the slump block allowed penetration of surface runoff into the slide. This added moisture greatly lowered its stability. It has been suggested that an important factor was the stripping of the top of the shale hill. The natural slope of the hill was thereby destroyed, and rainfall did not run off as readily as before. This is not believed to have been a determining factor by the writer, inasmuch as copious amounts of water were known to be introduced into the landslide area by other means.

Dake's proposals no. 1 and no. 2 are perhaps the most effective steps that can be taken to stop further movement. The surface of the slump block is now cut by dozens of deep cracks that trap all the rainfall that drains into the landslide area. So long as the cracks are allowed to remain open, and so long as the city maintenance crews continue to remove the toe of the landslide by grading and excavation on South and Sixth Streets, the slide will remain active. The ultimate destruction of several houses on Hillcrest Terrace is certain unless steps are taken to halt the slide.

Probably the only effective way of stopping the slide at this late date is to grade the entire slide area on as low an angle as possible from the intersection of South and Sixth Streets up to Hillcrest Drive. So as to minimize the infiltration of water, a layer of impermeable material should be spread over the graded surface. Erosion of this layer could be retarded by covering it with a

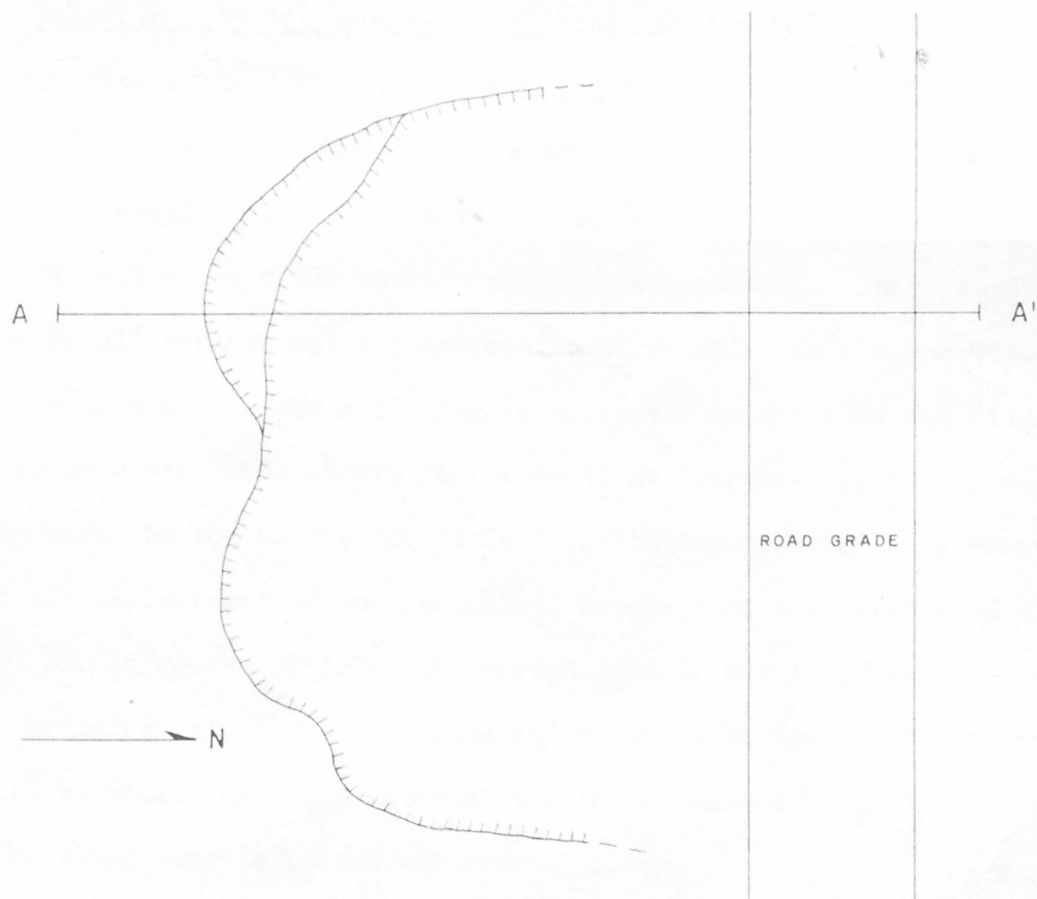
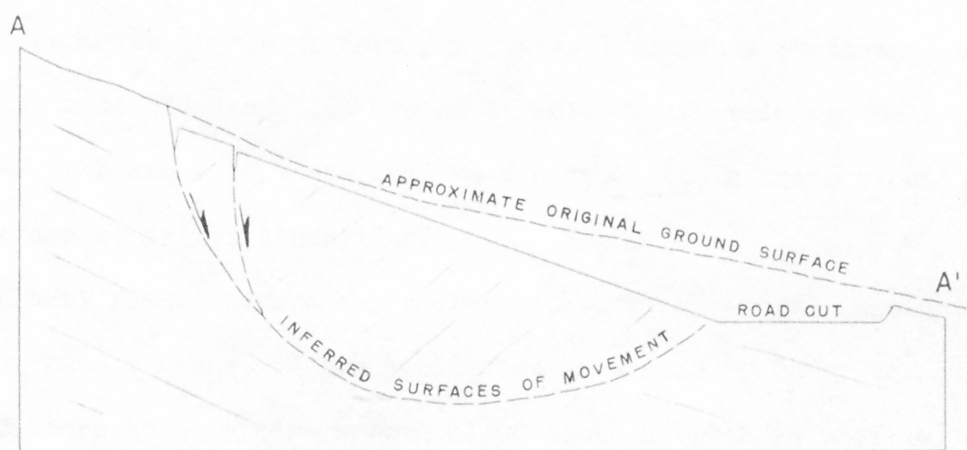
Figure 4. SKETCH MAP AND CROSS SECTION OF RESERVOIR HILL SLUMP

In July 1951, an excavation for a new road to the summit was made a short distance upslope from the north toe of Reservoir Hill (fig. 4). Three weeks after the completion of the cut, a crack appeared about 175 feet upslope from the floor of the excavation. It is the impression of a worker that an initial vertical movement of about 1 foot occurred in the space of a few seconds (Mr. Kenneth Shabino, oral communication). The initial movement took place during a long period of dry weather, and no other external change of conditions is known to have affected the area. On October 18, 1951, the main crack at the head of the slump was 1 to 3 feet wide and as much as 8 feet deep. On that date the maximum total vertical displacement was about 4 feet.

The immediate cause of the slump was doubtless the removal of the toe restraint by road excavation. Other factors that might have influenced renewal of movement on the inferred dormant slump block are unknown. The delayed action, by which movement started 3 weeks after conditions favorable to movement had been established, is analogous to the period of stability from 1940 to 1946 in the Hillcrest slump. The trigger action that reactivated the Reservoir Hill slump might have been an earth tremor of such small magnitude that it was not apparent to the residents of the area. The slump could possibly have been reactivated after a prolonged period of continued stress by vibrations created by a freight train on the railroad a short distance north of the slide area.

Possible remedial measures.- Although no remedy has yet been applied to this slump, the best program would be to re-establish the conditions that existed prior to movement. Evidently the slump was in equilibrium before excavation, so there is reason to believe that a restoration of the original slope would result in a stable condition. This remedy would entail replacement and compaction of material in the excavation at the toe of the hill and a filling in of cracks at the head and sides of the slump block. The safety factor could be increased by moving more earth onto the toe of the landslide than the amount originally excavated. With the replacement of toe restraint, movement on the reactuated slump block should cease. Filling the cracks solidly should prevent runoff from draining into the slump block and would stabilize the slope above the slump block. No more material should be removed from the toe area of the slump even to reduce the overall slope.
