UNITED STATES
DEPARTMENT OF THE INTERIOR
GEOLOGICAL SURVEY
Ground Water Branch

SECOND MEMORANDUM ON THE FLOW OF AGUA CALIENTE SPRING
AFTER ROAD CONSTRUCTION AT PALM SPRINGS, CALIFORNIA

J. F. Poland and L. C. Datcher

Long Beach, California
November 1953

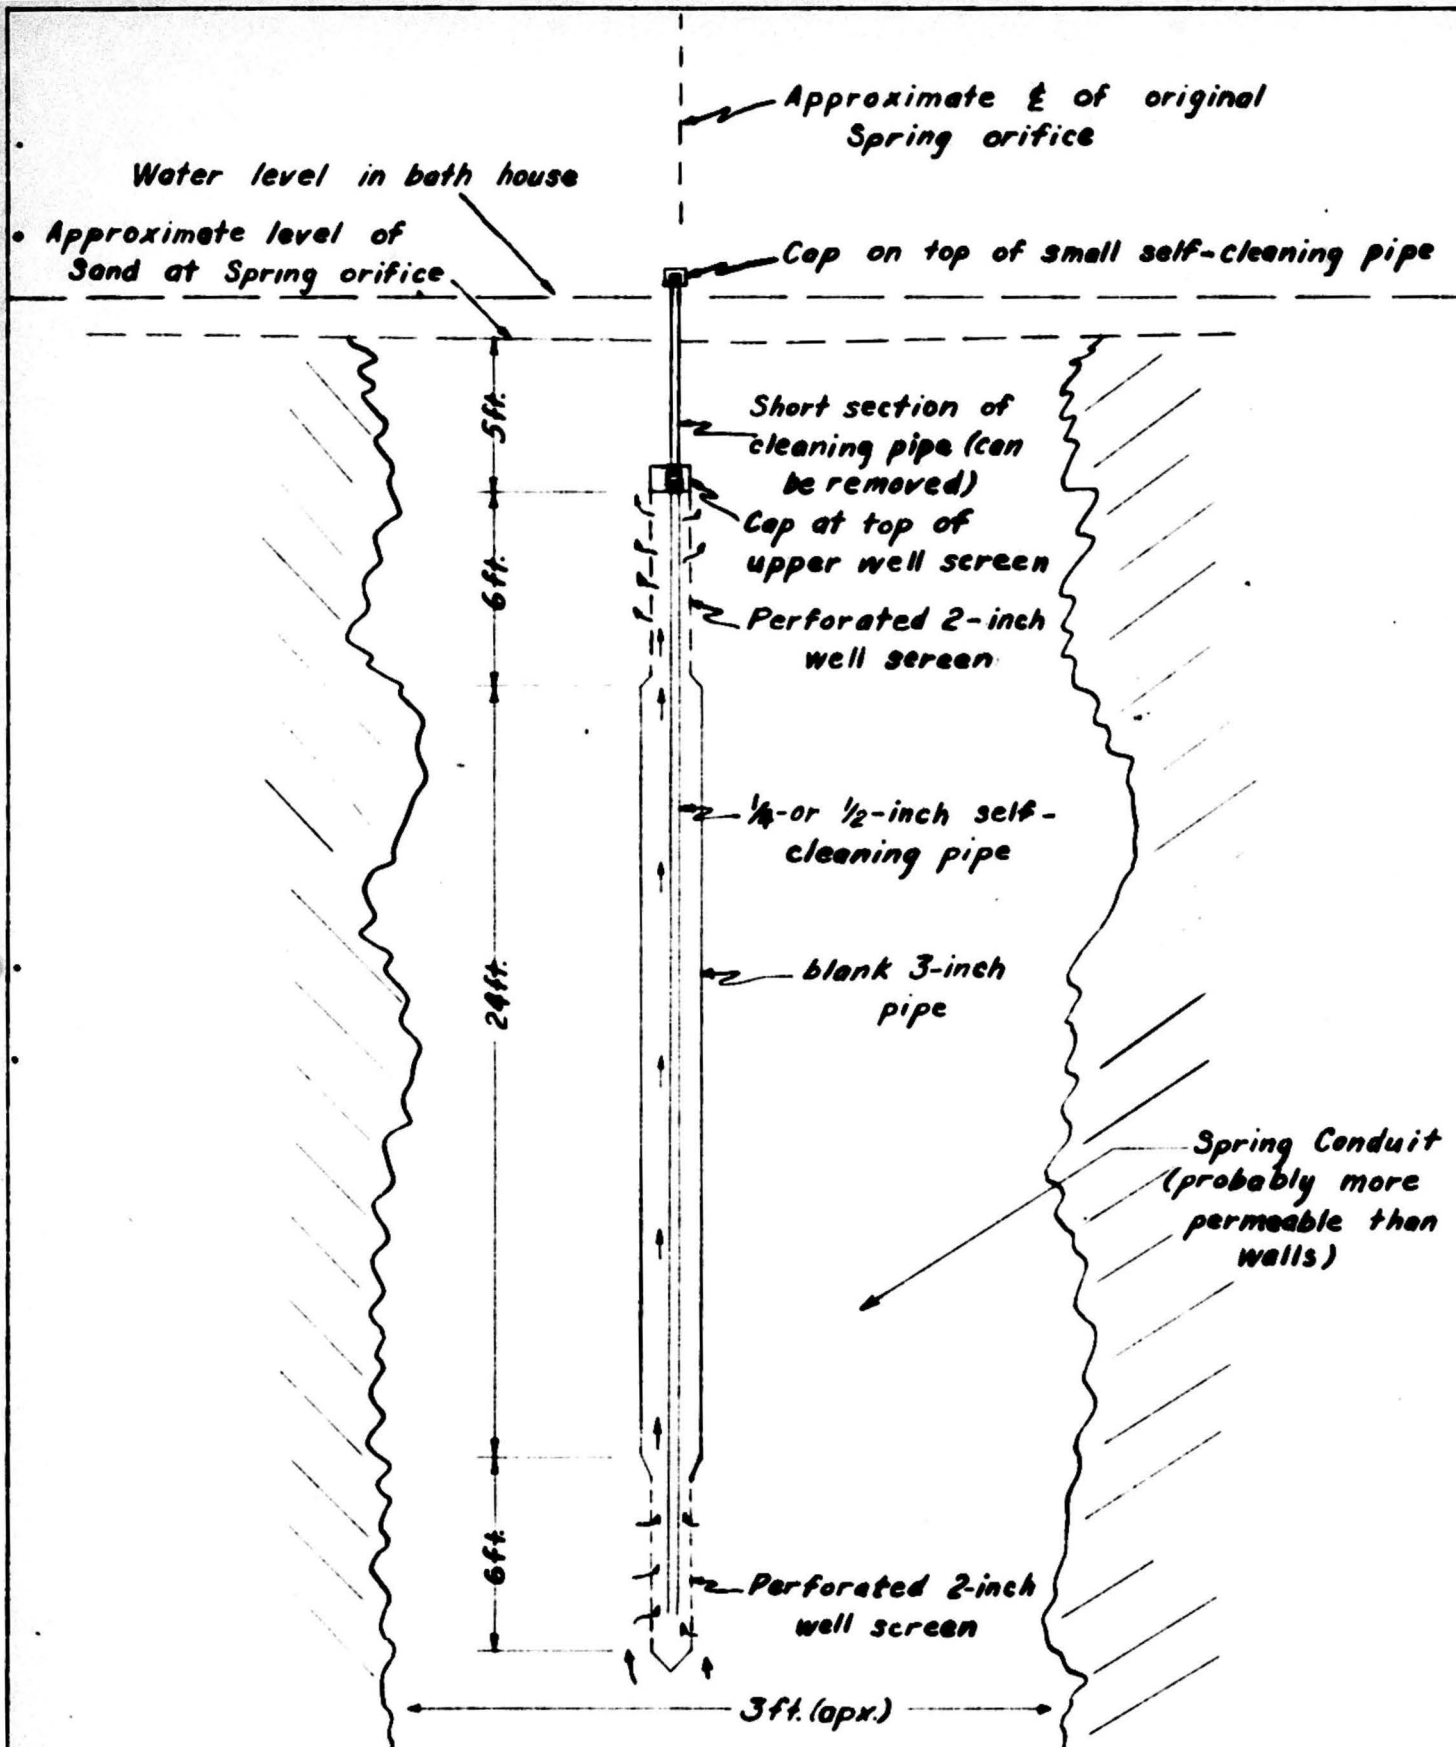
Diagrammatic Sketch Showing Suggested Method of Installing Pressure-Relief Pipe in Aqua Estante Spring, Palm Springs, California

It appears that the surrounding sediments have become unstable owing to the various operations in the area over the past several months, and that hydrostatic uplift is sufficient to continue the instability. One way to stabilize the mass is to reduce the hydrostatic uplift. It is believed that the simplest way to attempt this and at the same time return the spring to its old orifice is to insert a pipe vertically in the orifice to the depth necessary to reach clear rising spring water in the original chimney. This would reduce the hydrostatic head at the bottom of the pipe nearly to that at pool level; the only difference, which should be kept as small as possible, would be the head loss involved in movement of water into, through, and out of the pipe.

It is known that jetting has had some effect on the structure to a depth of 25 to 30 feet. Therefore the bottom of the pipe would have to be placed below 30 feet, and it is suggested that a depth of 35 feet be considered for an initial attempt. The pipe would have to be of such

Two ways in which hydrostatic uplift probably could be relieved are (1) by use of permeable tile for the pipe to be inserted in the spring, and (2) by use of metal, composition, or plastic blank pipe, with perforated screens at each end, for this purpose.

Therefore, it is suggested that a metal, composition, or plastic pipe with screens at each end would be simpler to construct and insert than would permeable tile.

foot for $2\frac{1}{2}$ -inch pipe, and 2.35 feet for 2-inch pipe. Either $2\frac{1}{2}$ -inch or 3-inch pipe thus would develop only a small head loss for a flow of 25 gpm through a 30-foot length--about 0.3 foot and 0.13 foot, respectively. Doubtless the head loss would be greater through the entrance and exit screens, but it is believed that a screen of low head loss could be made for each end of the pipe by fastening together two well points $1\frac{1}{2}$ to 2 inches in diameter and 3 to 4 feet long. The total head loss in screens and pipe should be considerably less than that for travel upward through the sediment. The over-all length of perforated and blank pipe should be such that the top of the lower perforations will be at least 35 feet below the land surface and the top of the upper perforations will be about 5 feet below the surface. This would require 24 feet of blank pipe if the perforated sections are 6 feet long.

In order that the pipe may be inserted vertically in the orifice it will have to be jettied down and will have to be made up as it is being placed in the jet hole, because there is only about 10 feet of vertical clearance below the pool-house ceiling. It is suggested that a strong anchor wire be fastened to the top of the perforated upper part of the pipe so that the pipe will not drift and also to assist in removing it from the hole should that become necessary.

Care should be used in selection of the screen size. The purpose is to obtain maximum permeability in the screen but at the same time use a sufficiently fine mesh to prevent the surrounding fine material from passing into and clogging the screen, because it would tend to increase the head loss and thus decrease the hydrostatic-uplift relief.

If thought advisable, a self-cleaning pipe of small diameter ($\frac{1}{4}$ to $\frac{1}{2}$ inch) could be installed inside the pipe and screen assembly so as to place its open bottom about a foot above the bottom of the lower screen, and to extend its top a few inches above the pool level. This cleaning pipe could be installed in two parts, the upper part being threaded into the cap at the top of the upper screen so that it could be removed at a later date if desired. (See attached sketch.) This top section, when in place, should be capped at the top (above pool level), so that by removing the cap any fine sediment that had entered the well-point assembly could be flushed through the small cleaner pipe. The residual head inside the pipe probably would be sufficient to cause upward flow in the cleaning pipe and discharge an inch or so above pool level. If not, the cleaning pipe could be pumped gently by supplying a slight suction. However, if it is desired to remove this top section of cleaner pipe, it would be necessary to place a seal or plug at the top of the lower section of cleaner pipe to prevent sediment from falling down the pipe.

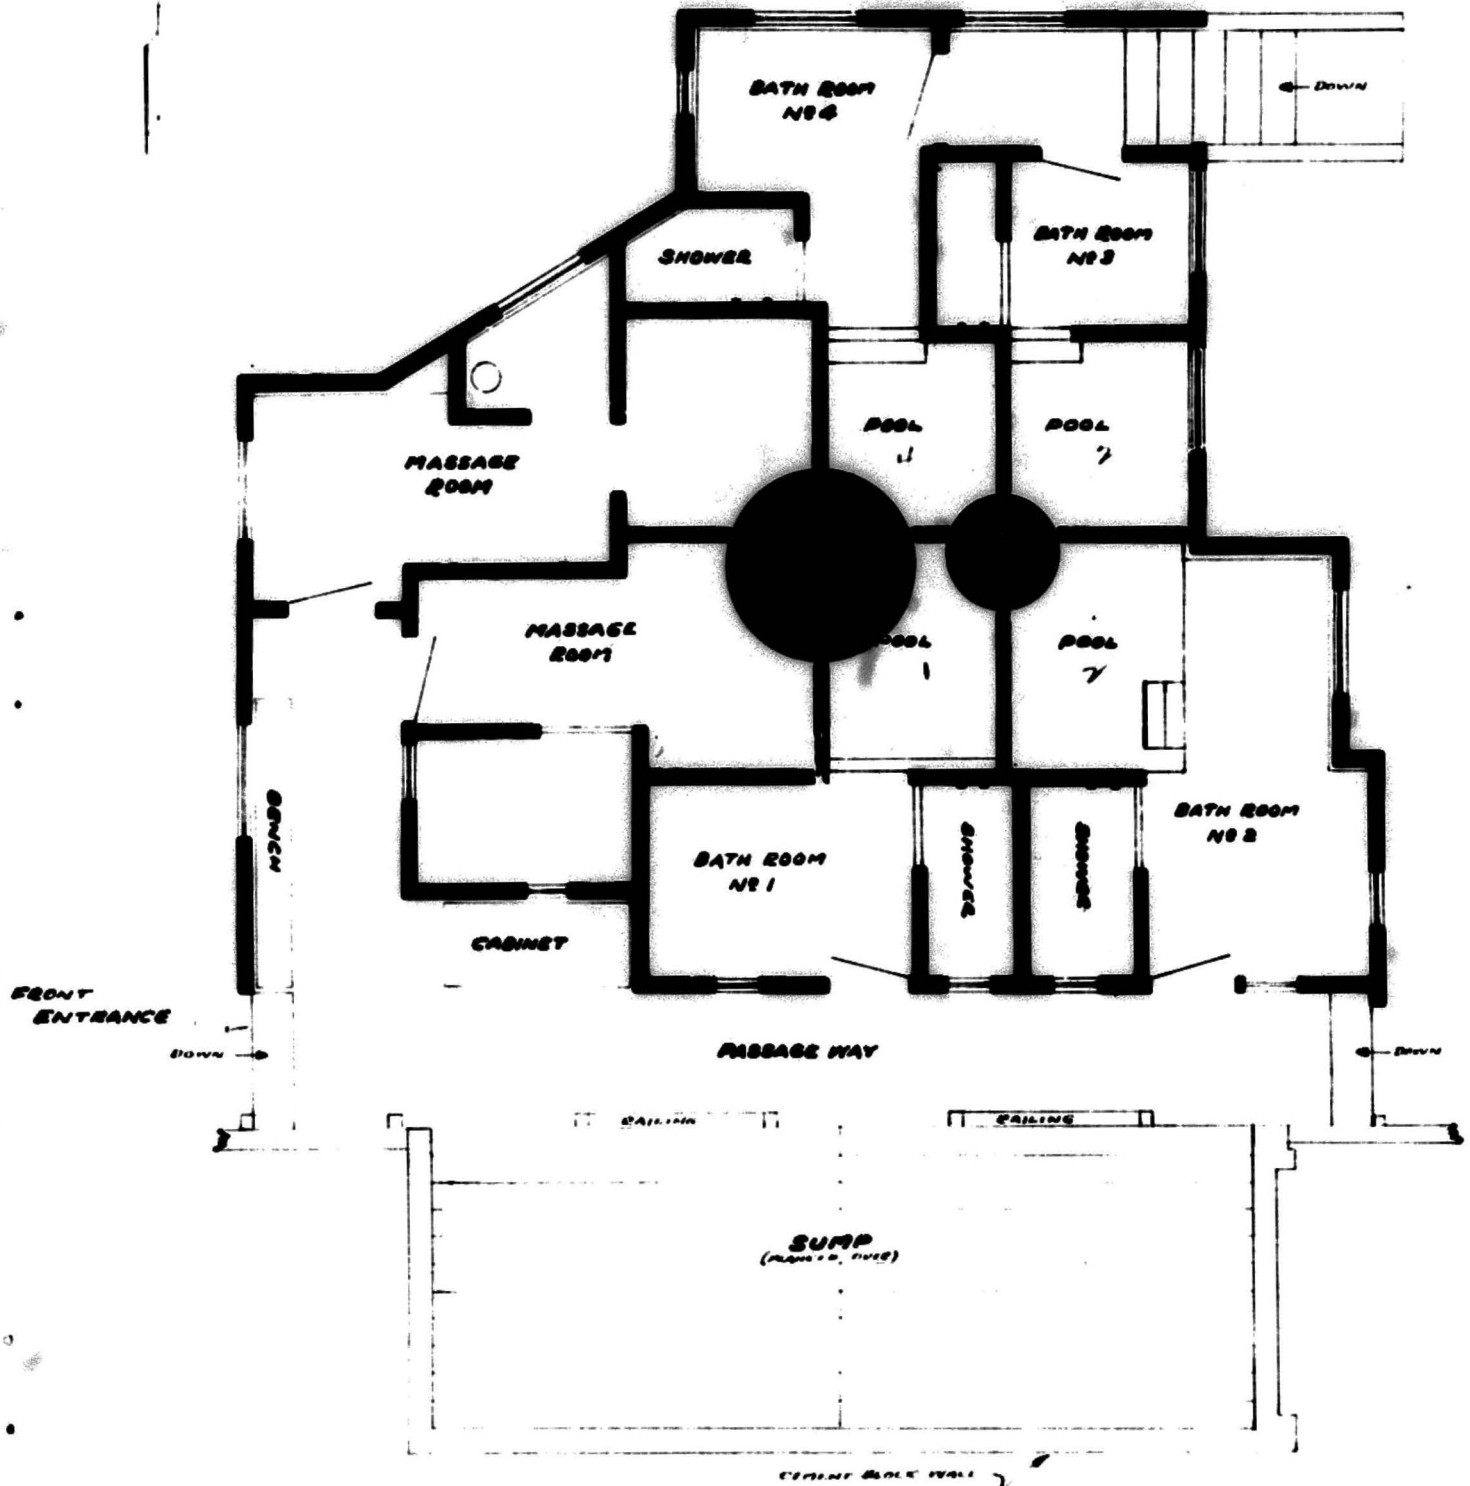
FLOOR PLAN
AUSA CALIENTE TRIBAL MINERAL BATHS
PALM SPRINGS, CALIFORNIA

A brief inspection indicated that the vent recently developed in pool no. 1 (see attached sketch of bathhouse) had closed up. There were slight concentrations of discharge at the initial orifice and near the west wall. Gas bubbles were rising intermittently and at random places within all four pool rooms.

appeared to be 2 feet west of the original spring center (at the intersection of the four pool walls). He reported that the large western cavity had opened and closed intermittently during the past few days. He reported further that an open pipe had been lowered in the orifice to the bottom of the opening but that the water discharging from it did not appear to clear up. He stated that a corked bottle was lowered on a stick to 11 feet, the cork was pulled, and the filled bottle brought to the surface. The water taken at 11 feet was also murky.
