LANDSLIDES IN THE
SAN FRANCISCO SOUTH QUADRANGLE, CALIFORNIA

M. G. ^oBONILLA

Open-file report

January 1960

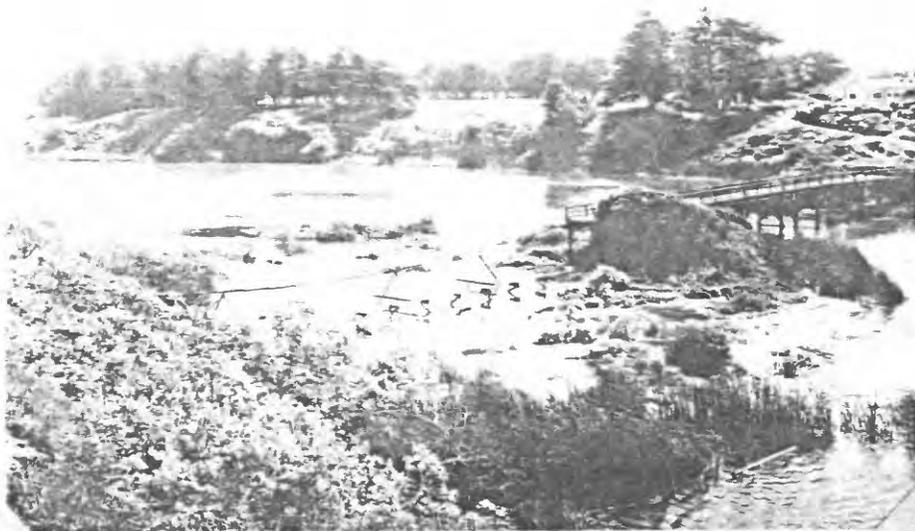
The exact dimensions of the slide deposit could not be determined because it was under water but about 30 feet of the embankment was destroyed. The vegetation displaced by the slide is visible on air photos taken four months after the slide. Measurements made on the photos show that the vegetation on the sides of the embankment moved at least 70 feet both eastward and westward from the original shoreline of the embankment. The material visible in the north end of the embankment was artificial fill composed of clean sand, and as a large deposit of dune sand is found a short distance north of the site, it is probable that all of the embankment was clean well-sorted sand obtained from the dunes. The slope of the embankment above water was on the order of 20° , and under water was presumably less.

The earthquake vibrations probably liquefied the saturated sand at the base of the embankment and the unsupported embankment collapsed and spread over the lake bottom. Slide 8, shown on figure 4, probably started as a sand flow, but removal of support by the flow resulted in slump failure near the head of the landslide.

Figure 3. Destruction of artificial embankment on Lake Merced. View looking southeast.

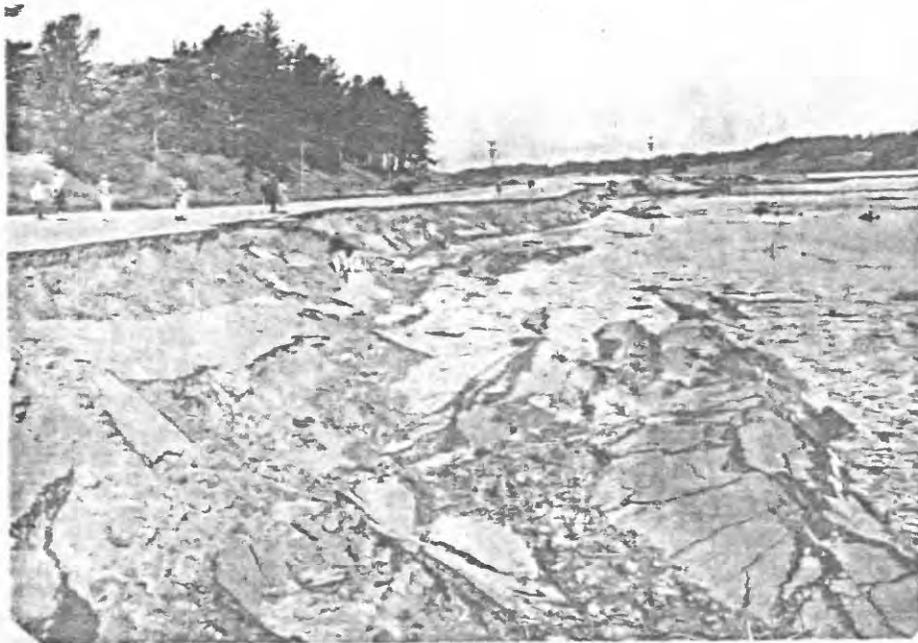
Figure 4. Damage to roadway by landslides along south arm of Lake Merced. View looking northwest.

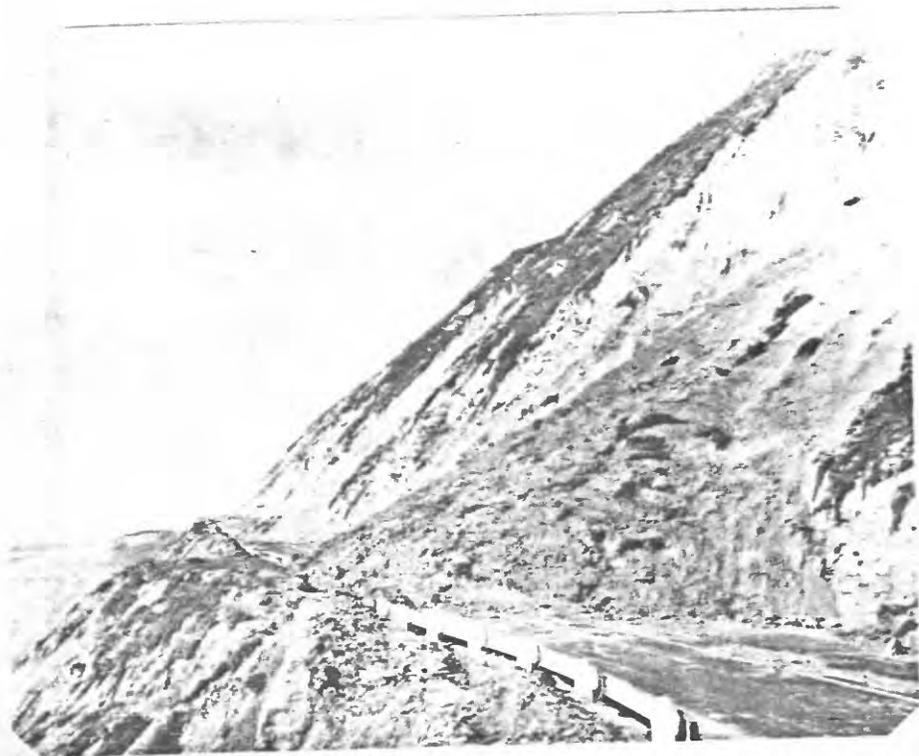
Slide 28 is a sand run that occurred along the sea cliff 4,300 feet south of the intersection of Albany Boulevard and Skyline Boulevard. The slide started during the main shock of the earthquake of March 22, 1957 and three hours later, when the photograph (figure 5) was taken, the slide covered the full width of Highway 1. Shortly after the picture was taken, an aftershock enlarged the landslide and small clouds of dust arose from the dry sand during the movement. The

Figure 5. Landslides blocking State Highway 1 on March 22, 1957. View looking northward. Slide 28 in foreground.

aftershocks increased the length of the slide by upslope movement of the scarp and, after the debris spilled over the highway, by downslope movement of the toe. The scarp eventually reached the top of the cliff and the toe reached the bottom of the cliff; at that time the slide was 560 feet long and 450 feet wide.

The slide probably began in friable medium to fine sand, undermined an overlying silty clay about 3 feet thick and spread into adjacent very fine sand and silt. The slide debris was mostly loose sand but contained blocks of friable sand several inches in diameter.

The beds of the Merced formation here dip about 60° to the northeast and the outcrop of the beds trends diagonally up the slope. The diagonal trend probably is the reason for the asymmetry of the slide in plan (see fig. 2). The shape of the slide debris, the appearance of the failure surface, and the type of debris indicate that the slide was principally a sand run. The slide debris above the highway was removed by maintenance crews and pushed over the highway toward the beach.

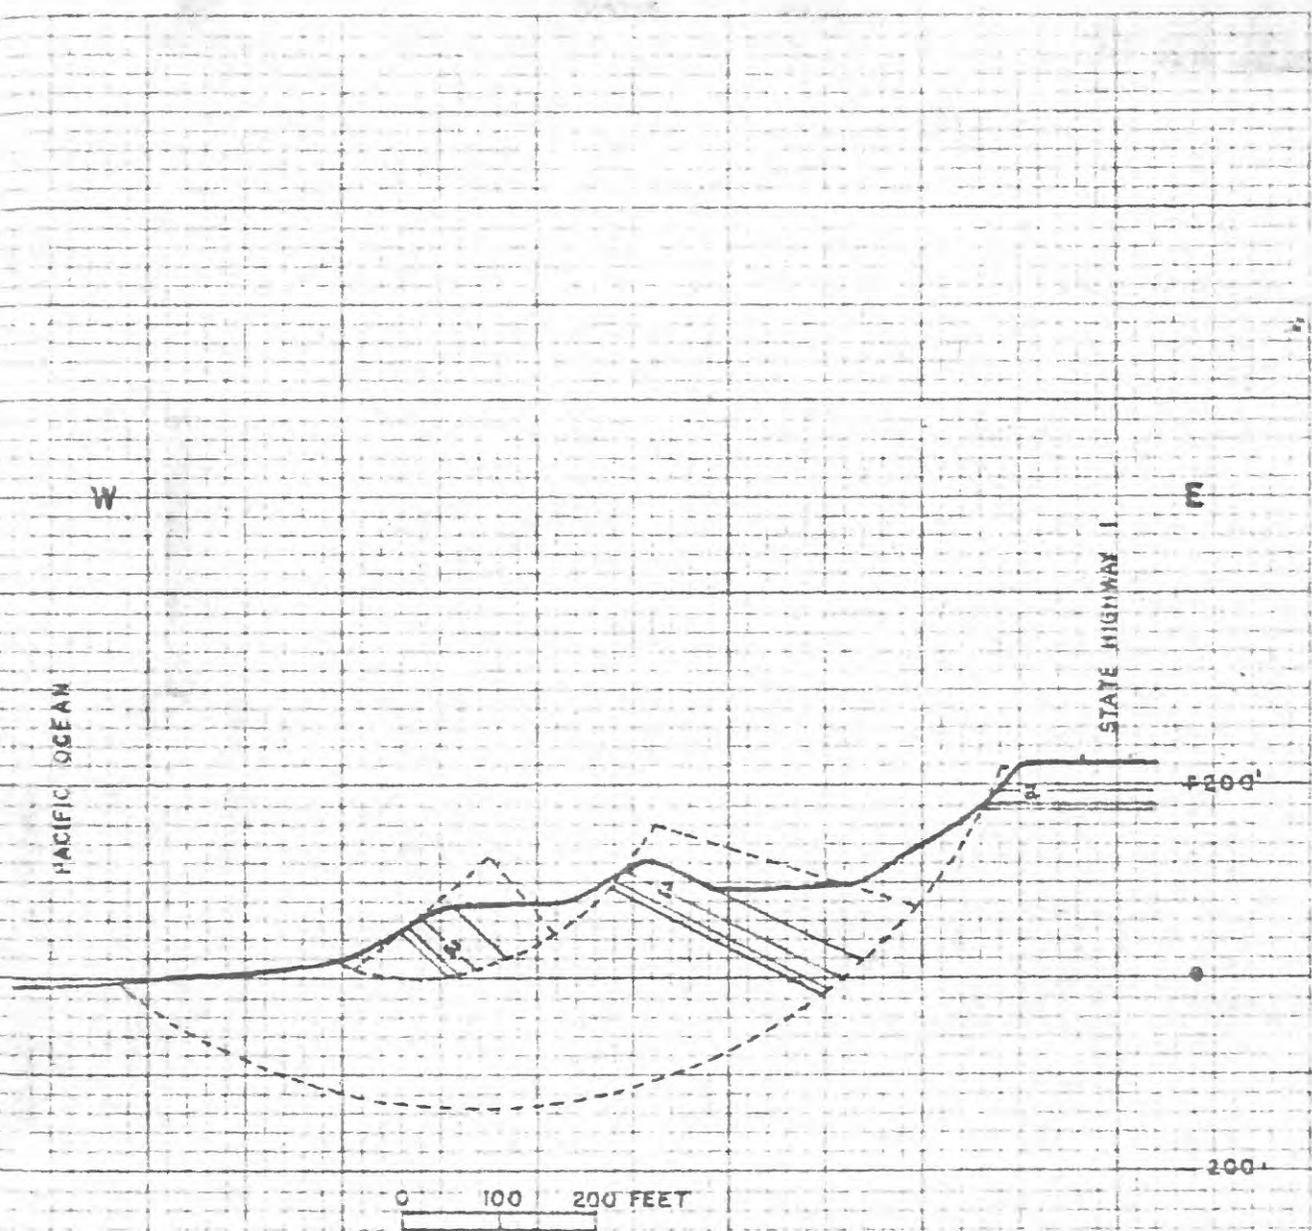
Results of tests made by the developers of the nearby Westlake housing project were used to estimate values of the angle of internal friction and cohesion for sediments of the Merced formation. The analysis showed that the surface of rupture would not intersect the observed scarp if the sliding surface were entirely in sand of the Merced formation, but it would if the sliding surface were mostly in silt and clay beds in the Merced. Using zero for the angle of internal friction and 2,350 pounds per square foot for the cohesion of silt and clay, the centers of rotation with the smallest safety factors were found. By making small cardboard models and suspending them from those centers of rotation, the attitudes of both the inclined topographic surface and the ash bed were reproduced closely (see fig. 6). Thus the occurrence of two slumps seems demonstrated. The deepest part of the surface of rupture of the main landslide, according to this analysis, extends 140 feet below sea level.

Figure 6. COMPARISON OF CALCULATED AND OBSERVED FEATURES OF SLIDE 15D

Solid lines show profile, bedding, and position of displaced topographic surfaces as determined from surface exposures; dashed lines show calculated positions of rupture surfaces and topographic surfaces. Ash bed indicated by letter "a".
