REHABILITATION OF WELLS IN THE HEADQUARTERS AREA  
WHITE SANDS PROVING GROUND, DONA ANA COUNTY, NEW MEXICO

Prepared for  
U. S. Army, Corps of Engineers  
and  
White Sands Proving Ground

Open-file report

1960

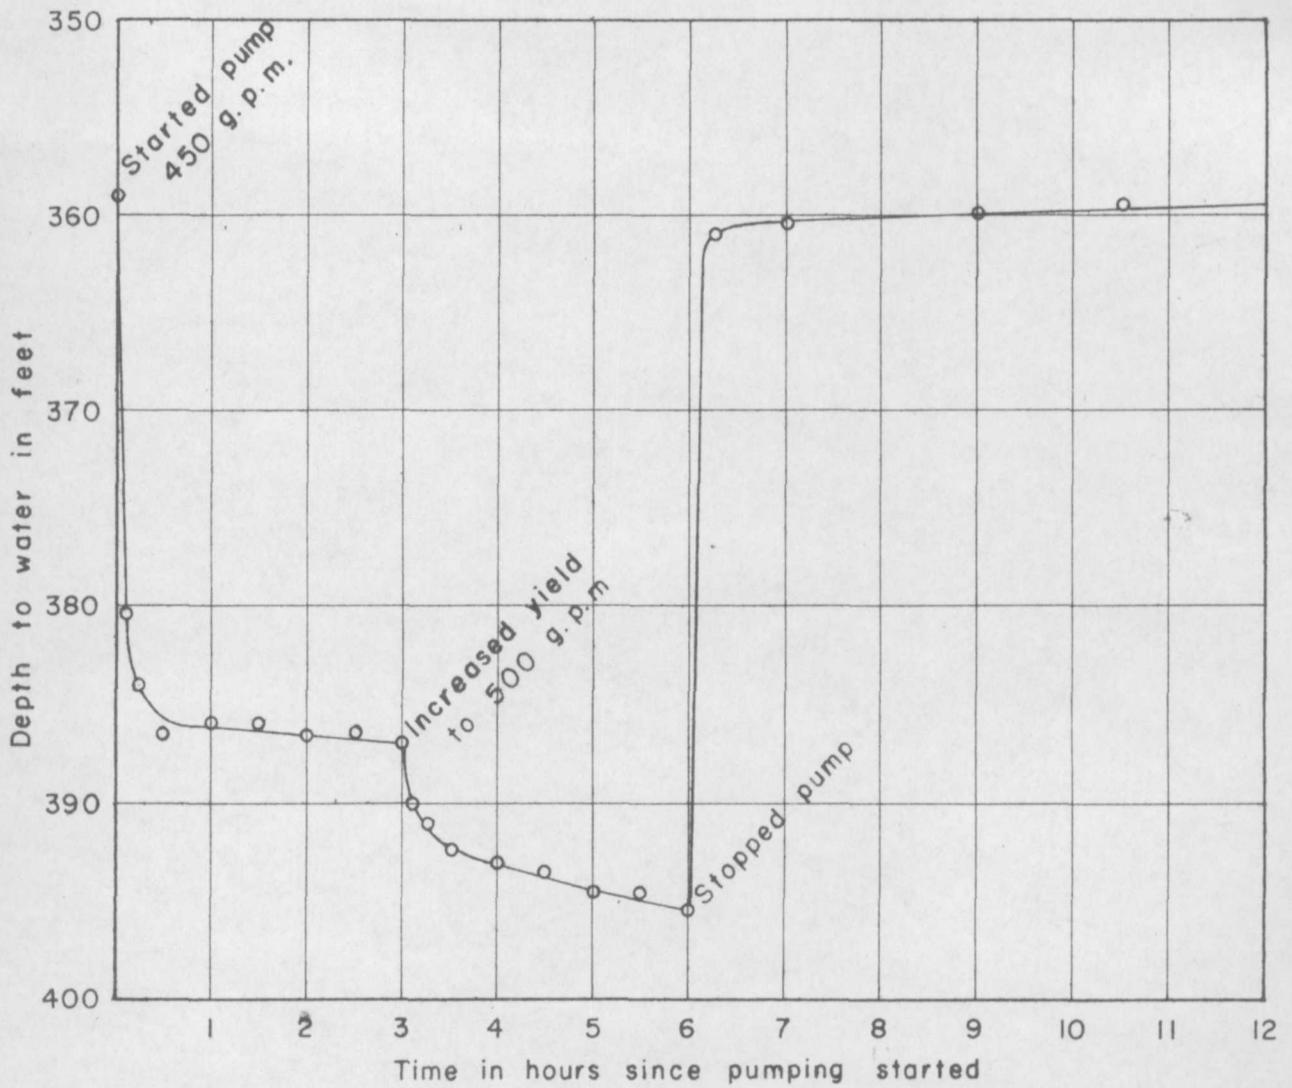
Following redevelopment, the well was test pumped on March 3, 1955 for 3 hours at a rate of 450 gpm and for 3 hours at a rate of 500 gpm. At the end of the 6 hours of continuous pumping, the depth to water, as measured by an air gage, was  $395\frac{1}{2}$  feet, representing a drawdown of about 38 feet. The water contained a small amount of coarse sand but no fine sand or clay at the higher rate of pumping. The tests indicate that the well probably could be safely pumped at a rate of 500 gpm. However, there will be less danger of moving undesirable amounts of sand, and the drawdown will be at least 20 percent less, if the well is pumped at a rate not exceeding 450 gpm. It would be advisable to set the pump bowls at a depth of about 450 feet to be certain that the pumping water level will still be well above the bowls as the water level declines.

On figure 1 are plotted the drawdown and recovery of the water level

in well 10 during a pumping test that followed rehabilitation. Figure 2

Figure 1.--Drawdown and recovery curves from pumping test of well 10 on March 3, 1955, following rehabilitation

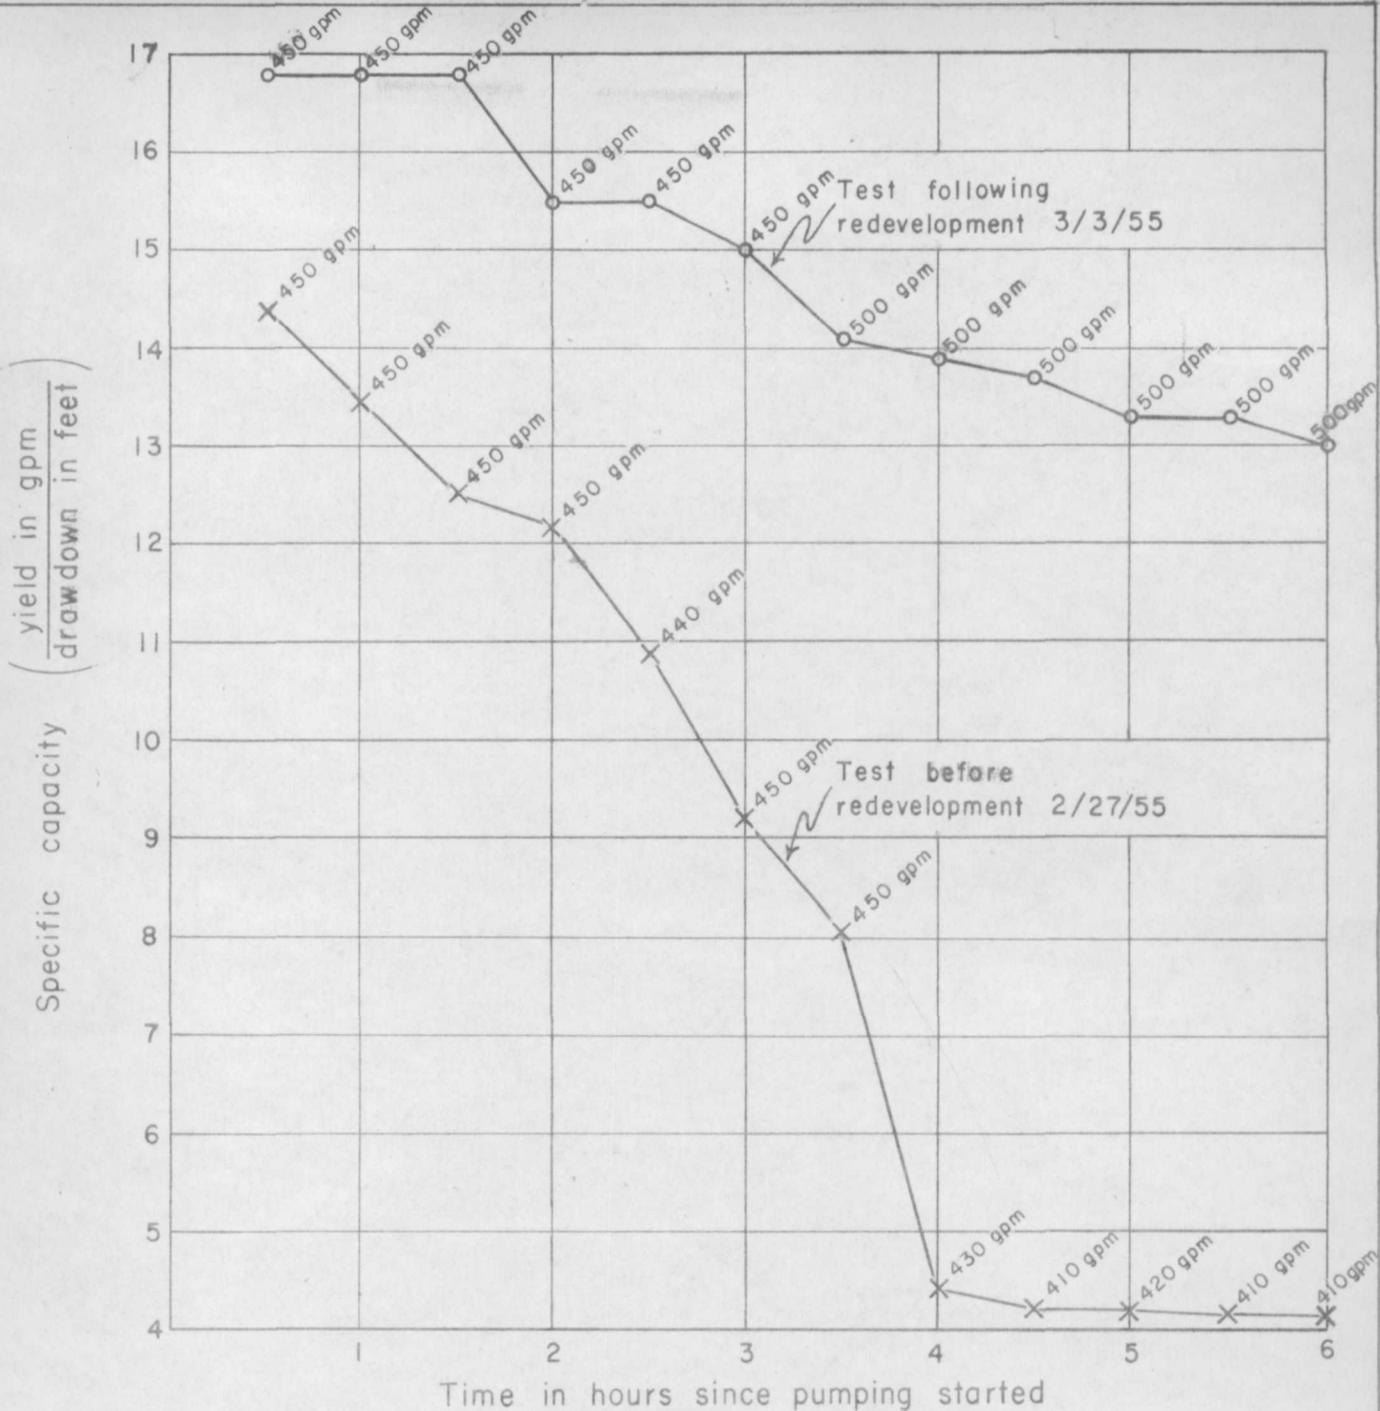
The maximum yield of the well is now about 700 gpm, compared to about 400 gpm before these operations, but it would not be advisable to pump the well at this rate because of the large drawdown that would result and the danger of pumping large amounts of sand. The original gravel used in the well is coarse and poorly sorted, and it is likely that the gravel would continue to pass large amounts of coarse sand at high rates of pumping.

is a graphic plot of the specific capacity of well 10 before and following the redevelopment operations described above.

Figure 2.--Specific capacity curves from pumping test of well 10 before and following rehabilitation

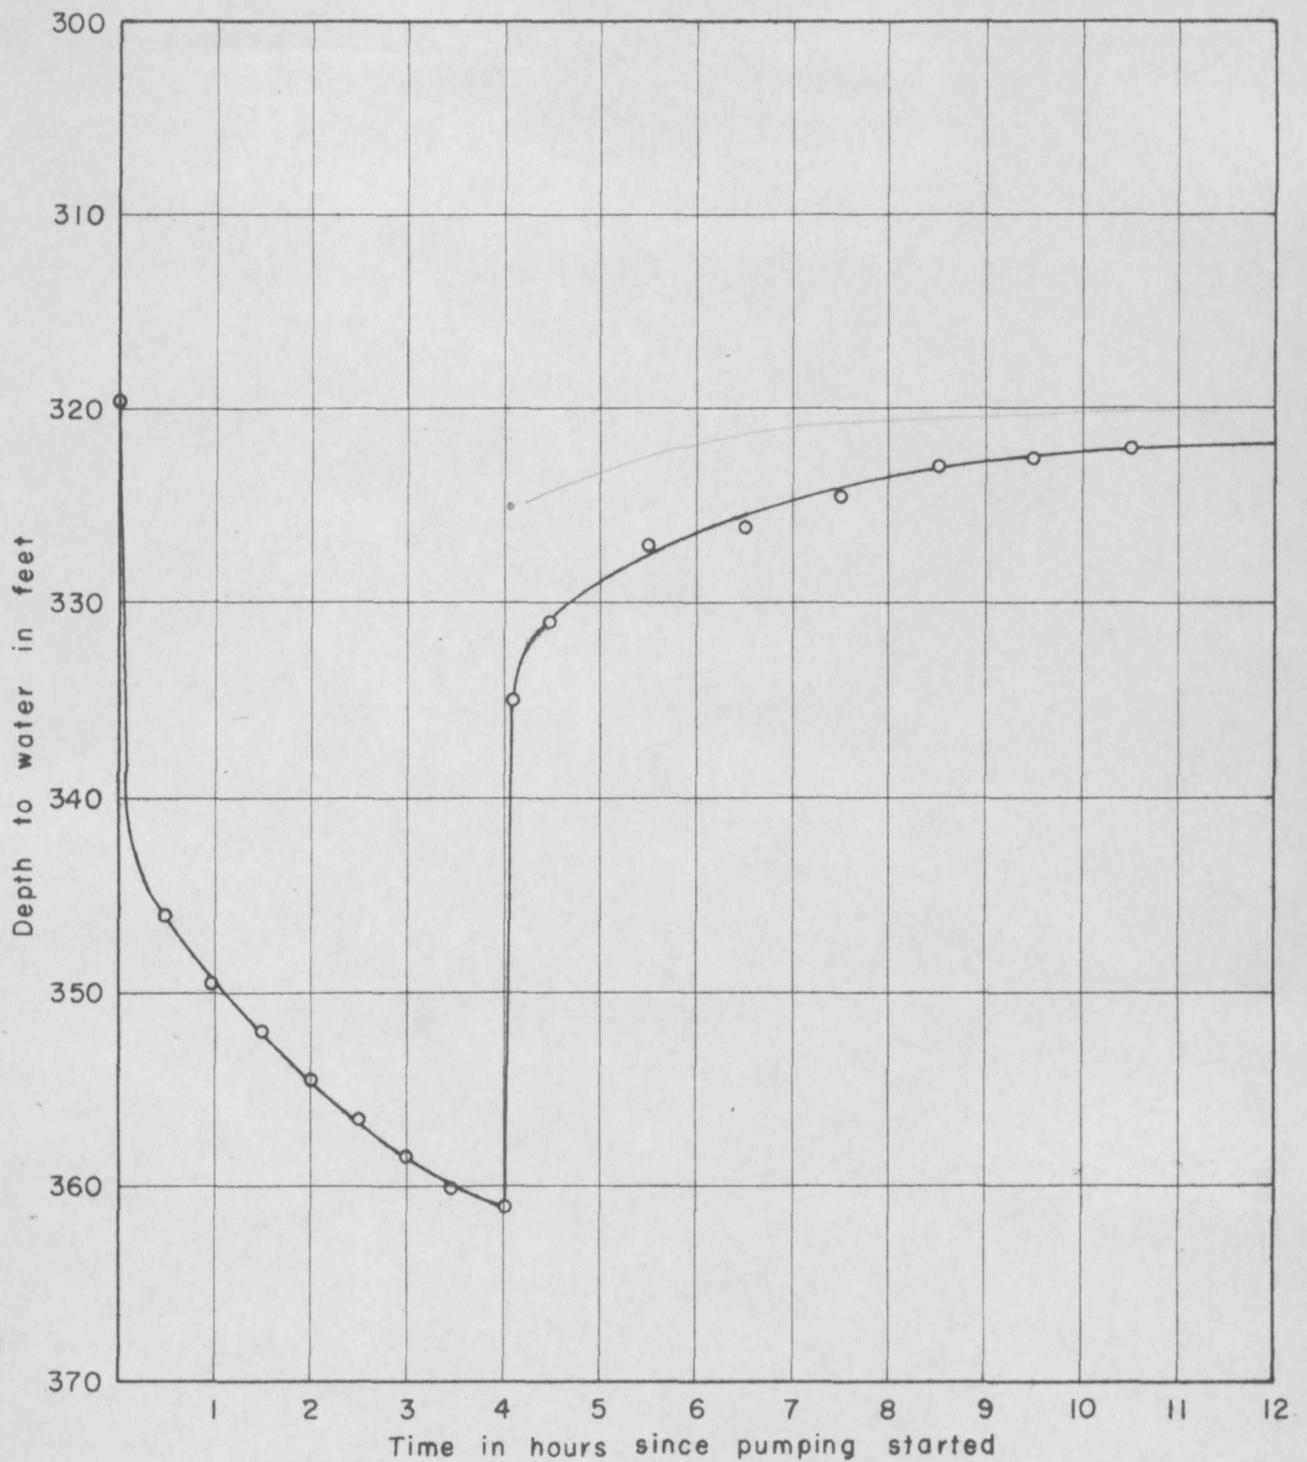
The final pumping test, the results of which are given graphically in figures 3 and 4, indicate that the well should safely produce at

least 400 gpm compared to 250 gpm before rehabilitation was undertaken. The nonpumping water level is about 305 feet, and if the well is pumped at a rate of 400 gpm the drawdown will be approximately 60 feet. It would be advisable to set the pump bowls at a depth of about 450 feet to keep the lower part of the well free of sand and to be certain that the bowls remain well below the pumping water level as the water level declines.

Figure 3.--Drawdown and recovery curves from pumping test of well 11  
on April 6, 1955, following rehabilitation

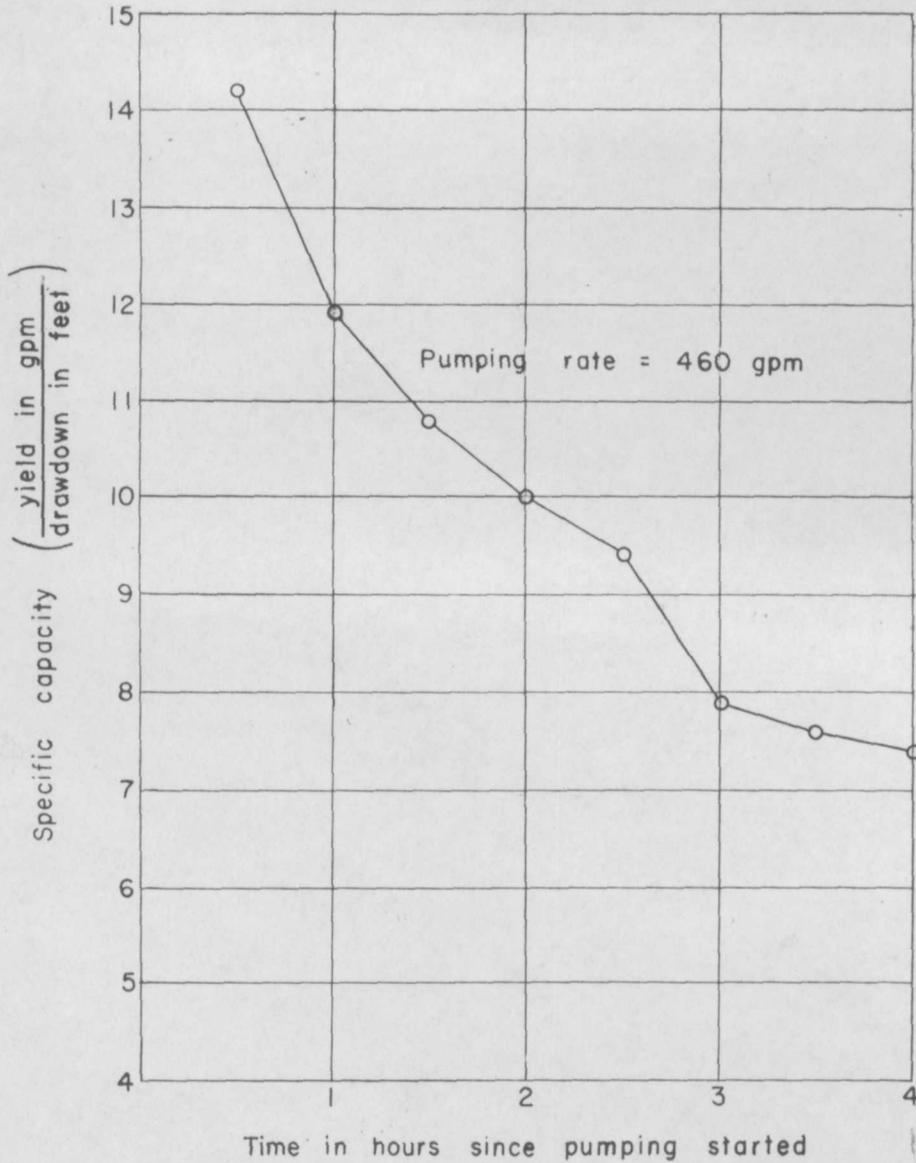
Figure 4.--Specific capacity curve from pumping test of well

11 on April 6, 1955, following rehabilitation

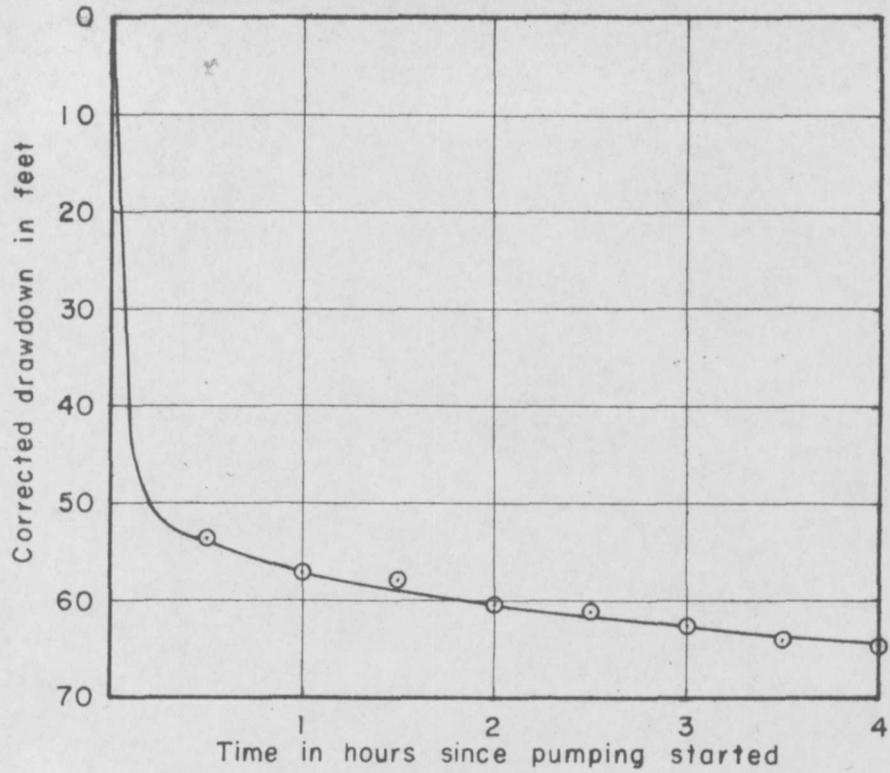
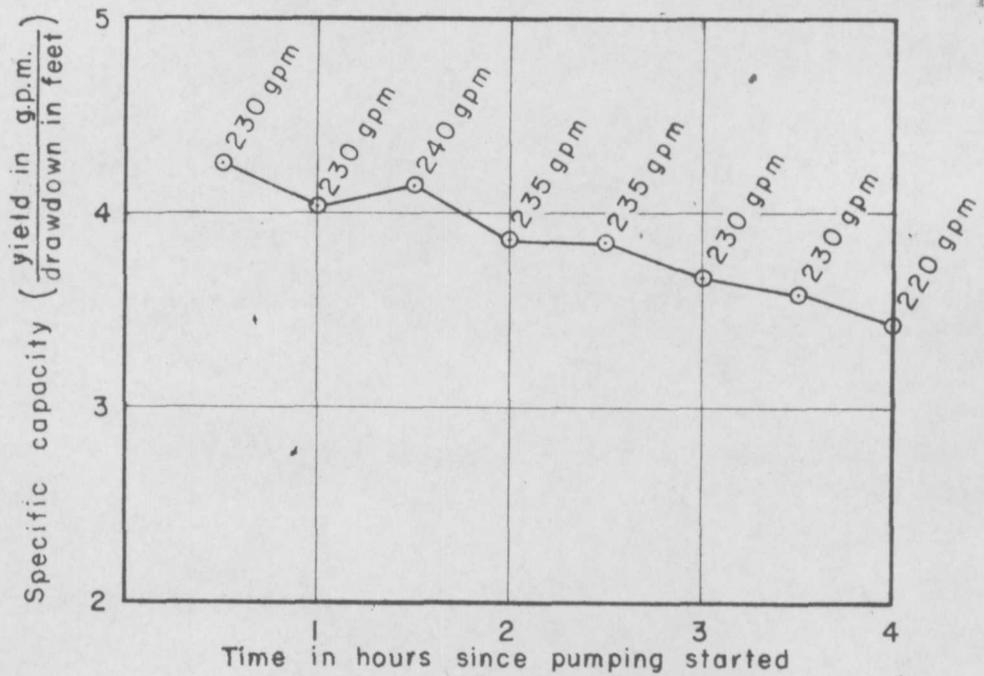
Figure 5.--Curves from pumping test of well 12 on August 7, 1955, following rehabilitation.

From 1:30 p. m. on August 6 until 9:00 a. m. on August 7, the well was not pumped, and the recovering water level was measured frequently with the airline gage. From 9:00 a. m. until 1:00 p. m. on August 7, the well was pumped at an average rate of about 230 gpm and the depth to water was determined frequently with the airline gage. The results of this pumping test are plotted on figure 5.

A.--Drawdown curve

B.--Specific capacity curve

The results of the final pumping test on August 7 following redevelopment are given in figure 5. They indicate that the well had a specific capacity of about  $3\frac{1}{2}$  gpm per foot of drawdown at the end of 4 hours of pumping at a rate of 230 gpm.

The well should at present produce about 250 gpm with about 75 feet of drawdown for short periods of pumping. The well probably should not be pumped at a rate higher than 250 gpm, as a higher rate of pumping may move large quantities of sand into the gravel pack, thus reducing the specific capacity of the well.

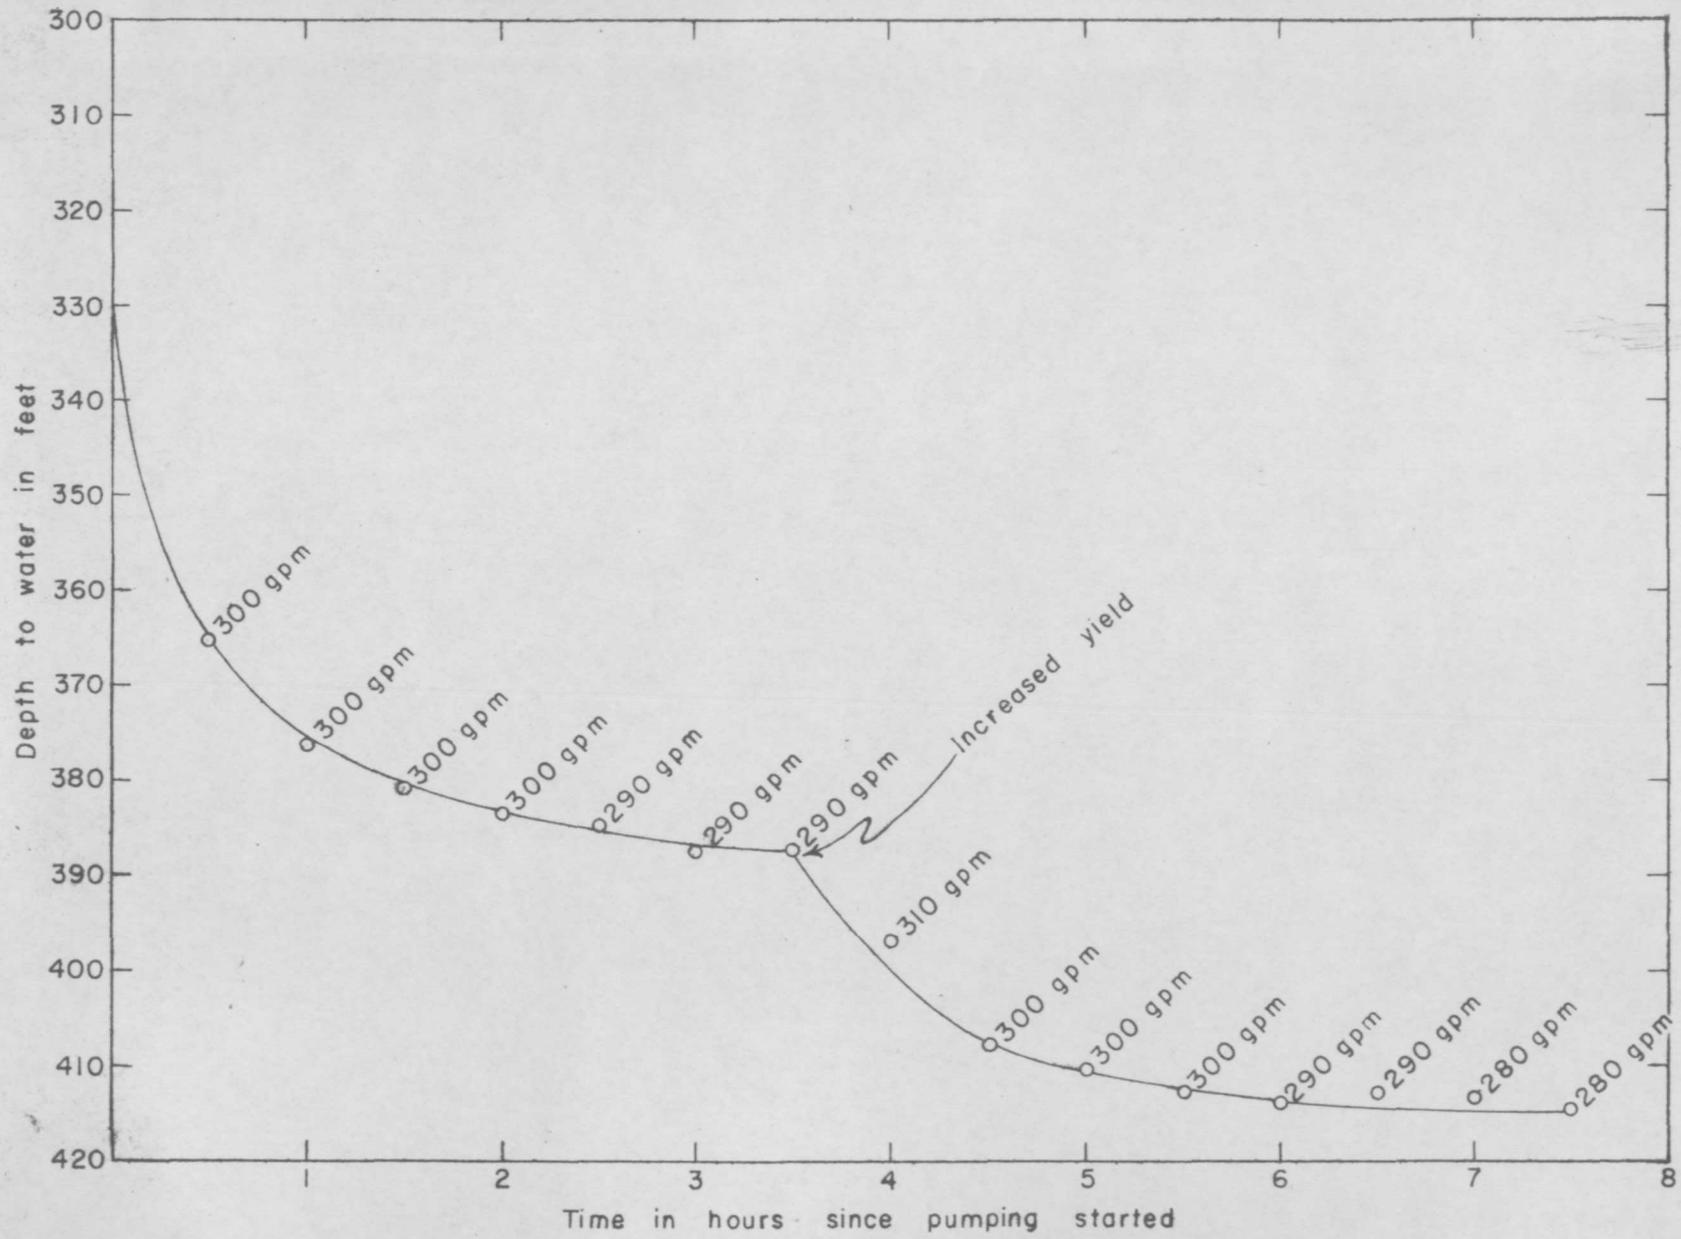
The results of the final pumping test on May 14, 1955 are given graphically in figures 6 and 7. They indicate that the well should

produce 300 gpm with a drawdown of approximately 100 feet. A pumping rate of 250 gpm will, of course, result in a smaller drawdown and will be less likely to move undesirable amounts of sand into the gravel pack. The original pump was set at an adequate depth and, if thoroughly cleaned, should produce somewhat more water than formerly. The life of the well undoubtedly has been increased by stabilizing the gravel pack and by removing large quantities of clay and sand.

Figure 6.--Drawdown curve from pumping test of well 13 on May 14, 1955, following rehabilitation.

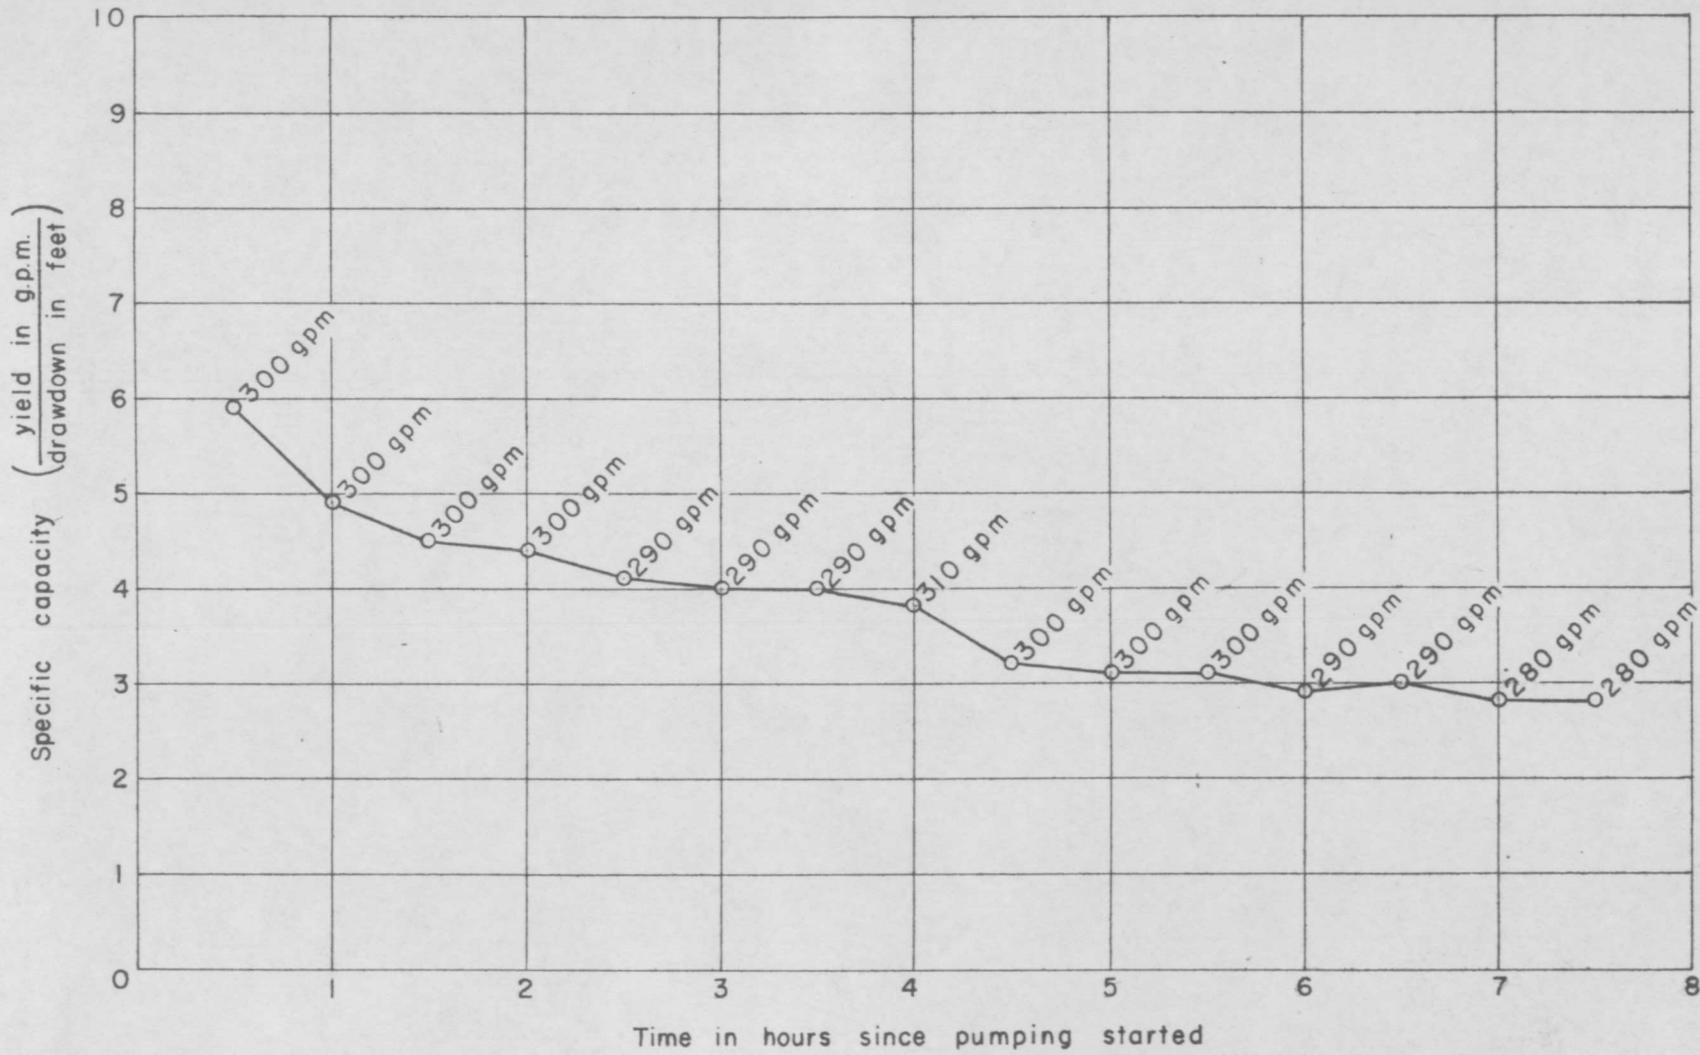
Figure 7.--Specific capacity curve from pumping test of well 13 on May 14, 1955, following rehabilitation.
