GEOLOGY APPLIED TO THE STUDY OF COAL MINE BUMPS AT SUNNYSIDE, UTAH^{1/}

by F. W. Osterwald and C. R. Dunrud^{2/}

ABSTRACT

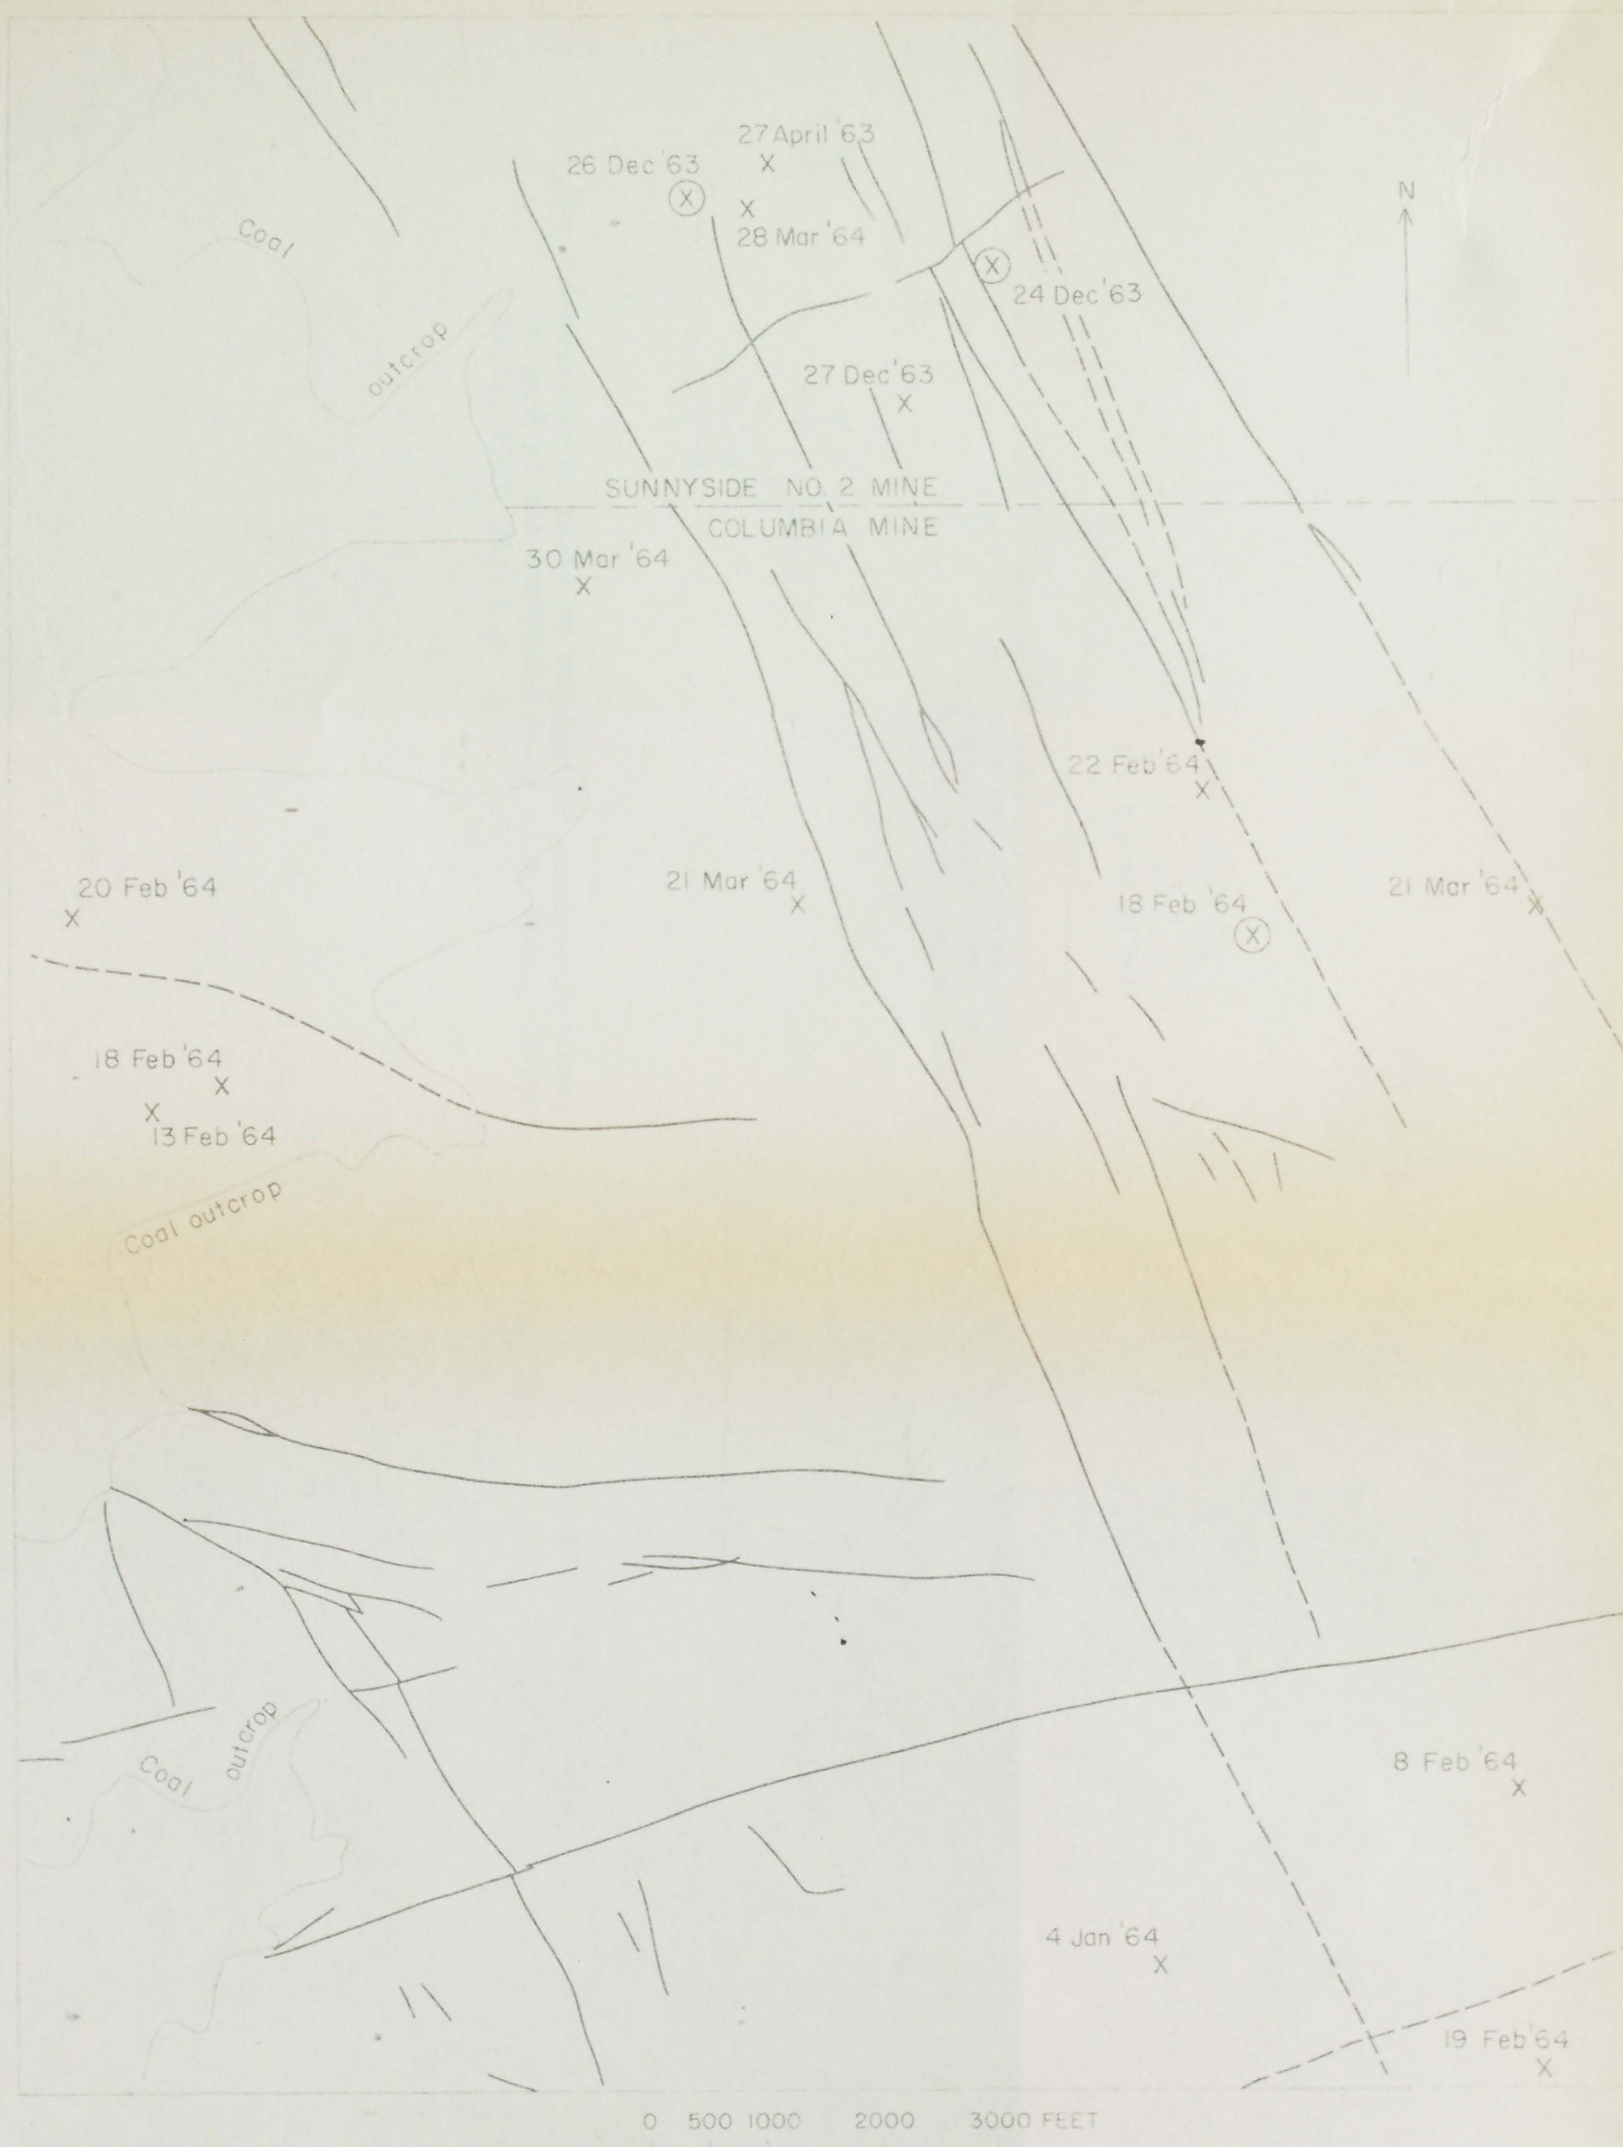
Several lines of evidence suggest a spatial and possibly a genetic relationship between faults and bumps, but this relationship is difficult to establish. Most areas are mined rapidly and abandoned, hence many faults cannot now be observed. Other workings which cut faults, although open, are strongly supported, so that the faults are not visible. Patterns of mining operations in the district are extremely complicated, and natural relationships obscured. Furthermore, apparent spatial relationships between bumps and faults may be merely the result of differential loading from an extremely variable thickness of overburden above the coal. Measurements of fault movement associated with bumps are difficult to make because many locations are inaccessible and because it is hard to predict exactly which places might move. Finally, most bumps can be located only with seismographs, but with our present seismic monitoring network bumps can be located only within about a 500-ft radius. This network and its use are described in a companion paper by Dunrud and Osterwald.³ Centers of many tremors, some of which are known by direct observation to be bumps, have been determined seismically to be within 1000 ft of faults (Fig. 2). Although a center 1000 ft from a fault cannot be definitely related to the fault, we assume it to be because the theoretical accuracy of our seismic network (500 ft radius) is not always achieved.

Figure 2.--Horizontal position of faults cutting Lower Sunnyside coal seams at depth in parts at Columbia and Sunnyside No. 2 mines. Locations of seismically recorded tremors indicated by X. Tremors known to be bumps by direct observation indicated by circled X. Lower level mine workings are not shown on map. Cover varies from 0 ft (coal outcrop) to about 2000 ft. Dashed lines indicate inferred faults.

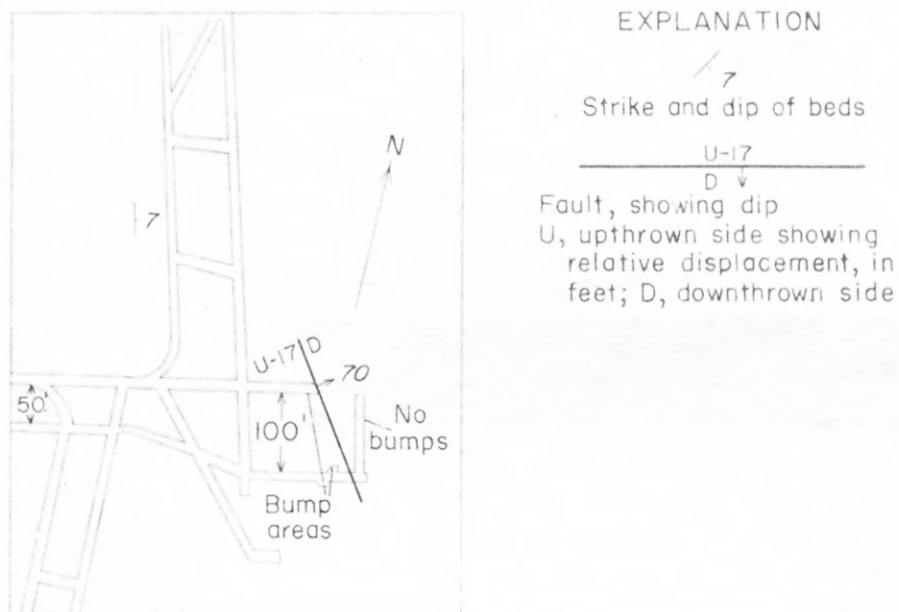
The relation between bumps and faults has been observed during mining in some workings of the Sunnyside district. For example, when a slope in the Sunnyside No. 2 mine (Fig. 3) and a rock tunnel in the Sunnyside No. 1 mine were being driven, many bumps occurred as faults were approached, but few bumps occurred after the workings passed through the faults.^{4,5}

Figure 3.--Relation of fault to bumping and non-bumping areas in part of the Sunnyside No. 2 mine, Utah. (After Watts, 1918, fig. 2.)

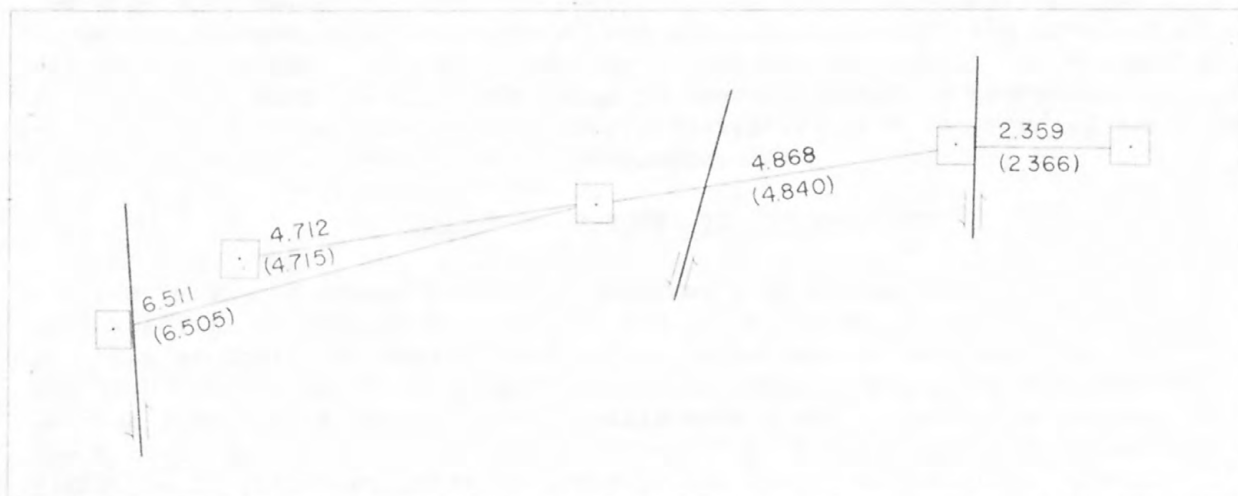
A series of surface and underground observations was made to study possible spatial and genetic relationships between bumps and movements along the Sunnyside fault zone (Fig. 1). Index marks were scribed in July 1960 on the ends of 5 roof bolts in an old air return which crosses several small faults in the upthrown side of the Sunnyside fault zone (Fig. 4). After a violent bump in the No. 1 mine on May 6, 1961, distances between the index marks were remeasured. Distances between all the bolts had changed, and the total distance across the measured span was shortened by 0.027 ft as shown by the numbers in parentheses on Fig. 4, implying that movement occurred within the fault zone, probably during the bump. We cannot say definitely that this movement occurred during the bump without having had continuous recording instruments with accurate timing. The area in which the measurements were made is no longer accessible, and no additional measurements are possible.

Figure 4.--Distances measured between roof bolts before and after violent bump, May 6, 1961. Vertical section near the roof of northwest side of air return, across small faults in upthrown side of Sunnyside fault zone, in the Sunnyside No. 1 mine, Utah.

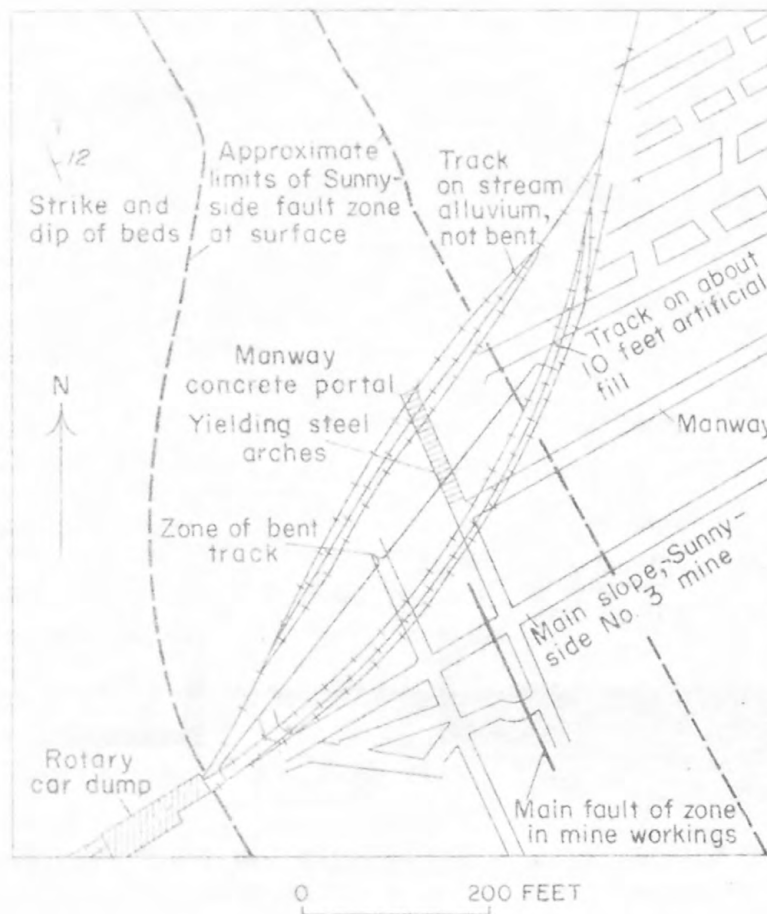
Movement on the Sunnyside fault zone that probably occurred during bumps can also be measured at the surface. Rails on the haulage road from the Sunnyside No. 1 mine to the car dump are frequently bent horizontally and vertically where the track crosses the fault zone (Fig. 5). Levels and positions of marked points on the rails were determined in July 1961. A bump occurred along a manway about 20 ft beneath the track on the following day. Levels and positions of the marked points on the track were remeasured immediately. Horizontal movements of as much as 0.1 ft and vertical movements of about 0.05 ft were found. Although bending of the track is commonly attributed by miners to subsidence of loose material into the manway, most bending takes place across a broad area where the track crosses the fault zone (Fig. 6) and is not restricted to the vicinity of the portal. Furthermore, after the July 1961 bump no loose material or evidence of subsidence could be seen in the manway, indicating that the bending resulted from fault movement and not from subsidence.

Figure 6.--Relationship of bent track to Sunny-side fault zone above manway, Sunny-side No. 3 mine.

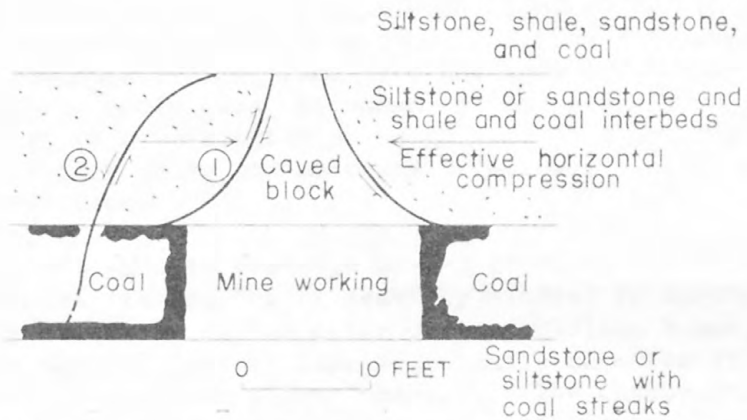
Figure 7.--Shear failure (1) of massive roof rock under inferred horizontal compression, followed by violent shear failure along symoidal fractures (2) that increase in dip downward.

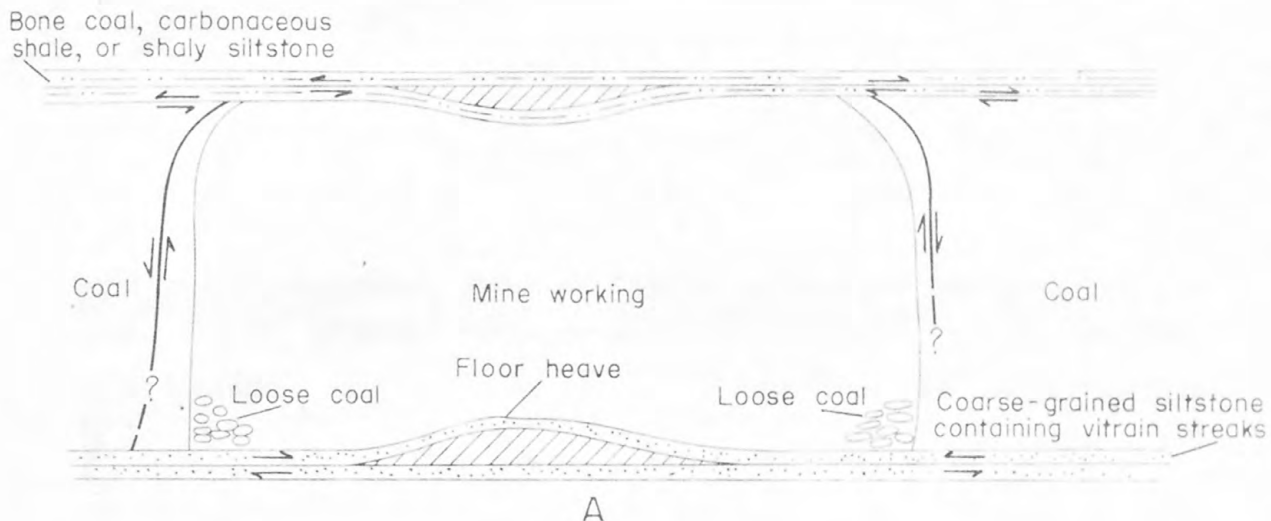
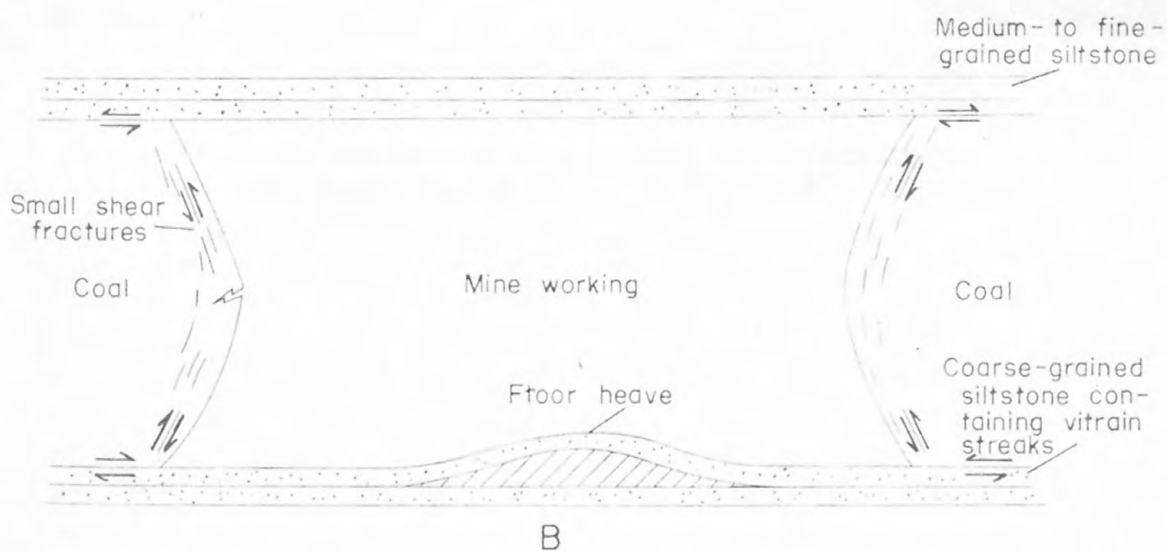
Ribs in the Sunnyside mines commonly fail in one of two ways. Where coal is free to slip beneath the roof, cymoidal shear fractures form within the ribs, but where coal adheres to the roof the ribs bulge and buckle (Fig. 8). Most bumps result from failure along cymoidal fractures, but loose coal is thrown down from some bulged ribs during bumps. Commonly one rib will fail along cymoidal shear fractures whereas the opposite rib will fail by bulging and buckling, which implies that coal is free to slip beneath the roof in one direction, but not in the other direction. This probably results from original sedimentary features in the bedding surfaces, such as ripple marks, channel fills, load casts, crossbeds, and slump structures, which impart pronounced but variable differences to the frictional properties of the surfaces in different directions. Such directional differences in the frictional properties of bedding surfaces may be the cause for many other observed differences in the deformation of opposite sides of mine workings in the Sunnyside No. 1 mine⁶ and in the Sunnyside No. 2 mine.⁵ In general, southeast ribs of slopes and downdip ribs of entries and crosscuts are deformed more and show more effects of bumps than northwest ribs and updip ribs, although in many places the reverse is true. Movement of coal into workings also is greater from downdip and southeast ribs than it is from updip and northwest ribs, which gives many workings an asymmetric appearance.

Figure 8.--Relation of common types of rib failures to lithology of roof rocks, Sunnyside district, Utah. A. Cymoidal fractures in rib where coal is free to slip beneath roof of bone coal, carbonaceous shale, or shaly siltstone. B. Bulged and buckled ribs where coal adheres to siltstone or where slip is impeded by sedimentary structures in the roof.

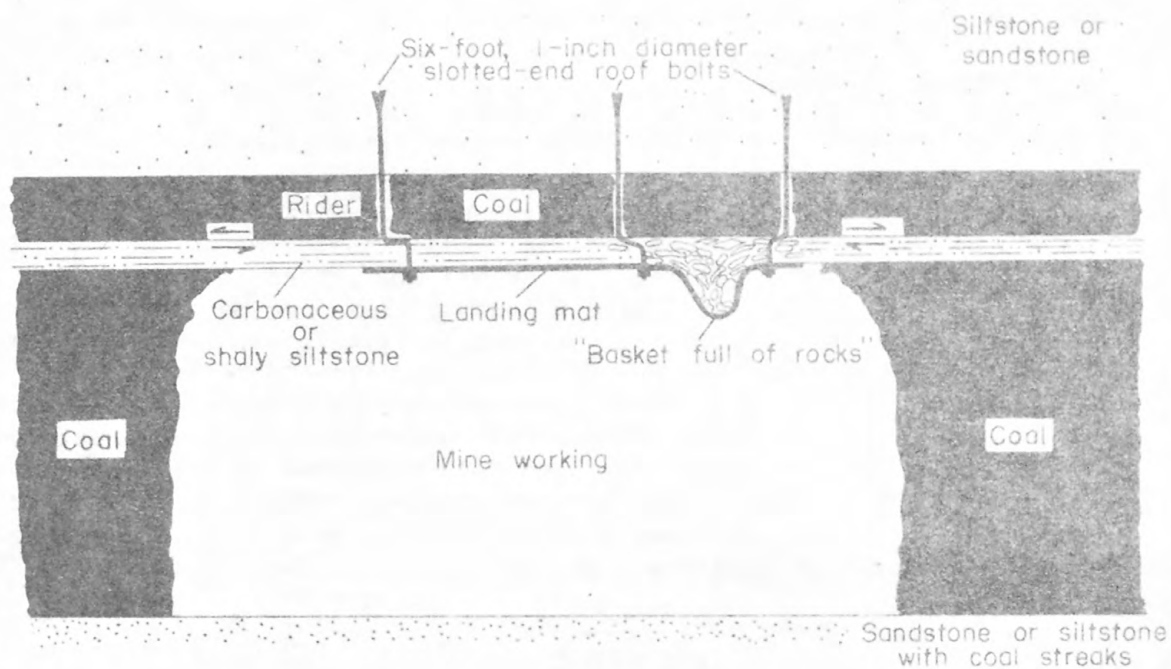
Figure 9.—Cross section showing failure of carbonaceous siltstone roof along linear belt with "baskets full of rocks."

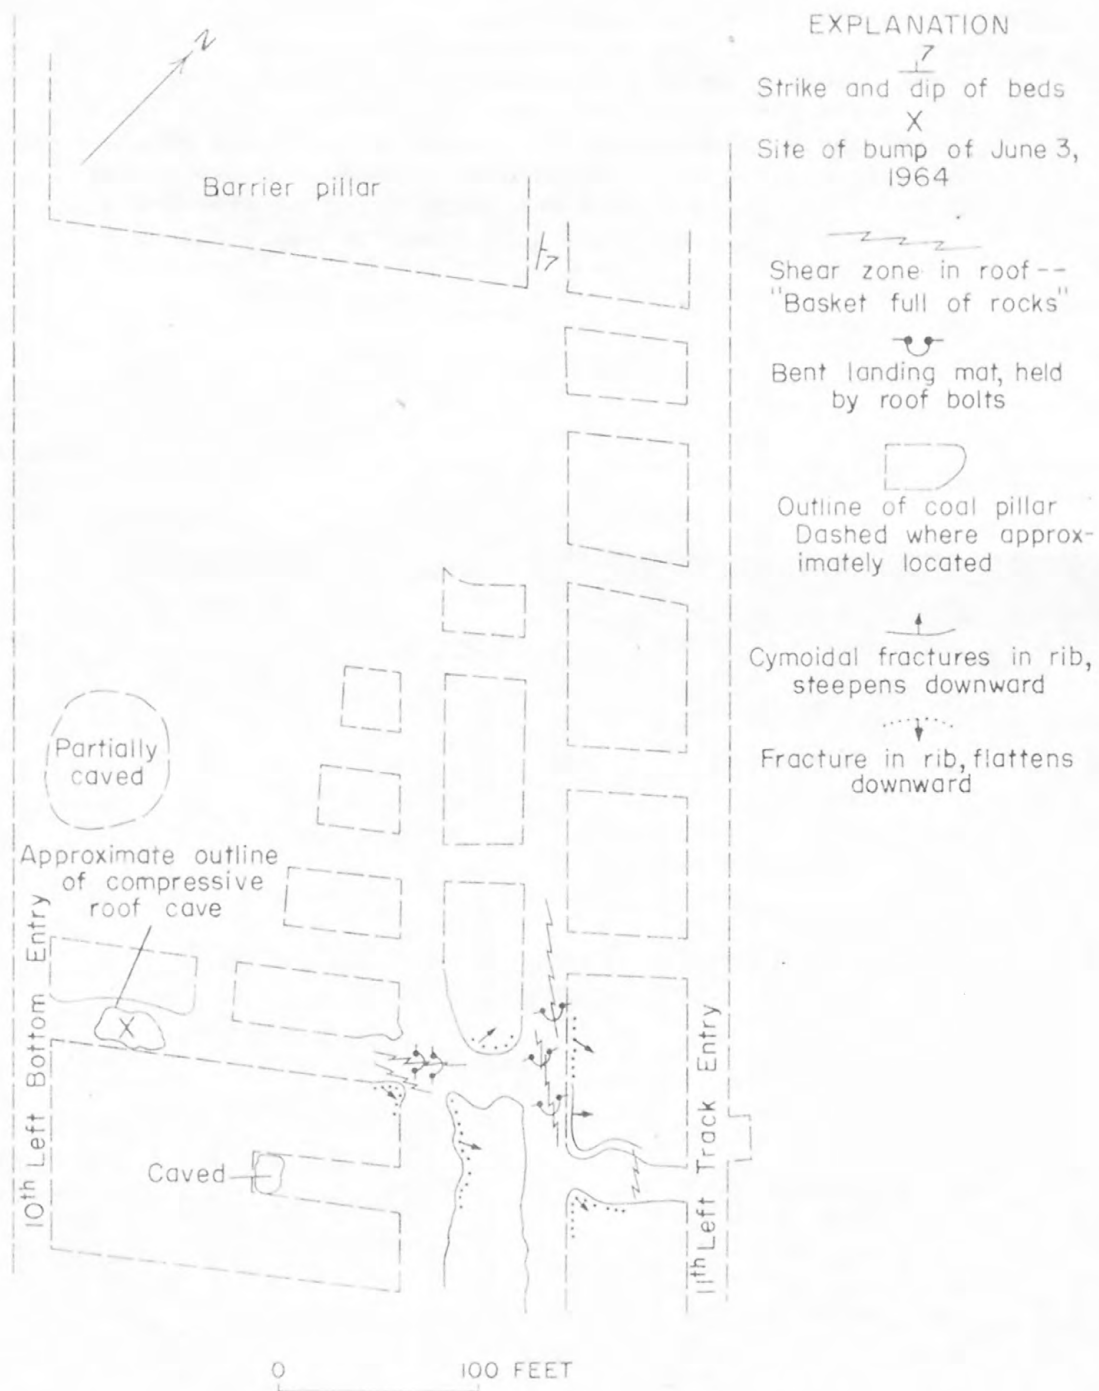
Figure 10.--Map of the northwest end of the 11th left entry, Sunnyside No. 1 mine, Utah.

One recent bump in the Sunnyside No. 1 mine illustrates these points (Fig. 10). A new retreating pillar line was started at the northwest end of the 11th left entry, leaving a large barrier pillar. Several rooms were driven, and pillar extraction was proceeding. The roof, however, had only partially caved, and in general, the massive siltstone had not caved. Consequently, additional stress was thrown on the working pillars, and a damaging bump took place at the point shown by X in Fig. 10. The bump consisted of violent failures of both roof and ribs, and probably included compressive shear failure of the roof and failure of ribs along cymoidal fractures. Subsequent geologic mapping showed that there had been considerable movement of carbonaceous siltstone into workings, and that shear zones ("baskets full of rocks") had formed in two directions at very acute angles to directions of the workings.
