RECENT SURFACE MOVEMENTS THROUGH JULY 1962

IN THE BALDWIN HILLS, LOS ANGELES COUNTY, CALIFORNIA

Staff, Geological Survey

January 1964

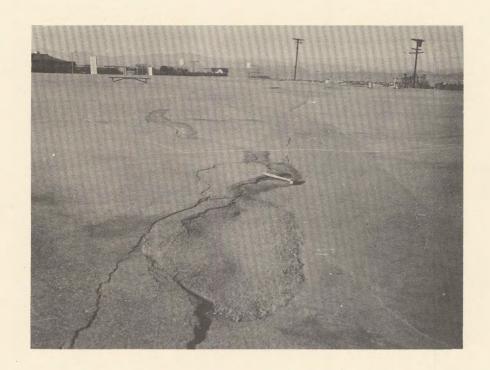
Some cracking may have begun as early as 1955, but this possibility has not been documented. In May of 1957, Professor F. C. Converse (1961, oral communication), a consulting foundation engineer, examined Crack I (figure 2) in a large compacted fill on the east side of Stocker Street. Within about a week he found that the crack extended southward through a school yard (see figure 5) and eventually the

Maximum vertical displacement on the five known cracks has occurred along Cracks I and II. According to one report, up to 4 inches of "cracking" had been observed in the school yard athwart Crack I by November 1957 (D. R. Brown, 1962, oral communication). Since November 1957, vertical movement on Crack I has exceeded 2 inches; therefore, the maximum displacement through July, 1962, may have been as much as 6 inches. The total movement on Crack II through January 1961 was about 4 inches, and by the middle of 1962 the total displacement amounted to a minimum of 5 inches. The displacement has resulted in disruption of pavement and foundations (see figures 5 through 7).

Figure 5.--Photograph showing extensive, locally broken, patching along major earth Crack I where it passes through school yard north of Overhill Drive.

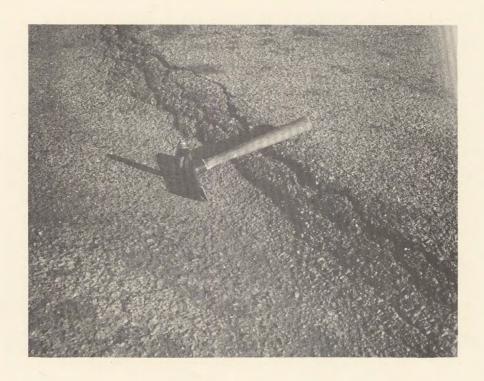
1963, however.) Characteristics of the movement on Crack II are

shown in figure 6, a photograph taken in a parking lot in January 1961.

Within a few months after resurfacing the lot, movement was again

observed on Crack II.

Figure 6.--Close-up photograph of major earth Crack II.

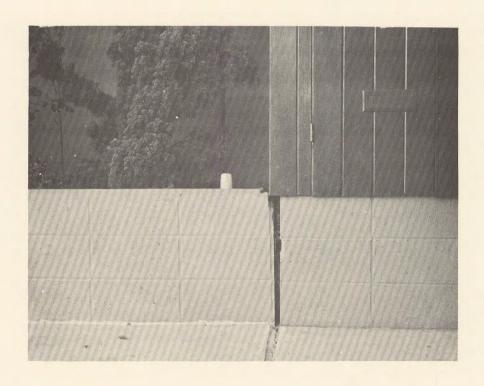
Figure 7.--Photograph of damaged residential foundation lying athwart major earth Crack I.

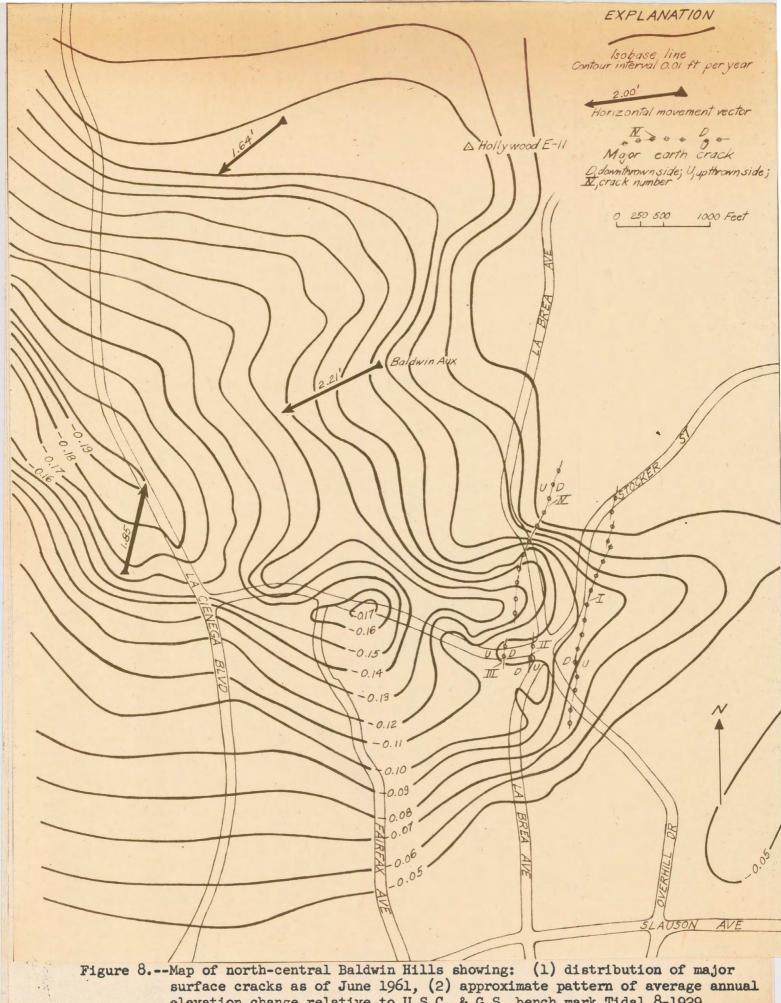
Information on the surface movement in the Baldwin Hills area recently has been summarized by the Los Angeles Department of County Engineer. A synoptic representation of these data as of June 1961 is given in figure 8, to which has been added the location of Cracks numbers I through IV. According to the Department of County Engineer,

the point of maximum annual subsidence established in this compilation is about 300 feet west of the area shown on figure 8. On figure 8, the shown later of vertical movement, shown by the isobase lines, is based on averaged values for individual survey stations in which the periods of observation vary from station to station. Thus, whether or not the particular point used in constructing the isobase lines shown on figure 8 is represented as experiencing rapid movement may be a function in part of the period of observation of the precise leveling. Furthermore, data compiled for individual stations reveal cases of apparent (though generally minor) reversals of movement during the total observation period so that even sense of movement locally might prove a function of the selected observation period.

Nevertheless, the combination of points of long observation with those of short observation is such that figure 8 probably represents the general character of vertical movement as of the date of compilation.

The relative horizontal movement of FRM Baldwin Aux. is shown on figure 8 and is based on a 1961 retriangulation of this point, relative to its position determined by a 1934 Cooperative Control survey of the metropolitan Los Angeles area (Alexander, 1962, p. 2469). Other horizontal movement vectors shown on figure 8 were determined from secondary triangulation related to the 1961 position of Baldwin Aux. A fourth vector has been determined for a point (not shown on figure 8) about 7,000 feet N. 52° W. from Baldwin Aux. Horizontal movement at this point is 0.95 foot S. 7° W. (Alexander, p. 2473).

surface cracks as of June 1961, (2) approximate pattern of average annual elevation change relative to U.S.C. & G.S. bench mark Tidal 8-1929 San Pedro as of June 1961, (3) horizontal movements relative to base line east of the Baldwin Hills for period 1934 to 1961.

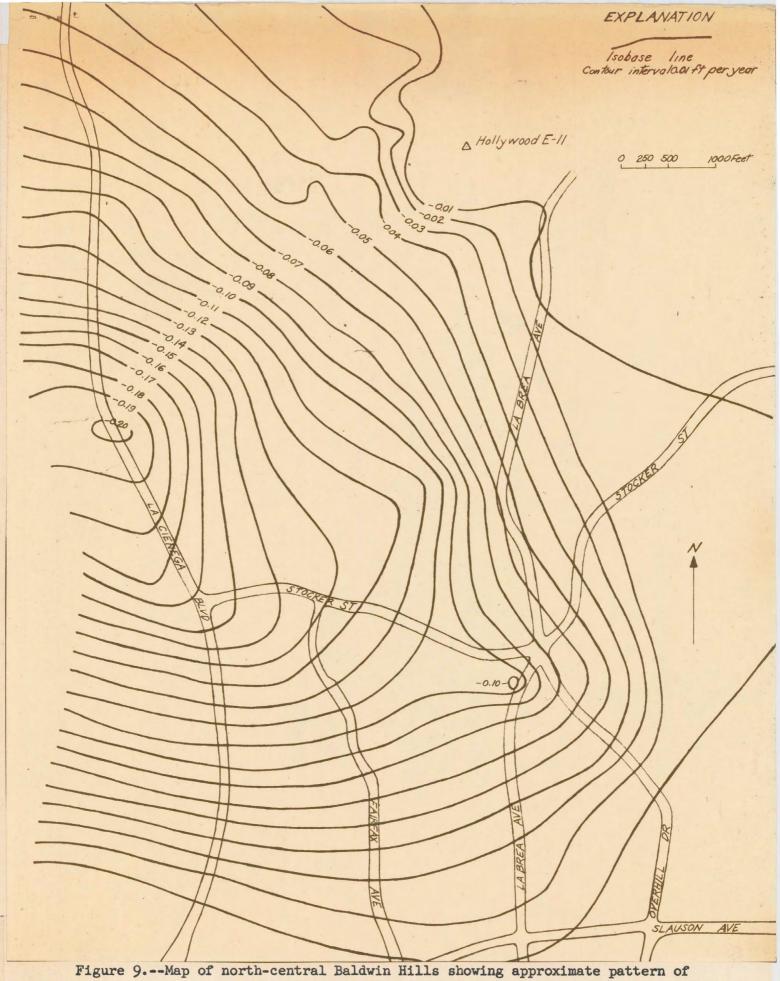
The approximate pattern of average annual elevation change in the north-central Baldwin Hills for the period 1950-54, as compiled by the Department of Water and Power, is shown on figure 9. According to Hayes' report of 1955 (1962, oral communication) the elevations of 174 precise bench marks had been established in the northern Baldwin Hills by 1950, chiefly within the area of figure 9. The 1950-54

period consequently became the first in which the dencity of stations was considered high enough to contour the relative nevement over the area shown. It is apparent that for the 1950-54 interval the general pattern of movement, relative to Hollywood E-11, was negative and more or less concentrically disposed around a point near the western edge of the map. The isobase pattern, moreover, is elongated comewhat along a northwest-southeast line roughly paralleling the axis of the Inglewood oil field structural dome.

The major difference in the movement patterns shown on figures 9 and 10 for the periods 1950-54 and 1954-50, respectively, is near the Stocker Street-La Brea Avenue-Cverhill Drive intersection. comparison of the survey data shows that in this area the isobase gradient increased sharply after 1954. Although the graben-like structures defined by Cracks I and IV is crudely reflected by the isobase pattern on figure 10, this relation cannot be clearly established without additional information. A minor difference in the isobase patterns between figures 9 and 10 is shown in the wedge-shaped

Figure 9.--Map of north-central Baldwin Hills showing approximate pattern of average annual elevation change relative to bench mark Hollywood E-ll for period 1950 to 1954.

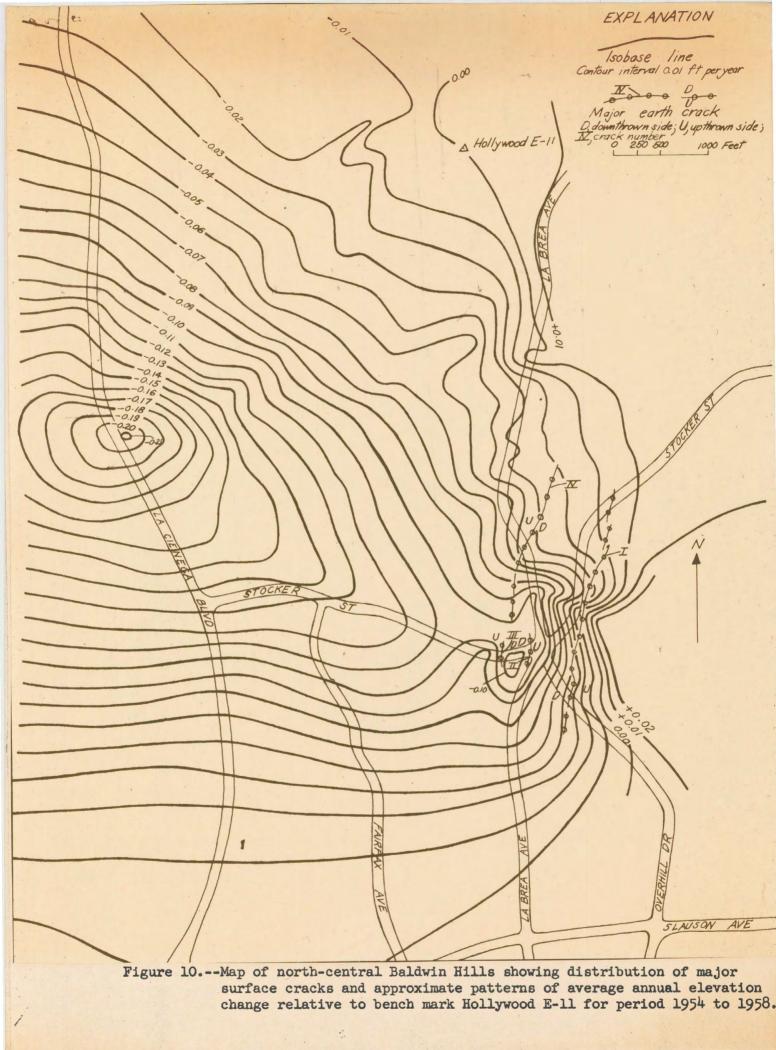
Toward the end of 1960 when it had become apparent that movement along some of the major earth cracks was continuing, the Department of Water and Power ran an interim series of precise level circuits in the area of cracking. Figures 11 and 12 present two interpretations of the pattern of average annual elevation change for the period 1958-60 based on the results of these interim surveys. Figures 11 and 12 differ between themselves only in the area extending north-northeast from the La Brea Avenue-Stocker Street-Cverbill Drive intersection; figure 12 shows a trough defined by more or less parallel isobases of negative movement whereas figure 11 shows a much more irregular configuration. However, figures 11 and 12 differ significantly from figure 10 in the same area. Figure 10 shows decreasing subsidence toward the northnortheast, whereas in figures 12 and 11, subsidence is represented as being more uniform or perhaps increasing respectively to the north along a zone crudely defined by a northward extension of Cracks I and IV. It must be stressed, however, that this indicated difference between figure 10 and figures 11 and 12 does not necessarily imply a change in the movement pattern between the two survey periods. Interpolation of isobase lines between widely separated control points is a subjective process, and prior to 1958 very few precise elevations hed been recorded northeast of the La Brea Avenue-Stocker Street intersection. A relationship of possible significance that shows up

on figure 12 and, to a lesser extent, on figure 11, is that a sharp break in the rate of vertical movement parallels Crack IV, but this break is displaced 150 to 200 feet east rather than being coincident with the crack. This anomaly may be a reflection of abatement of movement along Crack IV and the eastward shift of more pronounced subsidence. The evidence is inconclusive, but broken pavement and sagging curbs noted in the fall of 1961 suggest incipient cracking along a zone approximately 150 feet east of the northern reaches of Crack IV.

Figure 11.--Map of north-central section of Baldwin Hills showing distribution of major surface cracks and approximate pattern of average annual elevation change relative to bench mark Hollywood E-11 for period 1958 to late 1960. (Compiled by Department of Water and Power.)
