APPRAISAL OF NEAR-SURFACE SUBSIDENCE CRACKS
ON THE PANOCHÉ CREEK FAN, FRESNO COUNTY, CALIFORNIA

By William B. Bull 1930 -

Prepared in cooperation with the
California Department of Water Resources

OPEN-FILE REPORT

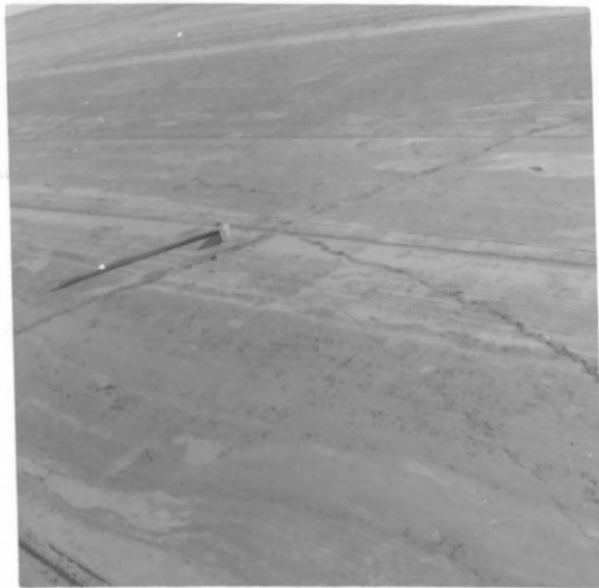
cracks intersect the first crack above the head of the mattock. The prominent horizontal bands and lines are the result of the trimming operation. The undulating bands are bedding; the moist clayey beds being darker than the drier sandy beds. A possible offset of about 2 inches is shown by the thin clay bed and the top of the thick clay bed in front of the 3-foot mattock handle. Other than this, offset of bedding or cracks is not apparent in the photograph.

surface subsidence occur only when the cracks encircle two or more adjacent centers of maximum differential settlement. Cracks around a single source of wetting, such as a test plot, do not intersect. Intersecting near-surface subsidence cracks have been observed in the vicinity of two adjacent test plots, and near irrigation ditches that were used at different times and were at right angles to one another. Intersecting cracks were fairly common along the canal--cracks without offset are shown in figure 2 and cracks with offset are shown in figure 9B.

Figure 2.--Intersecting crack fillings in trimmed
bank of canal at station 1927+30 L. Ma
is 3 feet long.

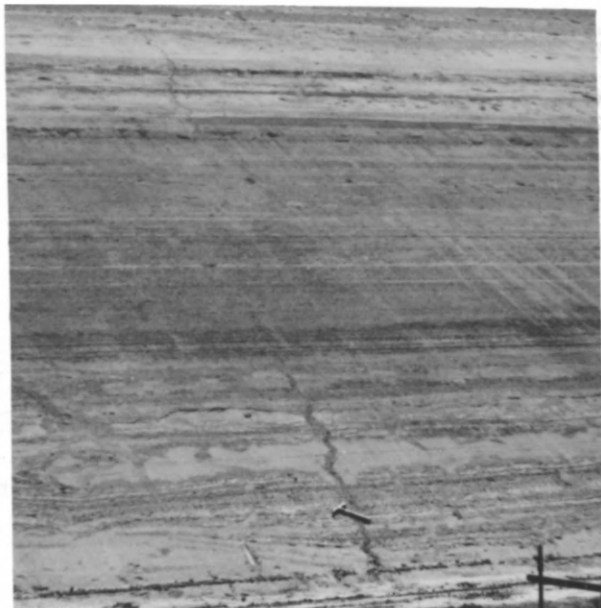
Many of the crack fillings extend up to the base of the tilled zone, which in some places had fragments of cotton plants or other vegetation. Compacted artificial fill was above the tilled zone and was easily distinguished from the bedded fan deposits under it. Many cracks died out below the tilled zone, indicating that they were discontinuous. In some reaches, the cracks extended to the tilled zone on one side of the canal but only part way up the other side of the canal (fig. 4A). The crack filling in figure 3 extends to the base of

Figure 3.--Crack filling at station 1929+40R. Photograph
by Merritt Bradley, U.S. Bureau of Reclamation.

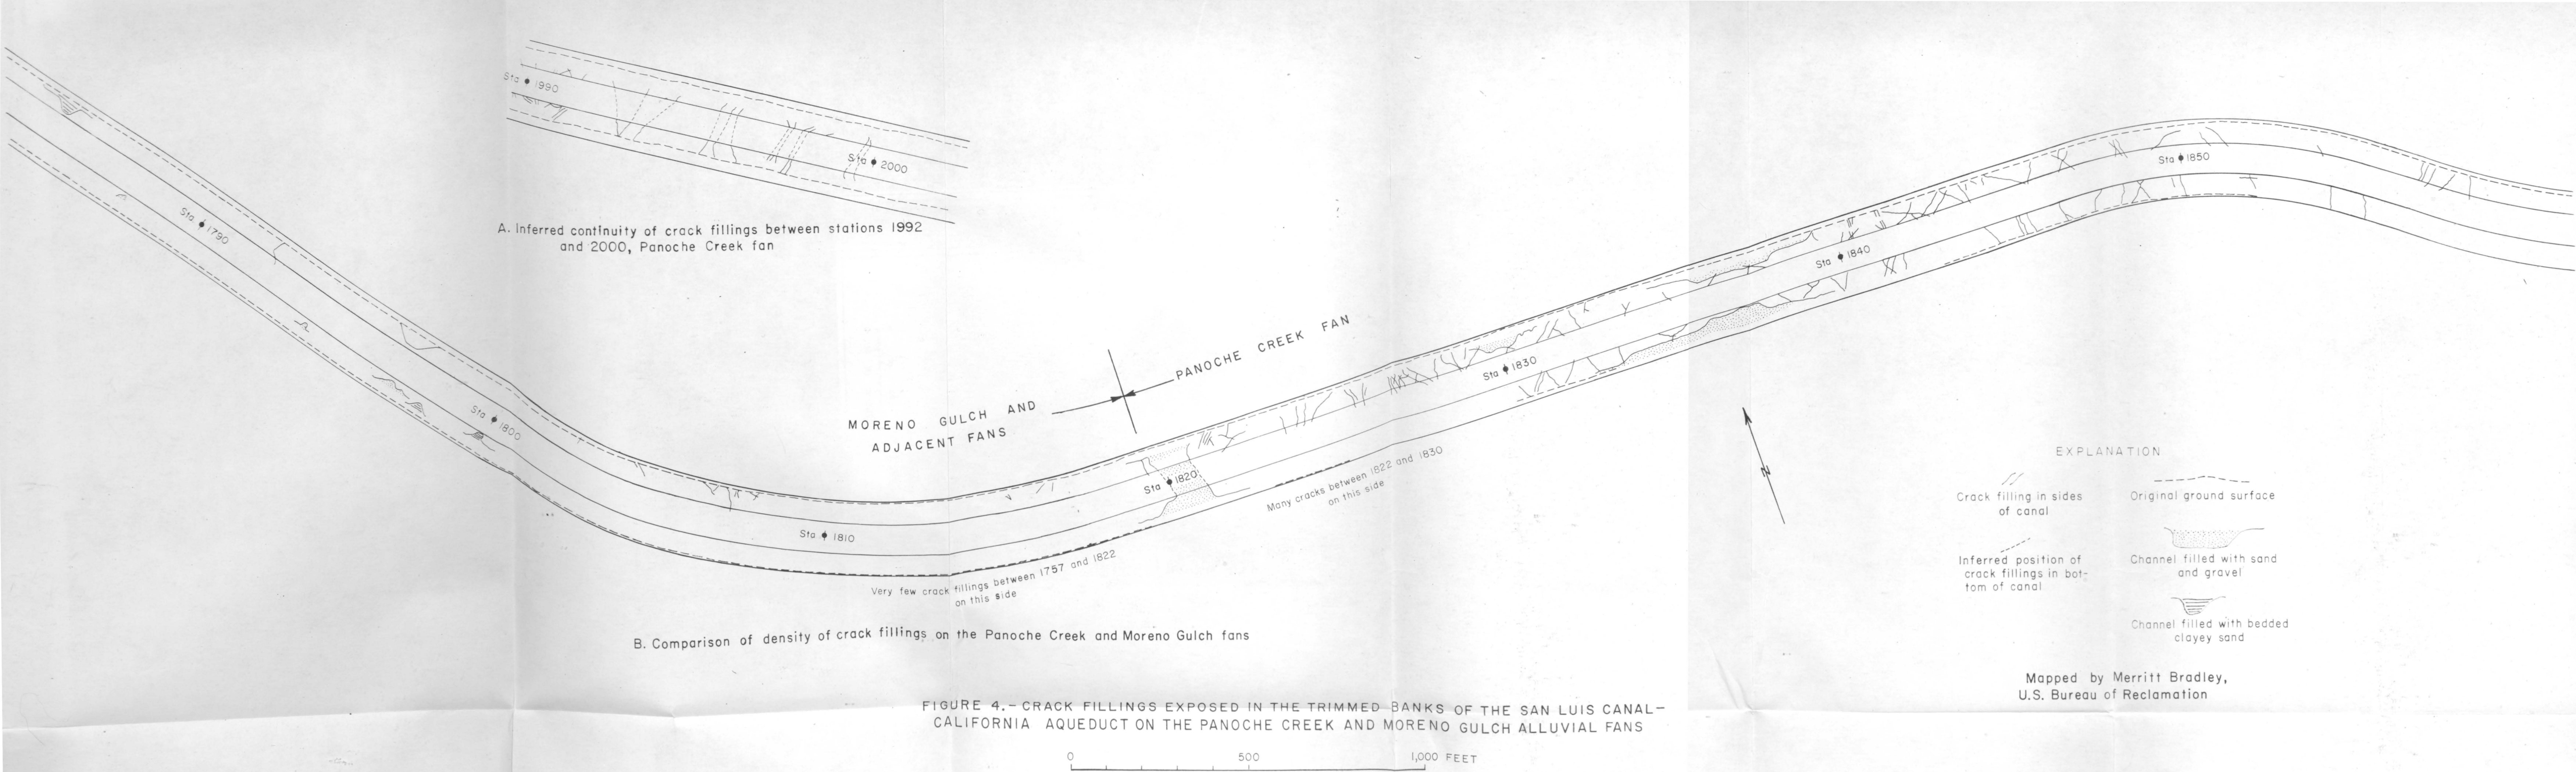
shown in the bottom of the canal between these stations. For 800 feet, not only the bearing, but also the number of cracks match from one side of the canal to the other, despite the fact that the banks of the canal slope in opposite directions.

A. Inferred continuity of crack fillings between stations 1992 and 2000, Panoche Creek fan.

B. Comparison of density of crack fillings on the Panoche Creek and Moreno Gulch fans.

The density of spacing of the cracks is very low on the Moreno Gulch and adjacent fans. The parts of these fans shown in figure 4B are representative of the crack spacing on the Moreno Gulch fan farther to the northwest. On the central part of the Moreno Gulch fan only 30 cracks were mapped in the left bank in 5,500 feet. Figure 4B shows that the distance between crack fillings decreases abruptly as the canal enters the Panoche Creek fan. The difference in the density of the cracks can be explained by differences in the application of water. On the Moreno Gulch fan, large areas were brought under irrigation at the same time, and because the deposits tended to be wetted uniformly, differential settlement was at a minimum. Maximum differential settlement probably occurred along supply ditches because they were flooded more of the time than the fields. Compaction due to prehistoric flows on Panoche Creek would produce a high density of cracking even if the amounts of subsidence were less than on the Moreno Gulch fan. Large areas would not be wetted at the same time by the stream; instead, different sections of the fan would be wetted along radial lines as the stream changed position on the fan. Cracks would form between the areas that settled and the areas that remained stable.

FIGURE 4.- CRACK FILLINGS EXPOSED IN THE TRIMMED BANKS OF THE SAN LUIS CANAL- CALIFORNIA AQUEDUCT ON THE PANOCHÉ CREEK AND MORENO GULCH ALLUVIAL FANS

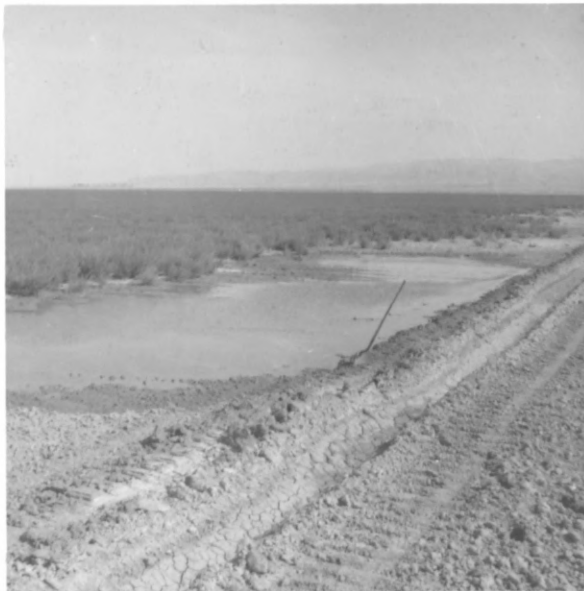
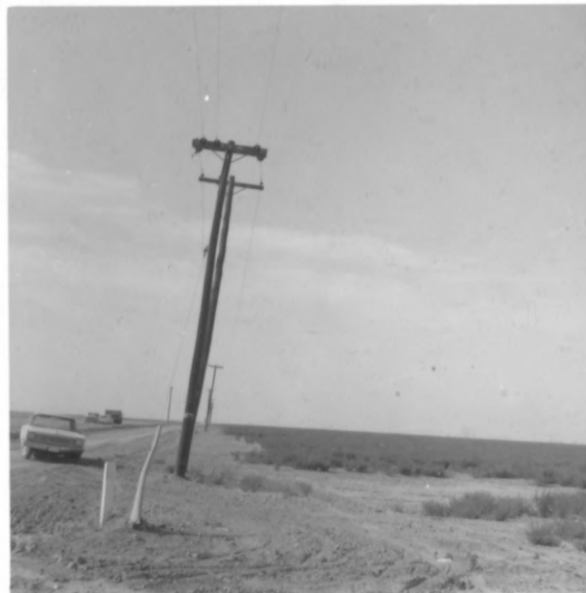
Figure 5.--Near-surface subsidence features on the Panos
 fan. Location shown on figure 1. A. Water in sub
 hollow along old ditch alinement. Fan slope is tow
B. Powerline poles tilt toward subsidence hollow a
 site. Fan slope is toward the right.

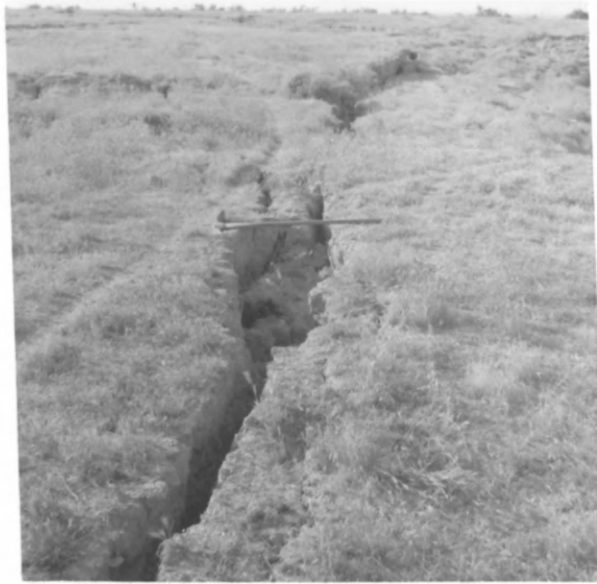
A. Mendota Test Site.

the crack width is a function of both variation in separation of the crack, and of slumpage of material into the crack. Figure 6B shows a similar crack in the canal bank that has been filled with clay. Cracks that divide and join, such as those shown in figure 7A, usually are the result of sec-

Figure 6.--Variation in width of near-surface subsidence

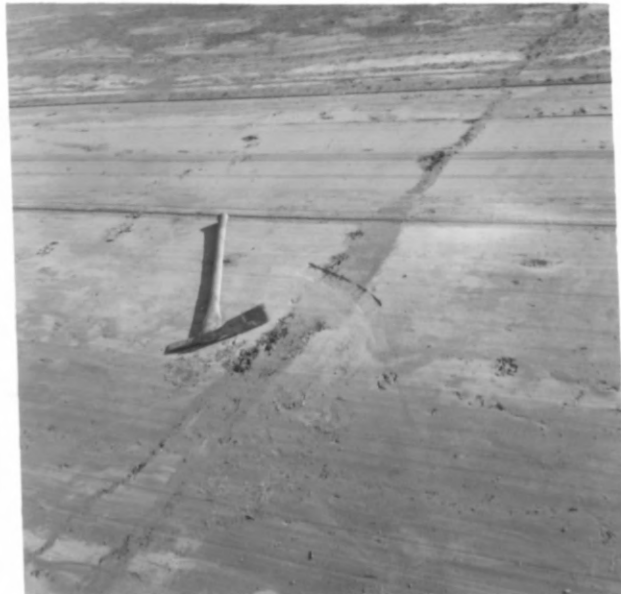
B. Panoche Creek fan, looking up 2-to-1 slope
bank at station 1921L.

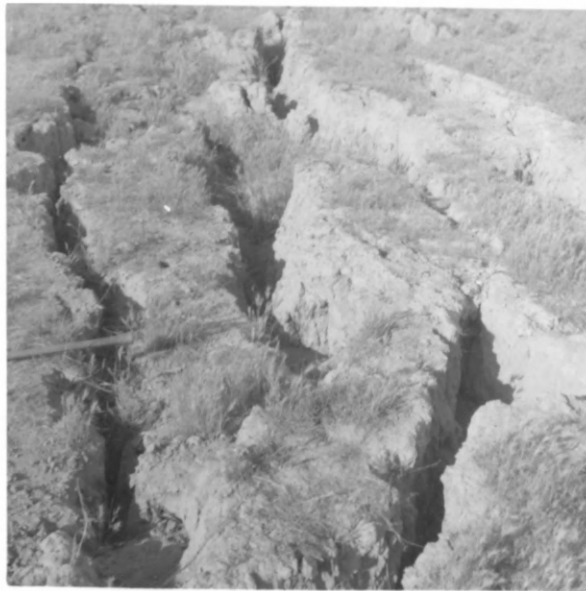
A. Mendota Test Site.

ondary slumping that occurs after the primary crack has opened. Similar features were common in the canal banks. En echelon crack patterns are one of the less common patterns, but can be observed both around test plots and in the canal banks, as is shown by figure 8. Cracks that intercept and

Figure 7.--Anastomosing near-surface subsidence cracks

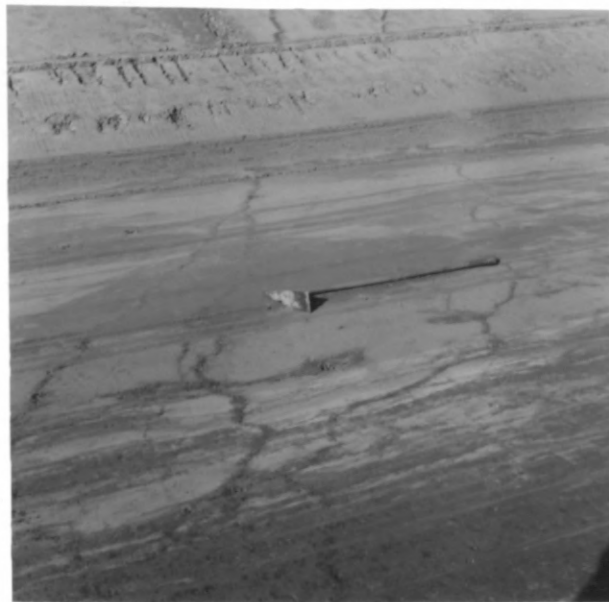
B. Panoche Creek fan. Looking down 2-to-1 slope
bank at station 1923+40L.

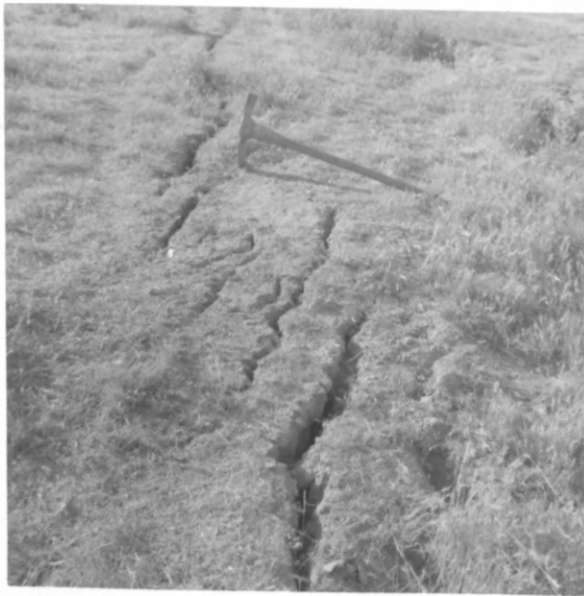
A. Mendota Test Site.

Figure 8.--En echelon near-surface subsidence cracks.

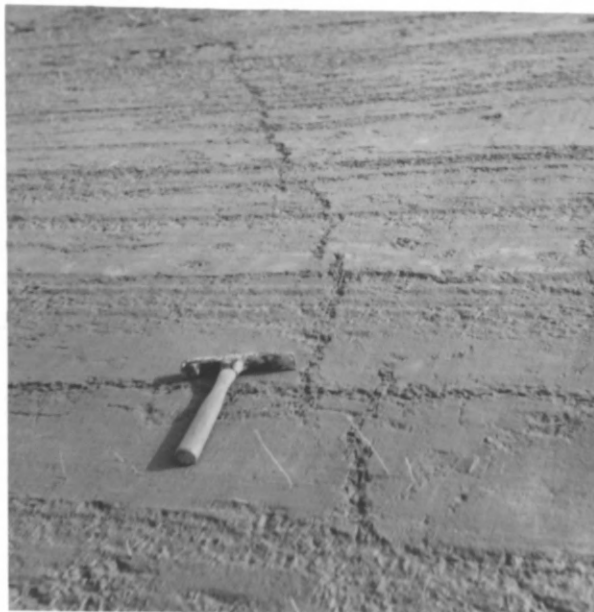
B. Panoche Creek fan. Looking up 2-to-1 slope
bank at station 1846+83L. Photograph by M
Bradley, U.S. Bureau of Reclamation.

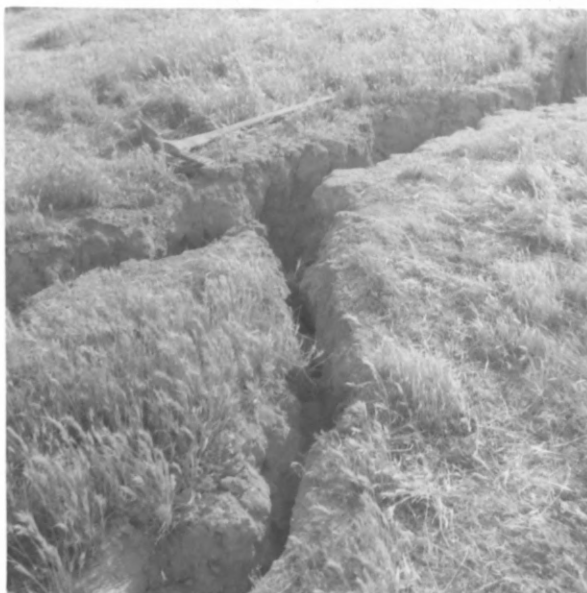
end abruptly at another crack are common both at test plots and along the canal on the Panoche Creek fan. An example at the Mendota test site is shown in figure 9A. Intersecting cracks resulting from near-

A. Intercepting cracks at the Mendota Test Site

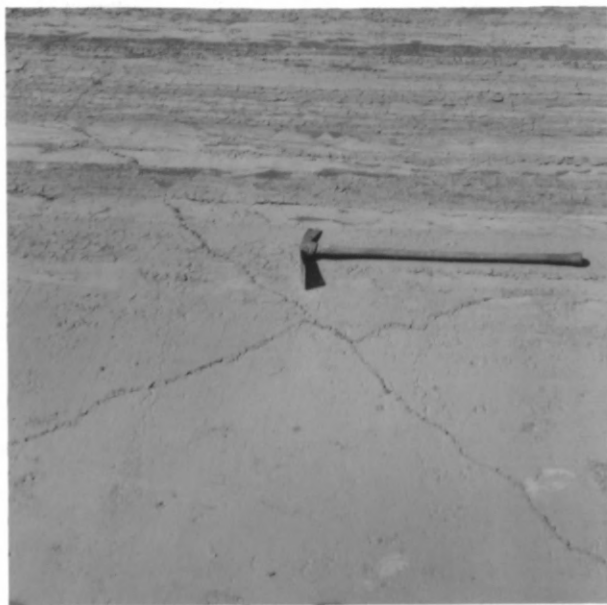
Individual cracks show a variety of patterns. Some divide and join repeatedly, and others split into many small cracks that die out within a short distance. A few en echelon crack patterns were noted. Many of the cracks end abruptly at another crack, or cannot be traced through a bed that is the same lithology as the crack filling. The cracks usually occur in sets that parallel each other, and in some places two sets occur that intersect each other. Most of the crack intersections do not show displacement on the trimmed slopes. The cracks that are offset usually are displaced less than 3 inches, but displacements of 6, 12, and 21 inches were noted on three cracks. (See fig. 9B.)

B. Intersecting cracks on the Panoche Creek fa
up the 2-to-1 canal bank at station 1974+

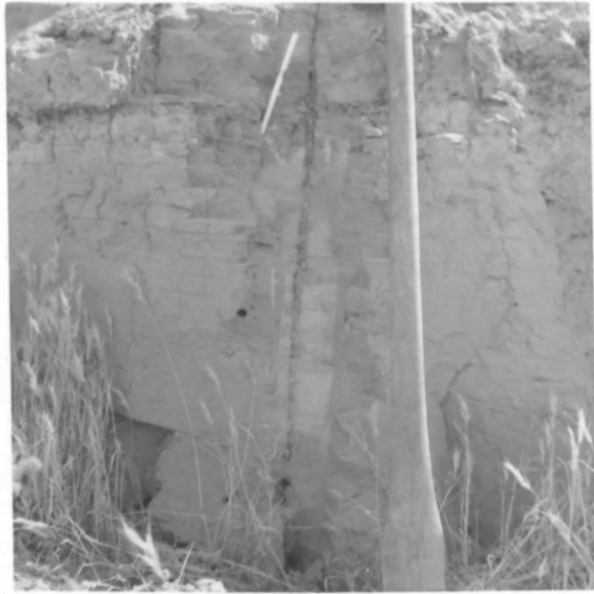
Crack fillings also were found in the banks of Panoche Creek. Cracks in reaches of the stream which was trenched as of 1854 cannot be attributed to irrigation by man, because the stream had the same course in 1854 that it does now, and irrigation did not begin until the 1880's. One of the prehistoric crack fillings is shown in figure 10.

The crack fillings are similar to those in the canal banks. They are filled with laminated clay, which has a polygonal pattern of cracking normal to the plane of the crack, are vertical, and trend roughly normal to the contours of the fan. Exposures of the cracks are not common in the banks of the stream because the cracks roughly parallel the overall stream course. Those that were found were in meandering reaches of the stream.

Figure 10.--Prehistoric near-surface subsidence crack filling in the bank of Panóche Creek.
