UNITED STATES
DEPARTMENT OF THE INTERIOR
GEOLOGICAL SURVEY
WATER RESOURCES DIVISION

CAUSES OF FLOODING OF LITTLE CHARLEY BOWLEGS
CREEK UPSTREAM FROM HIGHLANDS HAMMOCK
STATE PARK, FLORIDA

OPEN-FILE REPORT

68-196

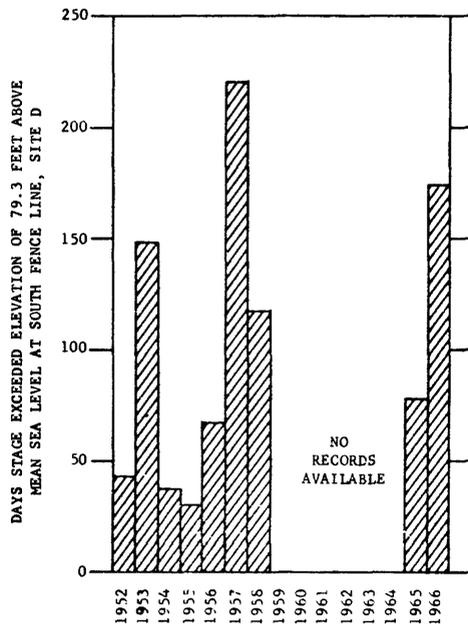
Periods of flooding between Sites D and E are shown on figure 3. The duration of this flooding may be as long as four months. The stage at which flooding occurs is based on the following field observations made in July 1967. On July 6, 1967, the park superintendent observed some flooding on low-lying pasture near the county bridge at Site E (fig. 4), 2-1/2 miles upstream from Site D. Gage height at Site D was 17.1 feet (79.4 feet above msl). Discharge at Site A was 70 cfs. On July 7, 1967 the stage at Site D was 17.3 feet or 79.7 feet above msl when an upstream land owner requested that boards be removed from the dam. The top row of boards was removed on July 7. Discharge at Site A was 92 cfs before boards were removed on this date. Bottom row of boards was removed on July 8. On July 11, 1957 a Geological Survey engineer noted some flooding near the county bridge at Site E (fig. 4) at a stage of 17.1 feet or 79.4 feet above msl at Site D. Discharge at Site A was 46 cfs with no boards on the dam. These observations establish that 79.3 feet above msl or 17.0 feet on the staff-gage at Site D is the approximate level above which flooding is expected in the vicinity of Site E.

Figure 3. Days of flooding between Sites D and E.

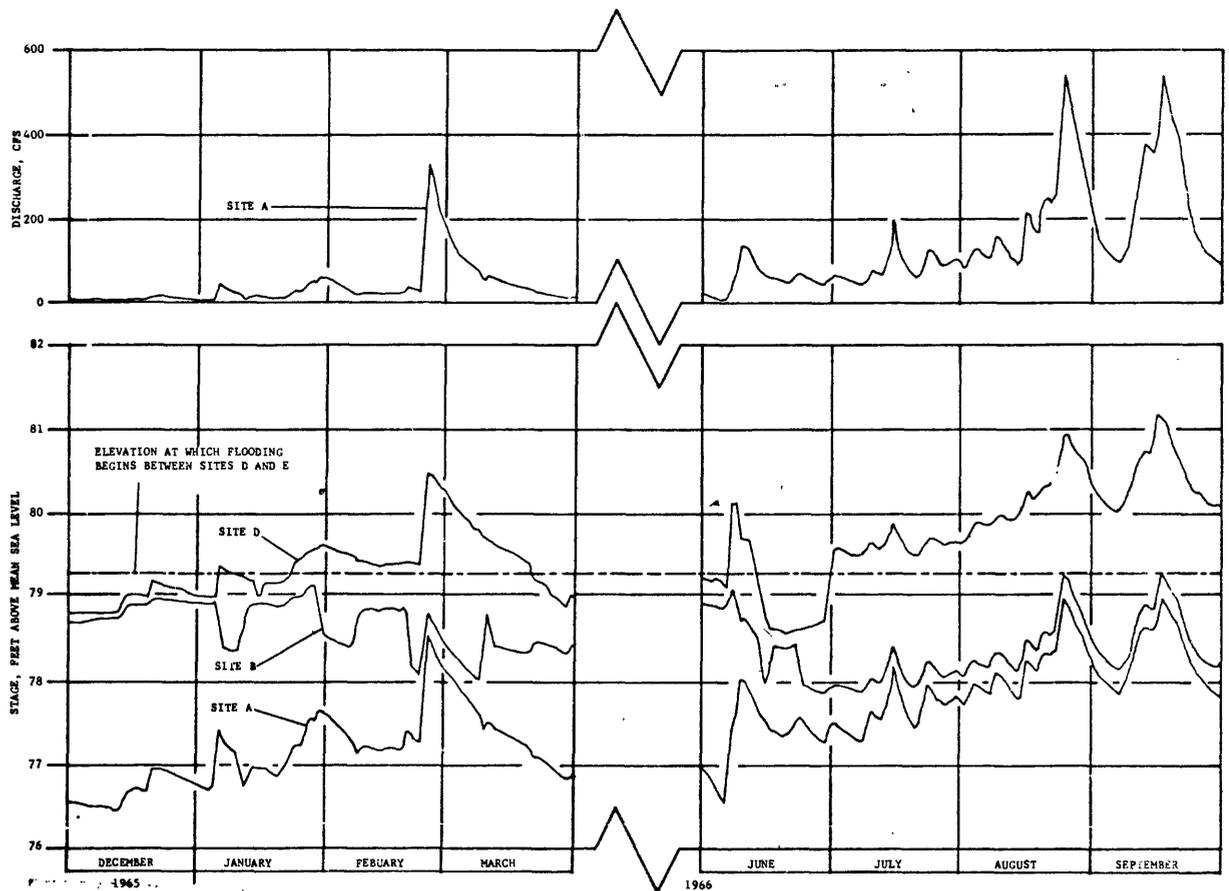
The slope of the water surface from Site D, to the dam at the northern boundary, Site B, is negligible during periods of little or no flow (all boards on dam). This relation is demonstrated by a comparison of elevations of water levels on figure 5 at the two sites during late December 1965. Removal of the two rows of flashboards increases the fall to at least 1-1/2 feet during periods of discharge of more than 200 cfs, even when the concrete crest is submerged. This relation is shown by a comparison of elevation of water levels at the two sites from August 15 to 26, 1966.

Figure 5. Discharge at Site A, water level of Little Charley Bowlegs Creek at Sites A, B, D, and flashboard regulation at control, Site B.

The following suggested schedule for operation of flashboards on the dam was developed from hydrologic criteria previously described.

1. In wet periods when the water level at the staff gage at south fence line, Site D, reaches 17.0 feet gage reading, or 79.3 feet msl, the top row of flashboards should be removed from the concrete dam at Site B to drain water from the park. Prior to or following heavy rains when the water level at the south fence line, Site D, is anticipated to rise or is rising and it is apparent that the 17.0-foot gage reading will be reached, the top row of boards should be pulled prior to reaching 17.0 feet. The water level at Site D should fall 0.1 to 0.5 foot in a day unless flooding occurs upstream. If the water level as indicated by the staff gage at Site D does not decline and continue to decline, the bottom row of boards on the dam should be removed.

2. When the water level at Site D declines to 16.0 feet, and water has drained from the lowlands near the county bridge, Site E, the bottom row of flashboards should be placed on the dam to conserve water for use by the unusual plant life preserved in the park. The water level at Site D should rise to 16.5 feet within several days and continue to rise. If the desired height is not reached, the top row of flashboards should be placed on the dam.

3. In general, flashboards should be placed on the dam at the end of wet periods in November or December and should not be removed until the rainy season begins about June, except when unseasonally heavy rainfall causes the condition given in item 1. Every effort should be made to conserve water during the dry period, December to June.

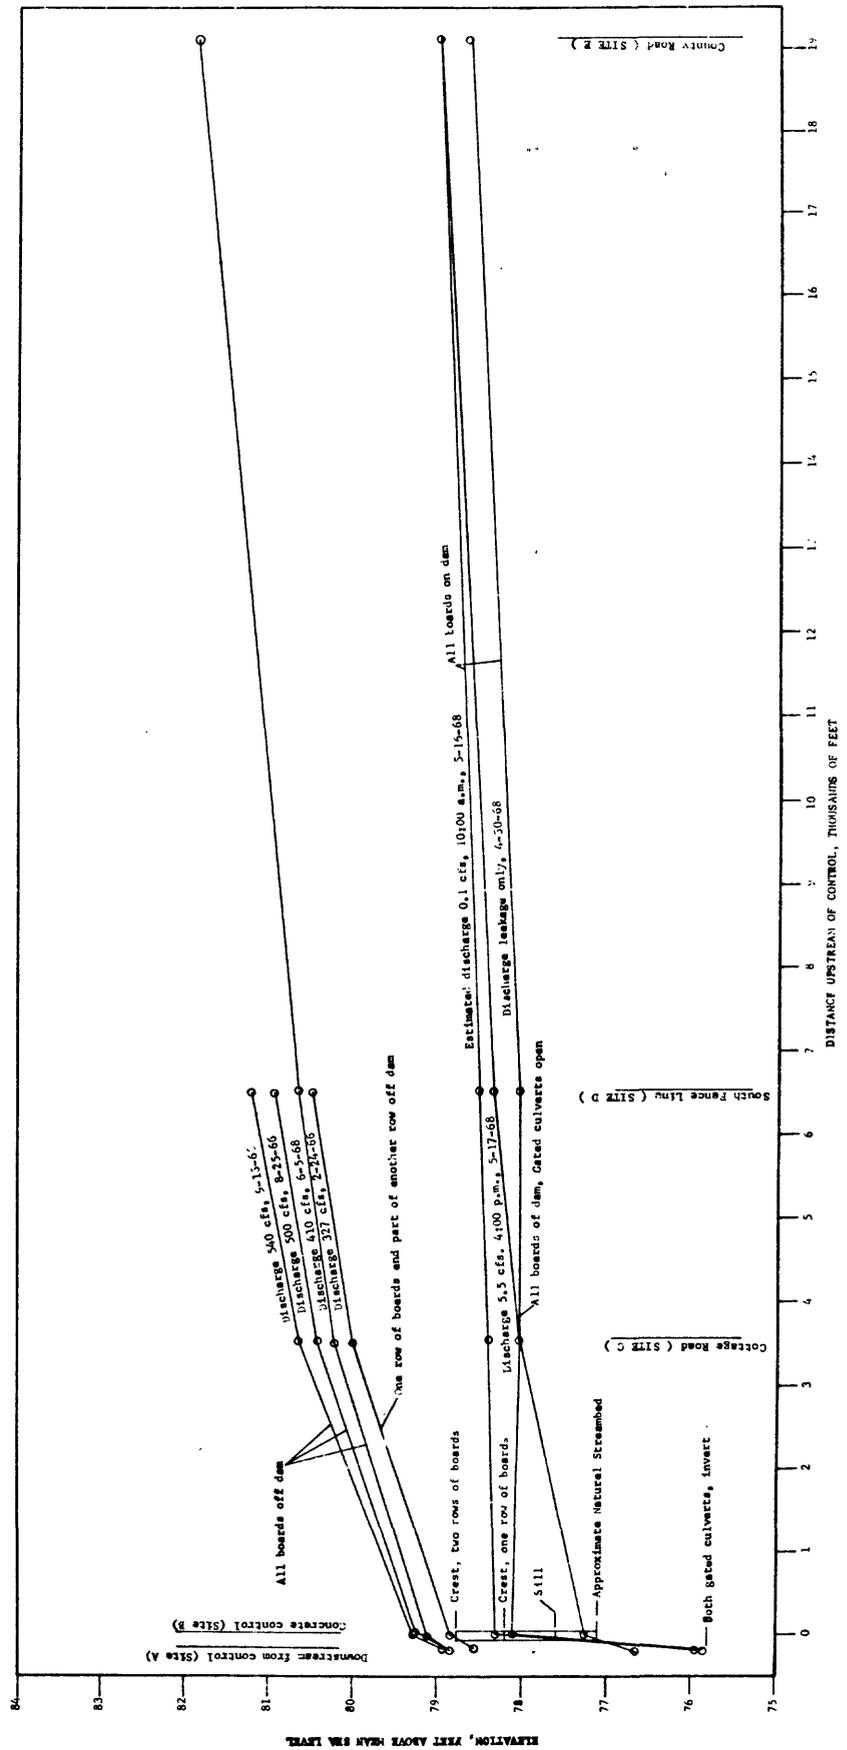
Profiles of the water surface for selected highwater periods are shown in figure 6. The increase in slope at Sites D, C and B indicates that flow at these sites was free of backwater affect.

Profiles of the water surface for a selected low-water period are also shown in figure 6. The profile shown for April 30, 1968 represents conditions near the end of an extended drought; with all boards on the dam; and with leakage through the boards only. The profile for 10:00 a.m. May 16, 1968, represents conditions after some rainfall at the end of the drought with all boards on the dam, and leakage only (estimated 0.1 cfs). All boards were removed from the dam and both 24 inch gated culverts (invert elevation 75.8 feet msl) were opened at 10:00 a.m. May 16, 1968. The profile for 4:00 p.m. May 17, 1968 represents conditions thirty hours after boards were removed from the dam and gated culverts were opened and immediately before all boards were placed on the dam and culvert gates were closed. The stage at Site B fell 1.07 feet while the stage at Site E fell only 0.02 foot. This comparison of profiles for May 16 and 17 shows that manipulation at the control structure (Site B) has little or no effect on stages at Site E.

Figure 6. Selected water surface profiles

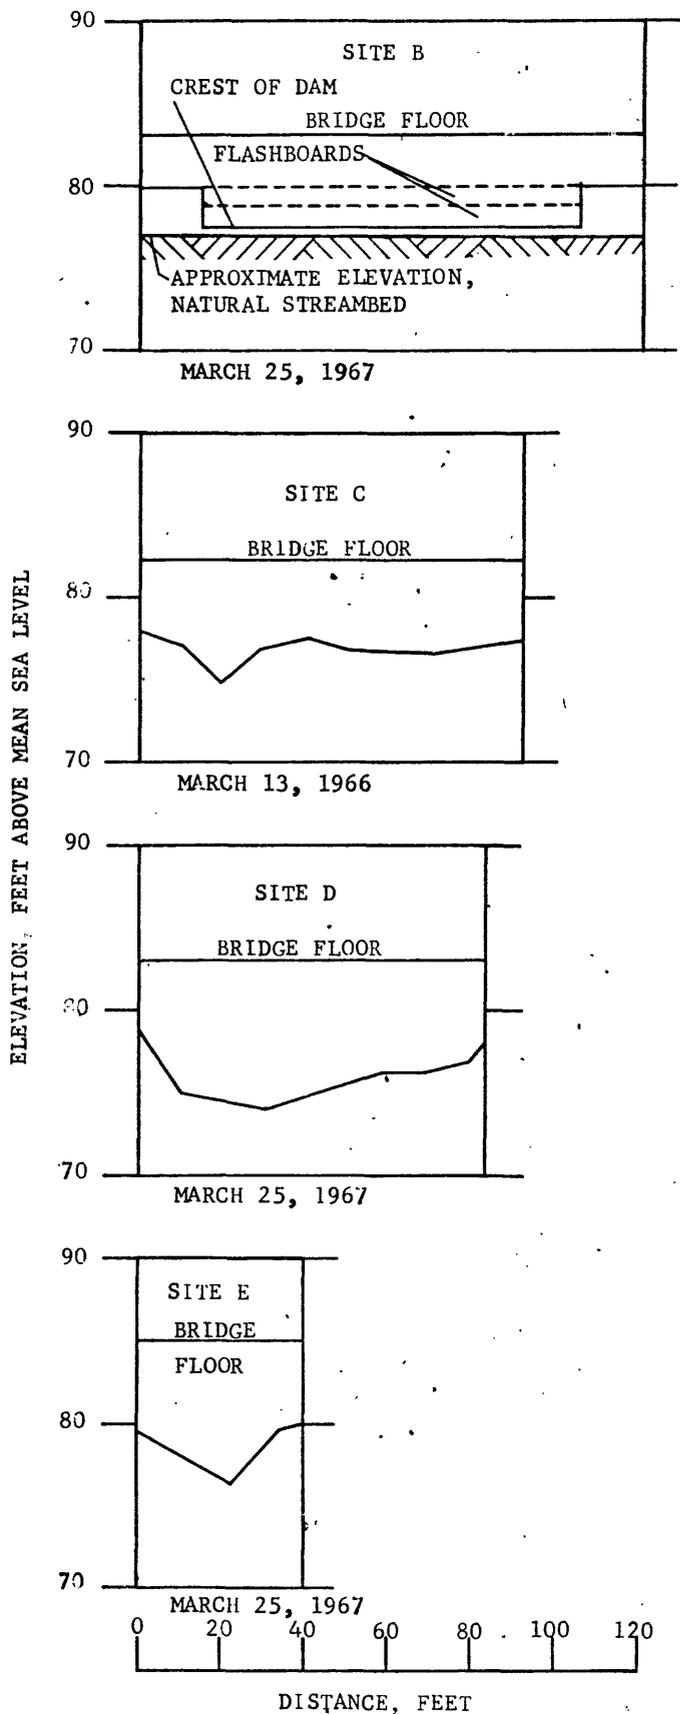
On July 11, 1967, the channel of Little Charley Bowlegs Creek within the park was inspected for constrictions which might cause backwater, and none were observed. In addition, cross sections of the channel were made at Sites B to E (fig. 7). These sections show that the area of the channel markedly increases downstream from Site E. In the reach extending a half mile upstream from Site D to the park limits, the channel is improved and has no constrictions that would cause backwater (fig. 8). The channel for another half mile or more upstream is badly choked by hyacinths and brush (fig. 9). Similar channel conditions continue farther upstream to a point near and south of Site E (figs. 10 and 11). However, just downstream from Site E the channel is only moderately clogged by vegetation.

Figure 7. Cross-sections of creek channel at Sites B-E.
