Turkey Investigation Report  
(IR) TU-5

BARTIN-AMASRA EARTHQUAKE, TURKEY

SEPTEMBER 3, 1968

John P. Albers

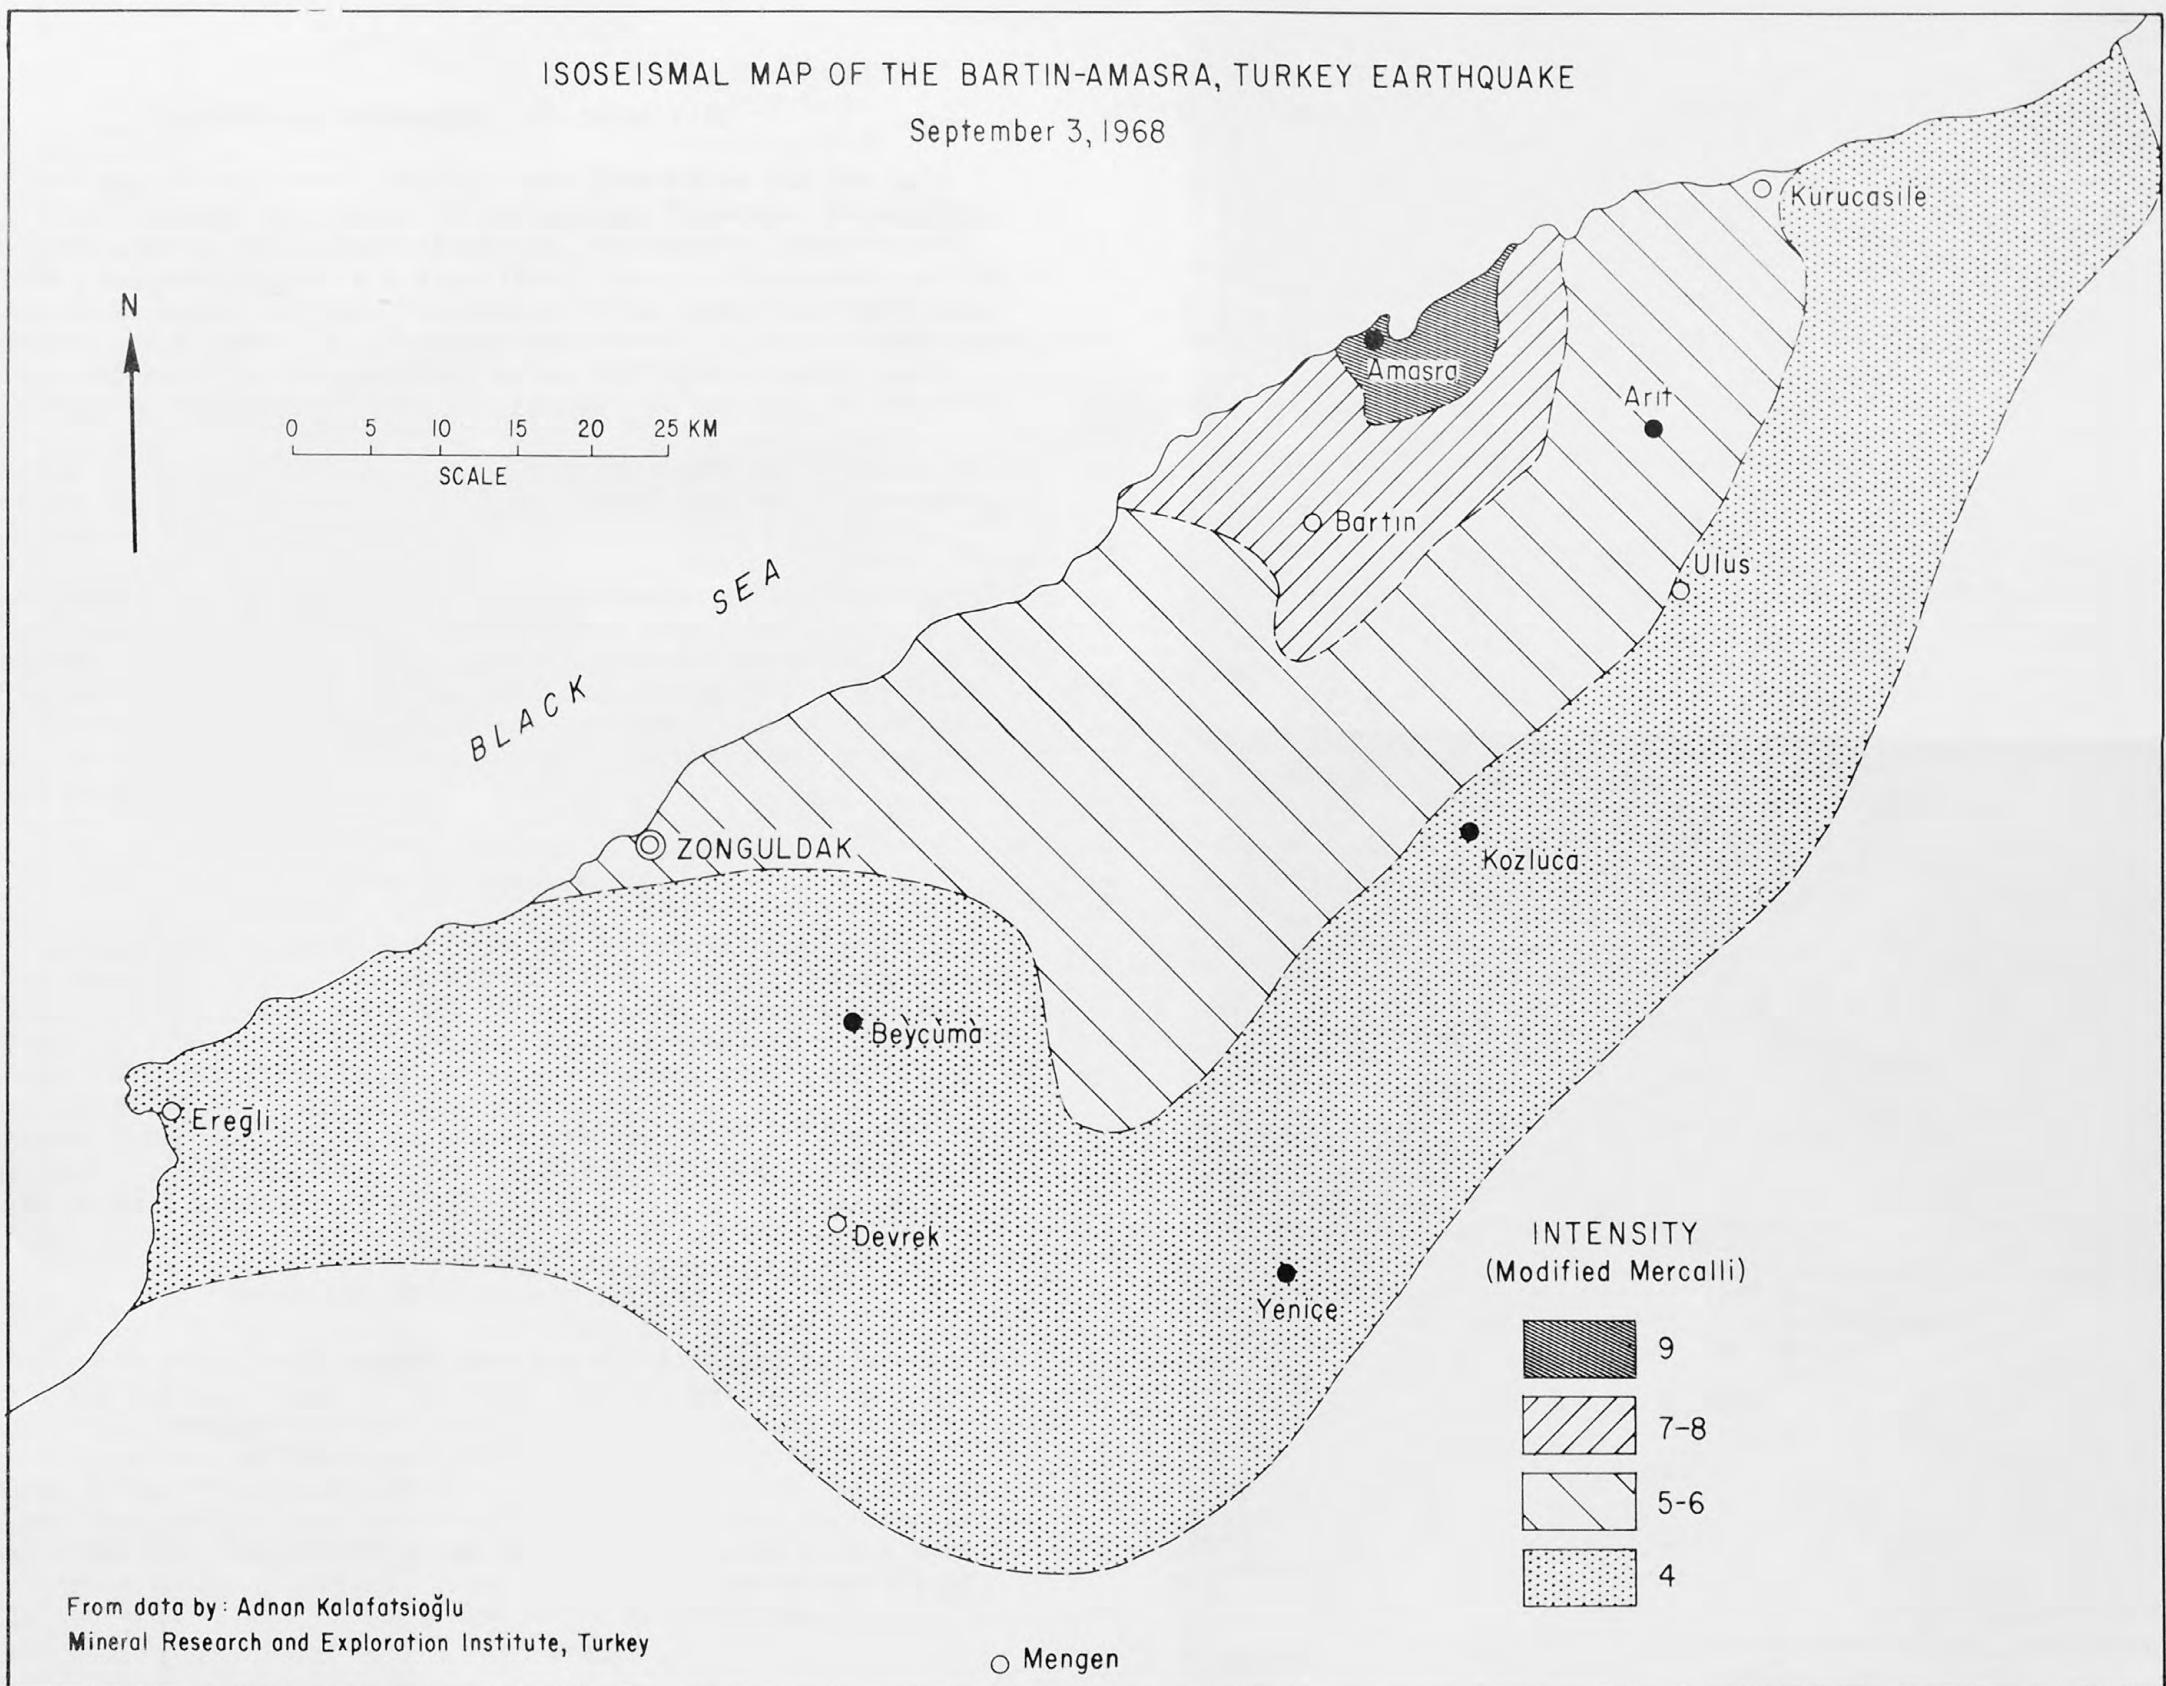
Figure 1

Maximum intensity on the modified Mercalli scale is estimated to have been IX. The earthquake was felt in Ankara, 200 km to the south, and in Istanbul, 280 km to the west.

Twenty-nine persons were killed and an unknown number were injured in the Bartın-Amasra earthquake. Two thousand houses were totally destroyed and 2,650 were partly damaged. Damage was principally in an area 15 km east-west by 20 km north-south, extending from a few kilometers west of Amasra to a few kilometers east of Çakraz on the Black Sea coast and south to the Kocairmak (river). Most intense damage was in the Amasra-Çakraz area.

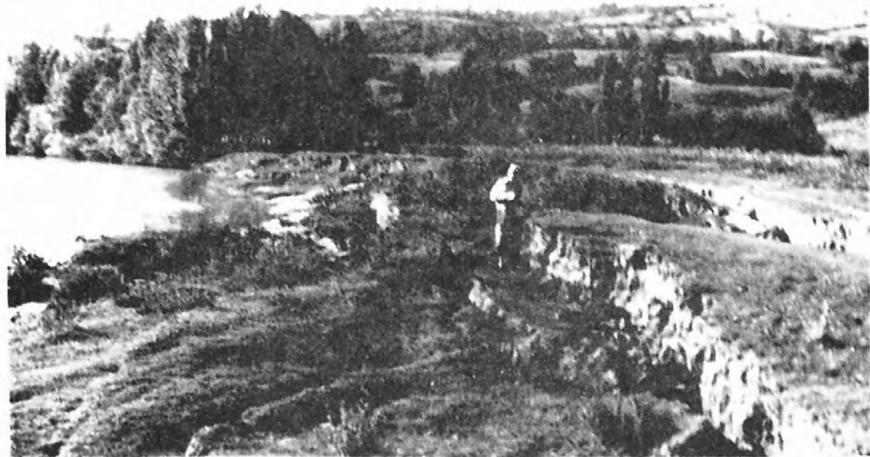
Just east of Bartın, about 150 meters south of the Bartın-Amasra road and about 100 meters north of the river, a series of cracks trends S.  $80^\circ$  E. for about 50 meters, from which point they trend S.  $40^\circ$  E. for 30-40 meters, thence S.  $80^\circ$  E. for another few meters, and then they die out. On the west end the cracks are as much as half a meter wide and have dropped down on the north; maximum displacement is 8-9 centimeters. Further southeast where the trend turns S.  $40^\circ$  E., the south

Figure 3.--Fracture along Bartın River east of Bartın, developed by slumping and landspreading.

side is downdropped as much as 40 cm and the cracks are 60-70 cm wide. A graben structure 2 meters wide and about 20 cm deep was seen at one place along this zone of cracking, the total length of which is more than 100 meters.

Because of the close spatial and directional relationships between the cracks described above and the river basin, it appears that the cracks are not truly tectonic features but formed rather by the differential response to shaking of water-saturated ground and dry unsaturated ground. The soggy saturated ground of the river bed compacted, settled in response to shaking relative to the drier soil, and cracks formed in places along the boundary between. Unconsolidated ground in alluvial plains along rivers spread toward the river cutbanks, producing tension cracks subparallel to the river.

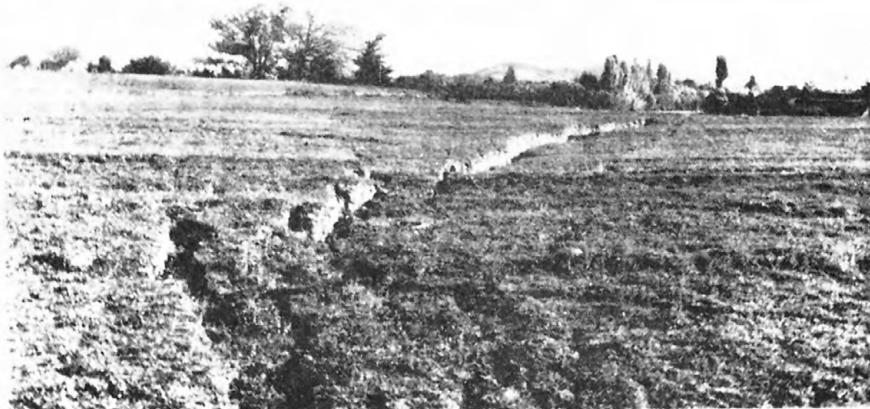
Figure 4.--Fracture along Bartın River east of Bartın, developed by slumping and landspreading.

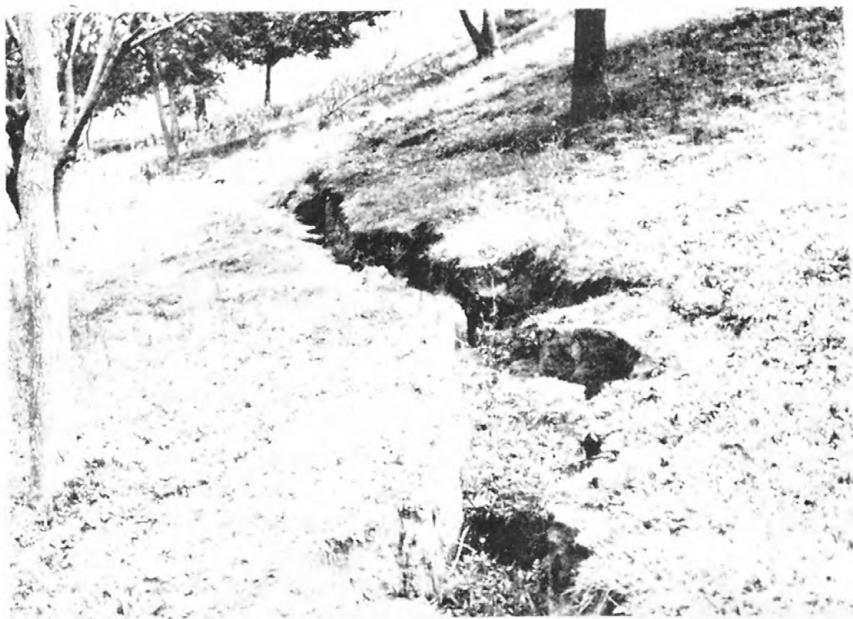
Another surface crack about 1 km southeast of Çakraz at the village of Ovaköy (fig. 5) trends N.  $40^{\circ}$ - $50^{\circ}$  E.; although it is entirely in soil, bedrock is exposed within one meter to the southeast. The crack thus appears to be the surface trace of a contact between bedrock and alluvium. Total length of the crack zone is 65-70 meters. The crack is as much as 80 cm wide and is downdropped a maximum of 30 cm on the northwest side. Soil on the northwest side of the crack is in a small swale or hollow about 50 meters wide and was soggy and water-saturated on September 25. The northwest side of the swale is bedrock but no cracks were formed along the contact between soil and bedrock on that side of the swale.

The crack at Ovaköy, like those along the river near Bartın, does not appear to be truly tectonic. It apparently results from the shaking and settling of water-saturated soil, in this case adjacent to bedrock.

Figure 5.--Fracture at Ovaköy near Çakraz. Bedrock is exposed a few feet to right of fracture.

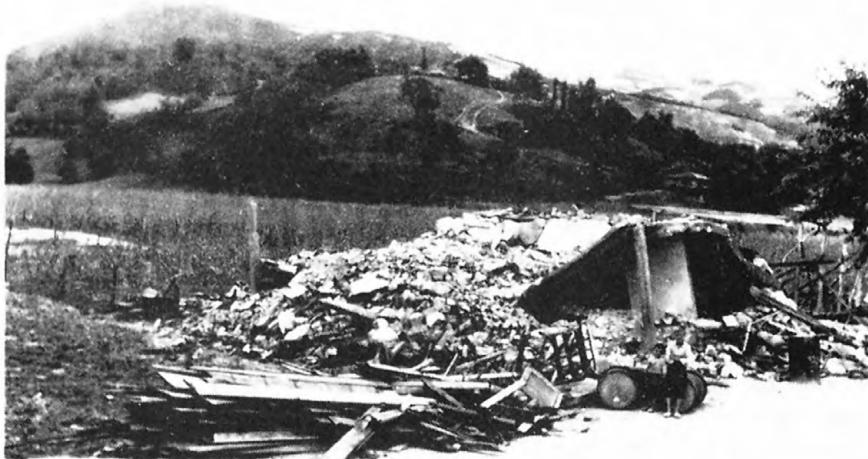
Figure 6.--Damaged house, Çakraz Valley. Approximately 100 meters to right of building in background a high minaret built on alluvium was undamaged.

Damage was generally severe in all the villages in the Çakraz valley (figs. 6 and 8), but even there some brick and cement block buildings withstood the shaking with little or no damage, whereas adjacent buildings were either extensively damaged or collapsed. The most severely damaged structures generally consisted of unreinforced brick, stone, or concrete walls supporting a 3- to 6-inch-thick flat concrete slab roof resting on light cross timbers. Although several minarets collapsed, at least one high minaret in the valley was left standing virtually undamaged.

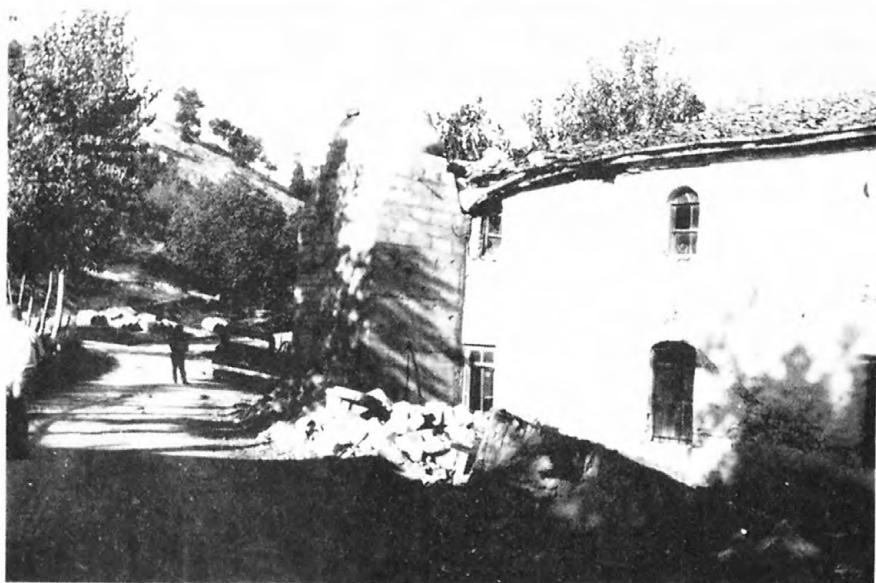
At Akpinar, a village about 5 km northeast of Bartın and built on alluvium, unreinforced stone and concrete buildings were heavily damaged. The upper one-third of a minaret built of unreinforced concrete toppled in a S.  $40^{\circ}$  W. direction from its base (fig. 7). Tension cracks developed commonly in stone, concrete, or brick building walls facing N.  $40^{\circ}$  W. and S.  $40^{\circ}$  E., but not in walls facing northeast or southwest.

Figure 7.--Toppled minaret, Akpinar Village.

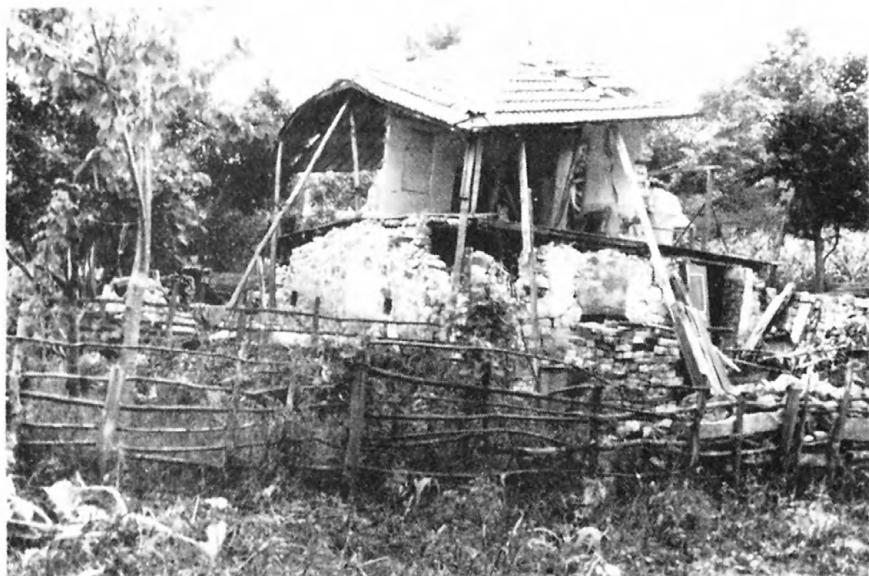
Figure 8.--Collapsed house, Çakraz Valley. Tile roof propped up after quake.
