UNITED STATES
DEPARTMENT OF THE INTERIOR
GEOLOGICAL SURVEY

THE EFFECTS OF PLUGGING A DEEP ARTESIAN WELL ON THE
CONCENTRATION OF CHLORIDE IN WATER IN THE WATER-
TABLE AQUIFER AT HIGHLAND ESTATES, LEE COUNTY, FLORIDA

Open-File Report

73-26

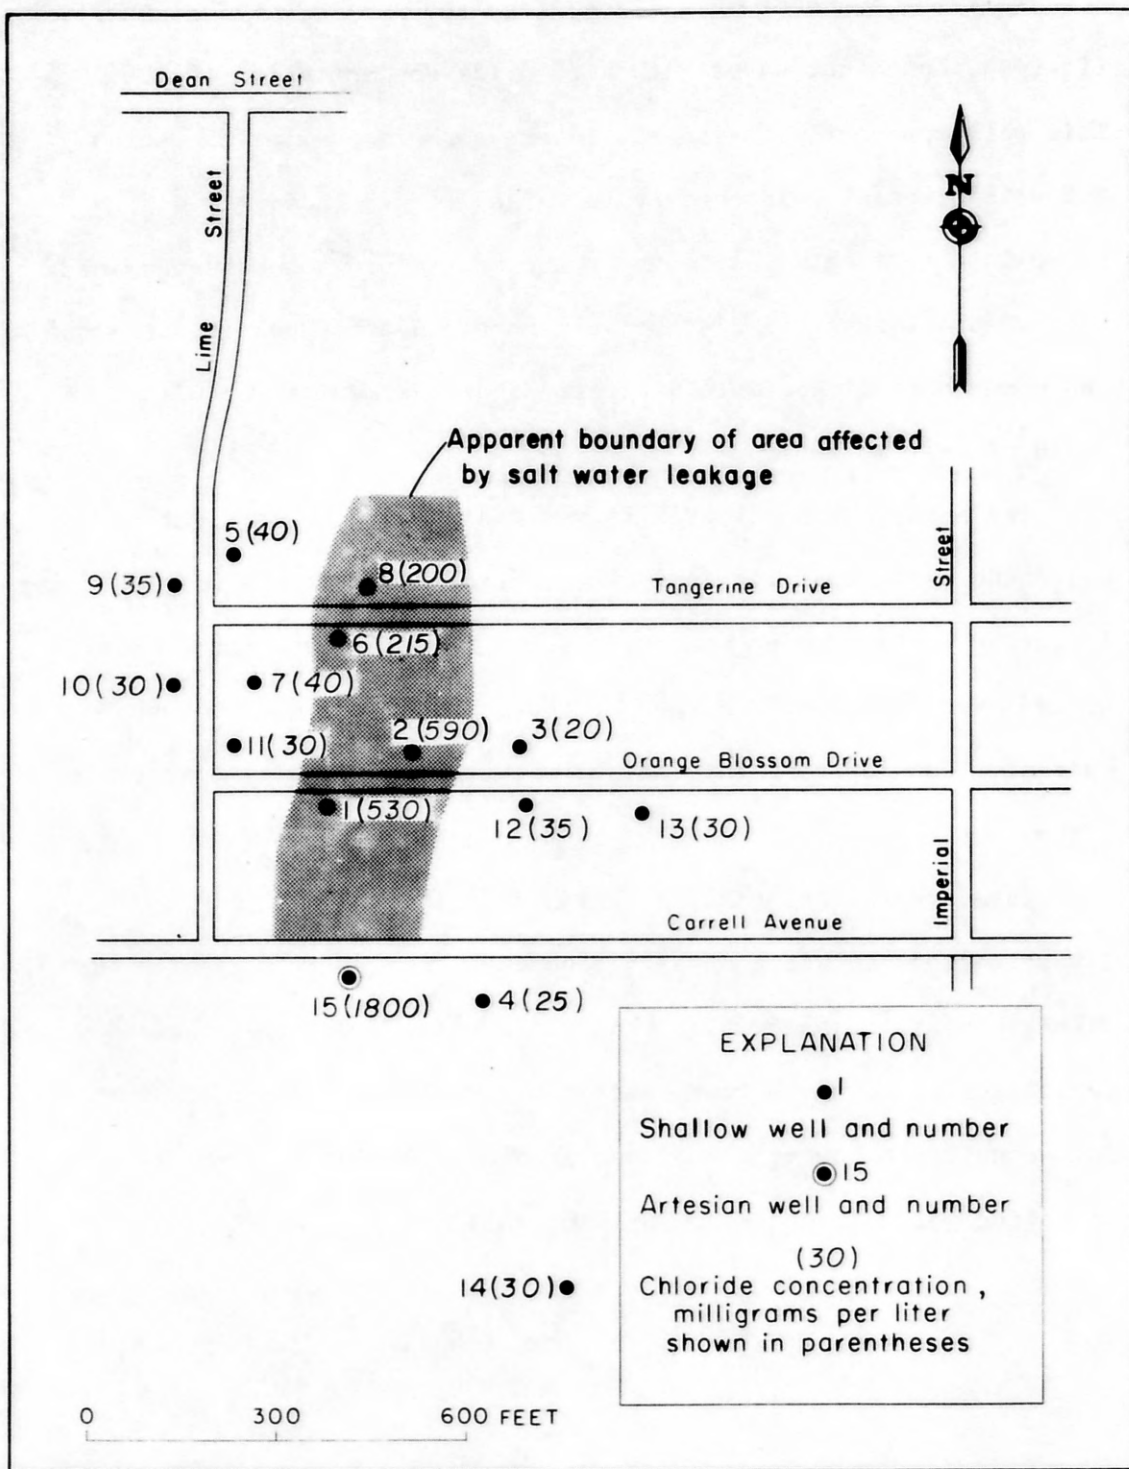
Figure 3 shows the location of 15 wells in the Estates and the chloride content in water samples collected from them on January 28, 1968. Except the samples from well 15, all were from wells 20 to 25 feet deep constructed in the water-table aquifer. As shown on figure 3, chloride concentrations in water from the shallow wells ranged from 25 mg/l in well 4 to 590 mg/l in well 2. Four shallow wells, numbers 1, 2, 6, and 8, aligned northward, yielded water much higher in chloride than from similar wells in adjacent areas.

Figure 3.--Map showing location of wells at Highland Estates and chloride concentrations in water on January 24, 1968.

Well 15, south of well 1 and along the same general alinement (fig. 3), contained water with a chloride concentration of 1,800 mg/l. This well apparently tapped the lower Hawthorn aquifer at depths below 485 feet as evidenced by the high artesian head, 19.4 feet above land surface. The depth of the well could not be determined because of blockage within the well bore. Geophysical logs run on the upper part of the well indicated that the casing extended to a depth of only 80 feet.

The metal casing of well 15 was badly corroded particularly where the casing was leaking. The control valve on top of the casing, installed in 1961 to prevent flow from the well, was closed. The ground around the well was wet, although no standing water was evident. Upon opening the control valve, the well flowed about 5 gpm.

Based on the information obtained during the preliminary investigation, it was generally concluded that well 15 was the most likely conduit through which the saline water was entering the water-table aquifer near the four water-table wells at Highland Estates. This conclusion however, does not preclude the possible existence of saline water in other zones than the lower part of the Hawthorn.

On February 15, 1968, well 15 was plugged under the supervision of H.J. Woodard and C.R. Sproul of the Florida Department of Natural Resources. A water-cement mixture containing about 16 bags of cement was pumped into the well during the plugging operation. This stopped all visible leakage from the well at or near the surface and no further leakage has been noted.

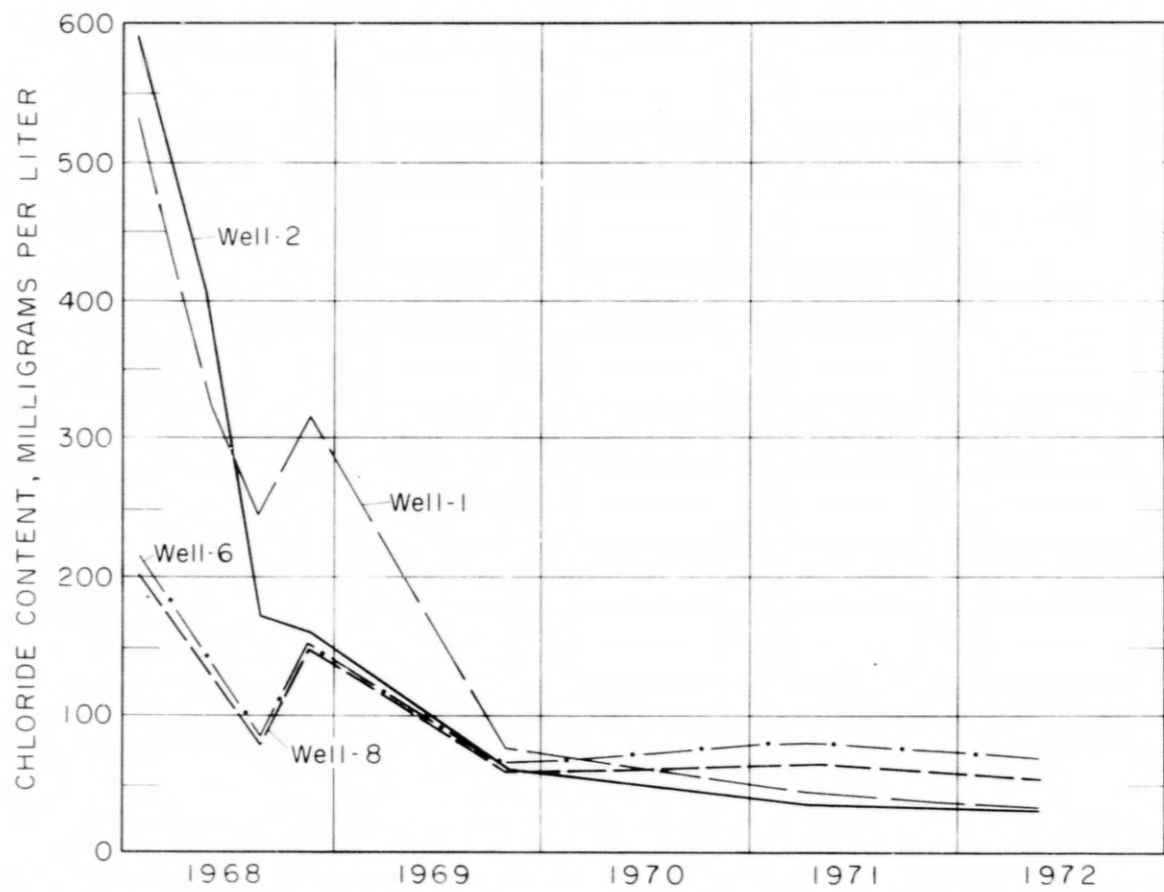
After well 15 was plugged, the chloride content of water from wells 1 and 2, about 270 and 370 feet from well 15, decreased 180-200 mg/l by May 1968 as shown in figure 4. The chloride content continued to decrease until August when the total reduction was 285 mg/l in well 1 and 420 mg/l in well 2. The chloride content of water from wells 6 and 8, about 540 and 620 feet from well 15, decreased 120-130 mg/l over the same period. The reduction in chloride concentrations probably was related in part to the dilution and flushing of saline water from the aquifer by rainfall which began in May.

Analyses made in November 1968, after this initial period of decreasing concentrations, indicated that chloride in water from wells 1, 6, and 8 had increased by 65-70 mg/l. This probably represents residual contamination from saline water that had gained access to the aquifer before well 15 was plugged.

Figure 4.--Variations in chloride concentrations in wells 1, 2, 6, and 8, 1968-72.

By October 1969, about 20 months after well 15 was plugged, the chloride content of water from wells 1, 2, 6, 8 was less than 80 mg/l, indicating a decrease of 452 mg/l in well 1; 528 mg/l in well 2; 151 mg/l in well 6; and 140 mg/l in well 8. Additional observations in April 1971 and May 1972 indicated some variation in chloride content in wells 6 and 8, but a continued decrease in wells 1 and 2.

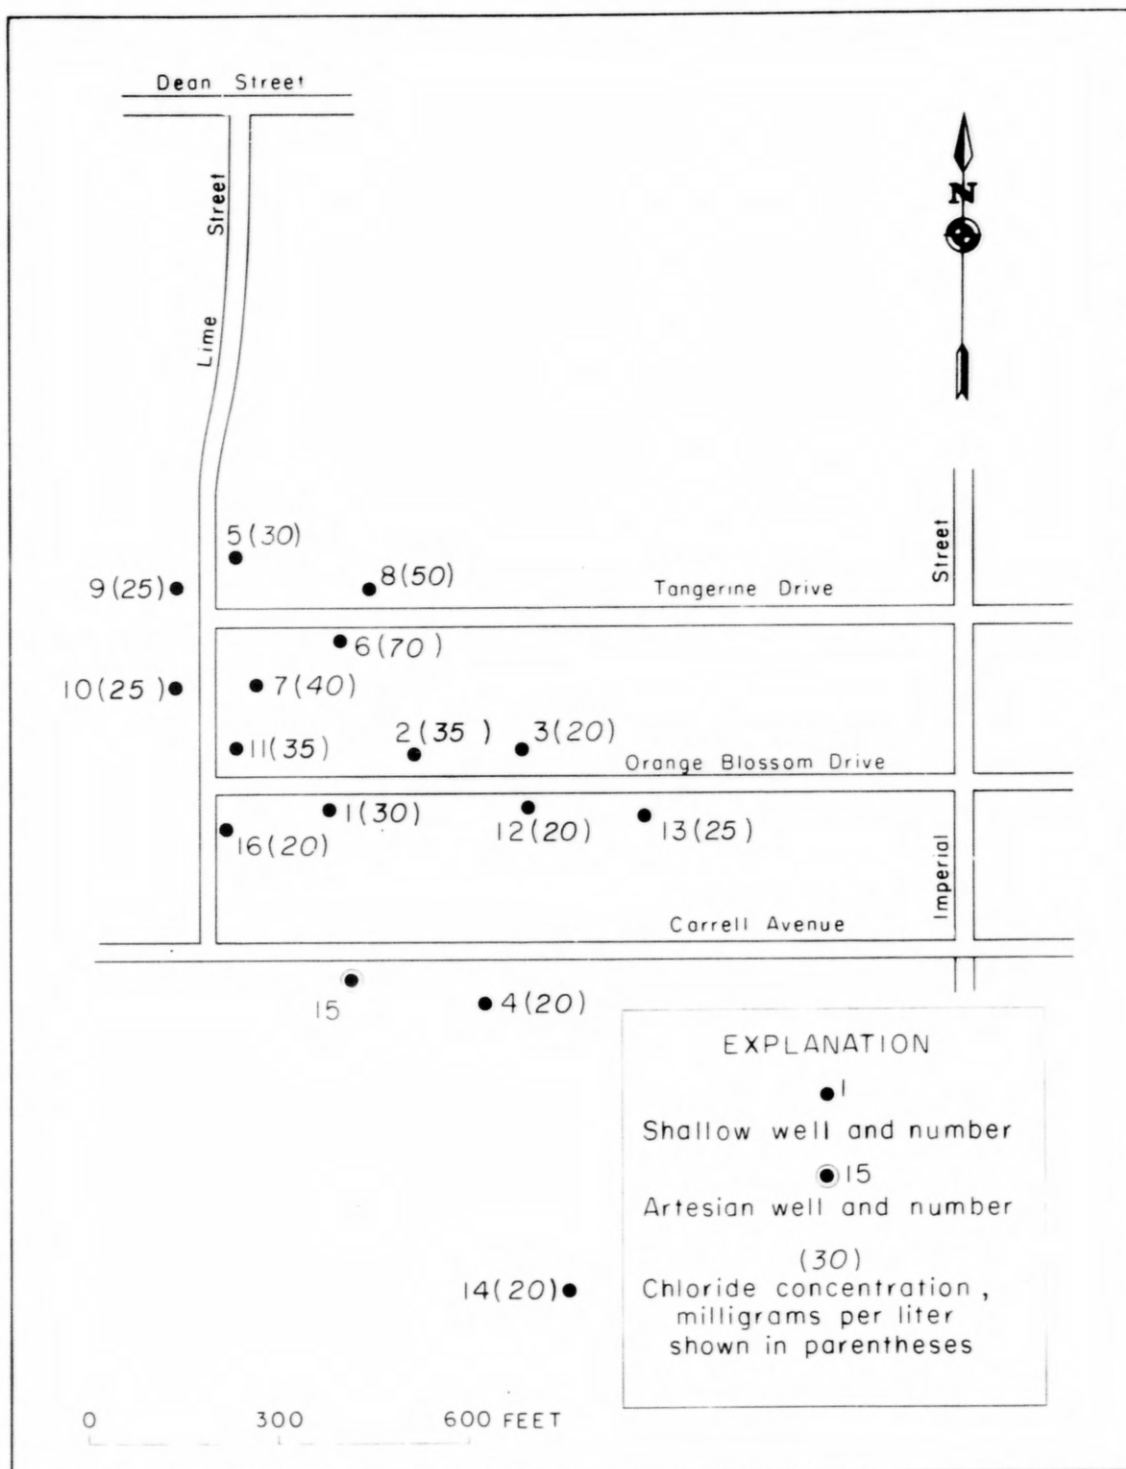
All except one of the wells sampled in January 1968 were sampled again in May 1972, more than 4 years after plugging well 15. The chloride analyses are shown in figure 5. Water from wells 1 and 2, formerly most affected by leakage of saline water from well 15, contain chloride within the normal range in water from other wells in the water-table aquifer. Wells 6 and 8 showed some residual effects of the saline water which entered the aquifer earlier.

The results of this brief investigation provides reliable evidence that surface discharge and subsurface leakage from well 15 were the primary sources through which saline water entered the water-table aquifer at Highland Estates. The results further indicate that rainfall will, in time, dissipate most of the effects of the saline water, provided the conduit remains tightly sealed.

Figure 5.--Map showing chloride concentrations in wells at Highland Estates on May 24, 1972.
