# MEASUREMENT OF LATERAL EROSION AT PROPOSED RIVER CROSSING SITES OF THE ALASKA PIPELINE

**MEASUREMENT OF LATERAL EROSION  
AT PROPOSED RIVER CROSSING SITES  
OF THE ALASKA PIPELINE**

*coble*  
**by James Brice, 1920 -**

**THE UNITED STATES DEPARTMENT OF THE INTERIOR, GEOLOGICAL SURVEY  
Water Resources Division, Alaska District - 1971**

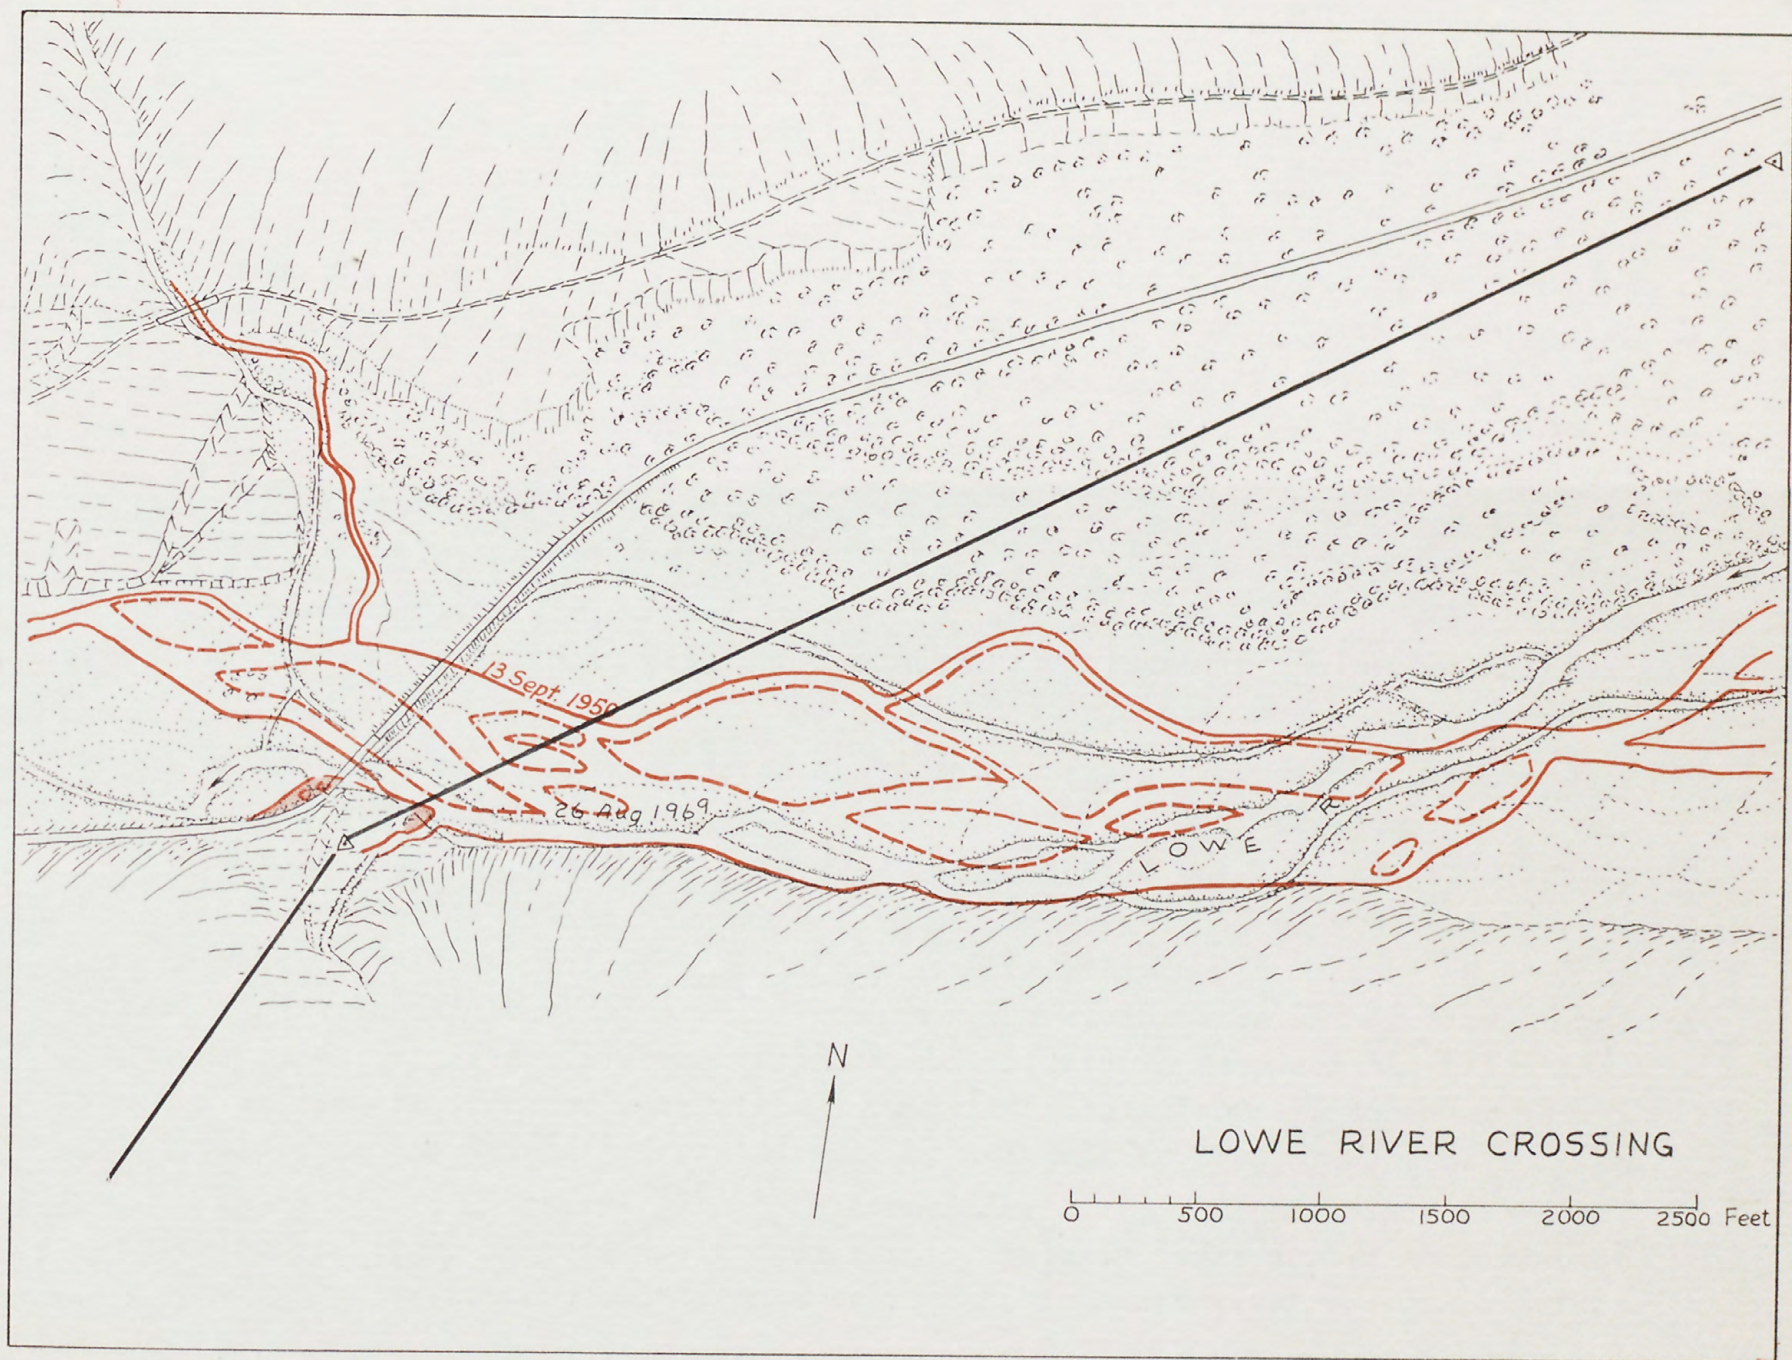
### Lowe River Crossing

The southern approach of the pipeline to the river channel is down the steep slope of the glacial trough occupied by the Lowe River and across a small fan made by a high-gradient tributary that courses down the valley side. The proposed pipeline route crosses the mouth of this tributary. As shown on the map, the tributary channel has shifted on the fan by about 100 feet between 1950 and 1969, although no shift is apparent between 1937, the date of an earlier photograph made by Bradford Washburn, and 1950. The fan itself has been trimmed back about 25 feet by the Lowe River, probably as a result of the construction of the Richardson Highway bridge, which diverted the course of the Lowe toward the south side of the valley. As the present river course is in approximate alignment with the bridge opening, not much further cutting of the fan is expected within the next few decades. Also, further significant shift of the drainage course on the fan seems unlikely, as it is rather deeply entrenched on the fan. If the pipeline were shifted a few tens of feet downstream from the tributary mouth, the potential for disruption by the tributary might be completely eliminated.

The braided anabranches of the Lowe River have shifted generally to the south since 1950, probably as a result of construction of the bridge and highway. Some southerly shift is also apparent between 1937 and 1950. The present bridge and highway embankment will probably hold the river to approximately its present course at the pipeline crossing for the next few decades.

The geomorphic evidence suggests that scour to maximum depths of about 6 feet will occur from place to place on the sparsely vegetated gravel flats north of the present channel. This estimate is based on the study of abandoned scour channels. The bed material of the Lowe River is moderately coarse for Alaskan rivers; it ranges in size from boulders about 2 feet in diameter to sand and silt, with material in the pebble and small-cobble size range being most abundant. As the channels are not confined (except at the bridge opening), they probably will shift laterally rather than scouring deeply at any one locality. Lowe River channels of significant size are unlikely to occupy the forested area crossed by the pipeline north of the river. In the past, this area has been occupied by channels on the Sheep Creek fan.

Terraces at various levels along Lowe River indicate that the recent history of the river has been one of degradation rather than aggradation, and the river is probably degrading slowly at present. Shifts of the main channel by lateral bank erosion and the abandonment of anabranches are to be expected rather than by abrupt changes in course direction.

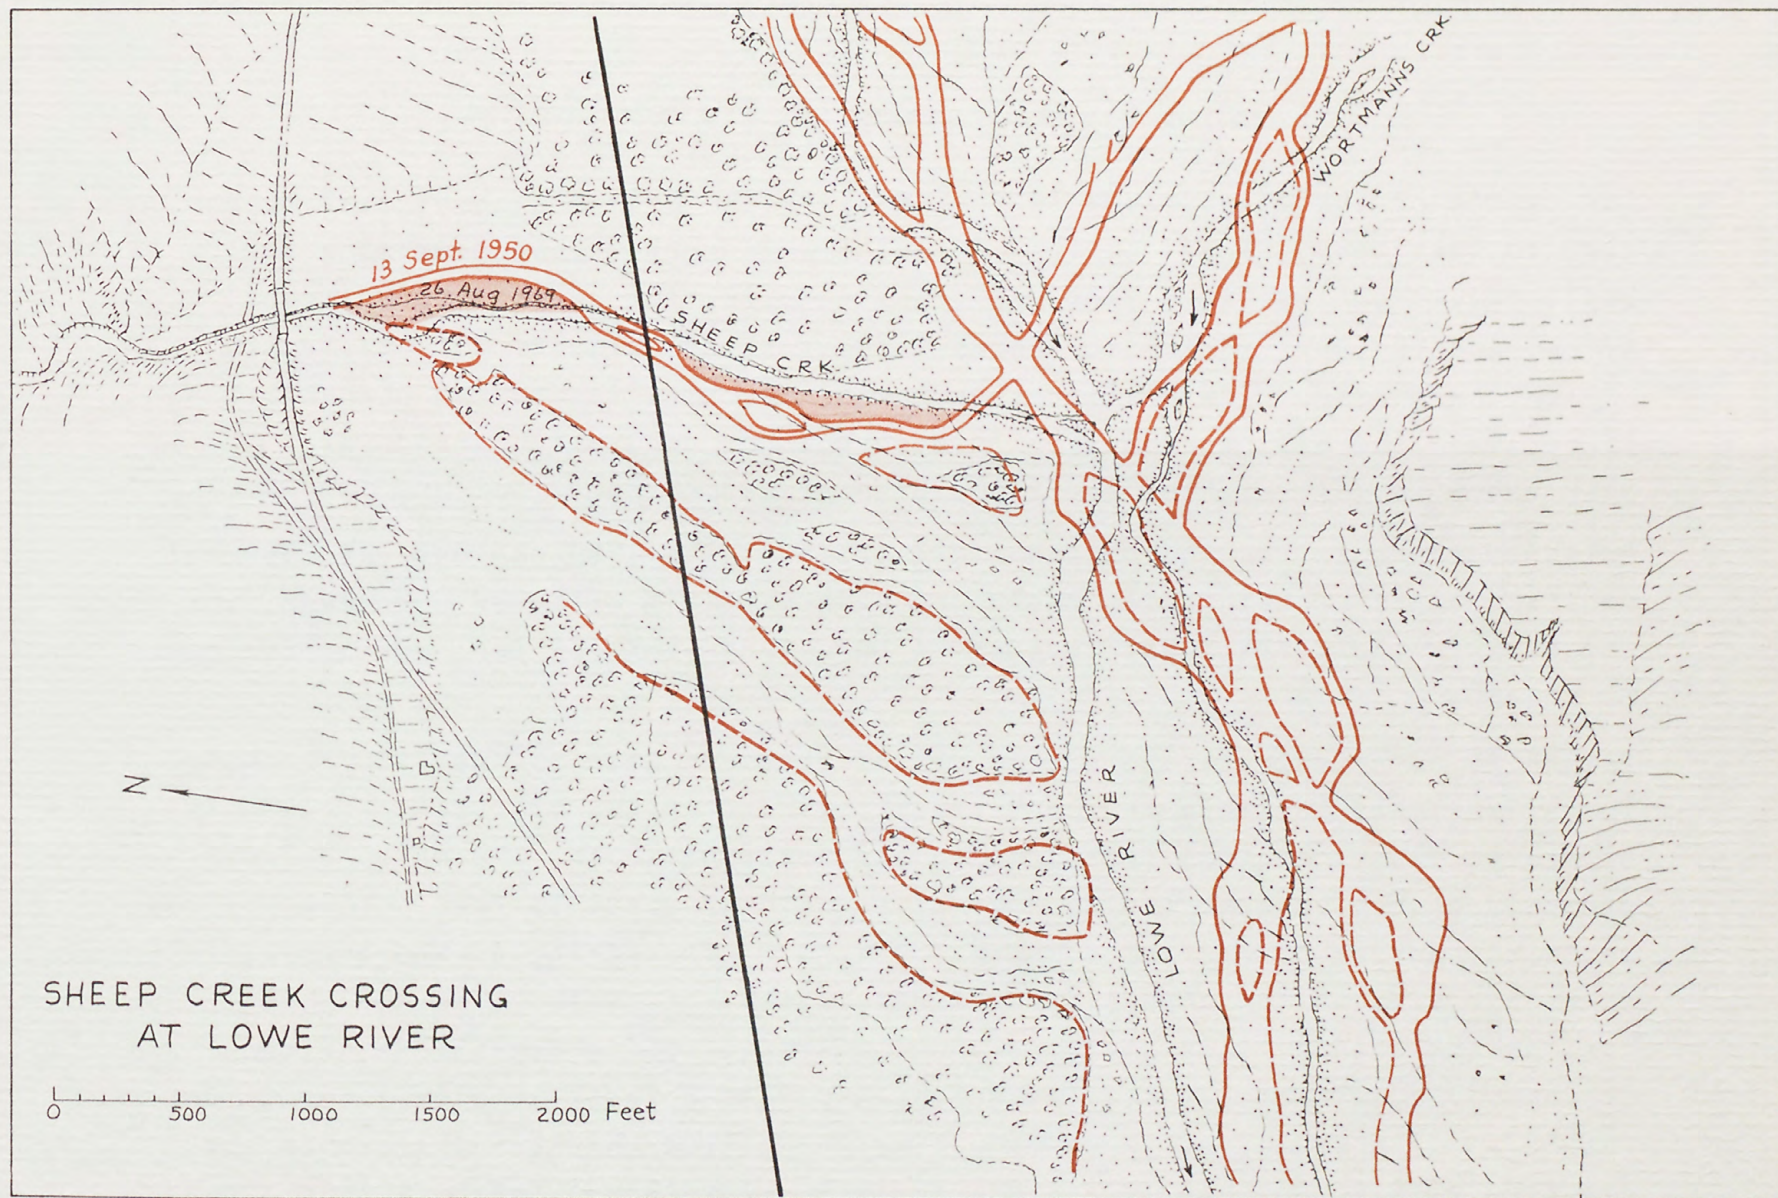
## Crossing of Sheep Creek Fan, Adjacent to Lowe River

Sheep Creek has a history of flooding resulting from the impoundment and subsequent release of water by a glacier about 4 miles upstream from the pipeline crossing. The highway bridge upstream from the pipeline crossing has been replaced several times and the existing bridge was constructed about 1962. Breakout of a glacier-dammed lake, probably on June 17, 1959, was accompanied by a surge of rock debris that buried a grove of balsam poplar trees on the fan to a depth of about 8 feet. (See red circle beneath the date "26 Aug., 1969" on map). Subsequent scour by the Sheep Creek channel has exhumed the trees to the same level at which they were originally growing. Several trees are still standing upright in the present channel, and one of these has adventitious roots marking the level to which it was buried. It is astonishing that any of these trees, which are only about 1 foot in diameter, could first be buried by a presumably high-velocity flood and then be exhumed without being uprooted or even tilted.

Between 1950 and 1969, the channel of Sheep Creek shifted about 200 feet at a point just upstream from the proposed crossing, although it has shifted only slightly at the crossing site. At the crossing site, banks of the channel are about 7 feet high. Future shifts of the channel are difficult to predict, particularly because the effects of glacial outbreaks are uncertain. Apparently, the effects of any outbreak in the period 1950-69 were depositional rather than erosional. If the next glacial outbreak should deposit debris to the north of the present channel (which seems likely, as this area is somewhat lower), the main channel could well be diverted to the south along one of its prior courses. The Sheep Creek fan is distinctly asymmetrical, its southerly growth being favored both by the steep gradient of the Lowe River trough and the outbuilding of the Wortmanns Creek fan on the opposite side of the Lowe River.

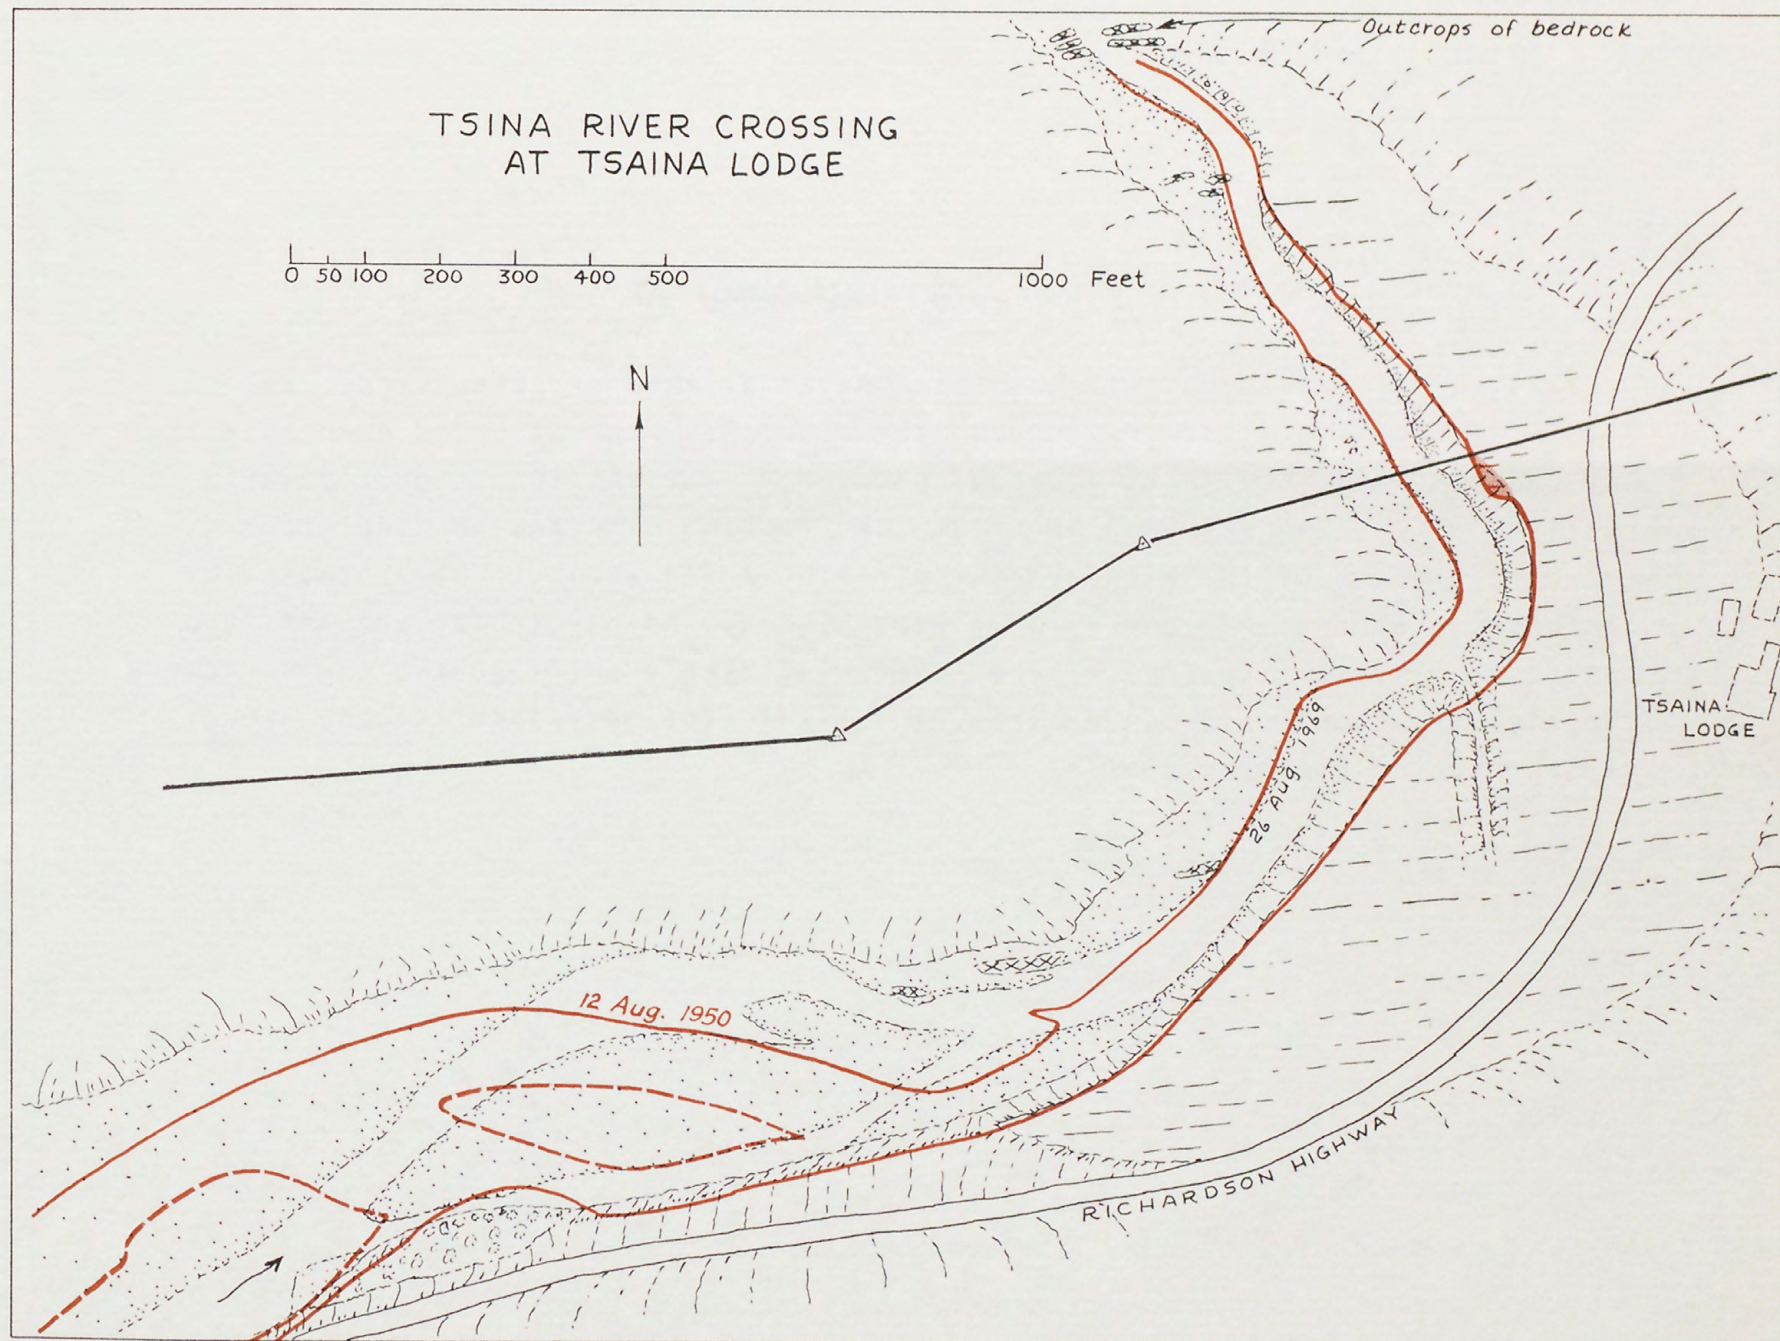
## **Tsina River Crossing at Tsaina Lodge**

The course of the Tsina River is incised into the bottom of a glacial trough that follows the regional strike of metamorphic rocks (low grade mica schist or phyllite). Just upstream from the crossing site, the channel cuts abruptly across the regional strike for about 1,500 feet, then turns abruptly again to follow the strike. The western approach of the pipeline to the channel is on bedrock and the eastern approach is across a terrace, which stands as a cut bank about 10 feet high on the right side of the channel.

Owing to the poor resolution and small scale of the 1950 photographs, lateral erosion at the crossing site could not be accurately measured. However, the cut bank in the terrace has receded no more than about 25 feet during the past 20 years.

Very high competence of the stream at the crossing site is indicated both by large imbricate boulders in the terrace fill and by the imbricate arrangement of schist blocks up to 5 feet long in and adjacent to the channel. Bedrock probably occurs beneath the channel at a depth of about 10 feet. This shallow depth to bedrock is predicted because of the close spacing of bedrock outcrops on either side of the channel downstream, which, as measured on the photographs, confine the channel to a width of about 20 feet. These downstream outcrops are presumably continuous at shallow depth, and form a local baselevel for the channel. If that is so, it seems unlikely that the channel upstream at the crossing site is notched to any great depth below them. There is thus a good probability that the pipe could be set in bedrock at the crossing site.

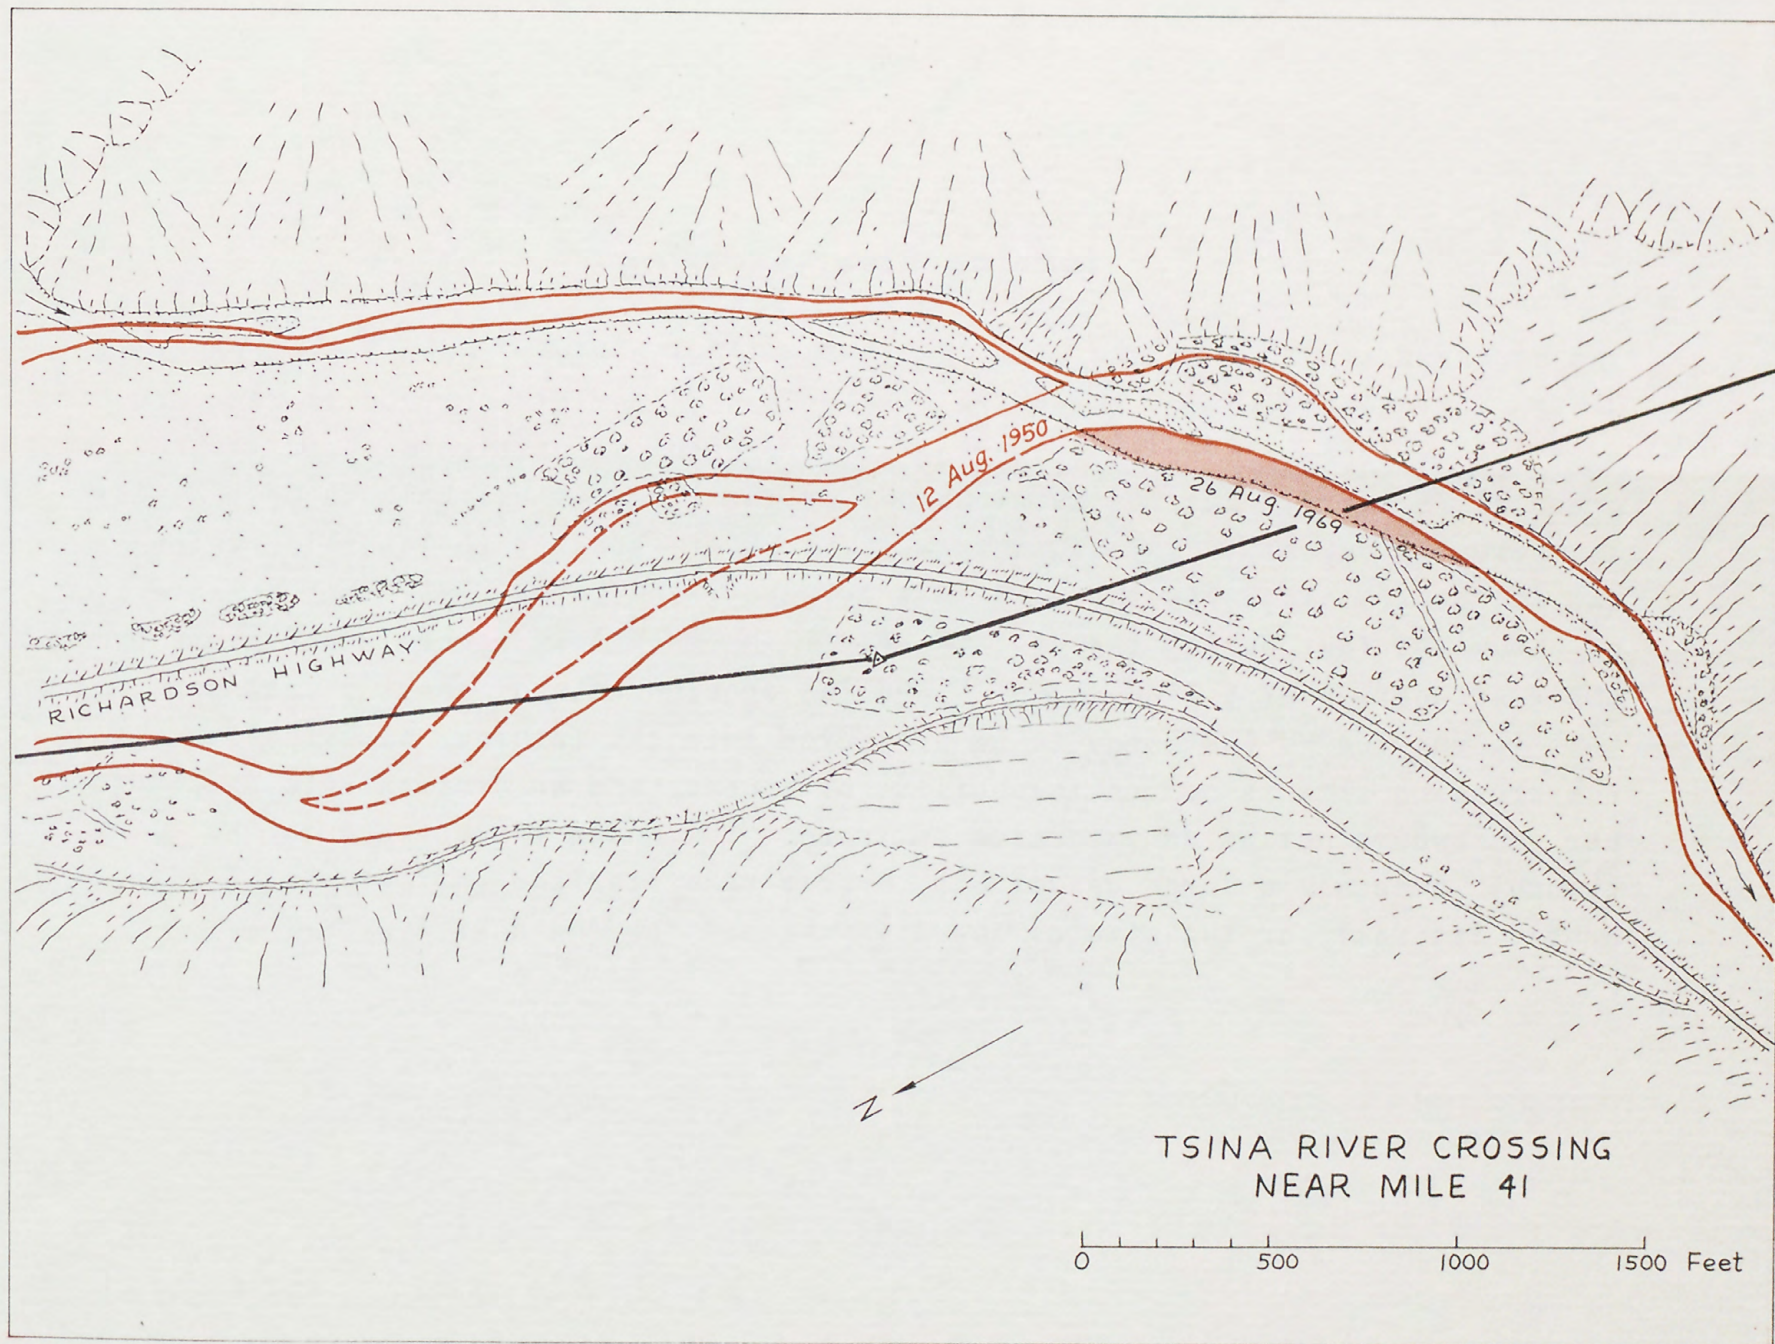
## **Tsina River Crossing Near Mile 41**

Lateral-shift measurements of the Tsina River at this crossing since 1950 have little natural significance, because the river has been diverted both by a highway embankment and by short levees. However, the river is not particularly confined by the highway embankment at the crossing site and no deep scour is expected. South of the highway, the pipeline route seems to be protected by the highway embankment; and north of the highway, no particular problems are apparent. The main channel of the river will likely shift to the south, toward the highway embankment, but by gradual lateral erosion rather than by abrupt redirection of its main course.

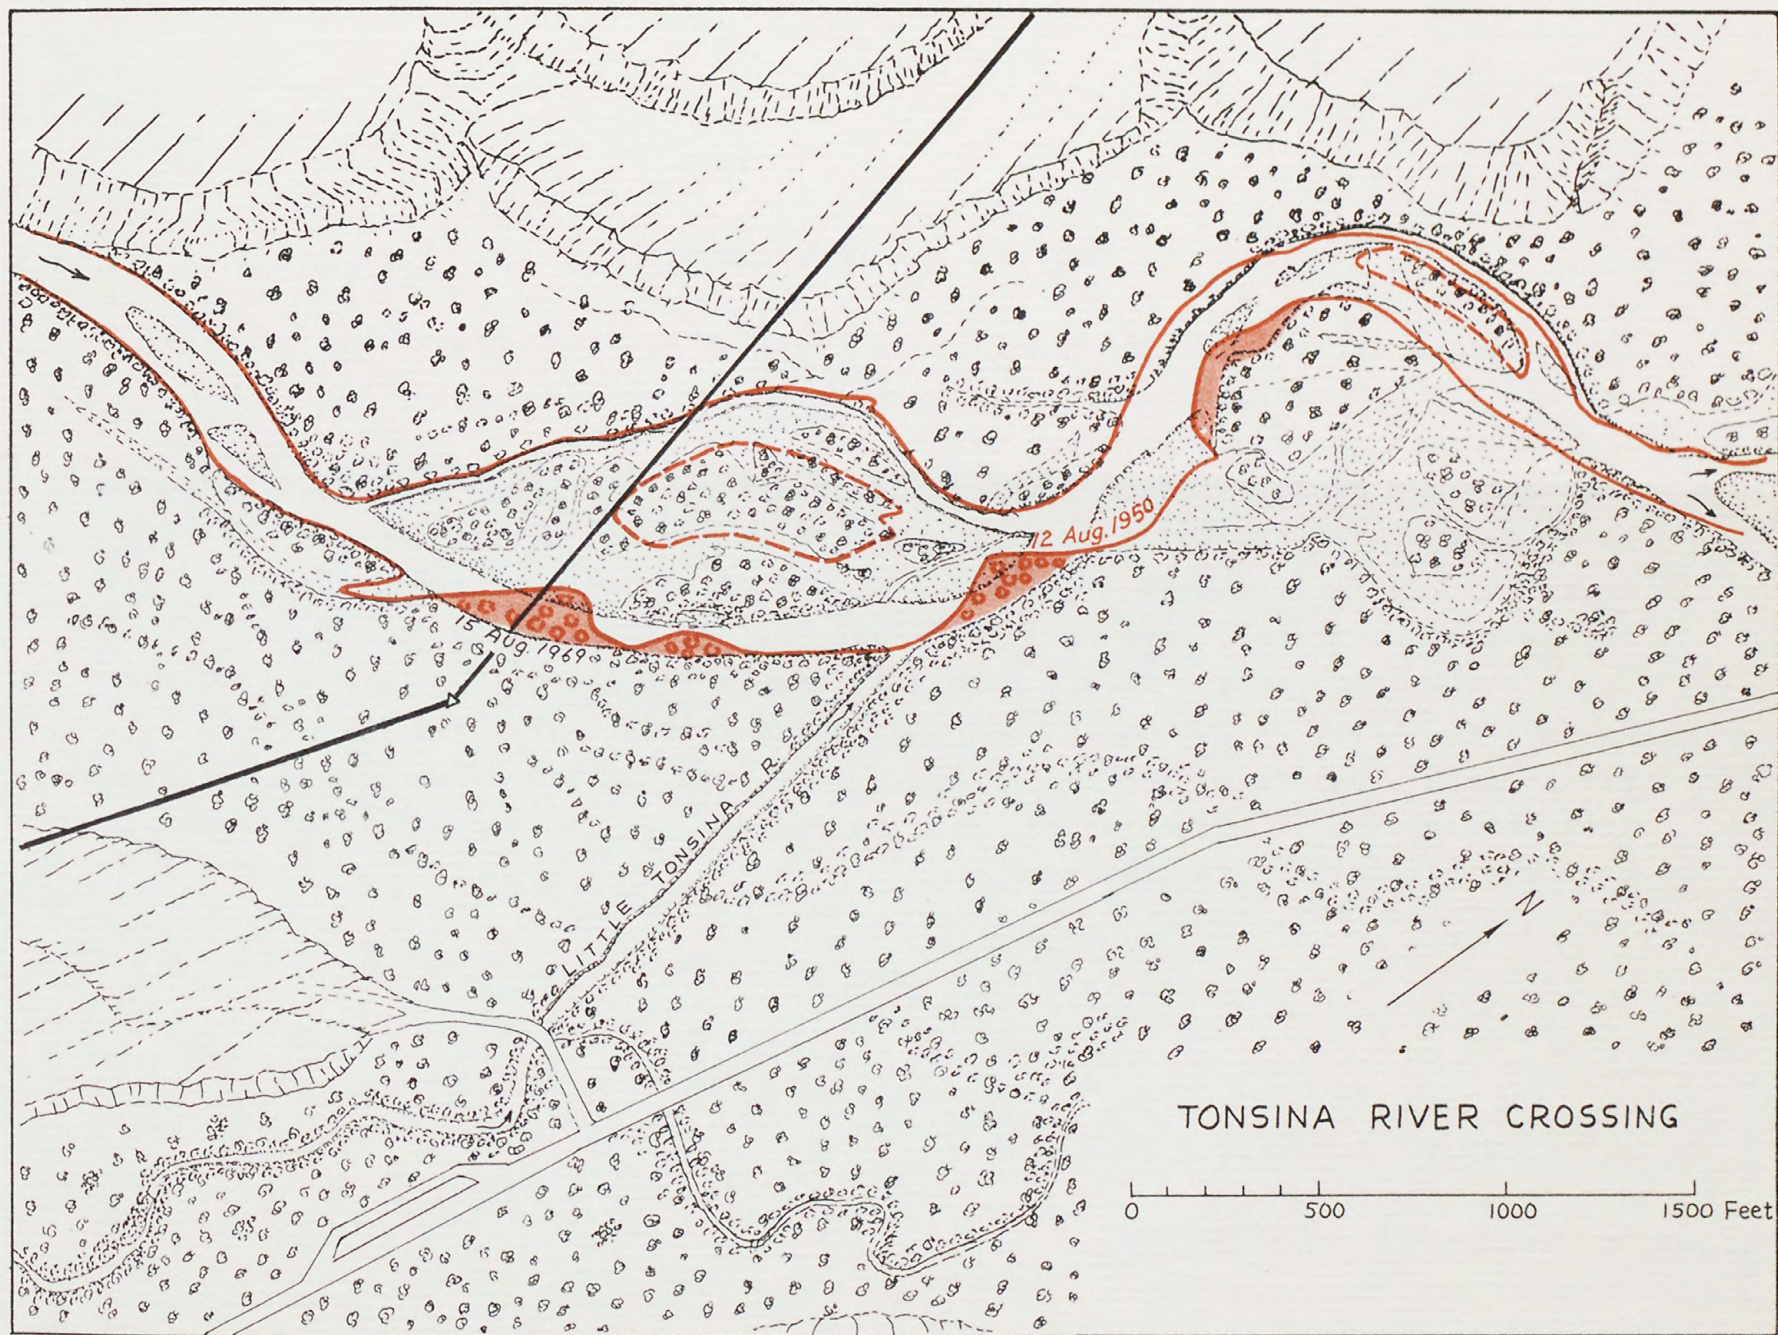
## **Tonsina River Crossing**

The southern approach of the pipeline to the Tonsina River channel is across a wooded surface that bears the scars of old channels. This surface is regarded as a low terrace, subject to flooding at infrequent intervals (say, on the order of 50 years), but the main channel of the river is unlikely to be redirected abruptly across it. This surface is, however, subject to lateral erosion and at the crossing site the river has trimmed it back for a maximum distance of about 125 feet during the past 20 years. Part of this removal took place by the reoccupation of a side channel, and the erosion rate of about 5 feet per year is considered too large to be projected into the future. Nevertheless, the crossing site is now on the outside of a bend, and an erosion rate of 2 feet per year would not be an excessive estimate. The northern approach to the channel is across a large gravel bar, mostly vegetated and unlikely to be either eroded laterally or the site of the main channel for the next few decades.

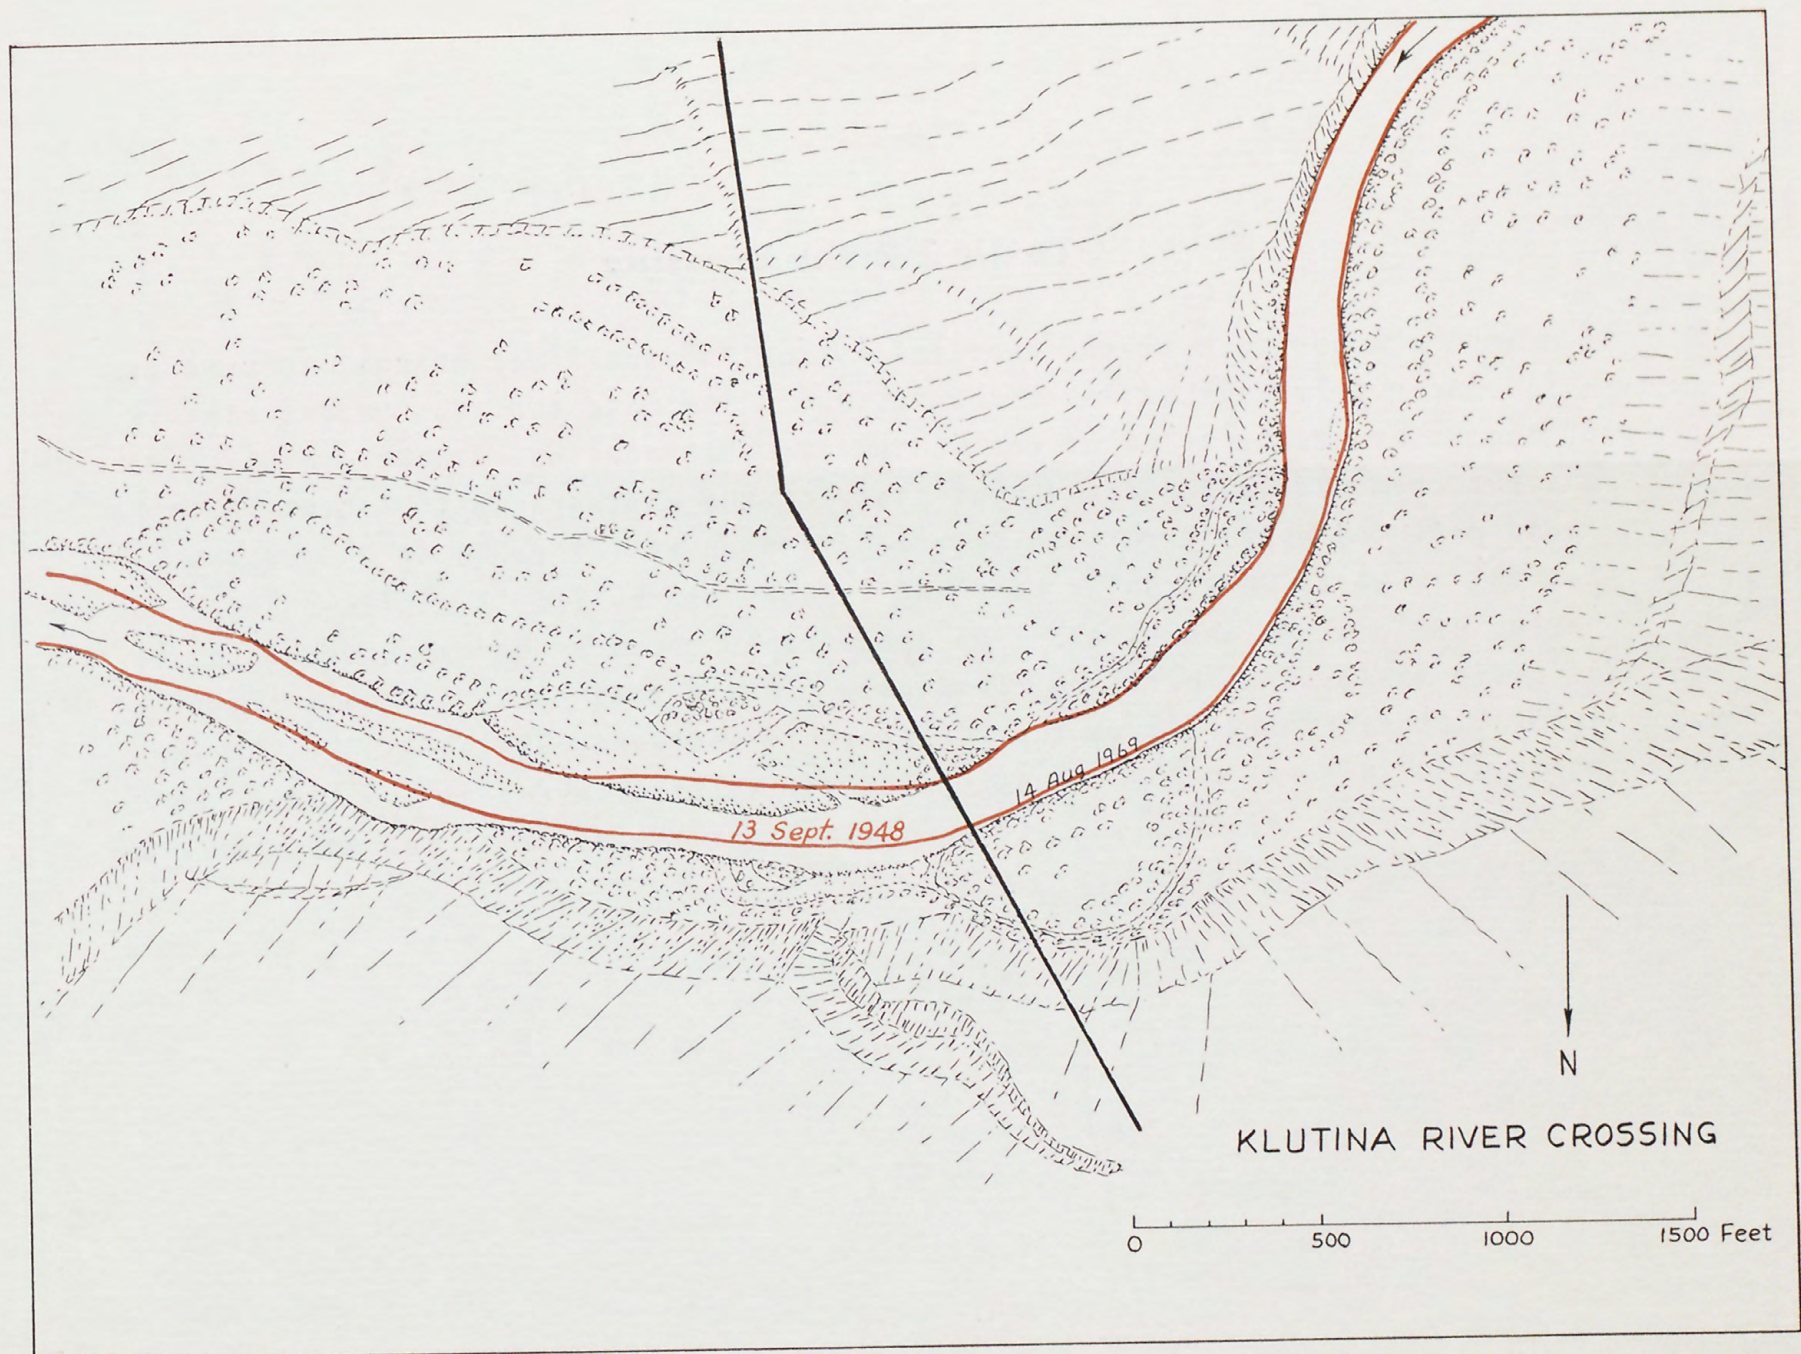
## **Klutina River Crossing**

The southern approach of the pipeline to the Klutina River channel is across a series of poorly defined low surfaces, some marked by old meander scars, which indicate that the recent history of the river has been one of continuous slow degradation. Areas flooded at intervals of 2-3 years appear to be confined to a narrow strip along the river. As examined in the field, the channel has an aspect of stability and no significant amount of lateral erosion occurred between 1948 and 1969. The most difficult engineering problem in approaching the Klutina seems to lie in the method of descending the steep terrace face that borders the river on the north. One suggested approach involves the large ravine just downstream from the proposed crossing. It may be pertinent to note that this ravine is not a rapidly eroding feature, as it shows no significant change between 1948 and 1969.

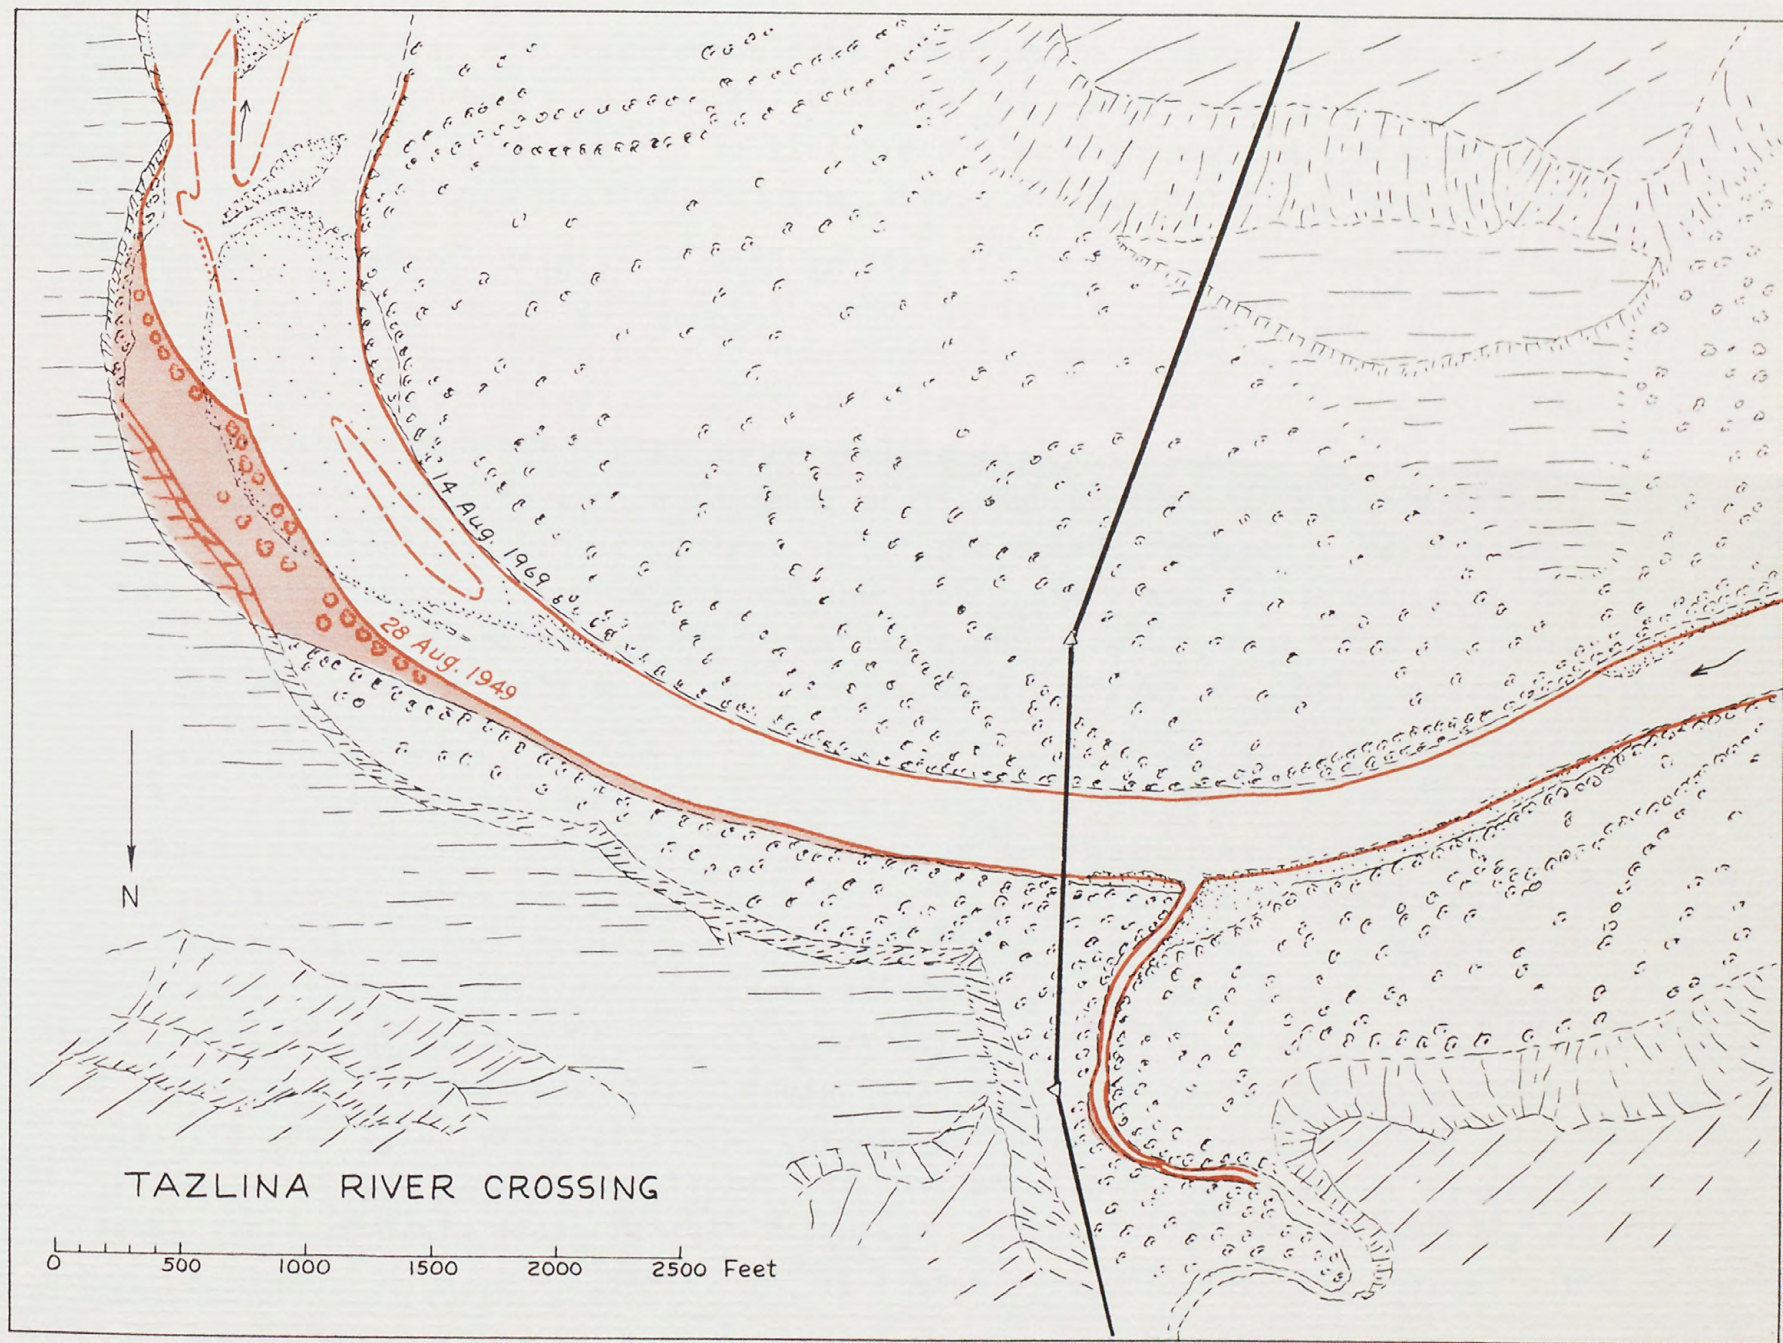
## **Tazlina River Crossing**

The southern approach of the pipeline to the Tazlina River channel is across a series of poorly defined low terraces, which indicate that the recent history of the river has been one of continuous slow degradation. The crossing site was not examined in the field, but study of the photographs indicates that the flood plain as usually defined (surface flooded at intervals of 2-3 years; or highest level to which point bars and islands are built) is confined to a narrow strip along the river. The photographs compared had an unusual degree of scale distortion, but I am reasonably certain that no significant amount of lateral erosion occurred at the crossing site between 1949 and 1969. On the other hand, several hundred feet of lateral shift occurred at the first bend downstream from the crossing site, showing that the river is indeed capable of substantial lateral erosion.

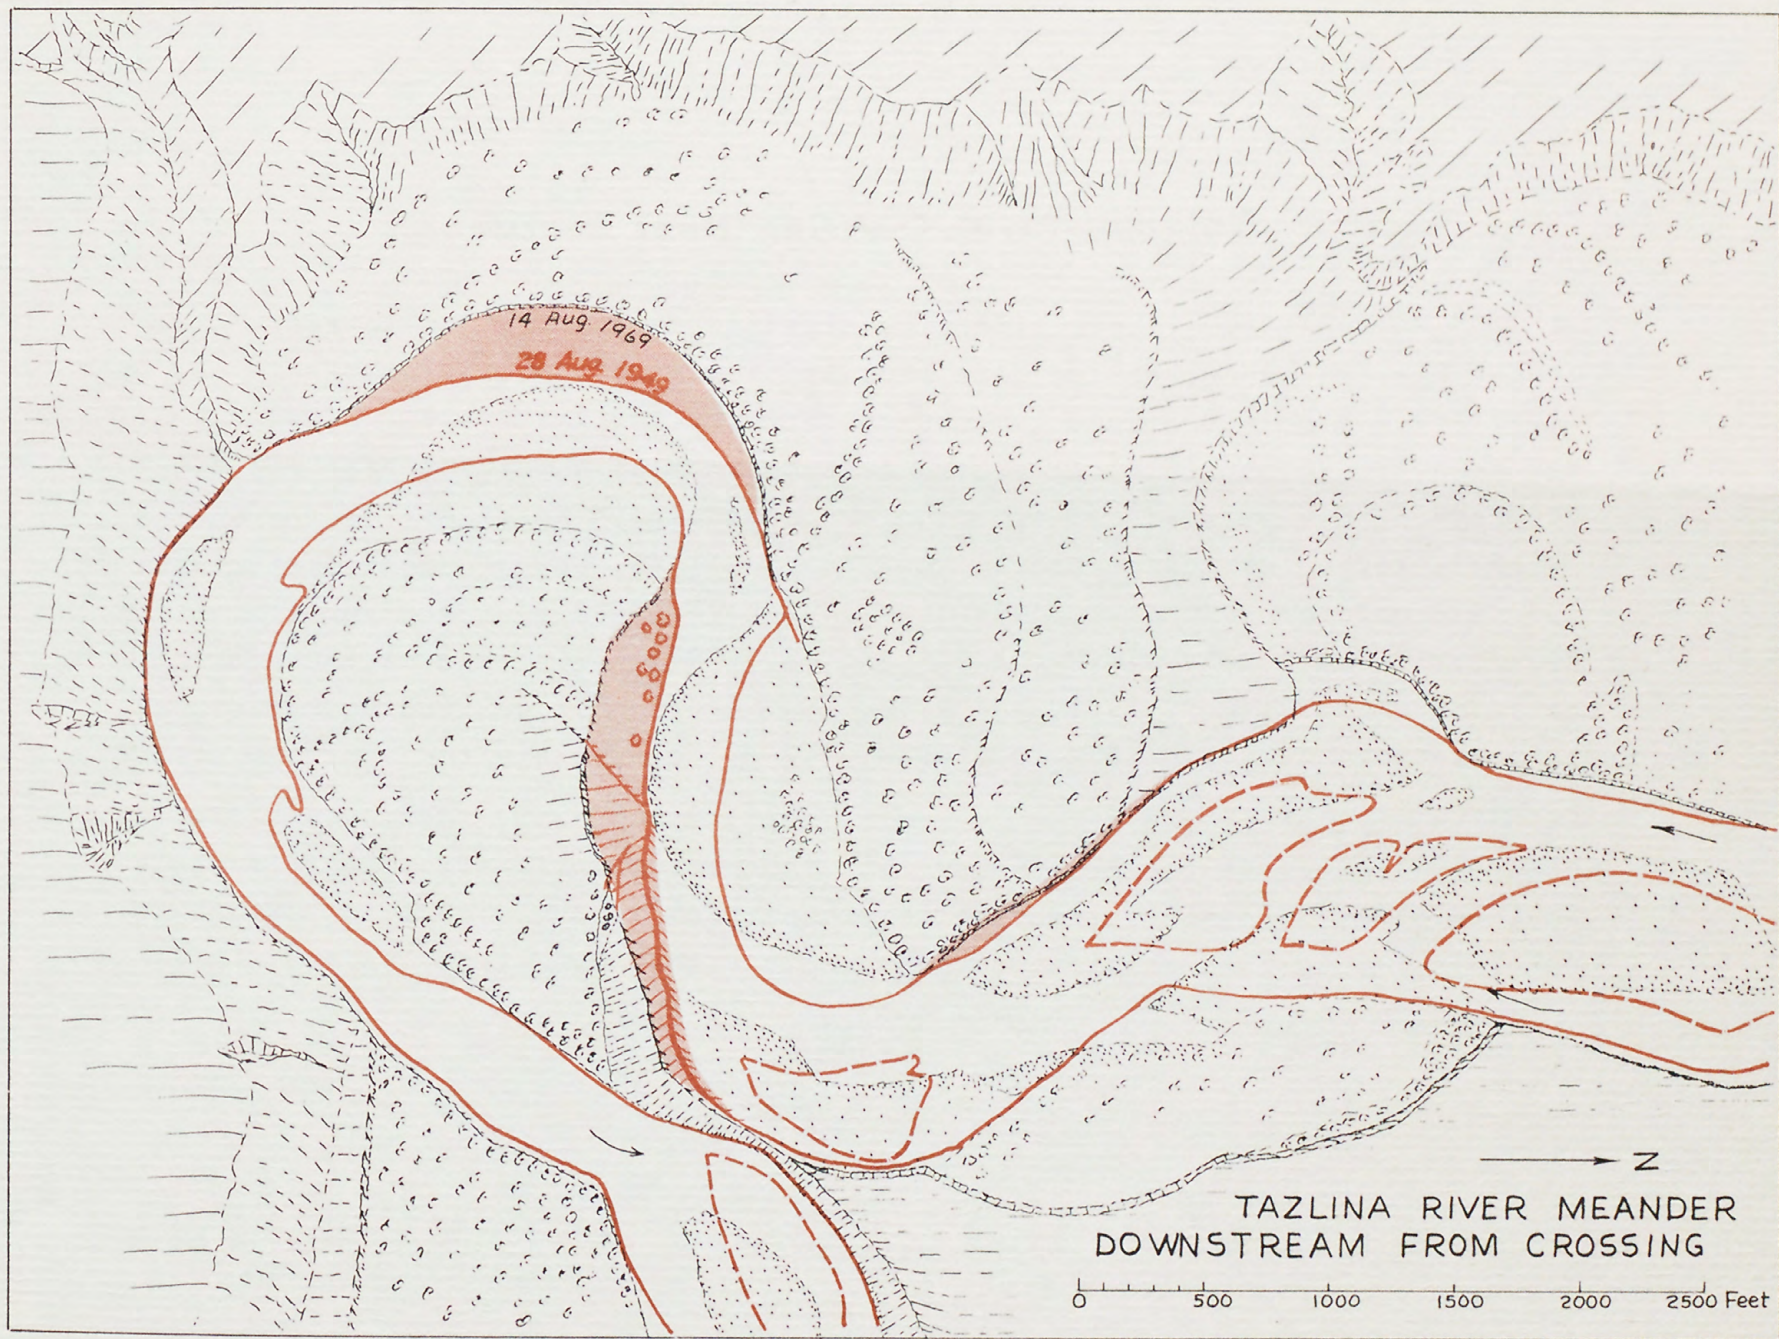
## Tazlina River Meander

A large meander, located about 10,000 feet downstream from the crossing site, is approaching the cutoff stage and questions have been raised as to the scour at the crossing site that would result from cutoff of the meander. The river course would be shortened 8,500 feet by the cutoff, which amounts to about 25 feet of fall.

When the erosional remnant at the meander neck is examined by casual comparison of the 1949 and 1969 aerial photographs, little change is seen. However, very careful comparison of the photographs at greatly enlarged scale shows that, downstream from the narrowest part of the neck, the remnant has been substantially reduced by about 150 feet of lateral erosion. The point of maximum lateral erosion has shifted downstream from the narrowest part of the neck, where cutoff is most imminent, but a bend is impinging directly against the remnant on its opposite side. The remnant does not consist of consolidated bedrock, but of unconsolidated terrace fill. When all factors are considered, the probabilities are better than even that the bend will be cut off within the next few decades.

However, cutoff of the bend will not necessarily result in drastic scour at the crossing site. The bedload of the river includes abundant cobbles and boulders and its gradient is in any case not smooth. Cutoffs are common along meandering Alaskan rivers, but no evidence of drastic scour (as indicated by increase in bank height) can be observed in the field. For example, on Hess Creek upstream from the crossing site, a cutoff (which probably took place in 1967) shortened the river course by 5,350 feet. The river merely widened its channel downstream from the cutoff and no change in bank height could be observed. In general, it seems that the step in gradient due to the cutoff is distributed over a short distance upstream and downstream from the cutoff and part of the excess energy is absorbed by channel widening. Perhaps 5 feet of scour might be expected at the Tazlina crossing site as a result of the cutoff.
