# MEASUREMENT OF LATERAL EROSION AT PROPOSED RIVER CROSSING SITES OF THE ALASKA PIPELINE

**MEASUREMENT OF LATERAL EROSION  
AT PROPOSED RIVER CROSSING SITES  
OF THE ALASKA PIPELINE**

*coble*  
**by James Brice, 1920 -**

**THE UNITED STATES DEPARTMENT OF THE INTERIOR, GEOLOGICAL SURVEY  
Water Resources Division, Alaska District - 1971**

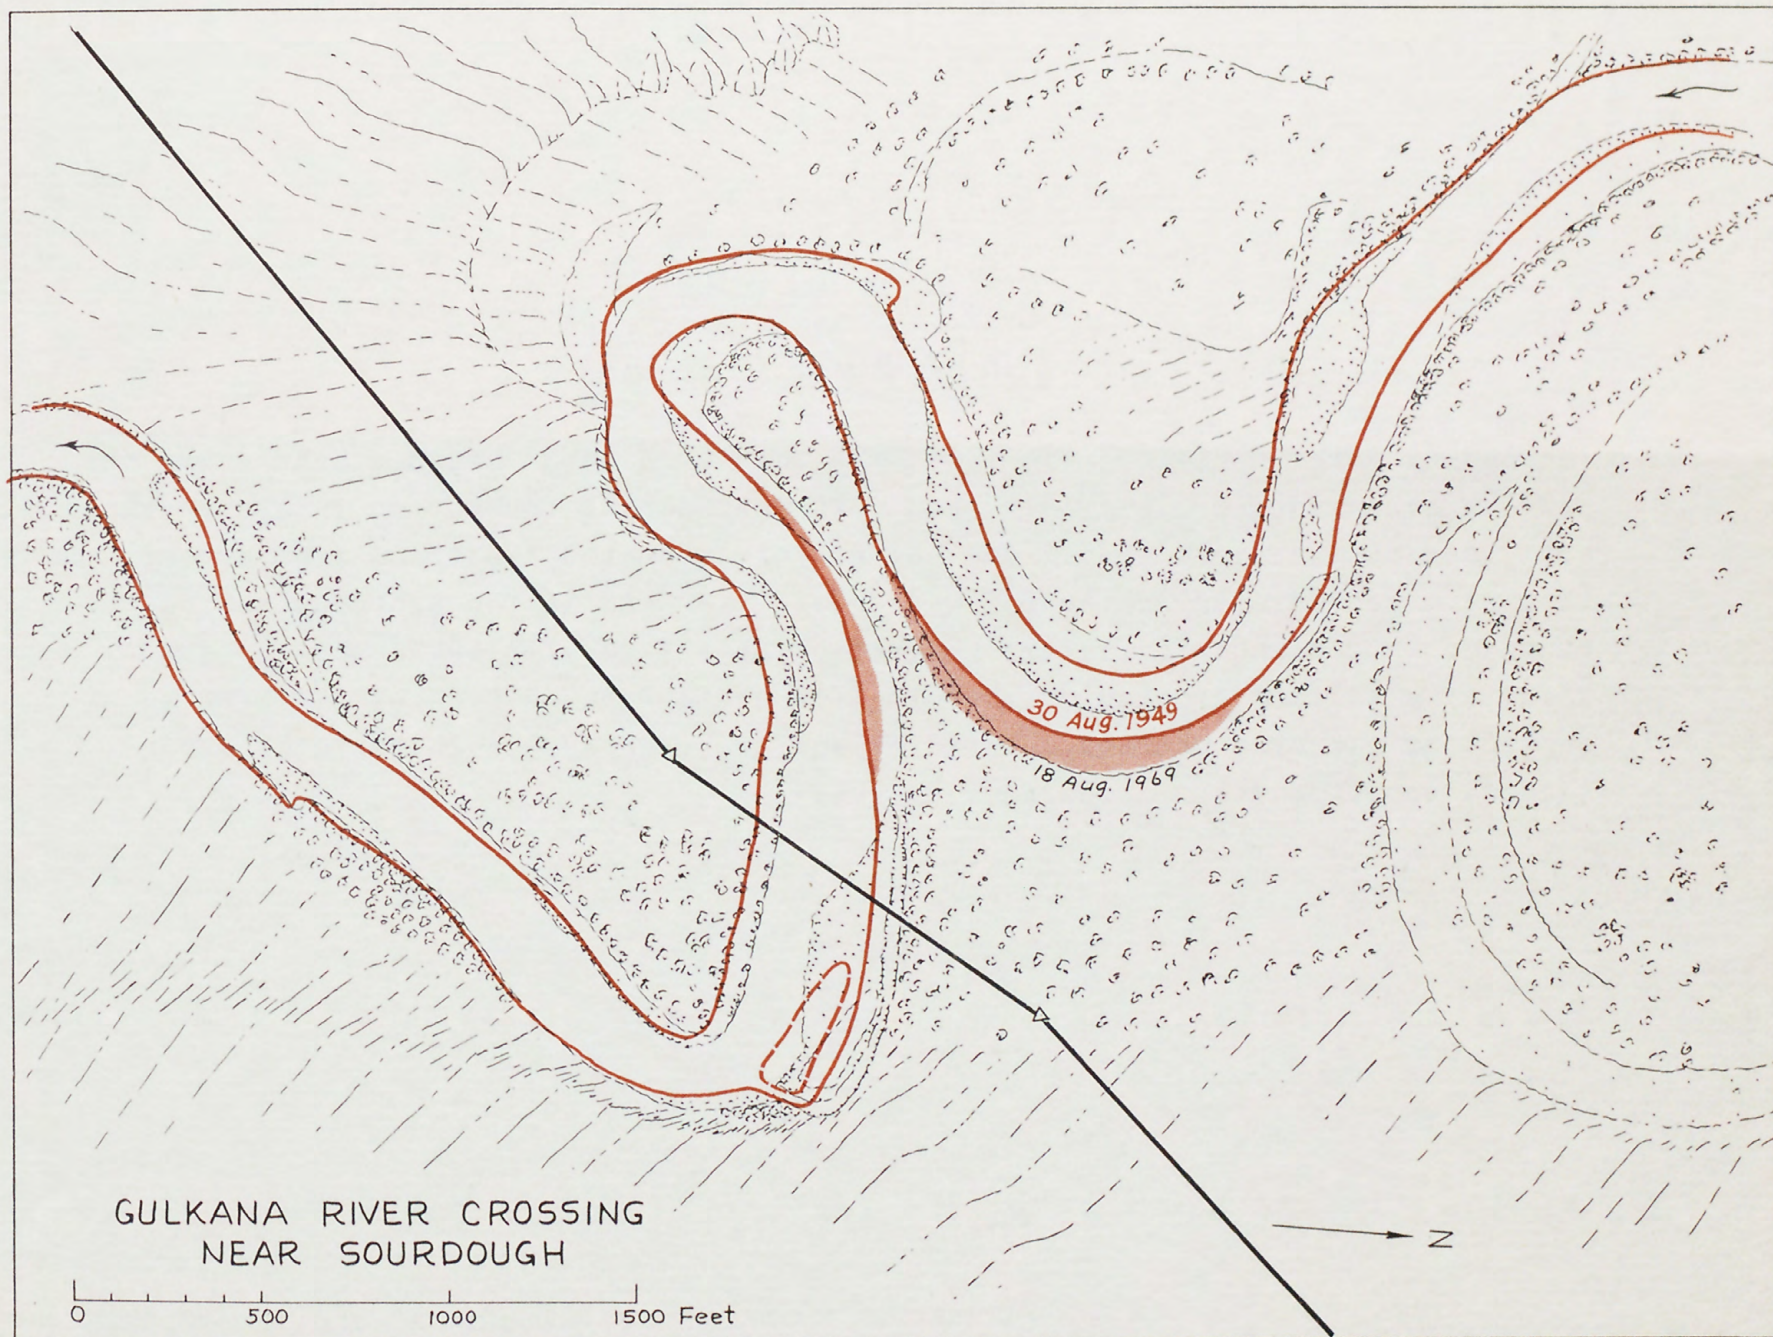
## **Gulkana River Crossing Near Sourdough**

As with most Alaskan rivers along the pipeline route, the low terraces that border the Gulkana River indicate that it is a slowly degrading stream and that its flood plain is confined to a narrow strip along the river. Lateral erosion has been low to moderate, amounting to a maximum of about 100 feet (1949-69) at the apex of a bend upstream from the crossing site. No significant amount of lateral erosion was discerned at the crossing site, but a cutoff is imminent at the next meander upstream, where the meander neck was reduced from a width of 200 feet in 1949 to a width of 120 feet in 1969. Field examination at high river stage on June 7, 1971, indicated that erosion is proceeding rapidly at this meander neck, and it will probably be cut off within the next few decades.

Cutoff will shorten the river course by about 2,500 feet, and several feet of scour will occur at the crossing site. The new channel made by cutoff would impinge directly against the right bank upstream from the crossing point and the resulting rapid bank erosion would probably extend downstream to the crossing.

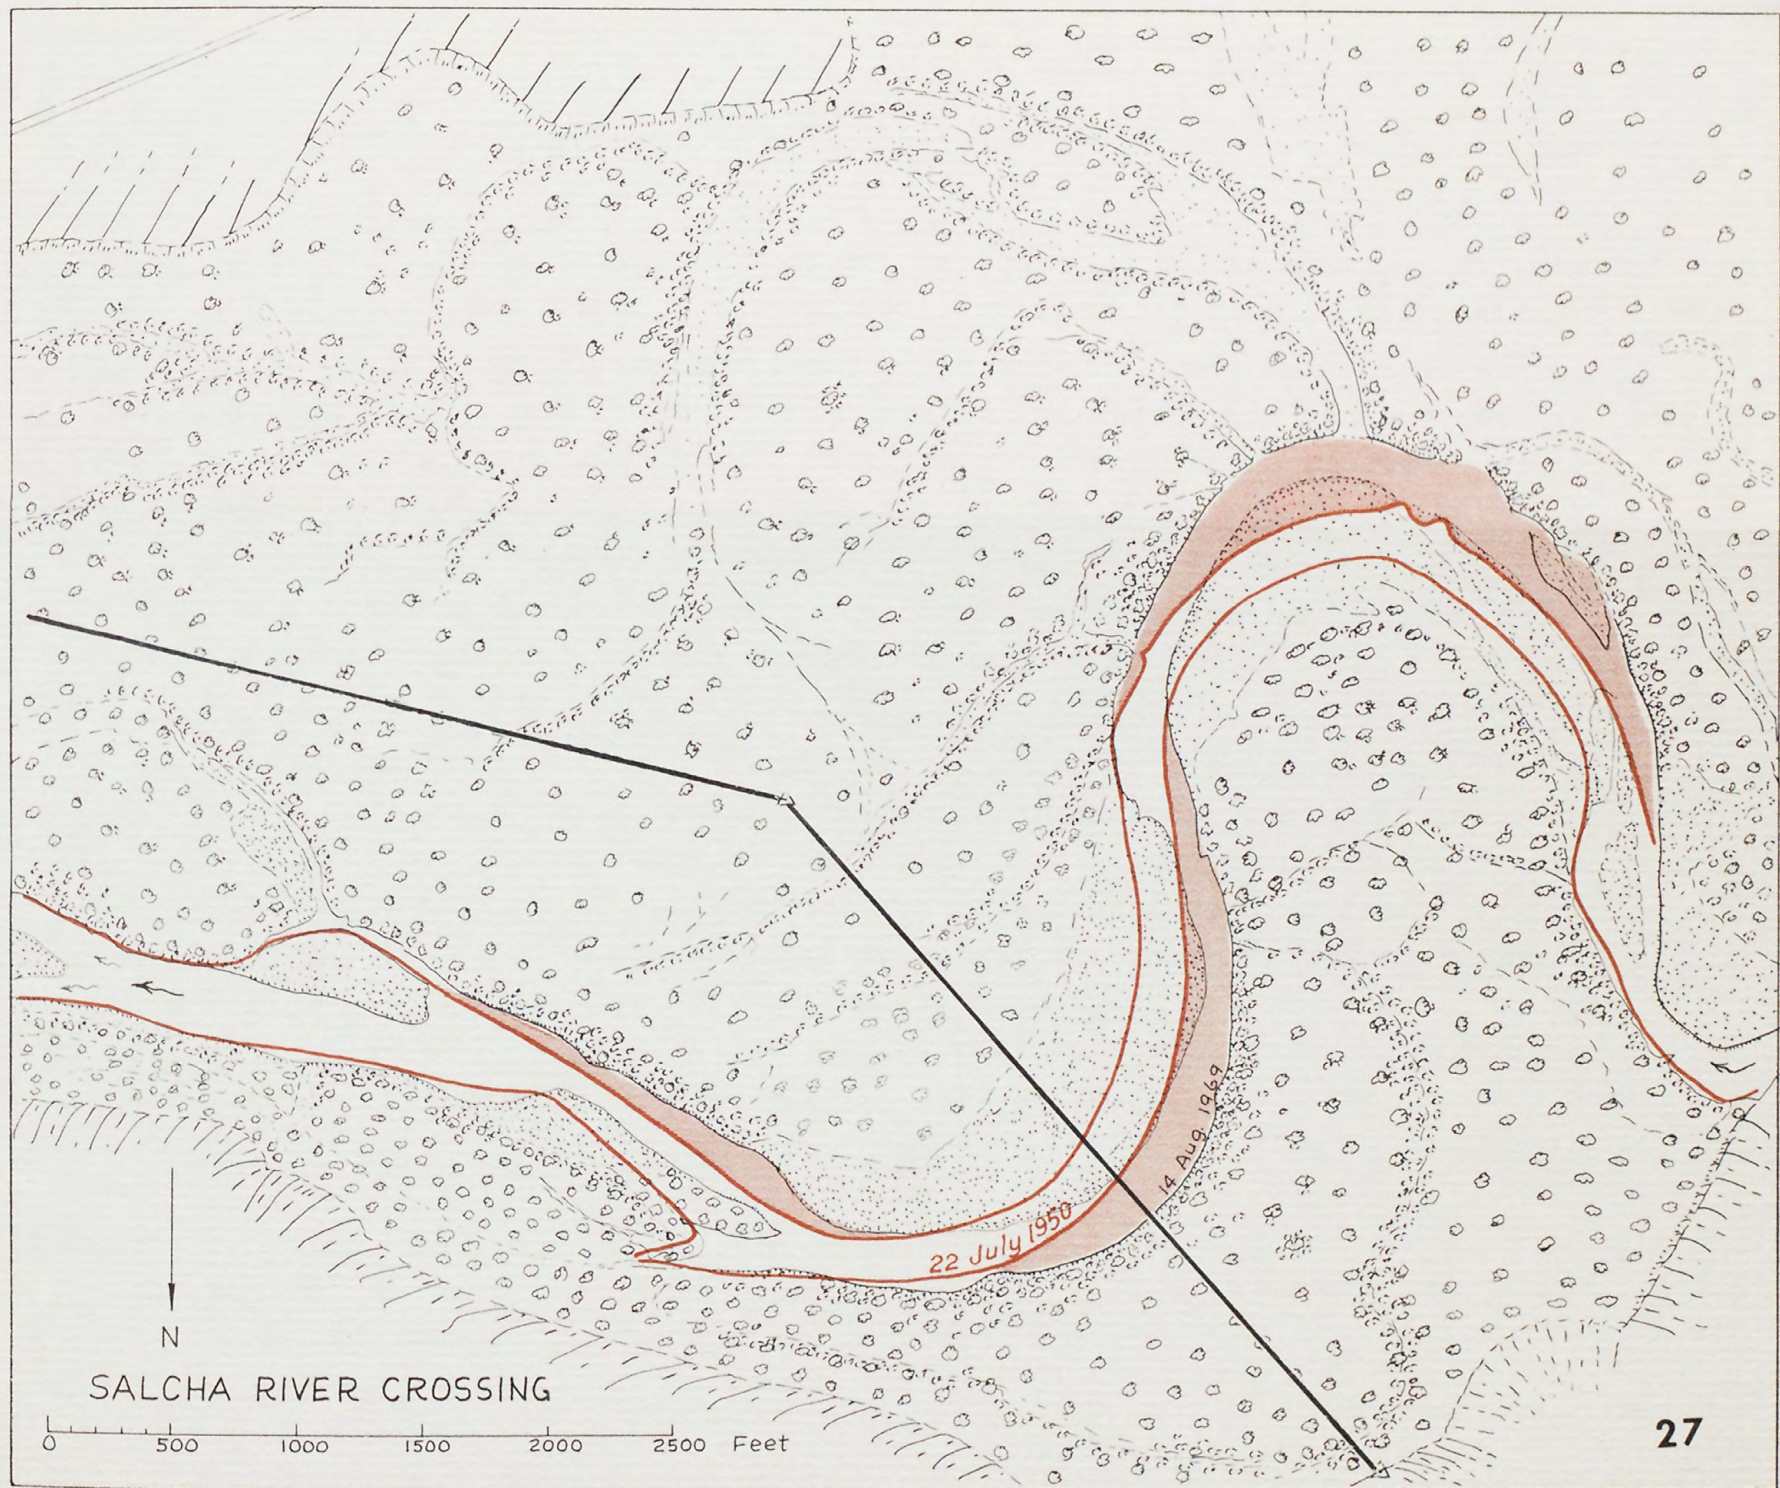
## **Salcha River Crossing**

The Salcha River crossing site is at the apex of a large meander bend where the concave bank migrated laterally about 225 feet during the period 1950-69. The next bend upstream, which is somewhat narrow, migrated about 300 feet during this same period. In the next few decades, the bend at the crossing can be expected to continue its lateral migration at a rate similar to that of the past. The surface crossed by the pipeline on the convex side of the bend is subject to flooding but not to significant scour because cutoff of the main channel across this surface seems unlikely.

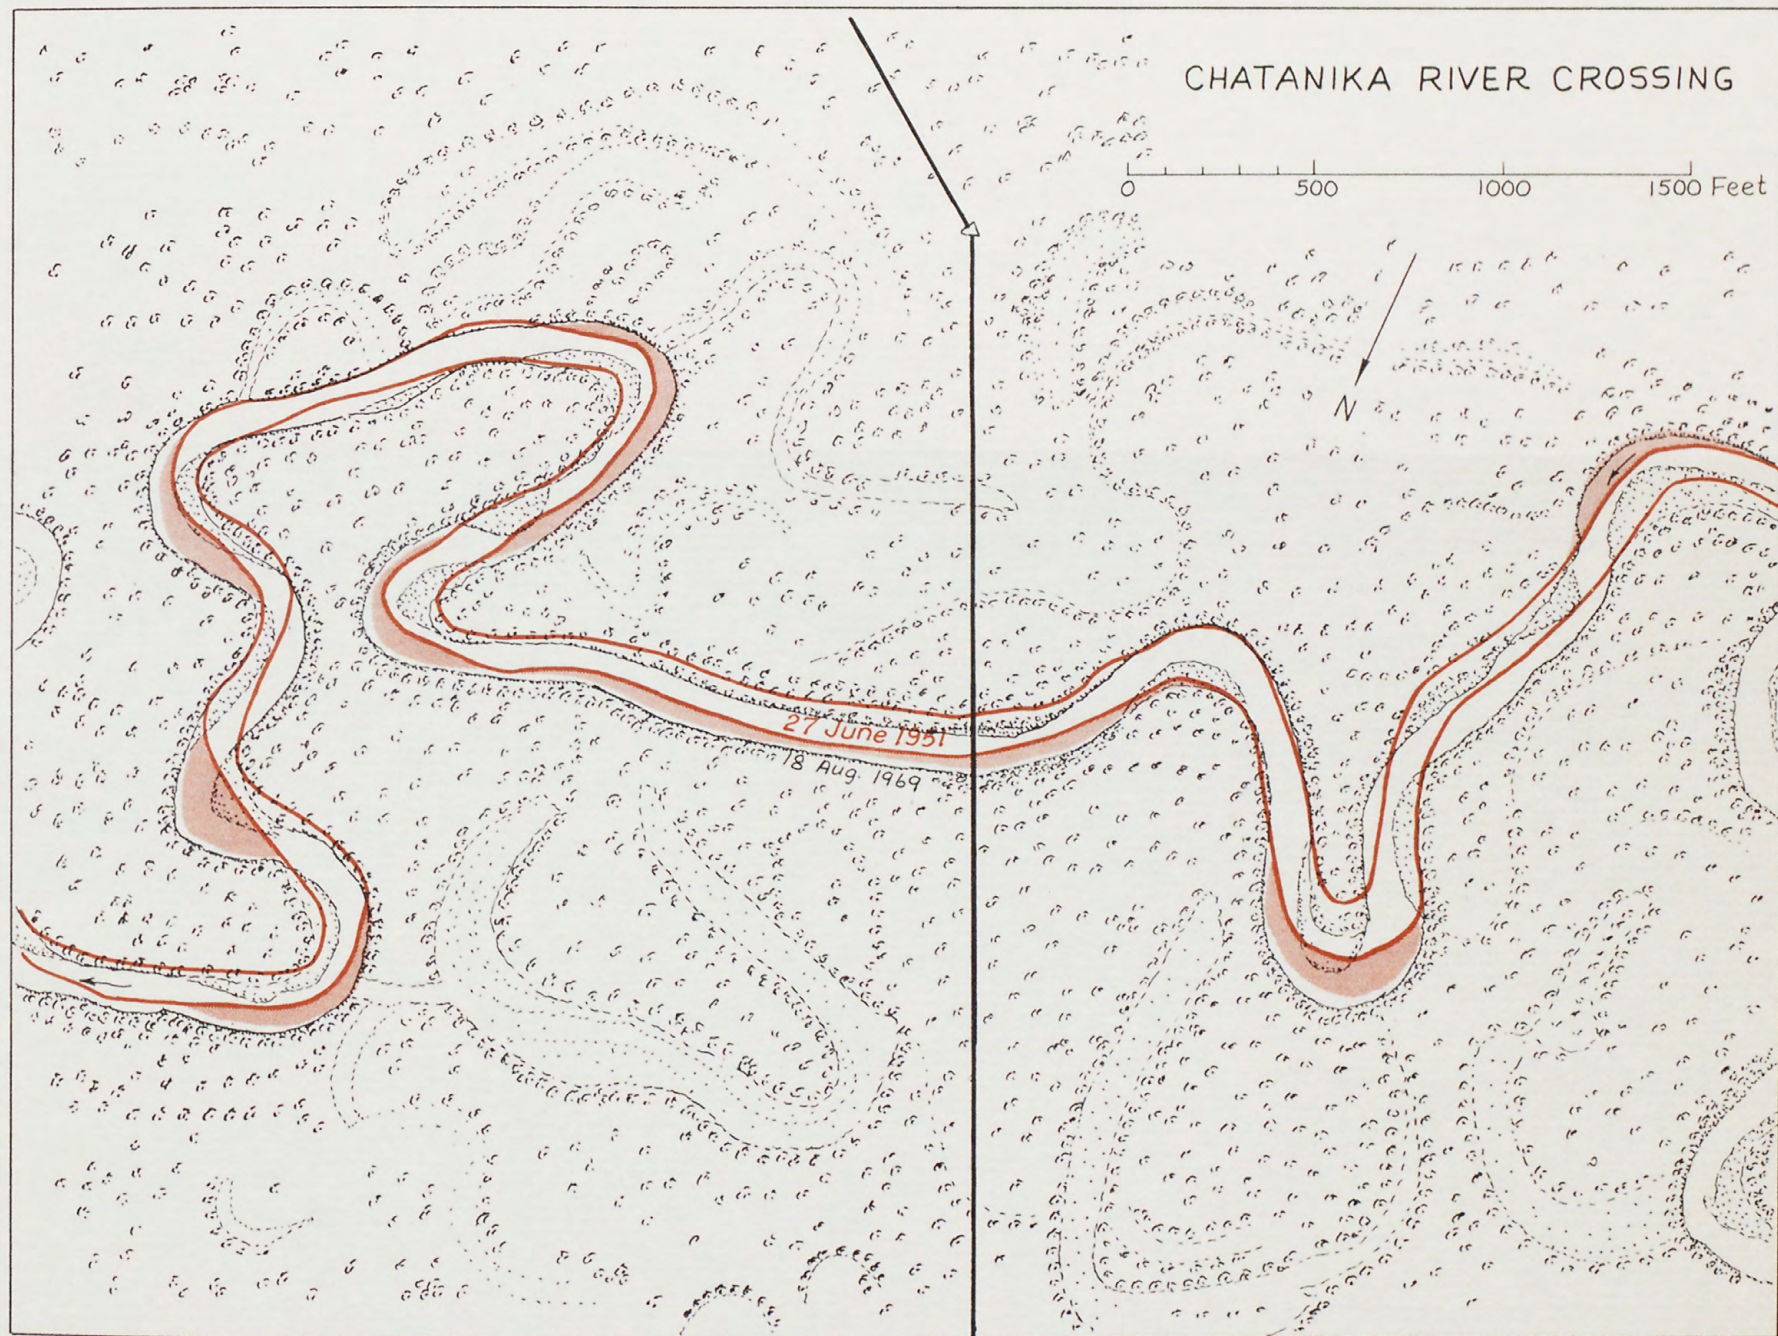
## Chatanika River Crossing

After descending the gently sloping valley sides of the Chatanika River, the pipeline route crosses a valley floor that is nearly flat but not all of which is regarded as flood plain. The outer edges of the valley flat are mantled with colluvium and the flood plain itself seems confined to the meander belt, as marked by the meanders themselves and by many oxbow lakes. The lateral migration rate of the channel was rather low for the period 1951-69, reaching a maximum of about 100 feet at the apex of a narrow bend. About 25 feet of lateral erosion occurred during this period at the crossing site, but a somewhat higher rate there may be expected in the future. An incipient point bar has developed on the north bank at the crossing site, and a new bend appears to be in process of development there.

The banks, which are composed mainly of silty sand and are about 6 feet high, are bordered from place to place by barely visible fissures at distances ranging from a few feet to about 10 feet from the edge of the bank. The fissures apparently mark the edges of blocks that have slumped downward a foot or so toward the river. Similar slump blocks along the banks were noted at the Kanuti River and at the Little Tonsina, and they are tentatively attributed to the undercutting of frozen silty banks. Obviously, the stability of frozen silt banks--as compared with banks of thawed gravel--is likely to be adversely affected by installation of the pipeline, and some means of bank protection will be necessary to prevent rapid lateral erosion.

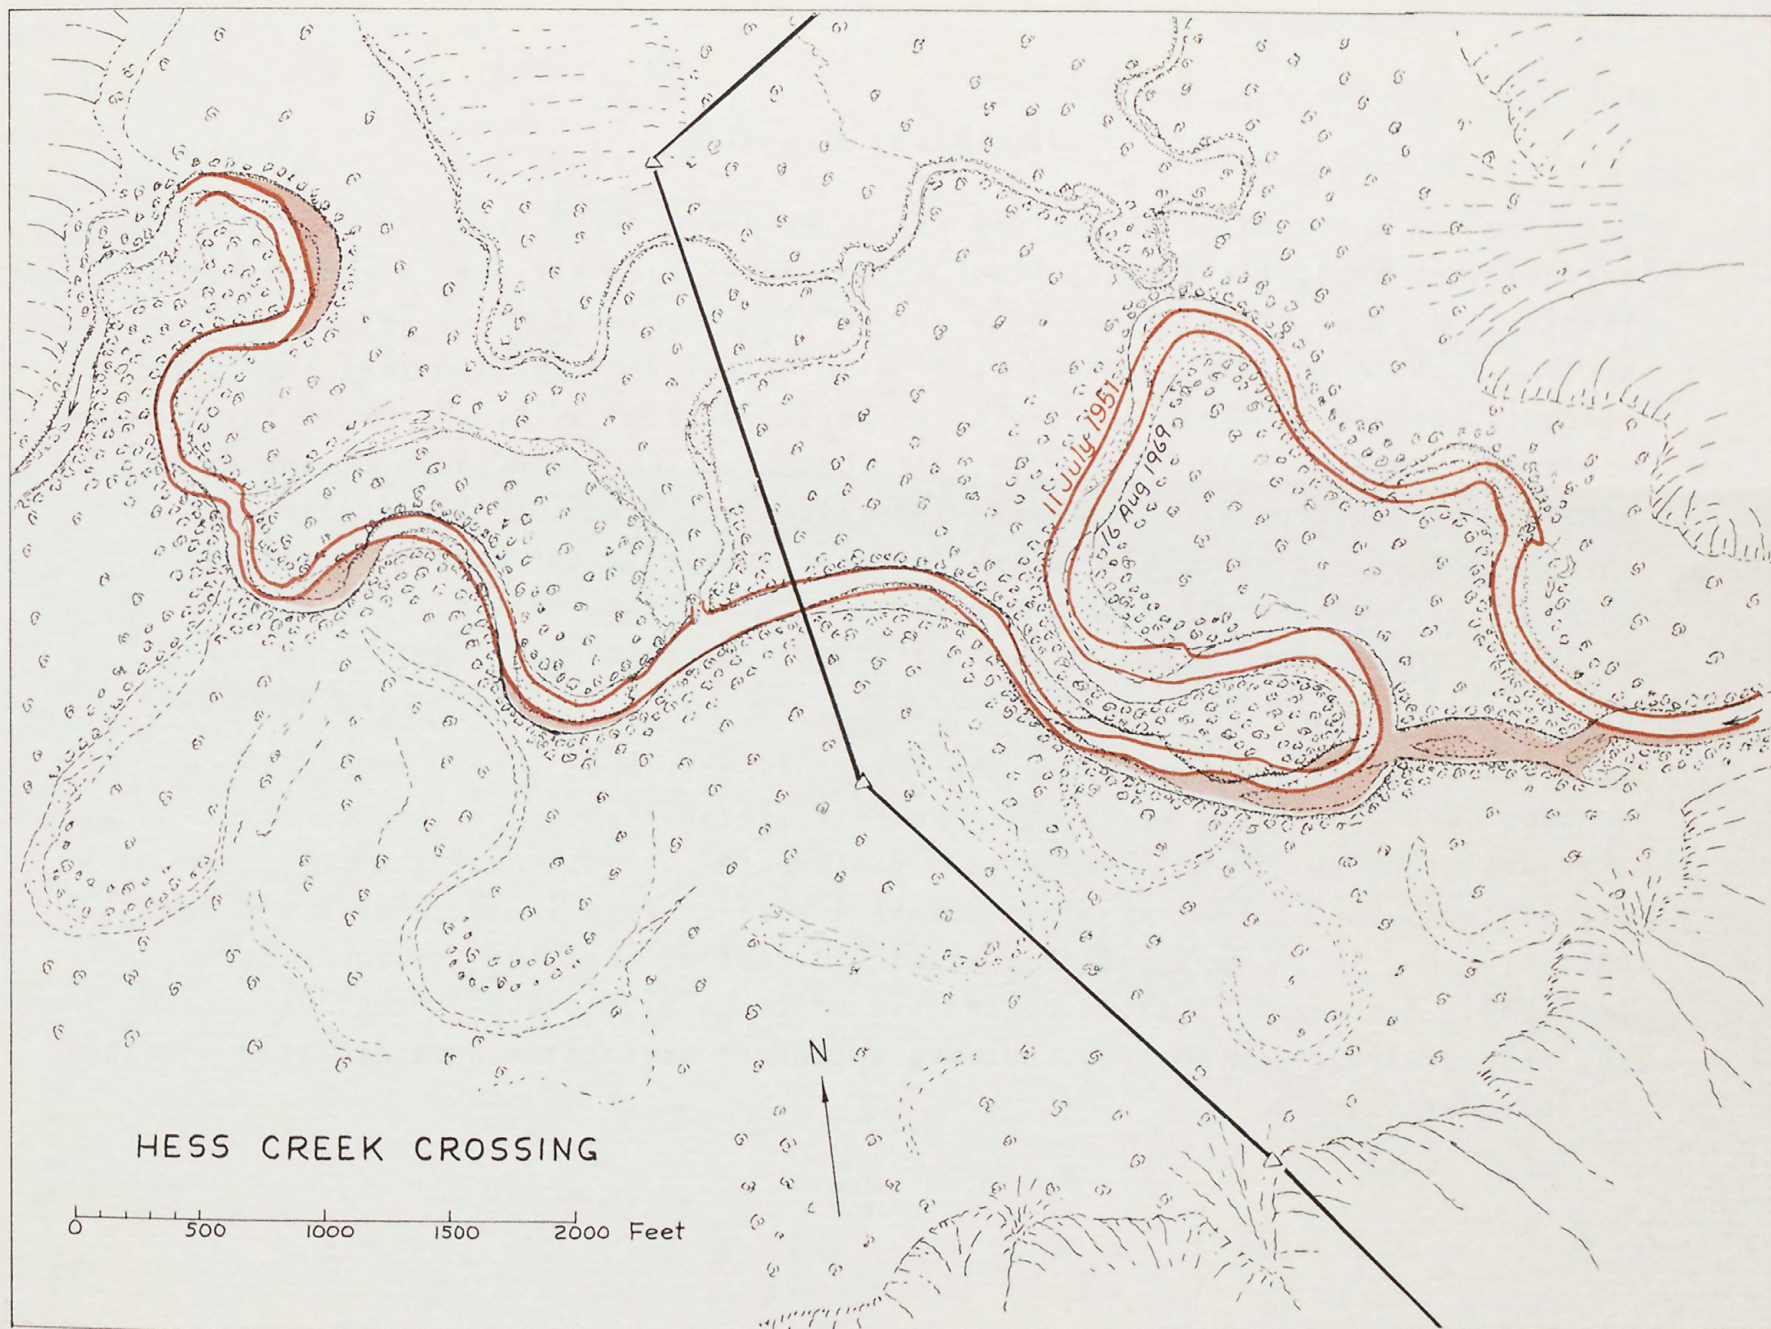
## Hess Creek Crossing

The flood plain of Hess Creek is roughly defined by its meander belt and includes most of the valley flat crossed by the pipeline route. Lateral erosion rates for the period 1951-69 were generally small and were insignificant at the crossing site. As shown on the map, a substantial channel cutoff has recently (probably in 1967) occurred upstream from the crossing site; no other cutoffs are imminent in the general vicinity. Where examined, the banks are about 7 feet high and consist of medium to fine gravel overlain by a foot or two of silty sand. These gravelly banks are less prone to instability resulting from installation of the pipeline than are the finer-grained banks along such streams as the Chatanika, but some means of bank protection will be needed to prevent rapid lateral erosion.

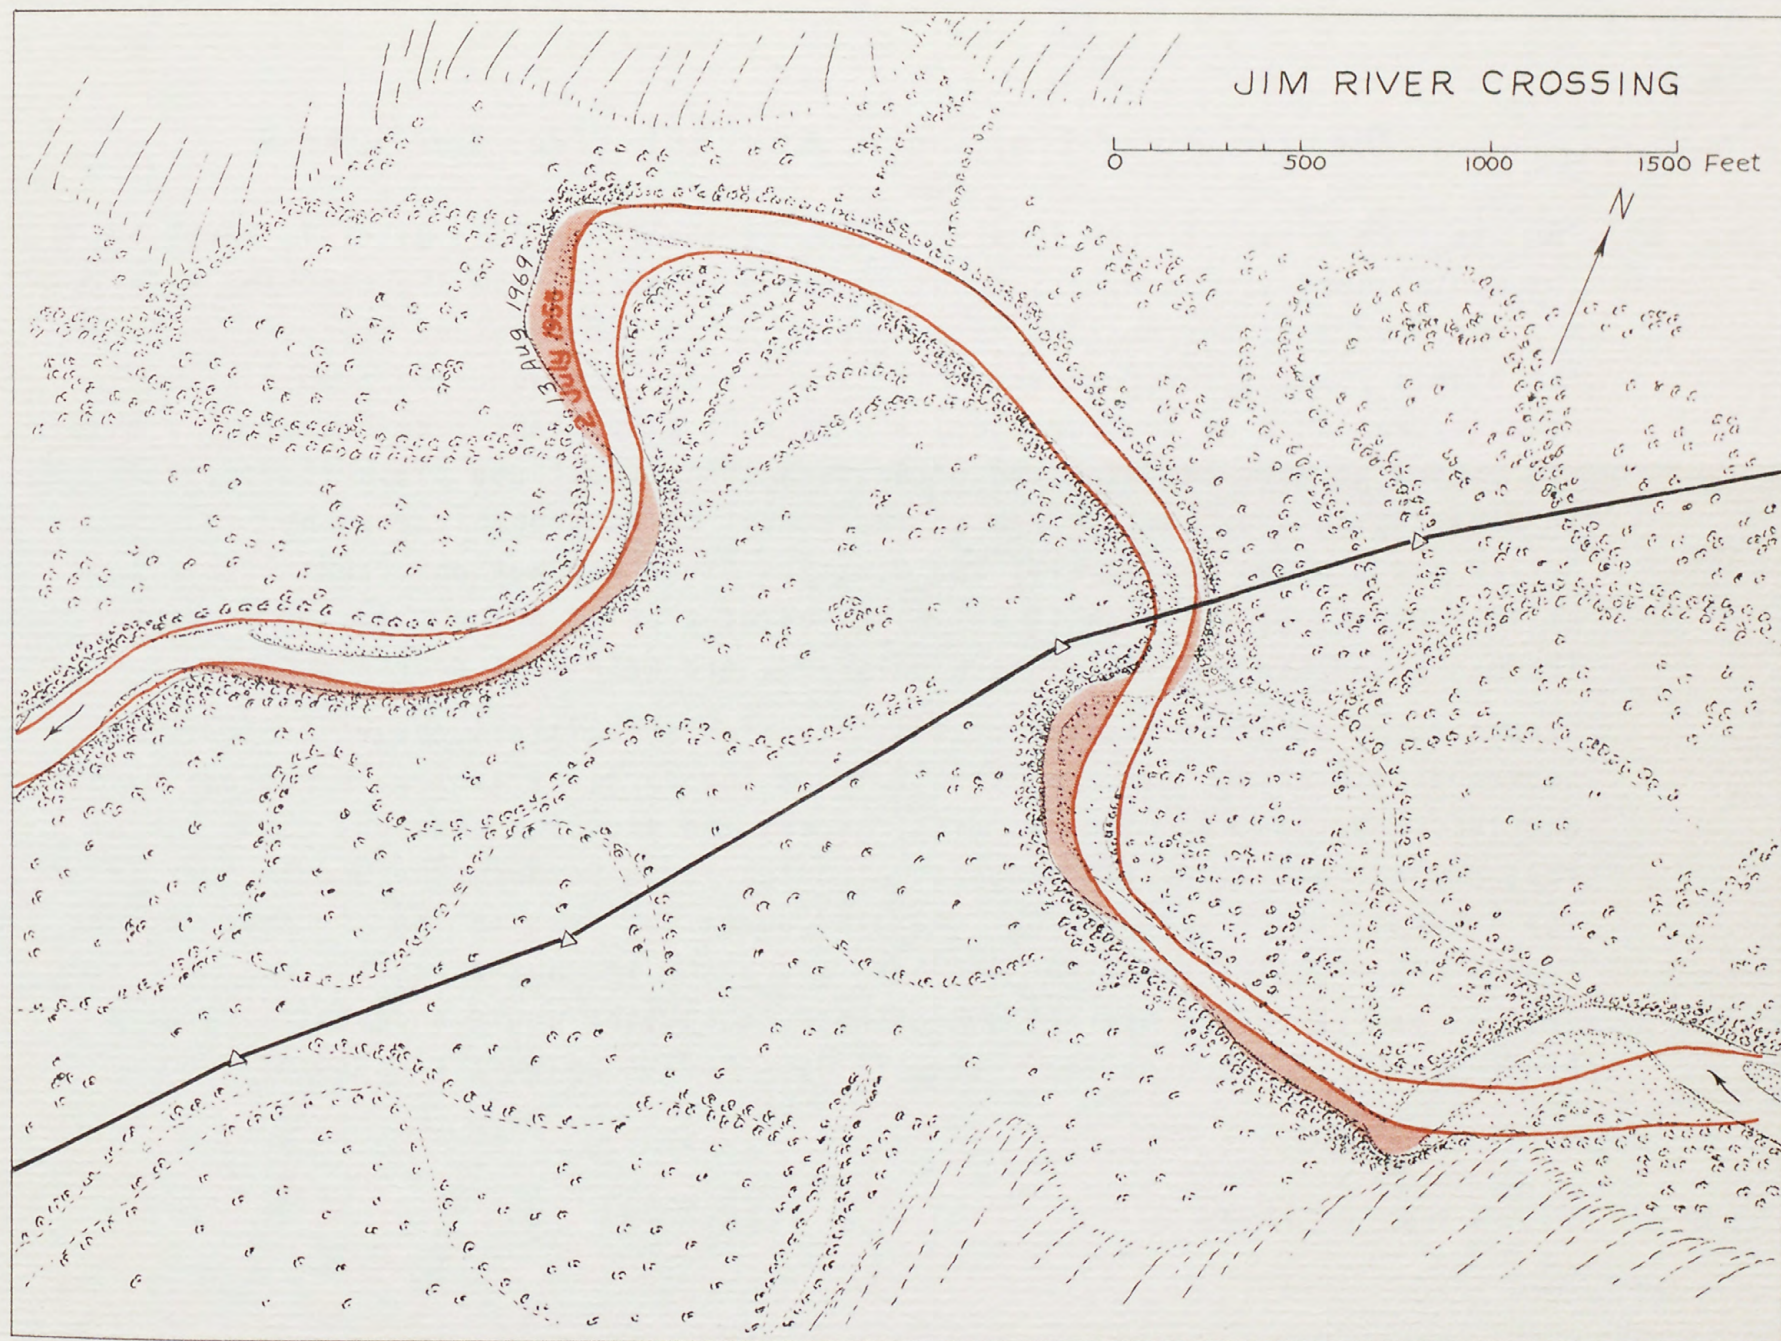
## Jim River Crossing

The pipeline approach on both sides of the proposed river crossing is across a surface that bears the arcuate scars of abandoned channels and is wooded, particularly on the western side, with mature firs. Several minor levels are distinguishable on this surface, ranging in height from about 5 feet above the river to perhaps 12 feet; and these are regarded as a series of low terraces formed as the river slowly degrades its channel. The flood plain of the river consists of a narrow strip sparsely vegetated with birch, balsam poplar, and shrubs, and occurring mainly on the landward edge of point bars. As exposed on point bars, the bedload of the river consists mainly of cobbles and small boulders; the exposed banks consist mainly of coarse gravel overlain by forest mat.

Upstream from the crossing site, the river has developed a new, rather sharp meander bend since 1955 (date of the earliest available aerial photographs) that has migrated laterally about 125 feet in the direction of the proposed pipeline approach. Lateral migration at a similar rate in the future can be expected, and it is apparent that about 500 feet of the pipeline would be in jeopardy. Bank stabilization by the use of large riprap would doubtless reduce the rate of lateral migration, but the option of moving the crossing site should be considered.

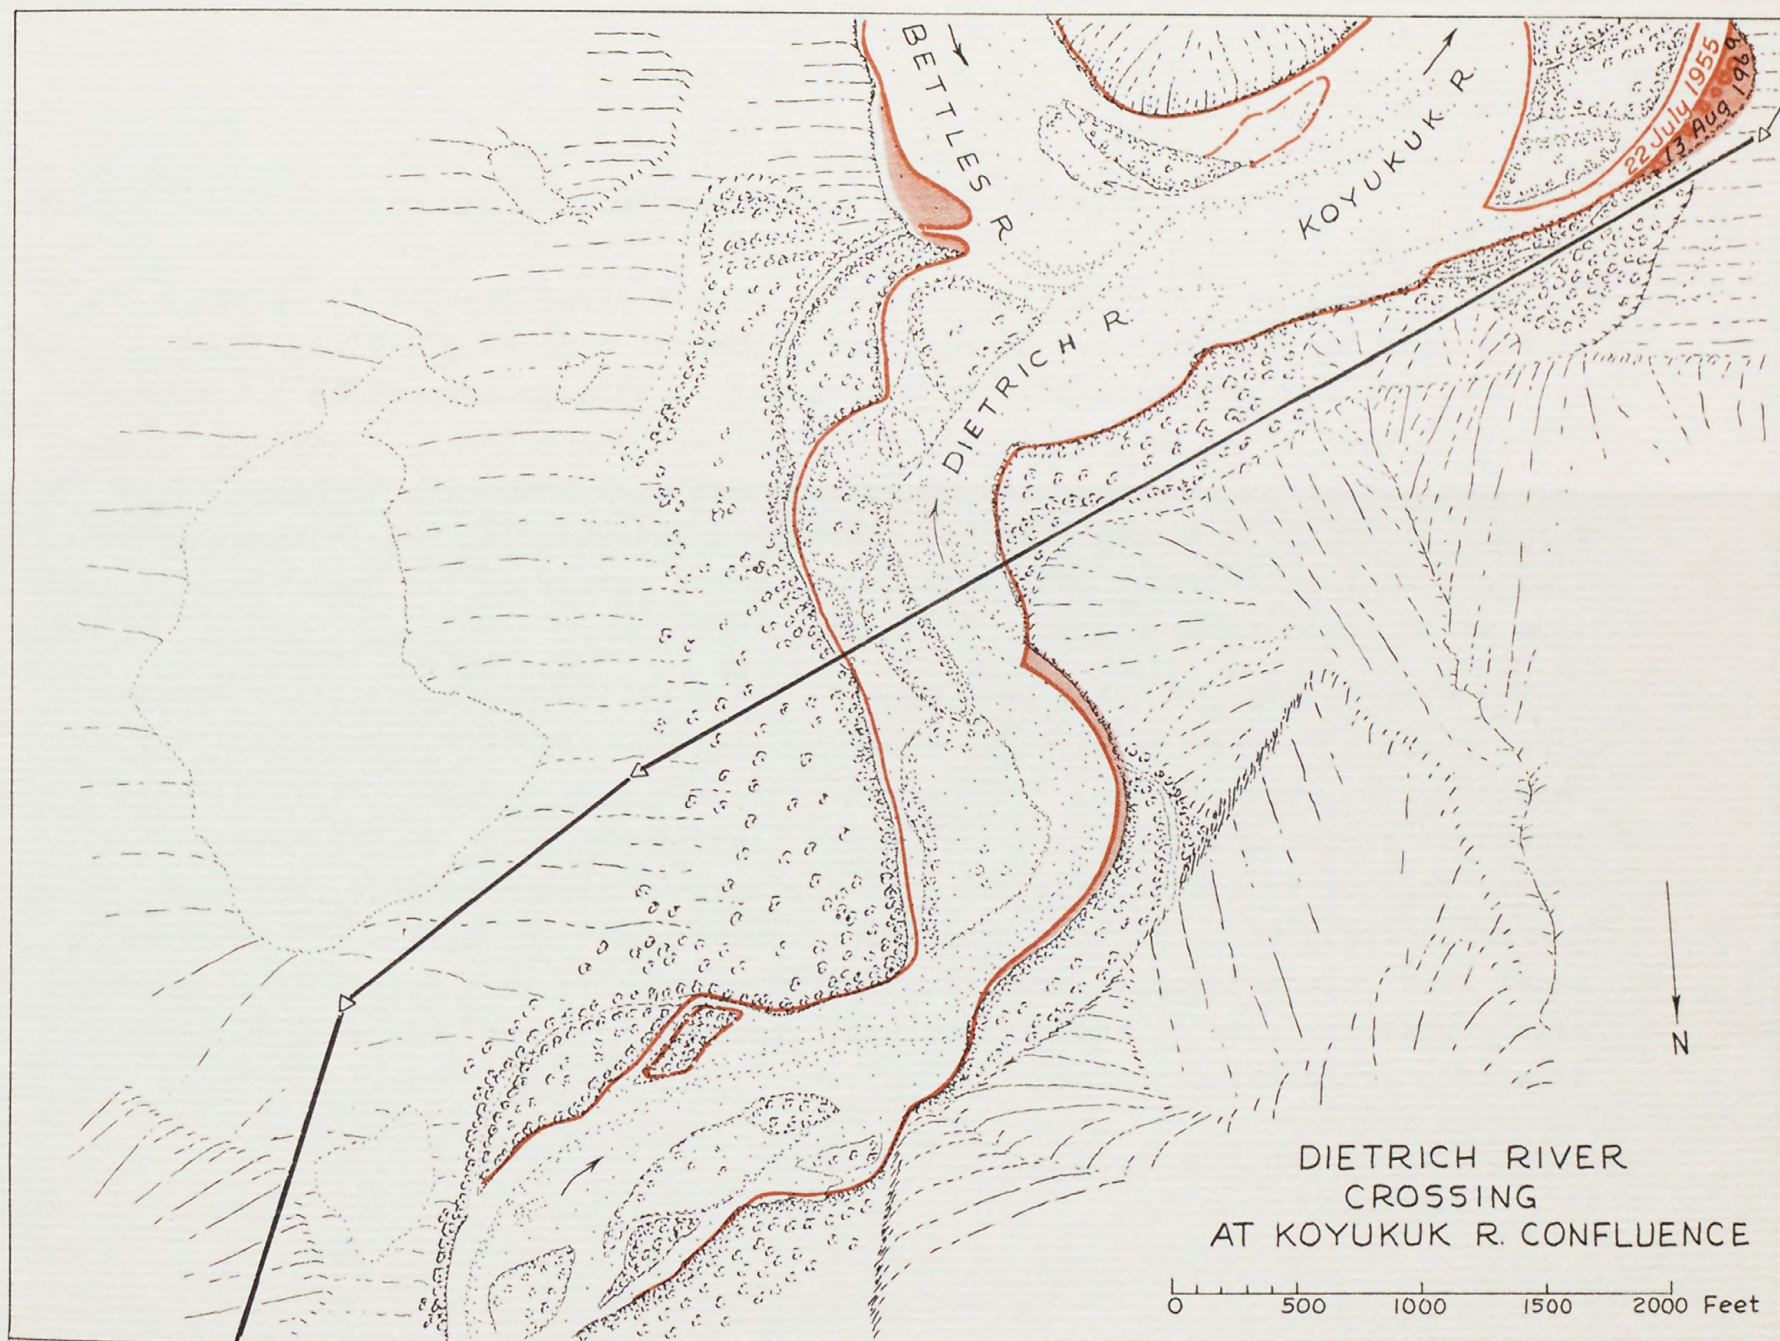
## **Dietrich River Crossing at Koyukuk River Confluence**

The Dietrich River at this locality occupies the floor of a glacial trough on the south slope of the Brooks Range. Just downstream from the crossing site is the confluence of the Bettles River, below which the combined rivers are called the Middle Fork of the Koyukuk. All three rivers are bordered from place to place by remnants of low terraces at different elevations, which indicates that the recent history has been one of degradation. The flood plain is difficult to distinguish from low terrace surfaces, but it is probably confined to a narrow strip along the river. The Dietrich River was not observed in the field at this crossing, although it was observed at a point a few miles upstream. The banks and bed material, where observed, are mainly of coarse gravel.

Except for pronounced lateral cutting at a few localities, the river course showed little change between 1955 (date of the earliest available photographs) and 1969. No bank erosion was discerned at the crossing site but about 4,000 feet downstream, where the proposed pipeline route borders the Middle Fork of the Koyukuk, the river bank has migrated about 200 feet in the direction of the route. Apparently, the river has been migrating in that direction during the last 15 years; and if migration continues, the river would undercut several hundred feet of the pipeline unless it were buried below the depth of scour.

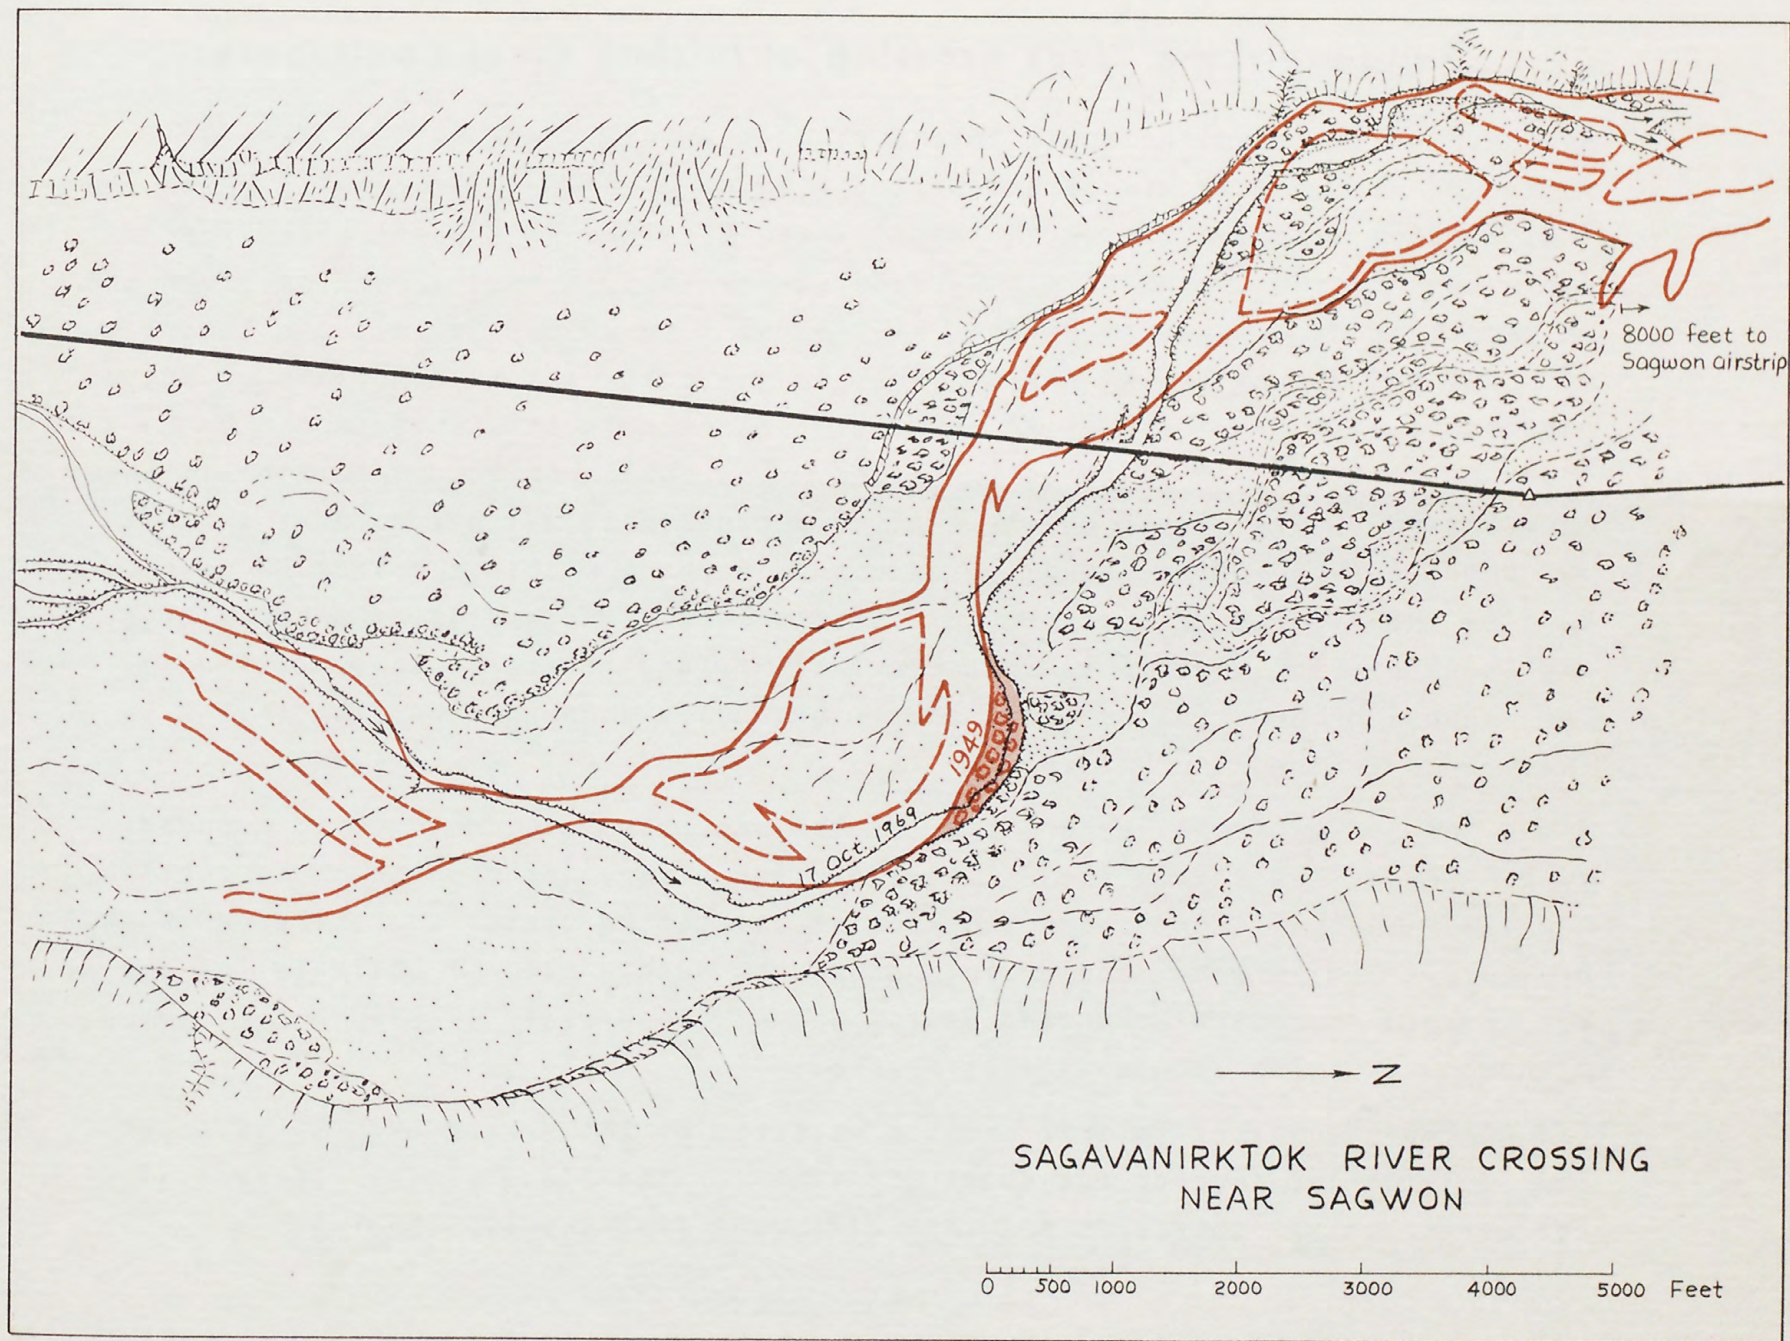
## **Sagavanirktok River Crossing Near Sagwon**

The western approach of the pipeline route to the river channel is across a nearly flat surface that can be regarded either as a flood plain or a low terrace, but the existence of a fairly recent, abandoned channel on the surface indicates that it is subject to flooding. Diversion of the main channel across this surface within the next few decades is not very probable, although it is subject to lateral erosion. During the period 1949-69, lateral erosion--amounting to a maximum of about 300 feet--has occurred mainly on the opposite (eastern) side of the main river channel.

On the eastern side of the river channel, the pipeline route is mainly on the flood plain. It crosses channels whose unvegetated condition indicates that they are still transmitting floodwaters, although they are in process of being abandoned as the channel shifts westerly. Abrupt diversion of the main channel across this surface under natural conditions is not very probable, although diversion could be promoted by the trench constructed for burial of the pipeline. Under such circumstances, where the pipeline trench is in approximate alignment with downstream flow in the main channel, special care must be taken to avoid diversion along the pipeline.

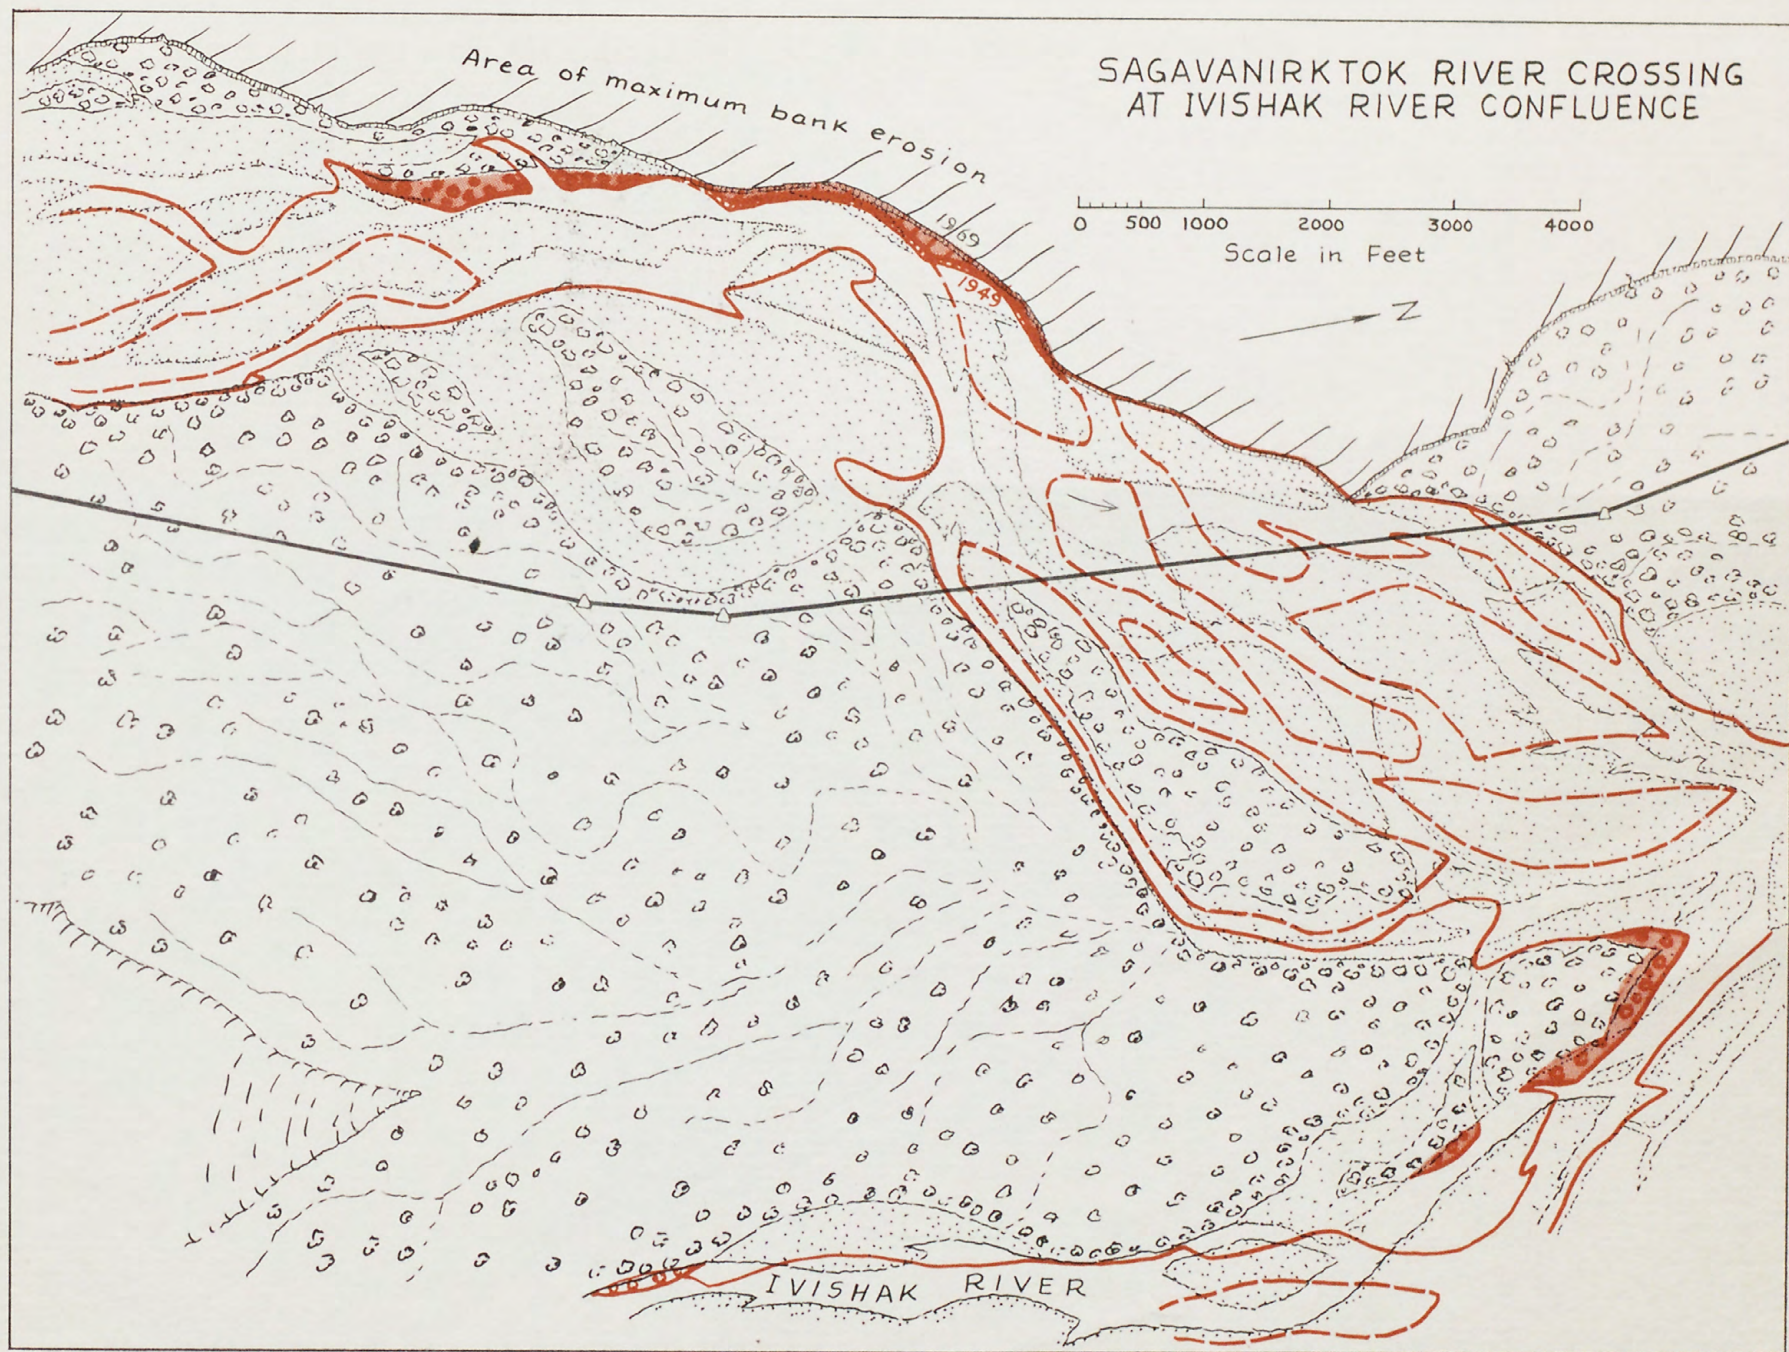
## **Sagavanirktok River Crossing at Ivishak River Confluence**

Approach of the pipeline route to the river channel is across a surface well vegetated with Arctic willow and marked with many abandoned channels, which are indicated by dashed lines on the map. Where examined at a point along the north bank of the channel, this surface stands about 5 feet above the river and is underlain by a layer of organic silt about 1 to 2 feet thick. The tundra mat of roots and mosses is well established in the silt, and is underlain by gravel ranging in size from pebbles to cobbles. In general, this surface can be regarded as the flood plain of the river. The southern (lower) part of it shows only sparse vegetal cover on the earlier photographs, which indicates that it was occupied by a main channel or anabranch perhaps within the last 50 years. Despite the rigorous climatic conditions in which it operates, the behavior of the Sagavanirktok appears to be typical of braided rivers in lower latitudes. The channel on one side of an island is gradually abandoned and the island is thus added to the flood plain.

Along the northwestern (upper) side of the map, the river channel is bounded by a terrace that stands 12-15 feet above the river. As seen in cross section, the lower part of the terrace consists of stratified gravel and the upper 6 feet consists of silt, sand, and gravel, capped by tundra mat. I estimate the age of the terrace at several thousand years; and it is scarcely likely to be flooded, although it is subject to lateral erosion.

The maximum amount of lateral erosion measured by the period 1949-69 is about 150 feet for the terrace and about 250 feet for the flood plain. In general, the earlier river course is not very different from the 1969 course.
