✓
UNITED STATES DEPARTMENT OF THE INTERIOR
✓✓
GEOLOGICAL SURVEY

FIELD RECONNAISSANCE OF THE EFFECTS OF THE EARTHQUAKE OF

APRIL 13, 1973, NEAR LAGUNA DE ARENAL, COSTA RICA

George Plafker

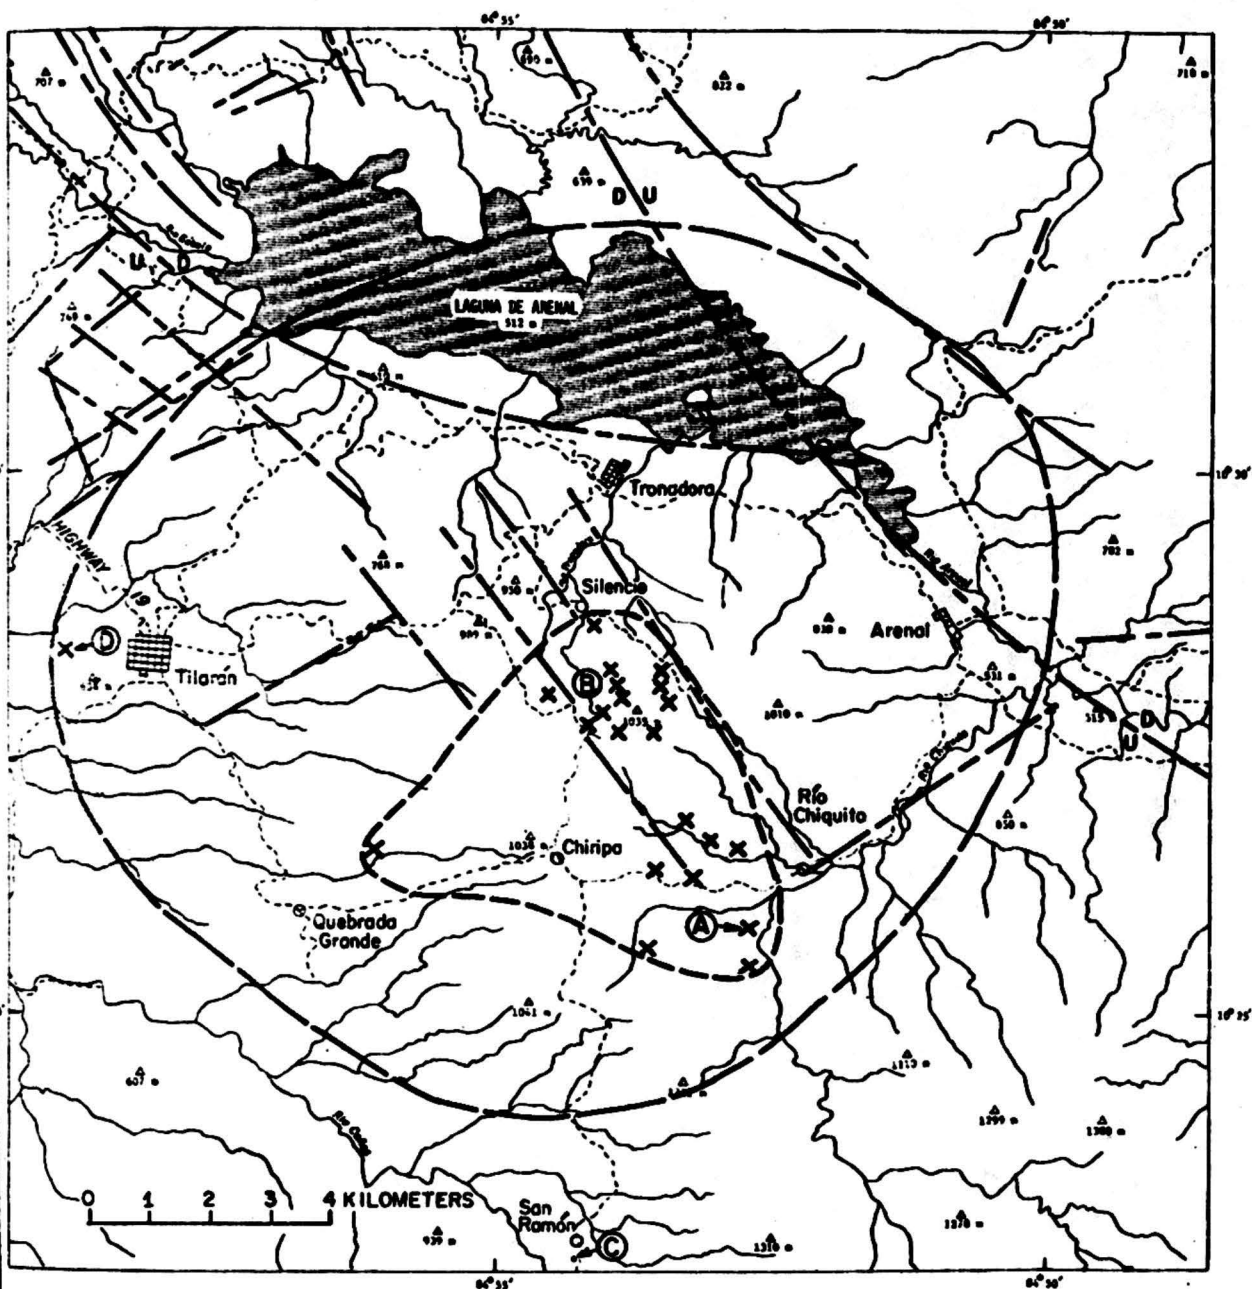
Figure 2. Damage area of the April 13, 1973 earthquake. Long dashed line outlines main zone of structural damage, landslides, and ground cracks. Short dashed line outlines zone characterized by severe ground effects and destructive landslides; crosses indicate larger landslides. Letters indicate locations referred to in text. Lineaments shown are from Dengo (1968) and unpublished map of I. C. E. (1972).

Damage from the earthquake of April 13, 1973, resulted from: 1) direct seismic shaking of structures, 2) a variety of earthquake-triggered landslides, and 3) earthquake-induced lateral spreading and cracking of unconsolidated deposits. All of the significant damage observed appeared to be confined to the area of about 150 km^2 that is outlined by the long dashed line on figure 2. The deaths and injuries resulted entirely from burial by landslides, the larger of which were concentrated within an area of about 20 km^2 which is outlined by a short dashed line on figure 2.

The largest and most destructive landslides involved poorly consolidated soil and debris along steep slopes, some of which developed into fluid, high-velocity debris flows. One of these, near the village of Río Chiquito (location "A" on fig. 2), buried the farm home of Mr. Lindor Chavez. Mr. Chavez was rescued with severe injuries but 13 members of his family who were also in the house perished. The landslide, which developed at the head of a small tributary of Río Chiquito, involved an estimated $75,000-125,000 \text{ m}^3$ of debris consisting mainly of lateritic soil with minor air-fall ash near the surface. The debris flow is roughly 500 m long with about 200 m vertical drop from the crown to the toe, which reaches almost to Río Chiquito. Rapid movement of the mass is indicated by the fact that at a bend along its course, the debris was banked up 10 to 15 m higher on the outside of the turn than it was on the inside. The lobe averages 3-5 m thick, and its steep-sided, leveed margins suggest that the debris had considerable viscosity in the lower part of its course where it spread out over the flood plain of Río Chiquito.

walls and ridge slopes, mainly in the area outlined by short dashes on figure 2. Most of these occurred in the headwaters of Río Chiquito and Río Tronadora; one large slide is located along Quebrada Grande. Approximate positions of some of the larger slides are shown by crosses on figure 2. Debris slides or flows along Río Tronadora in the area south of Silencio (near "B" on figure 2) caused the 10 other deaths attributable to the earthquake. Because I did not visit the site of the buried houses near Silencio, I do not know exactly which of the many slides buried them and the location shown on figure 2 indicates the general area where casualties occurred.

The one landslide involving rock that was seen in the earthquake-affected area is situated about 1 km west of Tilarán (location "D" on fig. 2). This was a fall of several thousand cubic meters of Quaternary andesite that is
