CLARK COUNTY FLOOD CONTROL DIVISION  
DEPARTMENT OF PUBLIC WORKS

A BRIEF HYDROLOGIC APPRAISAL OF THE JULY 3-4, 1975,  
FLASH FLOOD IN LAS VEGAS VALLEY, NEVADA

T. L. <sup>O</sup>Katzer,  
Patrick A. <sup>Glancy</sup>Glancy,  
and  
Lynn Harmsen

Prepared cooperatively by the  
U.S. Geological Survey  
Carson City, Nevada

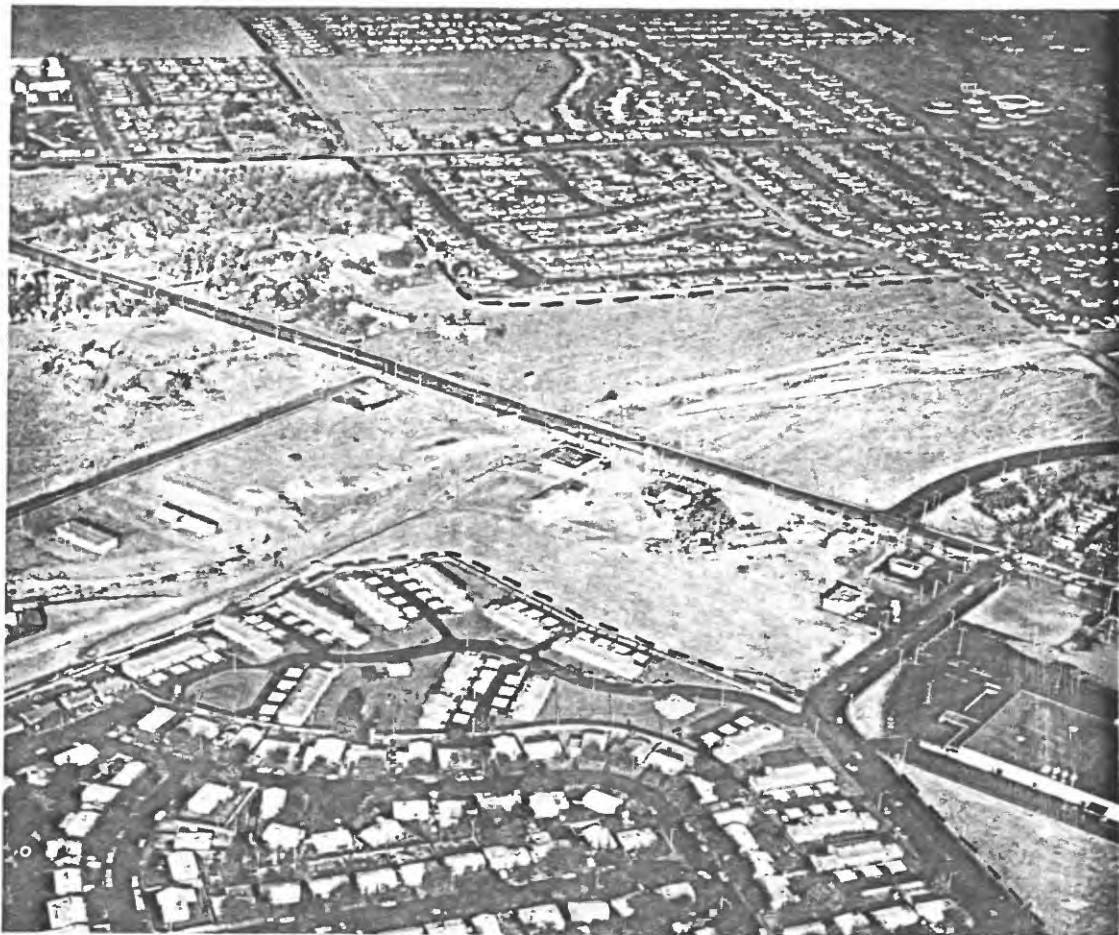
The alluvial fan system southwest, west, and north of metropolitan Las Vegas received the greatest amount of precipitation and therefore contributed most of the runoff. The complex drainage patterns superimposed on the alluvial surfaces, shown in figure 3, indicate that this type of storm runoff has occurred many times in the past. Much of the alluvial surface area was inundated by shallow sheet flow. The vegetation on the alluvium is sparse to moderate, consisting of desert shrubs and grasses, and is not very effective in retarding flows and promoting infiltration. Thus, as sheet flow moves downslope it tends to become channelized. As flow capacities of major channels are sometimes exceeded, areally widespread flooding occurs during particularly large runoff events, as shown in figure 4.

Figure 4. Las Vegas Wash flood plain at the junction  
of Las Vegas Wash and Las Vegas Blvd.  
Outline indicates approximate limits of  
major inundation. Photograph taken  
July 4, 1975.

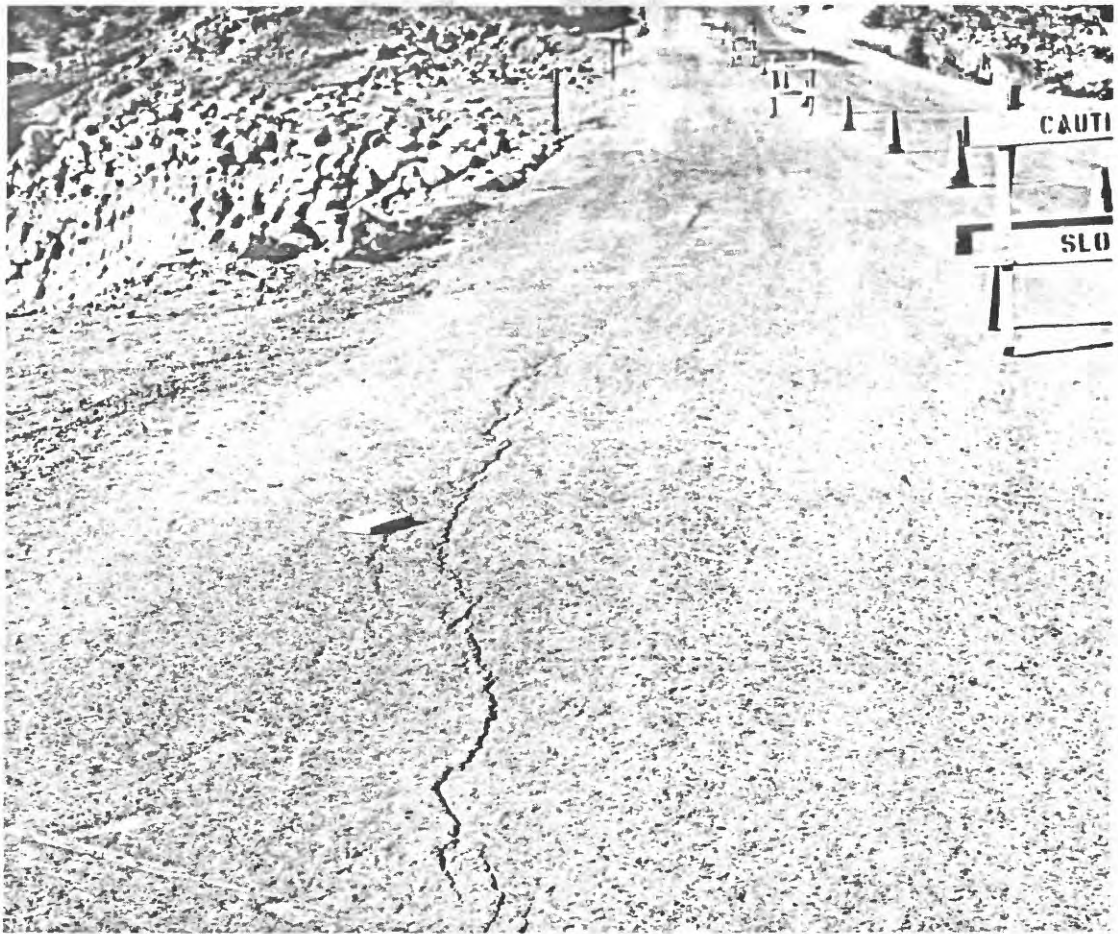
In spite of the reported intense nature of precipitation at many localities from time to time during the storm, subsequent observations did not generally disclose extensive rill erosion of the general landscape. However, many striking examples of ditch, gutter, and gully erosion were seen throughout areas subjected to intensive runoff. Major stream channels also exhibited numerous striking examples of lateral channel cutting and bank caving (fig. 11). However, obvious vertical downcutting along reaches of major channels was not common in and near the metropolitan area, possibly because the major channels are extensively underlain by deposits of caliche (calcite-cemented alluvium) that effectively armor the streambeds against vertical erosion. Vertical scour damage occurred locally at the downstream ends of culverts and similar drainage structures. Some concrete protective aprons or wingwalls were undercut and seriously damaged by the highly turbulent flow. A particularly dramatic example of this type of damage occurred near the mouth of Las Vegas Wash. There, concrete box culverts through the high fill of Northshore Road were progressively undermined after turbulence and vertical channel downcutting of flood flow destroyed the effectiveness of the protective riprap armor lining the channel and mantling the downstream fill slope (figs. 6 and 7). Damage at this site continued even long after peak flows had subsided, and the highway fill section required extensive reconstruction to prevent complete failure.

Figure 7. Evidence of impending failure of roadway  
on Northshore Road at Las Vegas Wash.  
Progressive failure of downstream fill  
slope continued on morning of July 7  
after cessation of flood flows.

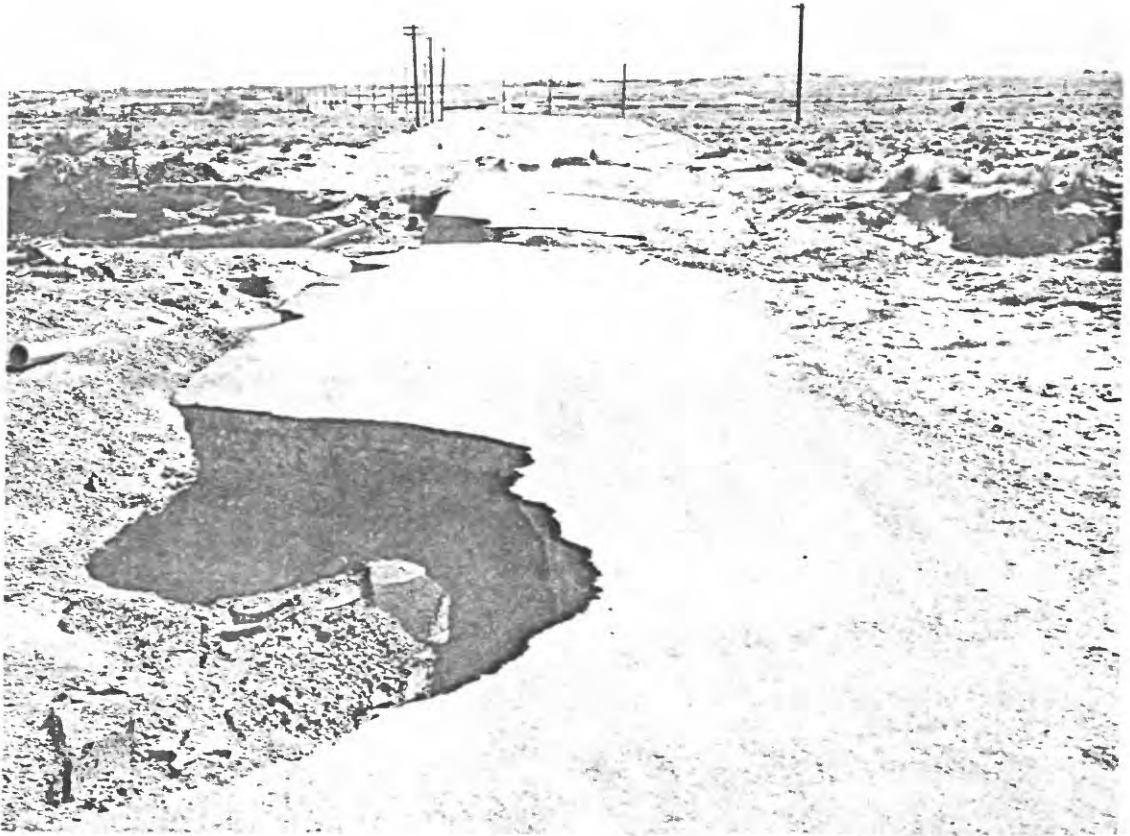
Figures 8 and 9 show severe but typical examples of eroded roads at diverse locations in the Las Vegas metropolitan area. In most situations, roads that were overtopped by heavy flows failed from progressive headward channel cutting through the roadbed (fig. 8). In other places, the road surfacing was laterally displaced en masse by streamflow (fig. 9). A particularly severe example of eroded roadway occurred where Lamb Boulevard was cut by Las Vegas Wash a short distance south of the intersection of Lamb Boulevard and Owens Avenue (fig. 10).

Figure 8. Erosion of Losee Street, just southwest of  
its intersection with Craig Road near  
North Las Vegas. Photograph taken  
July 6, 1975.

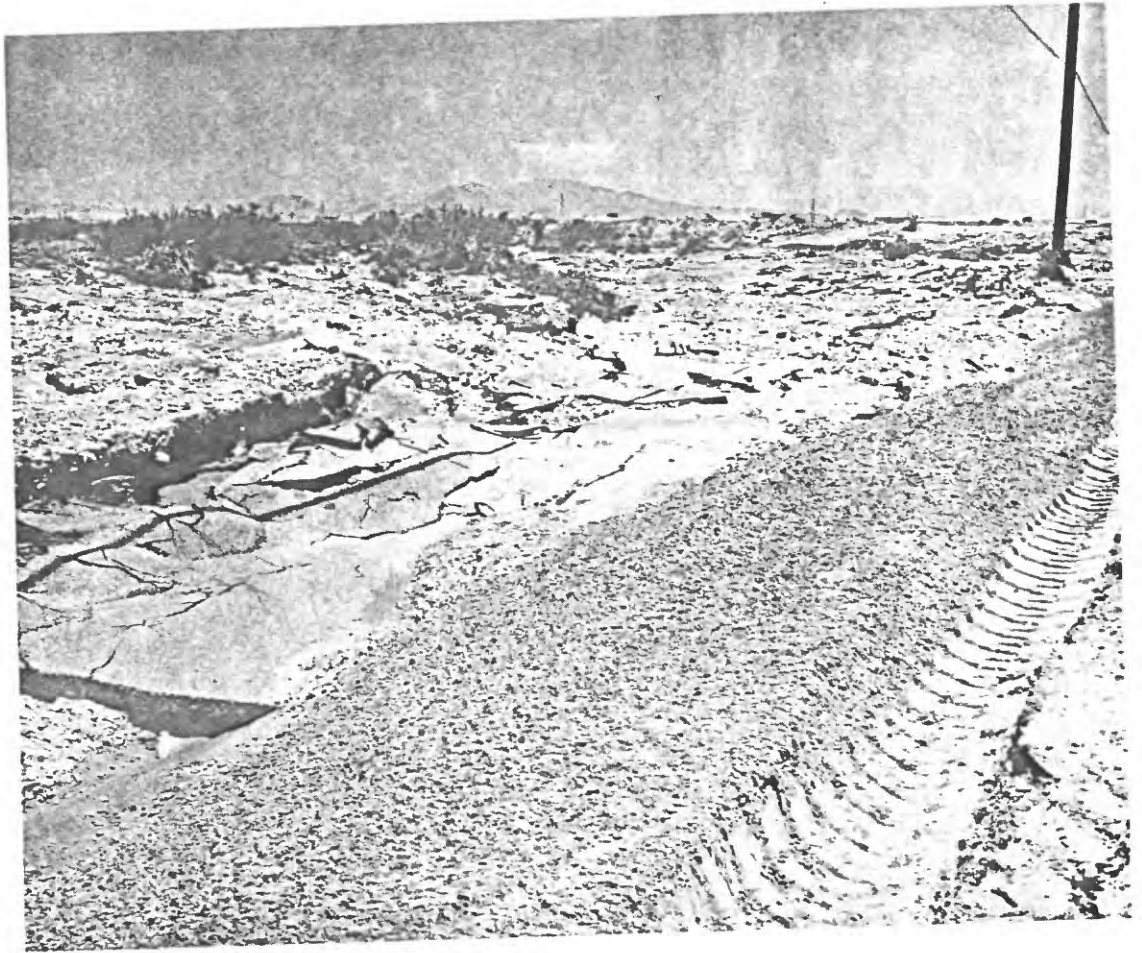
Figure 9. Asphalt road surface laterally displaced by floodflow on Tropicana Road just south of its intersection with Rainbow Blvd. Photograph taken July 5, 1975.

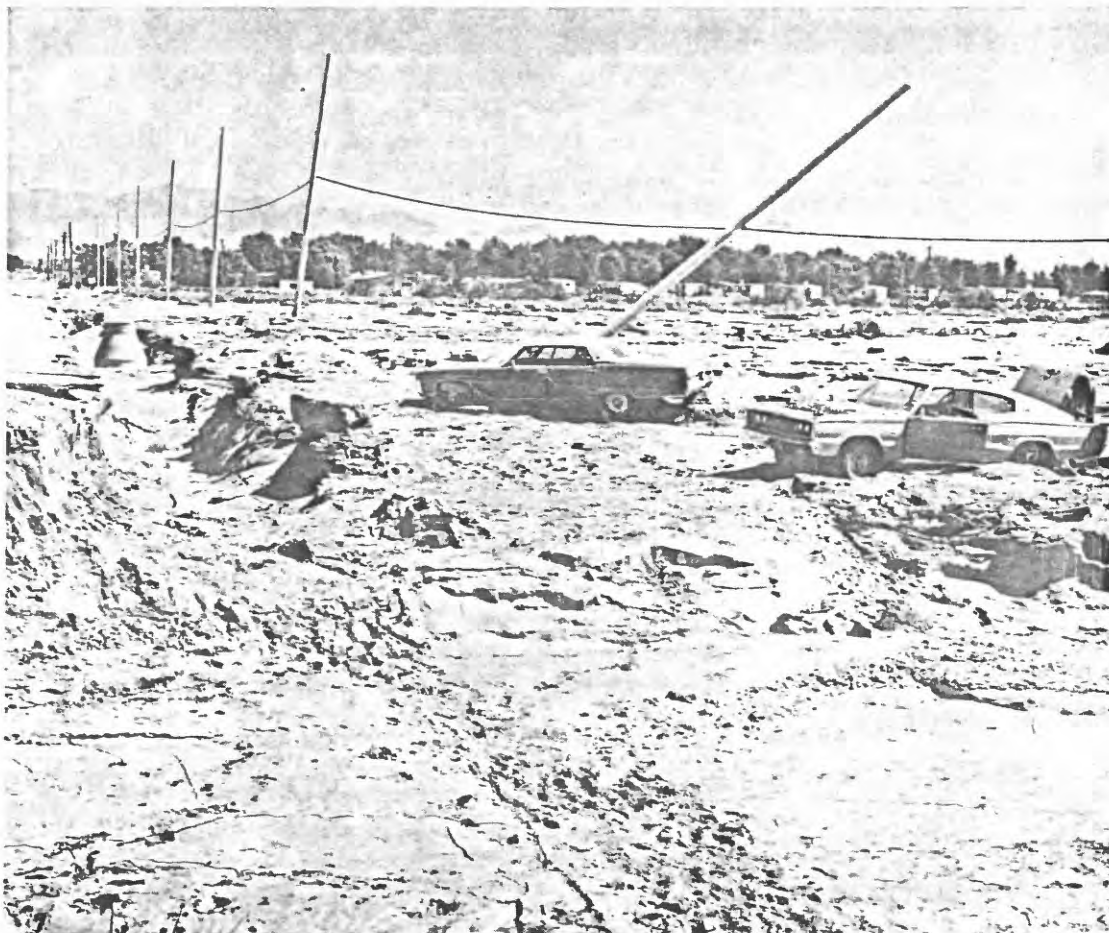
Figure 10. Erosion of Lamb Blvd. and damaged cars  
displaced by flood in the Las Vegas Wash  
flood plain. Photograph taken July 7, 1975.

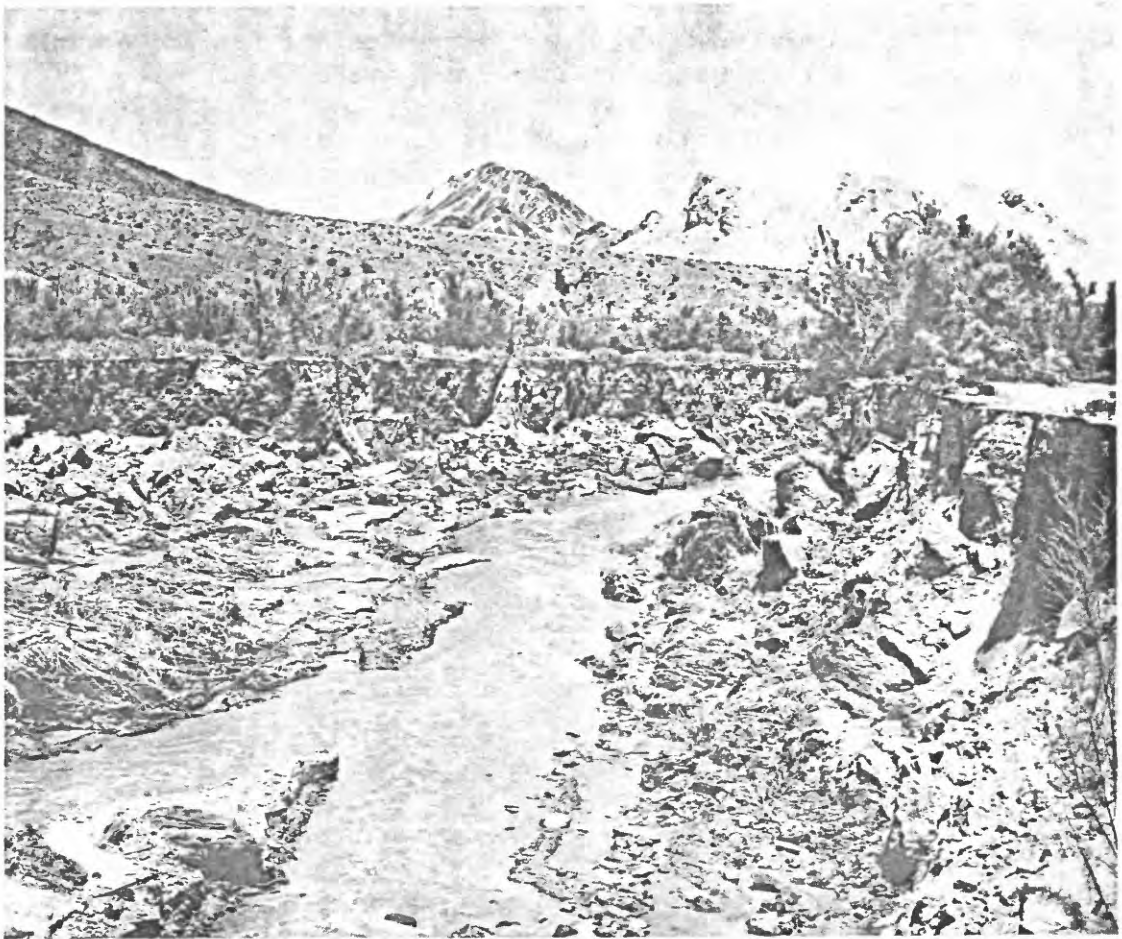
Wash, beginning generally about 2½ miles (4 km) downstream from site 11 (pl. 1). The characteristics of channel erosion along this reach of the wash are typified by figure 11. The site is near the former location of a Geological Survey streamflow gage which was lost when the streambank eroded during the flood. Recent drastic channel erosion in lower Las Vegas Wash had occurred prior to the July 3-4 flood, but the flood flows greatly accelerated the erosion and were largely responsible for the chaotic results typified by figure 11 and similar scenes elsewhere downstream.

Figure 11. A typical scene of channel erosion along lower Las Vegas Wash. Photo taken on July 9, 1975, in NE $\frac{1}{4}$  sec.28, T.21 S., R.63 E.

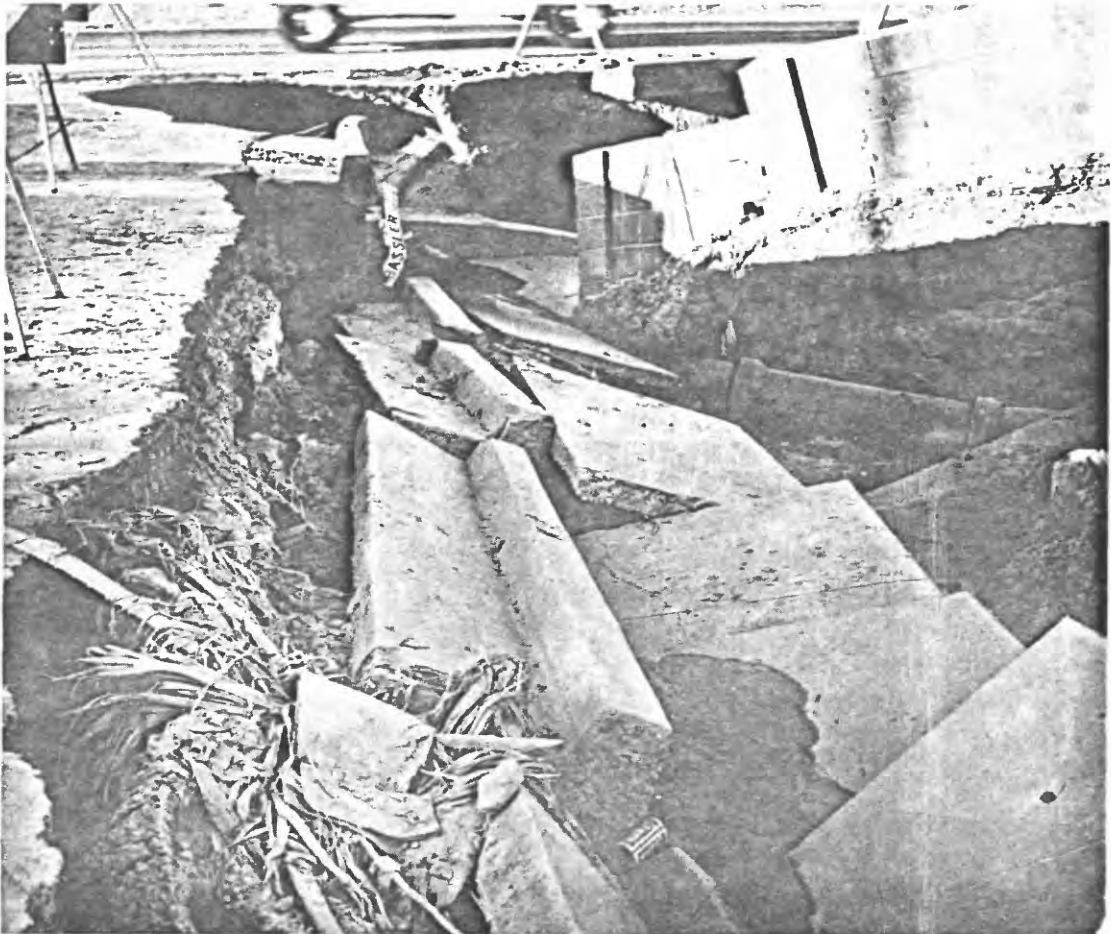
Lateral channel cutting by overbank flood flows also affected man's works other than road surfaces. Figure 12 shows effects of Las Vegas Wash undercutting masonry block walls, sidewalk, street curbing, sewer lines, and street signs. Similar erosion damage in other places included segments of people's yards and property-line fences.

Figure 12. Riparian erosion damage by Las Vegas  
Wash flooding to works of man at  
intersection of Cheyenne Road and Bassler  
Street. Photograph taken July 4, 1975.

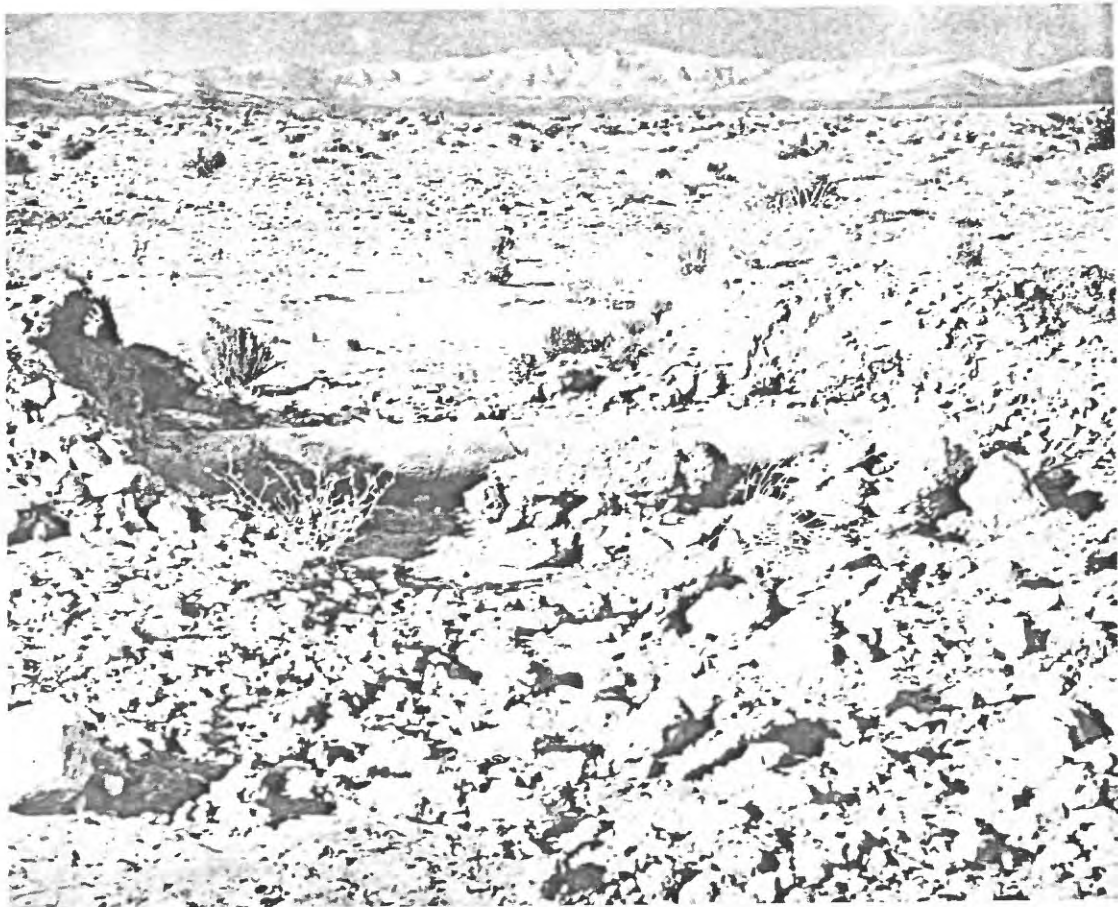
A minor erosion problem having the potential for serious consequences occurred in at least one area. Figure 13 shows a natural-gas line exhumed

Figure 13. A natural gas line exhumed by erosion of its thin alluvial cover along the south side of West Sunset Road, about  $5\frac{1}{4}$  miles (8.4 km) west of Interstate Highway 15. Photograph taken July 8, 1975.

by erosion. The line was constructed on top of the land surface and covered only with a relatively thin blanket of alluvium. The path of the pipeline lies across numerous shallow gullies that drain surface flow down the alluvium fan, creating the potential for exhumation by any moderate to heavy surface runoff. Exposure of the pipeline renders it vulnerable to further flood damage and vandalism, that could trigger more serious problems.

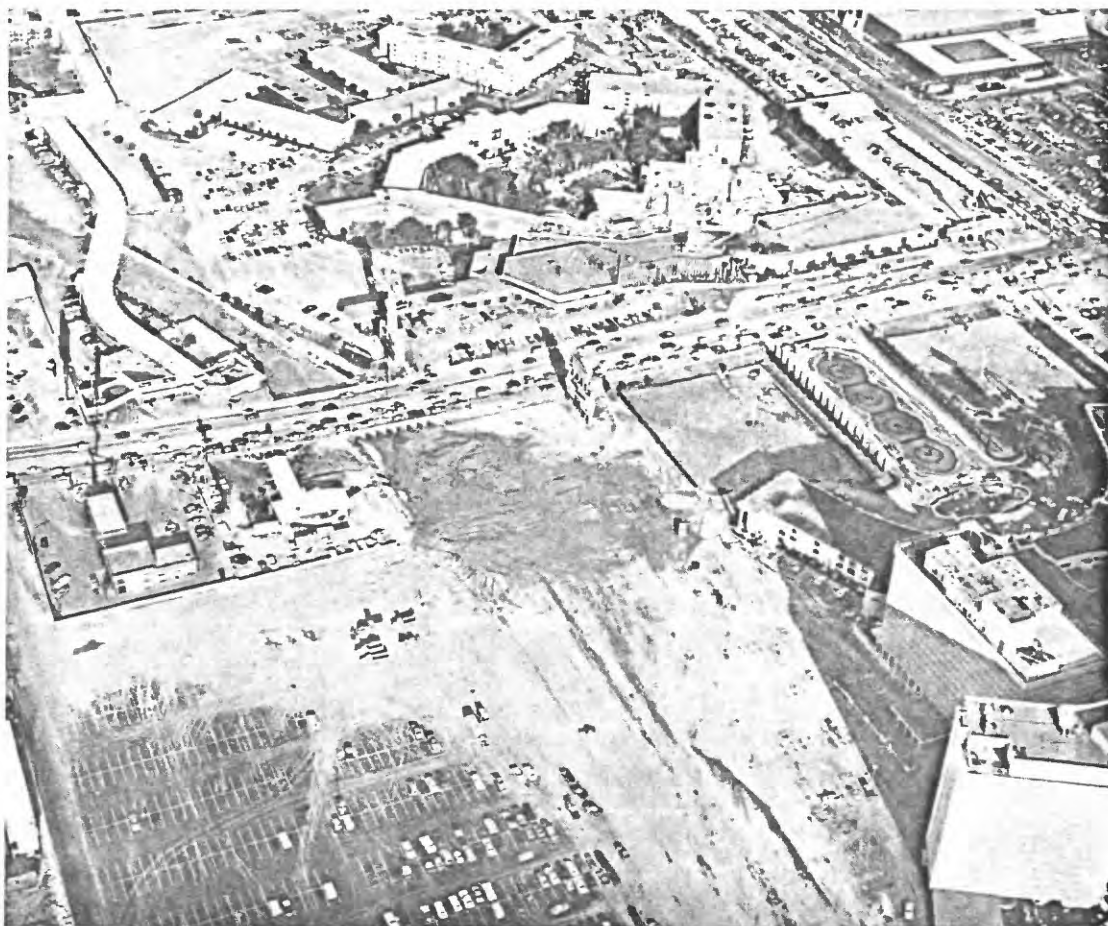
Sediment deposits created many problems and may actually have caused greater overall economic damage than that caused by erosion. One of the most obvious sediment deposits that received early cleanup attention was in Flamingo Wash at the Caesars Palace parking lot. Figure 14, an oblique aerial photograph of the parking lot, shows the general areal extent of the deposit. Figure 15 reveals the fine-grained character of the sediment as it was being gathered for removal on July 5. Although the deposit covered only a few acres at most, cleanup probably involved removal of several acre-feet of sediment.

Figure 14. Sediment deposits in Caesars Palace hotel-casino parking lot. Photographed about 7:00 p.m. on July 4, 1975, after cleanup operations had begun.

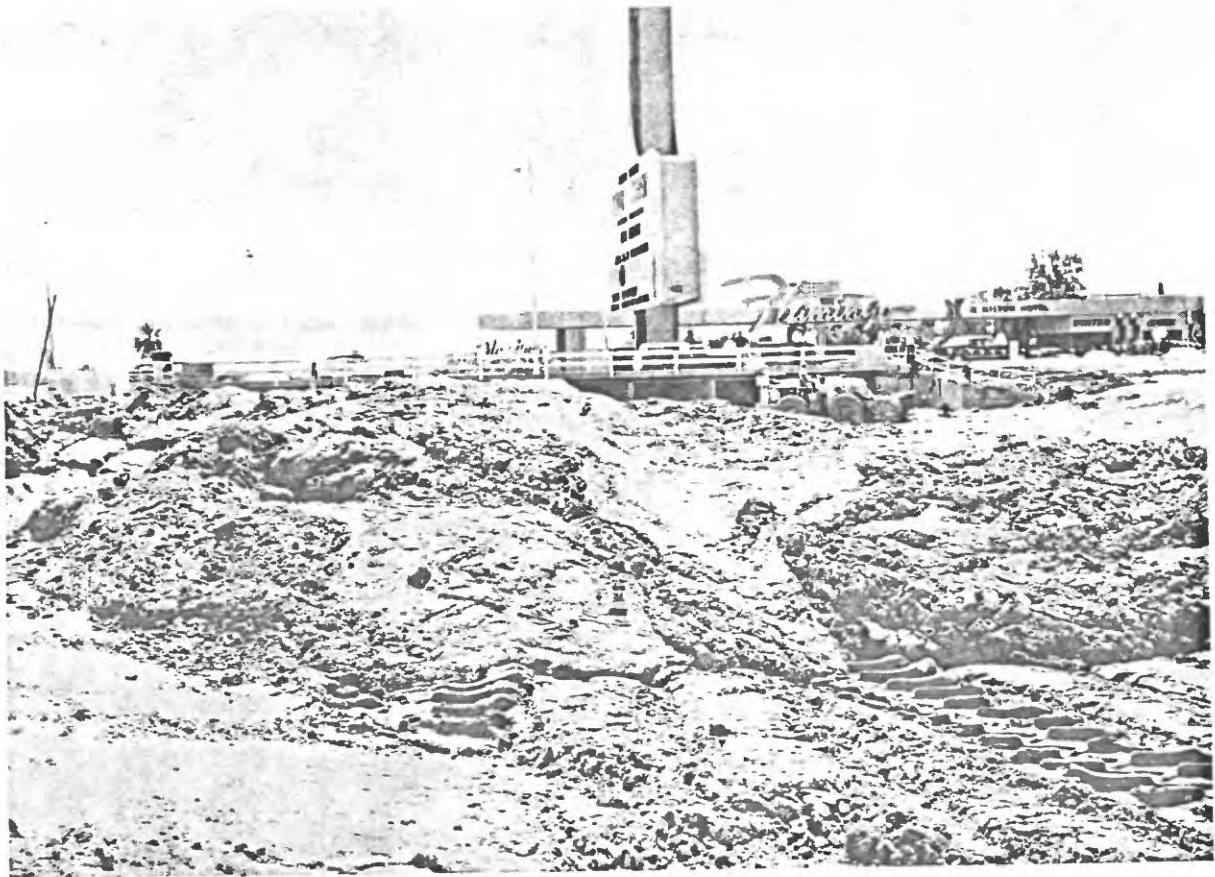
Figure 15. Character of sediment deposited in  
Caesars Palace parking lot. Photograph  
taken July 5, 1975.

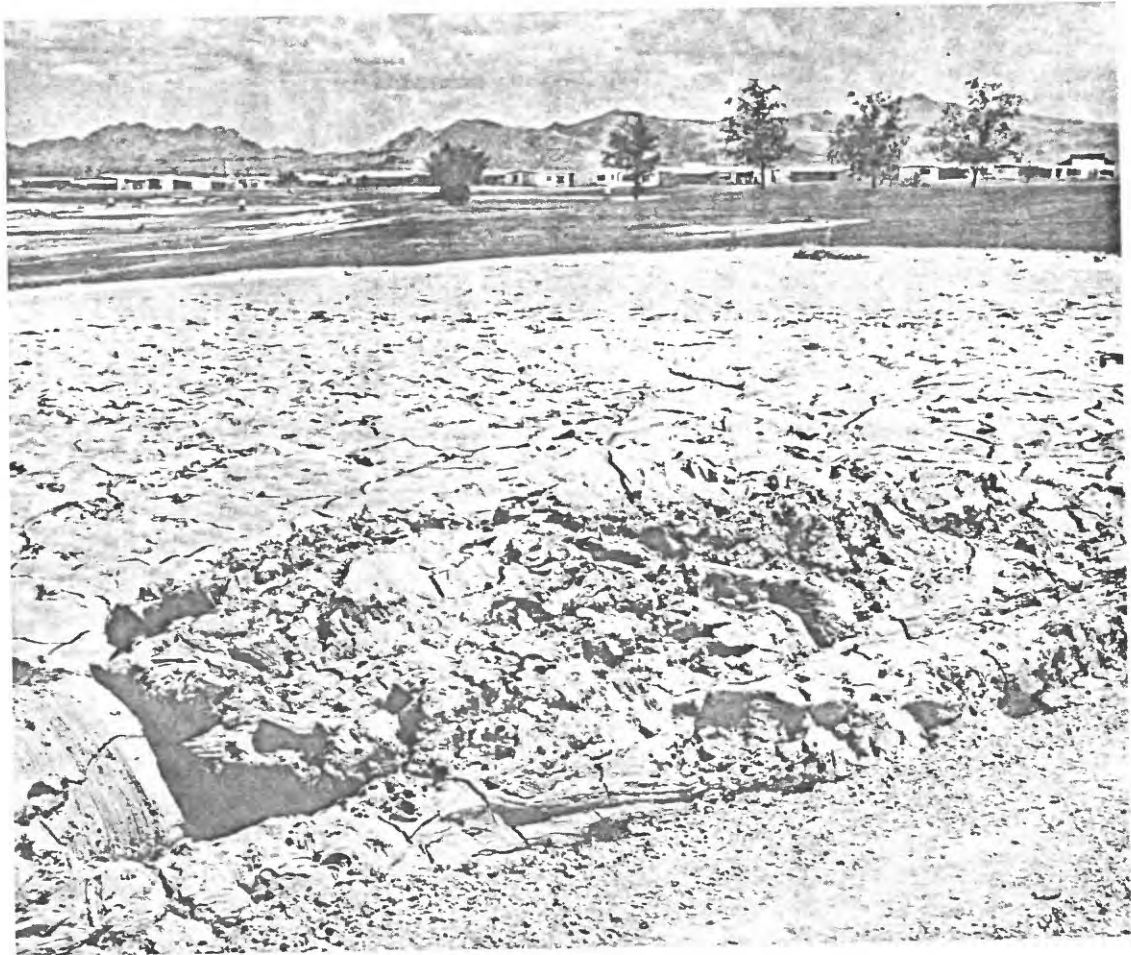
Figure 16. Sediment deposits on the Winterwood Golf Course near the junction of Flamingo and Las Vegas Washes. Photograph taken July 9, 1975.

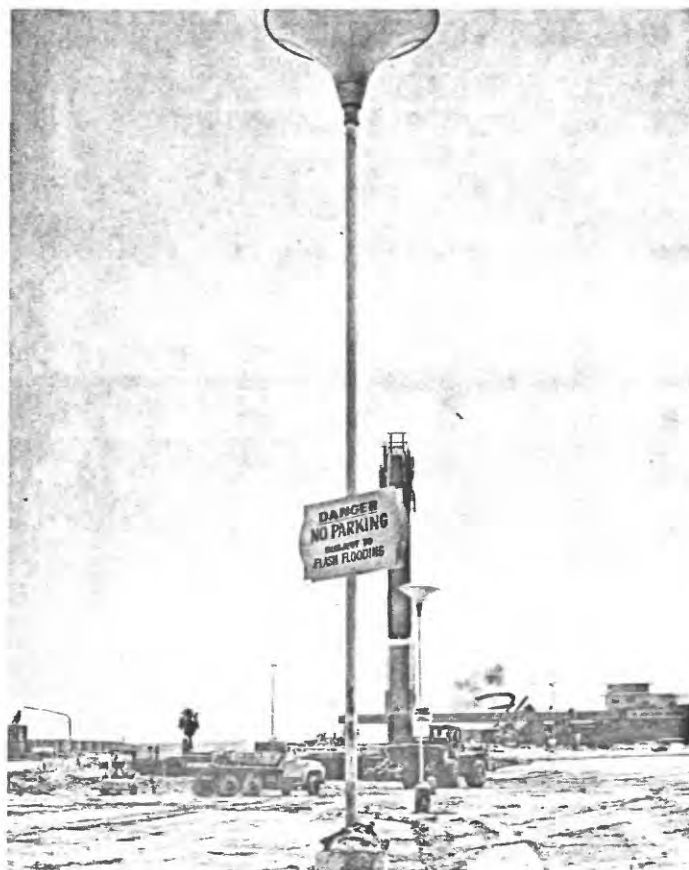
Heavy damage occurred along Flamingo Wash in the vicinity of Caesars Palace, where automobiles were parked in the flood plain, despite several signs warning of flash floods (fig. 17). Several hundred cars were damaged by submersion and collisions when they were moved by the flood waters. Many of the vehicles were piled up at the entrance to drainage structures under Las Vegas Boulevard South, commonly referred to as "The Strip" (fig. 18). The obstructions caused increased backwater, and more cars and a larger area were inundated (figs. 19, 20). Damaged automobiles along Flamingo Wash are shown in figure 21.

Figure 17. Flash flood warning signs posted in the asphalt covered streambed of Flamingo Wash near Caesars Palace hotel-casino. Post-flood cleanup operations in background. Photograph taken July 5, 1975.

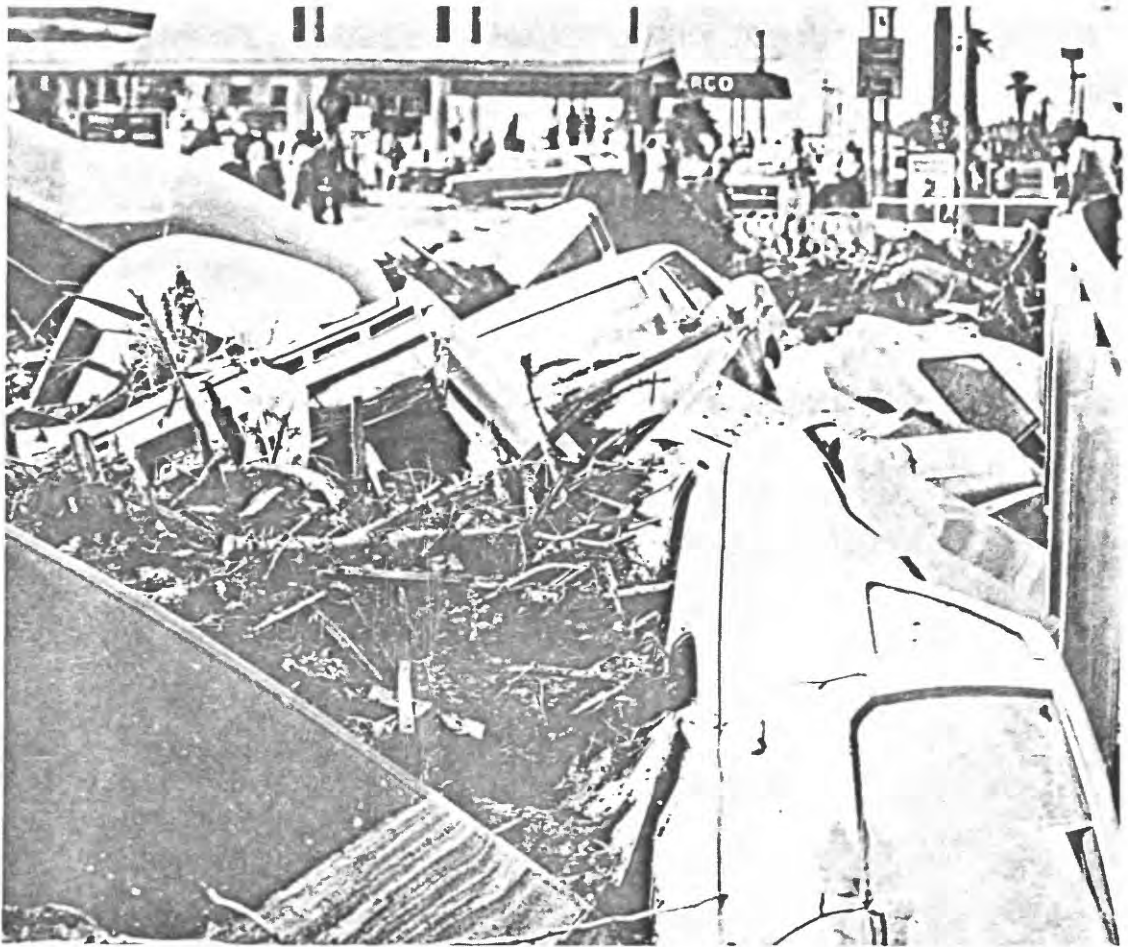
Figure 18. Chaotic conglomeration of automobiles and organic debris deposited against drainage structures of Flamingo Wash under Las Vegas Blvd. South. Photograph courtesy of David Lee Waite.

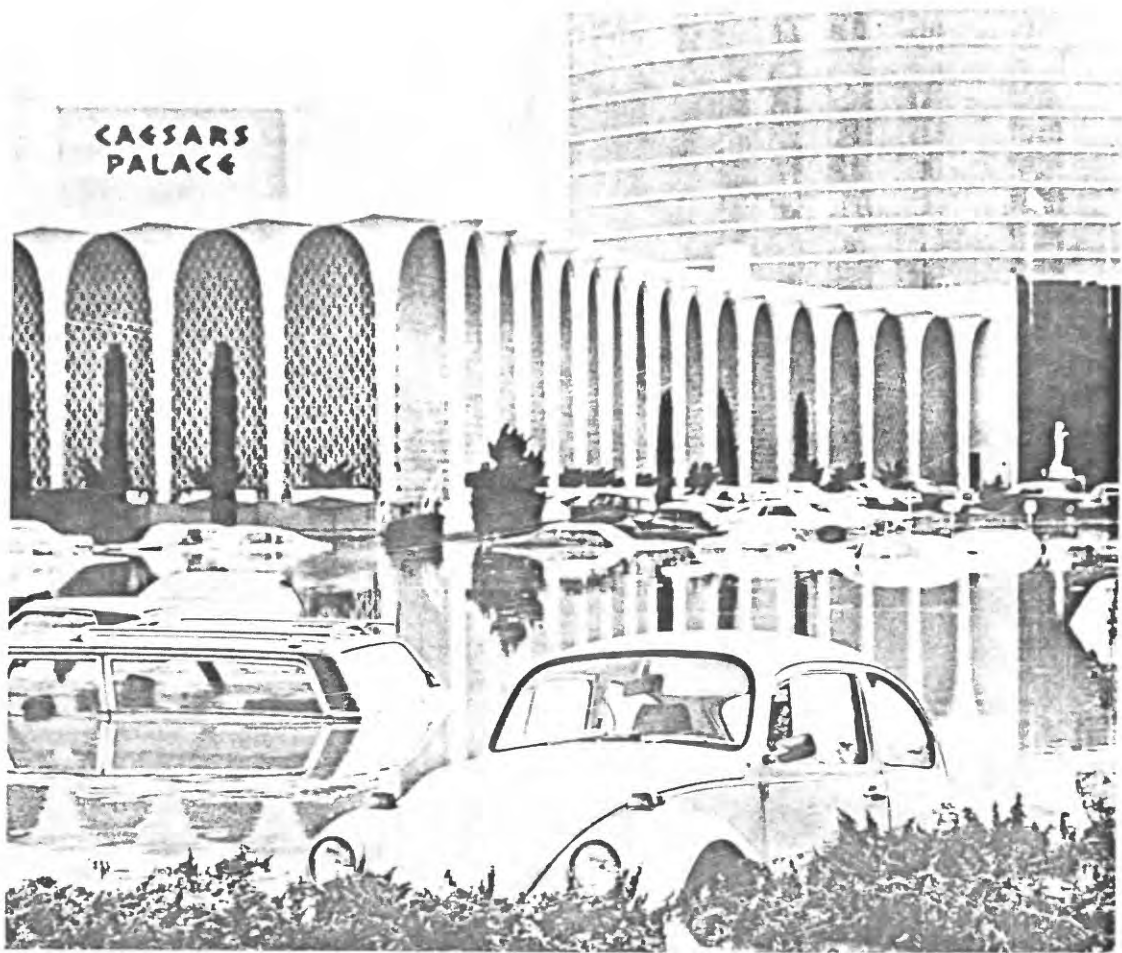
Figure 19. Partially inundated vehicles in Caesars Palace hotel-casino parking lot near Flamingo Wash. Photograph courtesy of David Lee Waite.

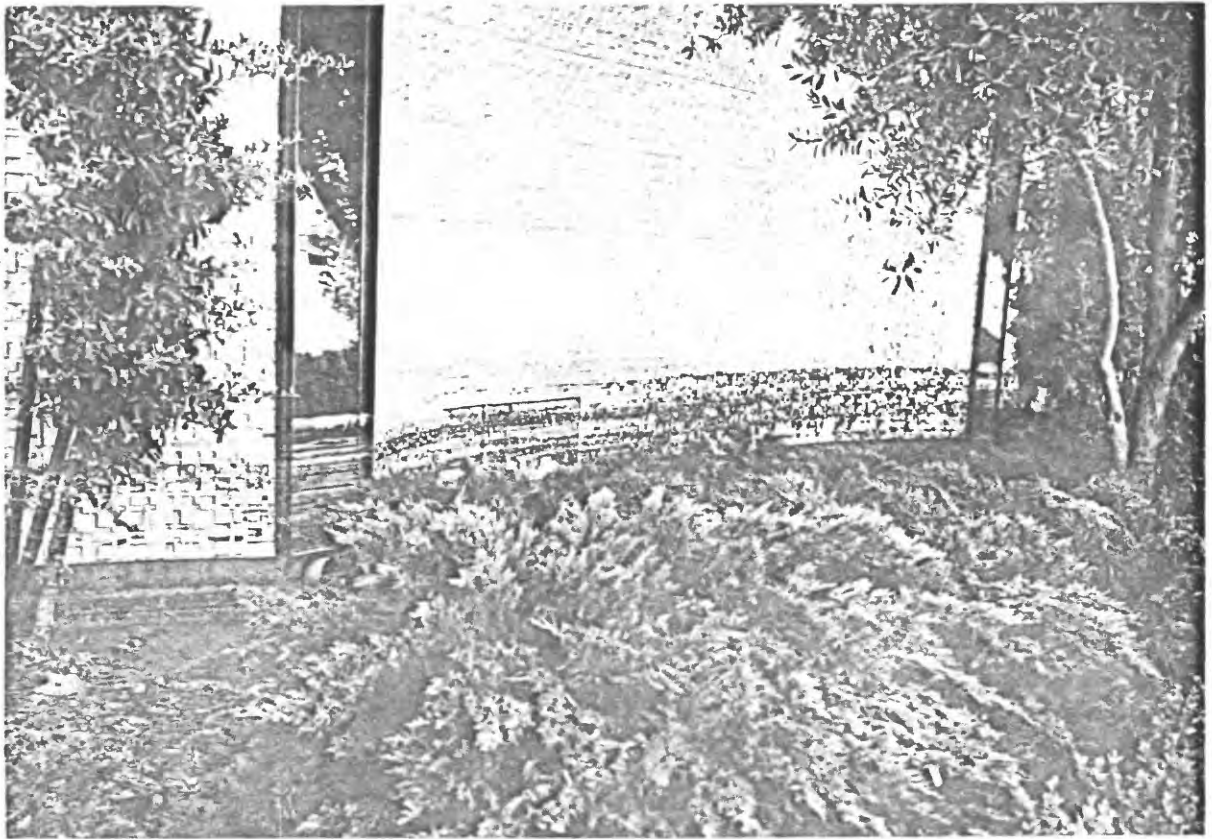
Figure 20. High-water marks of Flamingo Wash floodflow  
on the southwest wall of the Flamingo Hilton  
hotel-casino.

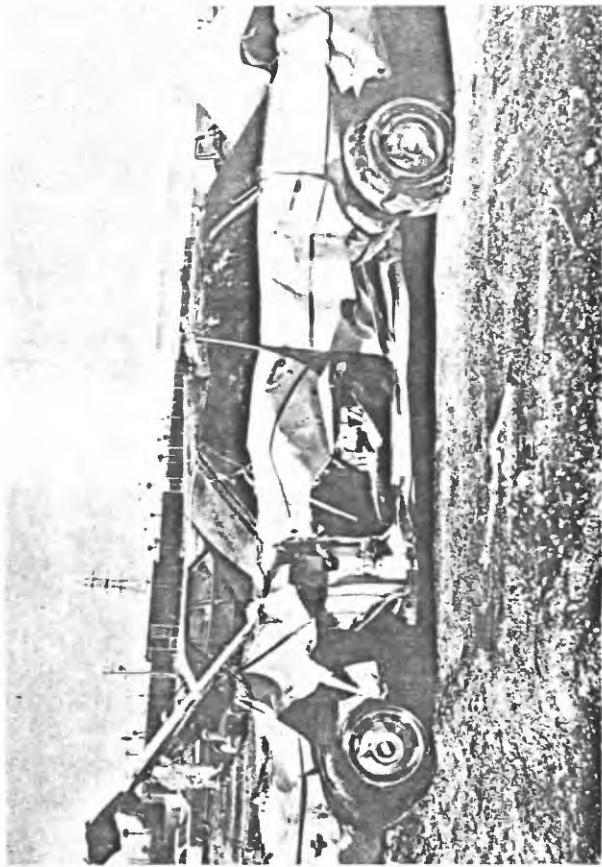
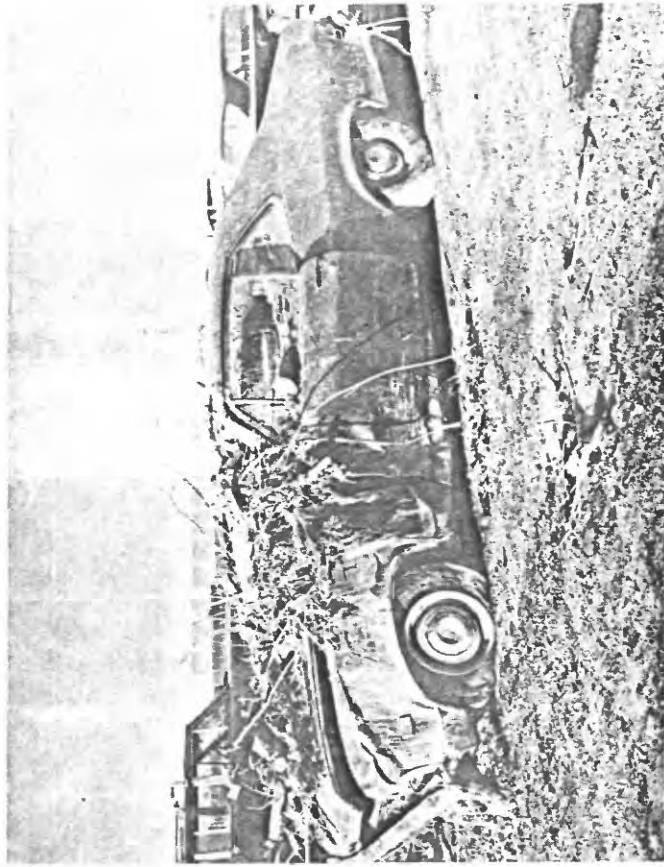
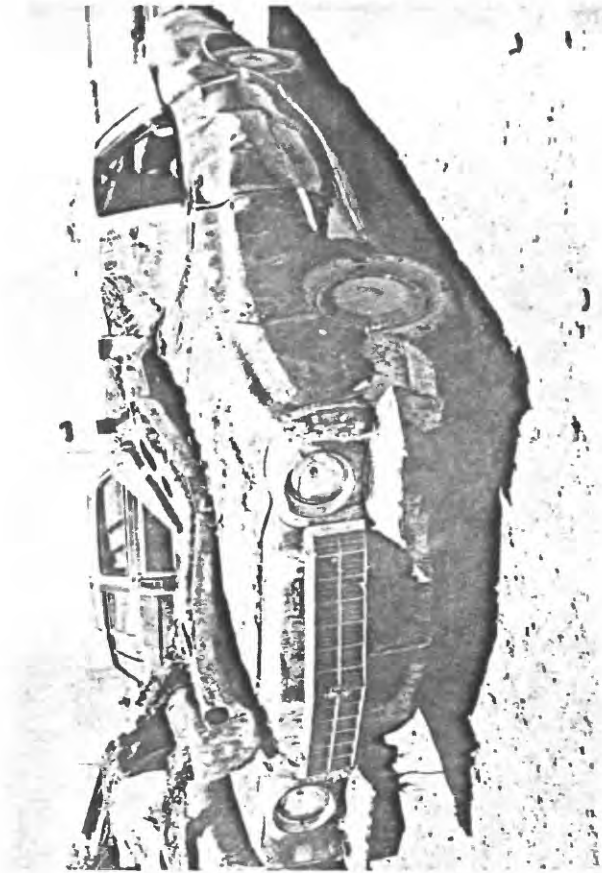
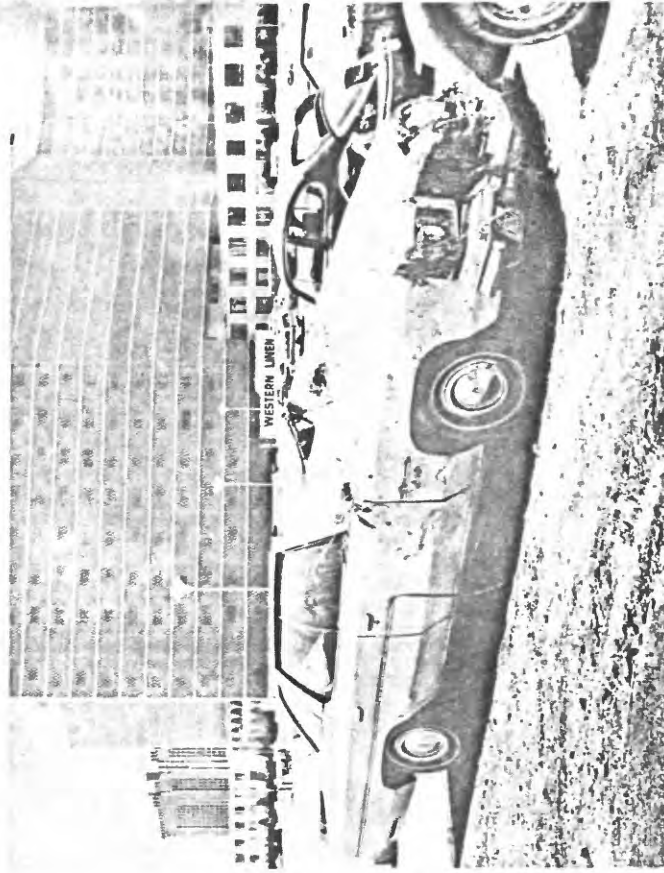
Figure 21. Examples of automobiles damaged near Caesars Palace hotel-casino by flooding of Flamingo Wash. Photograph taken July 6, 1975.

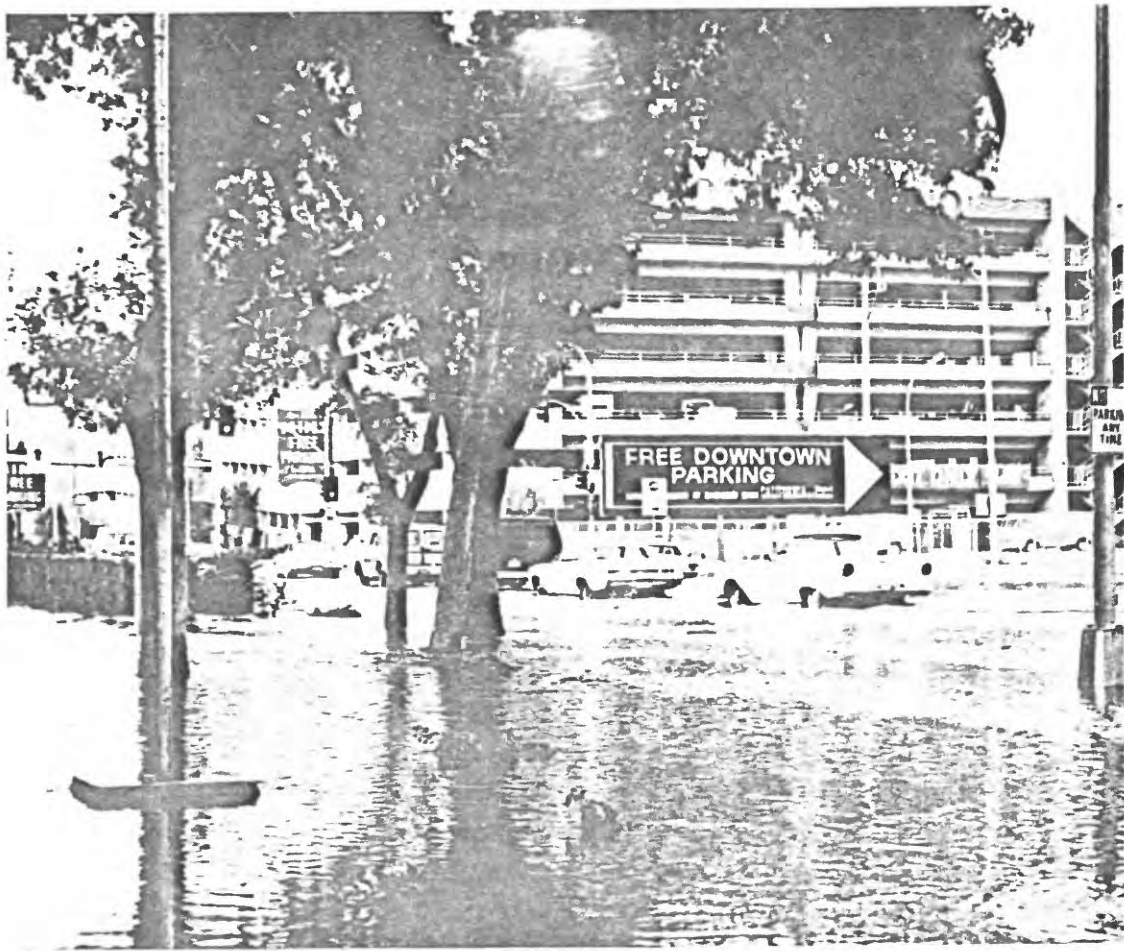
Overbank flooding of major creeks caused great damage to buildings that were invaded by the turbid water. Floodwater in the downtown business district is shown in figure 22. Many utility poles tilted to non-vertical positions during the flood (for example, see fig. 10). Streets were inundated and later left coated with sediment, as were lawns and other improved real estate features (figs. 15 and 16). Curbs and drainage structures were undermined and pipelines were exhumed and commonly damaged (figs. 12, 13). Sewage plants were inundated and deactivated by mud and water.

Figure 22. Flood water mainly from Las Vegas Creek  
invading downtown Las Vegas. Photograph  
courtesy of David Lee Waite.
