UNITED STATES DEPARTMENT OF THE INTERIOR  
GEOLOGICAL SURVEY

A Preliminary Inventory, Description, and  
Statistical Evaluation of Landslides in a  
Region of Projected Urban Development,  
Sheridan, Wyoming

Open-File Report 76-571

1976

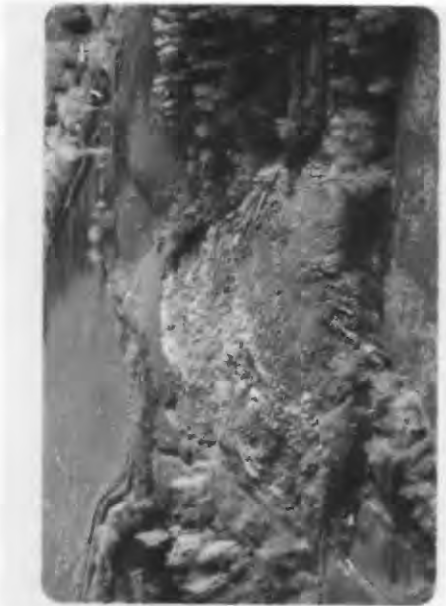
AREA 1-SITE 1

Location: SE 1/4 SE 1/4 sec. 16, T. 56 N., R. 84 W.,  
 Sheridan quadrangle  
 Formation: Wasatch  
 Elevation: 3820 ft  
 Type of movement: Complex - Earthflow/Slump  
 Direction of movement: S. 32° E.

The slide mass was very wet--nearly saturated over most of its surface. Springs emanate from a variable lithology at the scarp base, especially from carbonaceous layers. Soldier Creek, below the slide, has been diverted by the toe of the slide.

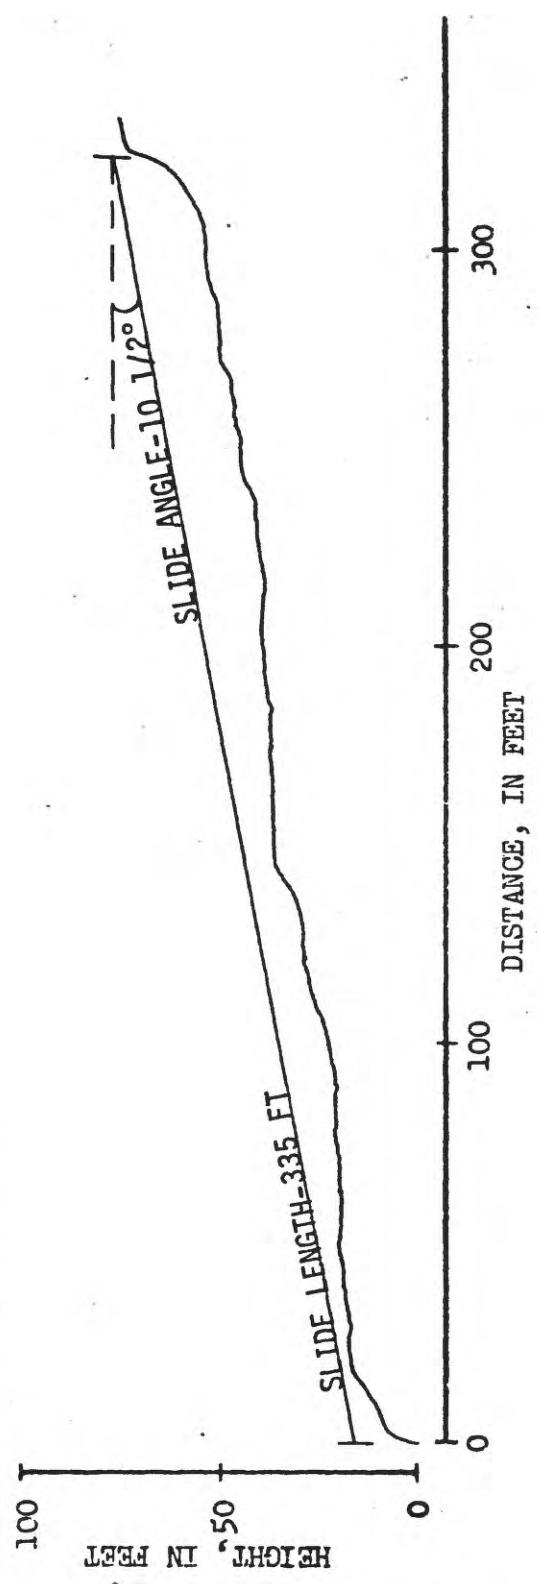
UNDISTORTED PROFILE

Scarp slope	34°
Estimated slide depth	40 ft

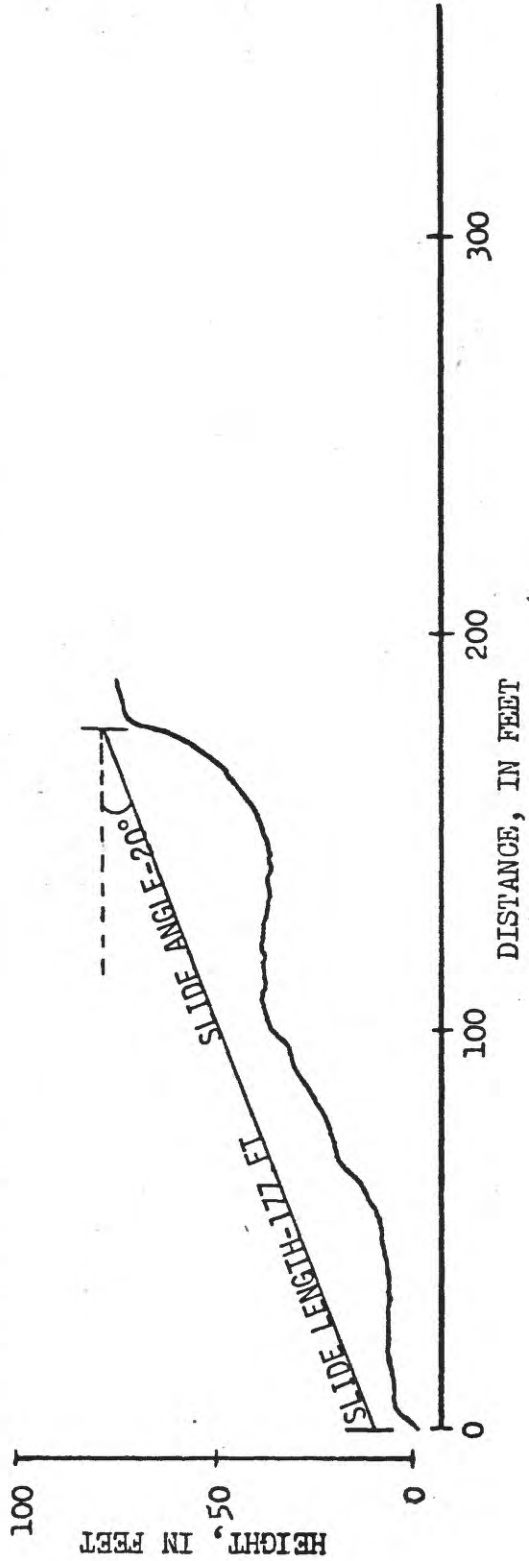
UNDISTORTED PROFILE

Scarp slope 47 1/2°  
Estimated slide depth 35 ft

Much of the surface of the slide mass was dry and crusted; however, the slide material was very wet 1 1/2 feet below the surface. Desiccation cracks in clayey zones are as much as 2 inches wide. Saturated zones and small springs at the scarp base, the middle of the slide, and the toe are associated with thin coal or carbonaceous shale beds. Goose Creek is actively undercutting the toe of the slide and adjacent parts of the hillside. An extensive terrace surface above the slide is irrigated at times.

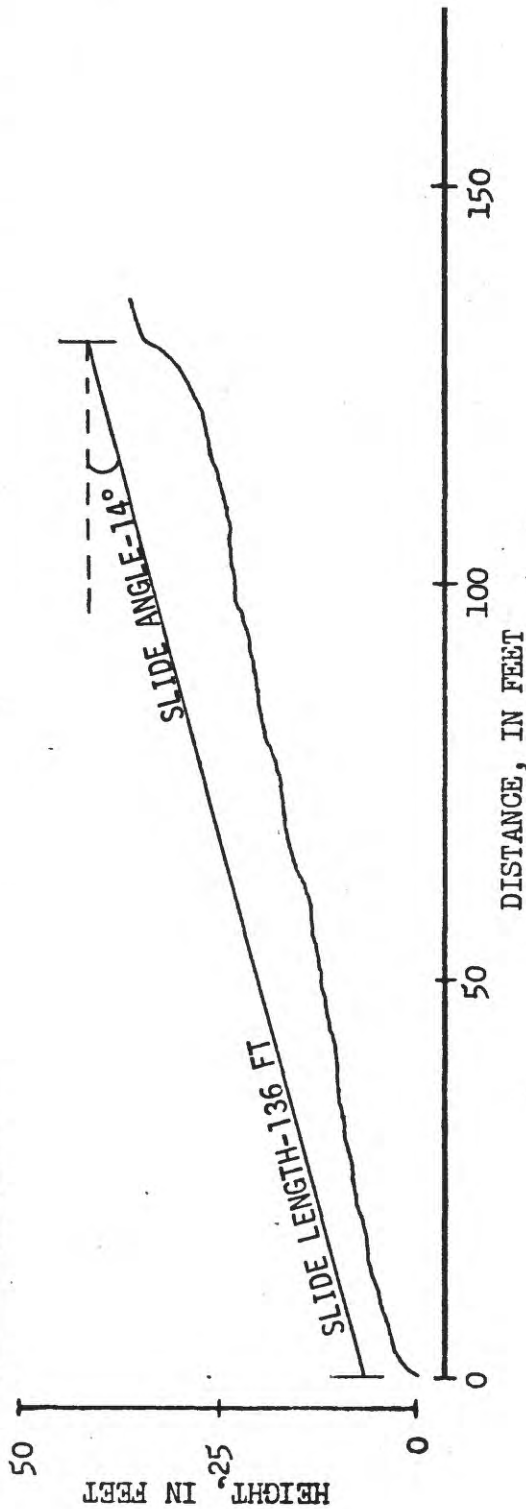
UNDISTORTED PROFILE

Scarp slope 30°  
Estimated slide depth 15 ft

The slide mass was damp to wet over most of the surface; some ponding occurs at the head of the slide where the mass is the wettest.

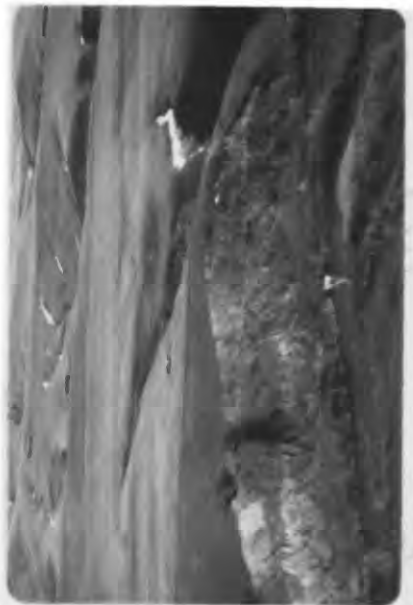
AREA 1-SITE 4

Location: NE 1/4 NE 1/4 sec. 1, T. 55 N., R. 85 W.,  
Hultz Draw quadrangle

Several areas of the slide mass are very wet. Ponding occurs at the head of the slide. Goose Creek runs near the toe but is not undercutting the present slope. An irrigated terrace surface extends northwest of the slide.

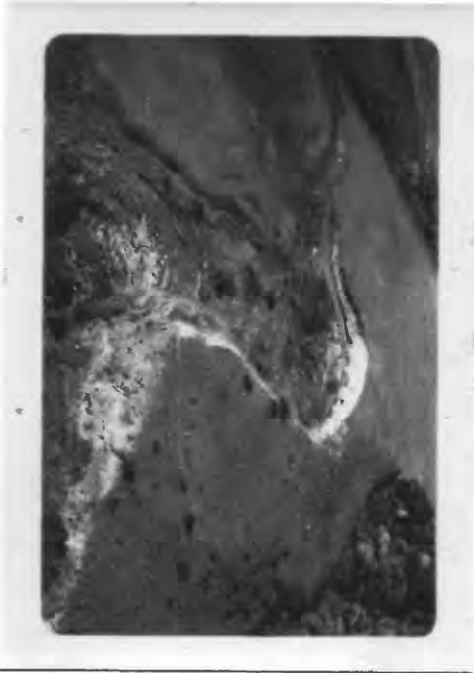
# AREA 1-SITE 6

Location: NE 1/4 NE 1/4 sec. 28, T. 55 N., R. 85 W.,  
Beaver Creek Hills quadrangle

The slide is part of a large slide area composed of several coalescing earthflow/slump-type movements. The failure occurs in a small drainage on a hillside topped by a terrace surface that has been extensively irrigated. The surface of the slide was dry, with the exception of a zone just below the head, where ponding occurs.

The airphotos of 1946 and 1963 clearly show irrigation ditches on the terrace surface previously mentioned. An irrigation ditch, which has cut a deep channel, parallels the slide area on the northeast side of the hill and has probably contributed to the wetness of the slide area below it.

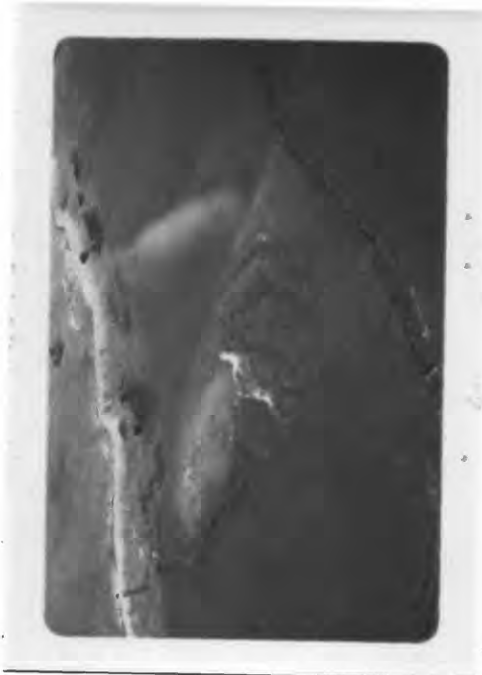
AREA 1-SITE 7

Location: SW 1/4 NW 1/4 sec. 1, T. 54 N., R. 85 W.,  
Beaver Creek Hills quadrangle

The landslide is located on the side of a small knoll in an irrigated field. The main ditch of the irrigation system that supplies water to the field is located just above and behind the slide. A smaller ditch leading from the main ditch runs directly onto the failed slope. The irrigation system was not in use at the time of these observations and the surface of the slide mass was dry.

The irrigation system present today is evident in aerial photographs taken in 1946; however, little or no slope movement is shown. The profiled slide is evident in 1963 airphotos, indicating that the failure occurred sometime between 1946 and 1963.

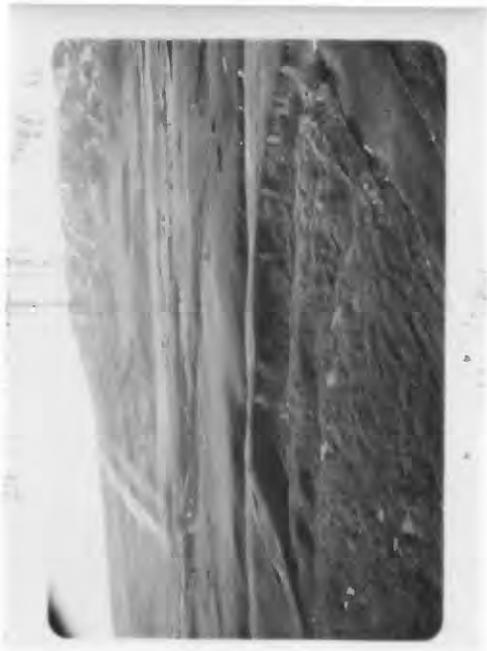
# AREA 1-SITE 8

SE 1/4 SE 1/4 sec. 1, T. 54 N., R. 84 W., and  
 Location: SW 1/4 SW 1/4 sec. 6, T. 54 N., R. 85 W.,  
 Beaver Creek Hills quadrangle  
 Formation: Fort Union  
 Elevation: 4500 ft  
 Type of movement: Complex - Earthflow/Slump  
 Direction of movement: N. 12° E.

The occurrence of the landslide has been reported by Lowry and Cummings (1966), who presented photographs of the site for the years 1954, 1958, and 1961 showing its development. Lowry and Cummings stated that the landsliding "is due in part to the disturbance of the equilibrium caused by the rechanneling of the creek into the toe of the slope, and in part by the irrigation of land above the slope."
