CHANNEL EROSION SURVEYS ALONG TAPS ROUTE, ALASKA, 1976

UNITED STATES DEPARTMENT OF THE INTERIOR
GEOLOGICAL SURVEY

By
Paul F. Doyle
and
Joseph M. Childers

77-170

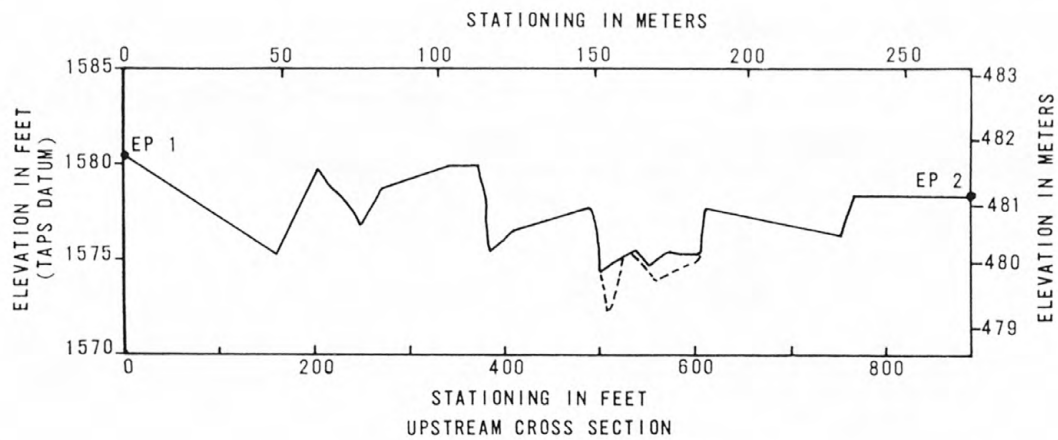
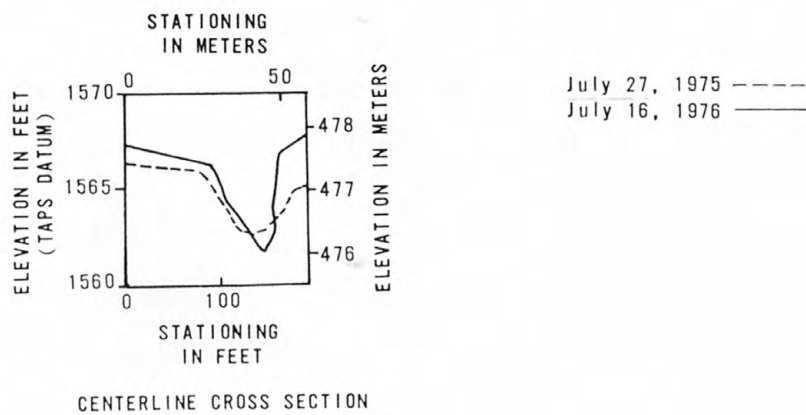
Figure 3.-- Cross sections of Snowden Creek near Dietrich Camp.

The crossing site was resurveyed in July 1976. No significant change was found in either the downstream or former centerline cross sections. Figure 3 shows the changes in the upstream cross section and the change due to construction in the centerline cross section since 1975.

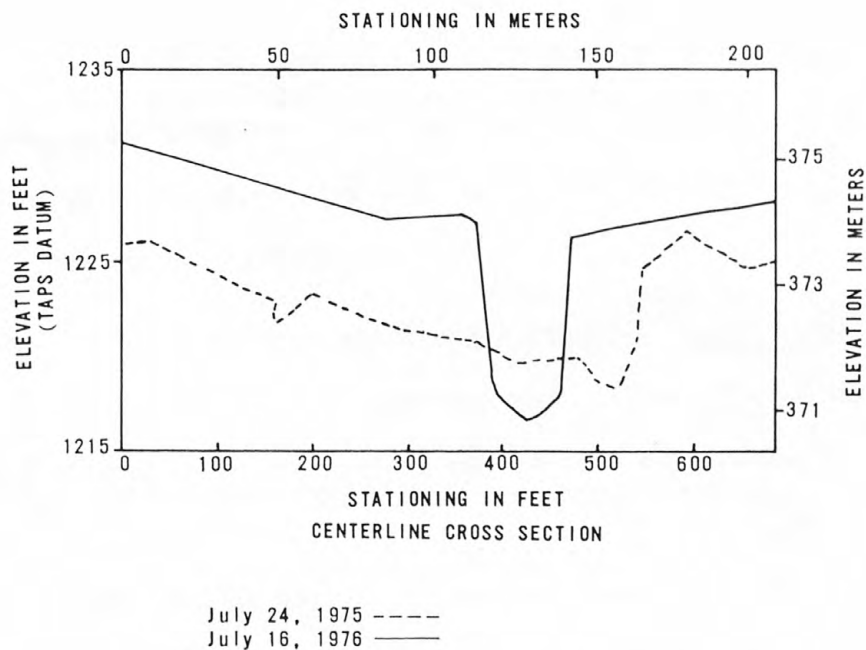
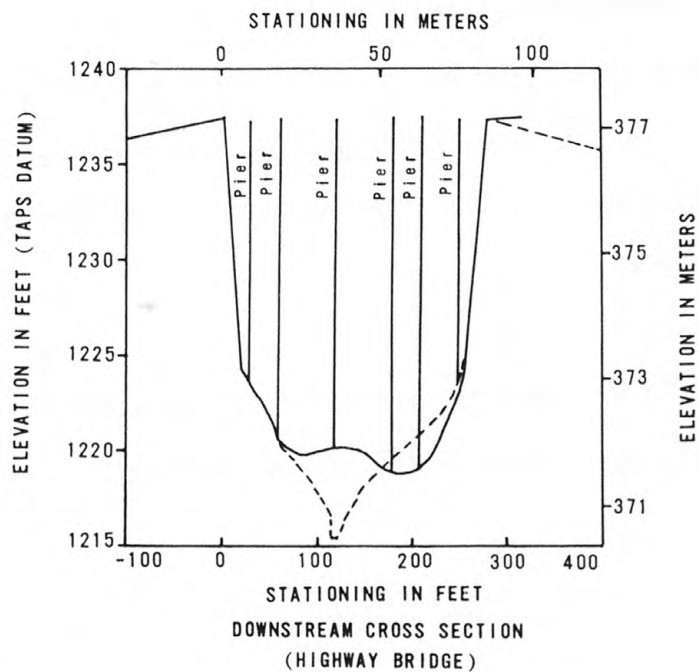
Figure 7.-- Cross sections of the Middle Fork Koyukuk River at Hammond River.

The crossing site was resurveyed in July 1976. There was no significant change in the upstream cross section. Figure 7 shows the construction change in the centerline cross section and the change in the downstream cross section. The floodway at the pipeline crossing has been greatly constricted by the construction. At the downstream section, the bed scour which took place during the spring of 1975 has been reversed and the thalweg elevation in this section is now 1 ft (0.3 m) higher than in 1971.

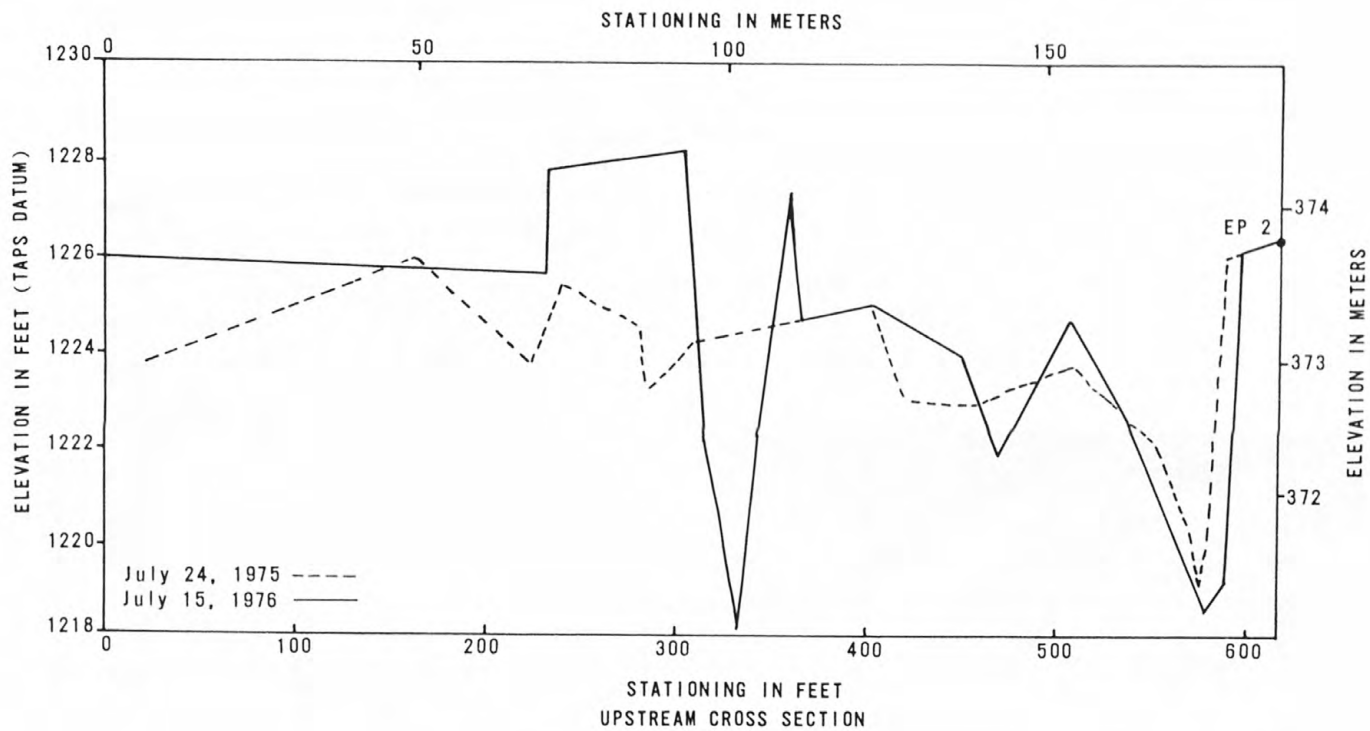
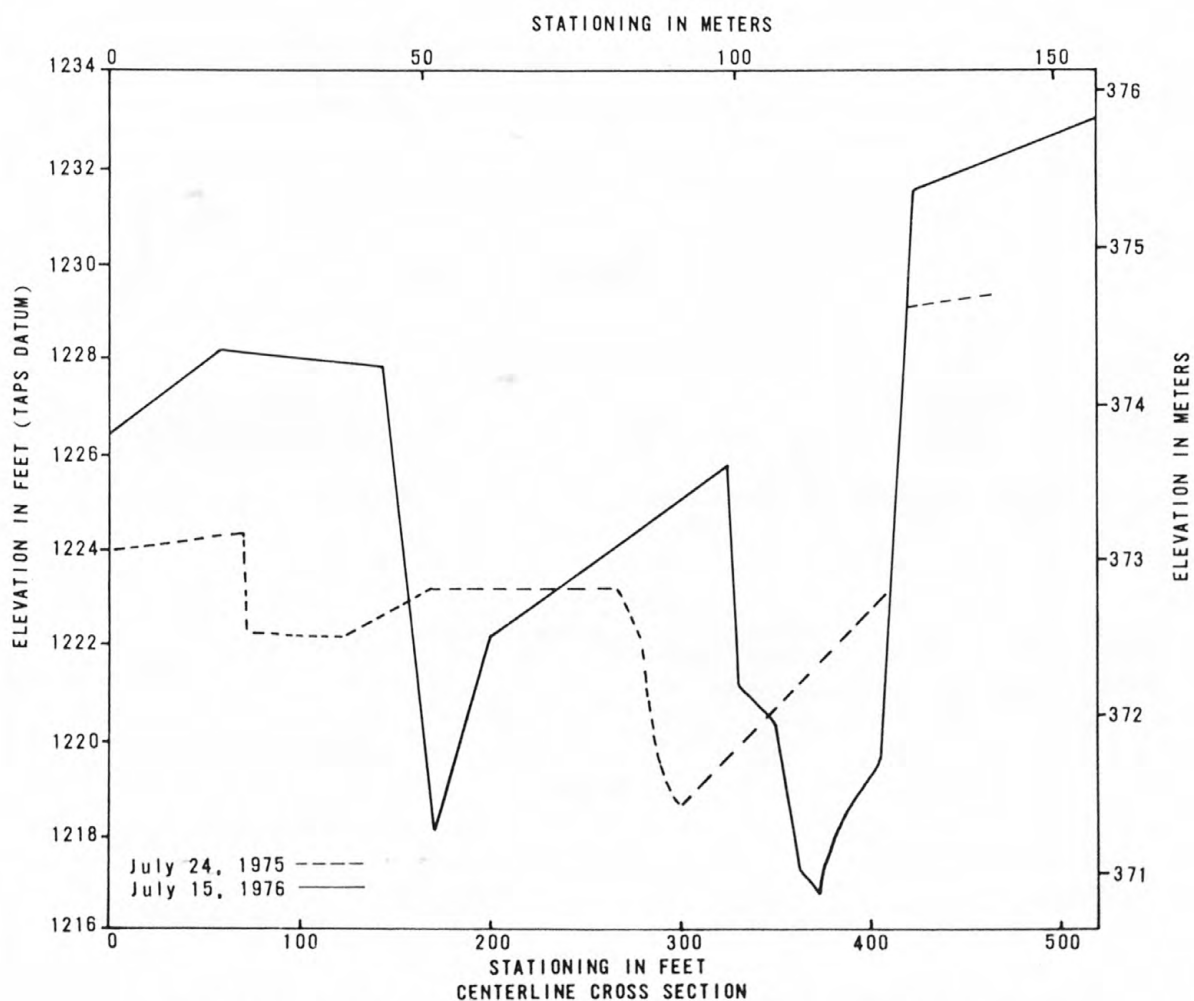
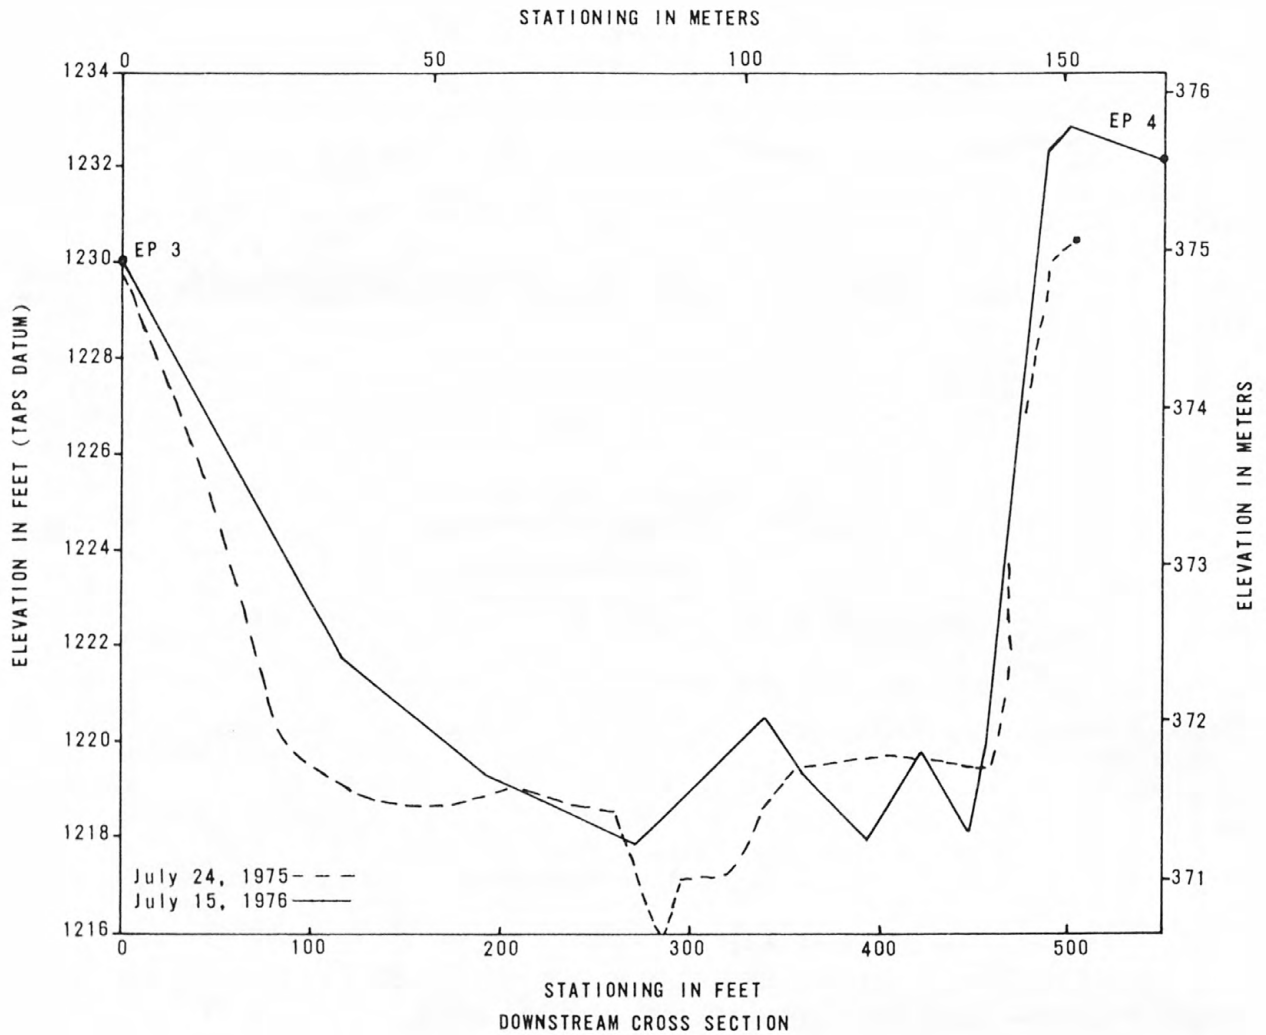
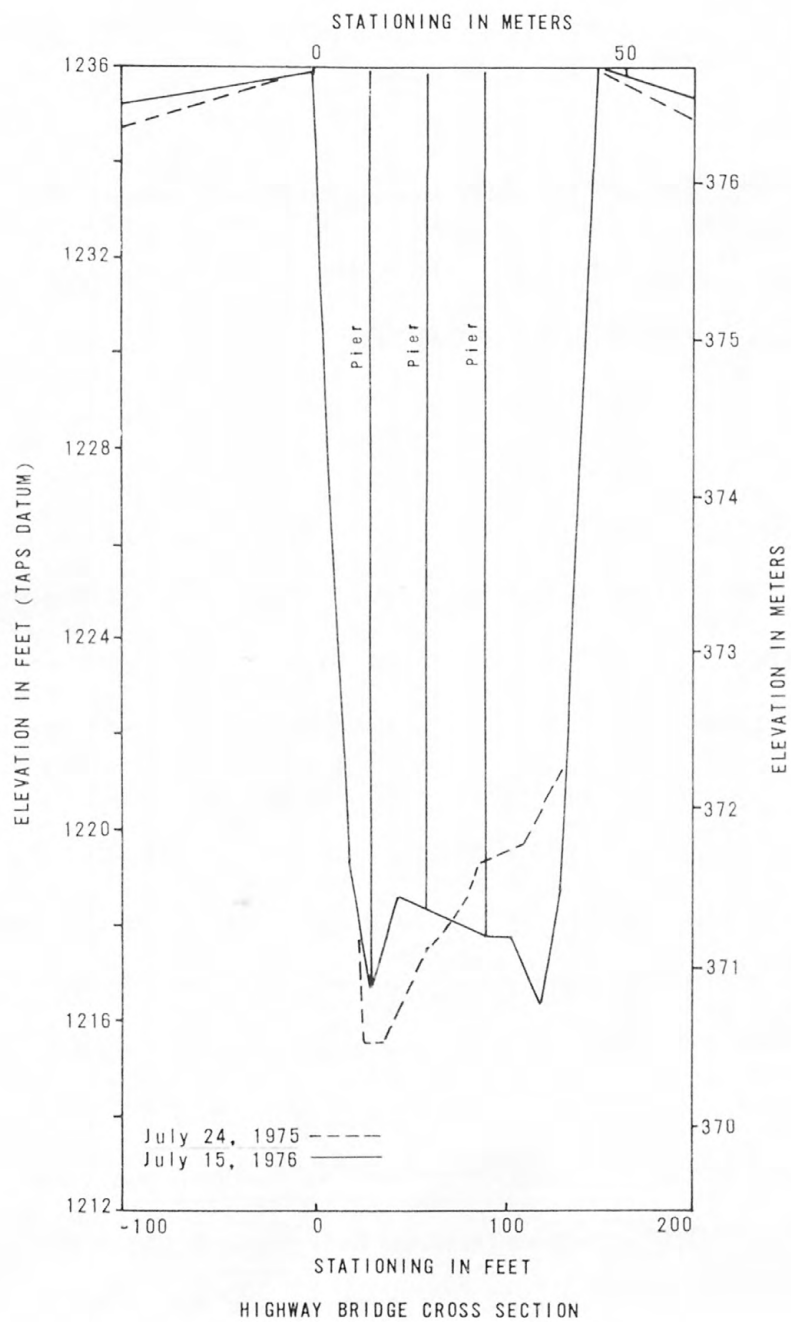
Figure 8.-- Cross sections at the Hammond River near Wiseman.

The crossing site was resurveyed in July 1976. Figure 8 shows the changes in all four surveyed sections since last year. The construction of the pipe bridge and dikes has caused much of the change. The upstream section right bank continues to erode. At the highway bridge, the thalweg has migrated from the left bank to the right bank and unlike the thalweg under Middle Fork Koyukuk highway bridge, the thalweg is at about the same depth as it was in 1975.

EP-4 was lost to construction, and a new EP-4 was located slightly downstream of its former position.

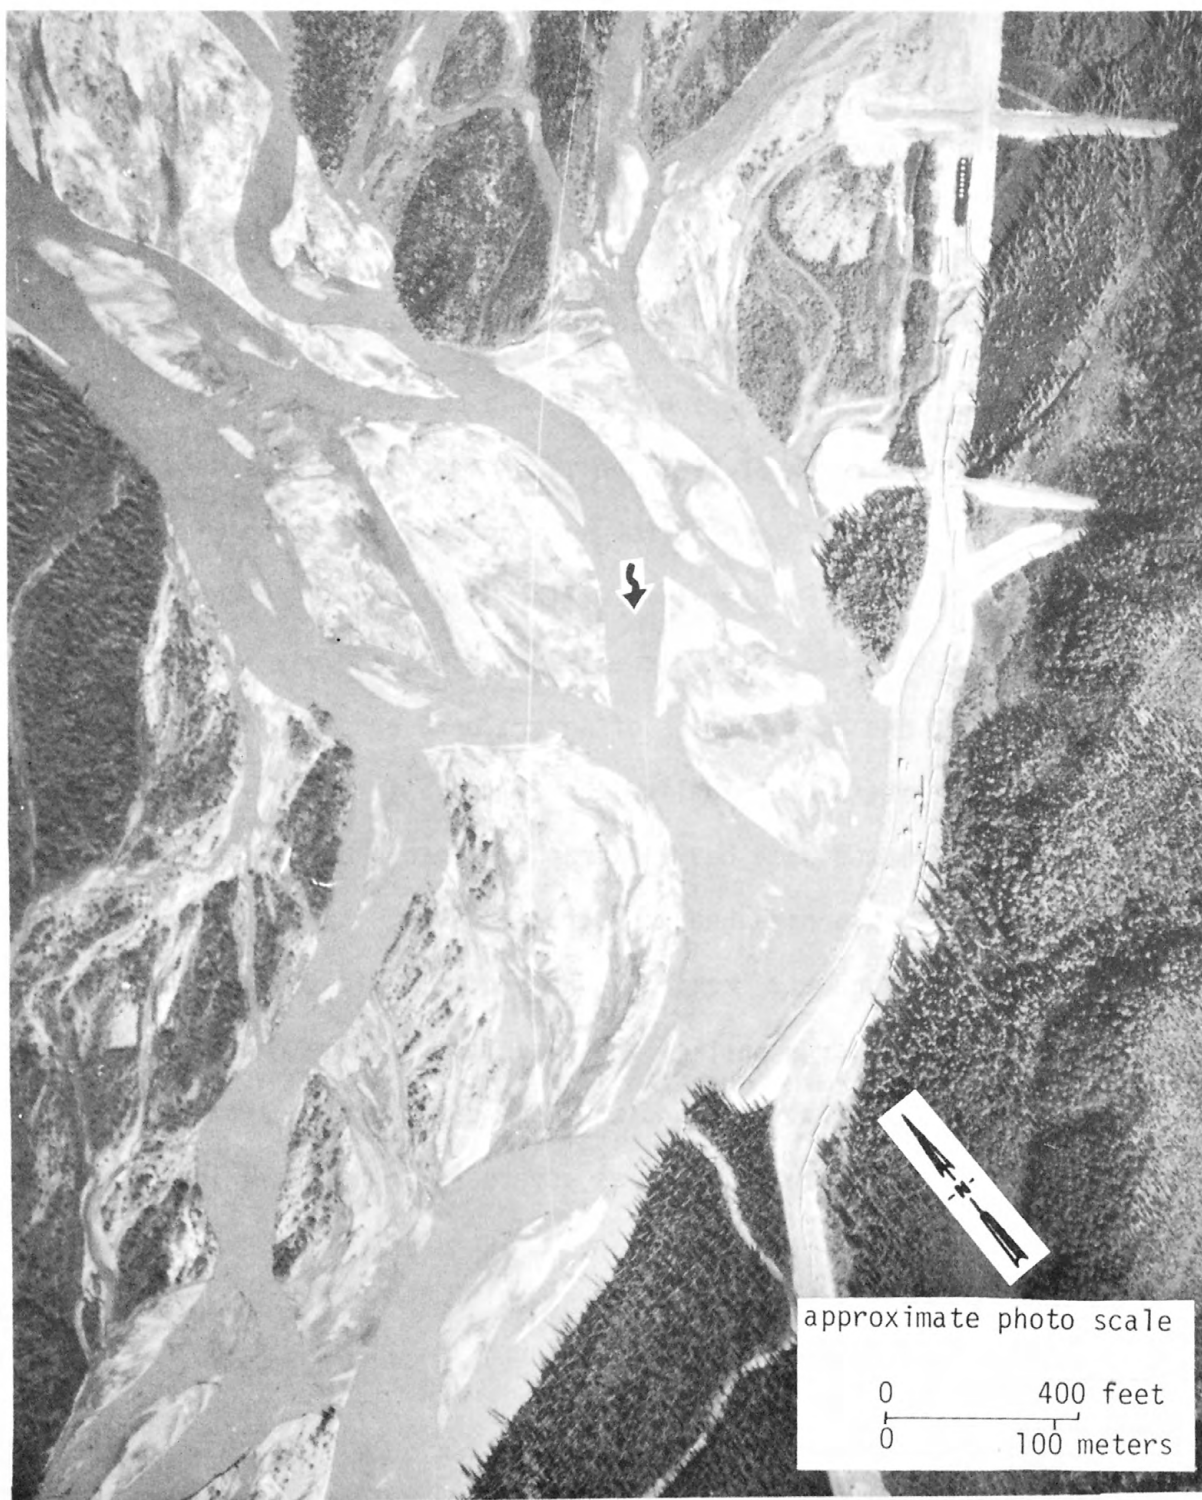
Figure 11.-- Middle Fork Koyukuk River near Coldfoot, July 9, 1976.

1976 Surveillance.--Photographic coverage of this site was obtained in July. Comparison of 1975 and 1976 photos indicates very little change since 1975 except for some channel migration within the stream banks. Figure 11 shows the Middle Fork Koyukuk River near Coldfoot at site A (from the 1975 report) on July 19, 1976. This has been one of the areas of severe bank erosion in the past at the spot where the pipeline passes closest to the active channel. A dike armored with heavy riprap has been placed along the bank and spur dikes have been constructed along the pipeline for protection against erosion. The photos indicate that during the past year a large part of the flow through this reach has shifted towards the right bank and thus the dynamic attack on the left bank at site A is not as severe as it has been in the past.

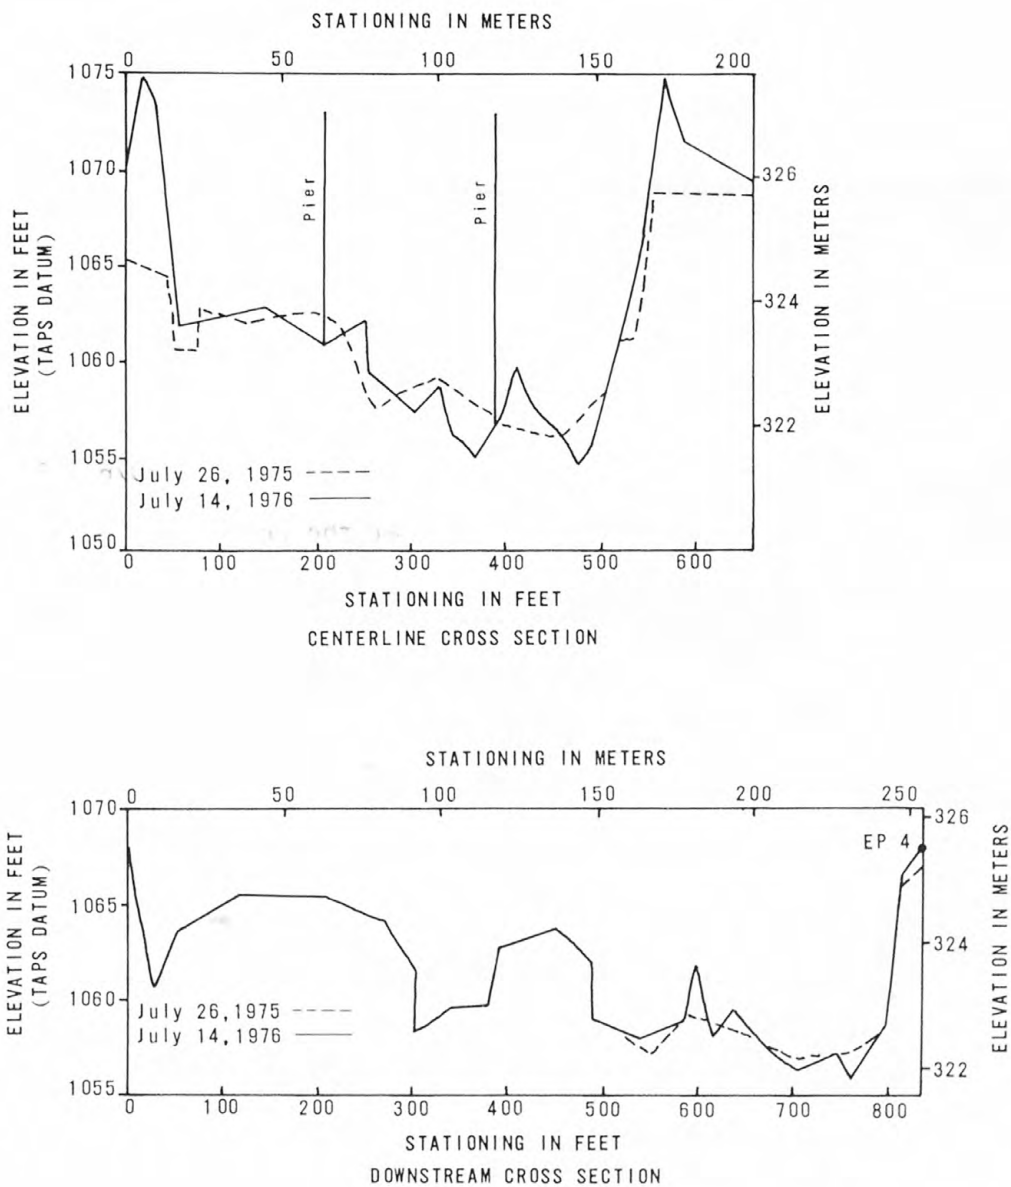
Figure 13.-- Cross sections of the South Fork Koyukuk River near Wiseman.

The crossing site was resurveyed in July 1976. There was no significant change in the upstream section. Figure 13 shows the changes in the centerline and downstream sections due mainly to construction.

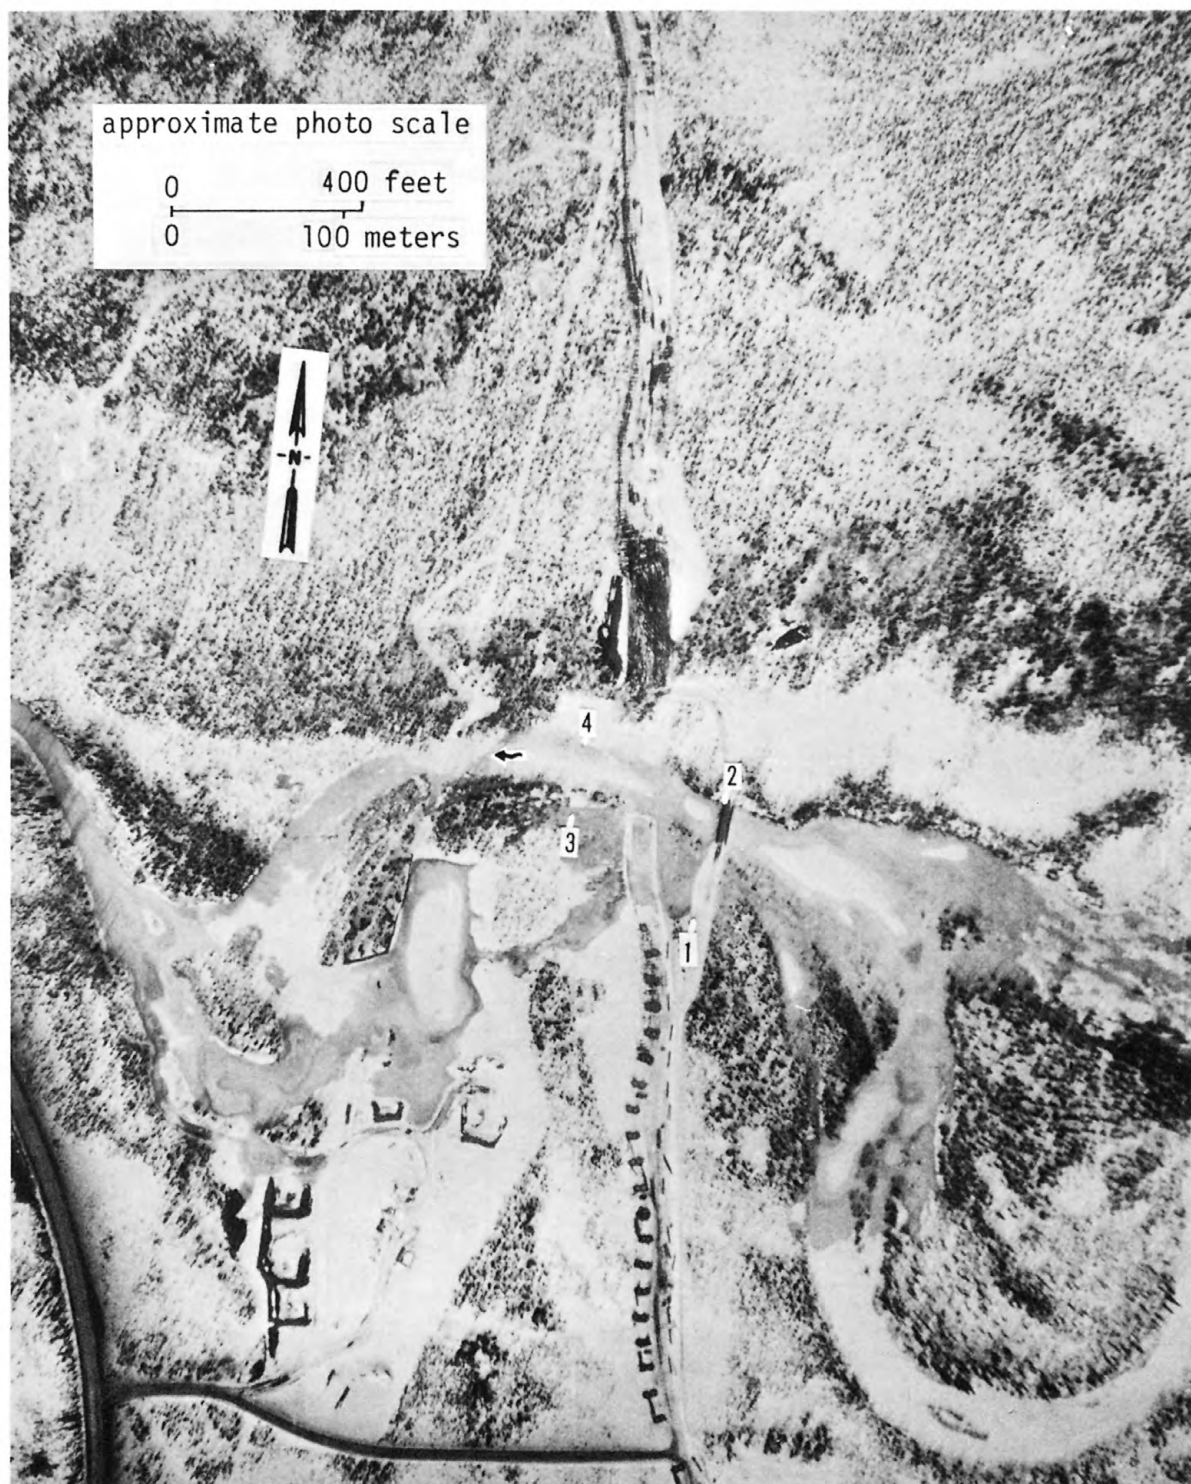
Figure 17.-- Prospect Creek near Prospect Creek Camp, April 15, 1976.

The main channel was again filled with icings at the time of spring break-up, with resulting overbank flow through the borrow pit downstream of the crossing. Figure 17 shows the icing conditions and the overbank flow on April 15, 1976. Visual inspection of the pit in July and comparison of 1975 and 1976 aerial photos indicates that additional headcutting along the northeast side of the pit has taken place since last year.

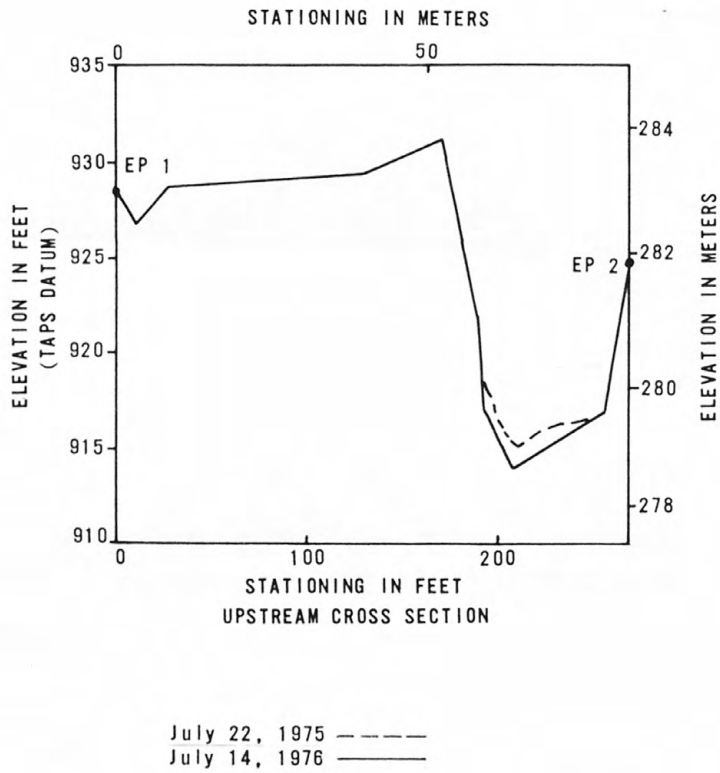
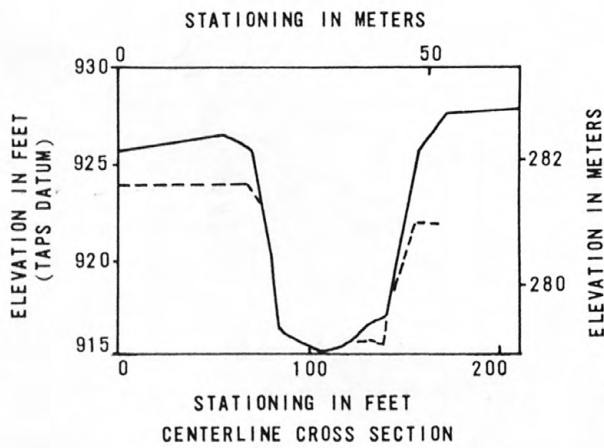
Figure 18.-- Cross sections of Prospect Creek near Prospect Creek Camp.

The crossing site was resurveyed in July 1976. No significant changes were found in the downstream cross section. Figure 18 shows the change at centerline section due to construction and the deepening of the upstream cross section.

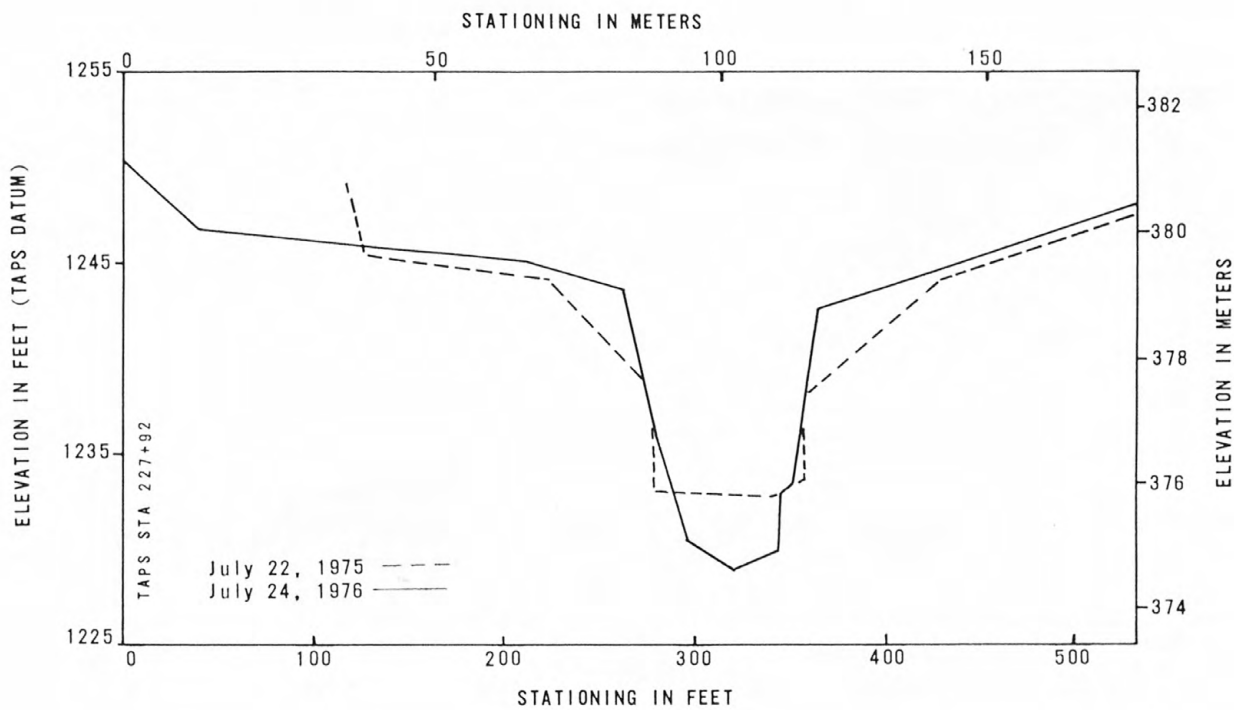
Figure 20.-- Centerline cross section of the Kanuti River near Bettles.

The crossing site was resurveyed in July 1976 and no significant changes were found in the upstream and downstream cross sections. Figure 20 shows the change in the centerline cross section due to construction.

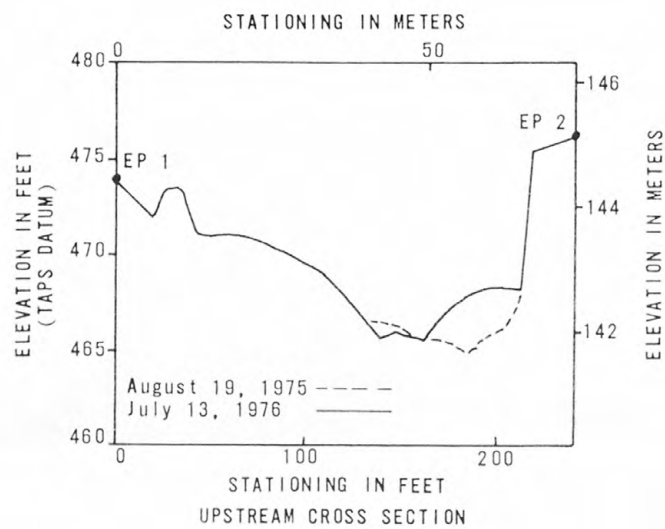
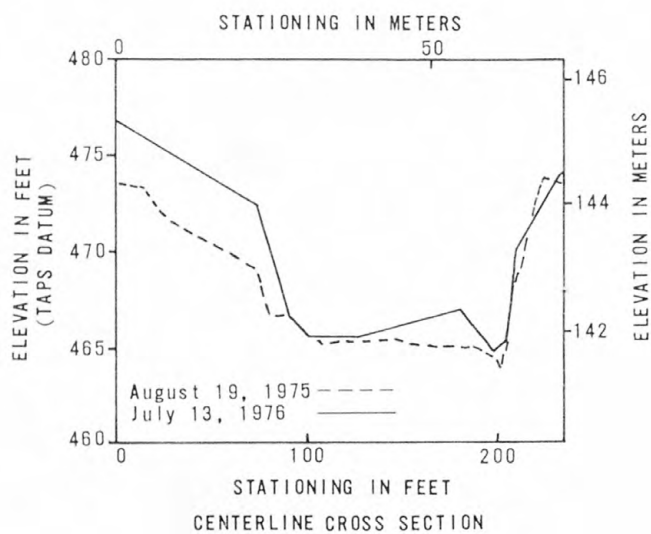
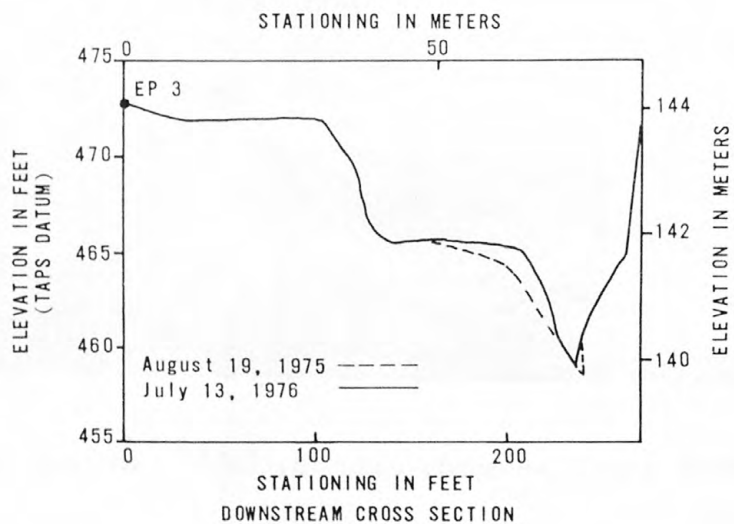
Figure 22.-- Cross sections of Hess Creek near Livengood.

The crossing site was resurveyed in July 1976. All three cross sections have changed within the stream banks, as shown in figure 22. This channel remains active. A meander cutoff occurred in 1975, most probably during the new MEF flood, about 1,500 ft (457 m) downstream from the TAPS crossing. The peak discharge since the 1975 survey is 8,300 ft³/s (235 m³/s) on May 5, 1976.

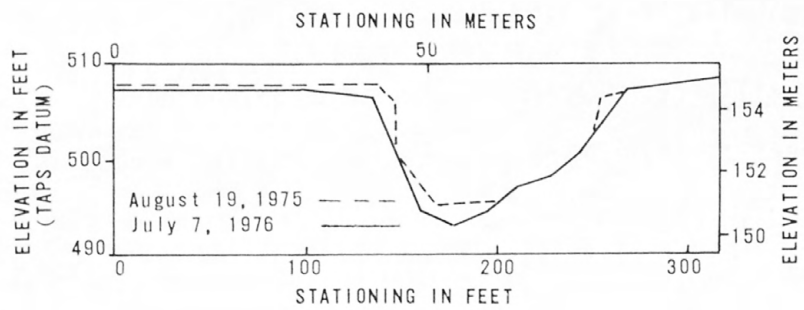
Figure 24.-- Centerline cross section of the Chatanika River near Olmes.

The crossing site was resurveyed in July 1976. No significant changes were found in the upstream or downstream sections. Figure 24 shows the changes at centerline due to construction. At the upstream section, the submerged log which was forcing flow against the left bank and causing undercutting in 1975 has been washed downstream, and the thalweg has shifted back toward the center of the channel.

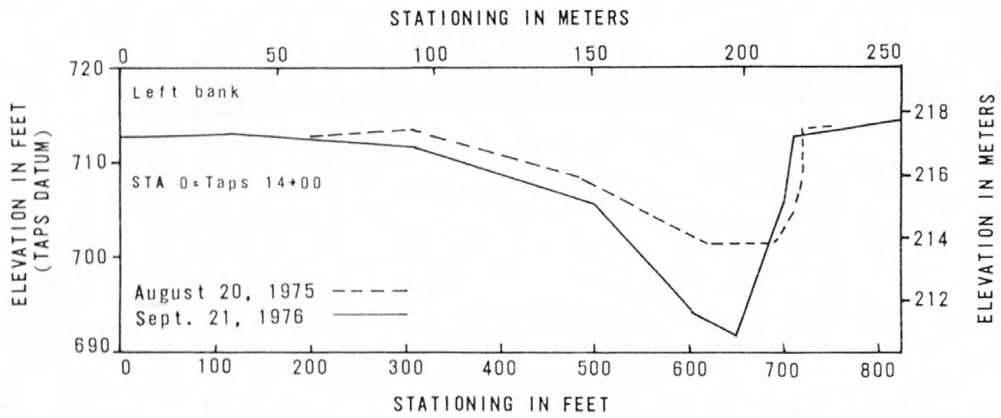
Figure 26.-- Centerline cross section of the Salcha River near Salchaket.

The crossing site was resurveyed in September 1976. No significant changes were found in the upstream or downstream cross sections. Figure 26 shows the construction changes at the centerline. The deep hole is a result of pipe burial.

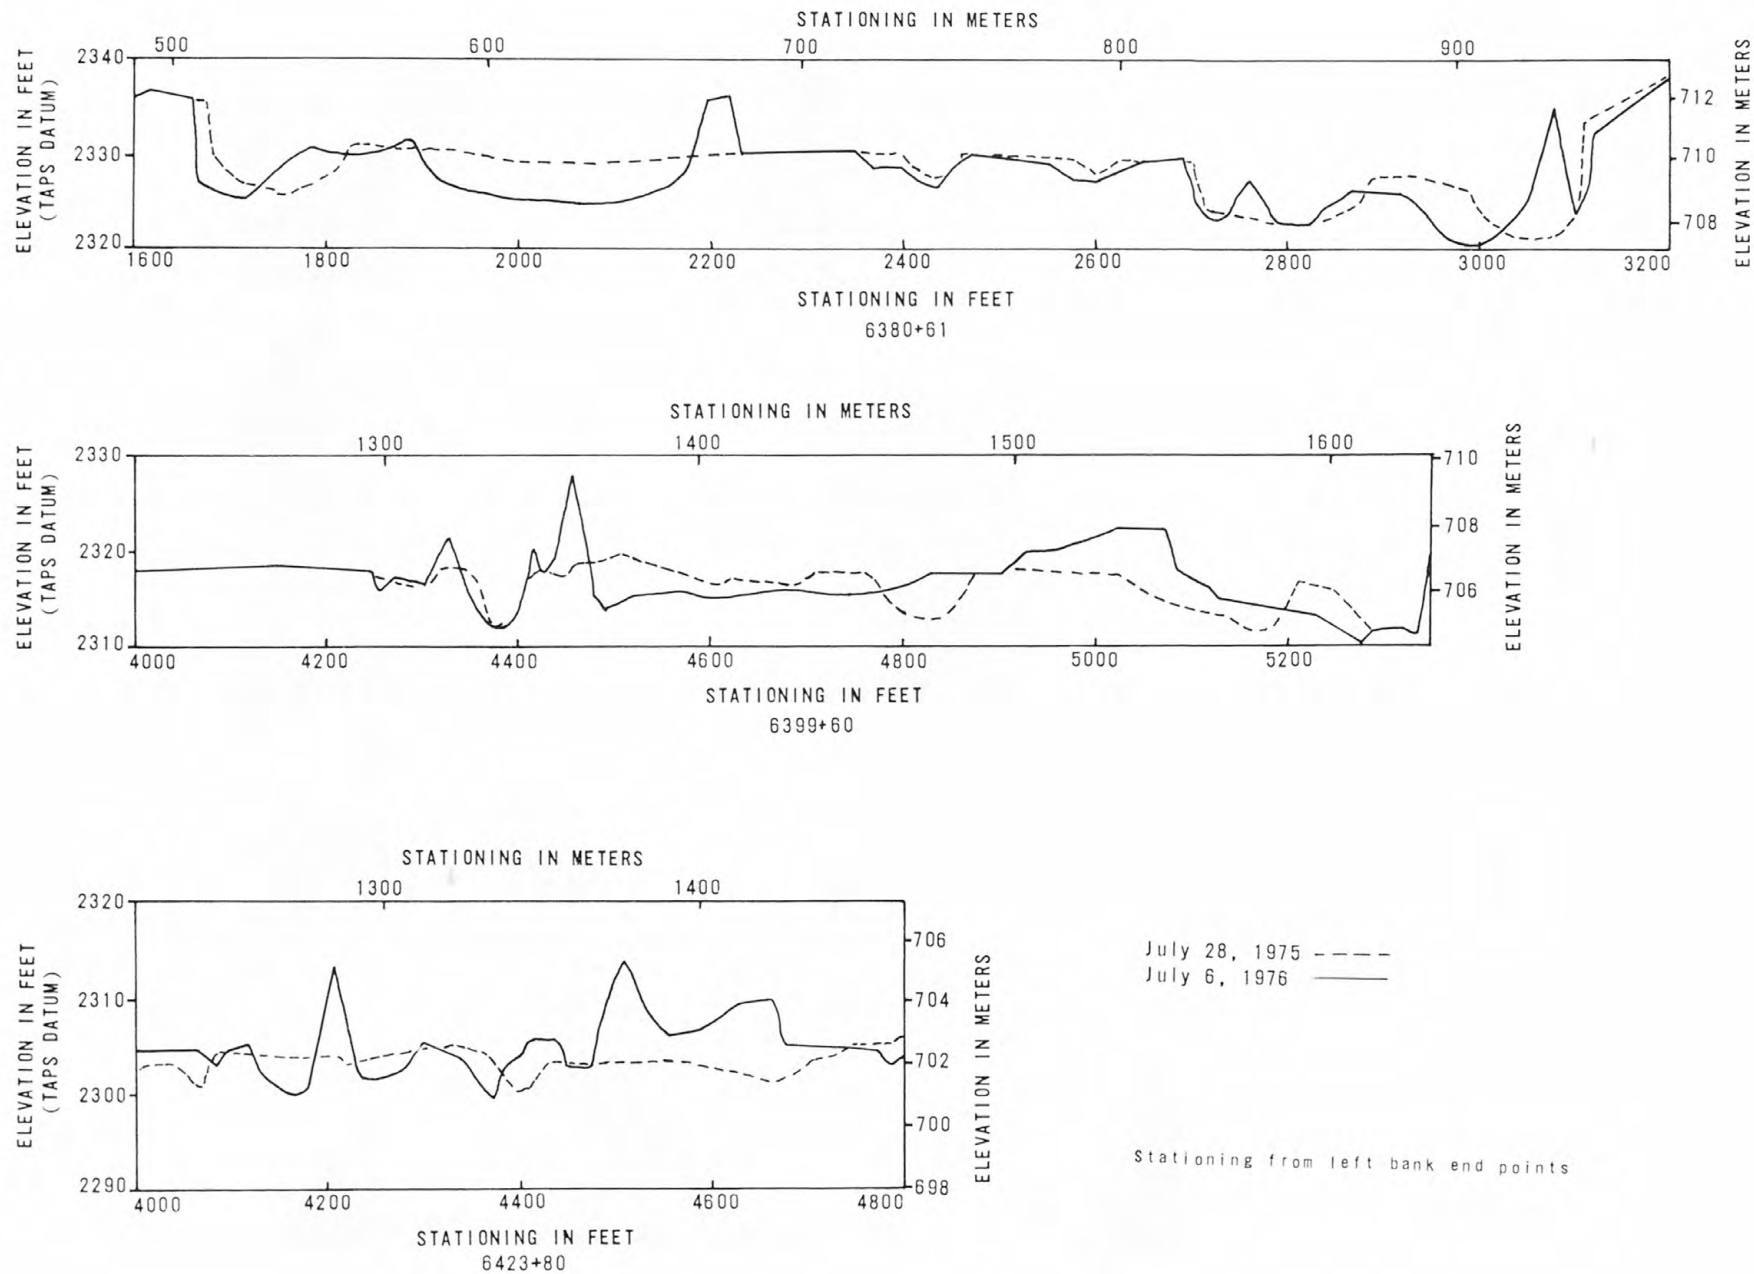
Figure 29.-- Cross sections of Delta River at Flood Creek.

The site was resurveyed photogrammetrically in July. Figure 29 shows the lateral dikes and the changes in three of the four resurveyed cross sections since 1975. Section 6452+70 was not found to be changed significantly. At section 6380+61 the left bank has eroded approximately 20 ft (6.1 m) since the 1975 survey. No underwater configurations were surveyed during a visual inspection of the site in September 1976, but it is estimated that the thalweg has not changed significantly in any of the sections.

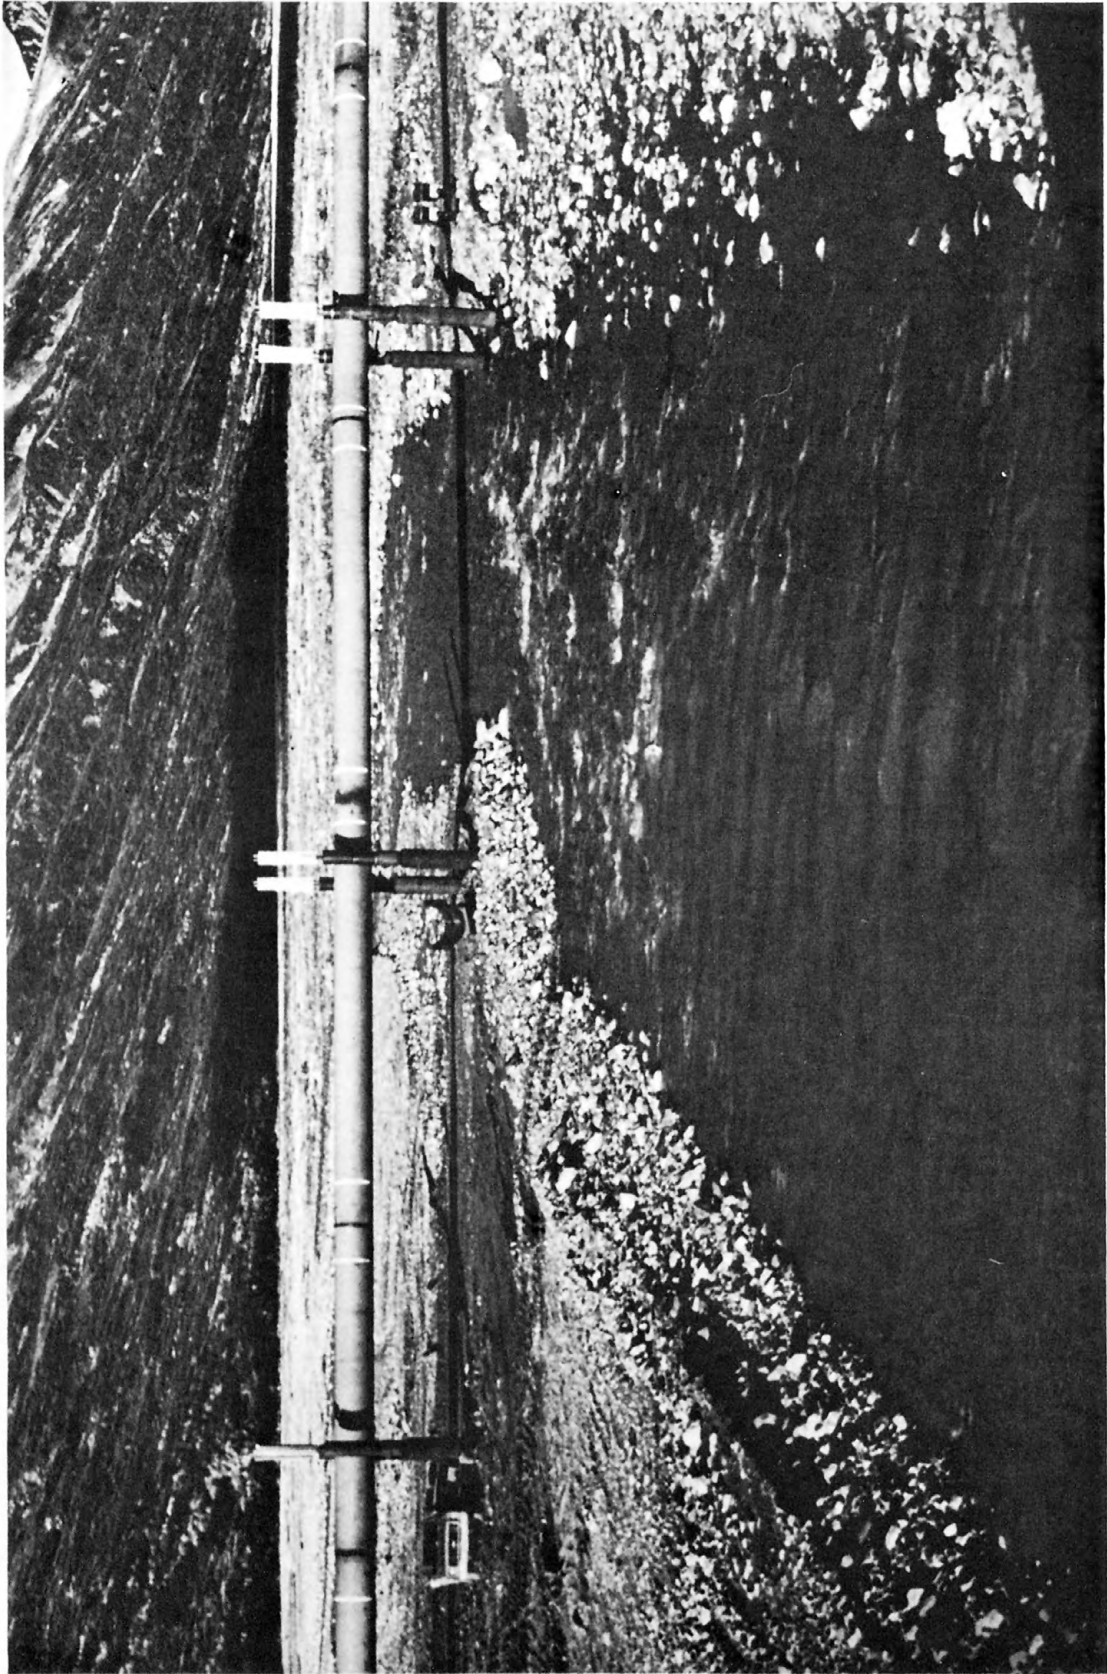
Figure 31.-- Pipe crossing Miller Creek on VSM's, September 22, 1976. AIR PHOTO TECH

Figure 30 shows the Castner Creek and Lower Miller Creek near Rapids site on August 1, 1976. The VSMs can be seen in place across the entire floodway. Figure 31 shows the completed pipe on a similar crossing on Miller Creek which is just south of these two crossings. The light truck under the pipe in the photo gives an idea of the scale.

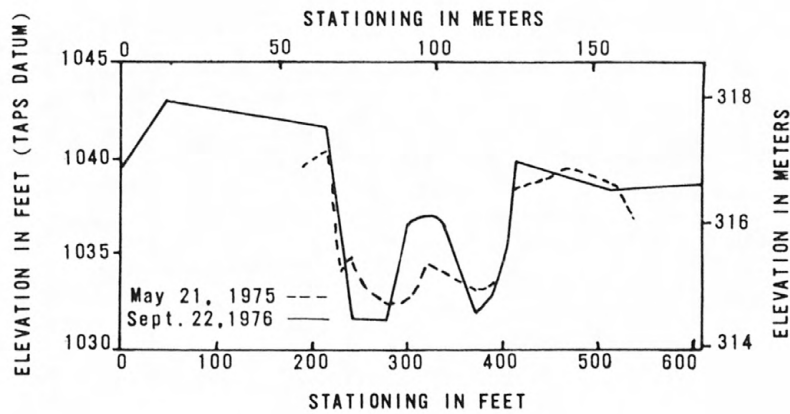
Figure 36.-- Centerline cross section of Klutina River near Copper Center.

The crossing site was resurveyed in September 1976. No significant changes were found in the upstream or downstream cross sections. Figure 36 shows the construction-related changes in the centerline cross section.

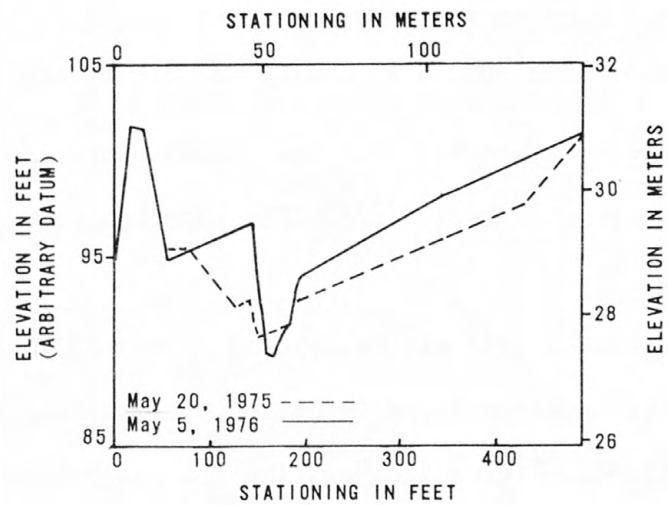
Figure 40.-- Centerline cross section of Tiekel River at Tiekel.

The crossing site was resurveyed in May 1976. There was no significant change in either the upstream or downstream sections. Figure 40 shows the construction-related changes at the centerline section. Apart from the dike on the left bank, the centerline cross section is much the same as it was in 1973.

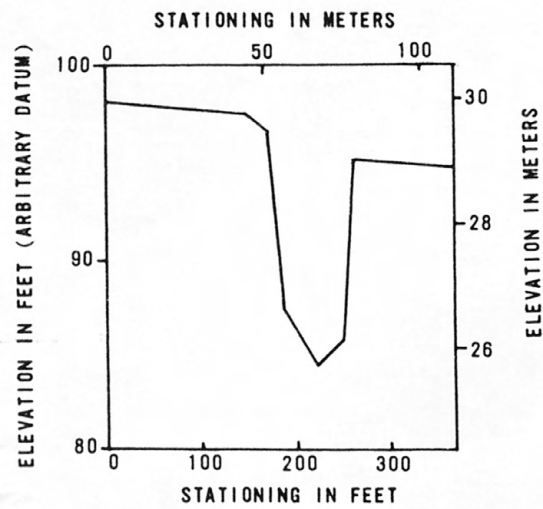
Figure 42.-- Centerline cross section of Tiekel River near Tiekel, May 8, 1976.

The crossing site was resurveyed in May 1976. There was no significant change found in either the upstream or downstream cross sections. Figure 42 shows the new centerline cross section.

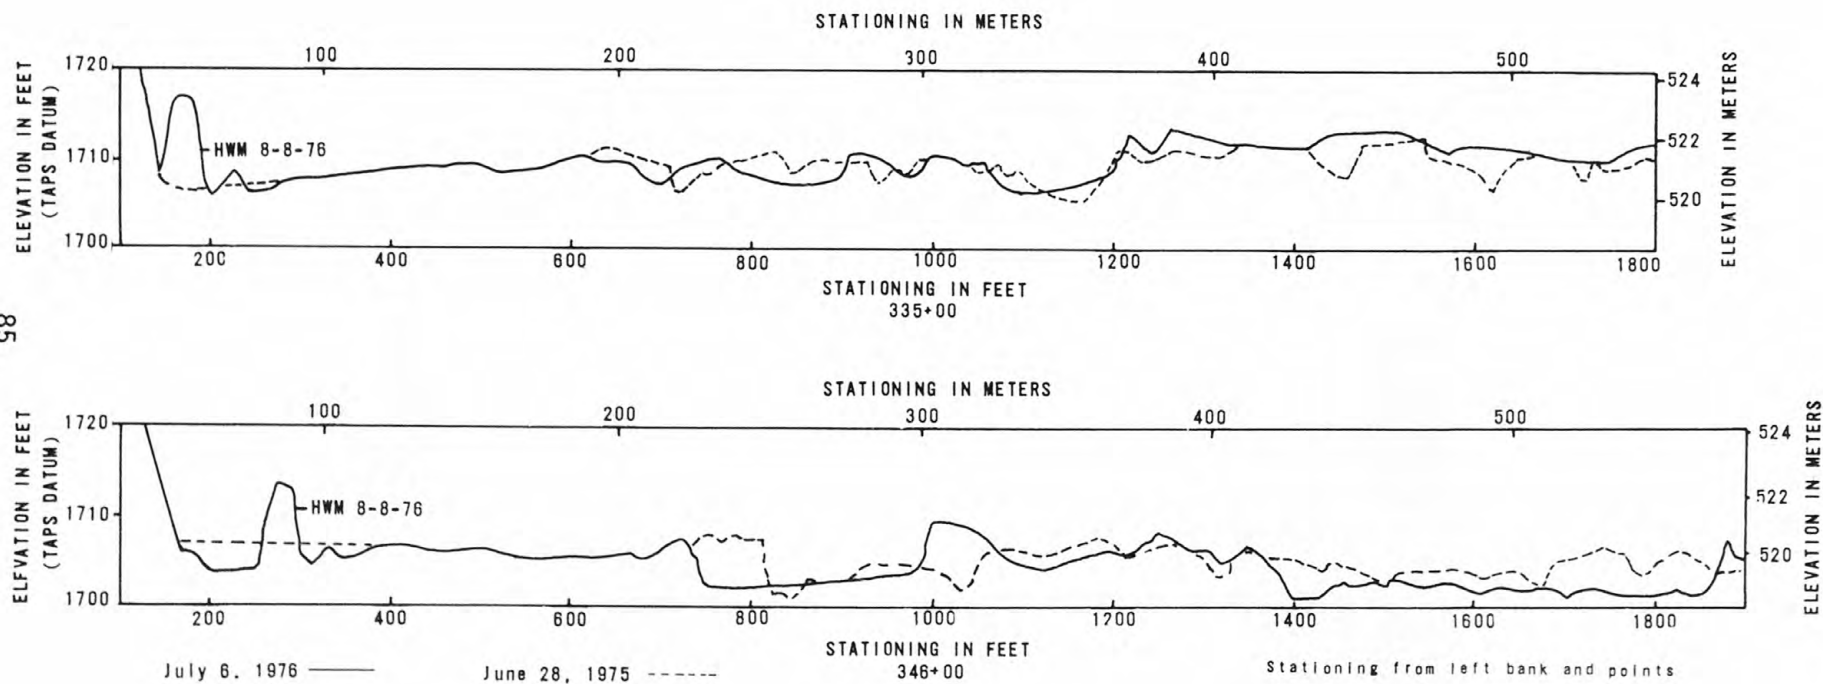
Figure 47.-- Cross sections of Tsina River at Ptarmigan.

The site was resurveyed photogrammetrically in July 1976. No significant changes were found in the channel way of section 305+50 or in the supplemental section. There has been no significant channel change in section 328+00, but a big stockpile of gravel has been pushed up on the right side of the channel way. Section 352+64 has changed considerably since the photogrammetric survey due to subsequent construction; therefore this section is not shown. Figure 47 shows the changes wrought by construction and subchannel migration in sections 335+00 and 346+00.

In September, a field survey was made of the site to determine high water elevations and thalweg depths in some channels. The break-out flood in August caused no apparent bank erosion and no evident deepening of the thalweg through this reach. Figure 47 also shows the high water marks from the August break-out flood along the left-bank dike. At section 352+64 where the dike was not yet built at the time of the photogrammetric survey, the high water mark was 1.5 ft (0.5 m) below the top of the dike.
