Joints, Fissures, and Voids
in Rhyolite Welded Ash-flow Tuff
at Teton Damsite, Idaho

Harold J. Prostka

Open-File Report 77-211

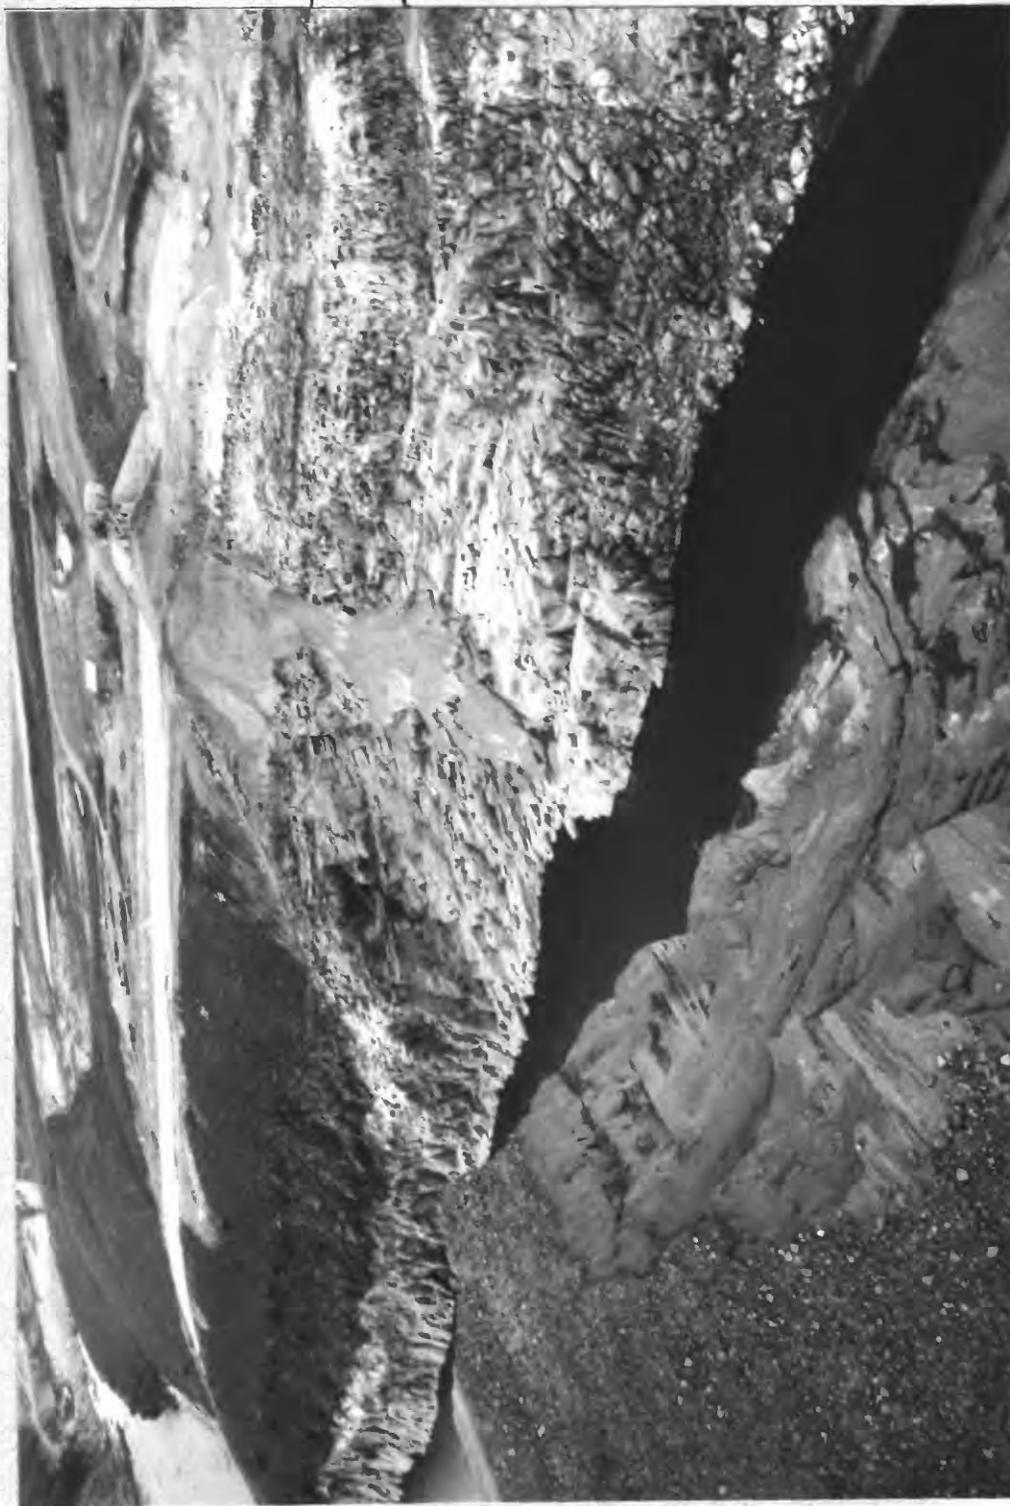
Figure 1.--Oblique aerial view of right abutment, Teton Dam, showing overall appearance of rhyolite welded ash-flow sheet. Note threefold subdivision of sheet upstream (to the right) of the embankment remnant in the key trench. Height of exposed canyon wall is approximately 230 feet. View to west taken June 1976.

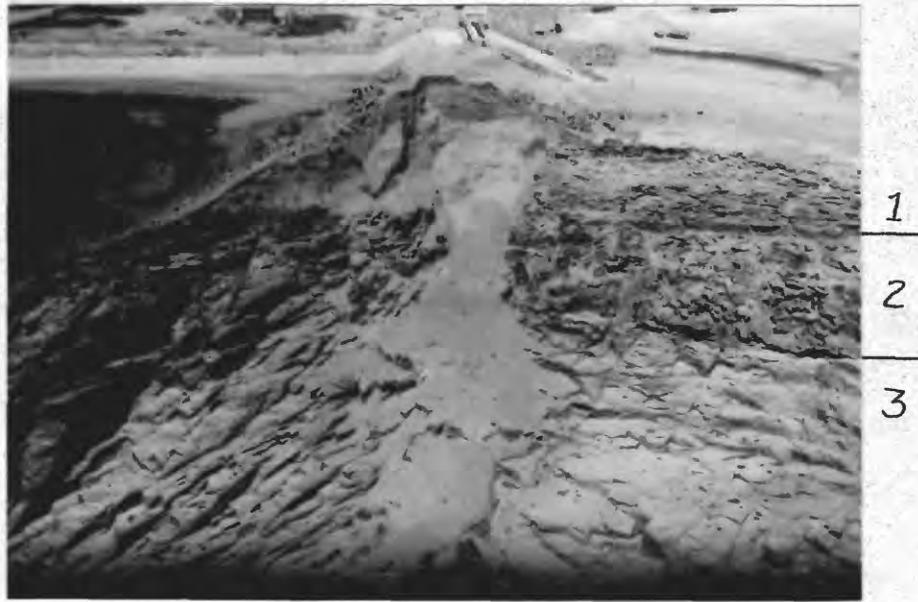
Figure 2.--Aerial view of right abutment, Teton Dam, nearly perpendicular to the canyon wall. Note abrupt termination of unit 2 just downstream from the embankment remnant. Thickness of unit 2 is about 61 feet. View to northwest taken June 1976.

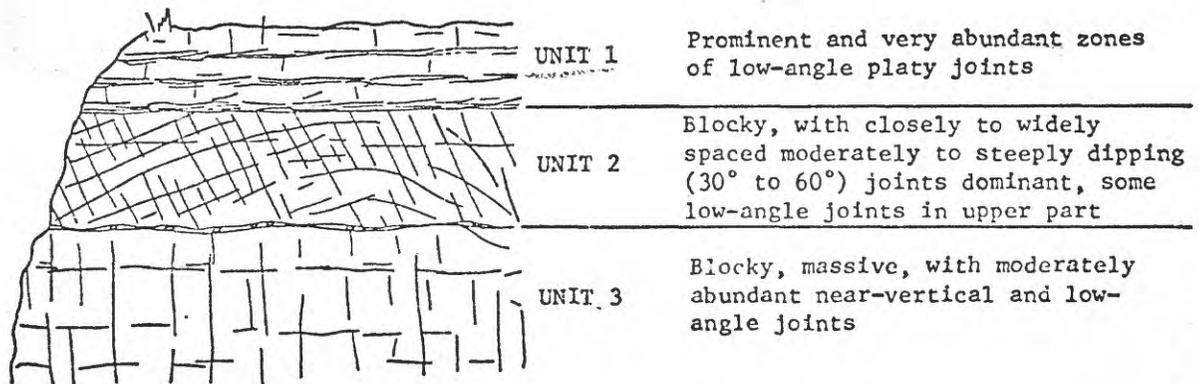
Figure 3.--Schematic section of welded rhyolite ash-flow tuff in right abutment, Teton Dam, as exposed after failure just upstream from the embankment remnant, showing principal joint features of the three informal units distinguished on Bureau of Reclamation post-failure geologic maps.

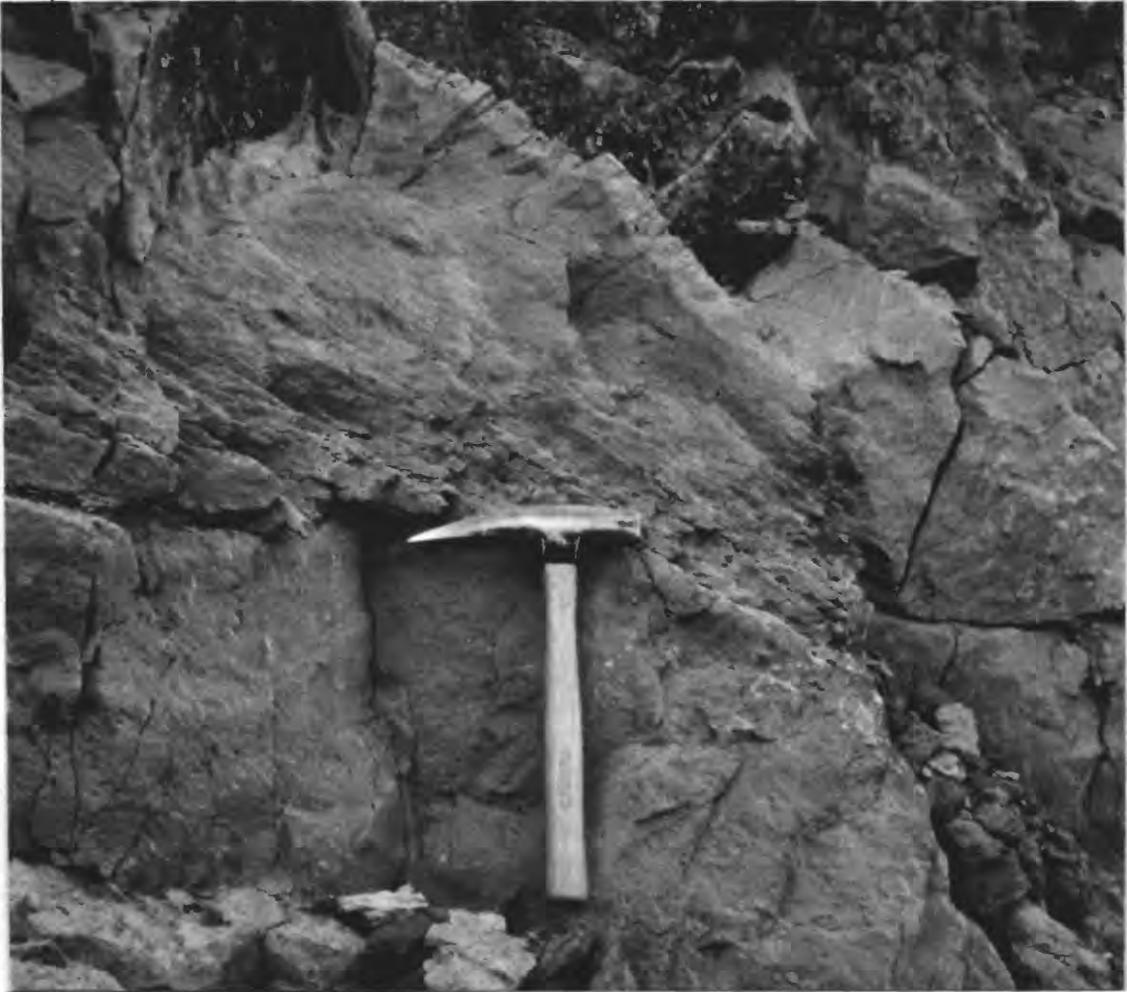
Figure 4.--Zone of closely spaced, short imbricate joints in unit 1 exposed along a haul road a short distance upstream from the right abutment. Hammer head is at the contact between the imbricate zone and underlying blocky welded tuff.

like the small imbricate joints in the platy zones of unit 1 (fig. 4) and many of the steep foliation joints in unit 2 (fig. 5). Voids along all three kinds of features are lined with coatings and replacements of silica and alkali feldspar that were deposited by gases escaping upward through the ash-flow sheet during compaction, cooling, and welding. The similar direction of dip of all three kinds of features and the presence of vapor-deposited coatings in voids along them suggest that they all probably formed at about the same time in response to tensional and shear stresses that developed during differential compaction and secondary flowage of the ash-flow sheet. These fissures and joints generally strike northwest, as do the axes of folds in the lower part of the sheet (fig. 7) in the vicinity of the damsite, and the predominantly northeast dips suggest that the upper part of the sheet may have slid northeastward over the lower part as a result of secondary flowage that may have been caused by differential compaction of the ash-flow sheet over irregular topography.

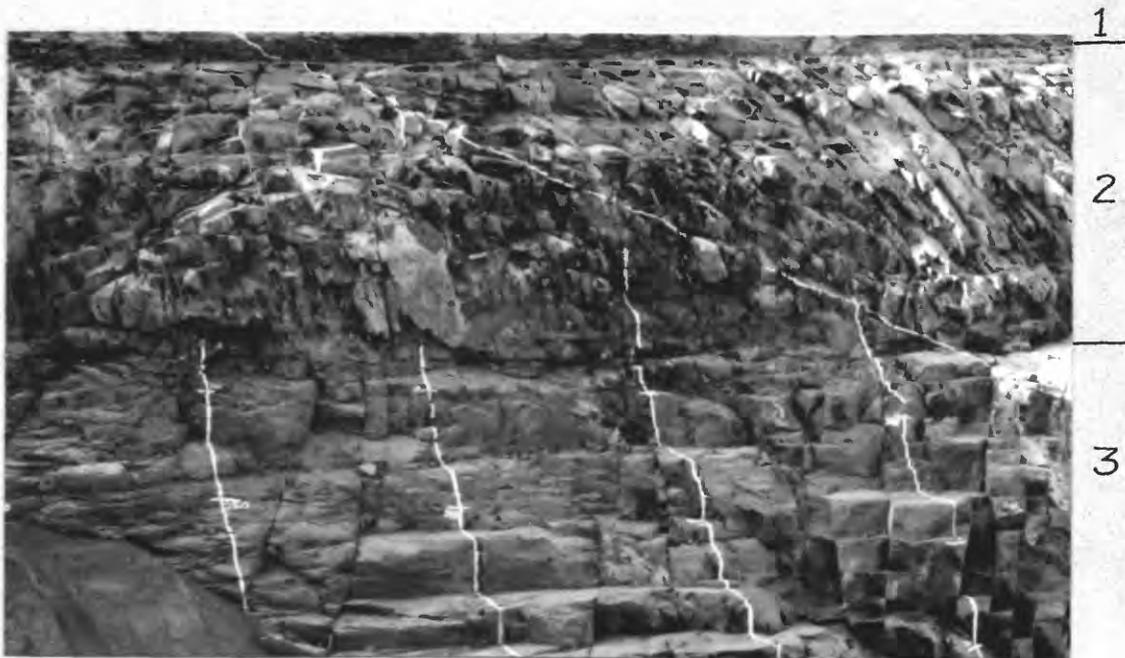
In addition to the steep joints there are many low to moderately dipping joints, many of which are curved and which define a broad archlike structure in unit 2 (fig. 5). The origin of these curved joints is not clear and no explanation for them is offered here.

Figure 5.--Right abutment just upstream from key trench, showing subhorizontal platy joints of unit 1, archlike form of curved joints superimposed on steep foliation and related joints dipping to the right (north-northeast) in unit 2 (see also fig. 3), and widely spaced joints in unit 3. Prominent white lines are engineering reference lines painted on the rocks. The parallel lines are at 50-foot intervals upstream from the dam centerline.

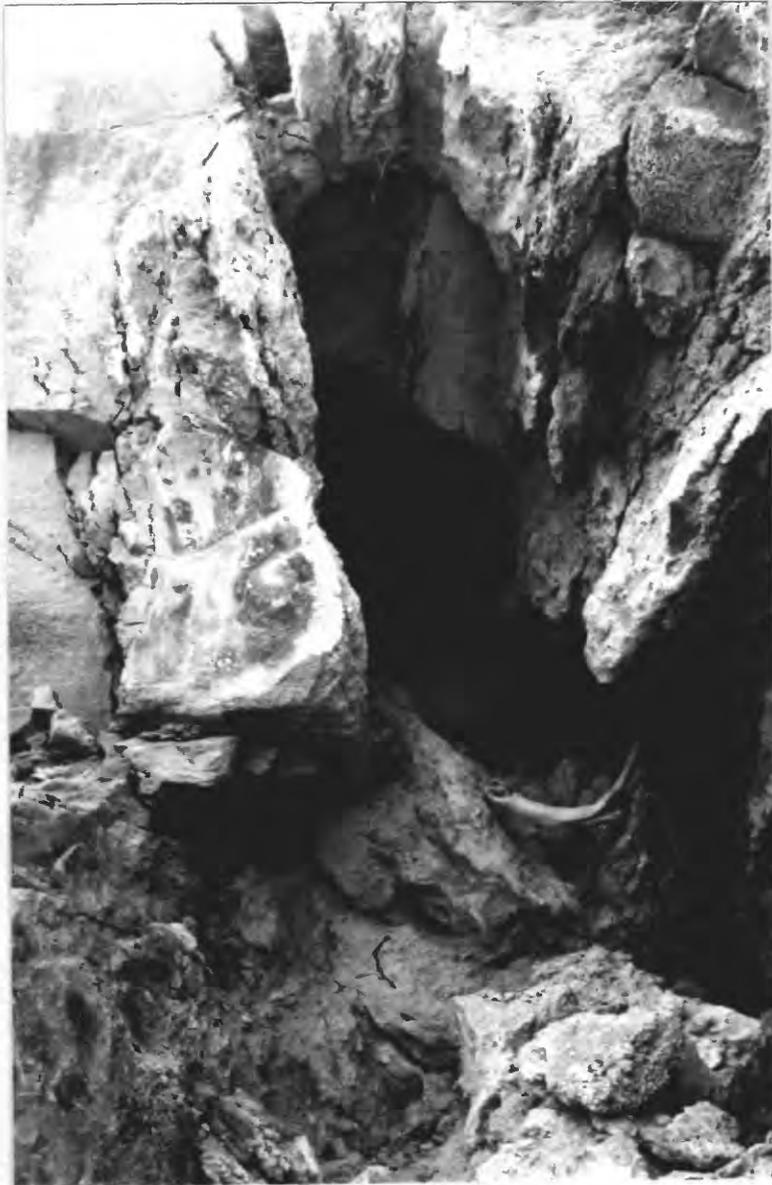
Steeply dipping fissures of lenticular to highly irregular shape, a few inches to several feet in length (fig. 6), are rare but are present in a few places in unit 1. These fissures generally dip northeastward

Figure 6.-- Steeply dipping irregularly shaped fissure about 2 feet wide that probably formed as a viscous pull-apart structure during secondary flowage of the rhyolite. Note small steeply dipping tension cracks along the left side of the large void. This fissure is exposed in unit 1 along a haul road a short distance upstream from the right abutment.

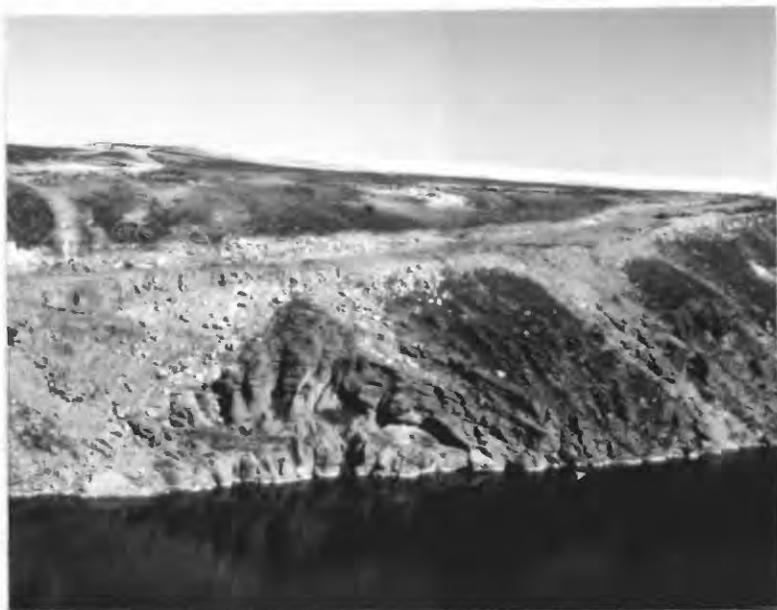
Figure 7.--Fold in lower part of ash-flow sheet exposed in right canyon wall less than 1/2 mile upstream from the dam. The axis of this fold is about in line with the arching of foliation over a pre-rhyolite topographic high exposed in the left side of the canyon just upstream from the intake tower.

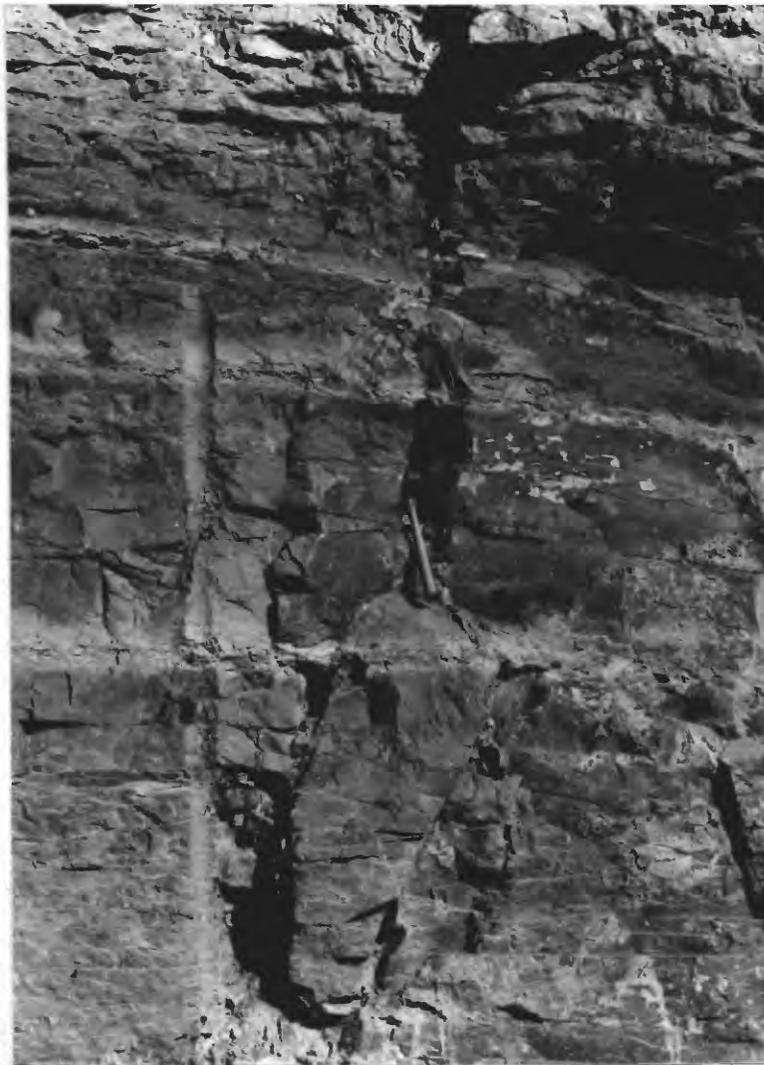
Figure 8.--Large vertical fissure apparently offset along several low-angle joints in unit 3.

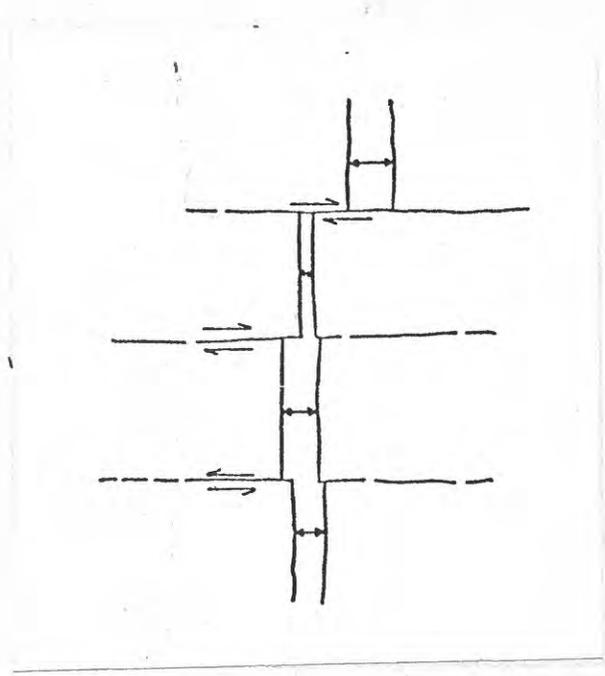
Figure 9.--Diagram of vertical fissure; horizontal offsets show how differential separation (\leftrightarrow) along a vertical joint is accommodated by slippage (\rightleftharpoons) along low-angle joints in rhyolite at damsite.

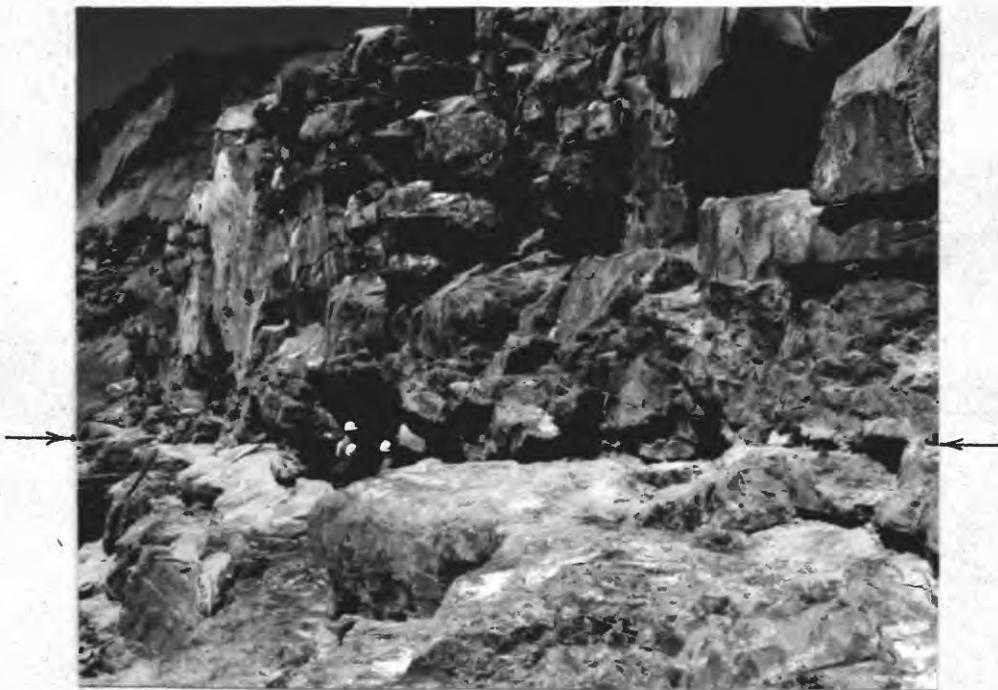
Figure 10.--View of prominent contact between unit 2 and unit 3 just upstream from embankment remnant. Arrows indicate location of contact.

Because the breccia fragments are all sharply angular and devoid of vapor-deposited coatings, the breccia must have formed when the rhyolite was relatively cold and brittle, sometime later than the episode of secondary flowage. Deposits of calcite on and between breccia fragments are not brecciated or fractured, indicating that no additional displacement has occurred along this zone since it was formed.
