UNITED STATES DEPARTMENT OF THE INTERIOR
GEOLOGICAL SURVEY

STUDY RESULTS OF 9 SITES
USED BY OFF-ROAD VEHICLES THAT ILLUSTRATE
LAND MODIFICATIONS

Open-file report

77-601

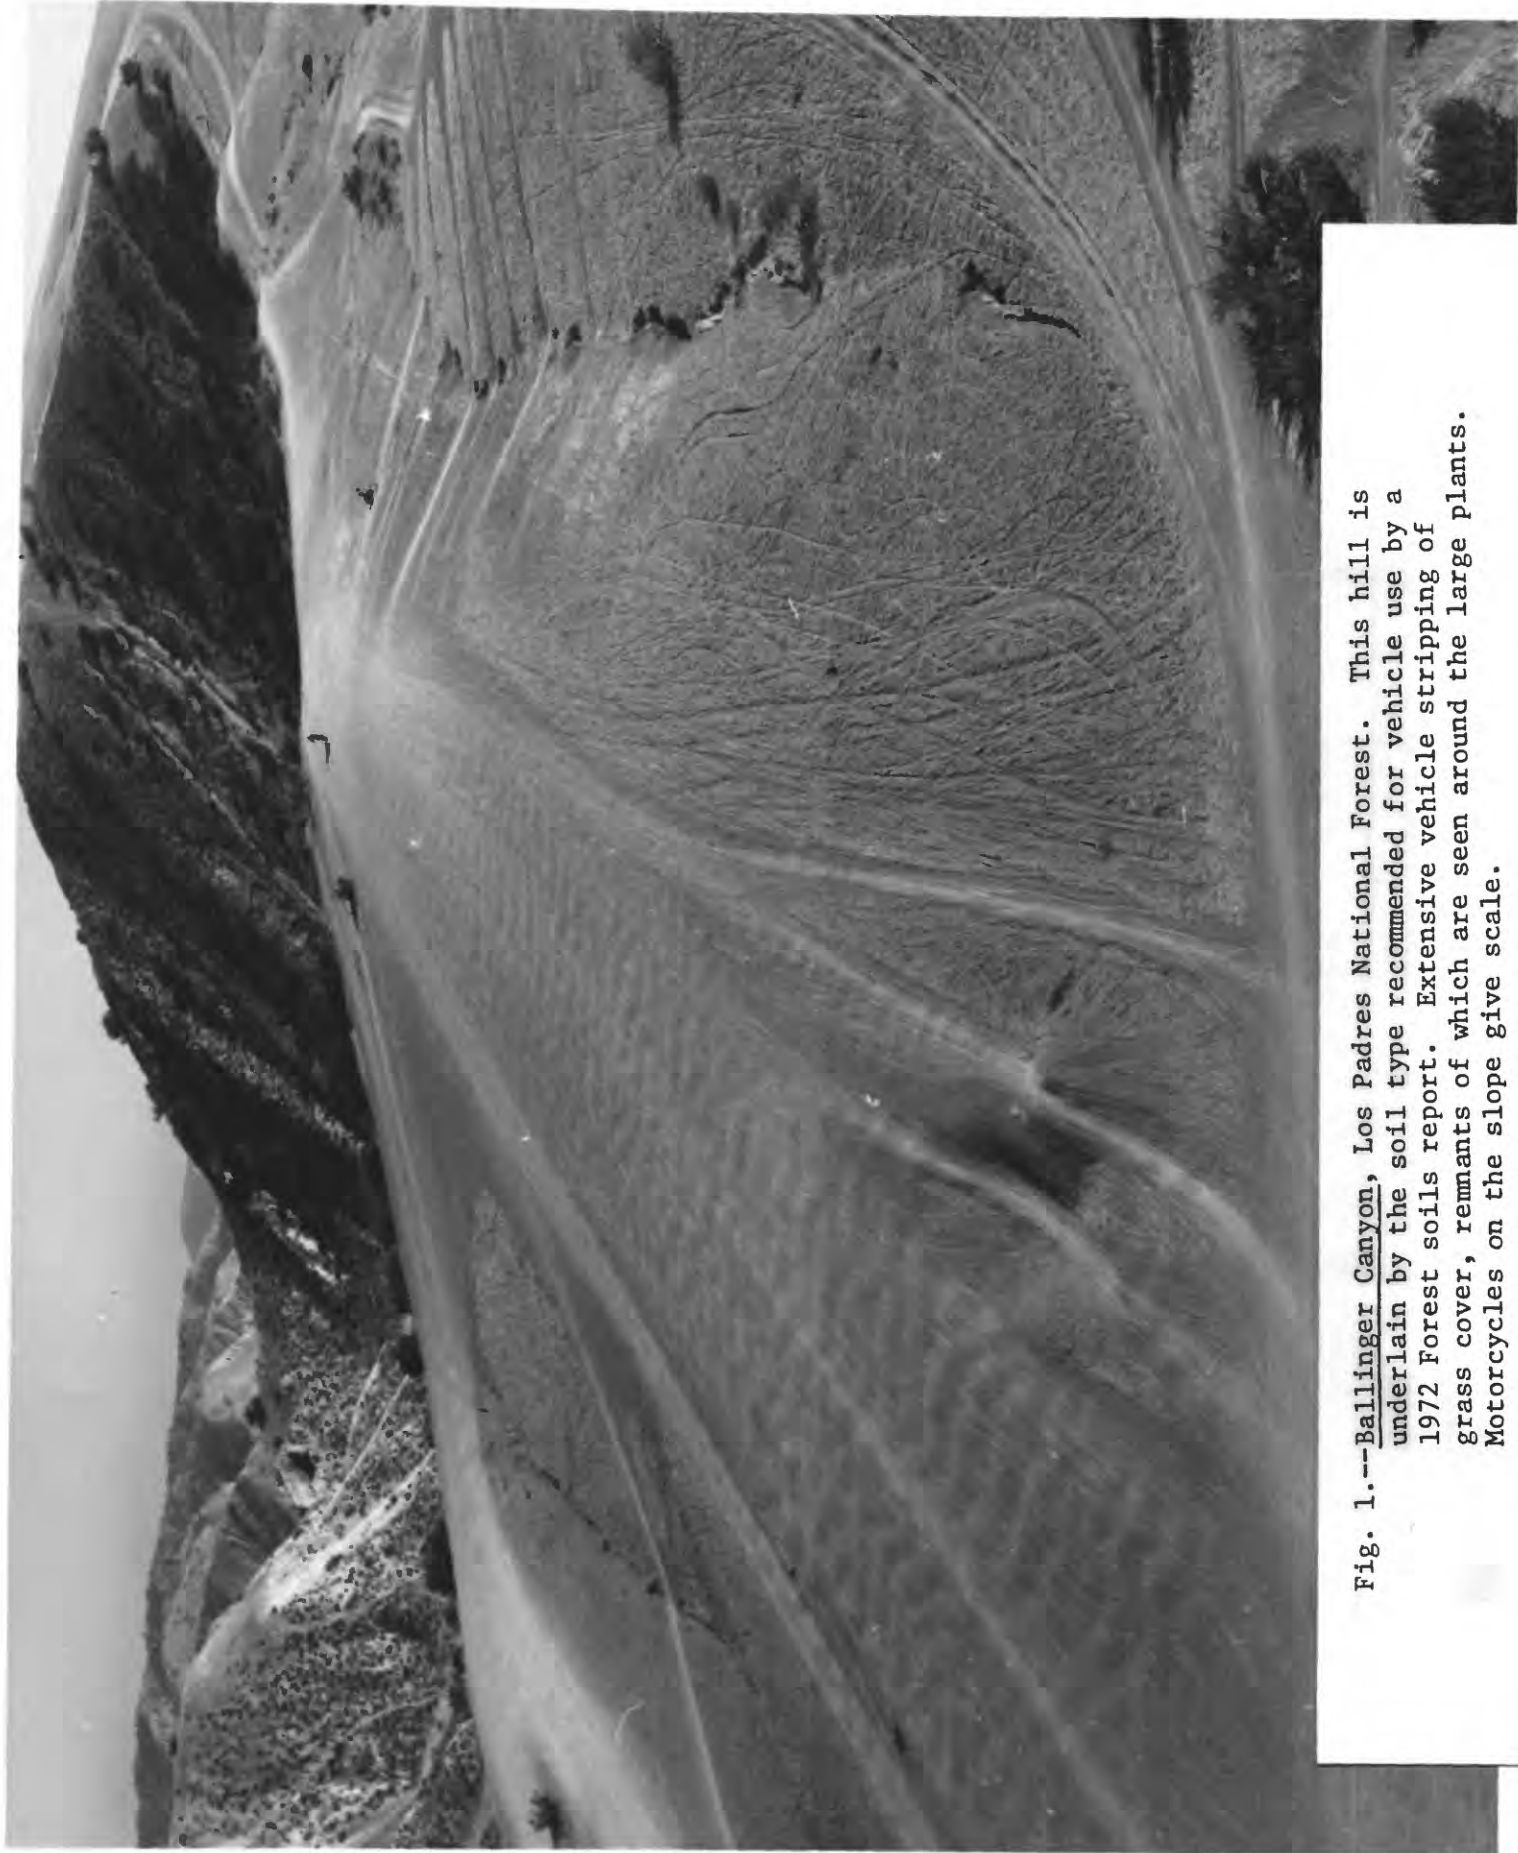
Grass cover is destroyed by a single traverse by a motorcycle, and large areas have been stripped (Fig. 1). Junipers growing on steep slopes are vulnerable to direct vehicle impact and to secondary effects

Fig. 1.--Ballinger Canyon, Los Padres National Forest. This hill is underlain by the soil type recommended for vehicle use by a 1972 Forest soils report. Extensive vehicle stripping of grass cover, remnants of which are seen around the large plants. Motorcycles on the slope give scale.

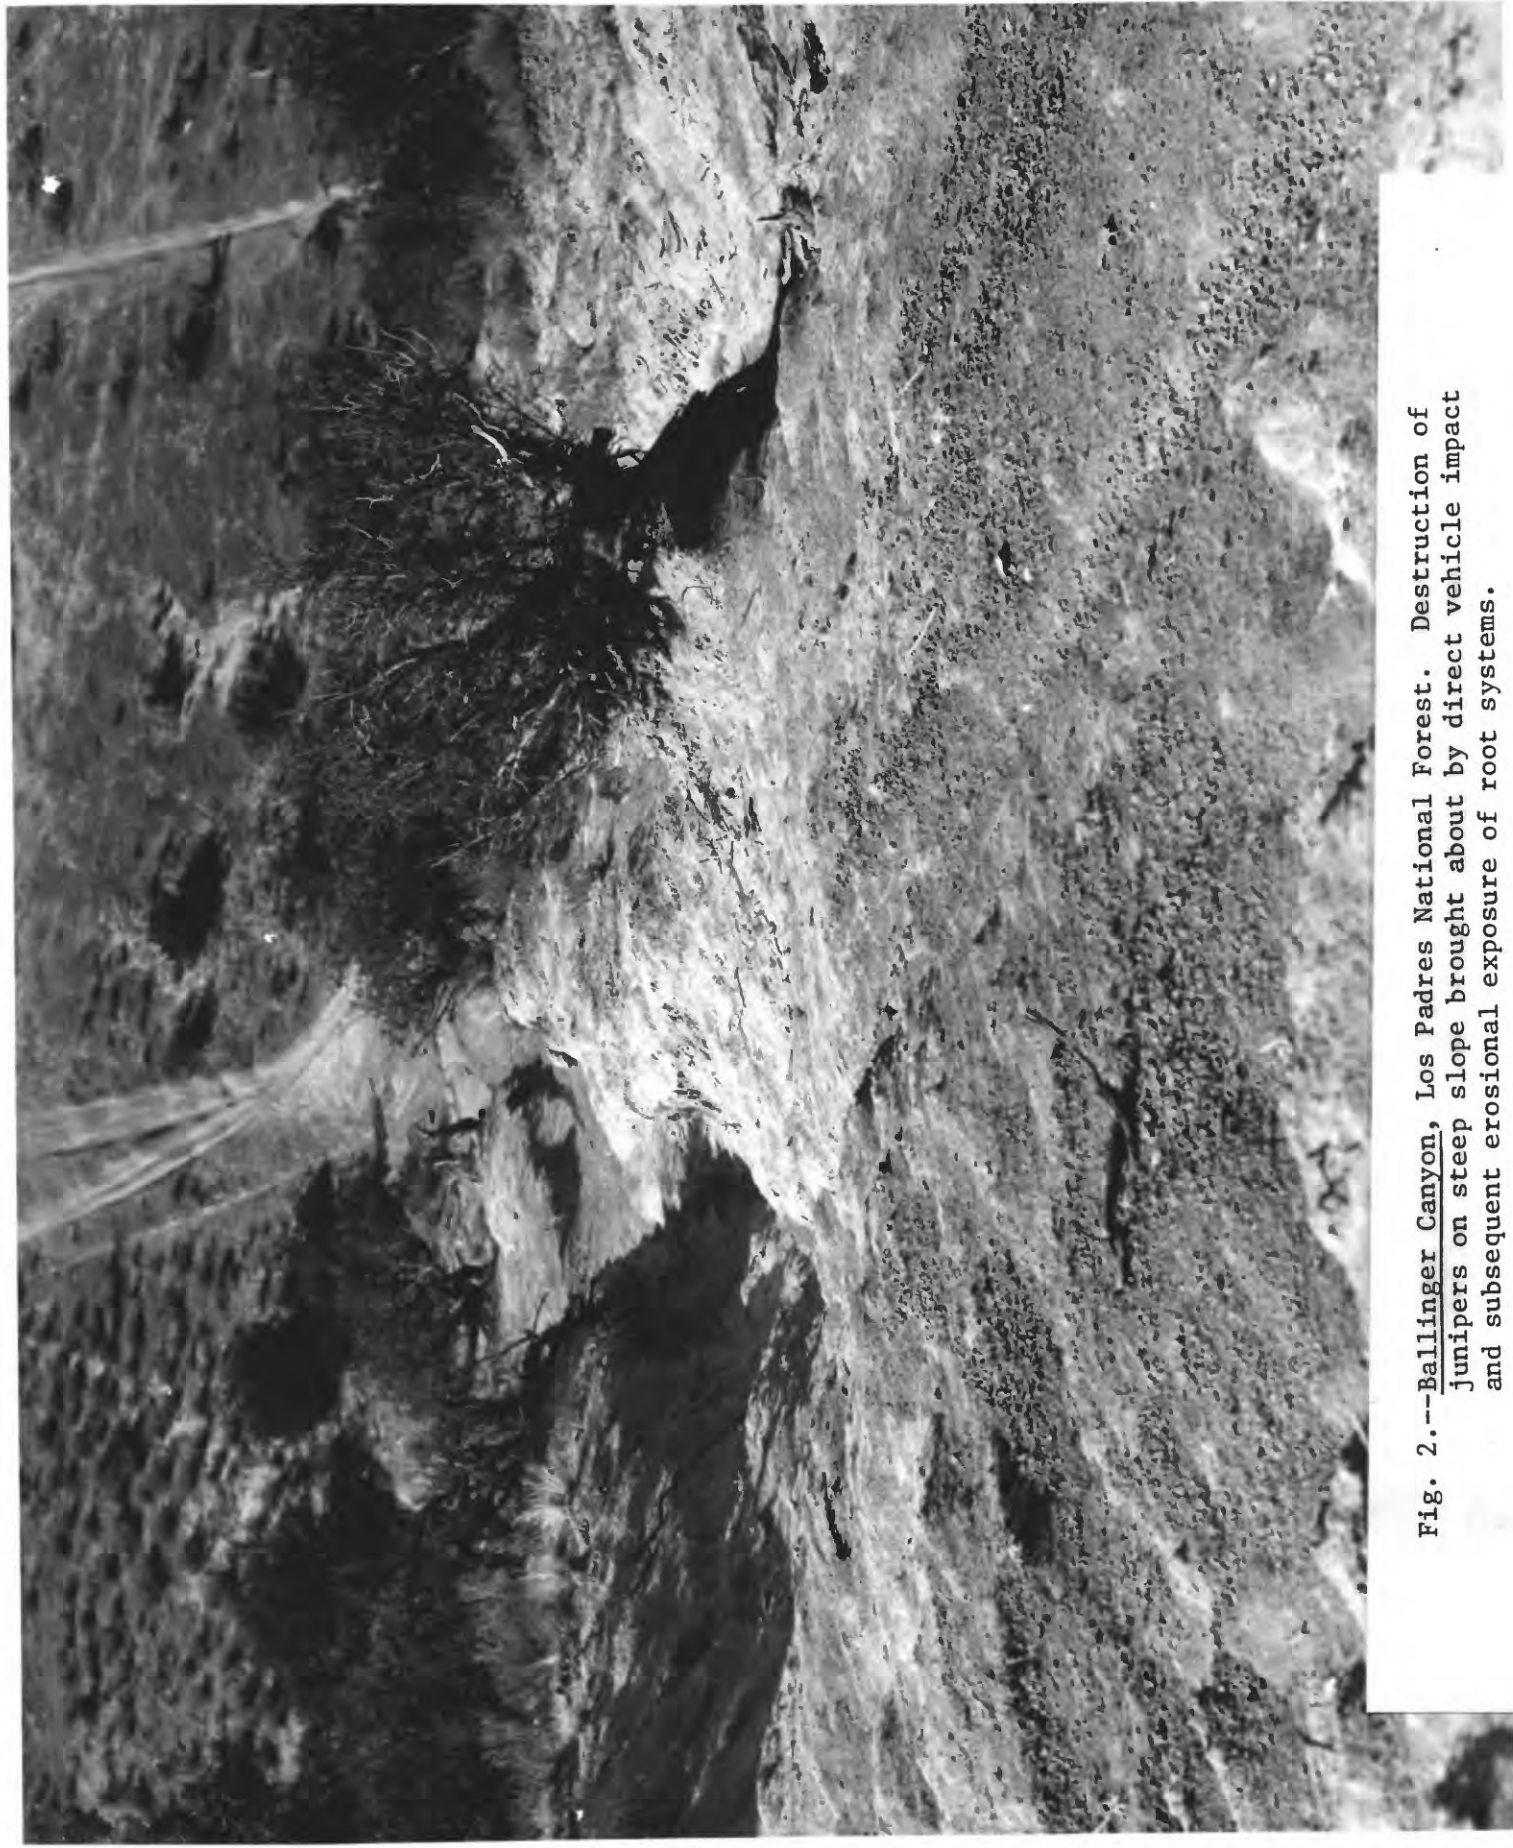
of erosion brought about by vehicle use (Fig. 2). Smaller shrubs are destroyed by multiple vehicle impacts. Impacts on wildlife have not been examined, but this canyon is habitat for an endangered species of lizard and a hybrid form of that species (U.S. Forest Service, 1976).

Fig. 2.--Ballinger Canyon, Los Padres National Forest. Destruction of junipers on steep slope brought about by direct vehicle impact and subsequent erosional exposure of root systems.

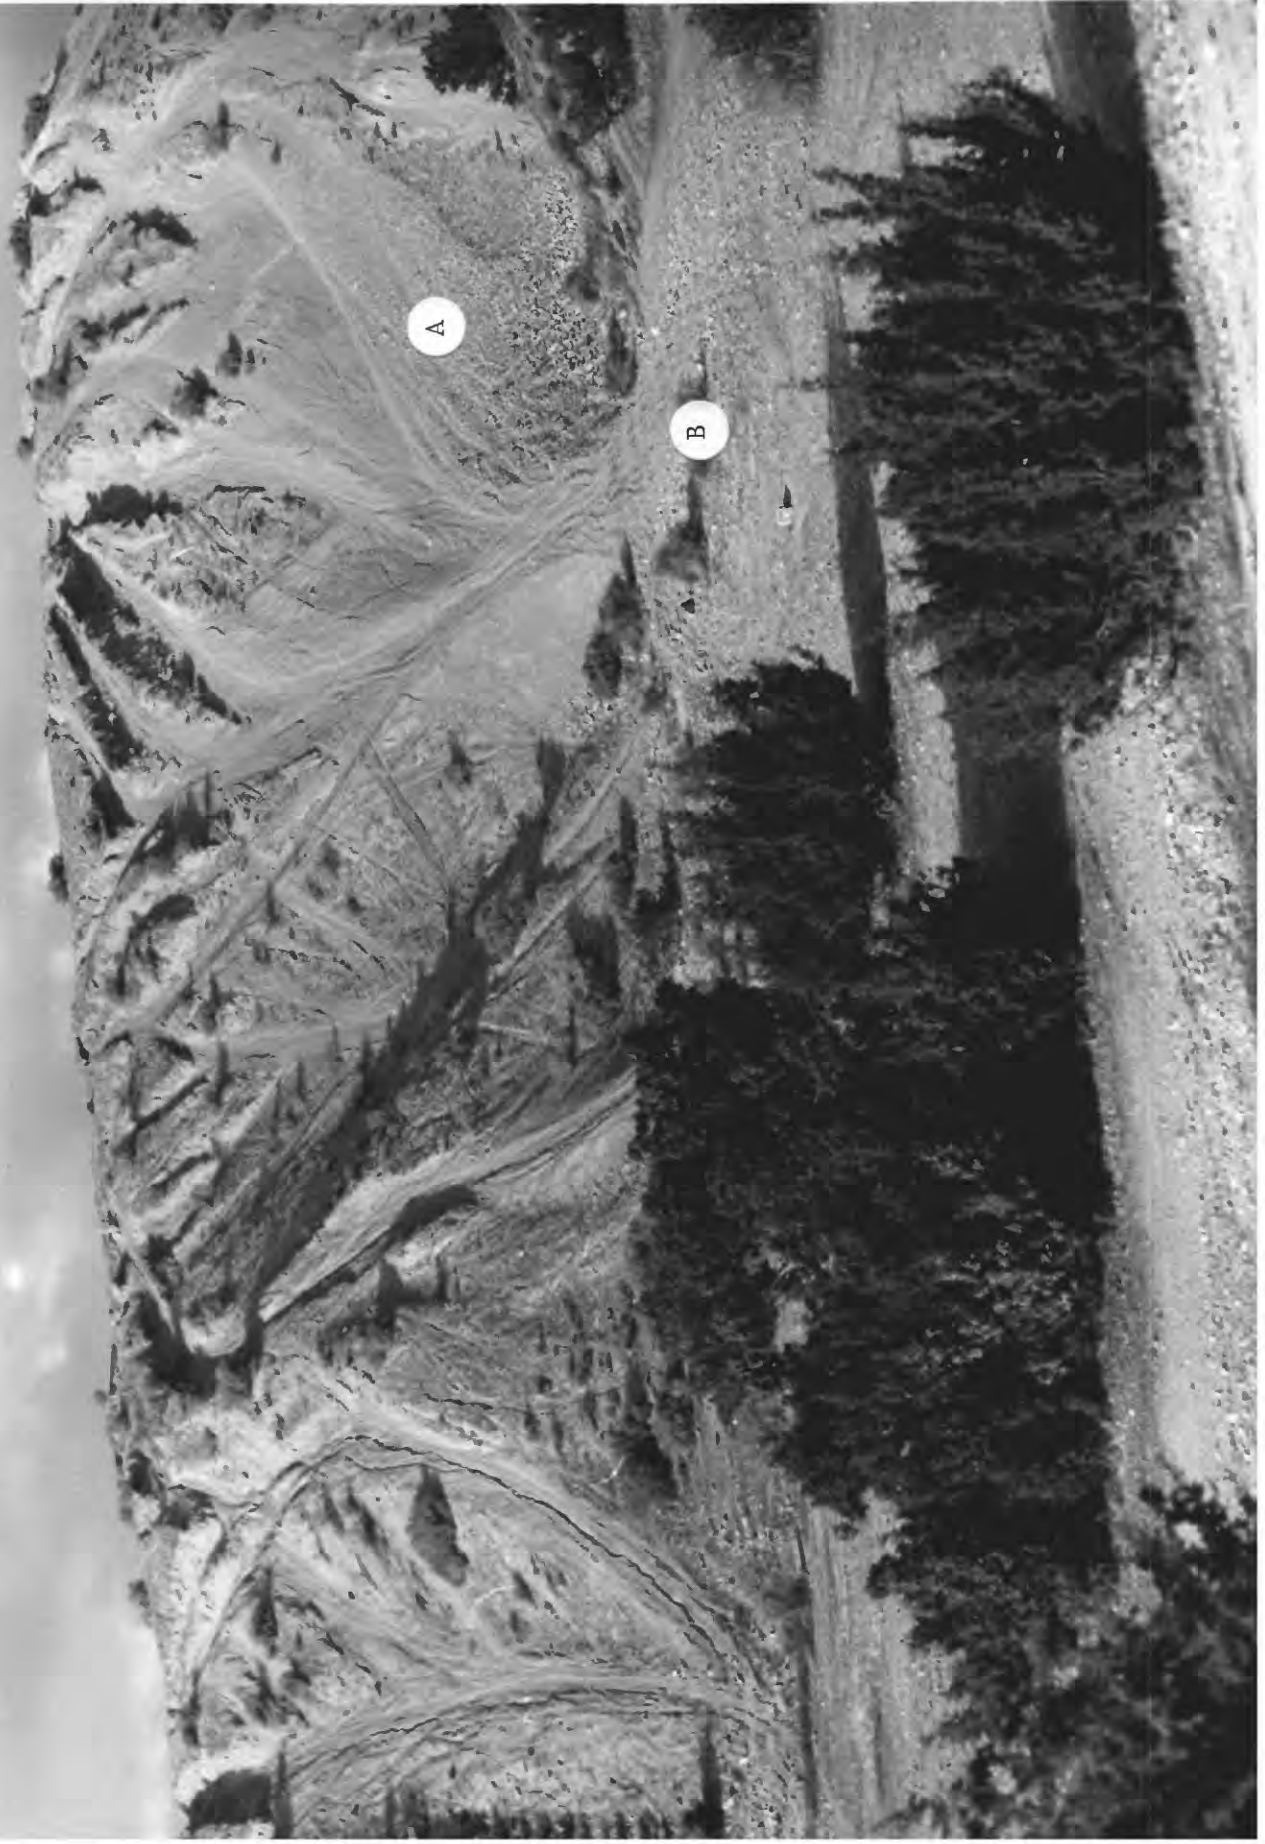
Fig. 4.--Ballinger Canyon, Los Padres National Forest. Steep slope underlain by the soil type recommended for vehicle use by a 1972 Forest soils report. The deep notches, which extend into bedrock, were cut dominantly by direct vehicular erosion.

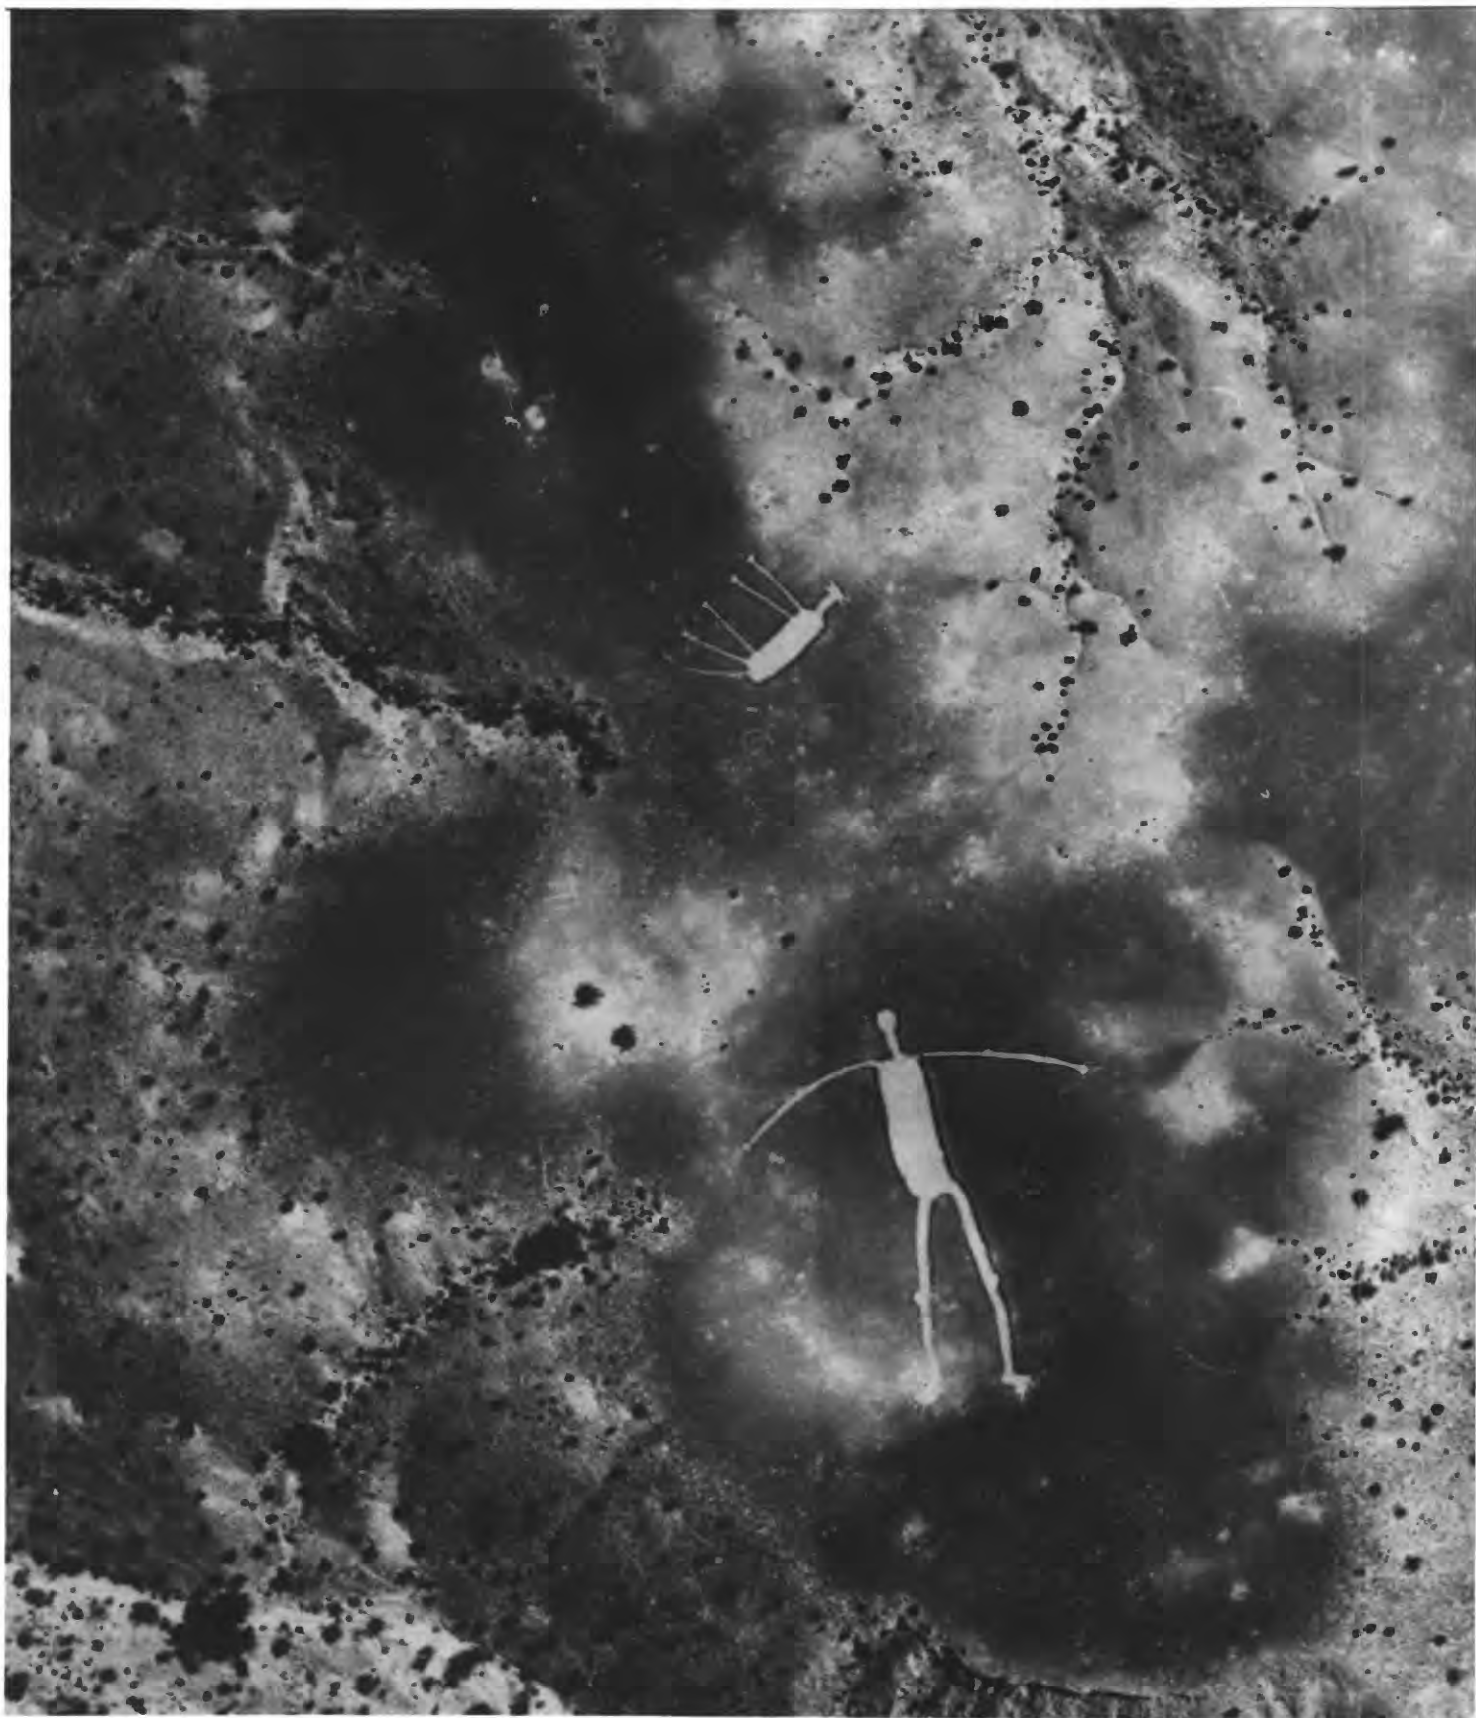
The intaglios near Blythe, California are a valuable archaeological resource that has suffered significant vehicle degradation (Figs. 6,7). The figures were constructed simply by scraping aside a layer of dark pebbles at the surface exposing lighter material beneath. Motorcycles have damaged at least one figure, either before protective fencing was erected, or by gaining access through a gate in the fence. Two efforts were made by 4-wheel vehicles to break down the fence around one of the figures. In the Yuha Desert, protective fencing around an intaglio was cut and the figure destroyed by motorcycles (Los Angeles Times, August 6, 1975).

Fig. 7.--Blythe, California. 1975 photograph of intaglios showing extensive vehicle damage (there are three sets of intaglios in the immediate area; this is not the same set as shown in Fig. 4, but all three sets have suffered similar degradation).

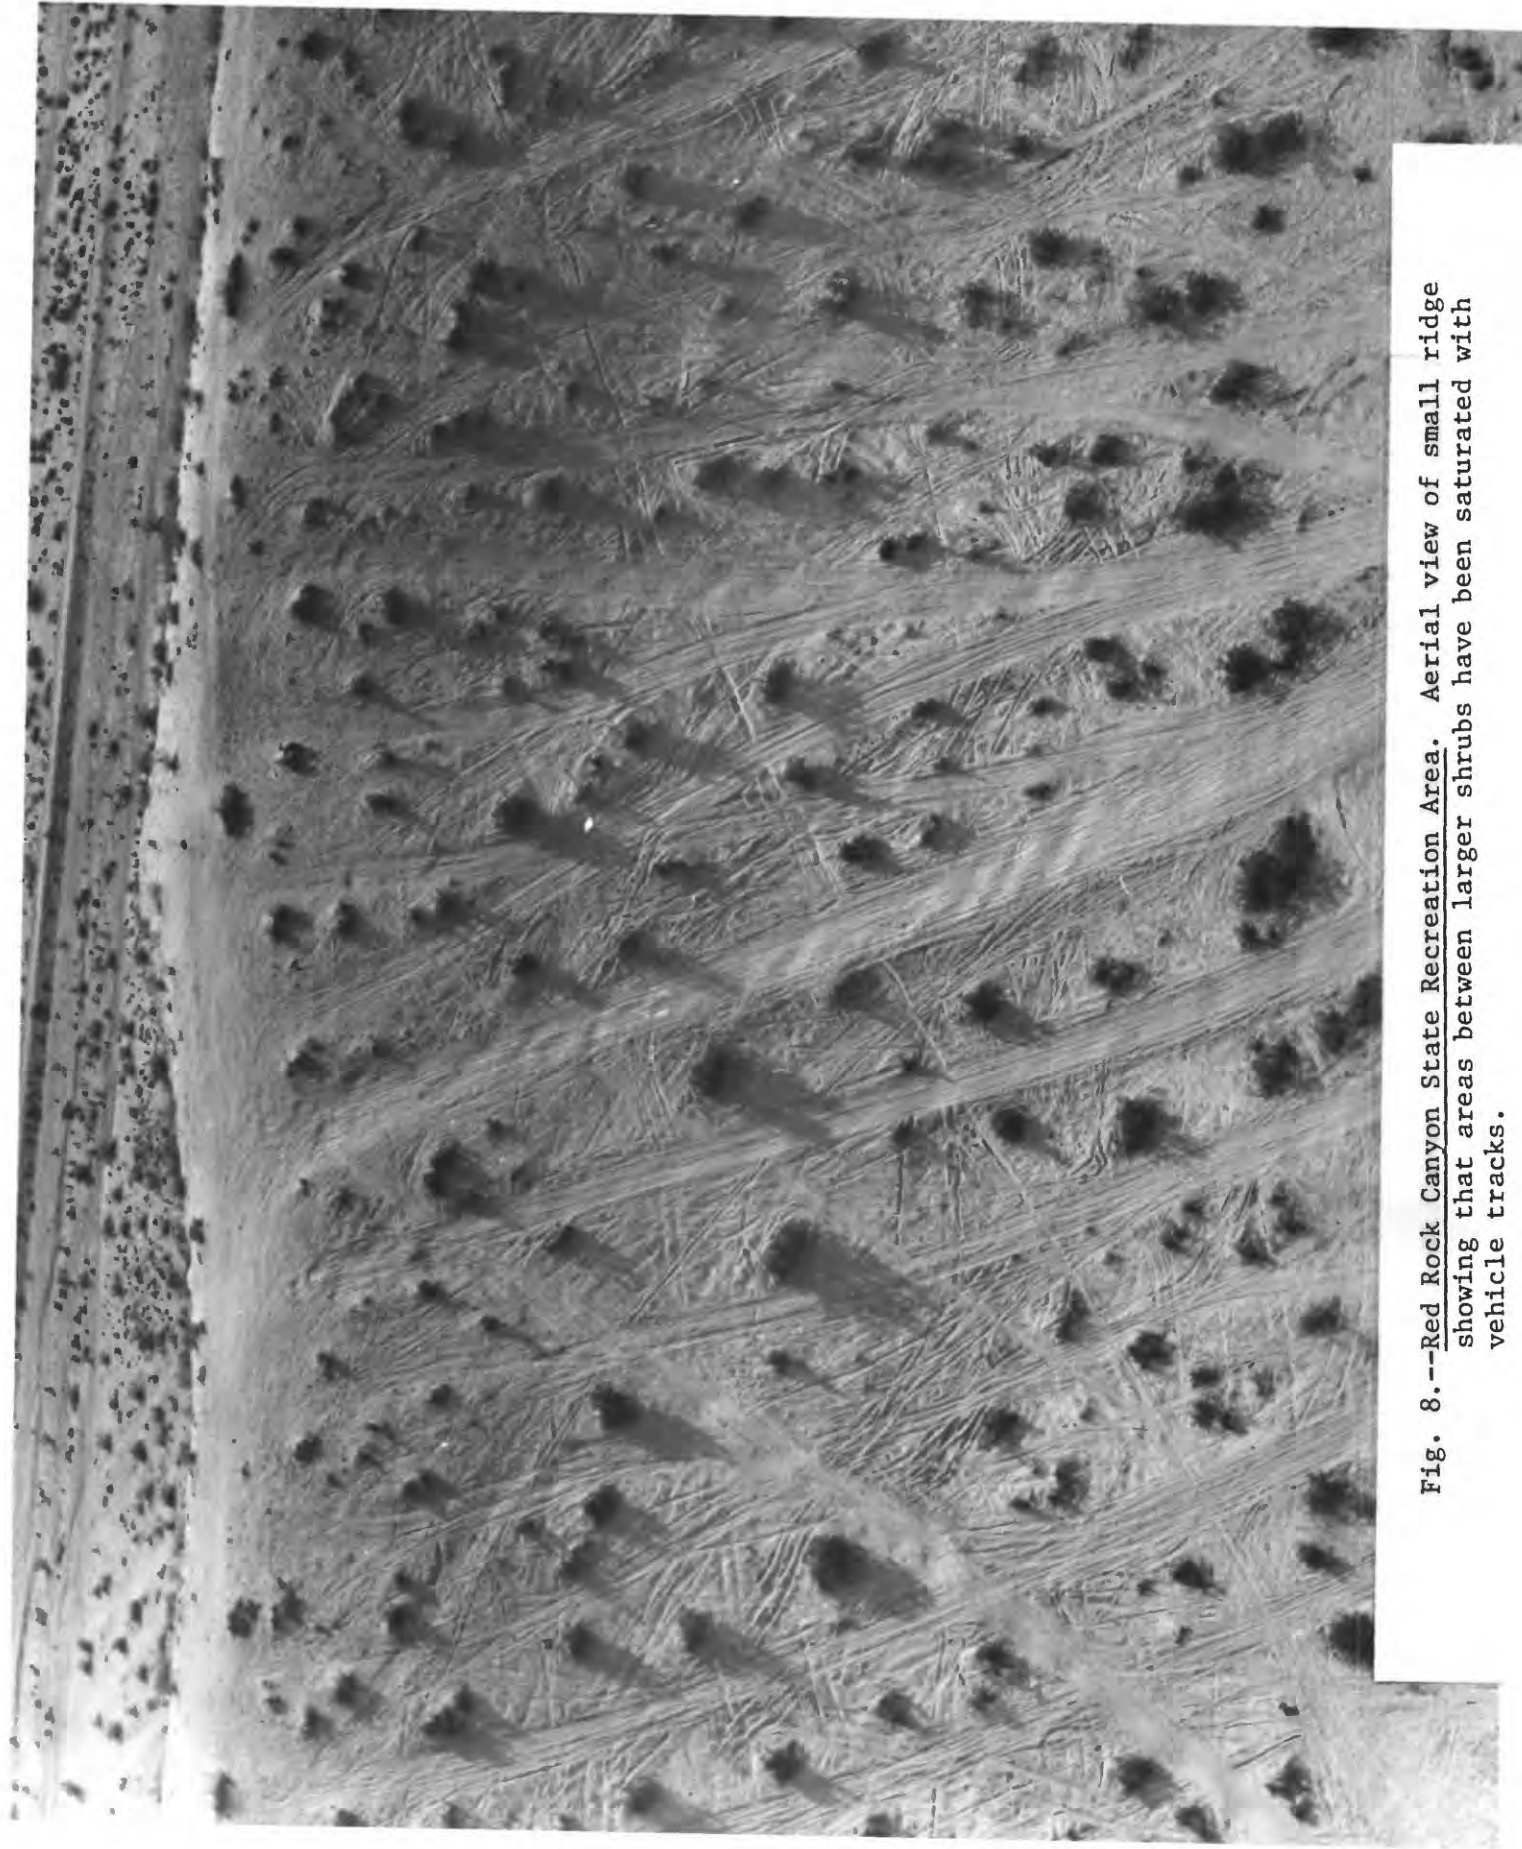
Intensive vehicle use has destroyed all but the larger shrubs on most of the hill (Fig. 8; Table 1). Small plants were extensively destroyed, and the larger creosote shrubs underwent progressive degradation by direct vehicle impact, by erosional exposure of root systems of plants on the steeper slopes, and by burial by eroded debris on lower slopes.

Fig. 8.--Red Rock Canyon State Recreation Area. Aerial view of small ridge showing that areas between larger shrubs have been saturated with vehicle tracks.

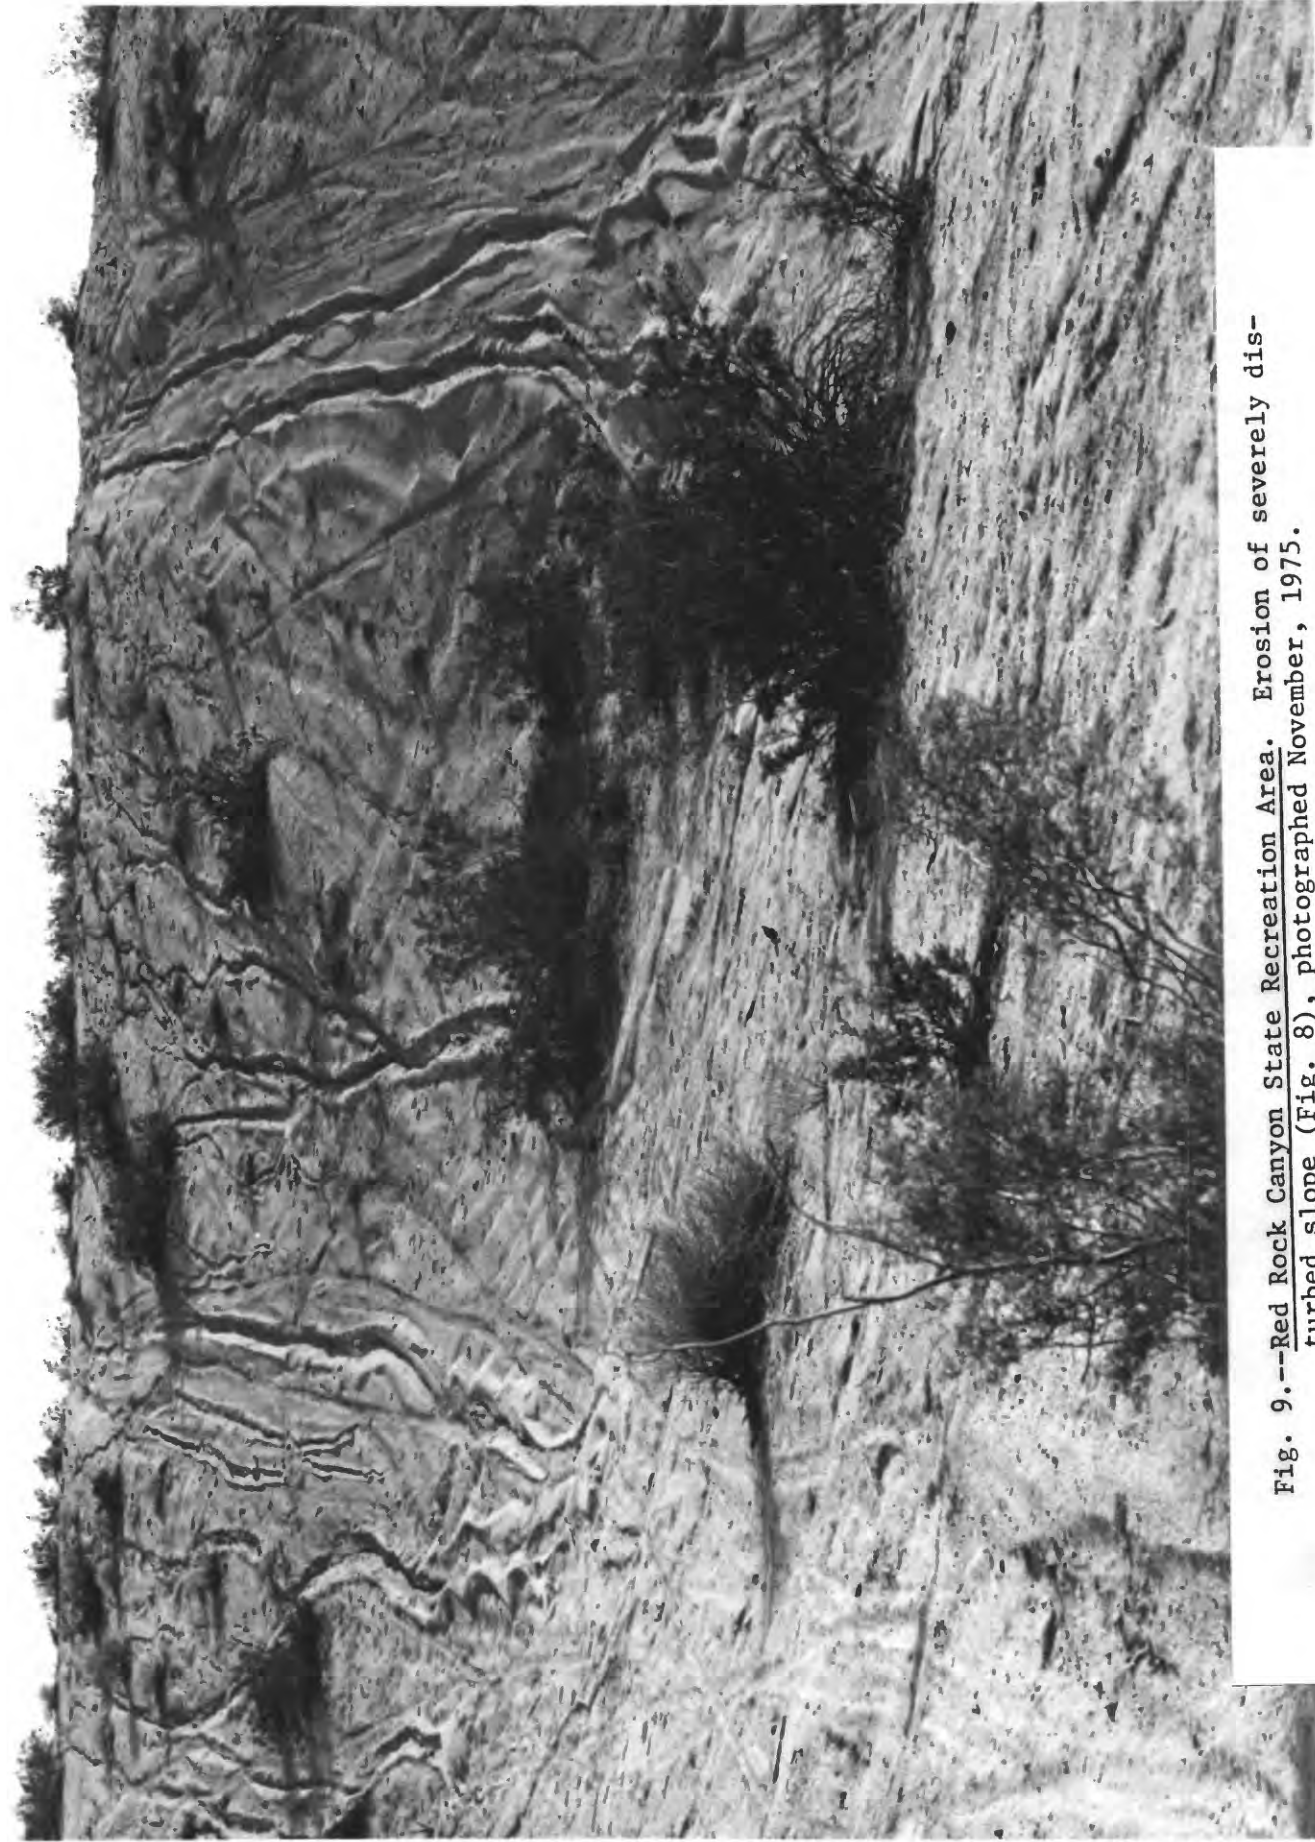
Fig. 9.--Red Rock Canyon State Recreation Area. Erosion of severely disturbed slope (Fig. 8), photographed November, 1975.

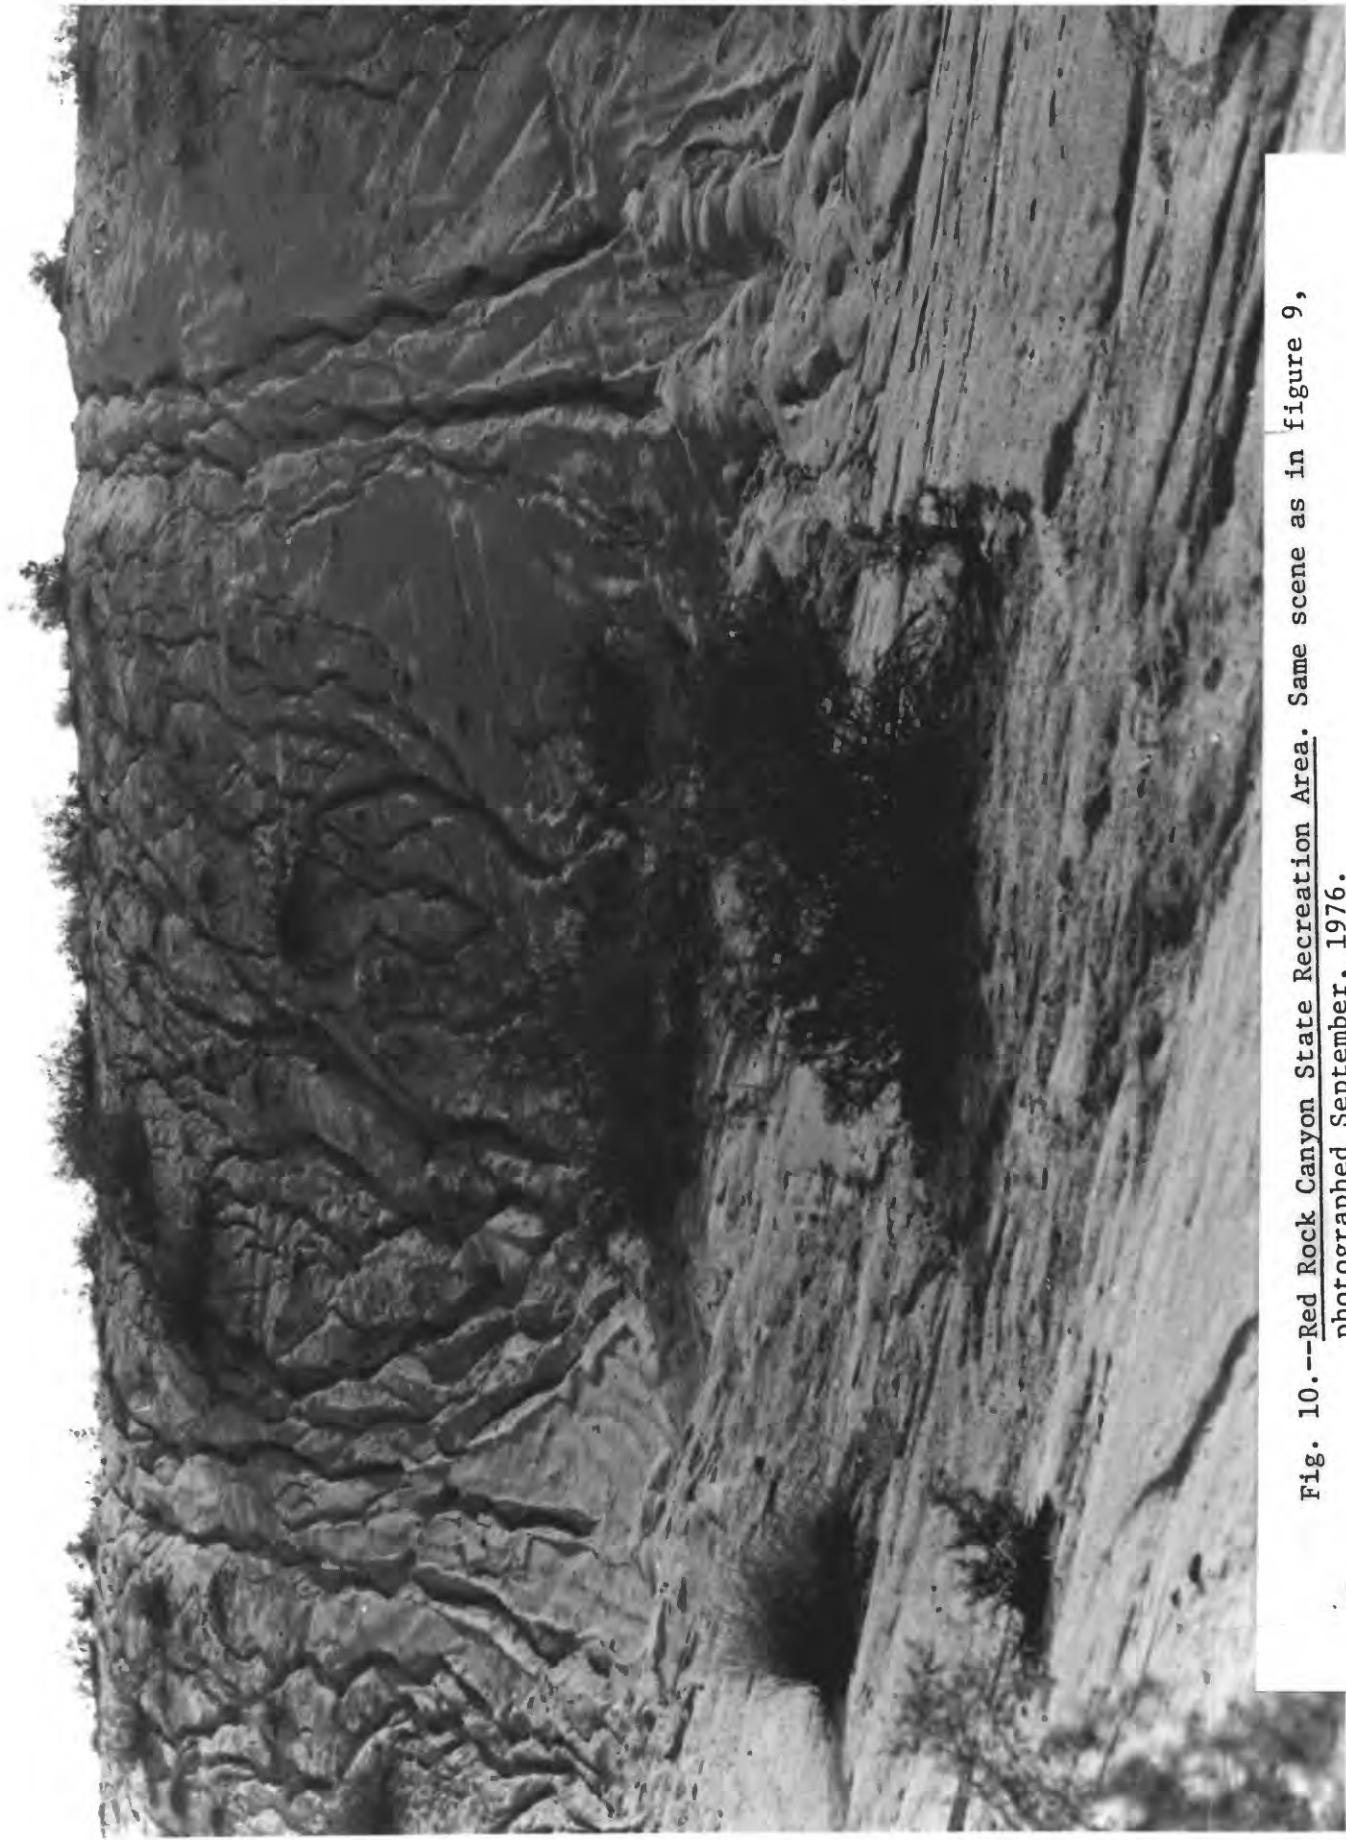
Fig. 10.--Red Rock Canyon State Recreation Area. Same scene as in figure 9,
photographed September, 1976.

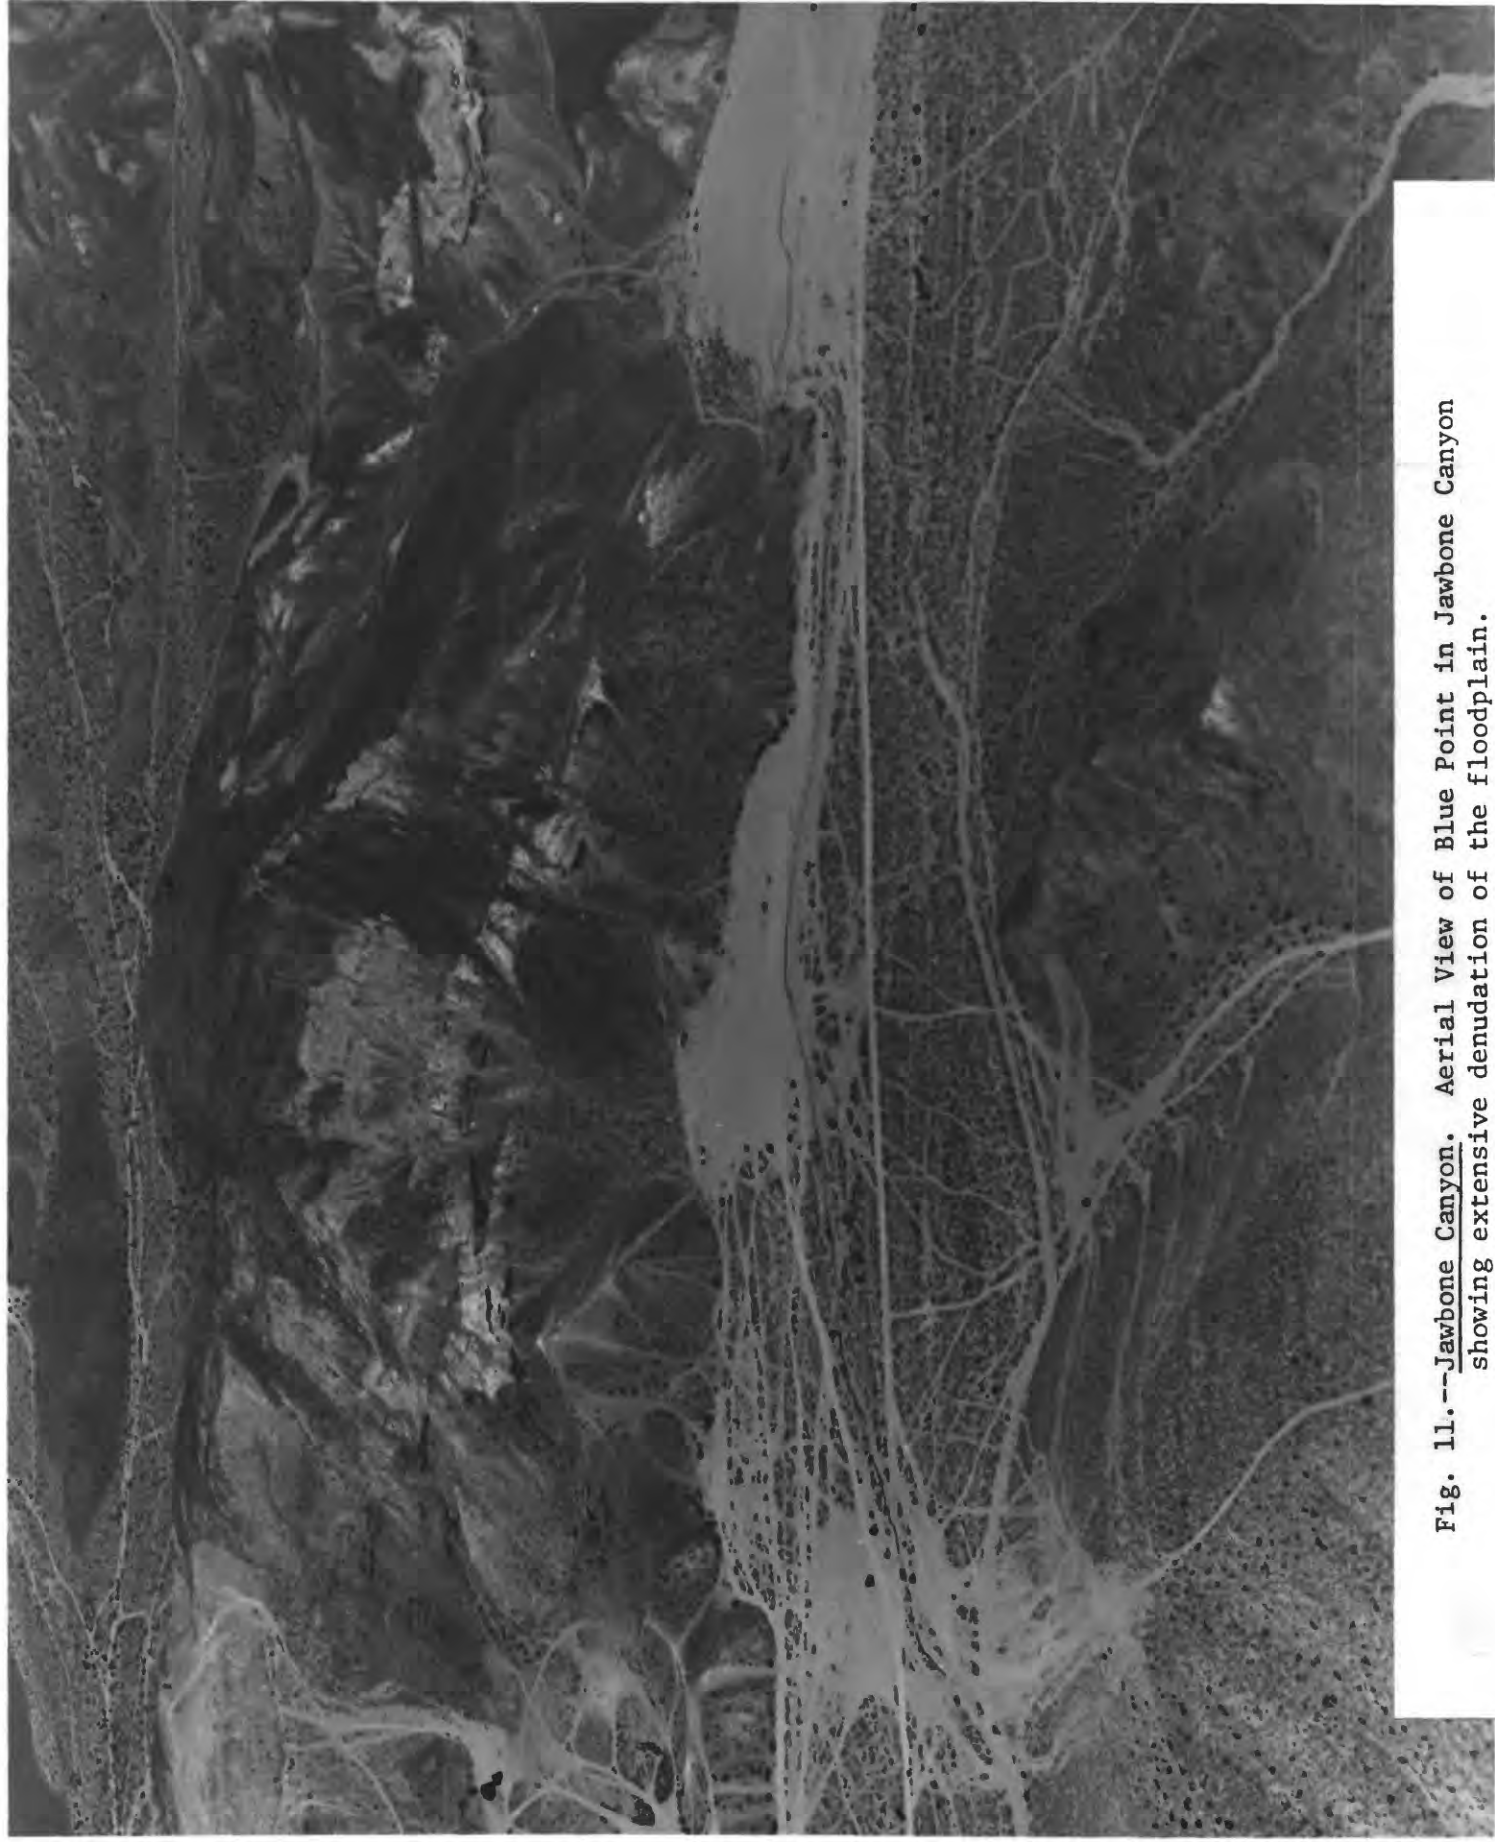
Intensive vehicle use has stripped all but the larger shrubs and joshua trees from large areas; some hillsides have been completely denuded, and floodplain habitat has been extensively degraded (Fig. 11). Surviving plants near intensive use zones are undergoing progressive degradation by wind and water erosion which expose the root systems (Fig. 12). Only modest root exposure of the shallow-rooted joshua trees makes them vulnerable to toppling by wind. Small plants undergo sand blasting by sand blown from the vehicle-disturbed areas. No studies have been published of the effects of habitat loss or direct vehicle impact on animal populations at the site.

Denudation of the floodplain (Fig. 11) as well as the hillsides acts to increase the frequency and magnitude of flooding, both in the canyon and downstream where highway hazards and threats of flood damage to crops have been exacerbated. This is a growing problem in other desert-facing canyons in the southern Sierra Nevada such as Dove Spring Canyon, Bird Spring Canyon, Horse Canyon, and Sage Canyon which are being progressively denuded by vehicle use.

Fig. 11.--Jawbone Canyon. Aerial View of Blue Point in Jawbone Canyon showing extensive denudation of the floodplain.
