UNITED STATES DEPARTMENT OF THE INTERIOR
GEOLOGICAL SURVEY

STUDY RESULTS OF 9 SITES
USED BY OFF-ROAD VEHICLES THAT ILLUSTRATE
LAND MODIFICATIONS

Open-file report

77-601

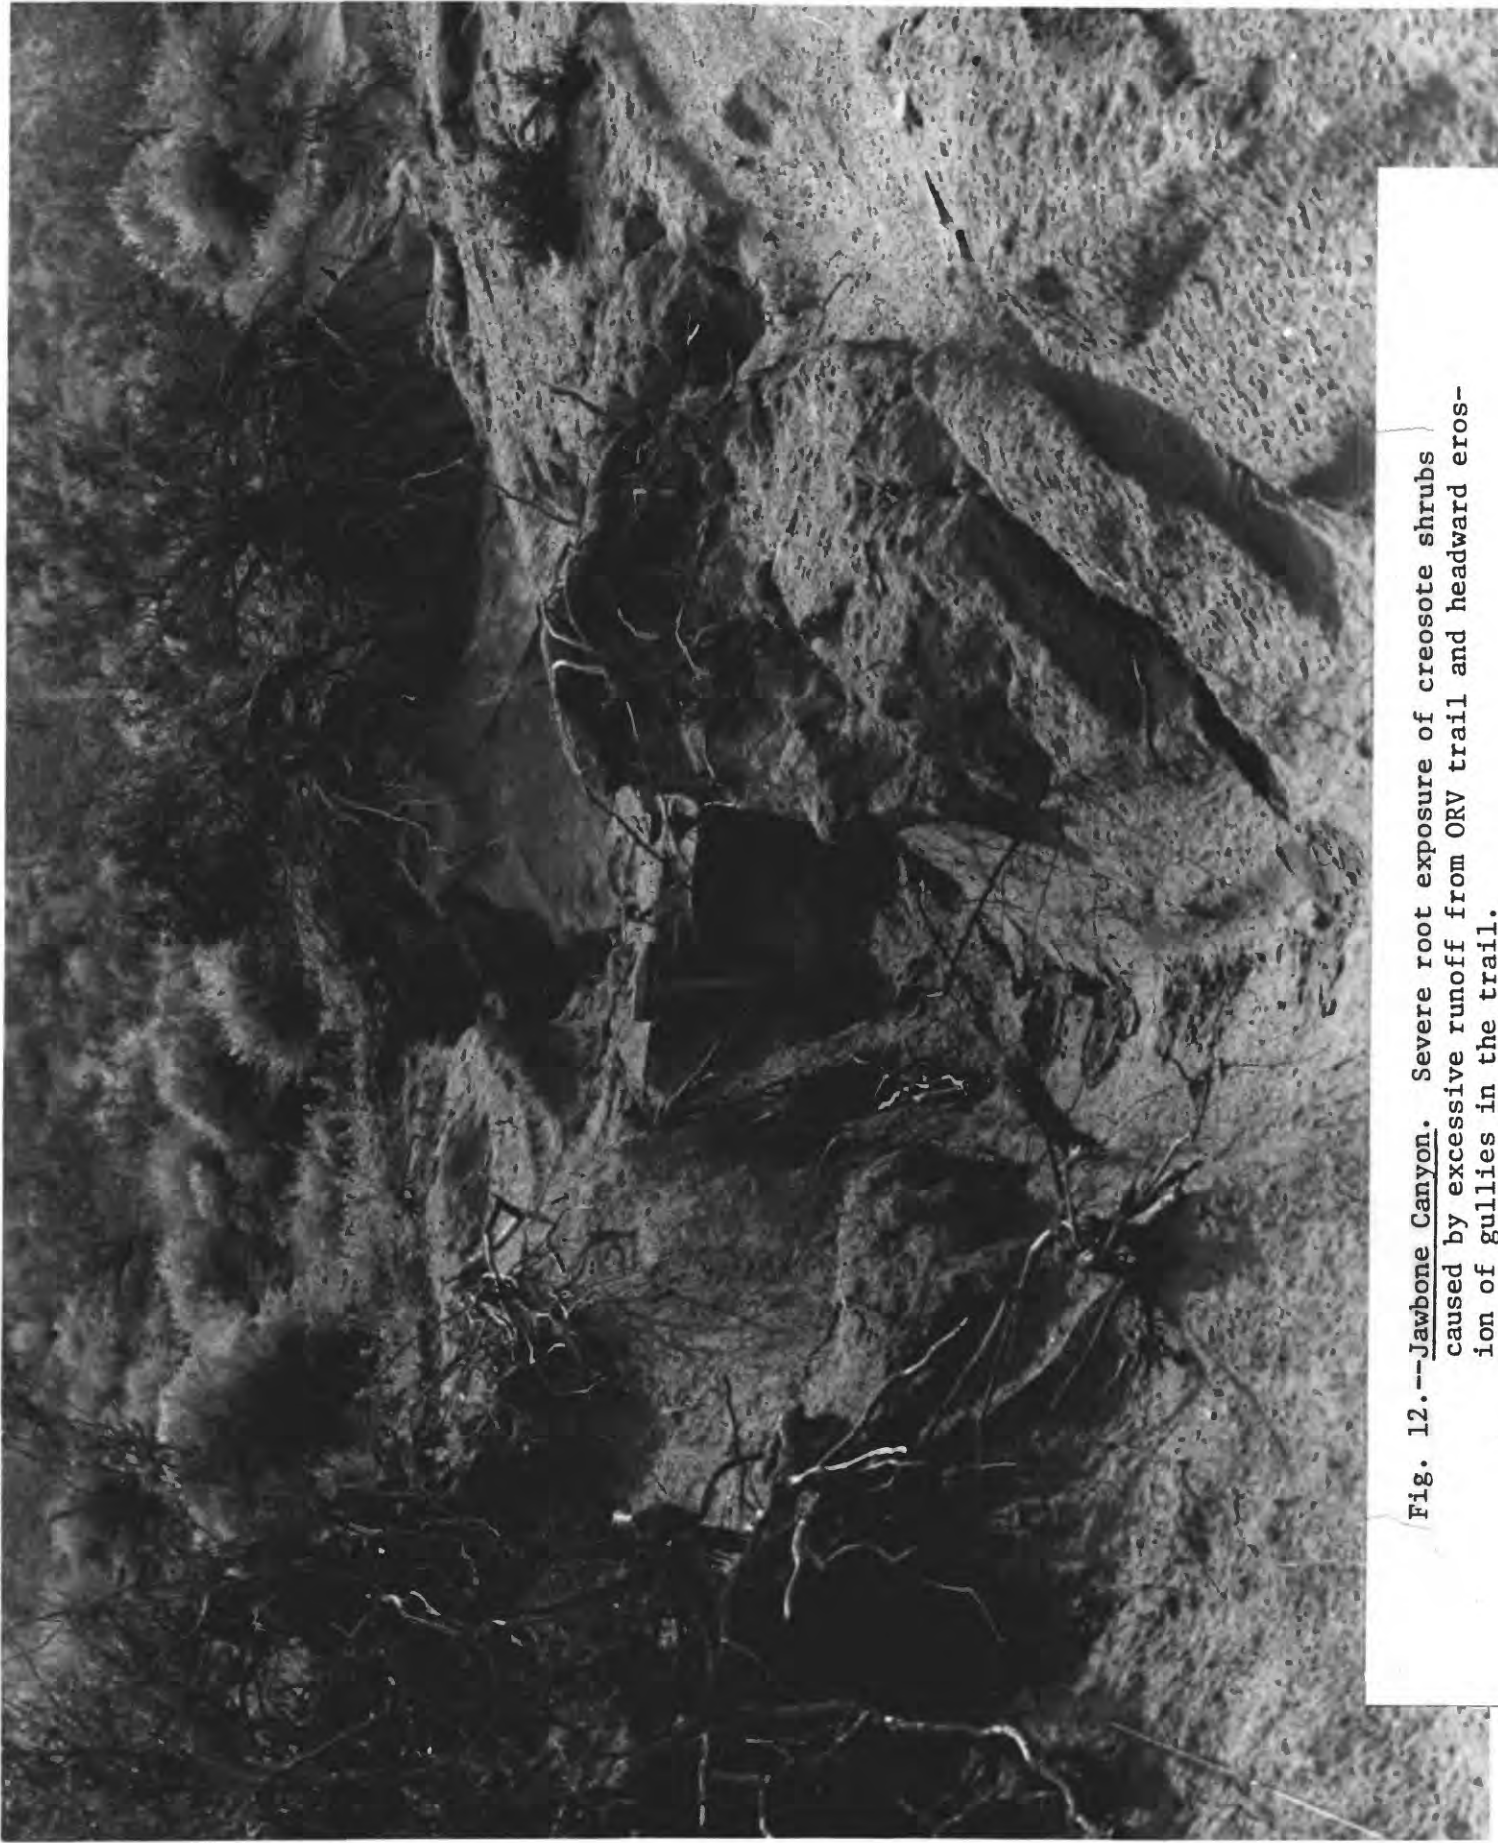
Fig. 12.--Jawbone Canyon. Severe root exposure of creosote shrubs caused by excessive runoff from ORV trail and headward erosion of gullies in the trail.

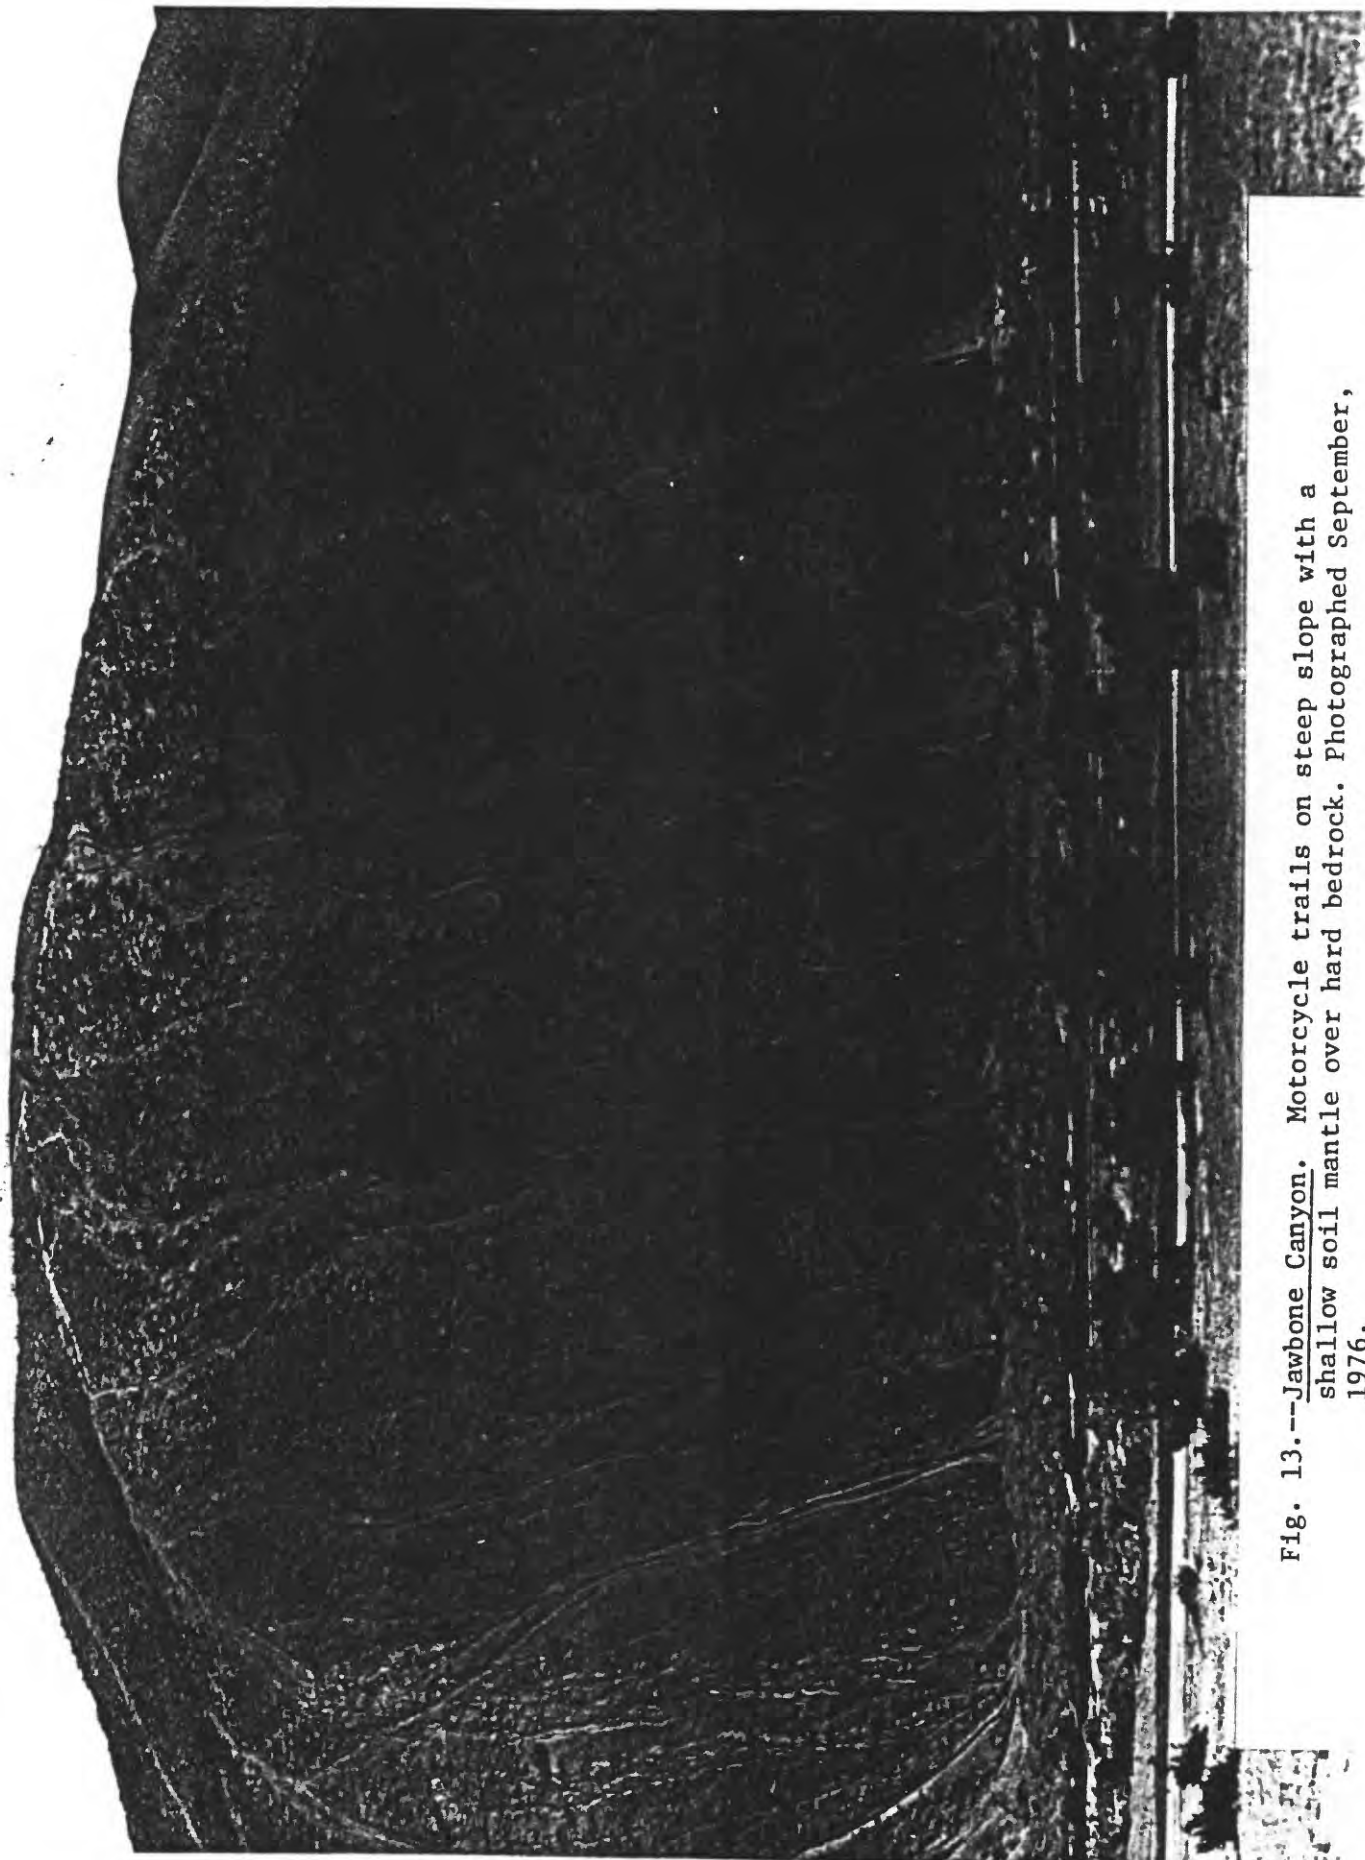
Fig. 13.--Jawbone Canyon. Motorcycle trails on steep slope with a shallow soil mantle over hard bedrock. Photographed September, 1976.

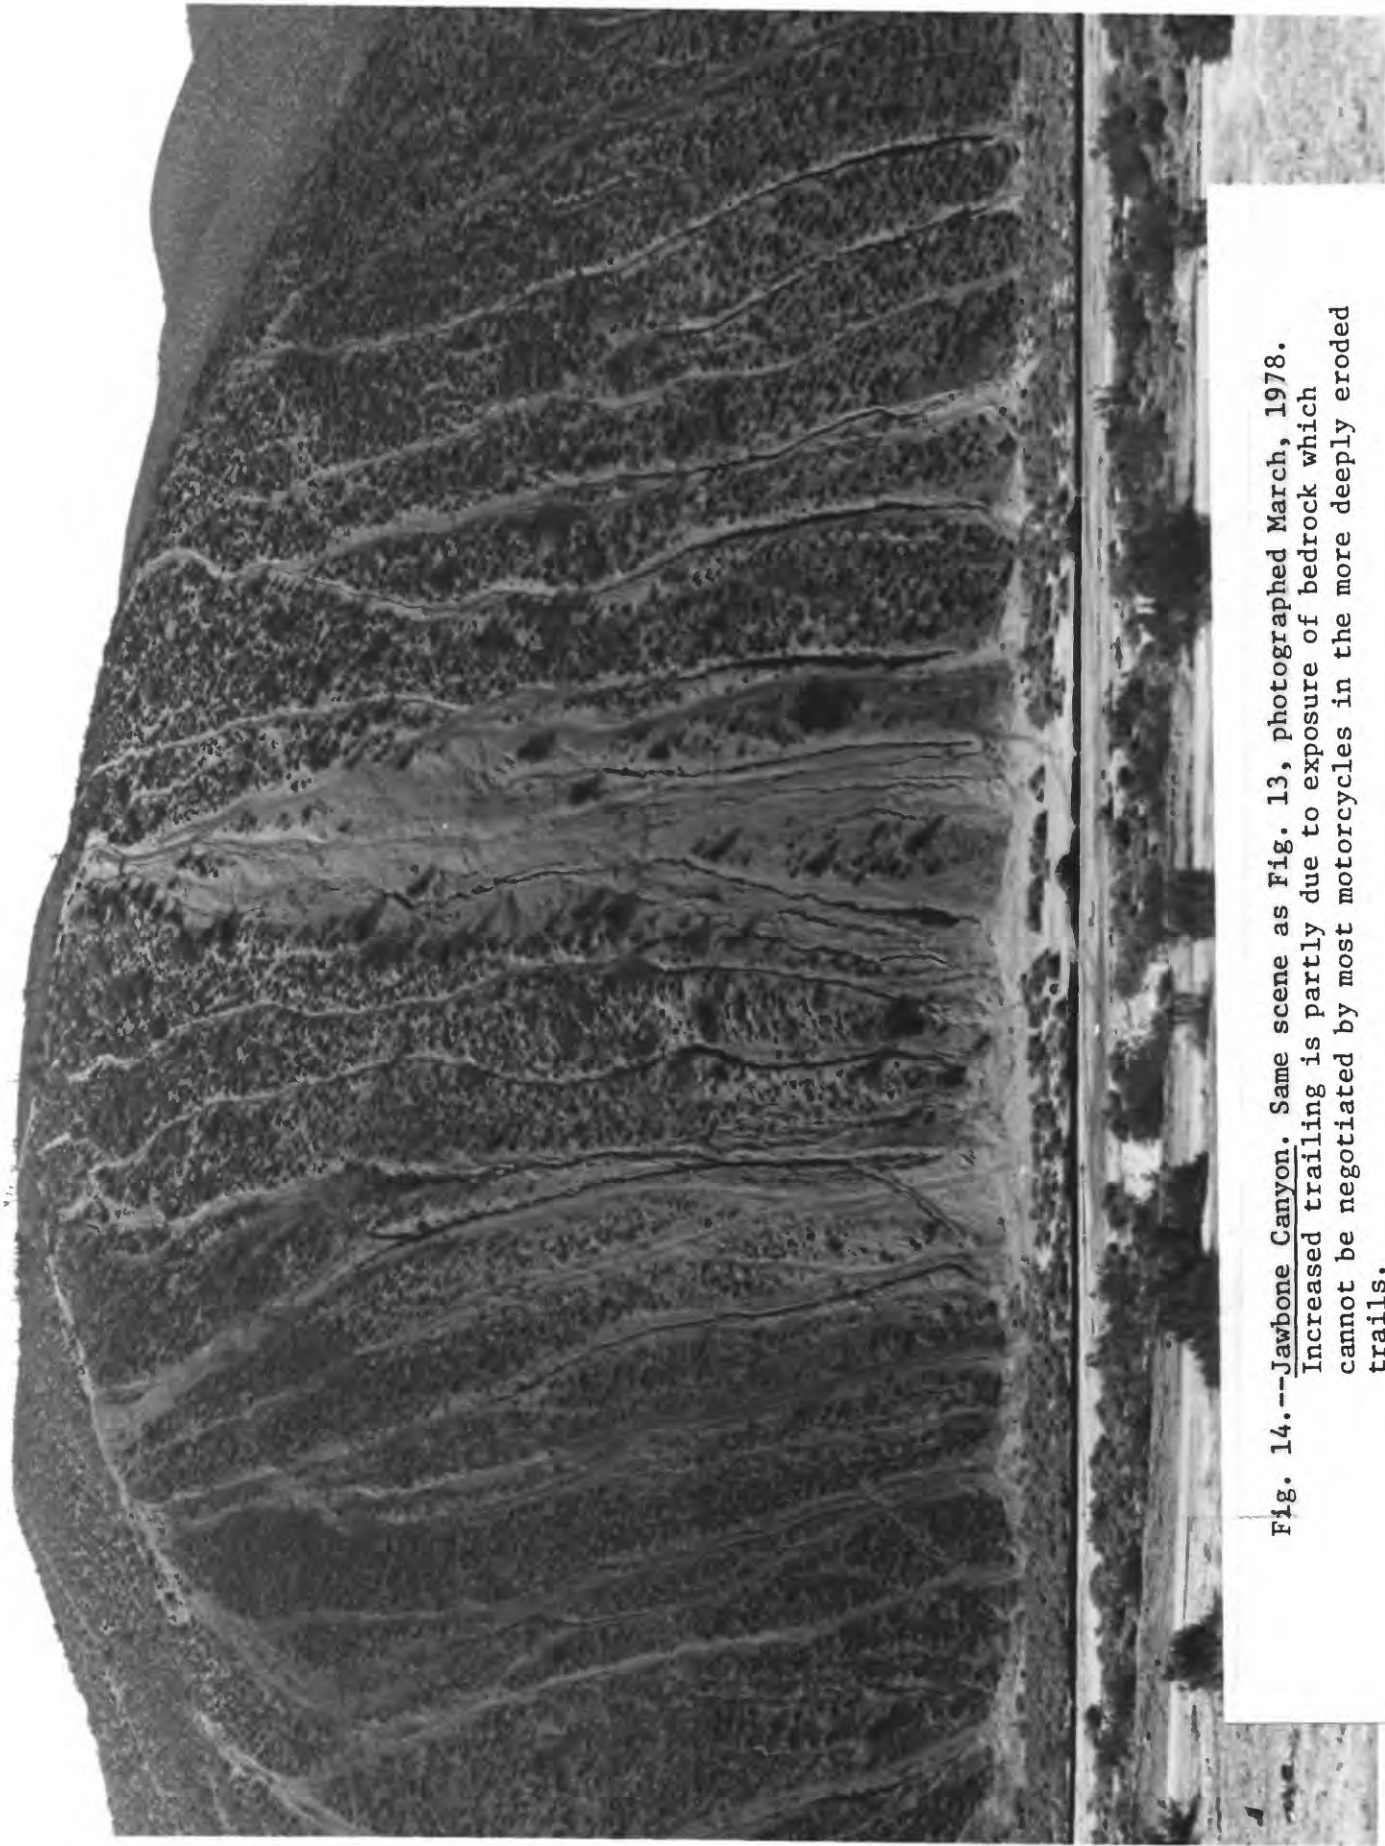
trails and new ones are established (Figs. 13,14). Figure 15 is a view down a trail used by both 2- and 4-wheel vehicles. Rain produced a thick slurry of the churned soil that flowed out over the valley floor much like a lava flow burying valley bottom soils and plants, and doubtless trapping many burrowing animals. In this manner, fine-grained soils that had been locked in a vertical section anchored by plants are now spread in a thin sheet with a large surface area exposed to wind erosion. Moreover, the deep leveed channel through which the slurry flowed now forces traffic to the sides and causes expansion of the damage. Some slopes with very shallow and sensitive soils have been stripped entirely of their soil mantle (Fig. 16). Such hills, underlain by hard bedrock, are no longer negotiable by most vehicles, and new sites are sought where the inevitable sequence is repeated.

Fig. 14.--Jawbone Canyon. Same scene as Fig. 13, photographed March, 1978.
Increased trailing is partly due to exposure of bedrock which cannot be negotiated by most motorcycles in the more deeply eroded trails.

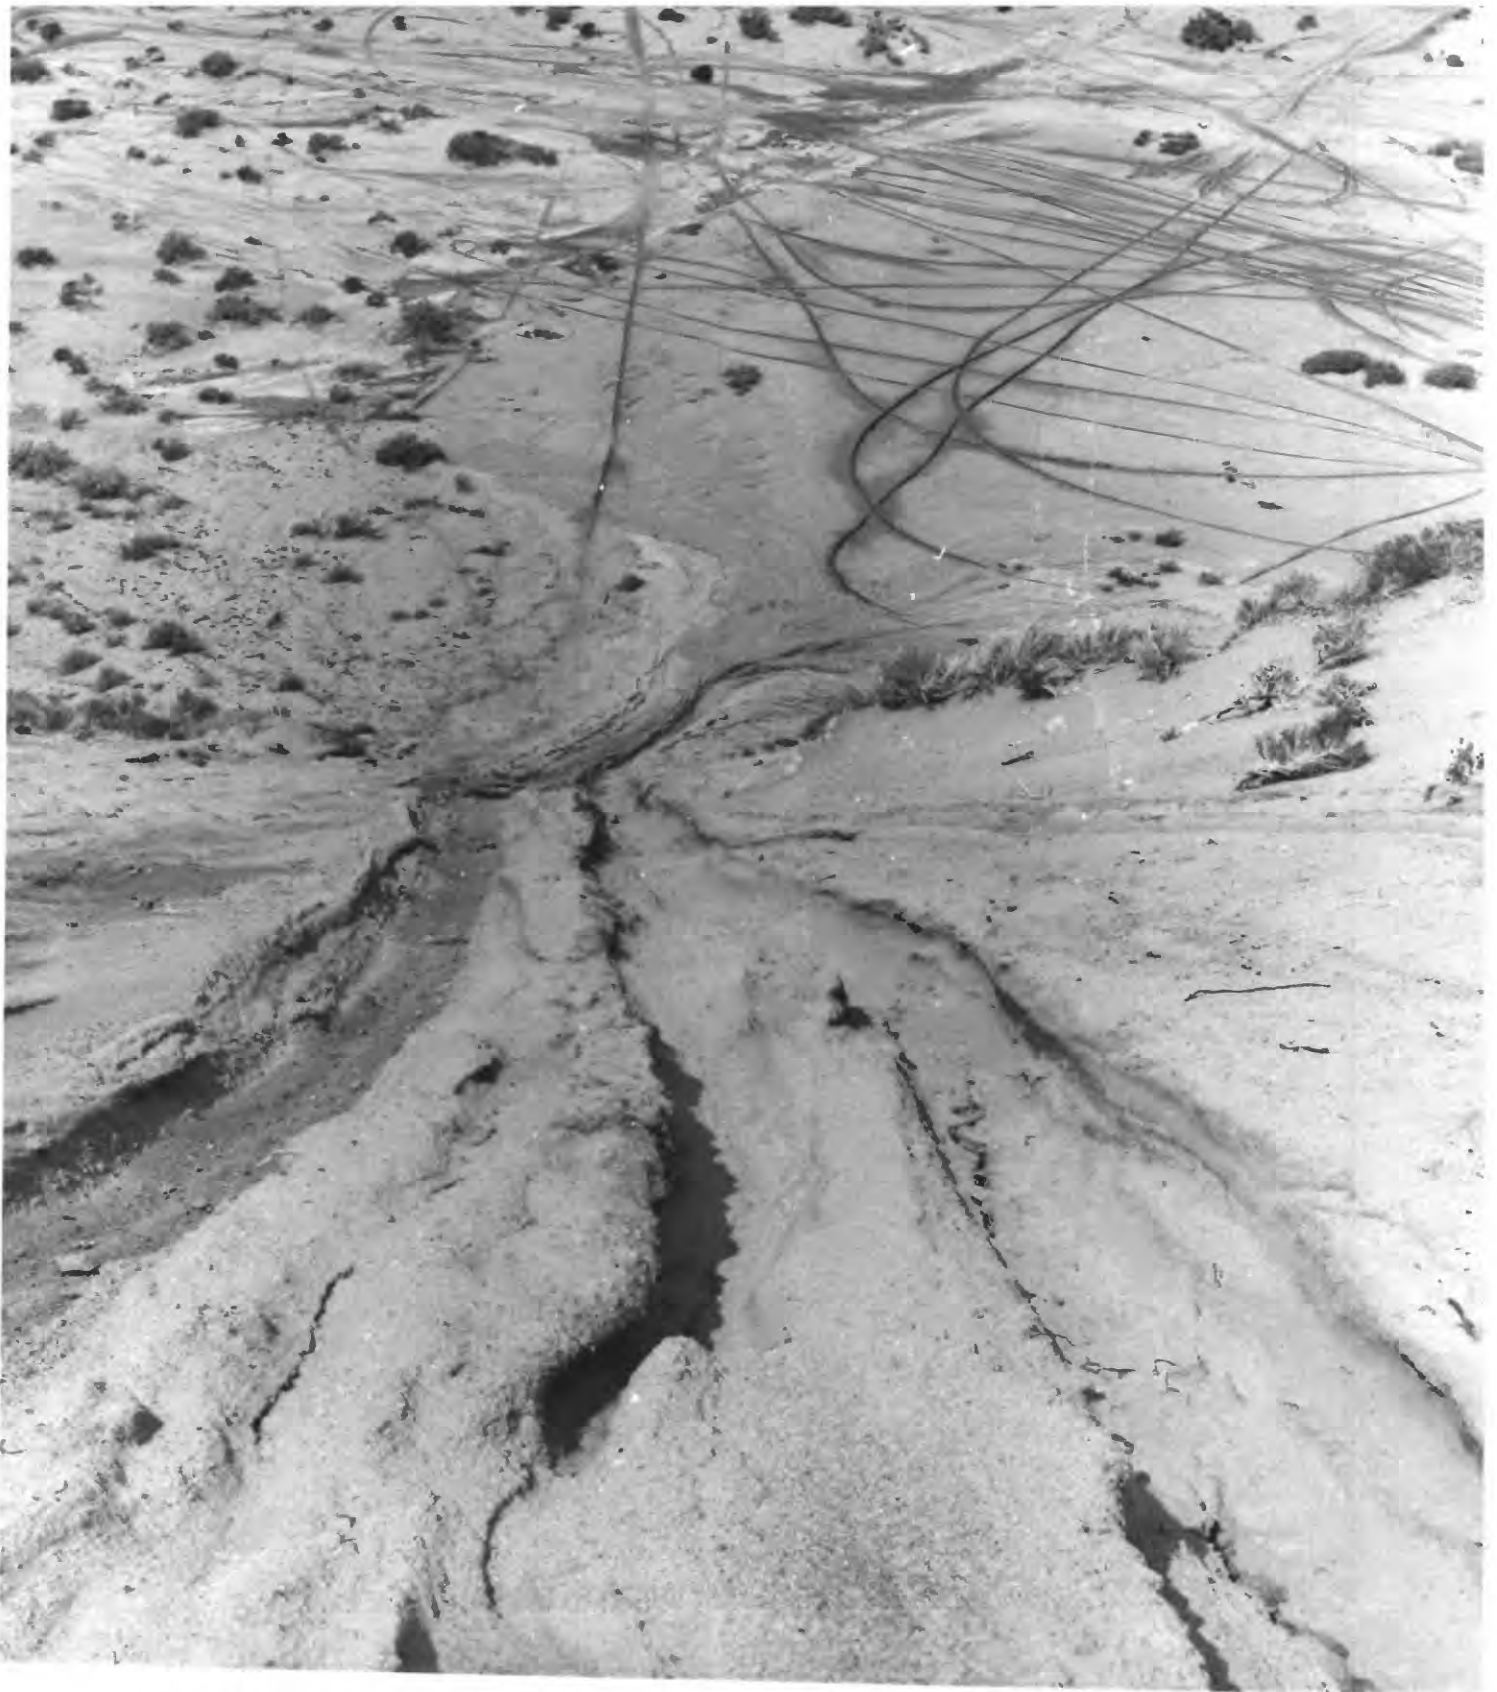
Fig. 15.--Jawbone Canyon. View down an ORV trail on steep canyon wall. Rain formed a thick slurry that flowed through the deep channel in the foreground and out over the valley floor like a lava flow (edges marked by arrows).

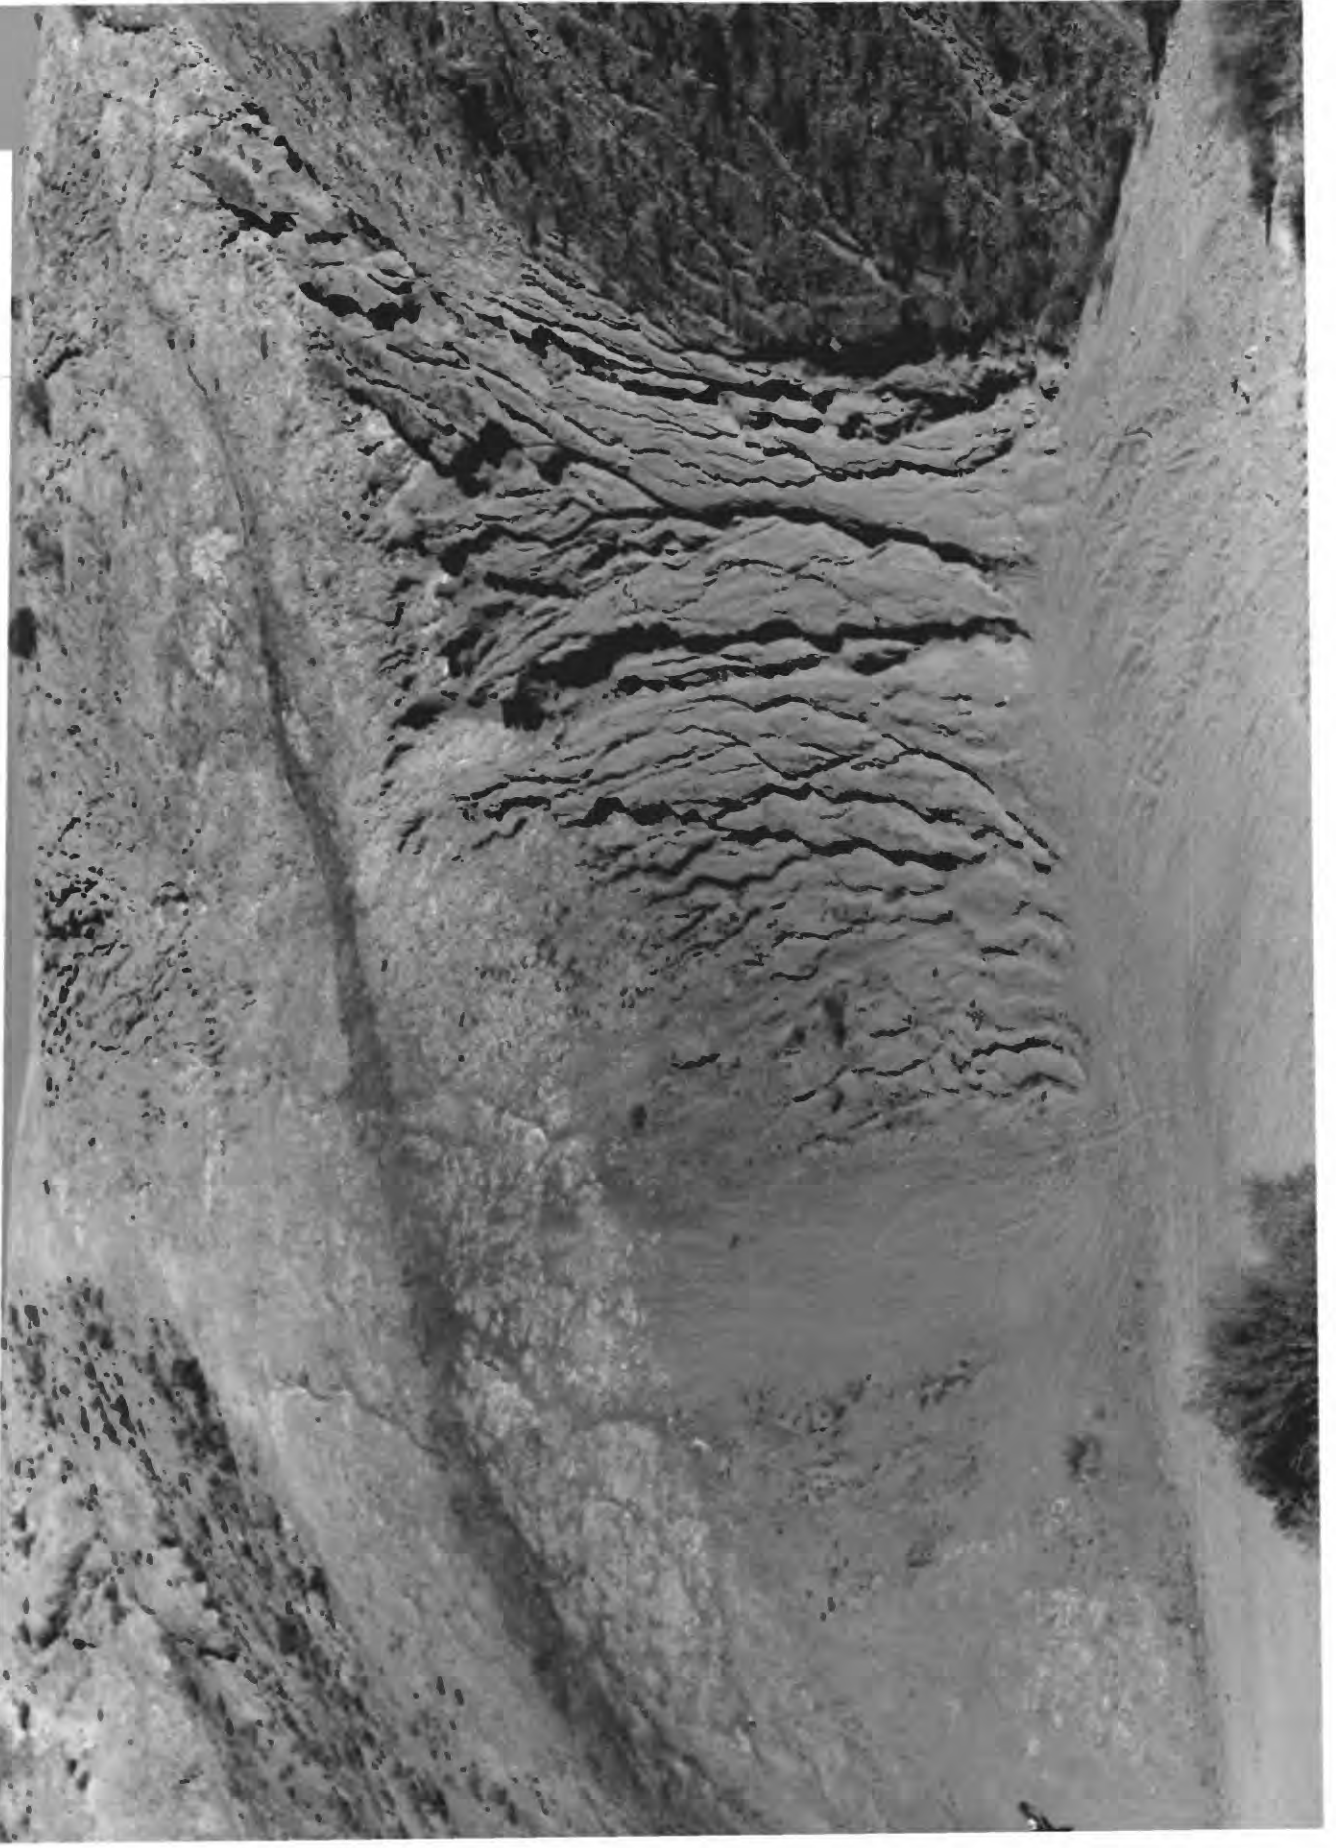
Fig. 16.---Jawbone Canyon. Central part of this hill has been completely stripped of soil exposing hard bedrock. Remnants of deeply gullied soil at right and center-crest reveal the cause: vehicle destruction of plant cover.

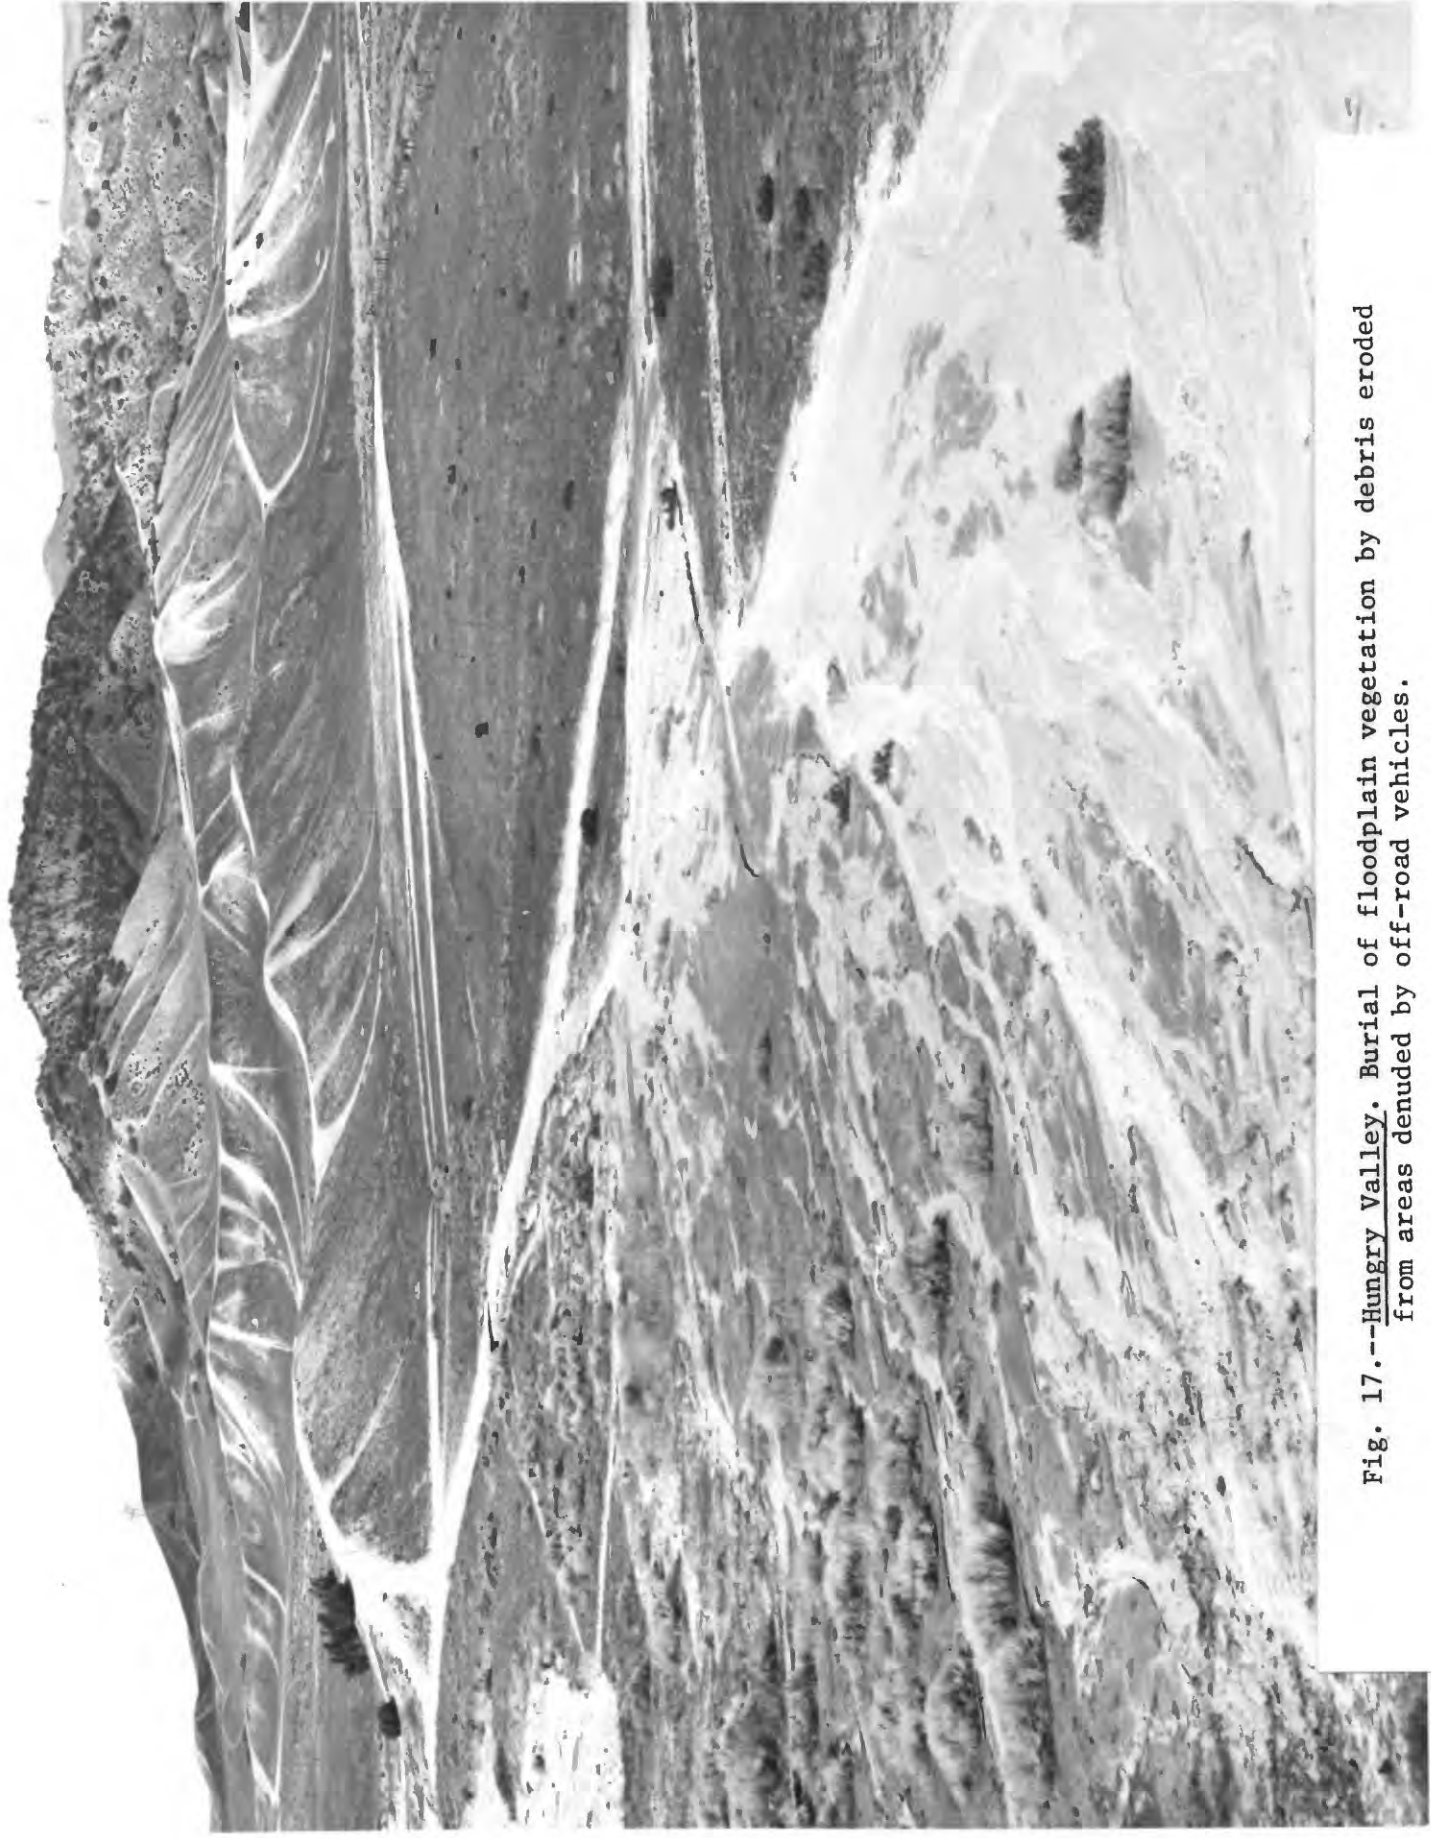
Fig. 17.--Hungry Valley. Burial of floodplain vegetation by debris eroded from areas denuded by off-road vehicles.

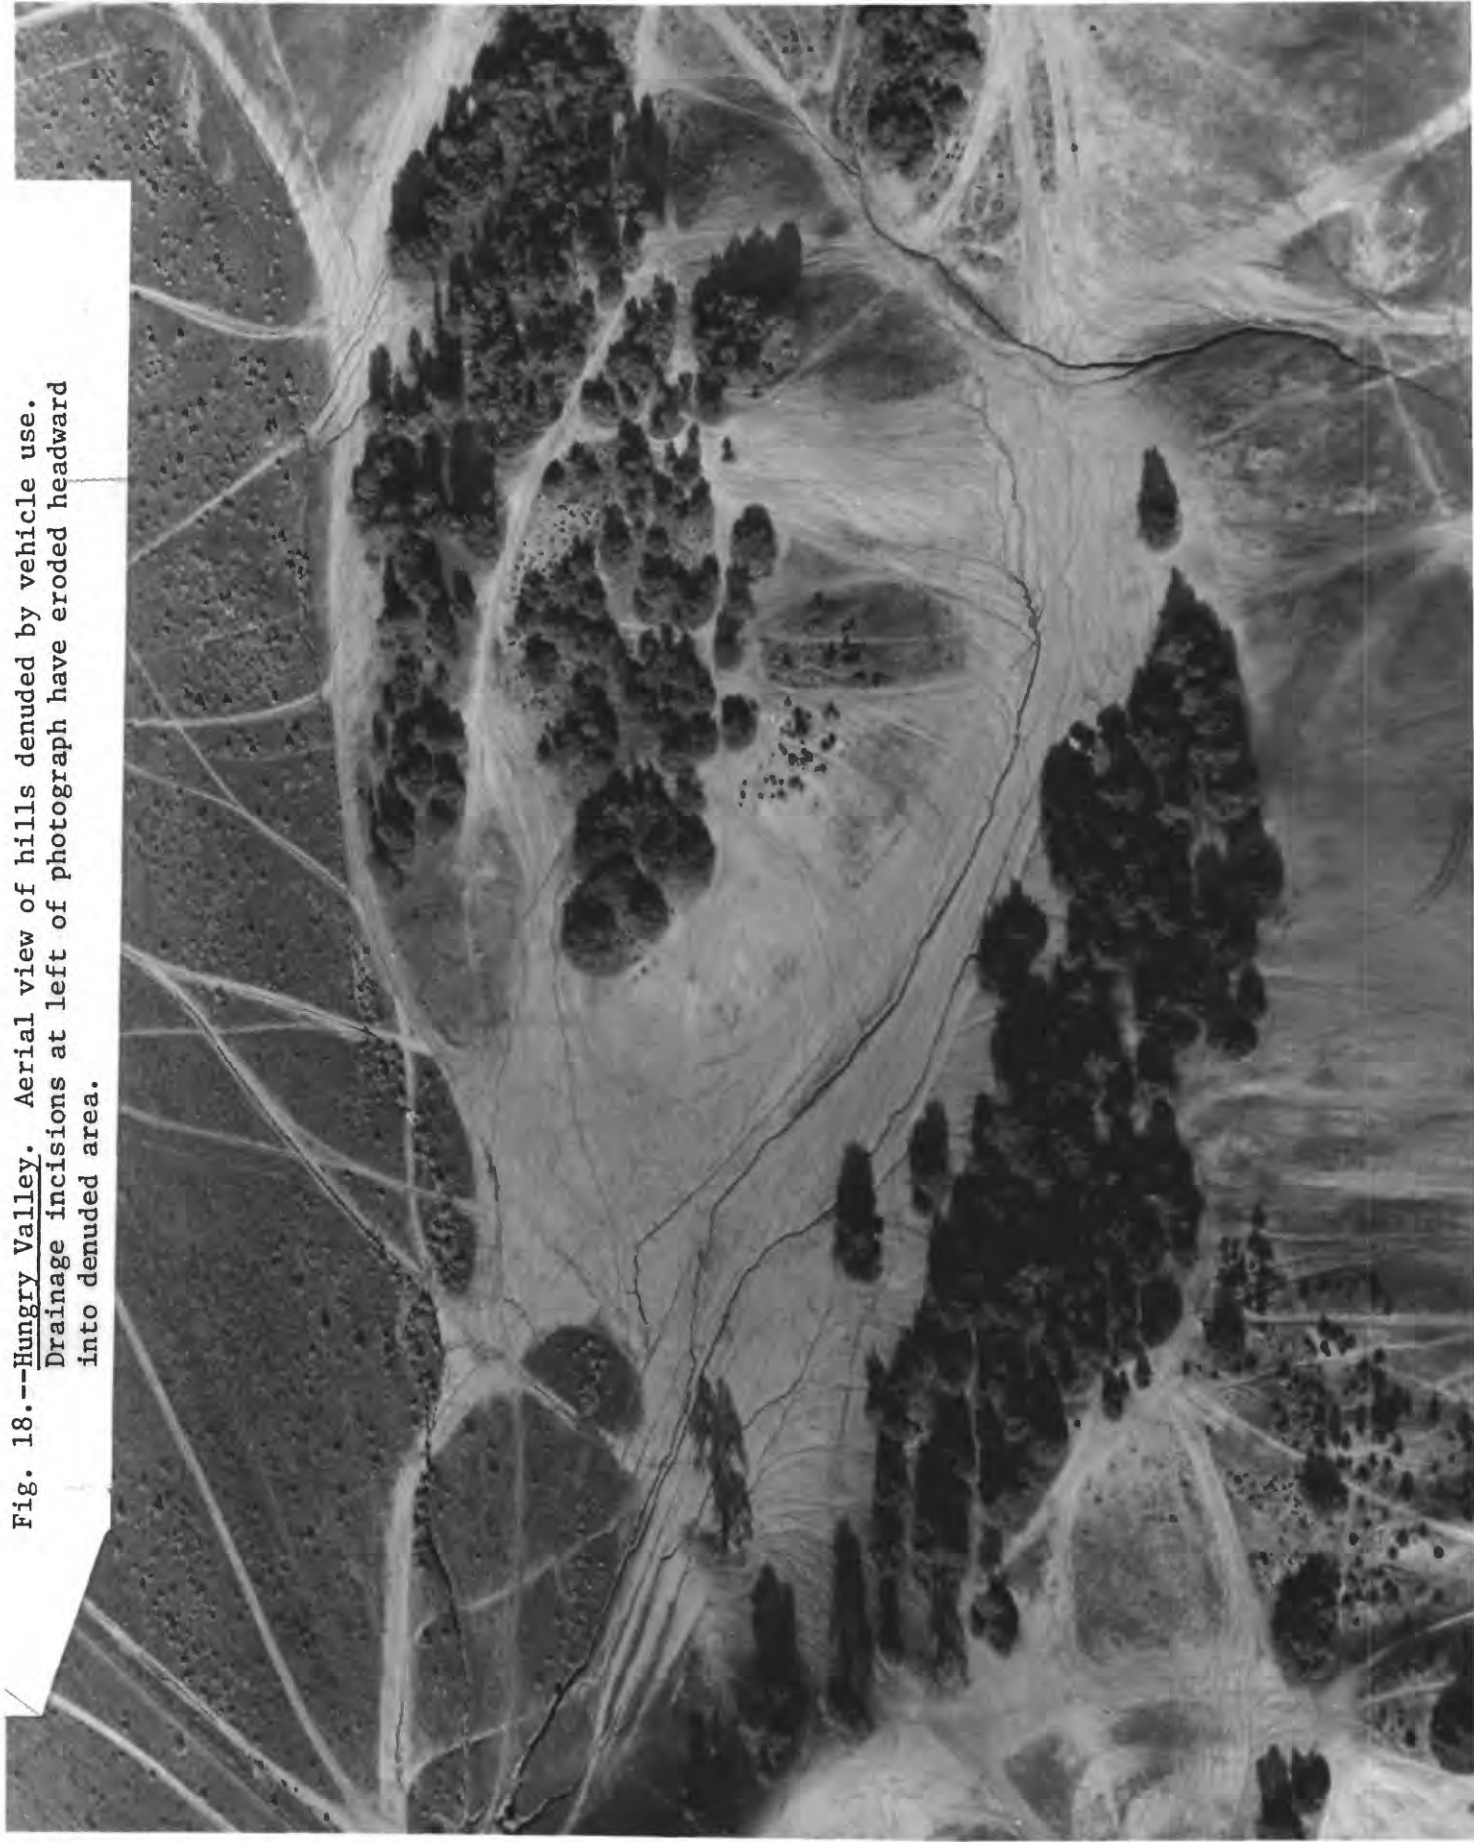
Fig. 18.--Hungry Valley. Aerial view of hills denuded by vehicle use.
Drainage incisions at left of photograph have eroded headward
into denuded area.

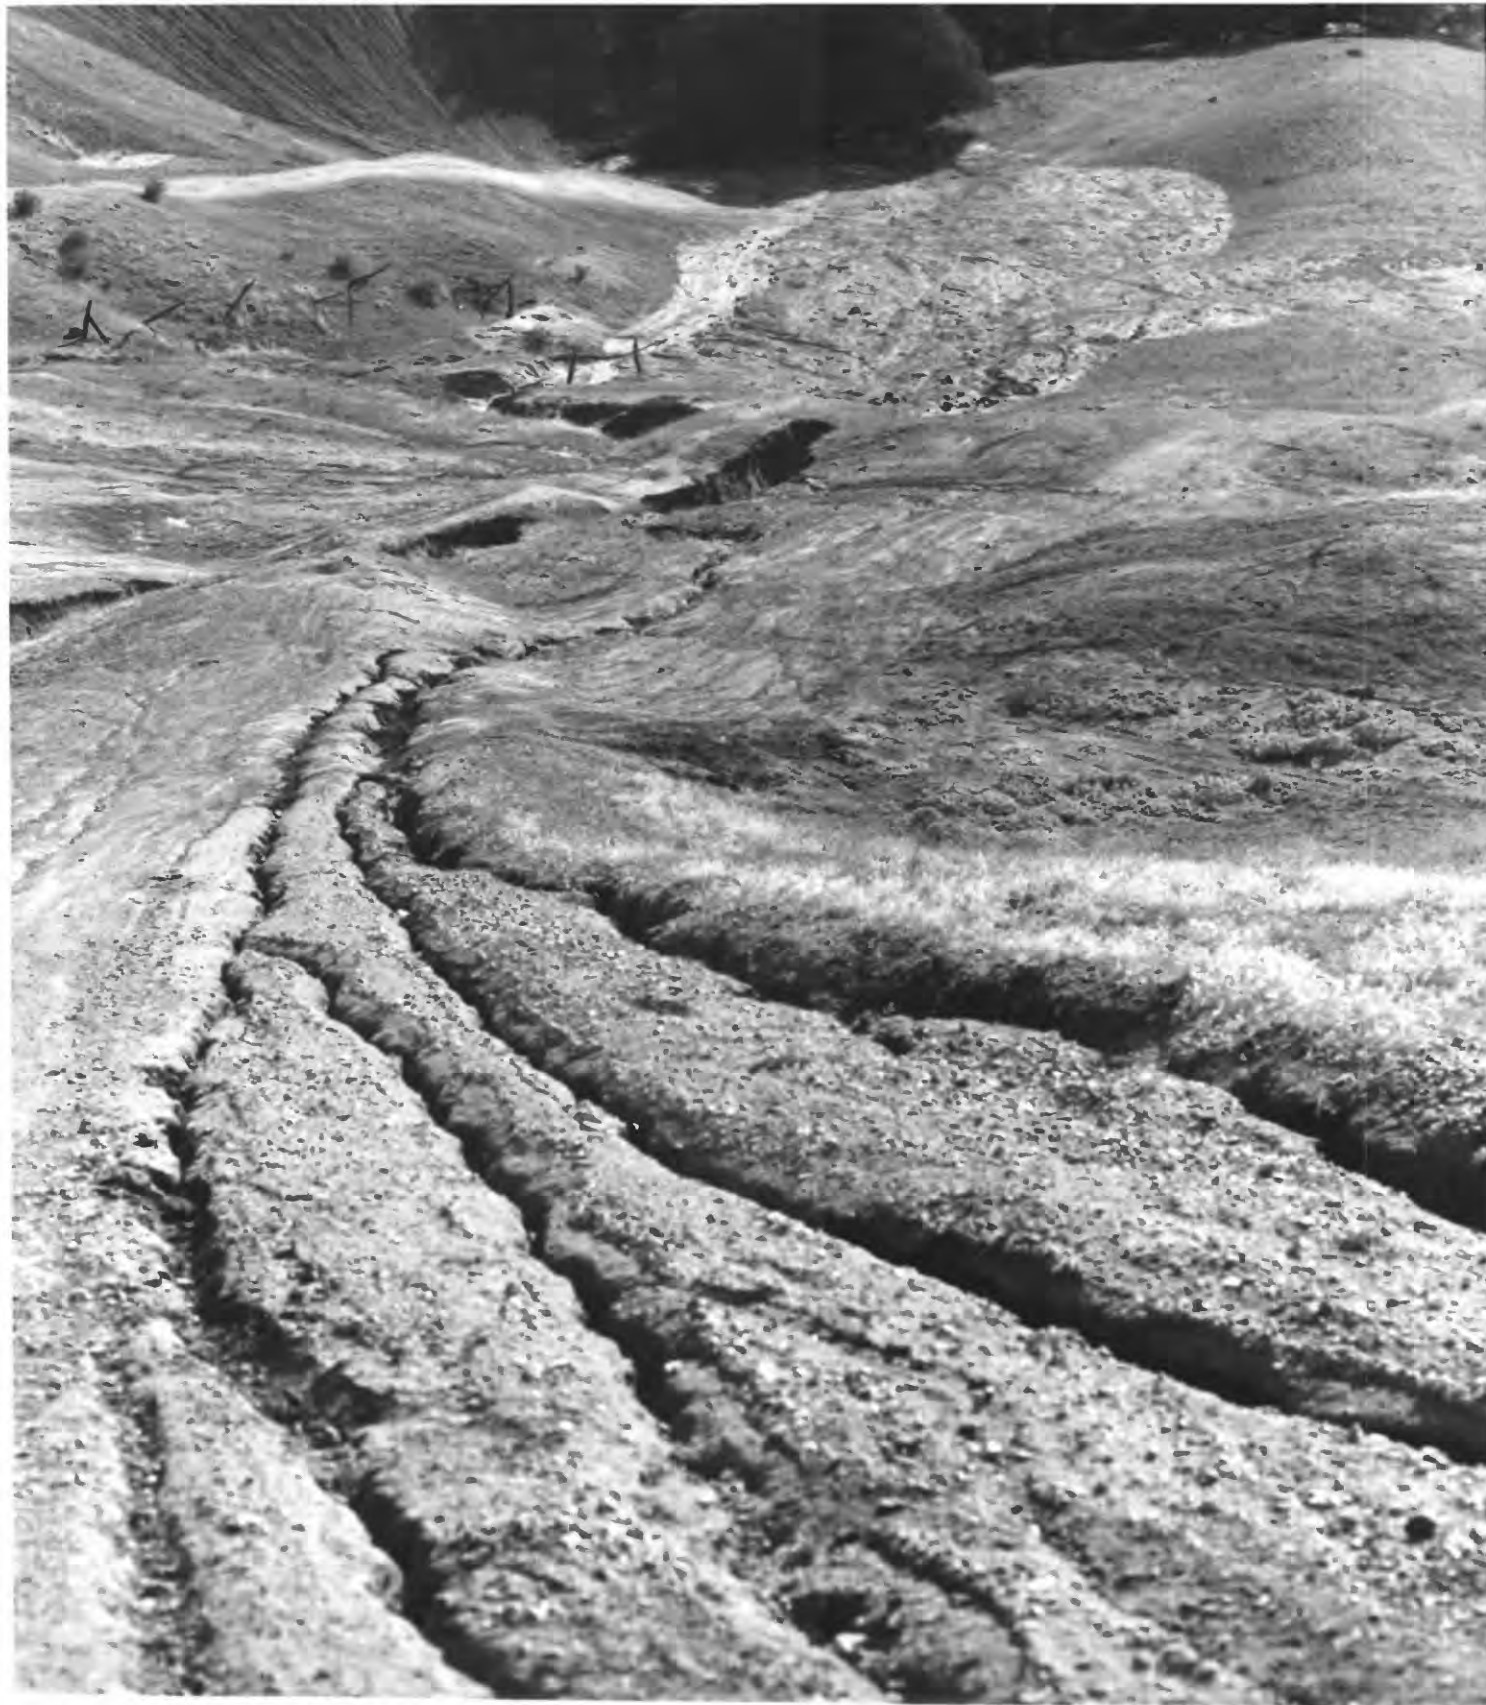
nature that resists direct displacement by vehicles and instead respond by compaction and formation of hard surface seals (Fig. 19). In this case, runoff is greatly accelerated and the erosional response is felt lower in the drainage system (Knott, 1978); this is visible in figure 19 where incision of the drainages by excessive runoff has migrated headward into the denuded zone.

Fig. 19.--Hungry Valley. Debris washed from gullies in ORV trails has accumulated in a local depression 17 X 50 meters across at base of slope. Very much more debris was carried beyond this local depression downstream. Photographed September, 1976.
