UNITED STATES DEPARTMENT OF THE INTERIOR
GEOLOGICAL SURVEY

STUDY RESULTS OF 9 SITES
USED BY OFF-ROAD VEHICLES THAT ILLUSTRATE
LAND MODIFICATIONS

Open-file report

77-601

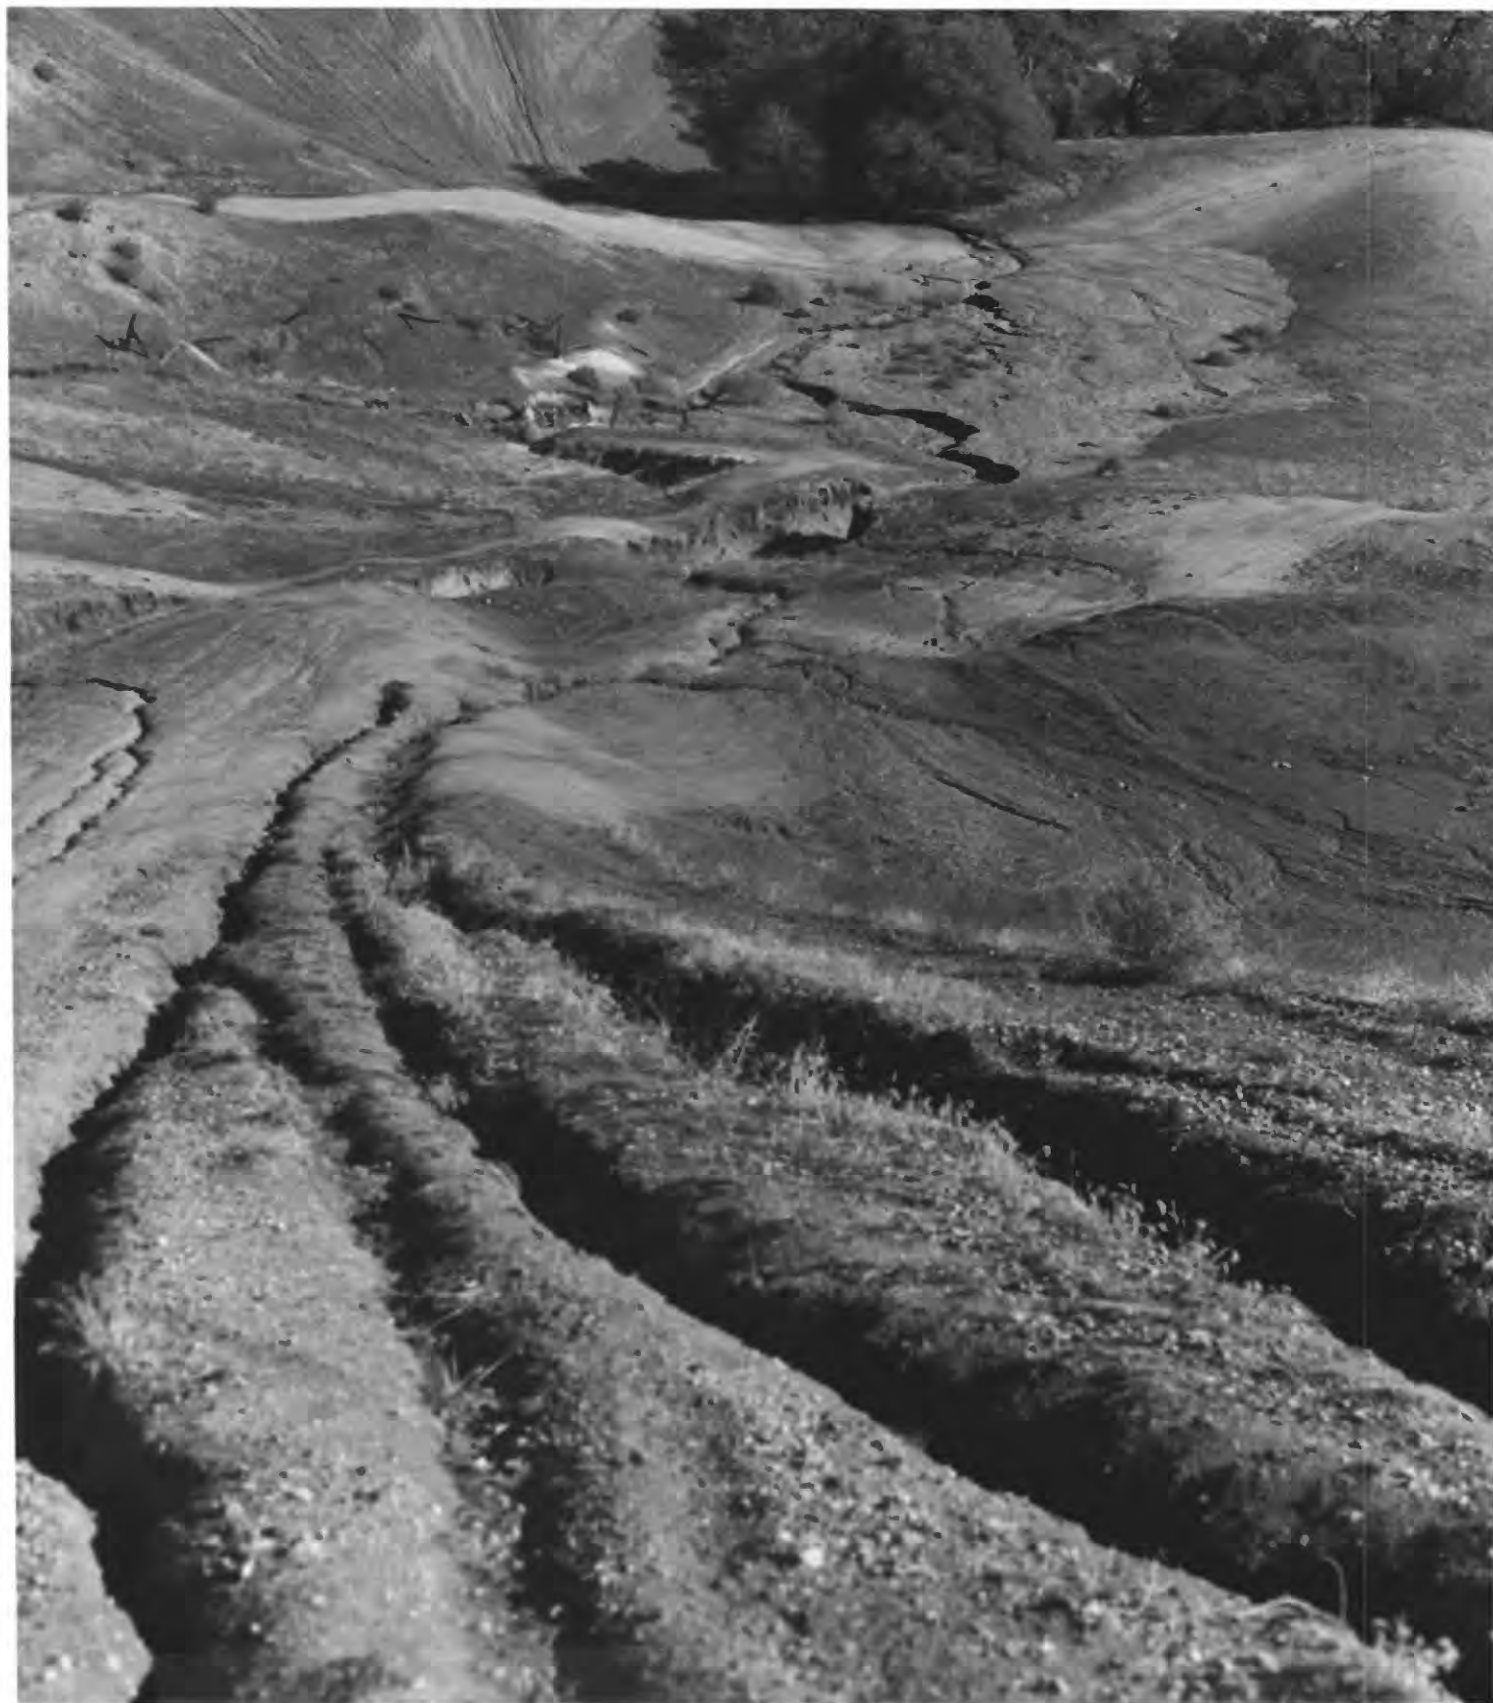
Fig. 20.--Hungry Valley. Same scene as Fig. 19, photographed March, 1978.
Note enlarged gullies in foreground and new gullying of flat area
above trees.

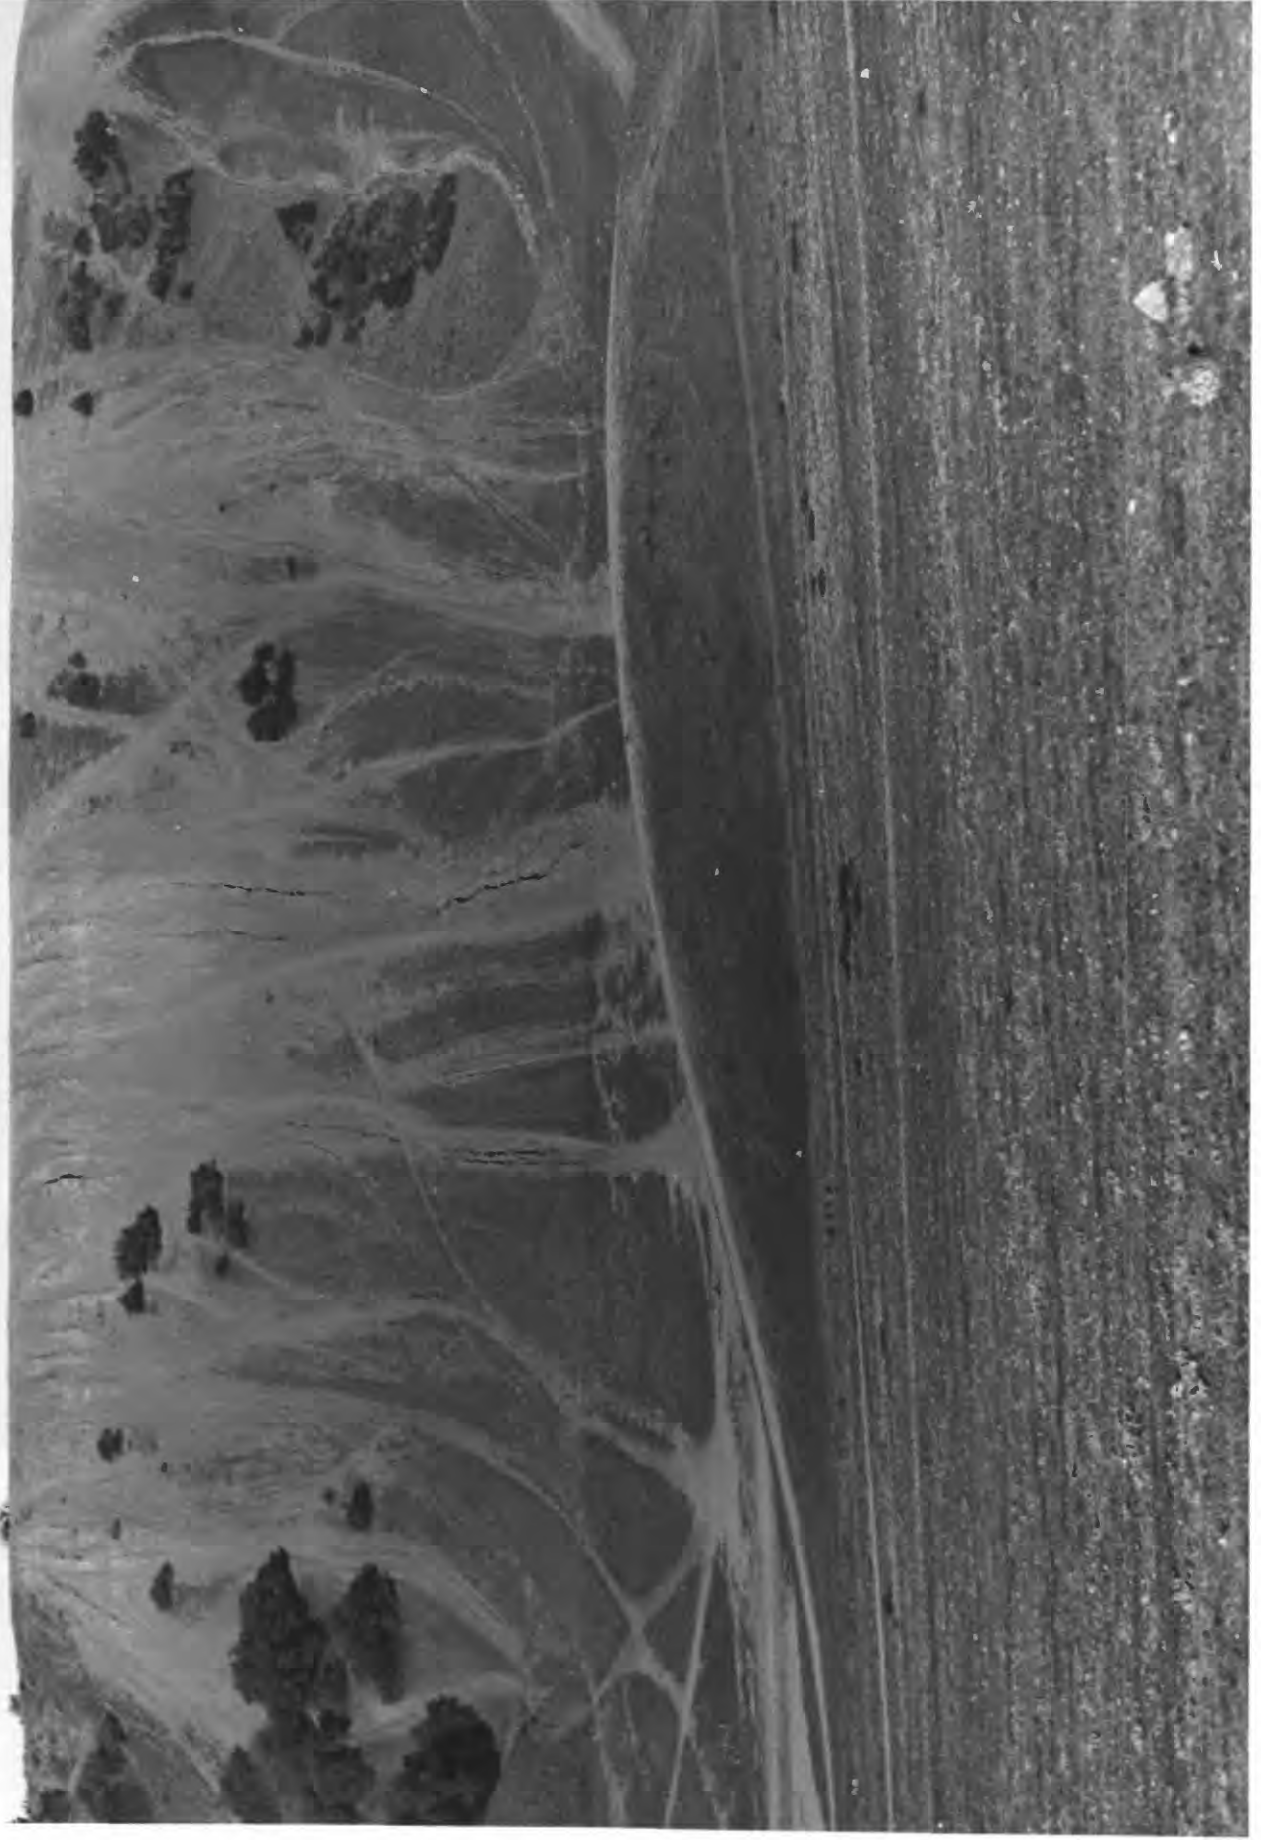
The effects of denudation of steep slopes underlain by the more erodible soils is shown in figures 21-22, photographed in May, 1976 and March, 1978.

Fig. 21.--Hungry Valley. Erosion of steep slope denuded by ORV traffic.
Photographed May, 1976.

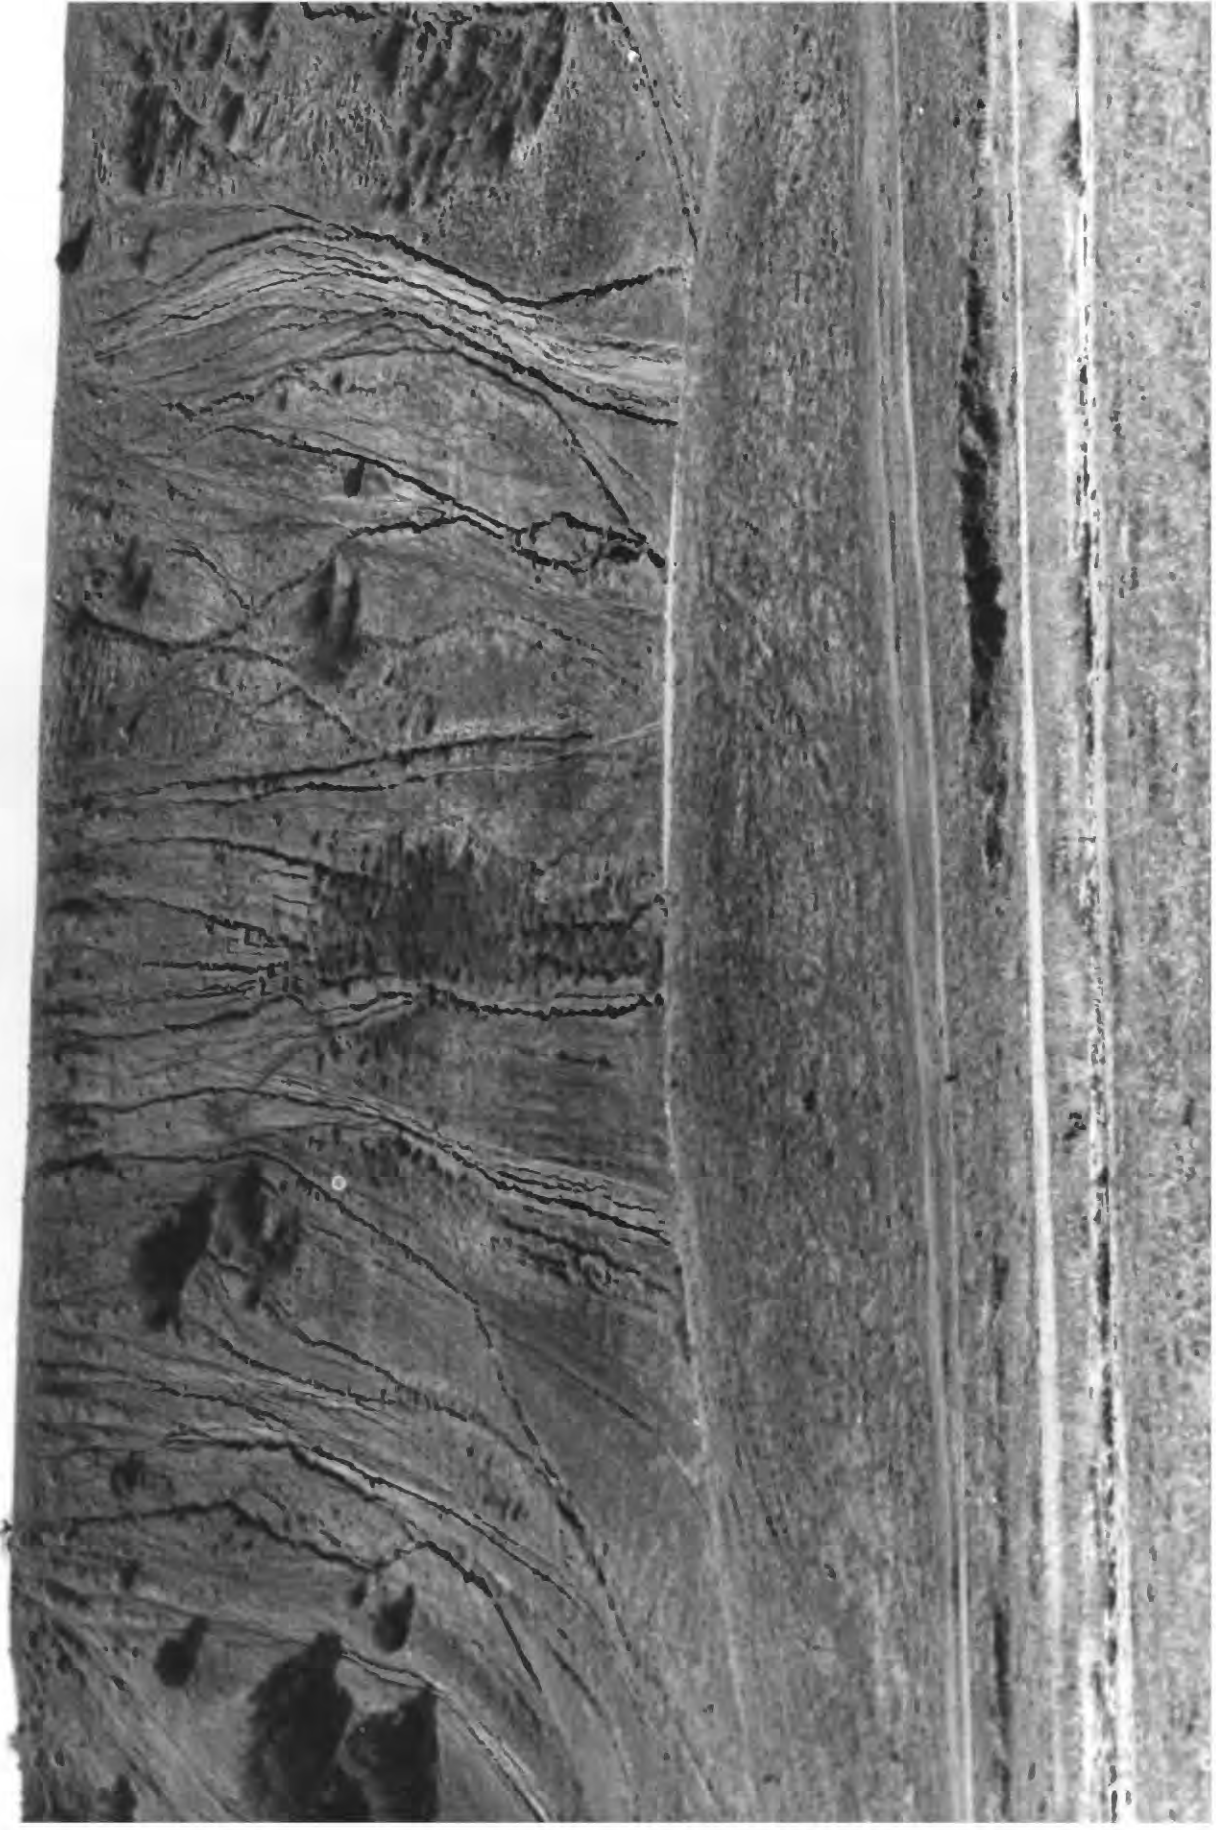
Fig. 22.--Hungry Valley. Same scene as Fig. 21, photographed March, 1978.

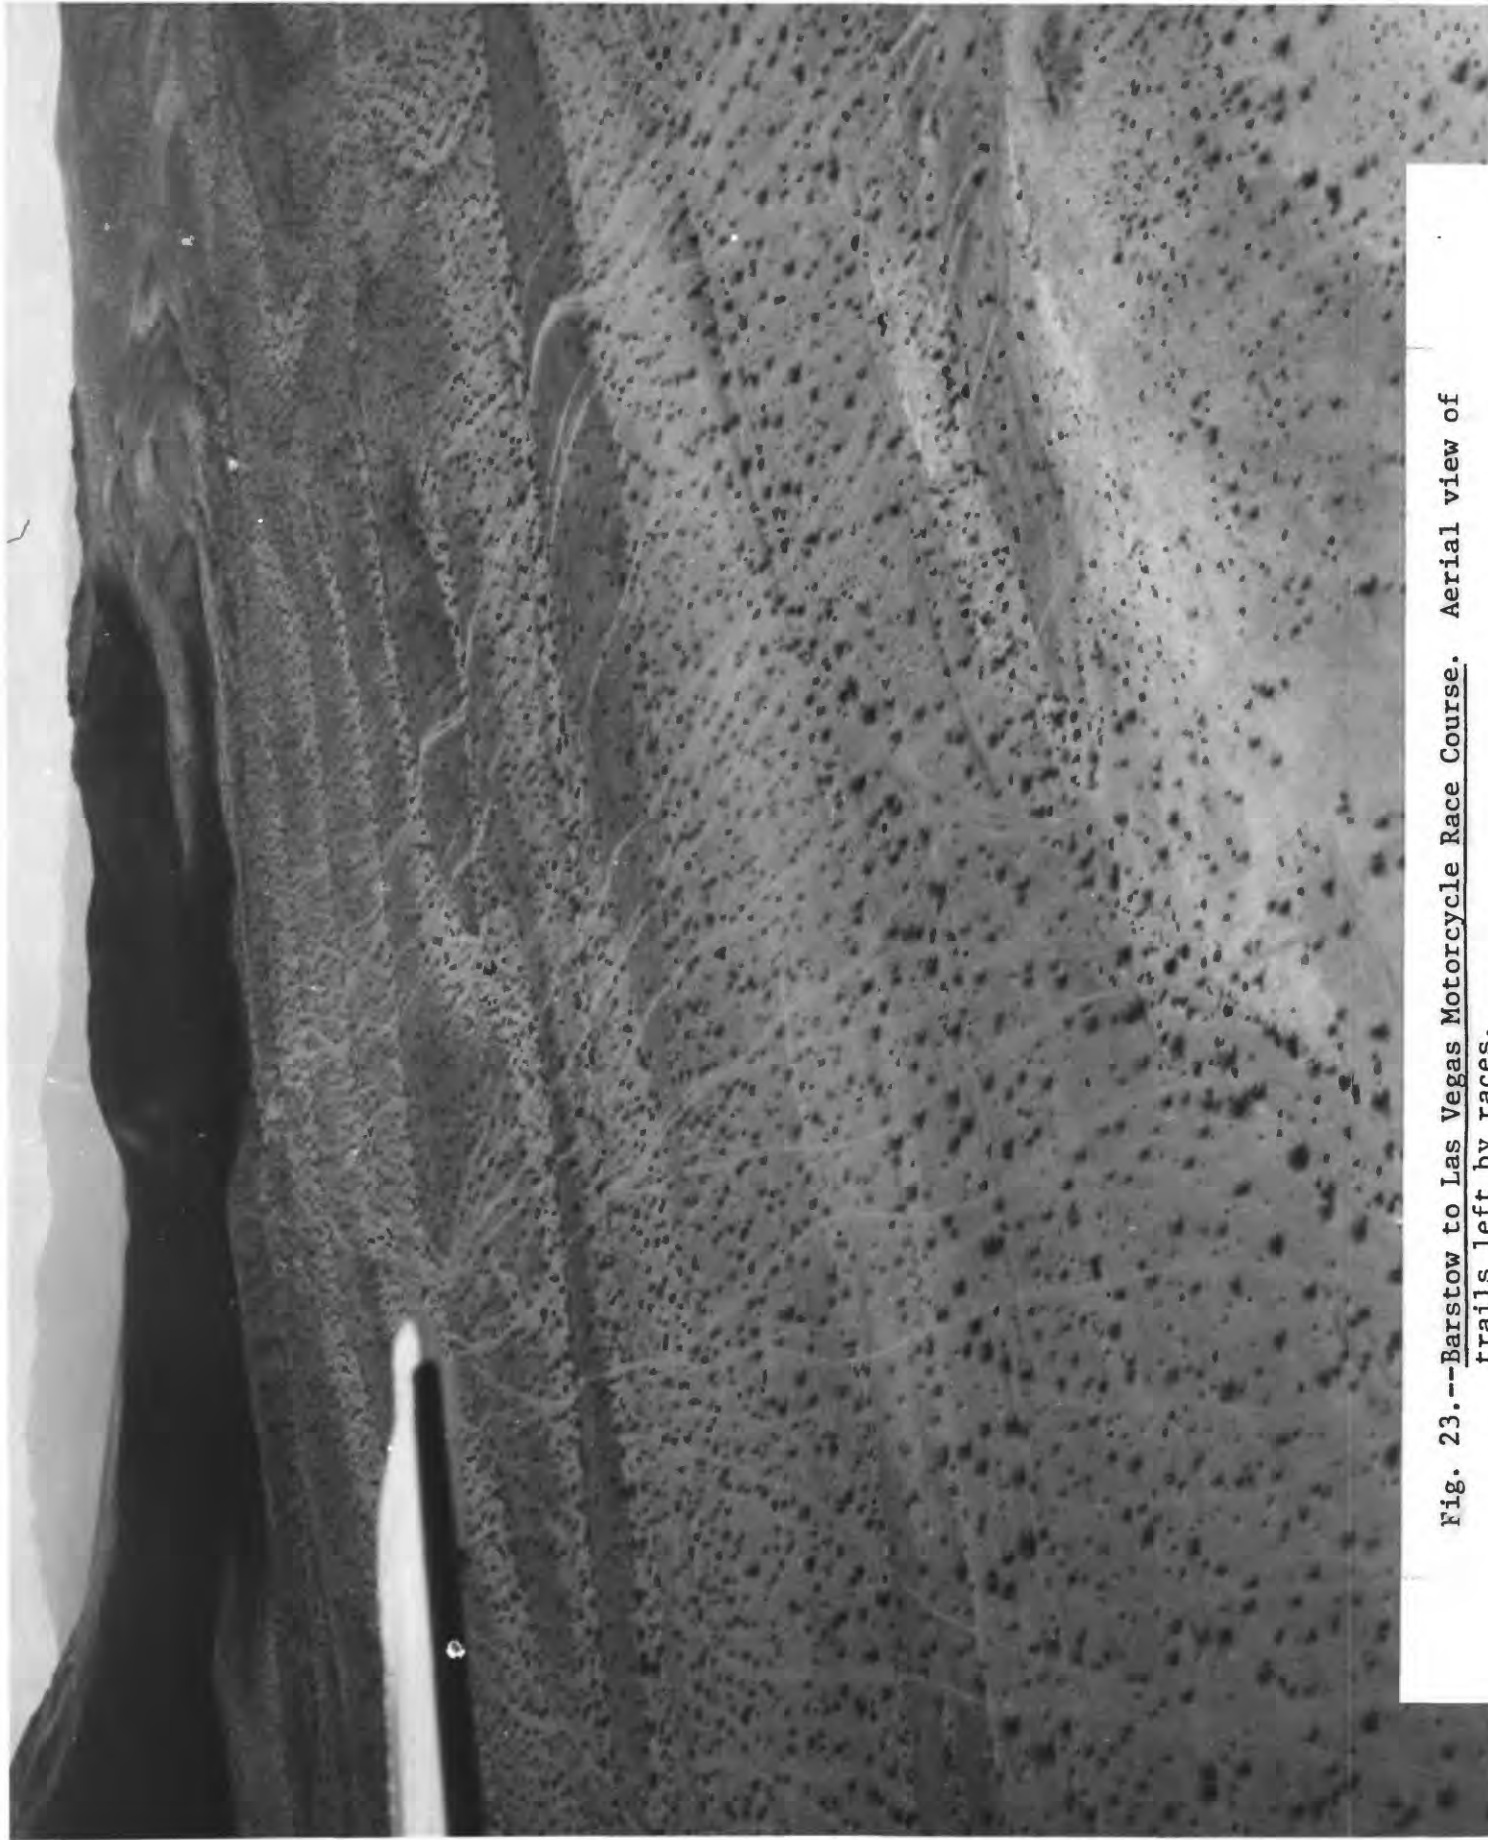
Fig. 23.--Barstow to Las Vegas Motorcycle Race Course. Aerial view of
trails left by races.

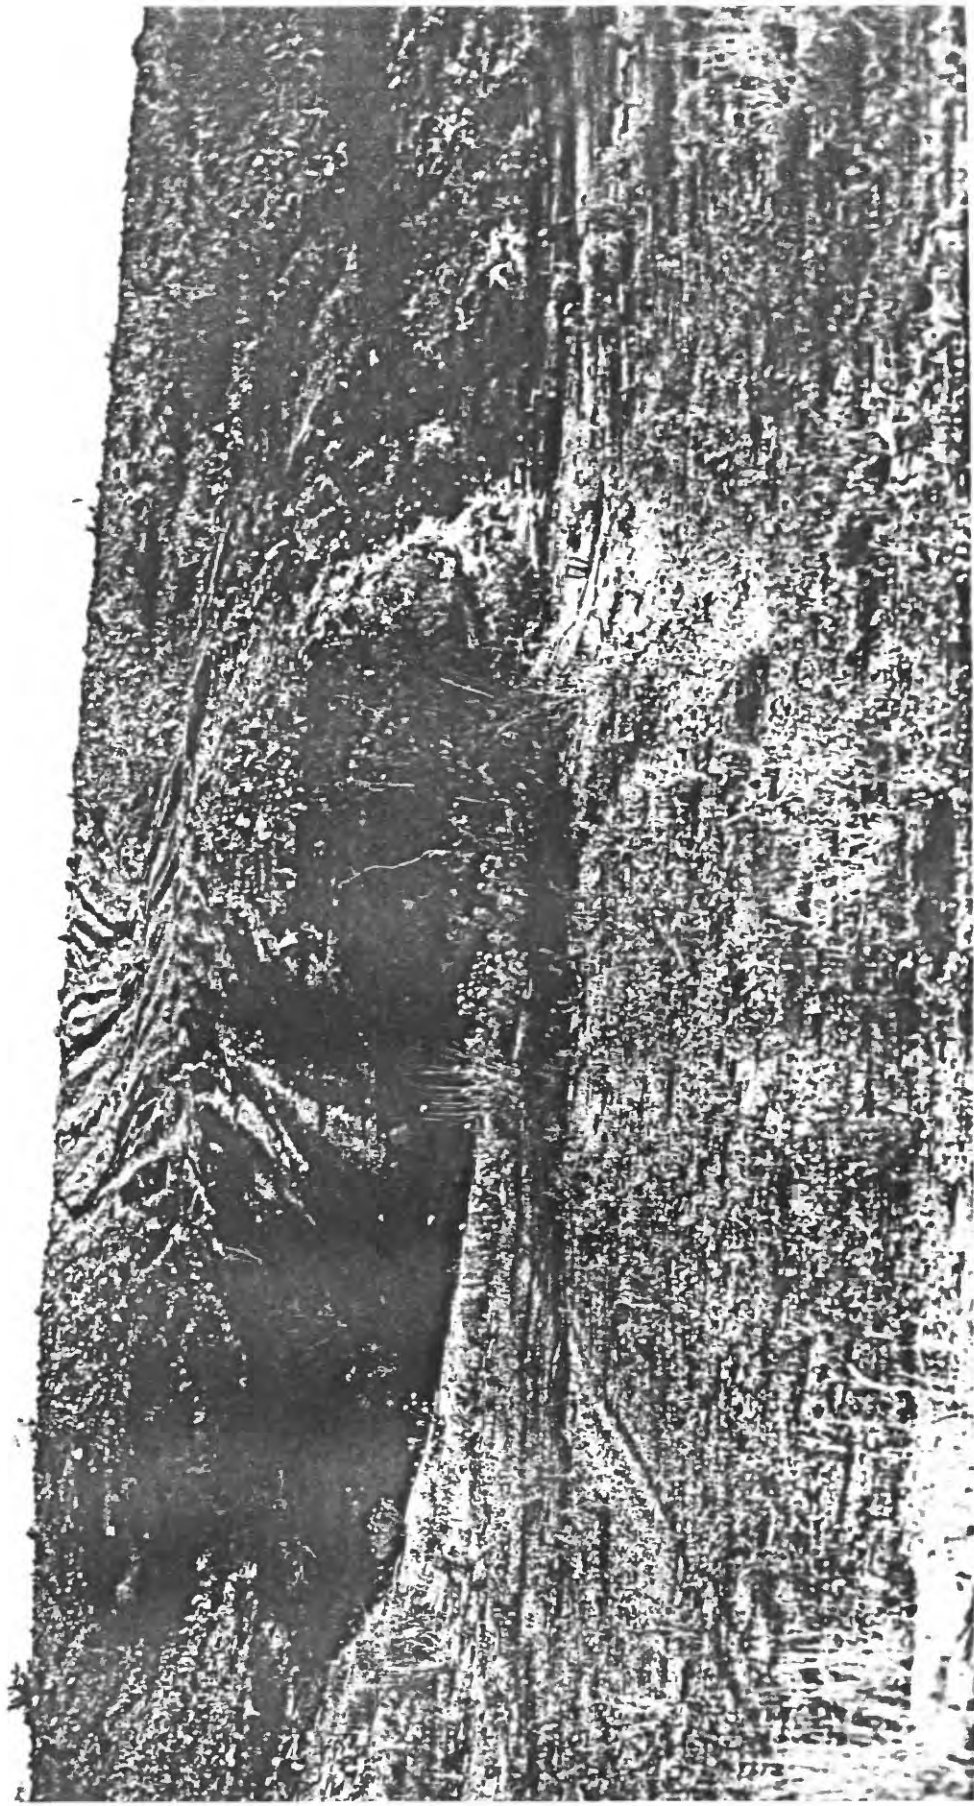
The only quantitative measurements made on soil modification on this course are surface strength measurements (Bureau of Land Management, 1975b; Wilshire and Nakata, 1976), which indicate substantial modification of soil structure. Direct mechanical erosion of soil during the 1974 race produced more than 610,000 kg of airborne particulates (Bureau of Land Management, 1975b). Predicted erosional consequences of surface disruption (Wilshire and Nakata, 1976) have been subsequently confirmed by Wilshire and Nakata (1977). Figure 23 is an aerial view of trails left by the 1974 race. The dark stripes crossed by the trails are very ancient surfaces capped by mature varnished desert pavements. With vehicular stripping of this cover, erosion has begun (Fig. 24).

Fig. 24.--Barstow to Las Vegas Motorcycle Race Course. Ground view of erosion of trails shown in Figure 18. Photographed March, 1977.

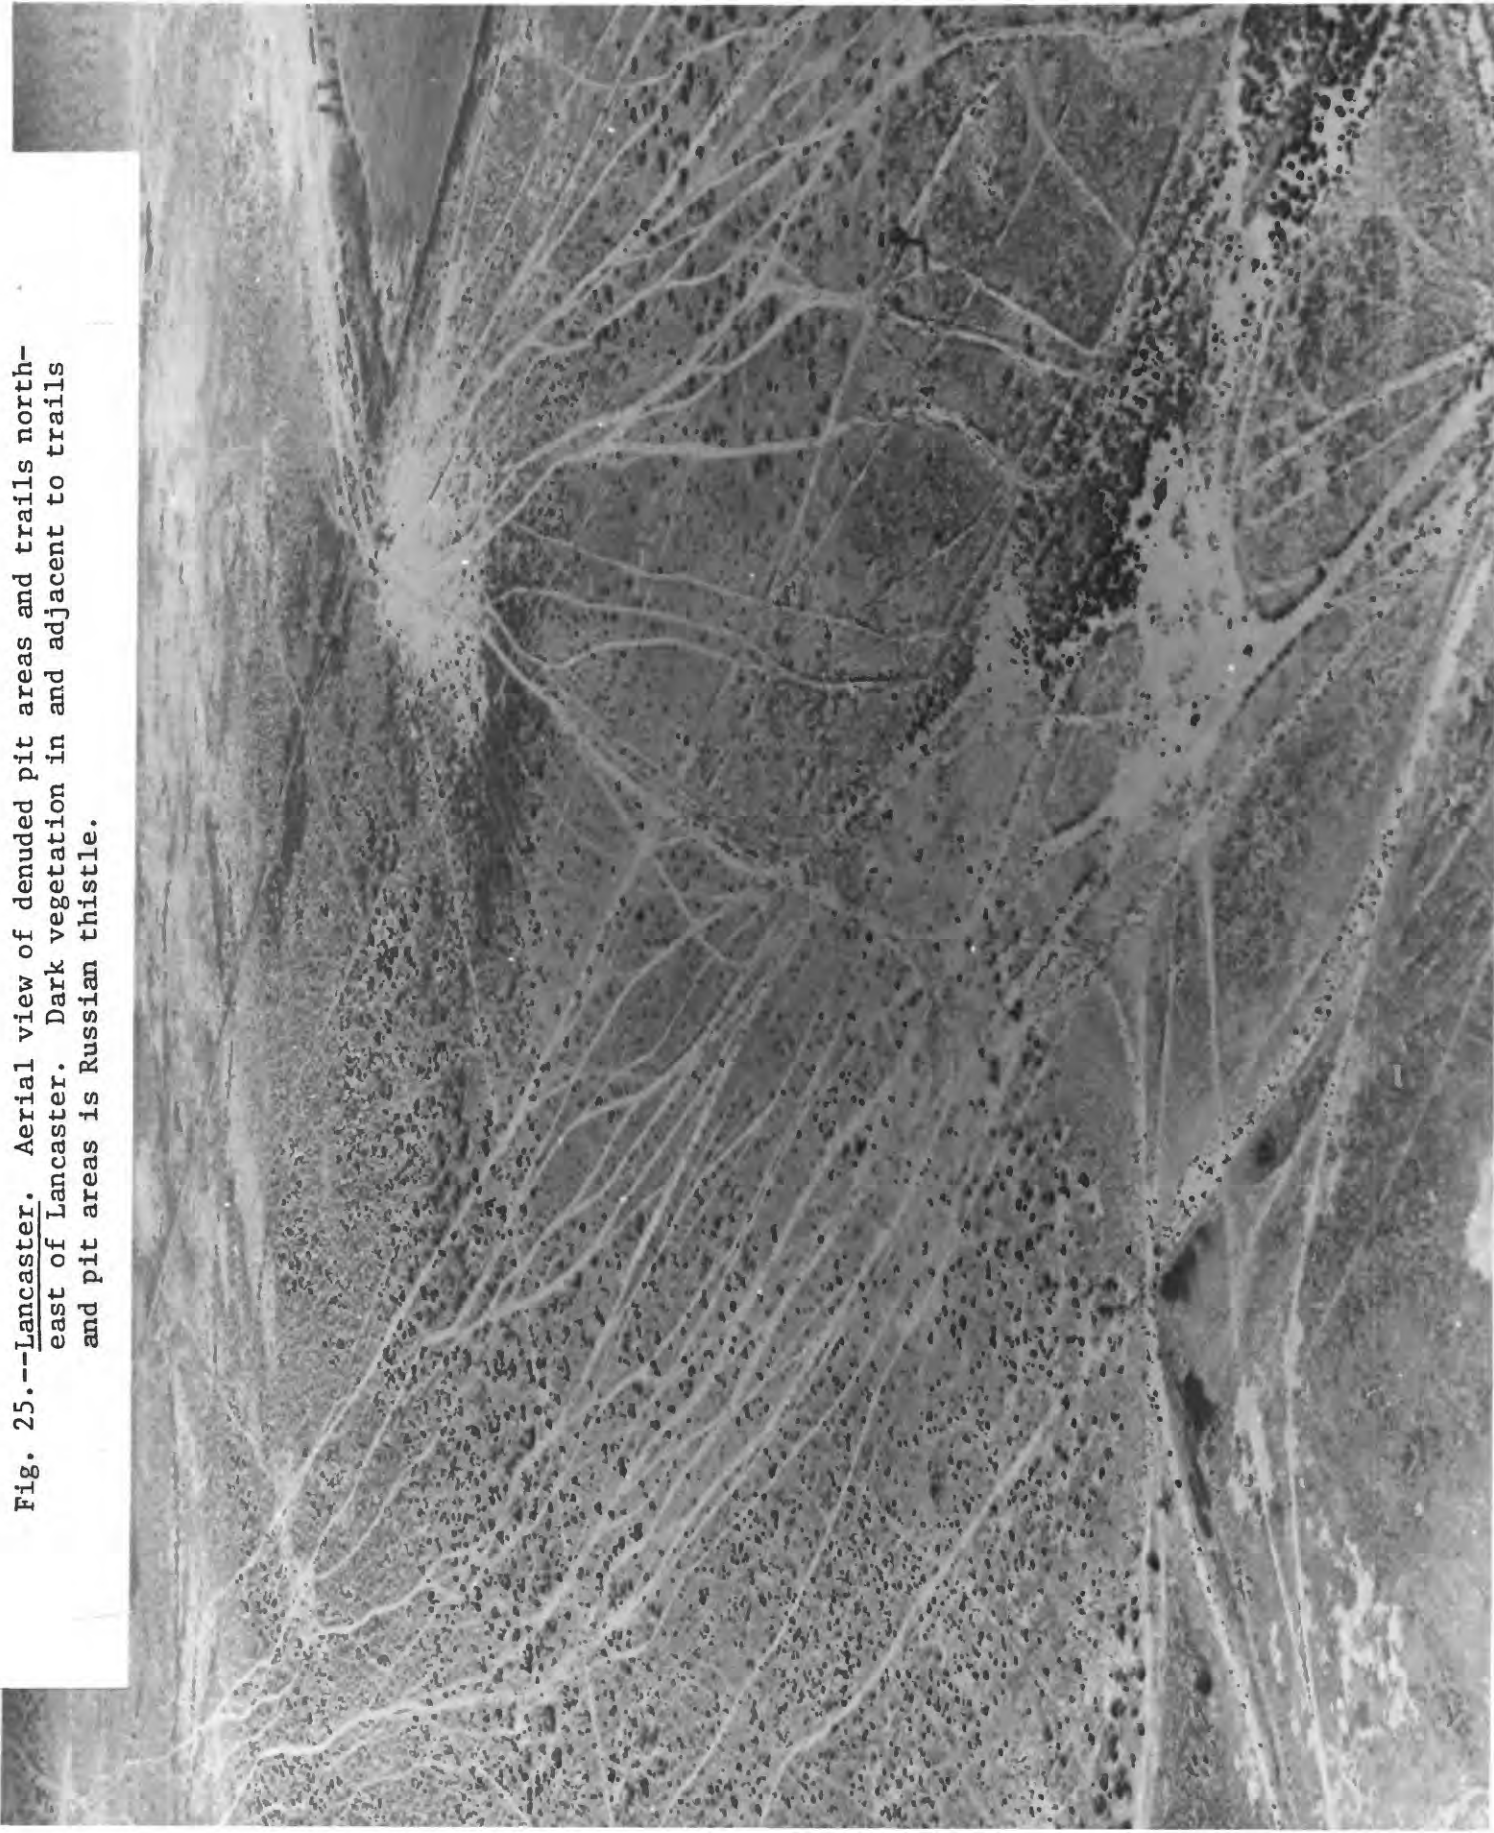
No systematic studies have been made of these sites although they represent intensive use of public lands. Figure 25 illustrates extensive denudation of flat terrain near Lancaster, mainly by motorcycles, Figure 26 illustrates severe impacts in Stoddard Valley mainly from 4-wheel vehicle competitive events, and Figure 27 shows denuded pit and trail areas in the Shadow Mts. used for random vehicle recreation and competititve events by both motorcycles and 4-wheel vehicles. Soil disturbances of the types illustrated create fetch areas for wind erosion; wind erosion of the denuded soils in turn contributes to air pollution and may cause dissemination of disease forms endemic in the soils.

Fig. 25.--Lancaster. Aerial view of denuded pit areas and trails north-east of Lancaster. Dark vegetation in and adjacent to trails and pit areas is Russian thistle.

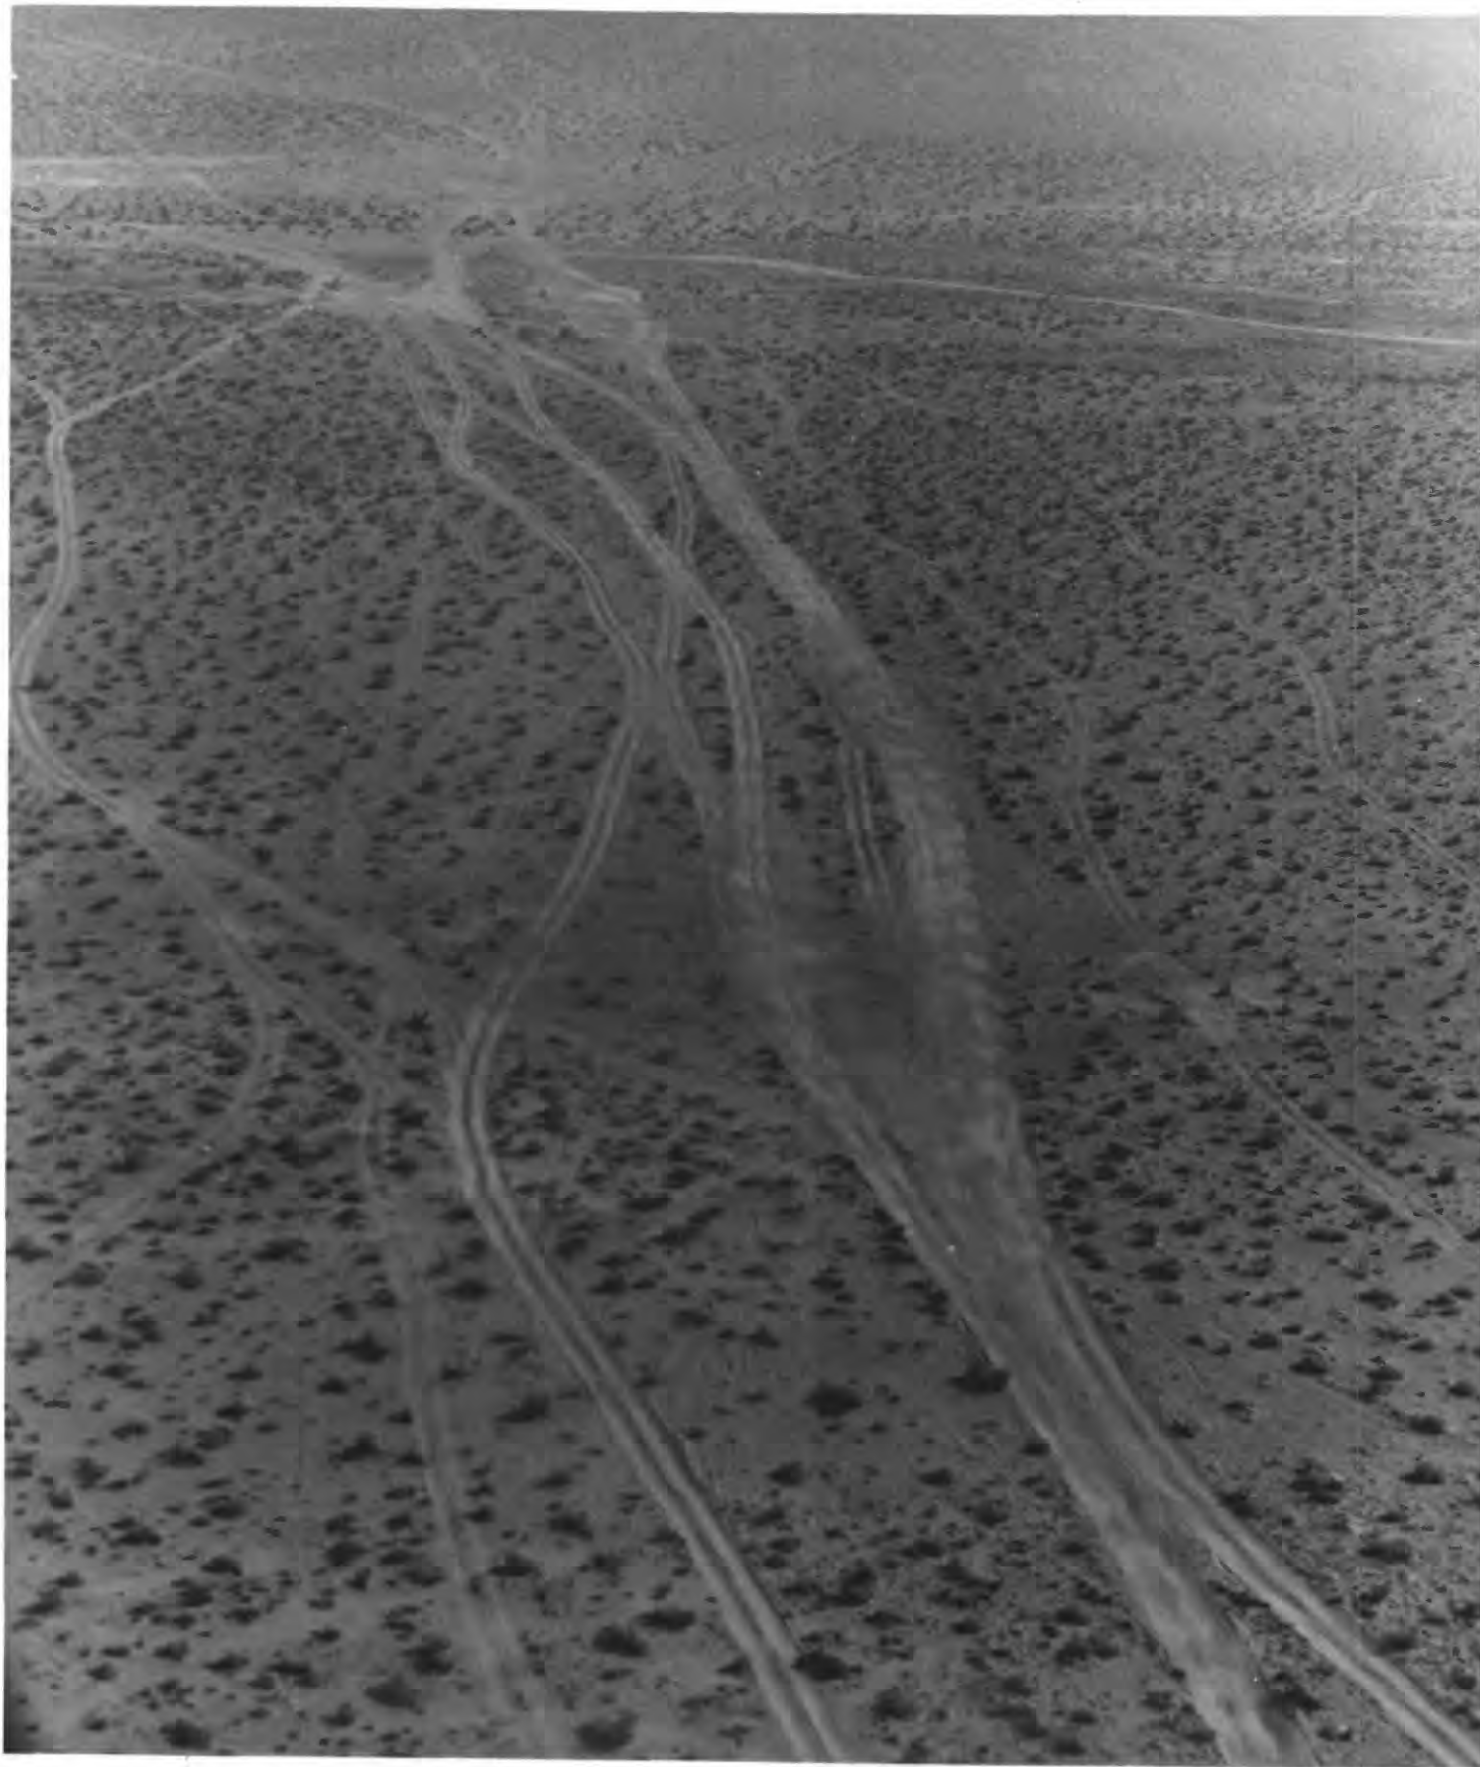
Fig. 26.--Stoddard Valley. Aerial view of trails left by 4-wheel vehicle competitive events.

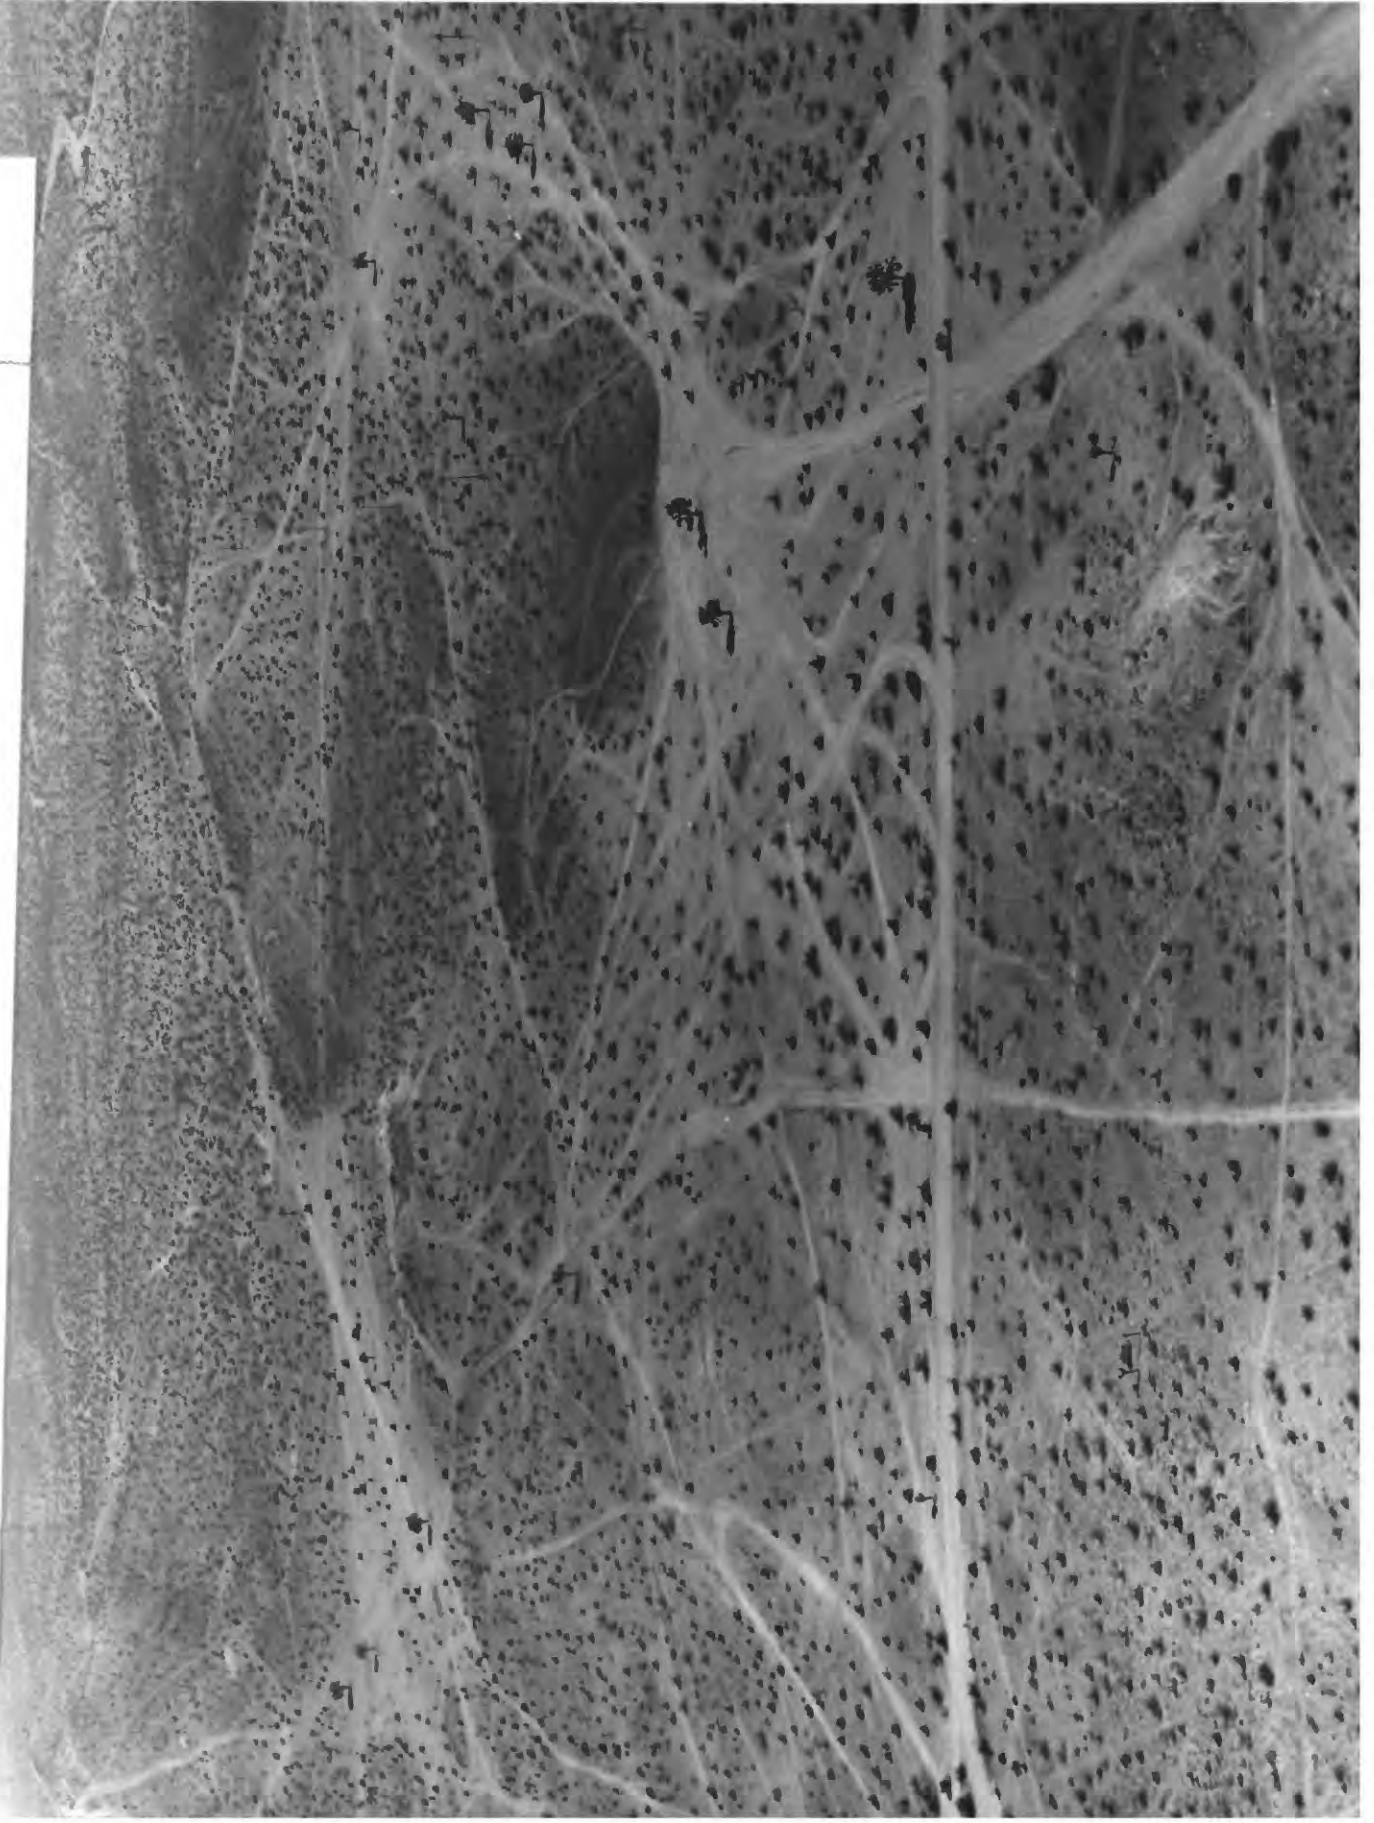
Fig. 27.---Shadow Mountains. Aerial view of pit areas and vehicle trails made by motorcycles and 4-wheel vehicles.
