UNITED STATES DEPARTMENT OF THE INTERIOR  
GEOLOGICAL SURVEY

PILLAR MOUNTAIN LANDSLIDE, KODIAK, ALASKA

OPEN-FILE REPORT

78-217

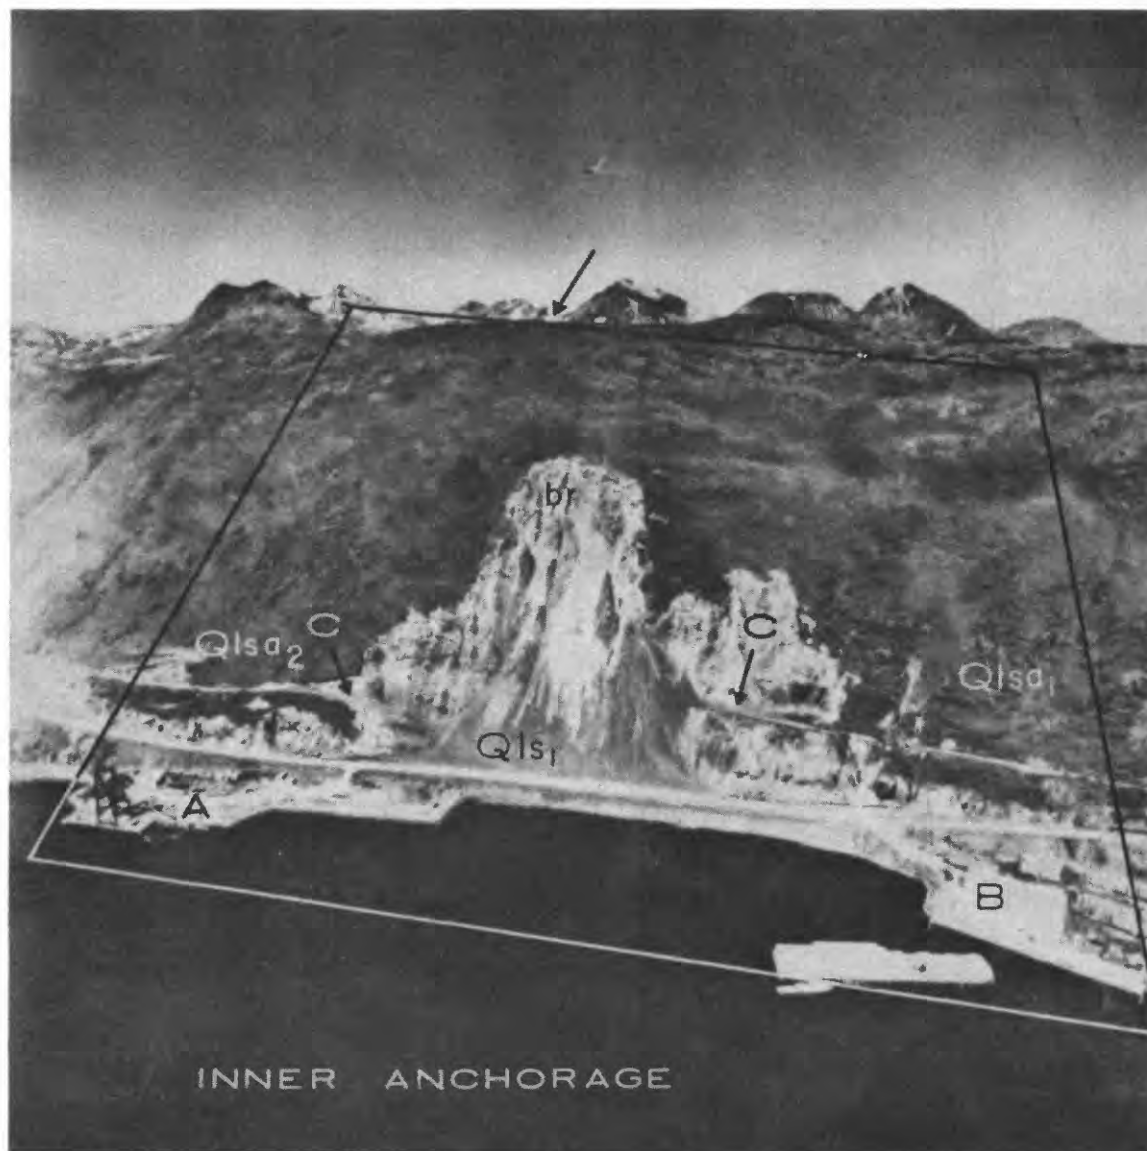
Figure 2. View northwest of Pillar Mountain landslide, Kodiak, Alaska, A, new city dock; B, dock; C, abandoned highway; arrow at skyline points to White Alice station;  $Qls_1$ , talus;  $Qlsa_1$  and  $Qlsa_2$ , ancient slide debris; br, slate, argillite, and graywacke; line indicates approximate boundaries of Plate 2.

Before 1957 or 1958, the face of the slide area was crossed by a highway at about altitude 38 to 49 m (125 to 160 ft), labeled C on figure 2 and Abandoned Highway on Plate 2. The roadway was moved to its present lower location at the base of Pillar Mountain because of rockfall and maintenance problems.

Renewed movement of the Pillar Mountain landslide began during the removal of approximately  $230,000 \text{ m}^3$  ( $300,000 \text{ yd}^3$ ) of rock from the toe of the slope of Pillar Mountain for use as fill for the new city of Kodiak dock (A on fig. 2). Material was quarried, pushed downhill from the abandoned highway (C, fig. 2) and collected at the base of the slope. It was then transported to the dock site. On Sunday, December 5, 1971, when the contractor had removed nearly  $230,000 \text{ m}^3$  of material from the base of Pillar Mountain, showers of small rocks and occasionally large rocks began cascading down the rock slope above the abandoned highway. The source for the rockfall progressed upslope from its initial altitude of about 91 m (300 ft) to about an altitude of 215 m (700 ft) for the first four days (12/5 to 12/8, 1971) and was primarily confined to a single gully (D. S. Esch and W. H. Slater (Internal Memorandum), 1971)

We learned in the fall of 1977 that the new city of Kodiak dock at the base of Pillar Mountain (A, fig. 2) is undergoing displacement. Five slope-indicator borings drilled to bedrock have been placed in the dock to measure displacement. The cause of the inferred displacement is unknown. It may be because of displacement in the fill or more deep-seated. The dock is at the base of an old landslide identified as Qlsa<sub>2</sub> in figure 2.

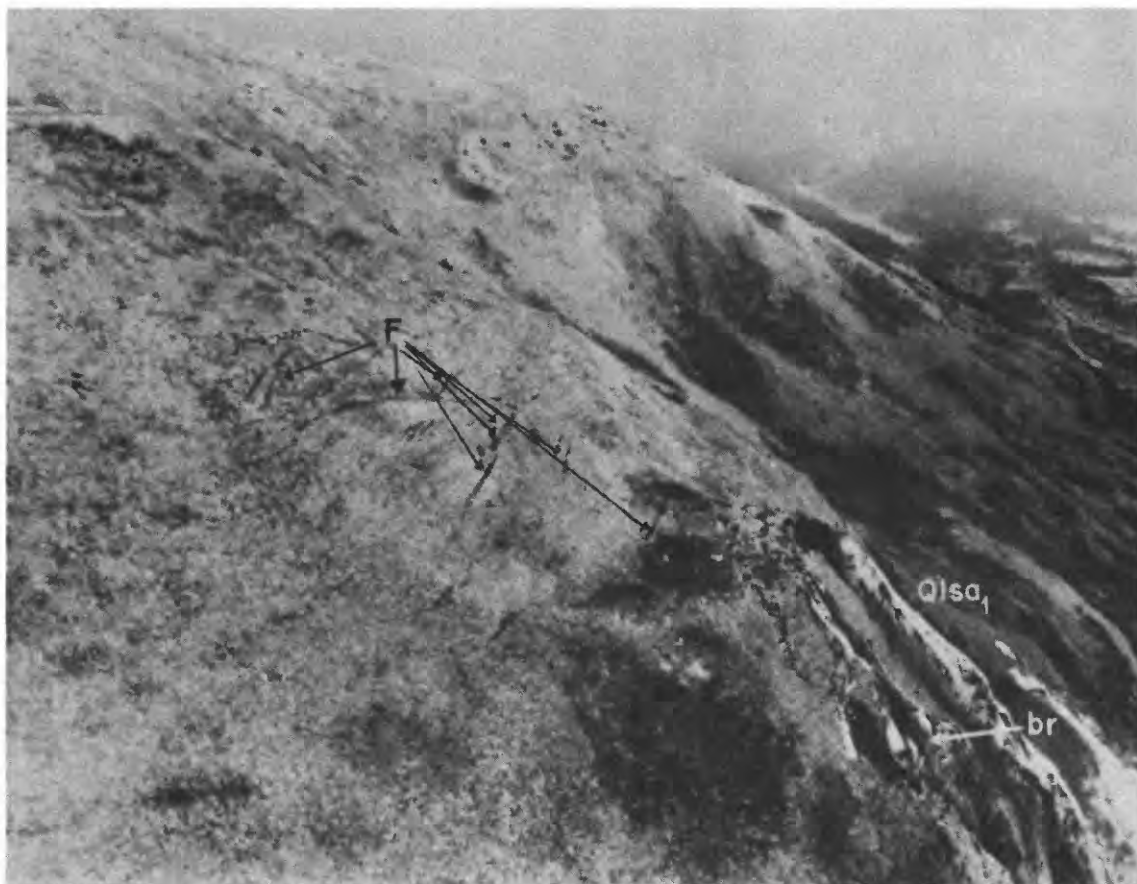
Figure 3. View northeast showing fractures on Pillar Mountain landslide, Kodiak, Alaska. F, fractures at about altitude 244 m (800 ft.);  $qlsa_1$ , ancient slide debris; br, slate, argillite, and graywacke.

fracture pattern suggested that the entire center block was moving downhill. Some of these cracks can be seen in figure 3. The uppermost crack was estimated to be approximately 122 m (400 ft) horizontally and 38 m (125 ft) vertically from the White Alice communication site (arrow, fig. 2) on the crest of Pillar Mountain at about an altitude of 381 m (1,250 ft). As snow was present on the ground and none in the cracks, the observers concluded that the cracks had developed no more than a few days prior to the December 9 aerial observations.

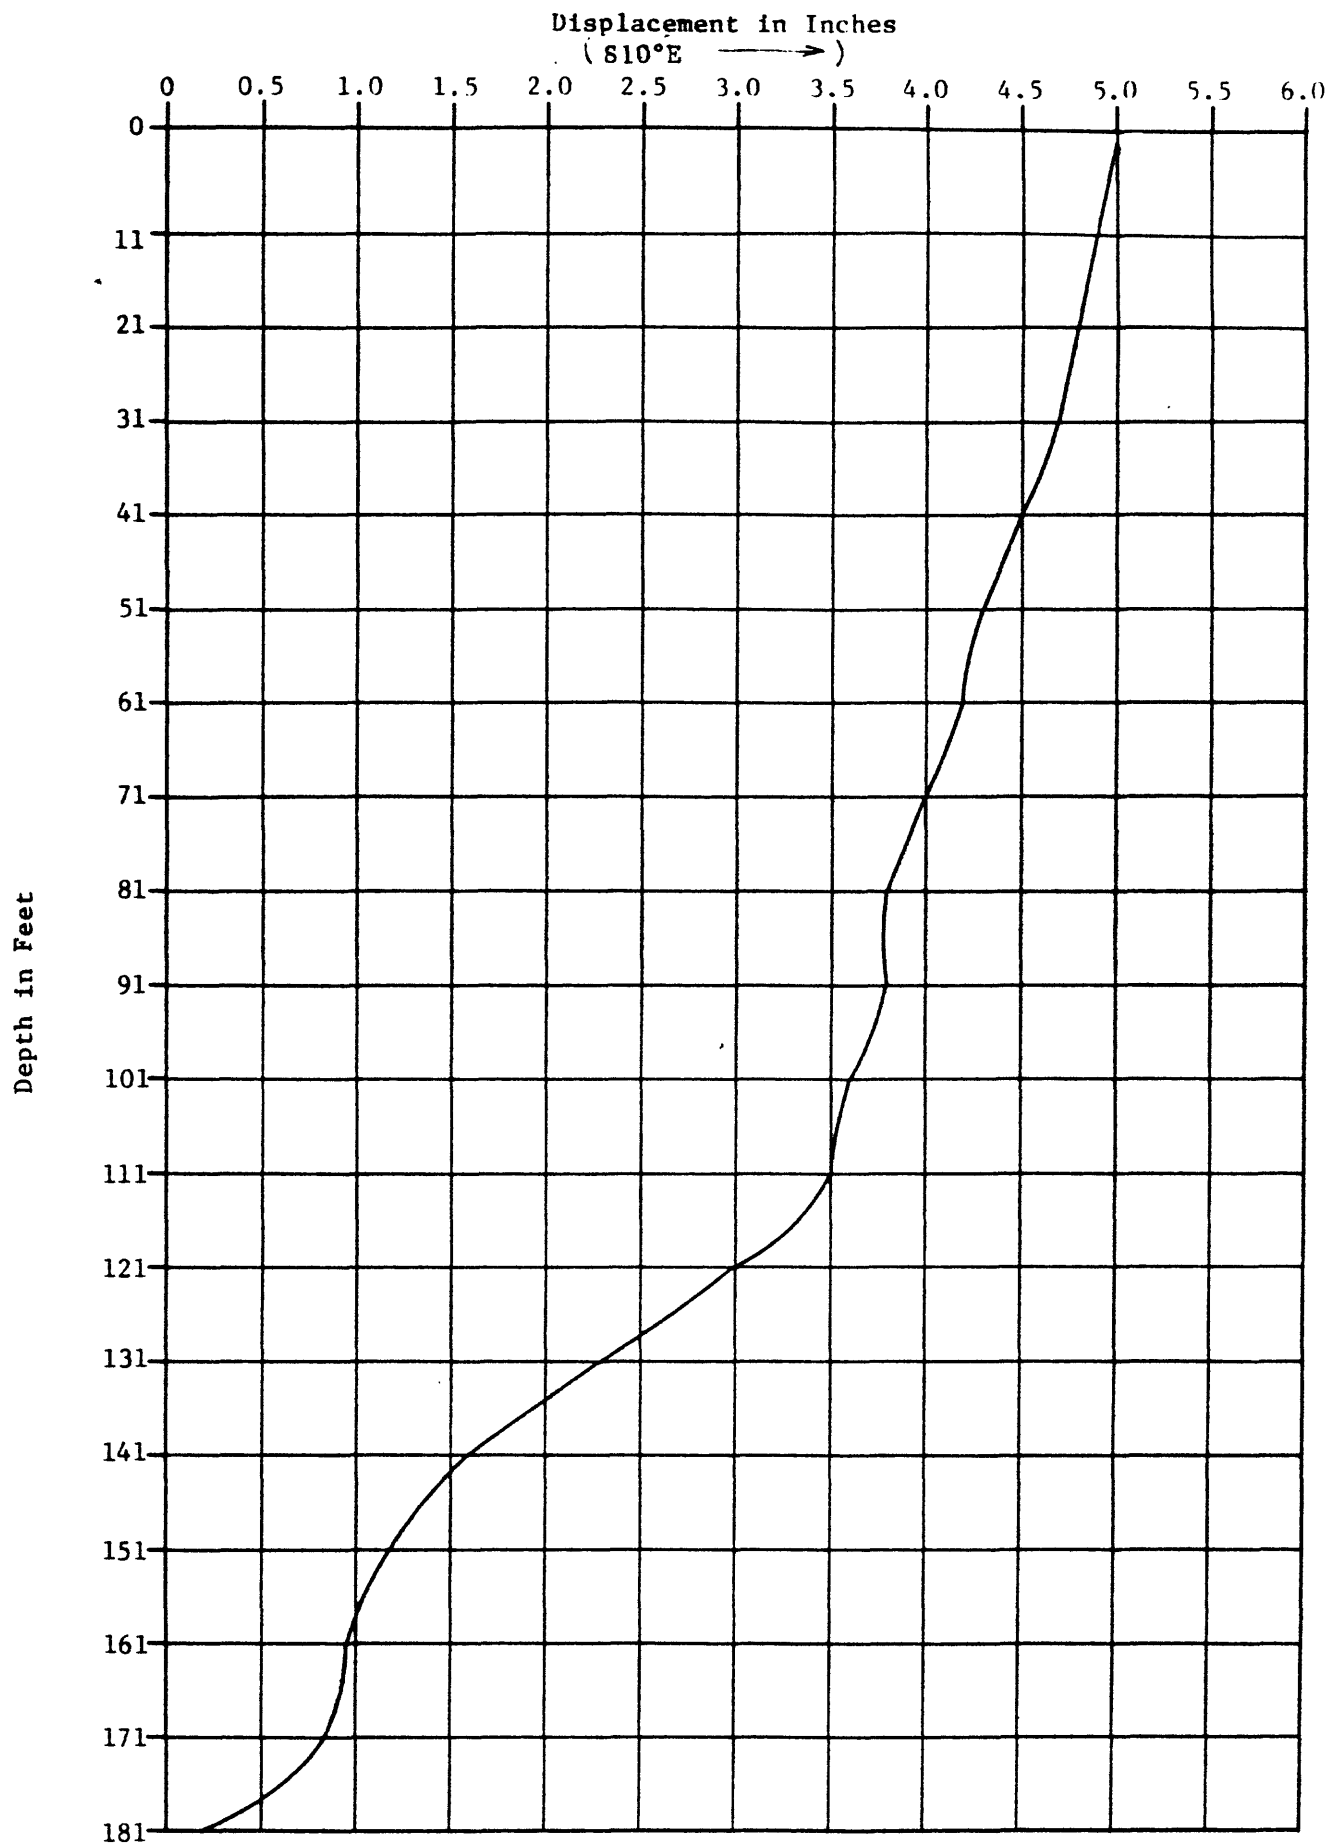
Slope-indicator readings on D.H. 1 (fig. 4) indicate a displacement of about 127 mm (5.0 in) in a S10°E direction between the initial reading on September 25, 1972, and readings on August 3, 1976 (plotted as dashed vector, Plate 2). More than one-half of the total displacement occurred between the depths of 33.8 to 49.1 (111 to 161 ft). Nearly 25 mm (1 in) of movement was recorded in the lower 6.1 m (20 ft) of the hole and the data do not conclusively prove that the casing extends entirely through the landslide.

Figure 4. Slope indicator data, D. H. 1, showing amount of displacement between September 25, 1972, and August 3, 1976

There is an apparent discrepancy of the data in D.H. 1. The slope-indicator data suggest 127 mm (5 in) of downslope movement between the top and bottom of the casing. The surface survey of the same point suggests 165 mm (6.5 in) of downslope displacement. The slope-indicator data suggest that movement may be occurring below the slope-indicator casing. We believe that this may be so and that the 38 mm (1.5 in) apparent discrepancy may in fact be a record of displacement below the casing between October, 1972 and October, 1976.

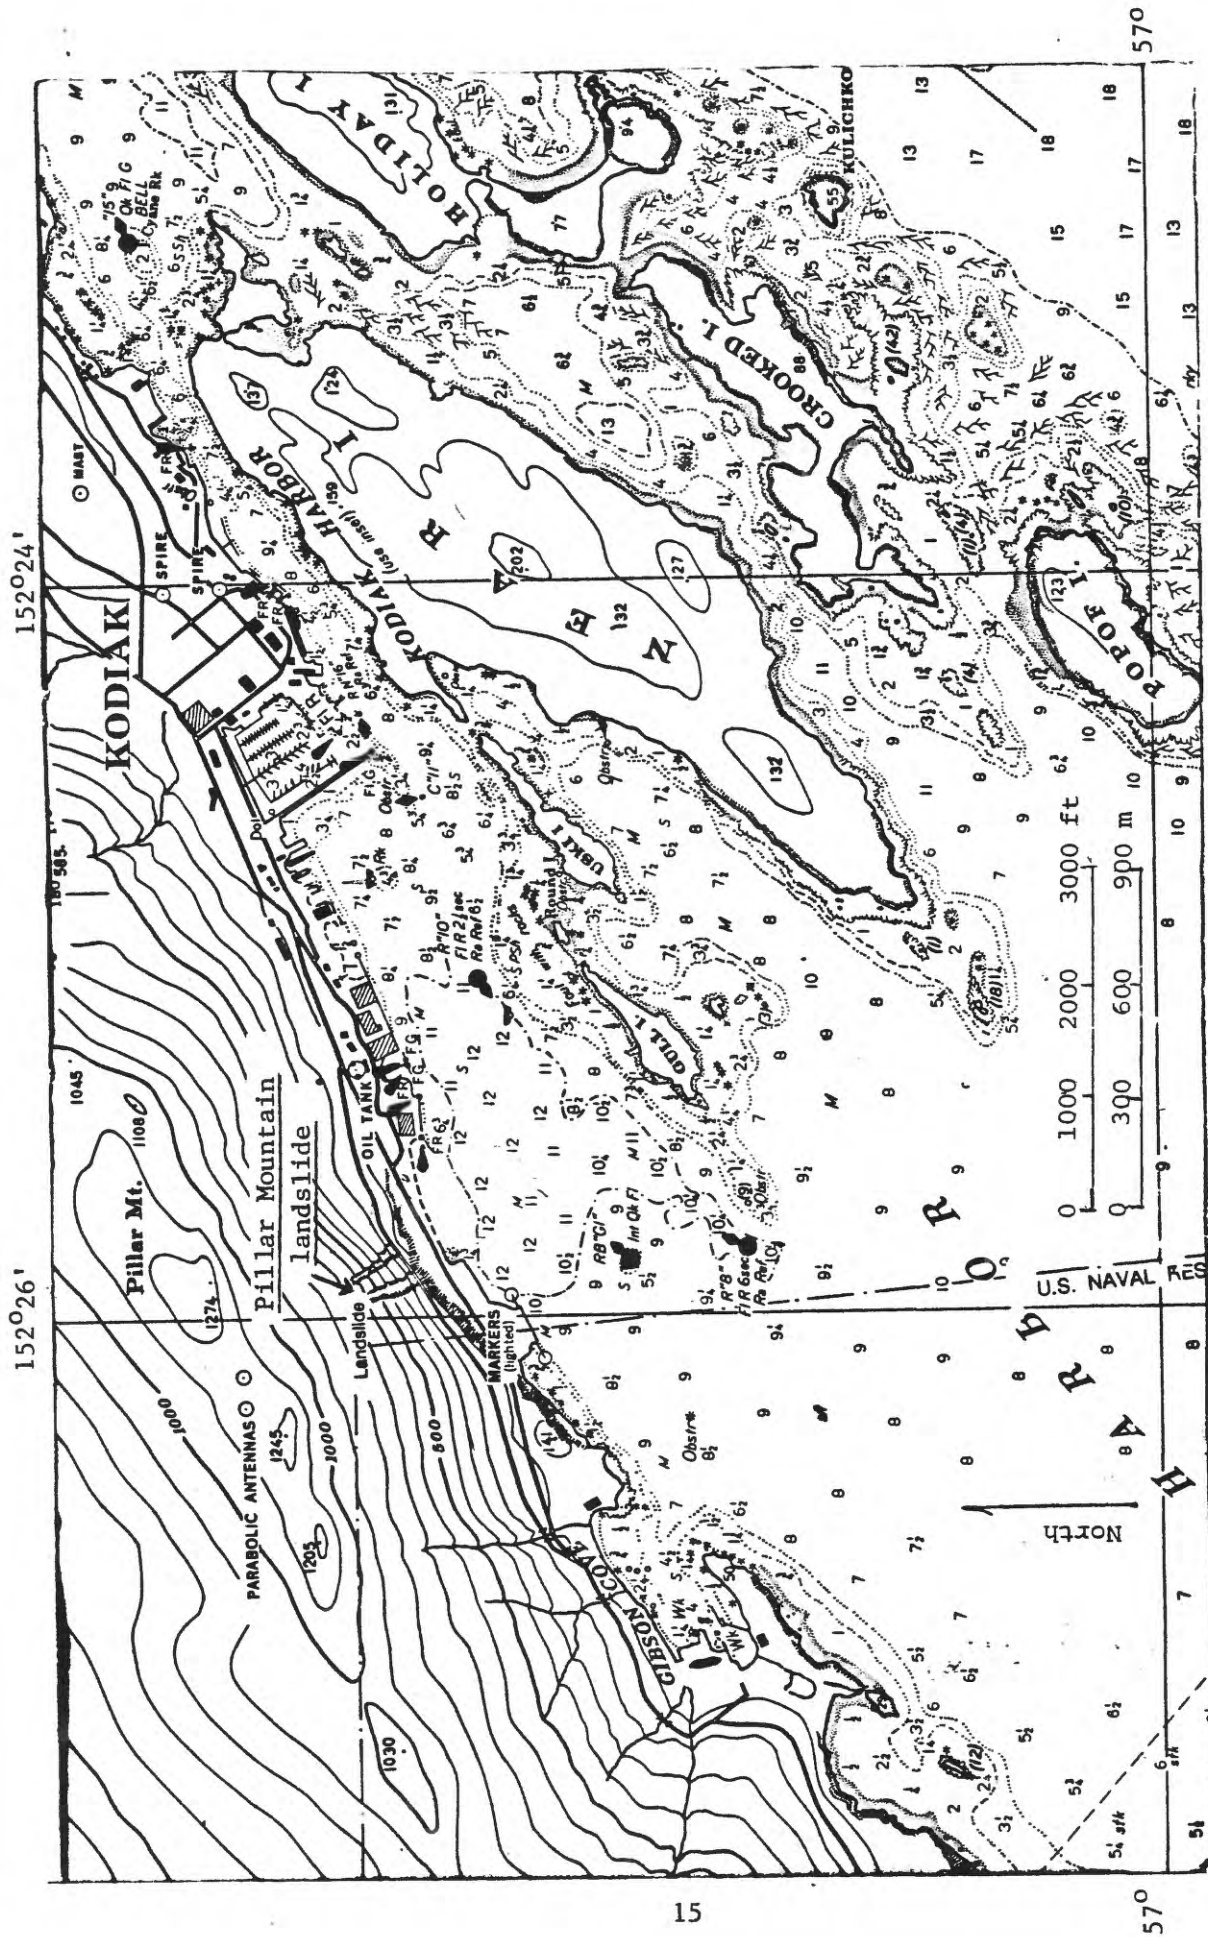
To determine whether the Pillar Mountain landslide had, in the past, slid to the bottom of the slope, we made an analysis of the offshore bathymetry at the base of the mountain. The study showed a large submarine basin with an average depth of 12 fathoms (fig. 5). On either side of the basin, the depth of the water is about 9 fathoms, or about 3 fathoms shallower than the basin. Although it is possible that the basin is a feature of marine processes, we believe it may exist because ancient slides on both sides of Pillar Mountain slid to the base of the slope or into Inner Anchorage, resulting in the relatively shallow depths below them.

Figure 5. Bathymetry of Inner Harbor, Kodiak, Alaska. Soundings in fathoms, datum MLLW; scale 1:20,000; from NOAA Chart No. 16595--Kodiak and St. Paul Harbors, May 10, 1975.

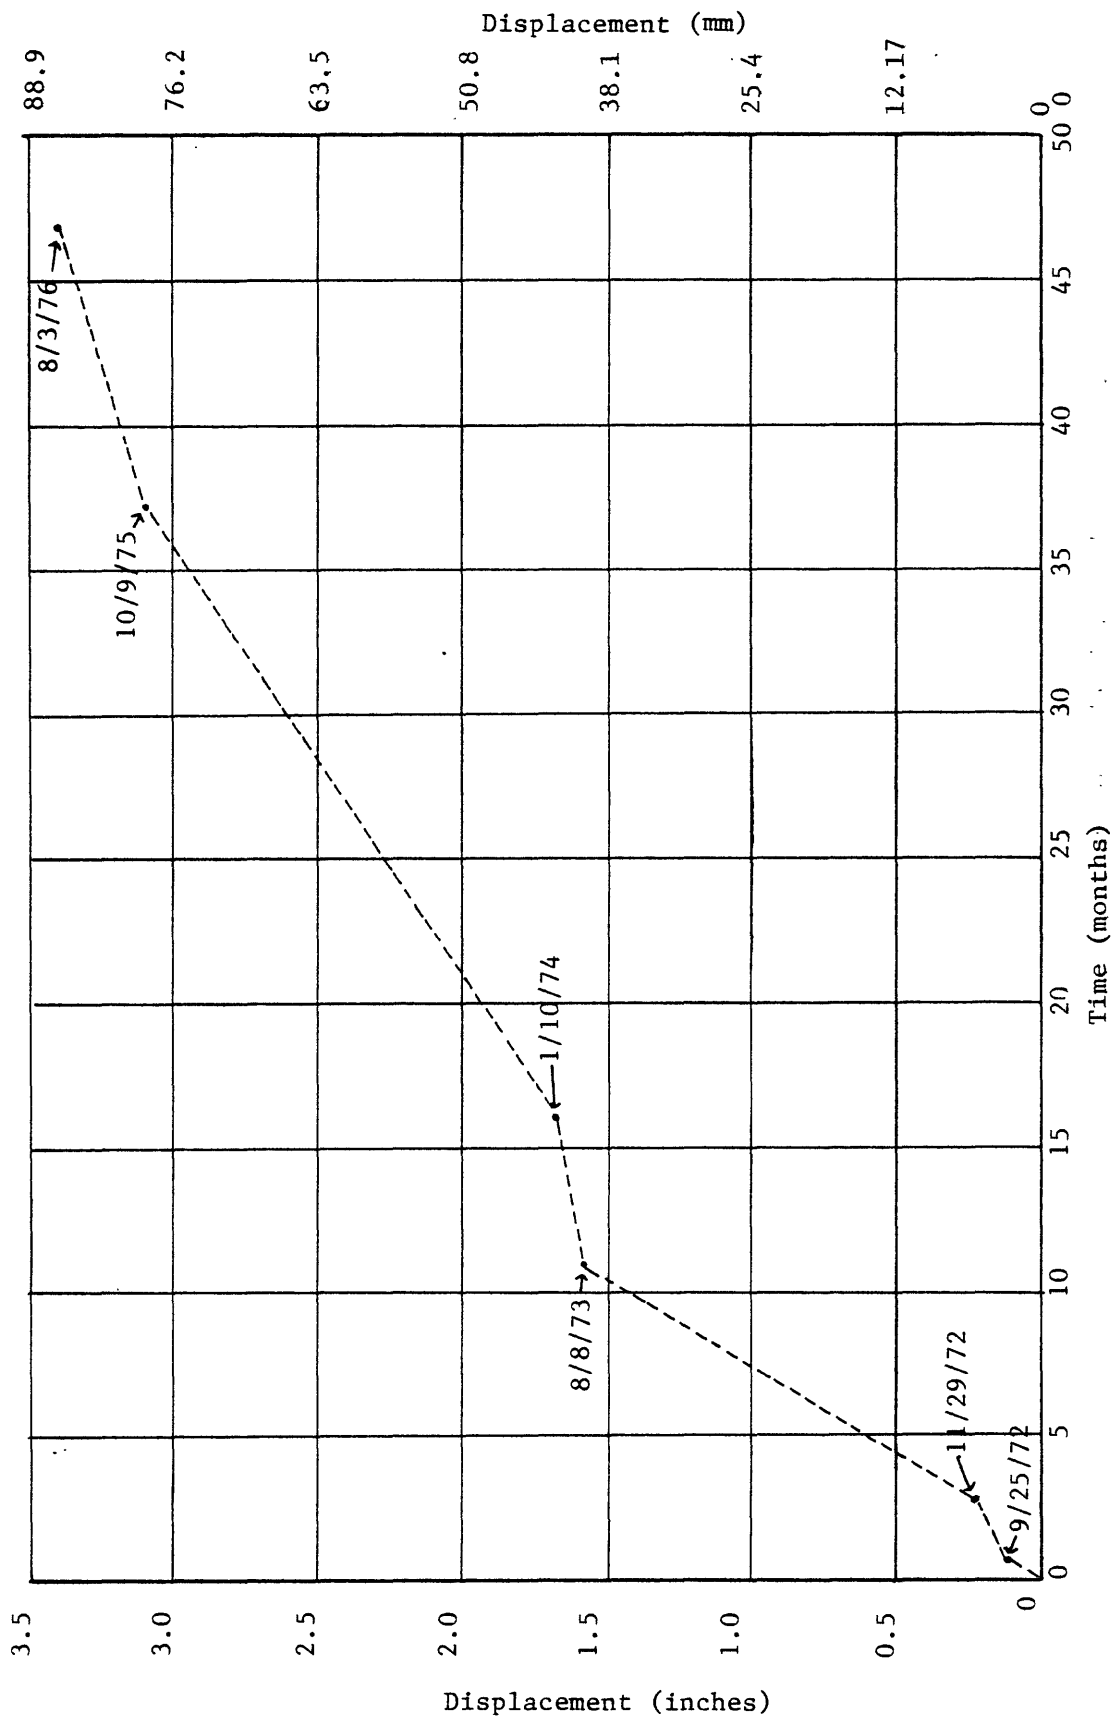
Movement of the Pillar Mountain landslide continues, although it has decelerated relative to the movement observed in December, 1971. Figure 6 shows time versus displacement between September 25, 1972, and August 3, 1976, at a depth of 33.8 m (111 ft) in D.H. 1. Because of the limited number of observations, we are unable to define the type and nature of movement.

Figure 6. Graph showing time vs. displacement at a depth of 111 feet (33.83 m) in D.H.I., Pillar Mountain Landslide, Kodiak, Alaska,
