UNITED STATES
DEPARTMENT OF THE INTERIOR
GEOLOGICAL SURVEY

The Willits, California, Magnitude-4.8 Earthquake
of November 22, 1977

Open-File Report 78-1075

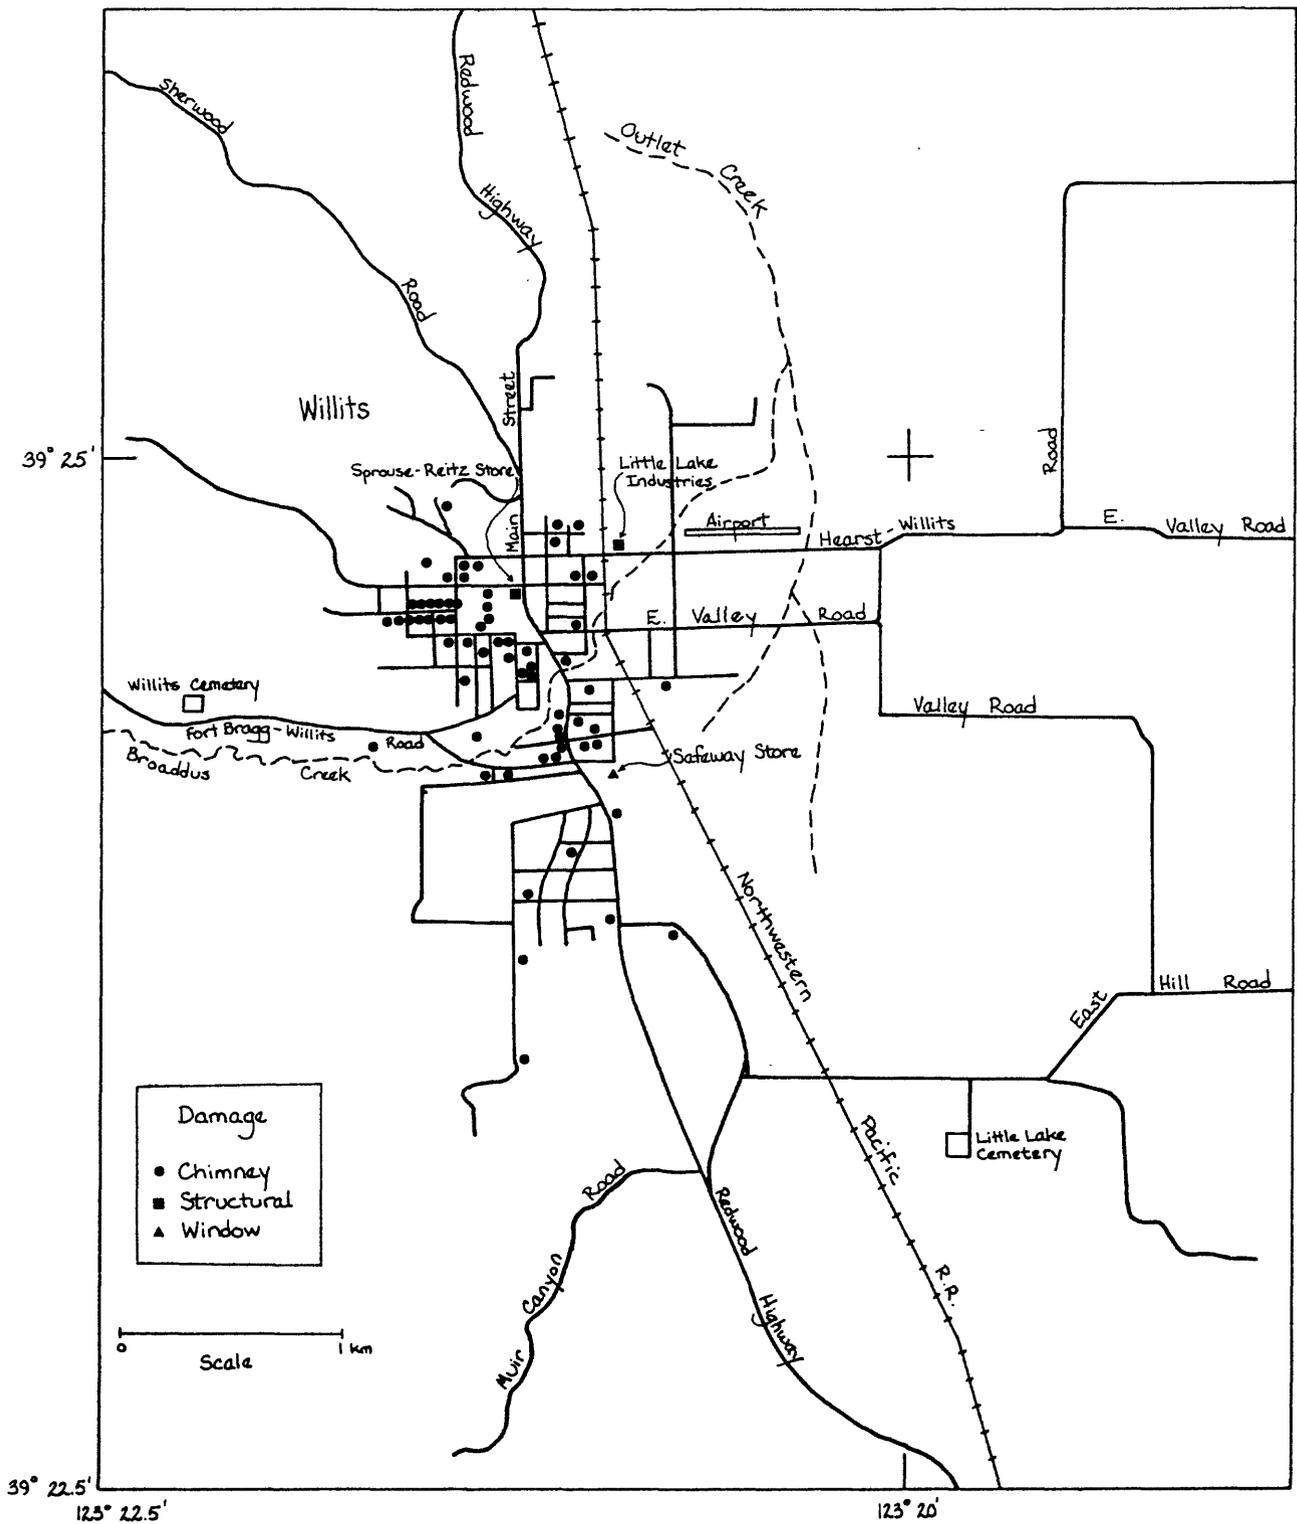
No physical evidence that an earthquake had occurred was found in the vicinity of the preliminary epicenter (USGS), which was stated to be 4 km east of Willits and was used in the reconnaissance study. The epicenter, determined by Berkeley and used in this report, 9 km east of Willits, is in an uninhabited, mountainous area. In the city of Willits, damage was concentrated in the business and residential areas west of the Northwestern Pacific Railroad tracks (fig. 1).

Two buildings were reported to have suffered structural damage: the Sprouse-Reitz Store at 150 S. Main St. and a warehouse-type building that houses Little Lake Industries near the northeast corner of Hearst-Willits Road and the Northwestern Pacific Railroad tracks. The team was refused entrance to Little Lake Industries; therefore, the nature of the structural damage could not be determined. The Sprouse-Reitz Store is in two old buildings, one brick and one concrete, joined lengthwise in an east-west direction. Flat roofs are supported by reinforced concrete columns about 30 cm square; there are no north-south walls in this store. The two parts of this store responded differentially to the shaking, as evidenced by cracks and offsets of as much as 12 mm along the join. Patches of new brick (ca. 1972) in the old brick wall also responded independently, as cracks outlined the patches and offsets of as much as 12 mm were formed. Near the building join, the concrete columns were cracked and the ceiling of the concrete building had dropped as much as 50 mm. Evidence of some pounding between the two parts was suggested by damage to cabinets and fixtures fastened to the wall near the join. Aftershocks on the morning of November 23 had damaged the front plate-glass windows, by north-south distortion of the building and window frames.

Figure 1.--Map showing the area of damage in Willits, California, from the November 22, 1977, earthquake.

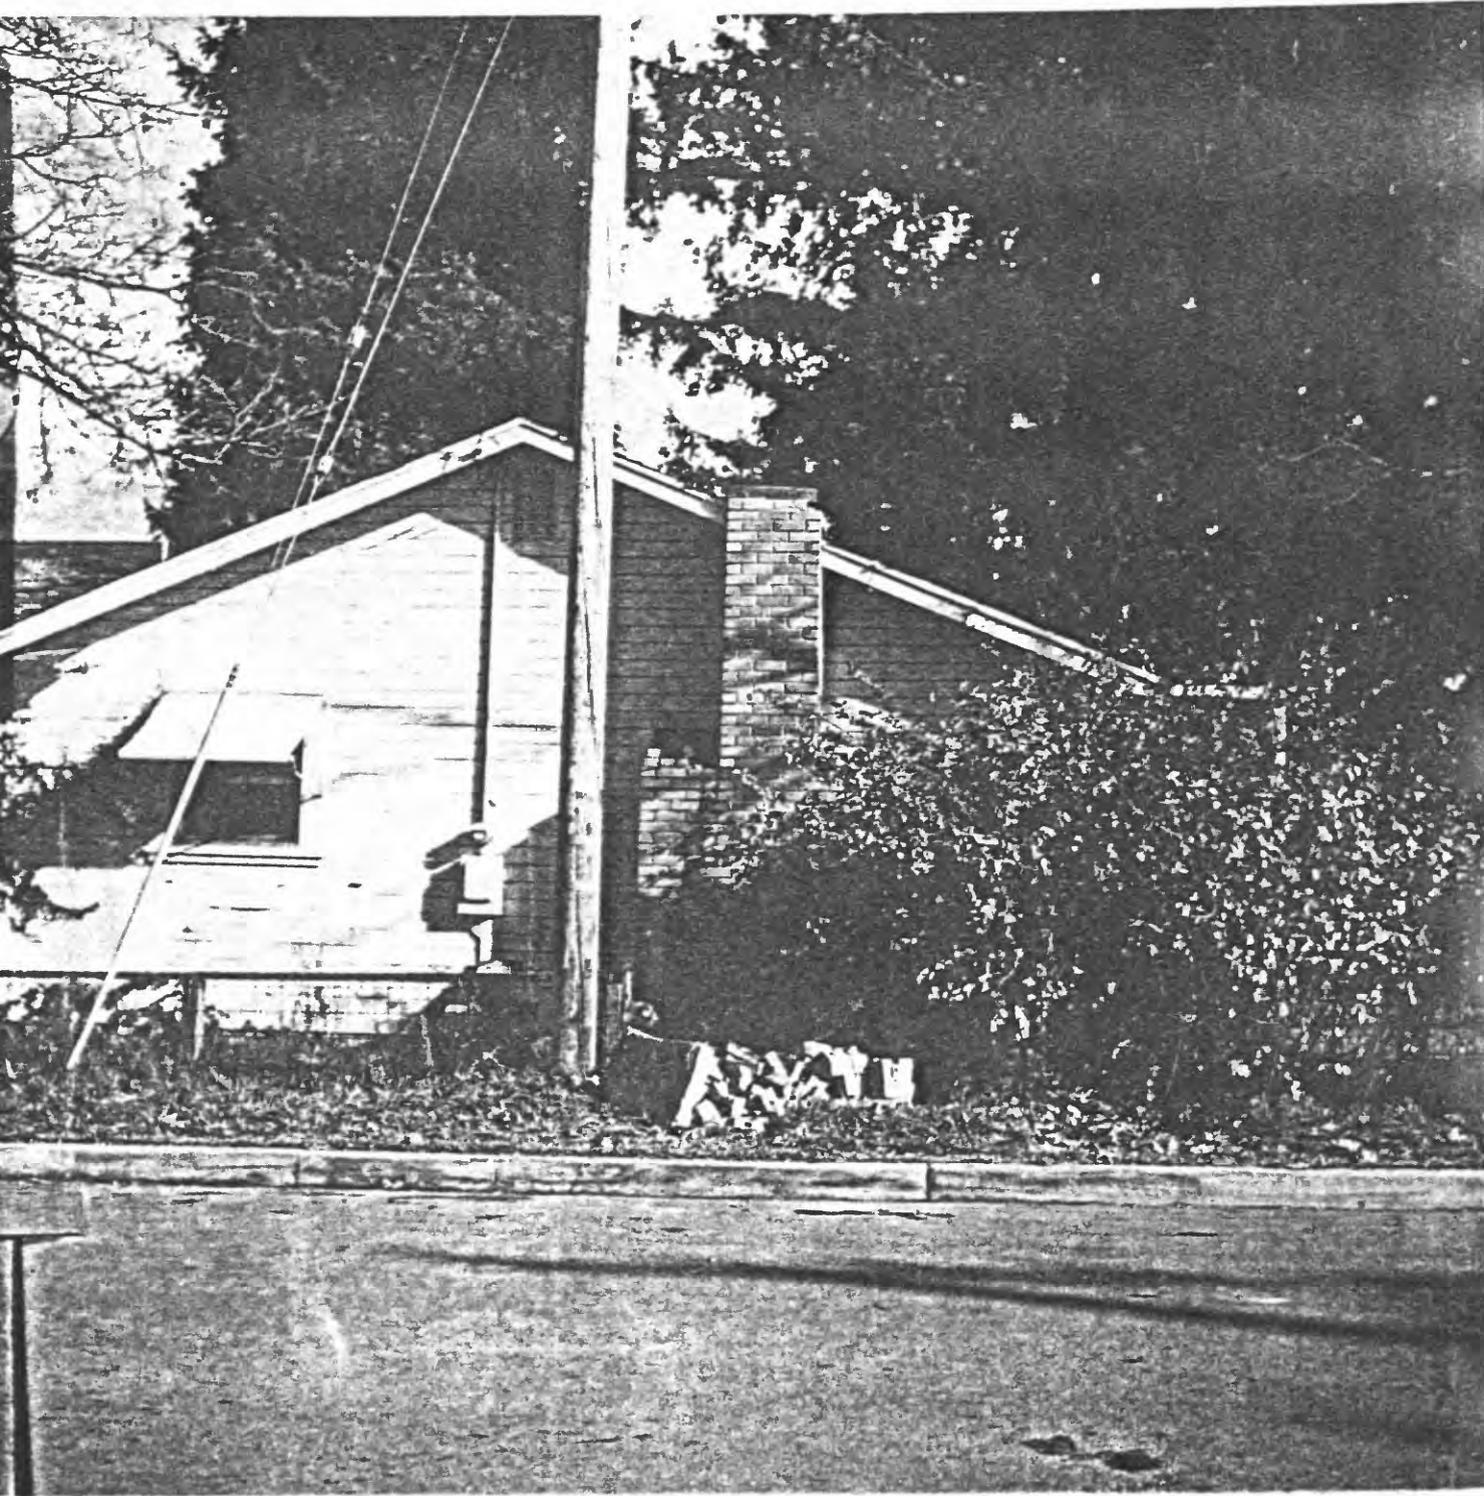
The damage described is mainly to old, weakened chimneys which probably were standing at the time of, or built shortly after, the 1906 San Francisco earthquake. The structural damage to two or three old buildings is normal for an earthquake of magnitude 4.8.

A drive-through inspection of the cemeteries revealed no toppled monuments; individual monuments were not examined for signs of having been rotated. On the west side of Main Street in the major residential district, damage appeared to have been restricted to brick chimneys on houses estimated to be at least 30 years old and more likely more than 50 years old. Damage to many chimneys was confined to the upper end, within the uppermost two or three courses of brick. Only a few chimneys were seen that had been reduced to the roofline (fig. 2), and it is not known if these chimneys actually collapsed to the roofline or were razed to that point during the subsequent cleanup operation which began soon after the main shock. At least ten of the damaged chimneys were broken midway between the roofline and top, the upper part being offset in a clockwise direction of 5° to 45° from the lower part; only two damaged chimneys were seen to be offset in a counterclockwise sense. The chimneys which suffered the most damage were old unreinforced brick and mortar construction. In contrast, newer chimneys, probably all less than 30 years old, appeared to be undamaged. Presumably, they contained reinforcing steel, but all were brick and mortar surrounding a fire-clay flue which itself may have acted as reinforcement. Forty-nine damaged chimneys were seen during the reconnaissance of the November 22 earthquake. A more accurate tally by the City Building Inspector later listed a total of 65 chimneys damaged by the November 22 shock. All of these defined a north-northwest-trending zone about 2.6 km long and 0.6 km wide, bounded on the east by the railroad and on the north by Willits Creek. Thirty-four of these chimneys were concentrated in the northern third of this zone; the remainder were scattered throughout the southern two-thirds. The highest concentration of damage was on Redwood Street, where 13 damaged chimneys were seen in a three-block area.

Figure 2.--Earthquake chimney damage, Willits, California, November 22, 1977.
(Photo courtesy of R. E. Wallace, U.S. Geological Survey.)
