CLODINE FAULT, SOUTHWESTERN HOUSTON

METROPOLITAN AREA, TEXAS

U.S. Geological Survey
Open-File Report 79-947
1979

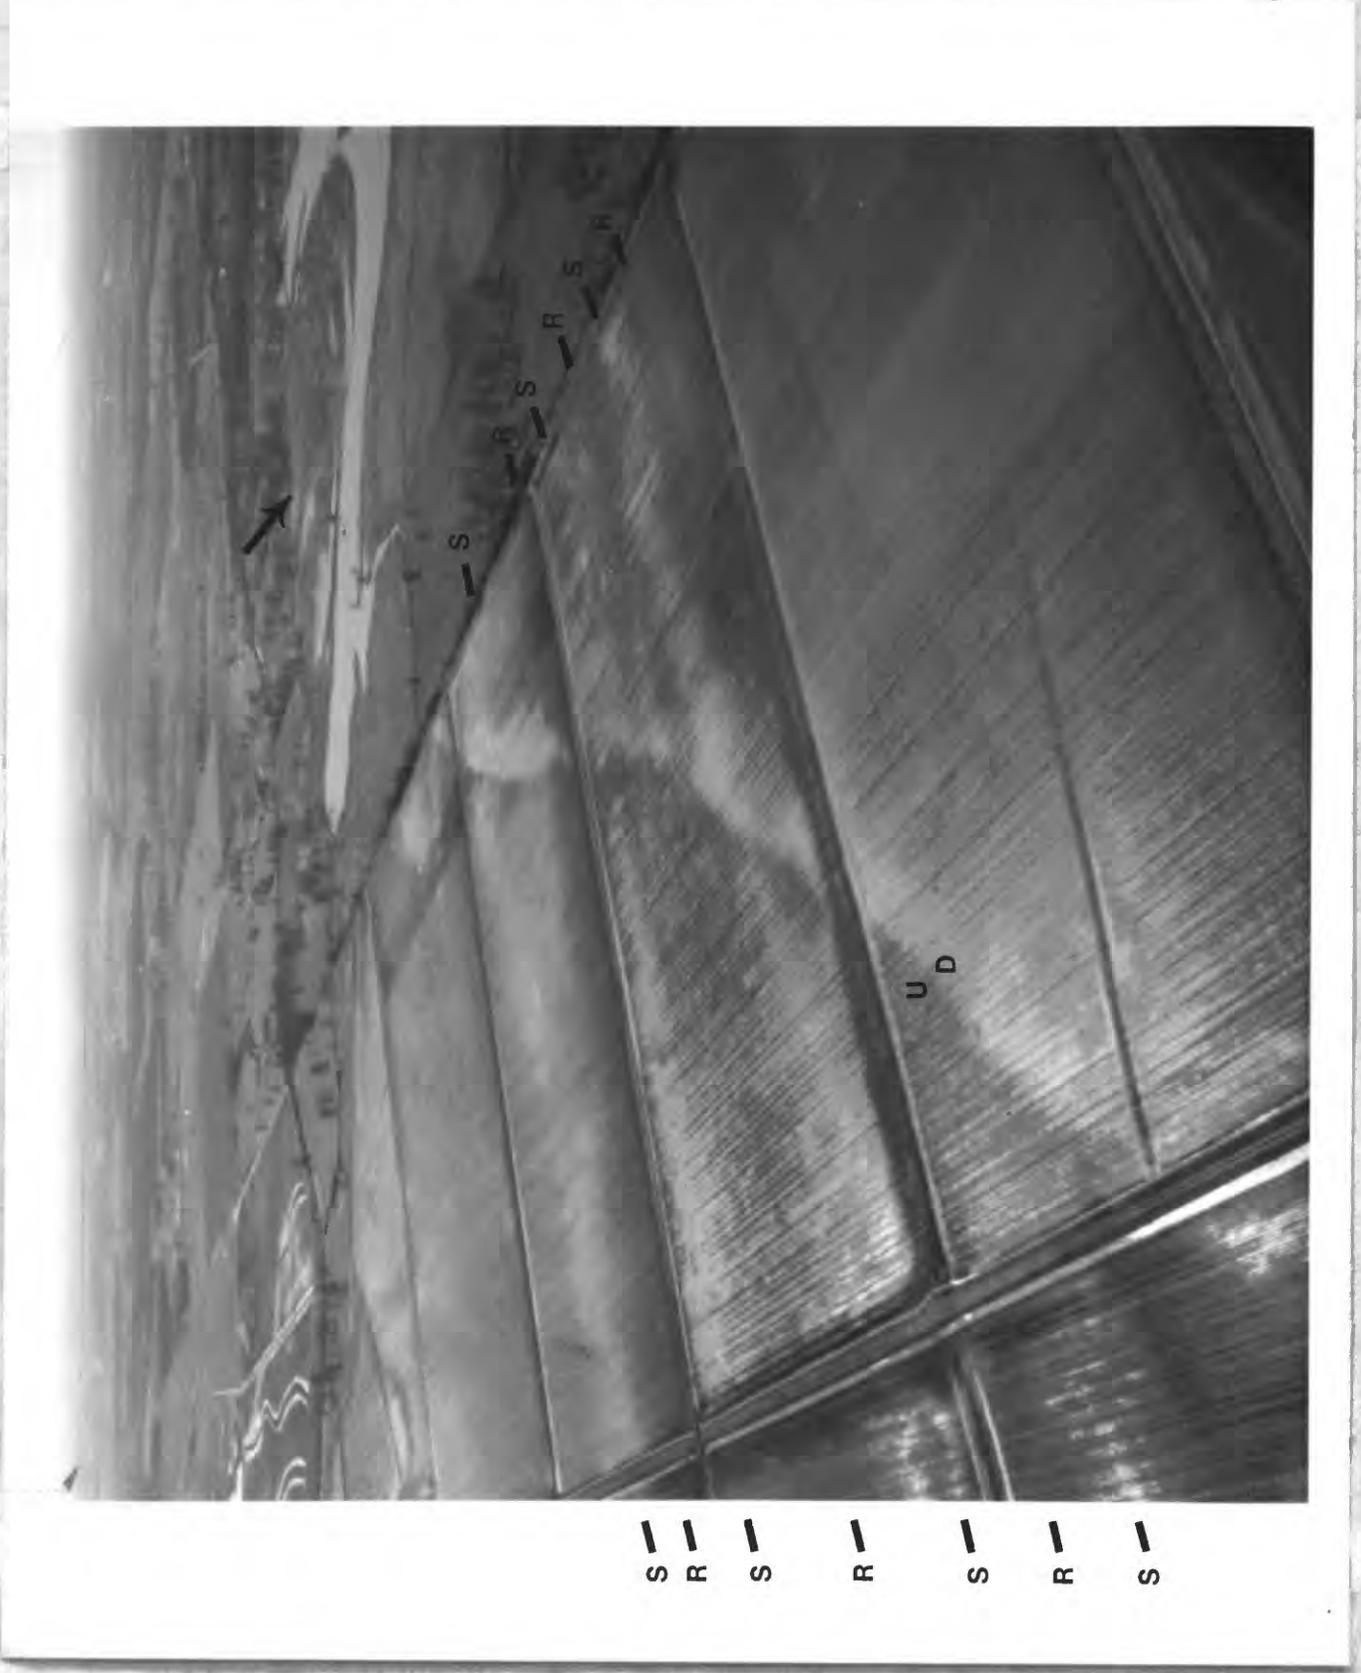
Figure 2. (following page).--Oblique aerial photograph (NASA photo S-78-26931) of western part of Clodine fault, looking southwest toward Figure Four Lake (pl. 1). R and S identify ridge-and-swale topographic features typical of point-bar* deposits. A similar but younger point bar is visible on the inside bend of Figure Four Lake (arrow), a remnant of an old and now-abandoned stream channel.

Topographic details of the faulted point bar are best visible on aerial photographs after a heavy rain, when water (light tones) occupies the swales of the point bar and the downthrown side of the fault is flooded. The slope that marks the fault may be followed readily through the fields, but the scarp has been all but destroyed by repeated plowing.

Offset of point-bar deposits in this area (fig. 2) furnishes the most conclusive evidence that the observed feature is a fault scarp.

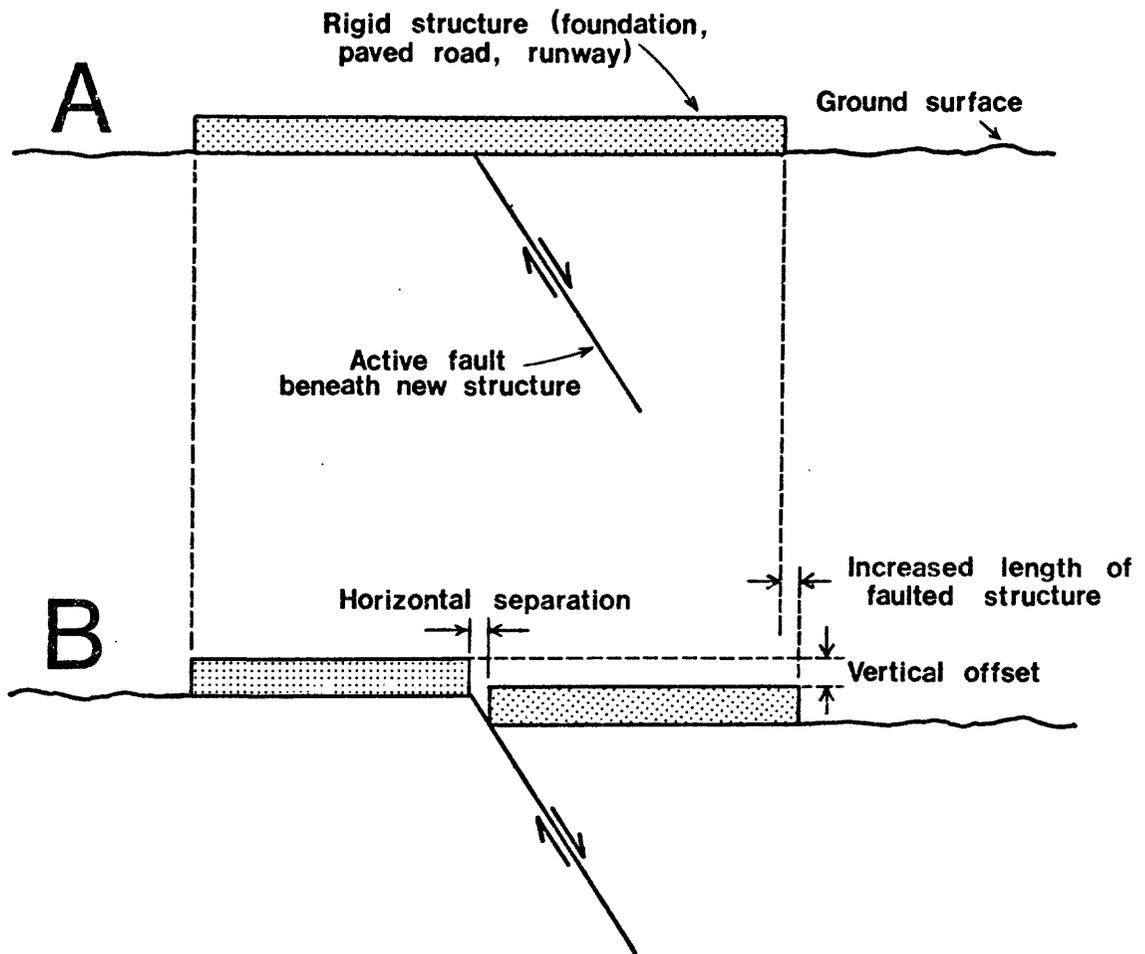
Figure 3.--Effect of fault movement on a rigid structure built on an active fault. A, original construction; B, structure damaged by fault movement. Both vertical offset and horizontal separation are necessary consequences of displacement. Rigid structures may literally be pulled apart as faulting proceeds.

Common effects of fault movement beneath buildings include foundation failure (and attendant periodic infiltration of water), tilted floors, distorted window and door frames, leaking roofs, and extensive damage to facing materials and interior walls. The road network in the Houston area has also been damaged by fault movement at hundreds of locations, some of which have necessitated repair at intervals as frequent as every 2 years.

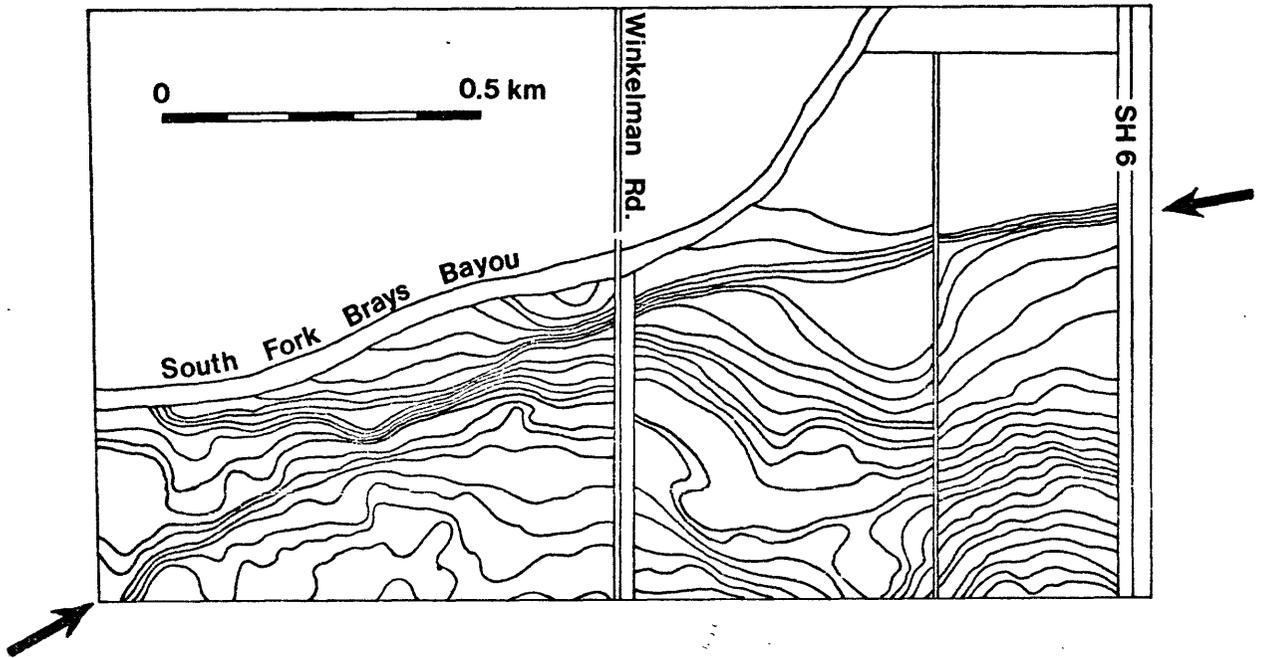
Figure 4.--Pattern of old rice levees, traced from a 1972 aerial photograph, in fields west of SH (State Highway) 6. Each sinuous line in the figure represents the crest of a levee, which is everywhere at a nearly constant elevation. Rice levees approximate contour lines as seen on topographic maps, and, like contour lines, they can be used to interpret the shape of the land surface: the more closely spaced the levees, the steeper the slope of the land. The zone of closely spaced levees that crosses the figure in an east-northeast direction (arrows) is the scarp of the Clodine fault. Although the fault scarp is apparent in the pattern of rice levees, grading of these fields prior to planting has modified and subdued all original slopes. The scarp is now 20-30 m wide. The trace of the Clodine fault can be located only approximately from surface evidence.

Closely spaced, subparallel rice levees (fig. 4) allow easy identification of the fault in this segment. The spacing of rice levees

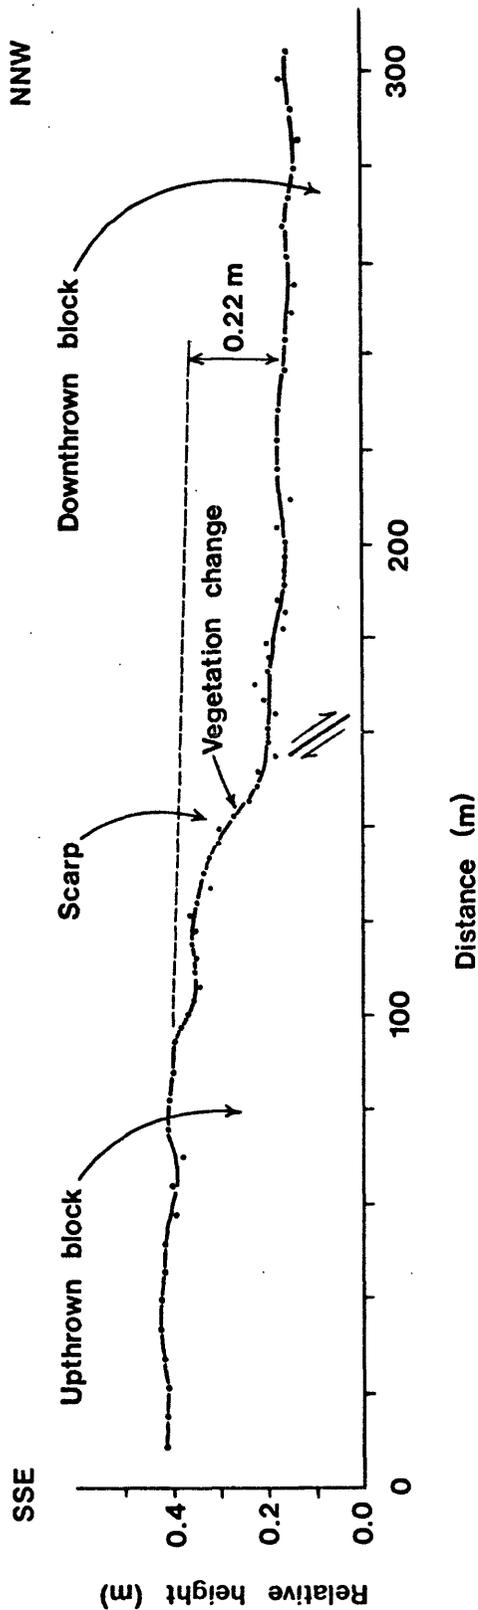
Figure 6.--Topographic profile of Clodine fault in field east of Farm-to-Market Road 1464 (pl. 1). The fault scarp, although well-defined, is also rather broad (about 20 m) and has probably been disturbed by past cultivation. Recent plowing has further subdued the scarp, yet it persists as an obvious element of the local landscape.

A well-defined vegetation break, from shrubs and prairie grasses on the upthrown block to broad-leaved grasses on the dowthrown block, was noted during our 1975 survey at the location indicated above.
