**DEPARTMENT OF THE INTERIOR
UNITED STATES GEOLOGICAL SURVEY**

**RECONNAISSANCE REPORT ON GROUND FAILURES AND GROUND CRACKS
RESULTING FROM THE COYOTE LAKE, CALIFORNIA,
EARTHQUAKE OF AUGUST 6, 1979**

**Open File Report 80-139
January 1980**

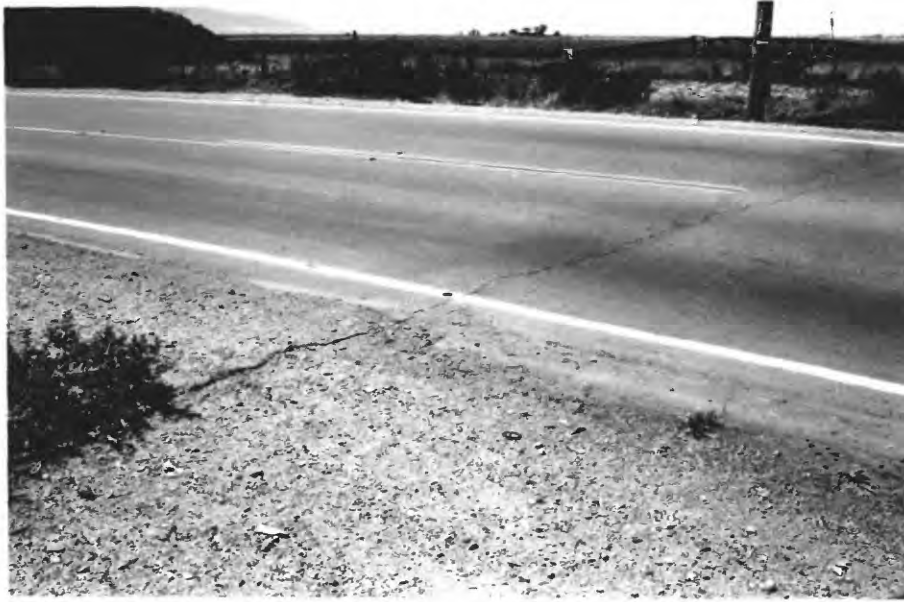
The longer crack, which was 10 m long and 10mm wide, contained several left-stepping en echelon segments with north-south strikes (fig. 1). The orientation of these

segments relative to the fault trace is consistent with right-lateral shear displacement on the fault (Slemmons, 1977). Maximum vertical offset on the crack was 25 mm, with the east side being displaced relatively downward. The crack showed no lateral offset on August 6. When the site was re-examined on September 25, 1979, however, 5 mm of right-lateral offset was observed on a north-striking subsidiary crack that developed after the earthquake (fig. 2).

The occurrence of these two cracks on and subparallel to the mapped fault trace, their association with a subsidiary crack that subsequently showed right-lateral offset, and the left-stepping en echelon segments in the longer crack indicate that the cracks were surface expressions of the fault.

Figure 1: (Site 3) Crack in pavement on trace of Calaveras fault, a few meters west of Shore Road bridge over Tequisquita Slough. View is northwest. Crack was 10 mm wide. Maximum vertical offset was 25 mm, with the east side down; crack showed no lateral offset. Crack contained several left-stepping, en echelon segments; strike of these segments relative to fault trace was consistent with right-lateral shear. This crack and a shorter crack through the north shoulder of the road had strikes subparallel to the fault. Highway center stripe ended at patch in pavement; the road had been patched before the earthquake, probably because of damage due to fault creep. The two cracks were surface expressions of movement on the fault during the earthquake. Photograph taken 8/6/79.

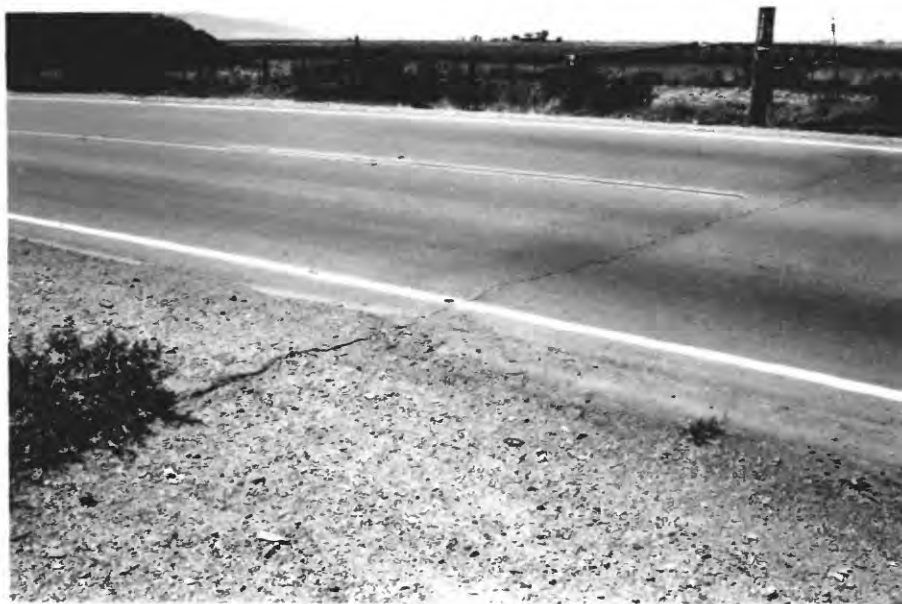
Figure 1: (Site 3) Crack in pavement on trace of Calaveras fault, a few meters west of Shore Road bridge over Tequisquita Slough. View is northwest. Crack was 10 mm wide. Maximum vertical offset was 25 mm, with the east side down; crack showed no lateral offset. Crack contained several left-stepping, en echelon segments; strike of these segments relative to fault trace was consistent with right-lateral shear. This crack and a shorter crack through the north shoulder of the road had strikes subparallel to the fault. Highway center stripe ended at patch in pavement; the road had been patched before the earthquake, probably because of damage due to fault creep. The two cracks were surface expressions of movement on the fault during the earthquake. Photograph taken 8/6/79.

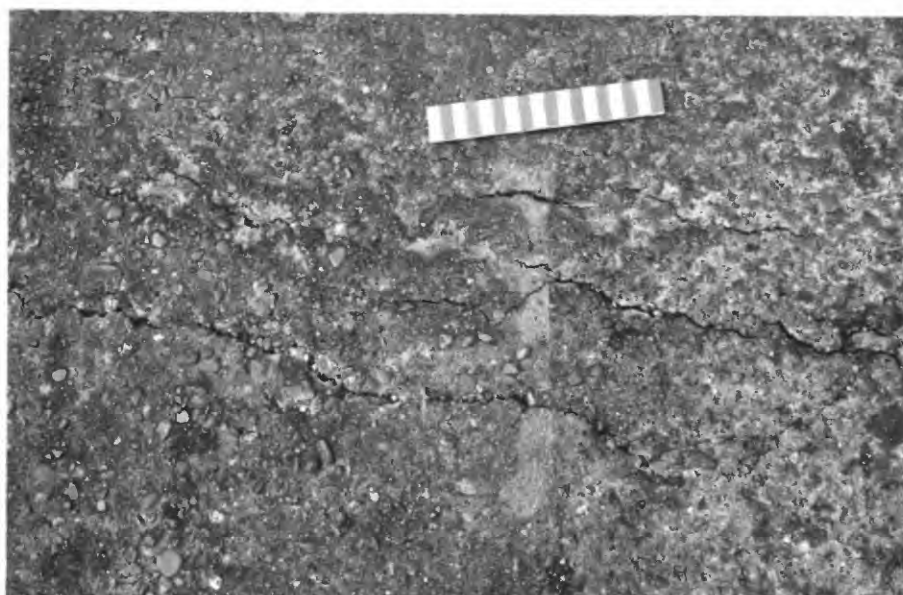
Figure 2: (Site 3) Part of crack shown in figure 1 and subsidiary crack (closest to scale) that developed after our observations on August 6. Scale is marked in 1 cm divisions. Offset of light-colored bar, painted after our visit on August 6, showed that 5 mm of right lateral displacement had occurred on the subsidiary crack. West is toward top. Photograph taken 9/25/79.

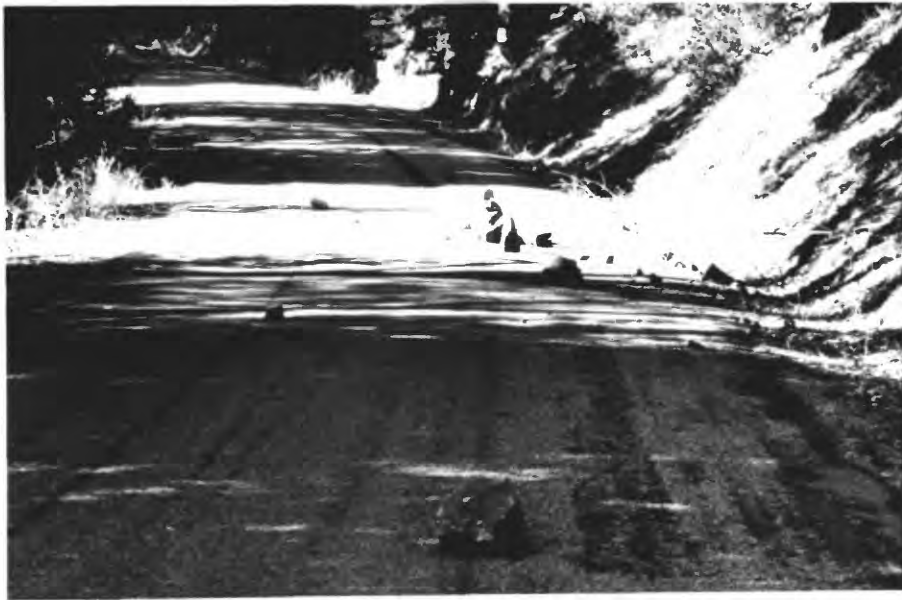
Site 9—Gilroy Hot Springs Road northeast of fire station: The greatest concentration of rock falls observed during the reconnaissance was between 4.6 and 5.5 km from the epicenter along a 3-km stretch of the Gilroy Hot Springs Road. Abundant boulders and cobbles from rock falls were strewn on the road (fig. 3). The rock falls originated on roadcuts through narrow spurs composed of moderately-cemented Franciscan graywacke with minor amounts of claystone. The largest boulder observed on the road was approximately 60 cm long, 60 cm wide, and 30 cm thick.

Figure 3: (Site 9) Boulders from rock falls along part of Gilroy Hot Springs Road between fire station and Coyote Creek bridge. Boulders of similar size were common along this north-south trending part of Gilroy Hot Springs Road, which had the largest concentration of rock falls of any area observed during the reconnaissance. View is north. Failures took place in roadcuts in graywacke with moderate amounts of claystone.

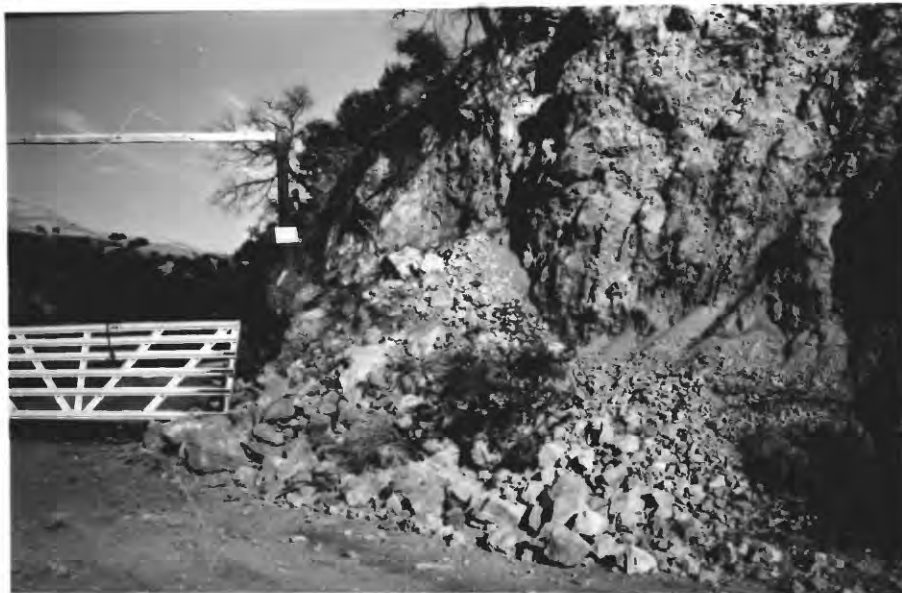
Site 11—East Dunne Avenue 0.4 km west of Cochrane Bridge: On the south side of the road, a rock fall with a volume of 10 m^3 , the largest we saw during our reconnaissance, occurred in a roadcut. The rock fall, which partly blocked an unpaved road, was in brecciated, hydrothermally altered serpentine (fig. 4).

Figure 4: (Site 11) Largest rock fall observed during reconnaissance (volume = 10 m^3). View is south. Failure occurred in roadcut in brecciated, hydrothermally altered serpentine.

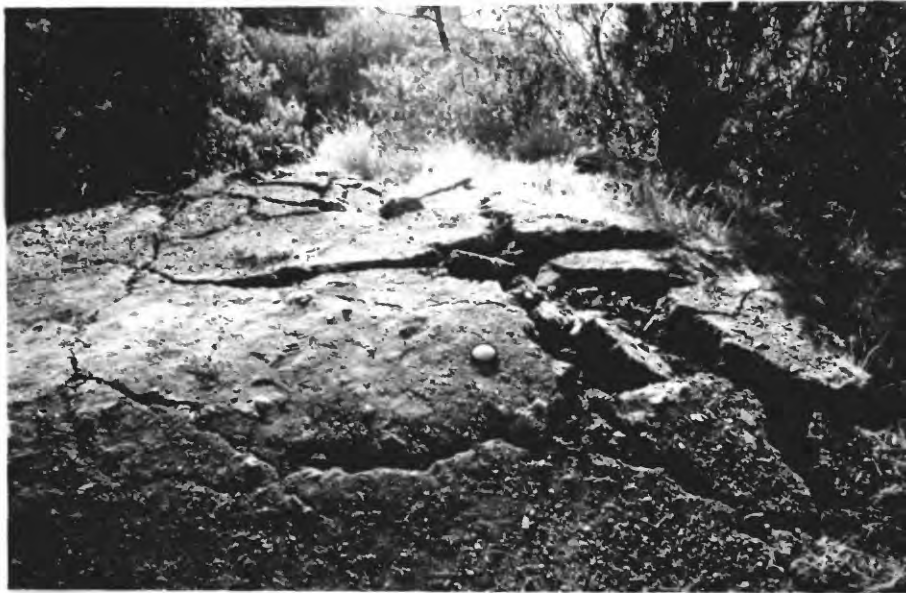
On the north side of the road, an unpaved turnout area was disrupted by numerous cracks, and material around the edges of the turnout was shattered into blocks, a few tens of centimeters on a side (figs. 5,6). These blocks slid off the edges of the turnout area; displacements ranged up to 30 cm. The cracked and displaced material was compacted fill consisting of a heterogeneous mixture of rock fragments, sand, silt, and clay. The rock fall and the turnout area were on the nose of a steep, high ridge less than 200 m from the Calaveras fault.

Figure 5: (Site II) Cracks and displaced blocks of compacted fill in highway turnout area on nose of steep, high ridge. View is north. Lens cap is 55 mm in diameter.

The most prominent cracking of a highway turnout area (Site 11) occurred on the nose of a steep, high ridge; this suggests that the ground motion was relatively severe in that topographic setting. Similar instances of severe cracking on steep ridges and

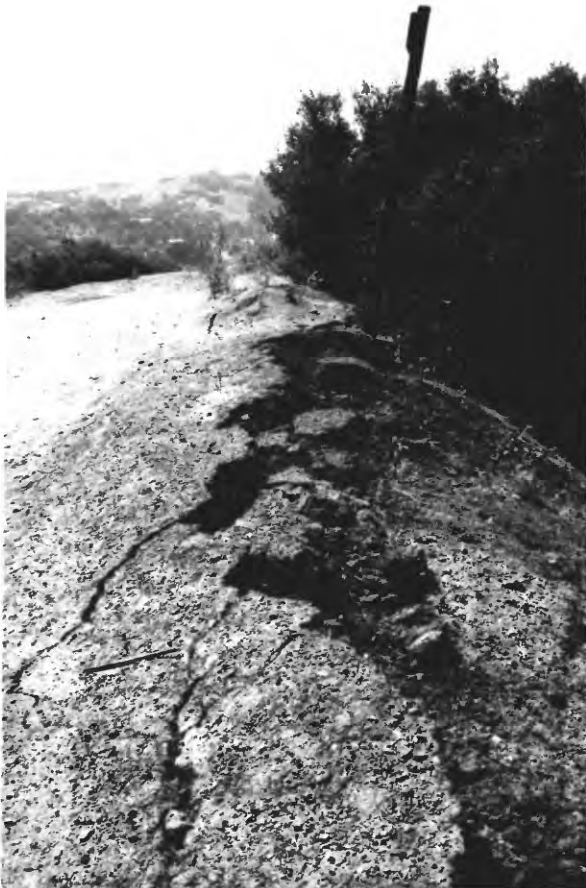
Figure 6: (Site II) Displaced blocks of fill on eastern edge of road turnout. View is north. Portion of signpost visible in picture is approximately 2 m long. Maximum displacement of block was 30 cm.

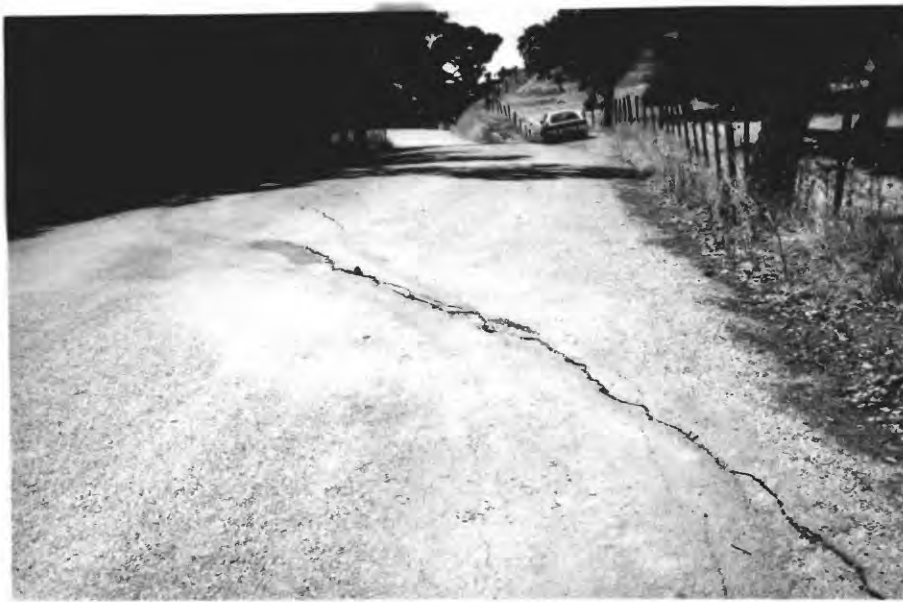
Reservoir. Most of these cracks were caused by movements of a few millimeters on rotational slumps (figs. 7,8); a few cracks were caused directly by shaking. This site was on the Calaveras fault in an area where the ground had been disrupted by numerous older landslides; the earthquake-induced cracks and slumps took place in old landslide deposits derived from weakly cemented sandstones, mudstones, and shales of the Berryessa and Santa Clara formations.

The most prominent crack in the pavement (fig. 7) was the crown of a complex slump about 20 m long and 50 m wide. Offsets on the crack indicated that the slump had moved up to 25 mm vertically and 18 mm horizontally. Movement was toward the western shoulder of the road where the ground sloped down toward the reservoir at an angle of about 45°.

Figure 7: (Site I2) Crack in highway pavement was part of crown of complex rotational slump. View is north. Segment of crack in foreground had strike of $N87^{\circ}W$; segment in background had strike of $N59^{\circ}W$. Offsets on the crack showed the slump had moved a maximum of 18 mm horizontally and 25 mm vertically.

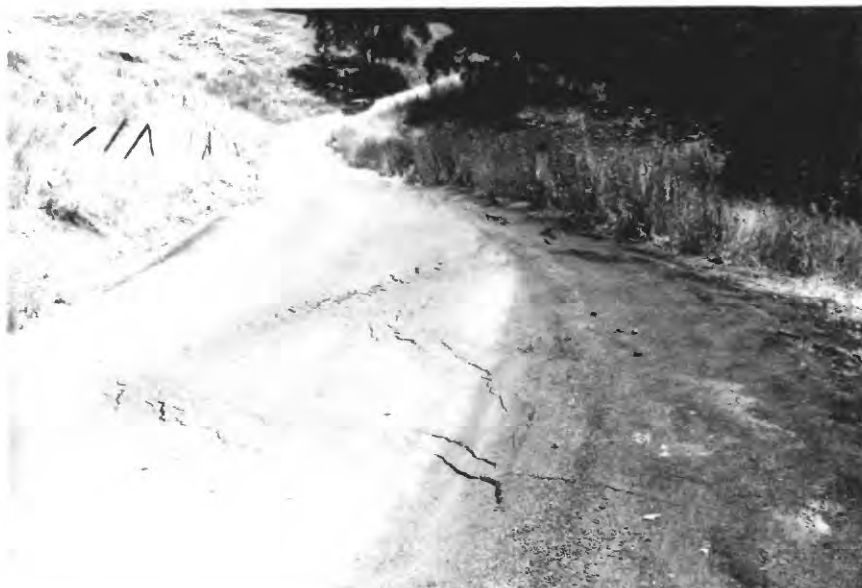
Figure 8: (Site I2) Crescentic crack in highway pavement was crown of small rotational slump. Location is 300 m north of locality of figure 7. View is southwest. Offsets on cracks showed slump moved a few millimeters during the earthquake.
