DAMAGE IN SAN MATEO COUNTY, CALIFORNIA
IN THE EARTHQUAKE OF 18 APRIL 1906

Robert Nason
U.S. Geological Survey
Menlo Park, California

U.S. Geological Survey
OPEN-FILE REPORT 80-176
This report is preliminary and has not
been edited or reviewed for conformity
with Geological Survey standards and
nomenclature

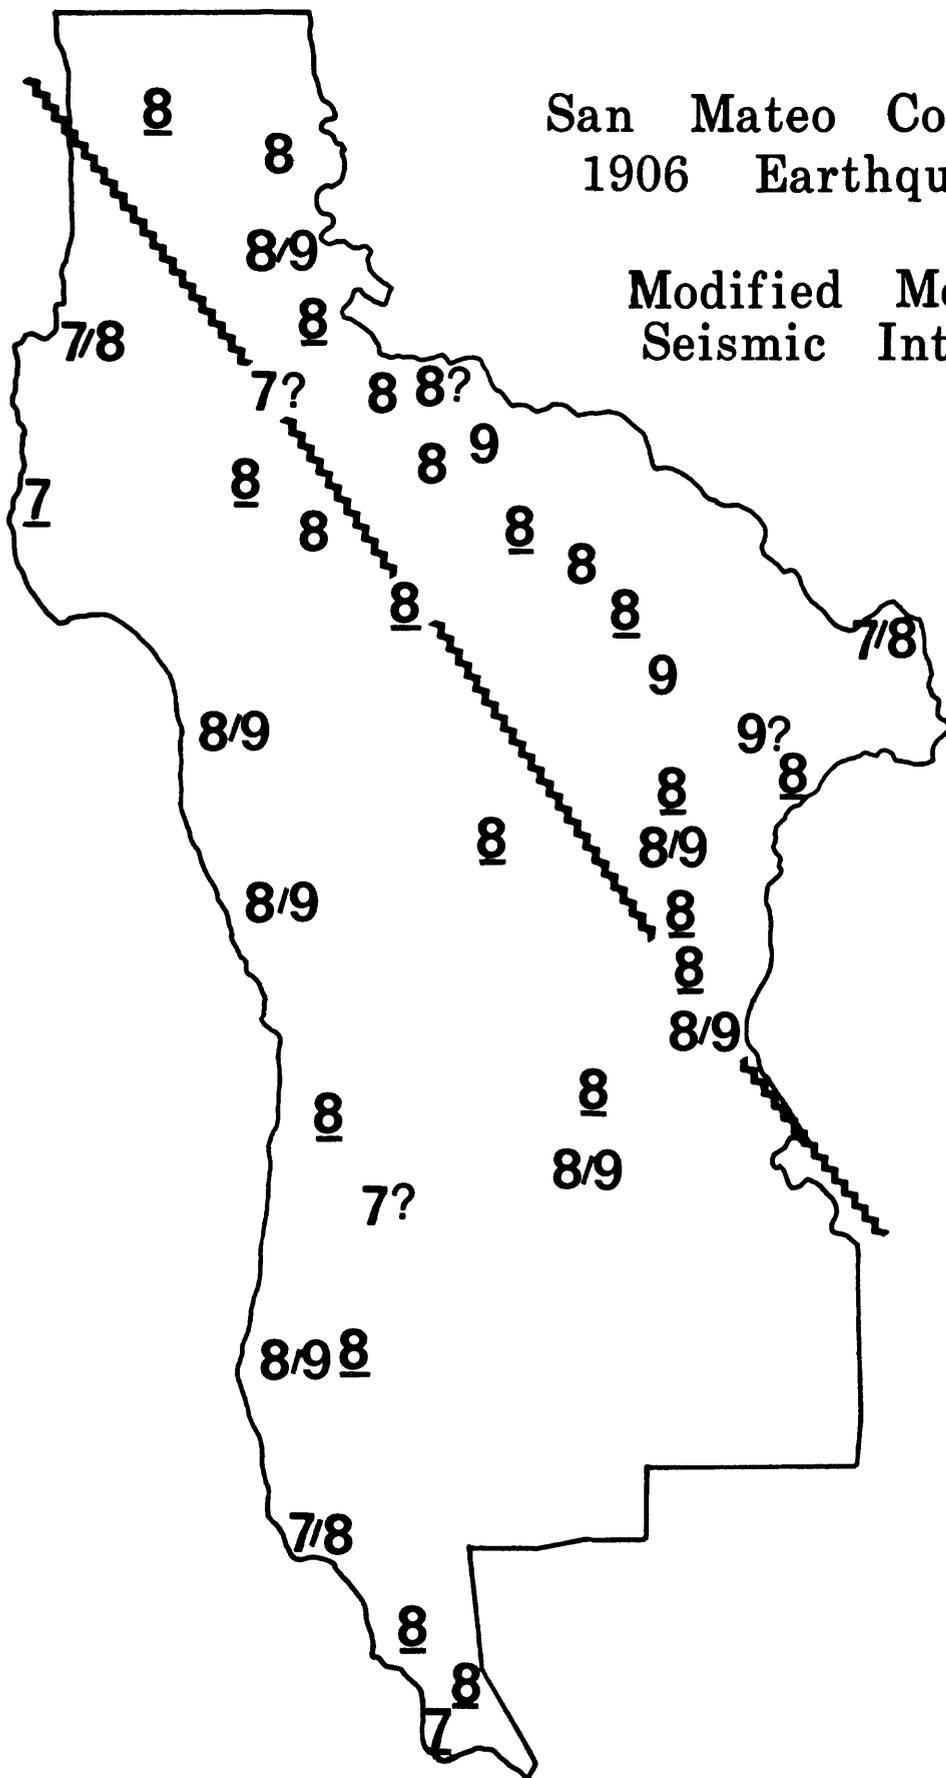
Modified Mercalli
Seismic Intensity

The seismic intensity ratings shown on the map of this study (figure 2) are compiled directly from the listings of table 3. It is noteworthy that the resulting map is different in many important ways from the map pattern shown by Lawson and others (1908), particularly in the hills. The Lawson report does not indicate what the rating at any site was based on. But it is clear that the listed earthquake damage is significantly greater at some places than is indicated on the Lawson maps.

For instance, on the coast south of Half Moon Bay at Pescadero (PE), the Lawson maps show intensity VII-VIII. But the damage (all but three chimneys fell in a sizeable town) indicates a much higher intensity of intensity VIII/IX. At Greenoaks Creek (GC) and Whitehouse Creek (WC) the described damages are that the chimneys fell and some houses shifted on foundations. The maps of the Lawson report show only intensity VI for these localities (at the boundary between V-VI and VI-VII), but these damages clearly indicate intensity VIII or possibly more. The damage data show that most locations in the hills of western San Mateo County were seismic intensity VIII or more.

Figure 2. Seismic intensity ratings using the Modified Mercalli intensity scale (Table 2), with the following notation to indicate the quality of the rating: At localities where the reported damage indicates only a minimum value for the intensity rating, but the actual seismic intensity might have been higher, the rating is underlined. Where the description indicates either intensity VII or intensity VIII, but not greater, the rating is given as intensity VII/VIII. At localities where the rating is uncertain, question marks (?) are used.

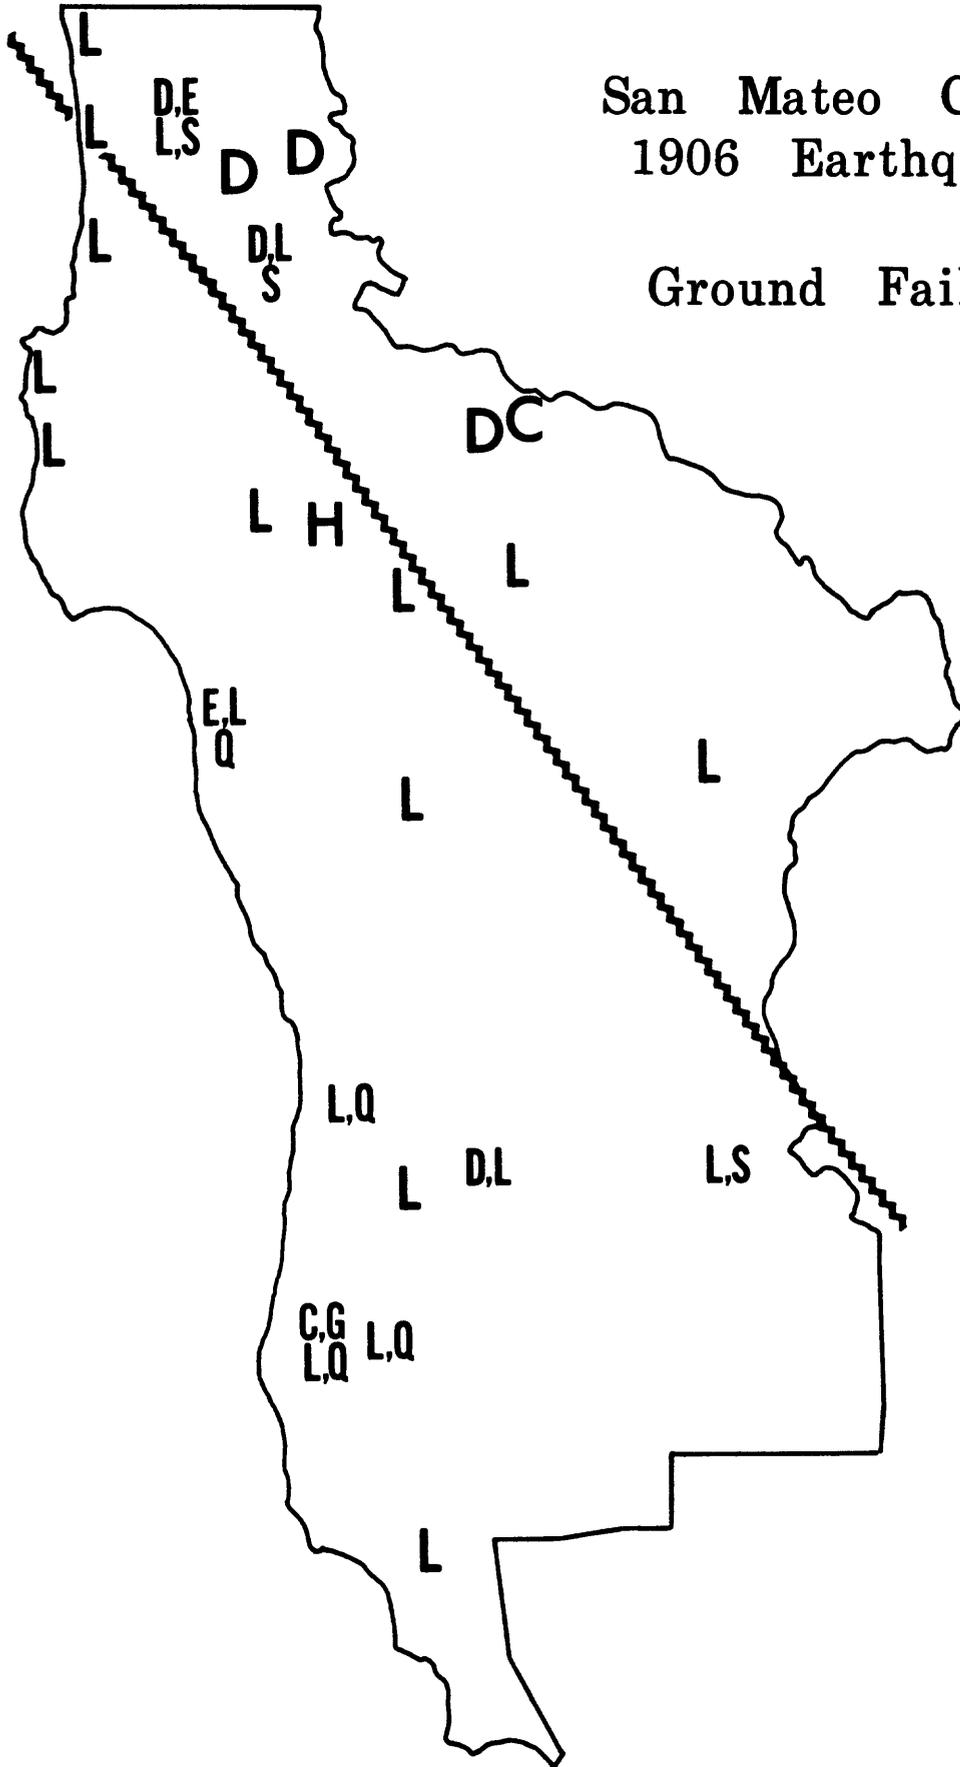
Ground Failures

Several types of ground failures were triggered by the 1906 earthquake. The known instances of ground failure are listed in Table 3 and shown on Figure 3. The seismic ground failures are also discussed in the report by Youd and Hoose (1978).

The most common type of ground failure was landslides. The largest landslide was at Mussel Rock, on the coast near the northern county line, and landslides occurred at many places in the hills. A special type of landslide that was called an "earth-flow" occurred near Colma and near Half Moon Bay.

Figure 3. Localities of ground failure in San Mateo County, as described in the listing of localities (Table 3). The letter symbols are: C, cracks; D, ground deformation; E, earth-flow landslide; G, escaping gas; L, landslides; Q, liquefaction; S, ground settlement; and H, shattered soil.
