UNITED STATES DEPARTMENT OF THE INTERIOR  
GEOLOGICAL SURVEY

Surface faulting near Livermore, California  
associated with the January 1980 earthquakes

Open-File Report 80-523

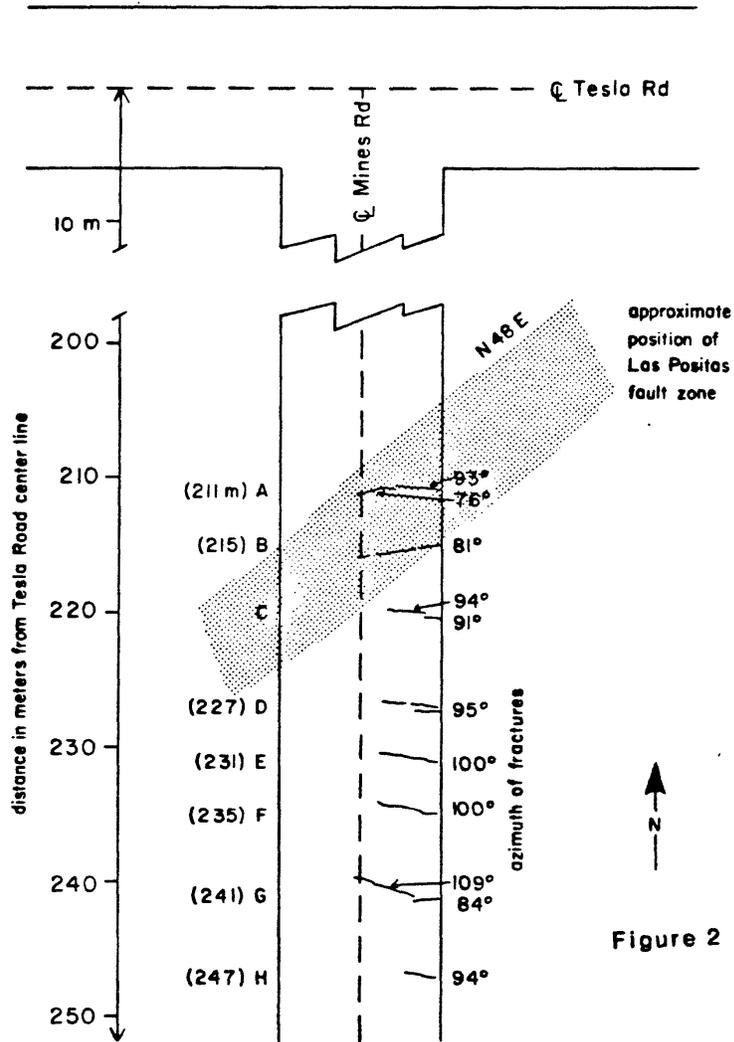
At Mines Road (location 33) eight sets of fractures designated 33A-33H were observed on 7 February as sketched in figure 2. The fractures are located 210 to 250 m south of the centerline of Tesla Road. Azimuths of segments of the fractures range from  $76^{\circ}$  to  $109^{\circ}$  but trend approximately perpendicular to Mines Road; the fractures are largely confined to the northbound lane. Only 33A was noted to extend across the centerline on 7 February. Prior to 7 February, other investigators used orange spray paint to mark fractures 33A, 33B and 33C; fractures 33D-33H had not been painted. On 7 February, no measurable vertical or lateral displacements were associated with the fractures 33A-33H. No apparent post-paint propagation or extension of fractures 33A-C was observed.

On 29 February location 33 was reinspected. Blue paint had been applied to fractures 33D-33H. Fracture 33G now crossed the centerline of Mines Road, but had not grown since application of the blue paint. No displacements or apparent propagation of fractures other than 33G was observed.

The fractures at Mines Road (location 33) exhibited dusty, weathered surfaces and did not expose freshly broken, black asphalt as did other fractures caused by tectonic displacement or by non-tectonic ground failure. Although fractures 33A-33C apparently coincide most closely with the trace of the Las Positas fault (Herd, 1977; figures 1, 2, this report), the absence of measurable displacement and the rather aged appearance of the fractures and their geometry (perpendicular to Mines Road) suggests a non-tectonic origin. The extension of fracture 33G across the centerline of Mines Road observed on 29 February followed a period of heavy rain. The extension of this feature,

Figure 2. Sketch map showing fractures in the pavement of Mines Road in relation to the centerline of Tesla Road and the approximate position of the Las Positas fault zone.

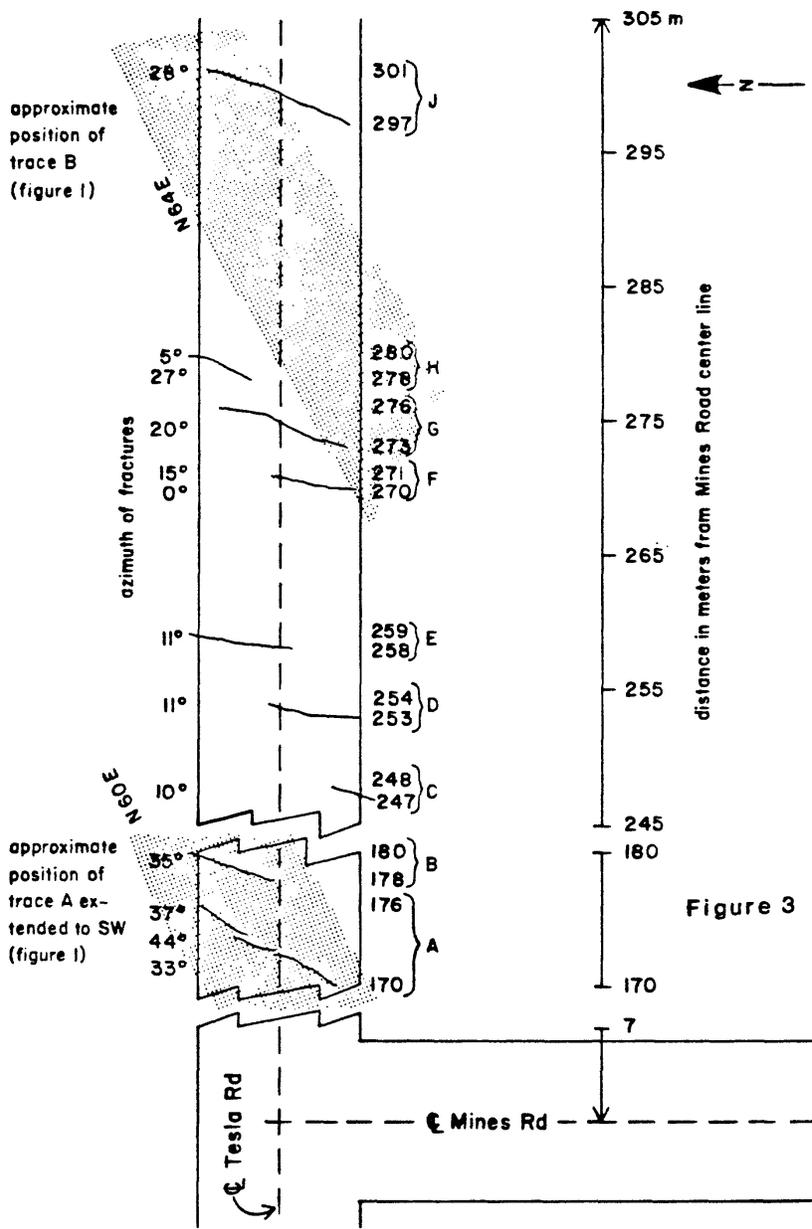
Figure 3

At location 34 along Tesla Road (inspected 7 February) nine fractures comprise three right-stepping en echelon sets of fractures (sketched in figure 3). Fractures 34A, 34B, and 34F-34I coincide with mapped traces or lie on the projections of mapped traces of the Las Positas fault zone (figures 1 and 3). Fracture 34C displays about 1.5 mm left-lateral strike slip displacement. Post-earthquake propagation of fractures C, E, and F apparently occurred; the cracks extended through and beyond spots of blue spray paint which reportedly marked the ends of the cracks at the time the paint was applied. Surfaces of all fractures at location 34 exposed fresh, black asphalt. Commonly, pebbles had been "popped" from their position adjacent to the fracture edge.

The observed left-lateral strike-slip displacements, the right-stepping en echelon distribution of fractures associated with mapped traces of the Las Positas fault, the unquestioned recency of the fractures and their growth or extension following the earthquakes of 24 and 26 January indicate that the fractures on Tesla Road are probably tectonic in origin.

Figure 3. Sketch map showing fractures in the pavement of Tesla Road in relation to the centerline of Mines Road and the approximate positions of traces of the Las Positas fault zone, designated Trace A and Trace B in Figure 1.

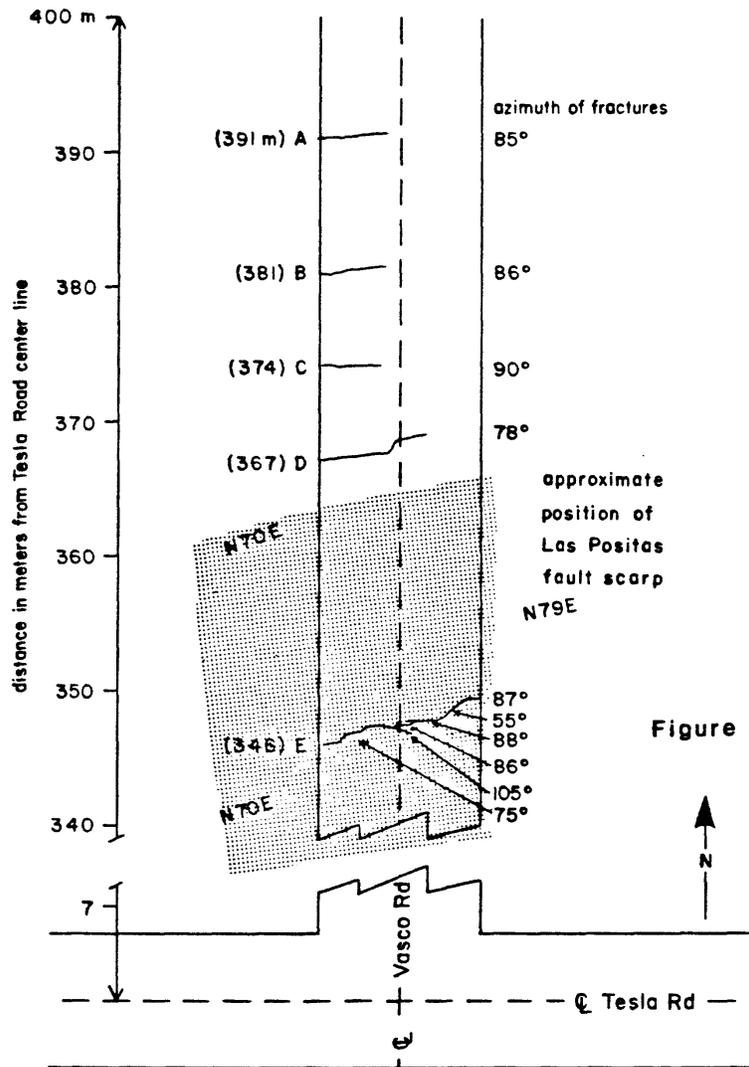
At location 35, examined 7 and 29 February, five fresh fractures were mapped (figure 4) near the Las Positas fault intersection at Vasco Road (called "Las Positas Ave" on pl. 1 and fig. 1). Positions of fractures were measured, using a tape, north from the centerline of Tesla Road. Fracture 35E, a prominent break near the crest of the scarp of the Las Positas fault, exhibited left-lateral strike slip displacement of about 0.5 mm. Fractures 35A-D did not exhibit displacements. Fractures 35A-35C occurred only in the southbound lane; only 35D extended across the center line of Vasco Road. Fractures 35A-35D trend generally perpendicular to Vasco Road, and have merely opened with slip vectors oriented downslope and perpendicular to fracture trend; these features are interpreted as non-tectonic ground failure.

The small amount of left-lateral strike-slip measured at 35E coincident with the trace of the Las Positas fault indicates that surface rupture on the Las Positas fault extended at least 1.1 km from Tesla Road to Vasco Road. This interpretation is strongly supported by data from an alignment array which showed about 6 mm of left-lateral displacement across the fractures at location 35 between 21 February and 26 March (P. W. Harsh, personal communication), even though fracture 35E showed no obvious change between 7 February and 1 April 1980.

Figure 4. Sketch map showing fractures in pavement of Vasco Road in relation to the centerline of Tesla Road and the approximate position of the north-facing scarp of the Las Positas fault.

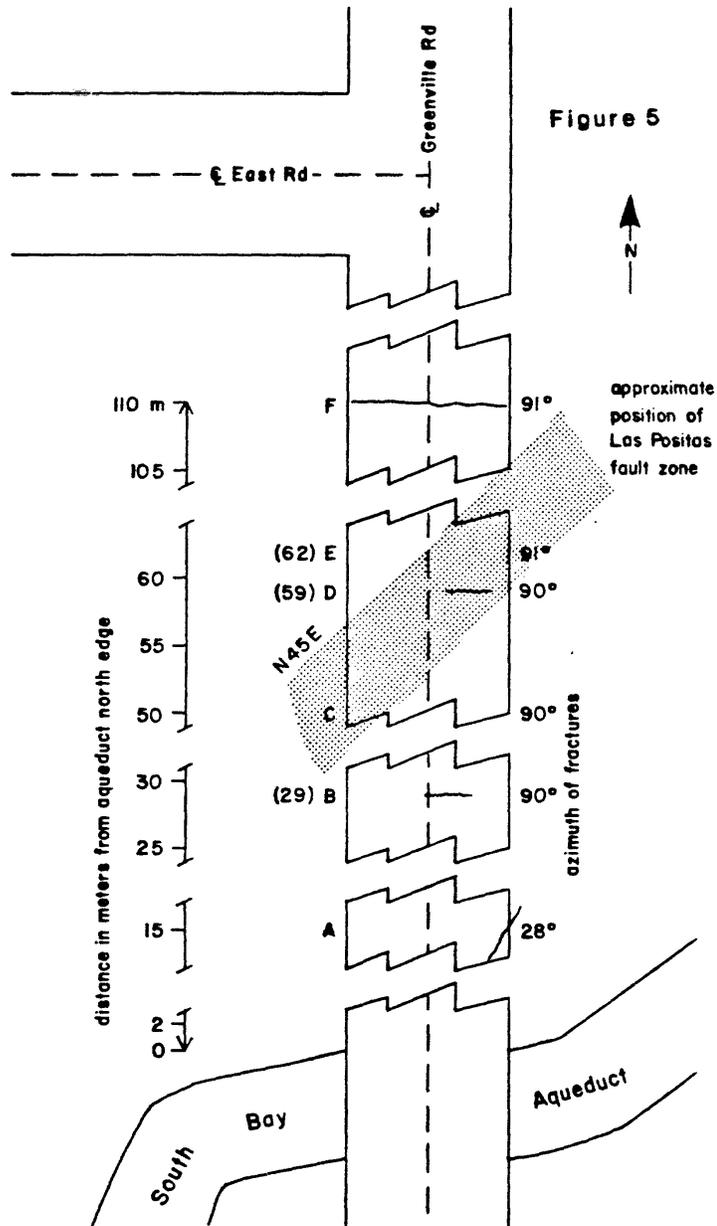
At location 36, near where the Las Positas fault zone intersects Greenville Road (figure 1), four fresh fractures without measurable lateral displacement were noted. Three fractures trend perpendicular to Greenville Road and one is diagonal to it. As mapped on 7 February these features are shown relative to the northeast abutment of the Greenville Road bridge where it crosses the South Bay aqueduct (figure 5). No extension or growth of fractures was observed on 29 February. The orientation perpendicular to Greenville Road and the absence of growth or a history of propagation indicate a probably non-tectonic origin for these fractures.

Figure 5. Sketch map showing fractures in Greenville Road in relation to the South Bay aqueduct and the approximate position of the Las Positas fault zone.
