STABILITY OF TOUTLE RIVER BLOCKAGE:
MT. ST. HELENS HAZARDS INVESTIGATIONS

Open File Report 80-898

July 1980

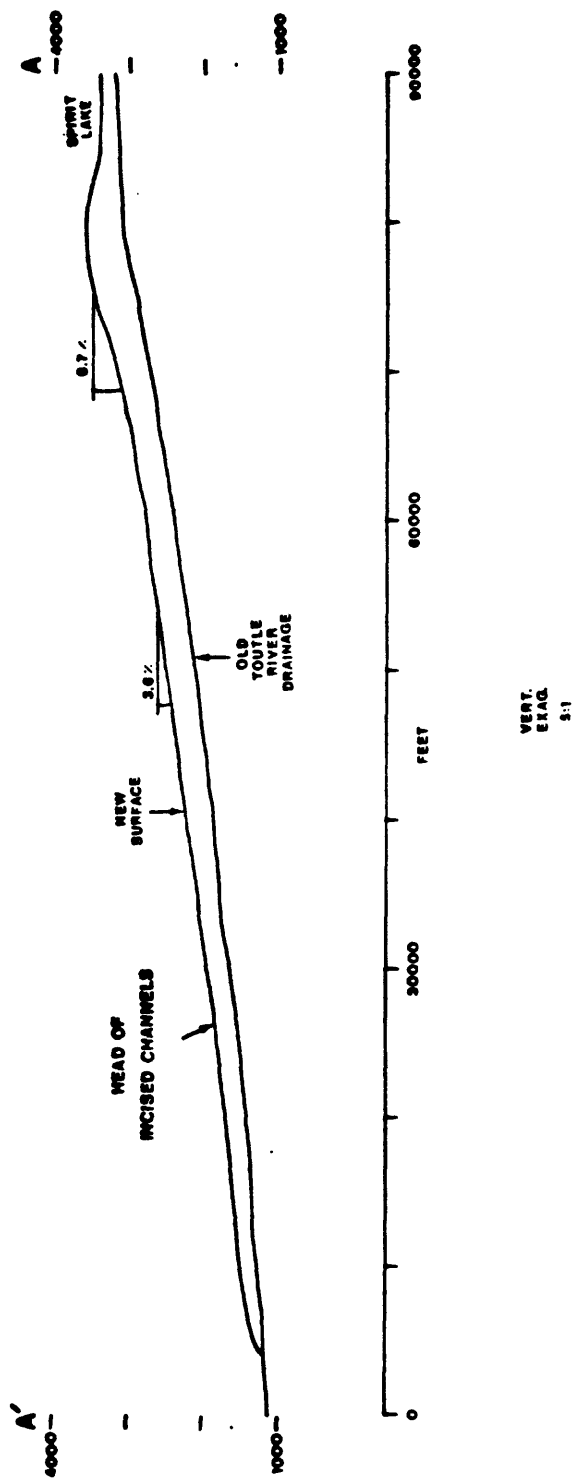
Figure 1.-- Preliminary Section through debris blockage in Toutle River drainage

Between May 19 and 22, Ray Wilson flew two reconnaissance flights over the debris blockage in the Toutle River. From visual observations, comparisons with pre-eruption topography, and a few helicopter altimeter measurements, Ray drafted the preliminary section through the blockage shown in figure 1. Other investigators drafted the lateral extent of the blockage as shown in figure 2.

The length of the blockage as shown on figures 1 and 2 is

about 11 miles. The depth of the debris ranges up to approximately 600 ft with an average depth of about 300 ft. General slopes on the blockage range from about 3.8 percent on the long downstream tail of the embankment to about 6.7 percent on both sides of the crest. Locally, near hummocks and depressions, the slopes are relatively steep.

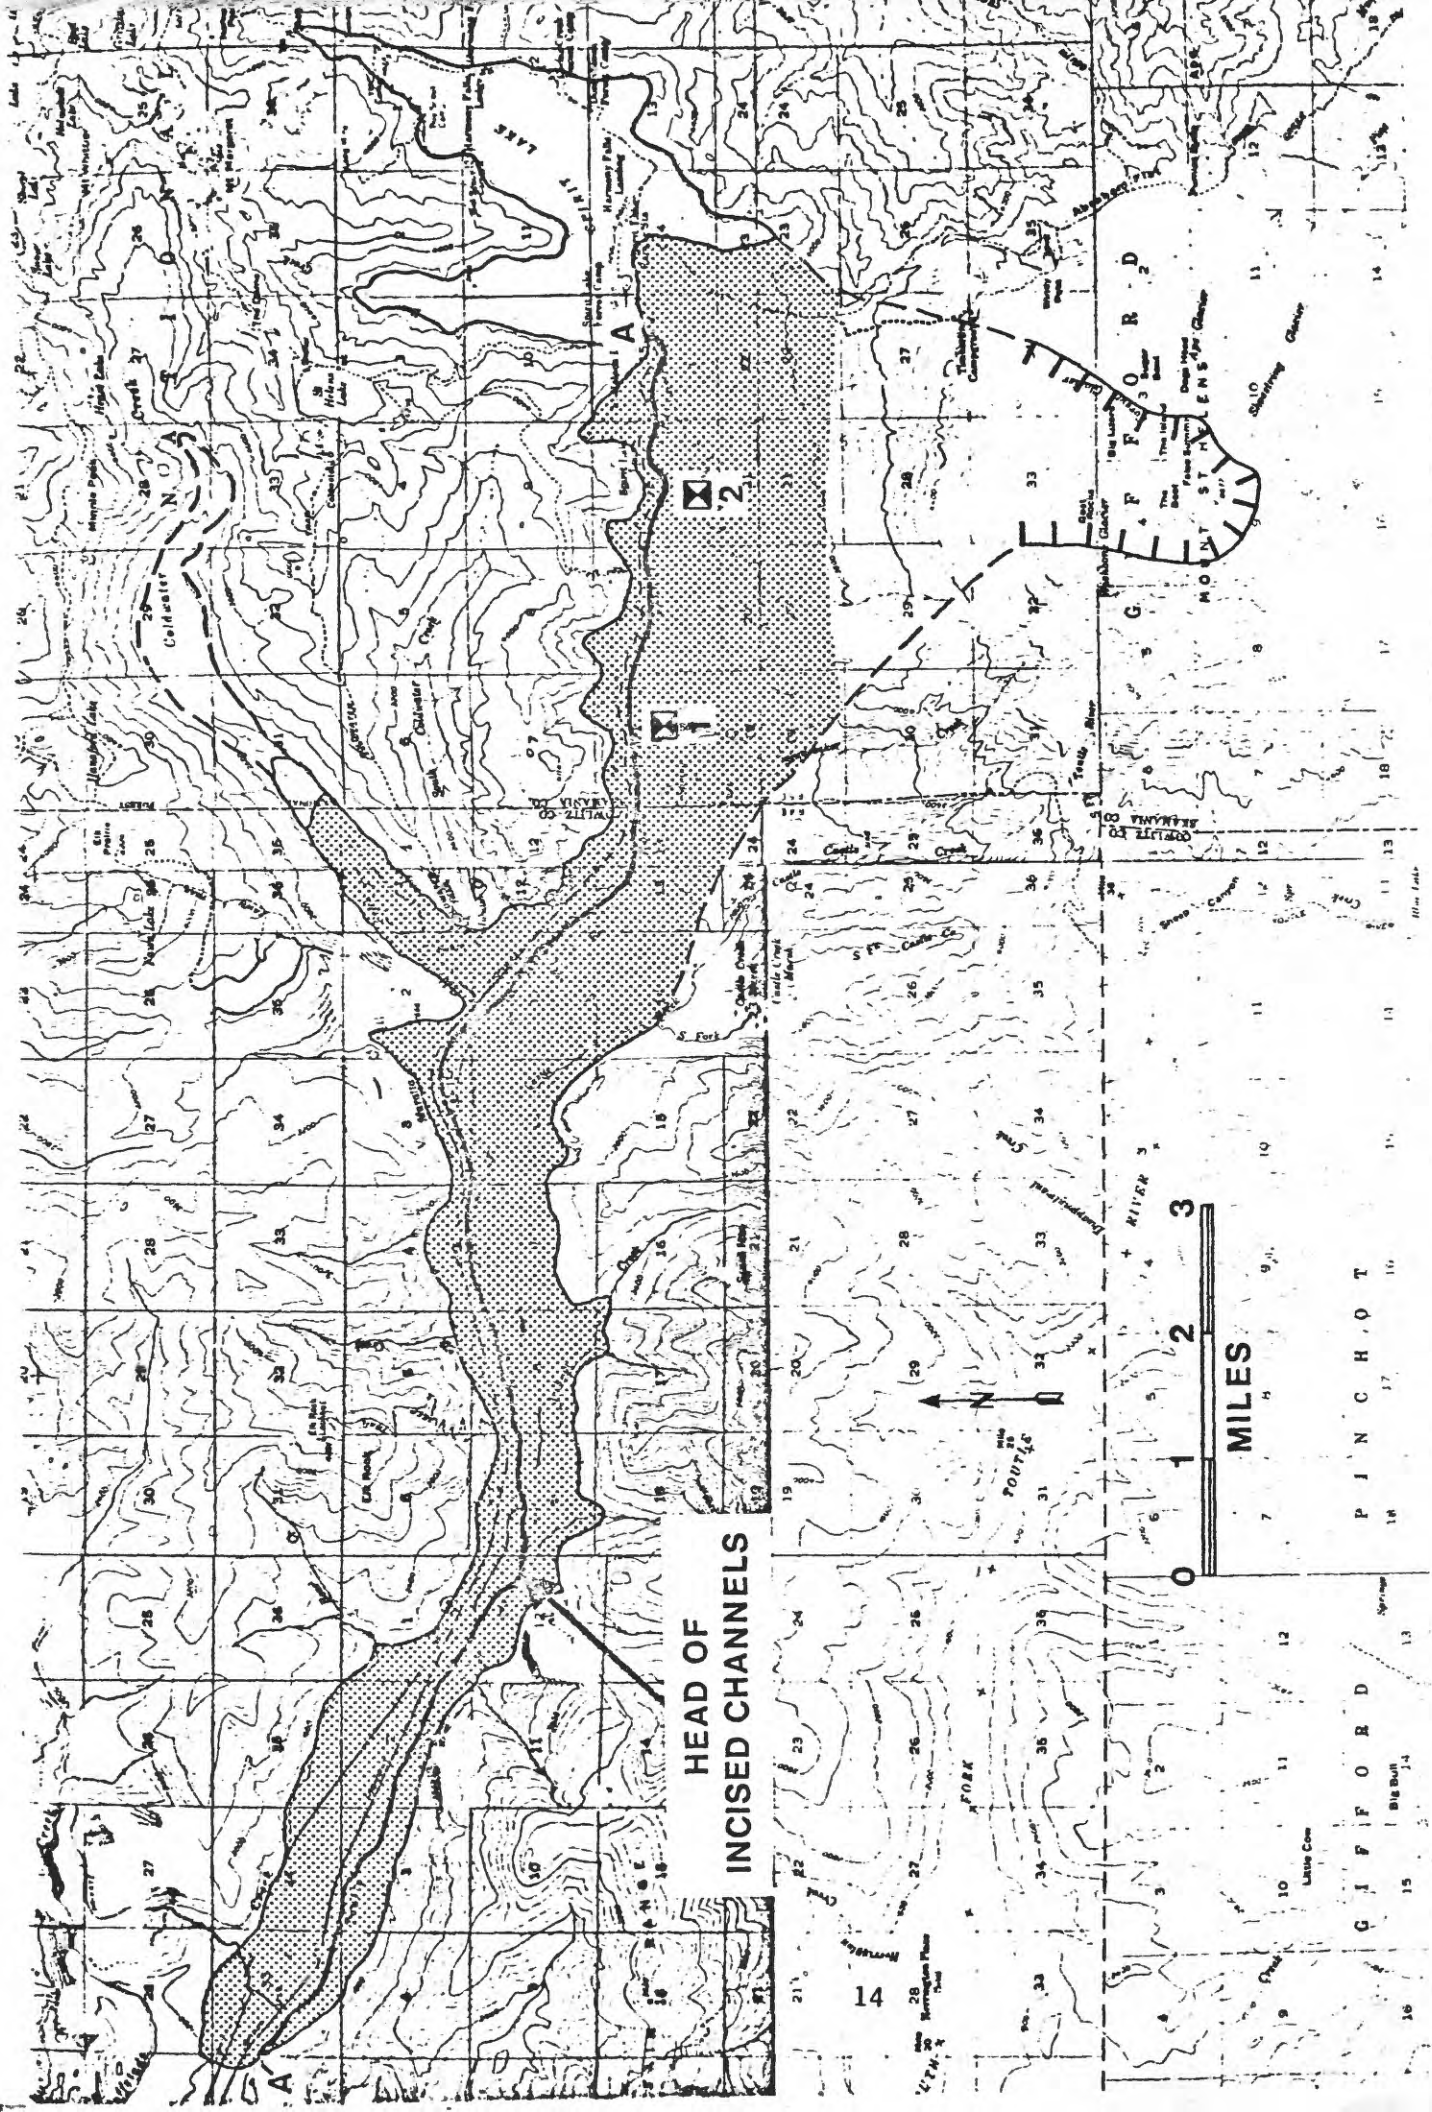
Figure 2.--Preliminary map of Toutle River debris flow adapted from an unpublished map by J. Moore, P. Lipman, and D. Swanson, U.S. Geological Survey. Points 1 and 2 are landing sites mentioned in text

We landed on the debris embankment (near Point 1 on figure 2) to inspect materials exposed by incisions into hummocks and pit walls. Within a foot or two of the surface the materials were fine-sand-sized ash which in topographically lower areas was wet and may have been reworked by water. Below the ash, the sediments were a heterogeneous mixture of sands, gravels, cobbles and boulders, with sporadically distributed large blocks of ice. The color, texture, and mineral composition of the coarse-grained matrix varied greatly from place to place. However, the material was consistently well graded (poorly sorted), ranged in size from fine sand to large boulders, and was loosely packed. The coarser grained material is landslide debris from the massive slope failure that occurred on the north side of Mt. St. Helens at the time of the May 18 eruption. The hummocky nature of the

We measured the altitude at lake level with the helicopter altimeter and measured the altitude of the lowest point on the crest of the blockage (point 2 on Fig. 2) in a similar manner. The difference between the two measurements was 200 ft plus or minus about 10 ft. At the crest, the surface of the blockage is covered with several feet of ash; however, the surface is hummocky and a few exposures revealed coarse-grained landslide debris beneath the ash.
