THE MAY - JULY 1978 EARTHQUAKE
SEQUENCE NEAR THESSALONIKI
GREECE

Richard P. Maley, Charles G. Bufe and
Robert F. Yerkes
U.S. Geological Survey
345 Middlefield Road
Menlo Park, California 94025

OPEN-FILE REPORT 80-937

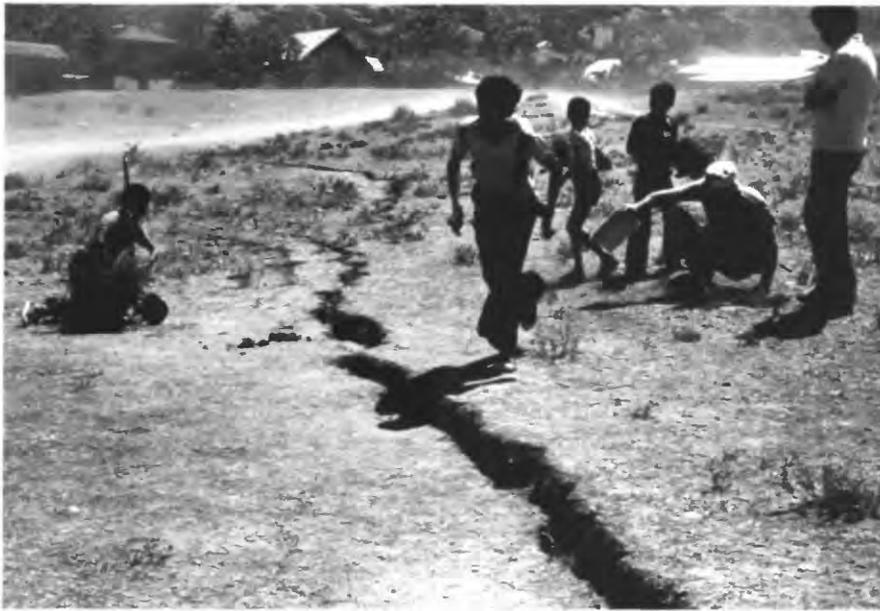
1. A zone of discontinuous, step-to-the right ruptures along a west-northwestly trend, passing through the towns of Stivos (Figure 2) and Skolari. Numerous ejection craters and fissures (example in Figure 3) were observed in the dry river bottom south of Skolari.

Figure 2. Ground rupture through the soccer field at Stivos, looking eastward.

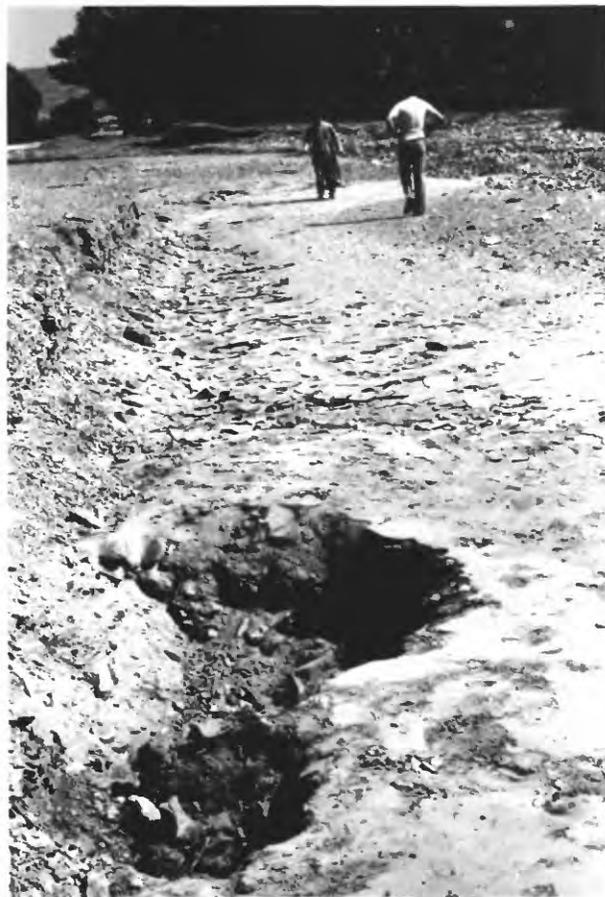
Figure 3. Ejection craters in the riverbed along a WNW trend of ground rupture southeast of Skolari.

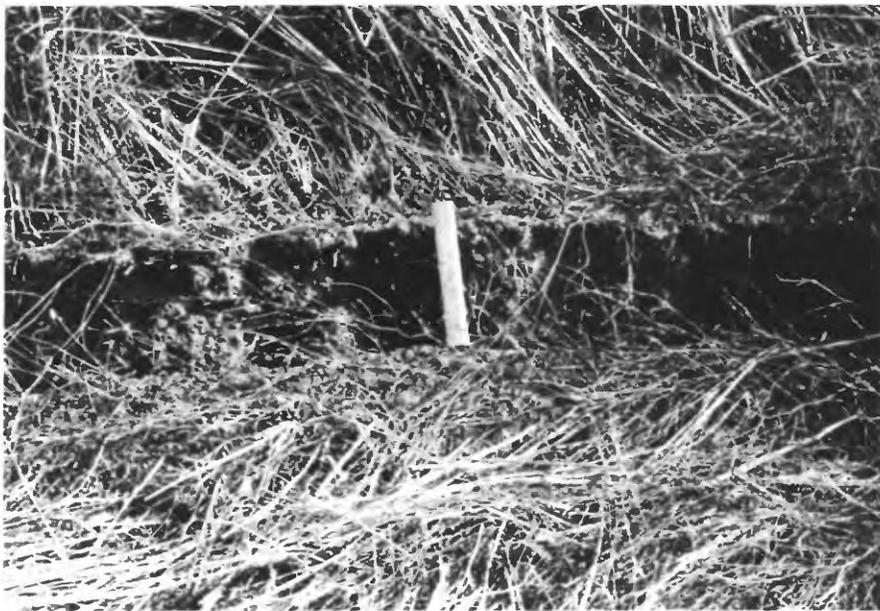
2. An east-west trending zone of open ruptures along the south side of the valley with north-side-down scarps passing through the towns of Yerakarou (Figure 4), Nikomidhion, and Stivos. Maximum observed displacement was 30 cm vertical, with a 10 cm tensional opening on a rupture east of Yerakarou. Some of the observed displacement may have resulted from slope failure; however, the zone occurs along the base of a probable fault-line scarp off-setting the flood plain by approximately 3 m. The northwest-trending 1978 ruptures and many of the 1978 and earlier earthquakes occurred along the northwest-trending faulted boundary between the Rhodope (Serbo-Macedonian) massif of crystalline and metamorphic rocks on the north and intensely deformed Mesozoic metasedimentary rocks of the Vardar "root" zone on the south.

Figure 4. View of the scarp at Yerakarou, looking south. The scale is 30 cm long.

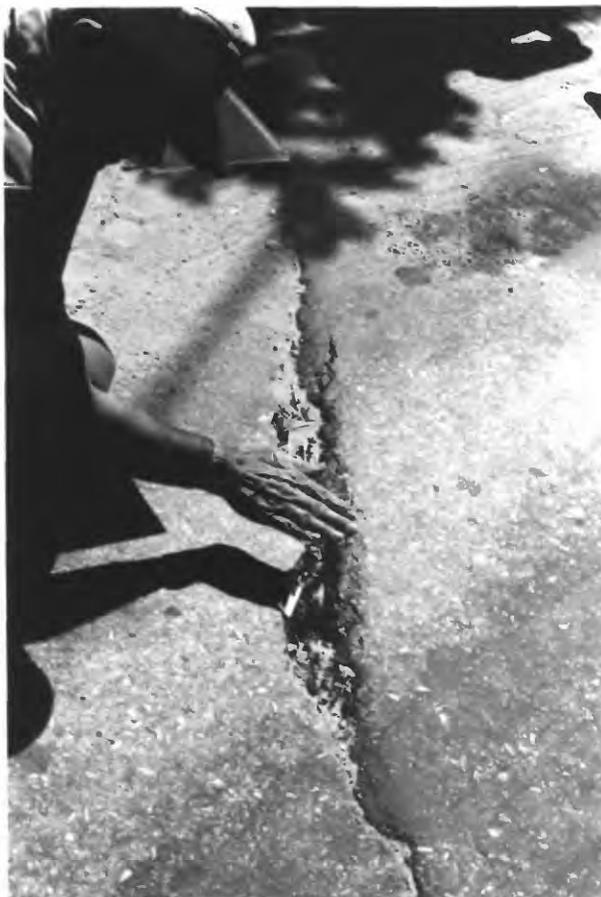
Many interesting observations of various phenomena before and after the main shock were made by the local residents. Residents of Skolari reported a stream of very hot air escaping early in the morning of June 21 from a fissure (Figure 5) where the fault crosses a macadam road. On the delta south of Lake Volvi fountaining of hot water was reported from a zone of fissures. Residents reported that from the beginning of the fore-

Figure 5. Ground rupture crossing a macadam road in Skolari where townspeople reported a stream of hot air venting through the cool pavement on the morning of July 21, about 8 hours after the main shock.

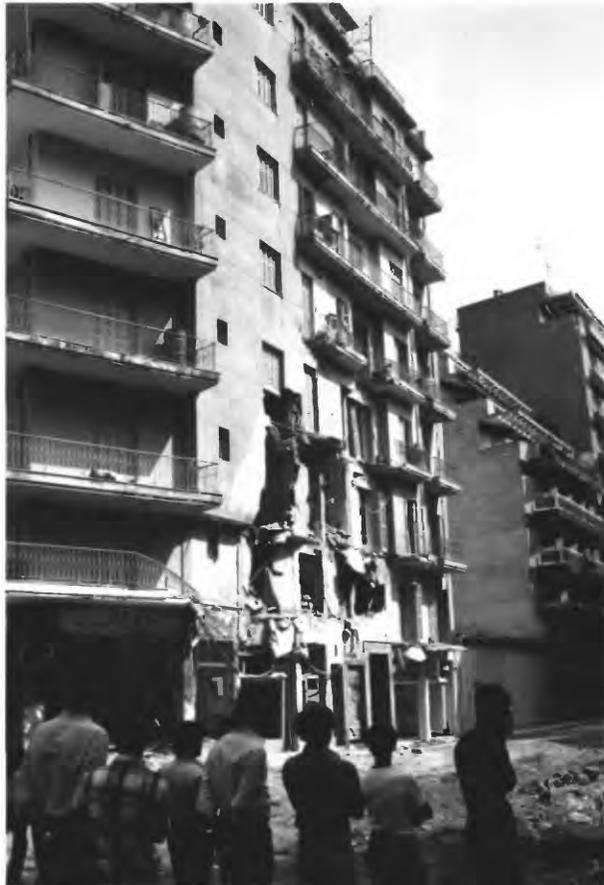
The collapsed eight-story reinforced concrete building that caused a majority of the fatalities during the earthquake, was cleared away by the time the USGS team arrived. During the collapse the building or part of it apparently fell against an adjoining building tearing out a section of the exterior wall and knocking down several balconies (Figure 8). Considering the unusual soil conditions in this area of the city, a contributory factor could be an anomalously high ground response at the site. Perhaps records from a Yugoslavian accelerograph installed approximately 50 m from the collapse, will shed some light on this possible effect, particularly if there is data from the July 4 aftershock.

Figure 8. External damage to an eight-story building caused by the collapse of an adjacent structure.

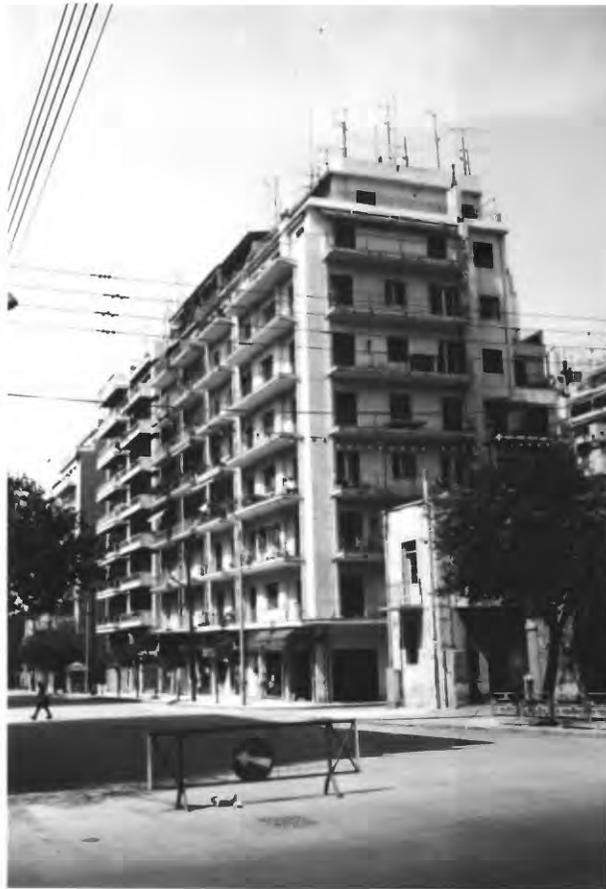
A second eight-story reinforced concrete building located two and one-half blocks from the collapse site, had badly damaged ground floor columns (Figure 9). The corner columns were intact while the interior frontal columns suffered failures near grade and at 1-1/2 to 2 m heights (Figure 10). Engineers from the Ministry of Public Works (MPW) reported the structure was leaning 5 cm toward the street. The building has forty owners, similar to western condominiums, and since they could not be located in a short period of time, the MPW was considering shoring up the building to prevent possible collapse during another strong earthquake.

Figure 9. An eight-story reinforced concrete building with first-floor column damage.

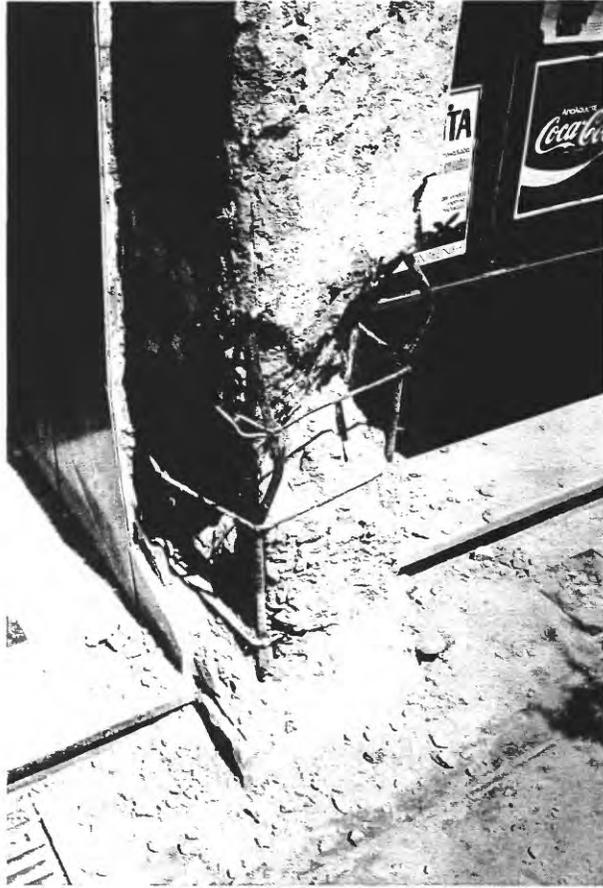
Figure 10. Column damage on the first floor of the eight-story reinforced concrete building shown in Figure 9.

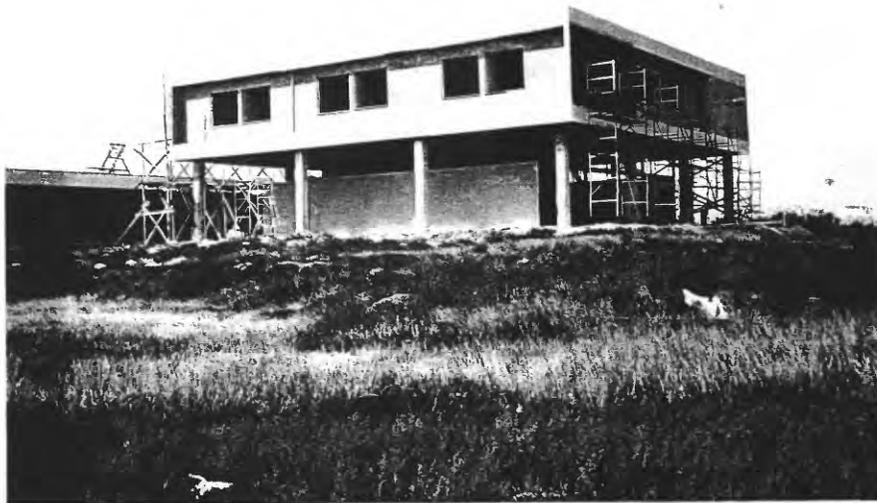
A two-story reinforced concrete police station under construction 300 m from the airport terminal suffered column damage and failure of tile walls on the ground floor (Figure 11). The second floor was not damaged. The building is square, approximately 20 m on a side, and has

twelve equally spaced square perimeter columns, 50 cm wide and 5 m high. There are no shear walls in the structure although a vertical reinforced concrete element supporting the stairs may have provided some lateral resistance. This is suggested by less serious column damage on the stairway side of the building. There is a small interior steel frame along the back of the building and the sides. Its purpose is unknown. The columns were damaged within the first 80 cm above the floor and near the tops of the columns (Figure 12). In every instance the upper damage occurred at the pour joints (Figure 13). There was no evident distress at the column beam connections.

Figure 11. A two-story reinforced concrete police station under construction near the Thessaloniki airport.

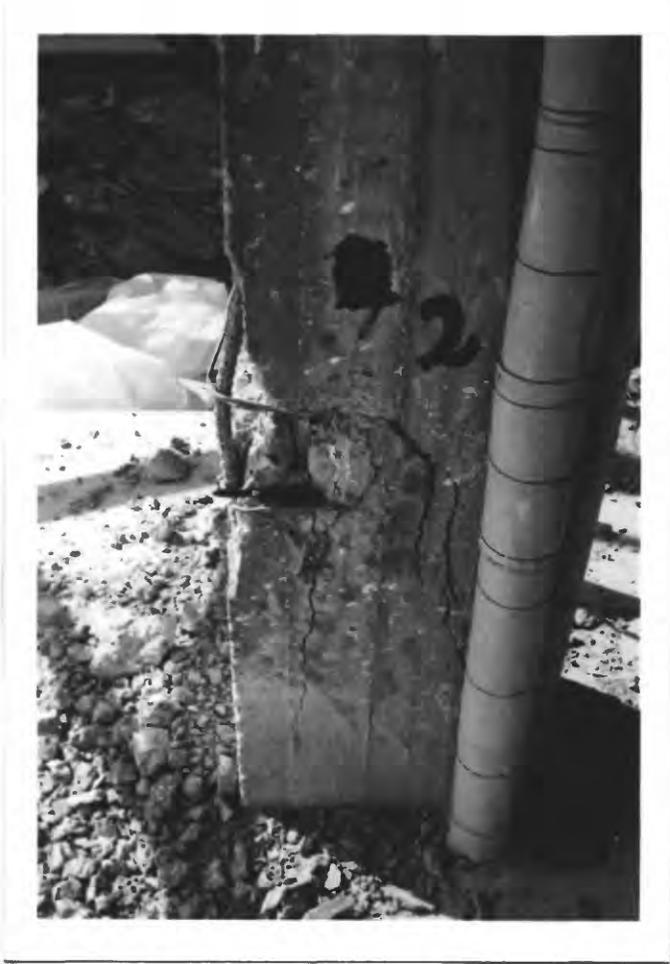
Figure 12. Damage near the base of a column at the police station.

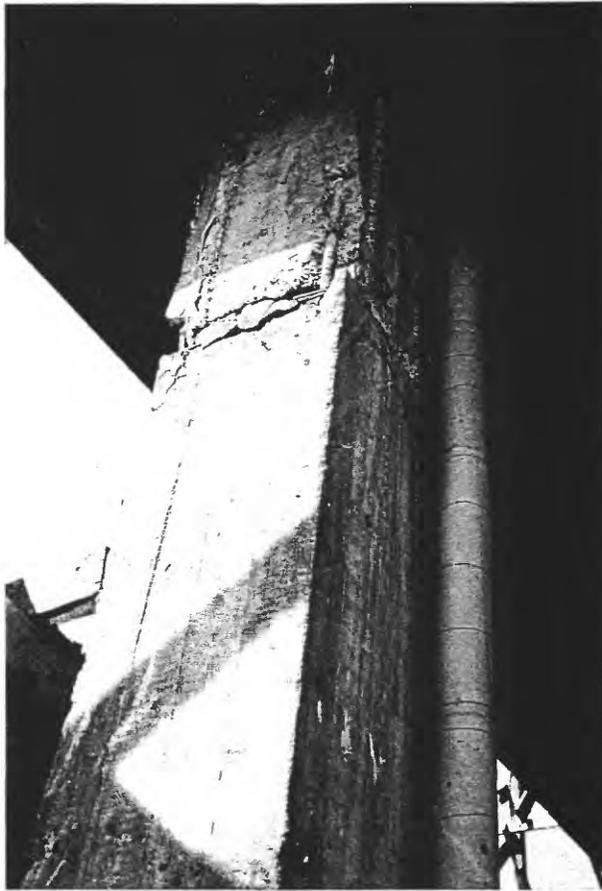
Figure 13. Damage at a column pour joint at the police station (Figure 11).

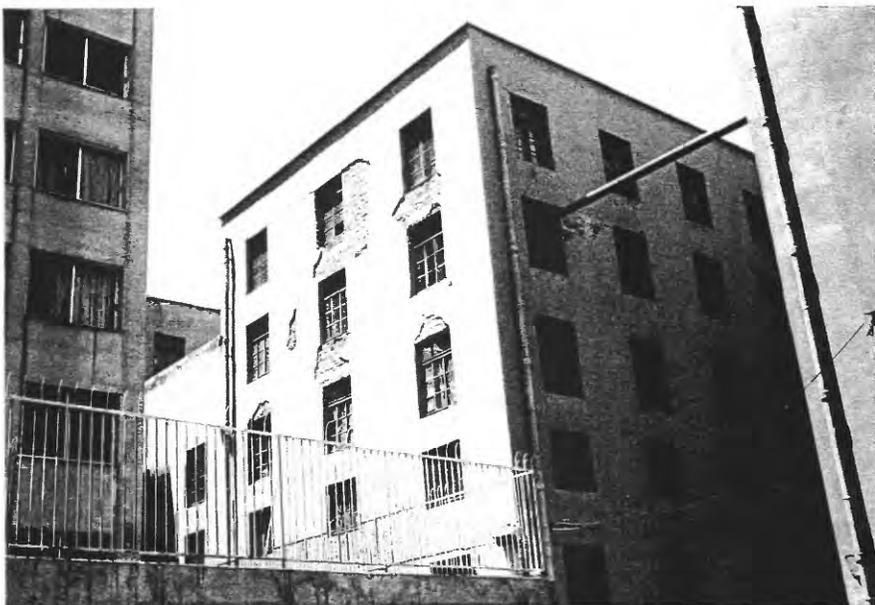
Non-structural damage, though wide-spread throughout Thessaloniki, was concentrated in the older more ornate buildings. Typical external damages consisted of fallen parapets, cornices and overhangs, plaster spalling from hollow tile walls (Figure 14), fallen ornamental brick-work, marble facades that separated and dropped off walls, and spalling between adjacent buildings that were constructed with no separation. In one instance, decorative hollow concrete blocks used as

Figure 14. Spalled exterior plaster on a medium rise building in Thessaloniki.

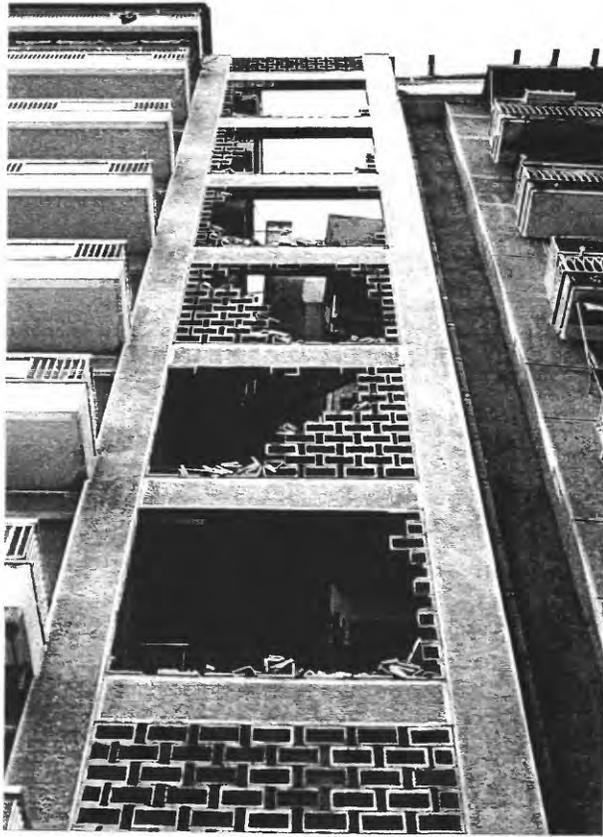
facade for an exterior stairway collapsed both inward on the stairs and outward on the street and sidewalk (Figure 15). An ornamental brick arch fell along Aristotle Plaza (Figure 16). A nearby column lost its brick covering (the column was undamaged). A church located near the eight-story collapse was undamaged, but all exterior panels separating adjacent windows had fallen off.

Figure 15. Collapse of a hollow-tile facade between two buildings in Thessaloniki.

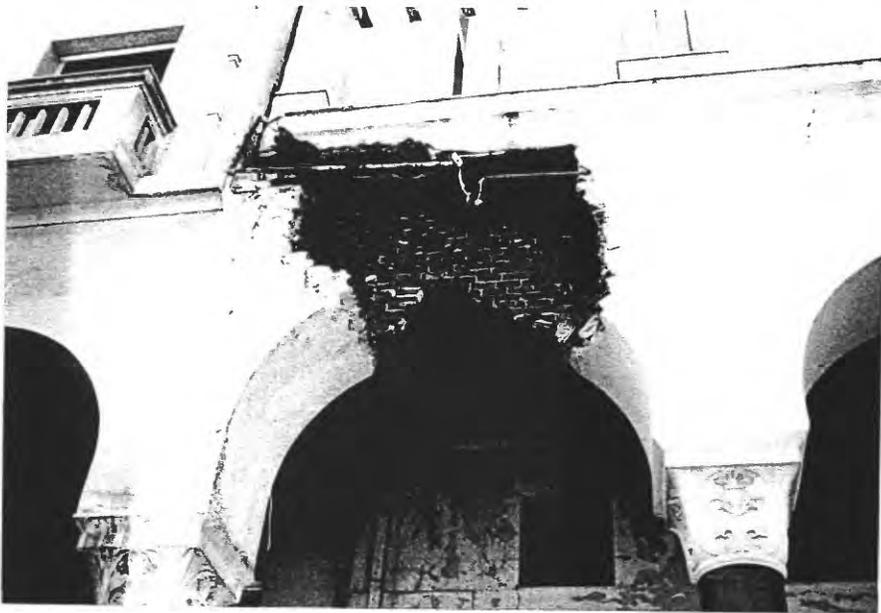
Figure 16. Unreinforced brick arch collapsed on Aritstotle Plaza in Thessaloniki. Newer buildings on the same street have reinforced concrete arches.

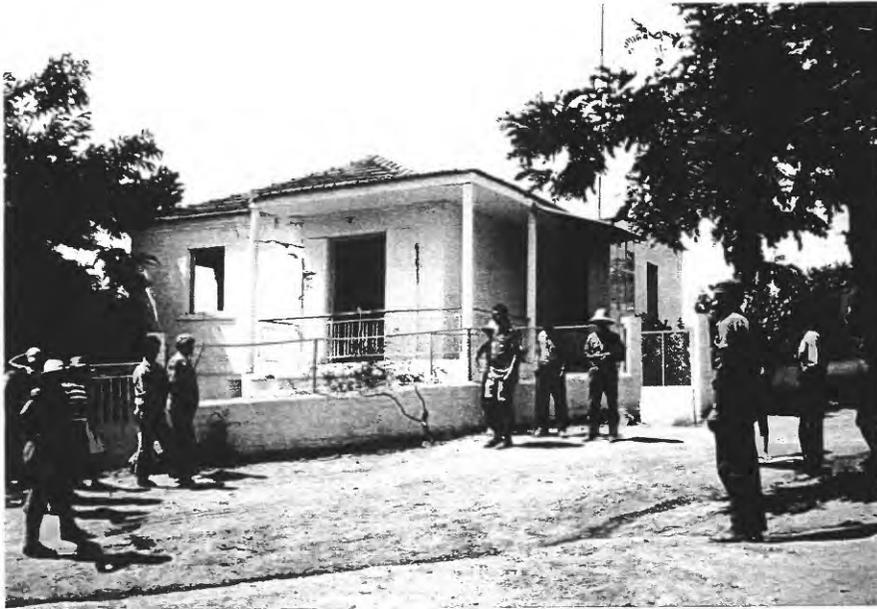
The fault zone passed directly through Skolari rupturing a concrete slab in a garage, cutting through the main road in town, and extending beneath a house that was damaged but did not collapse (Figure 17). Numerous unreinforced mud brick and concrete block farm buildings suffered total collapse (Figure 18). Much of the damage in Skolari was clearly traceable to the existence of faulting passing through or near buildings. The newly built church, location of a Yugoslavian aftershock accelerograph, was undamaged.

Figure 17. Fault zone passing through a house in Skolari.

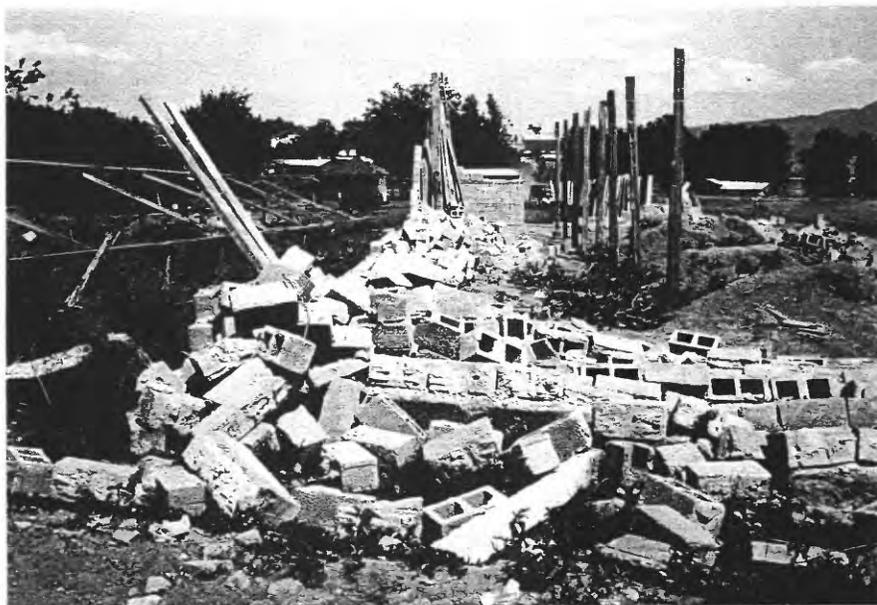
Figure 18. Collapse of an unreinforced concrete block farm building near Skolari.

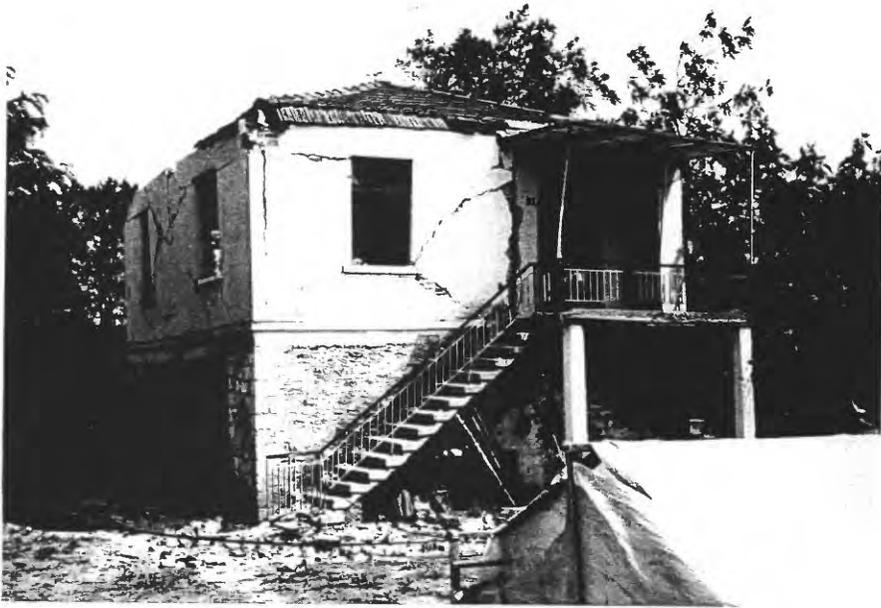
Ground rupturing passed through Yerakarou severely damaging several buildings, most notably several residential structures in the path of the fault zone. The damage included a two-story house constructed with a ground floor of reinforced concrete columns and beams joined to walls that were a mixture of concrete blocks and cemented rocks (Figure 19). The first level of the building was undamaged except for some holes in the wooden ceiling caused by fallen debris (Figure 20). The second floor, which appeared to have been constructed at a later date, consisted of unreinforced brick and hollow tile. The second floor was severely damaged; both exterior walls were near collapse and the interior tile walls toppled on to the bed, couch, table and floor (Figure 21). Fortunately, the building had been evacuated when the foreshocks occurred, that is with the exception of the mother-in-law who survived the earthquake while sleeping on the ground floor. Some residences located away from the fault zone had badly cracked tile walls and could not be safely occupied (Figure 22).

Figure 19. The rupture zone passed through this house in Yerakarou. The building has a reinforced concrete first floor and a tile wall second floor.

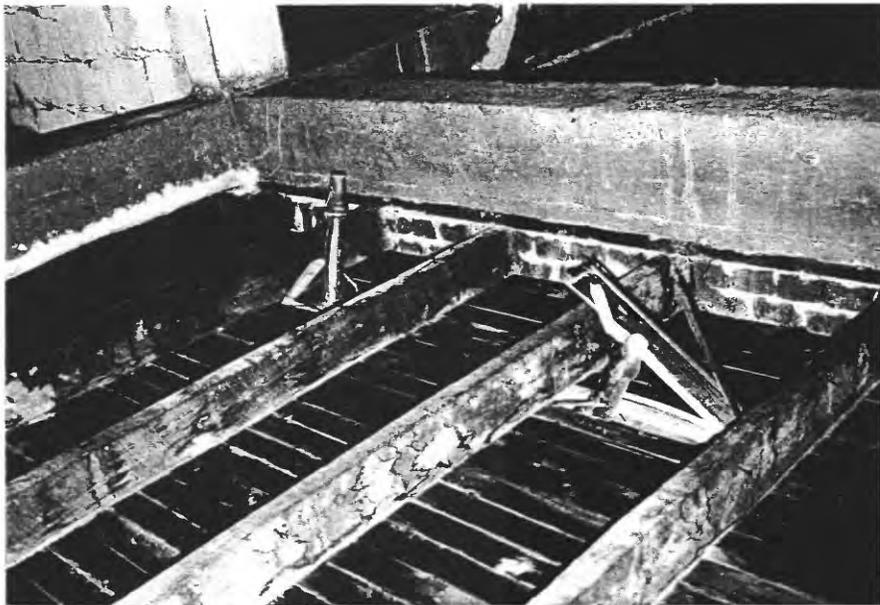
Figure 20. Tile partition fell upon a table on the second floor driving the legs through the first floor ceiling. House in Figure 19

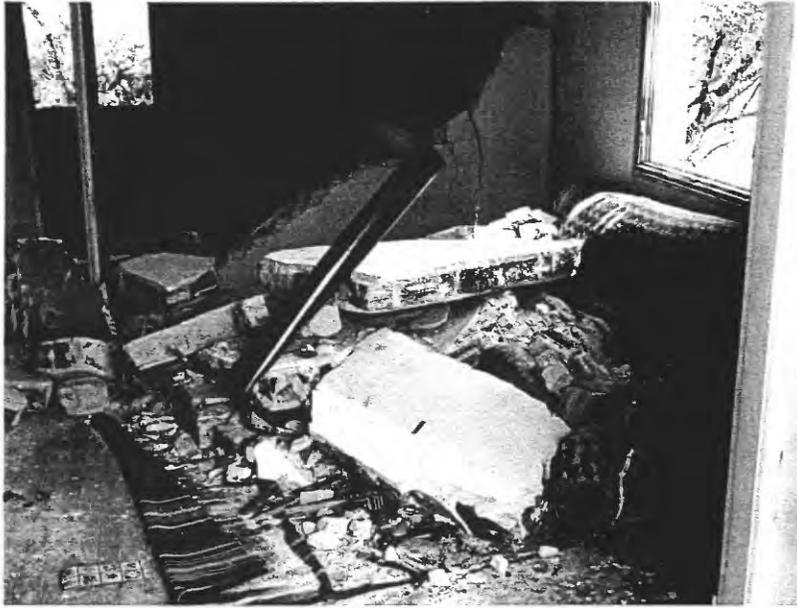
Figure 21. Hollow tile collapsed onto the couch on the second floor of the house shown in Figure 19.

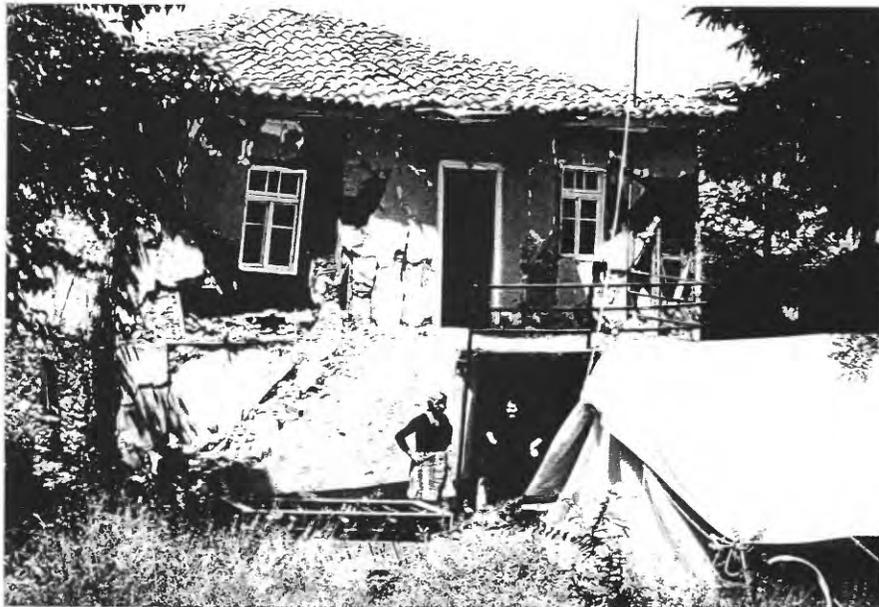
Figure 22. A badly damaged residence in Yerakarou.

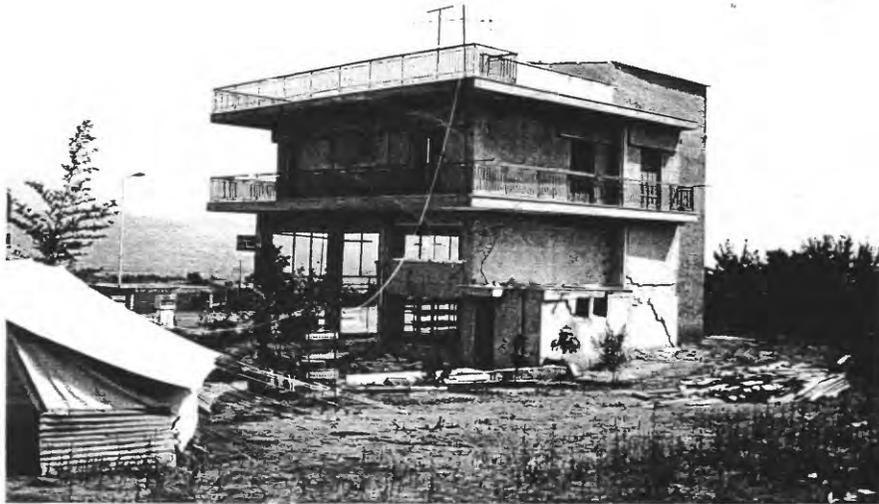
Faulting crossed the highway northwest of Stivos passing with 10 to 20 m of a two-story reinforced concrete building under construction for the office and residence of a FINA service station (Figure 23). The structure is approximately square with nine irregularly spaced 17 cm square perimeter columns, four at the front and three on the sides. Several columns were damaged at the base, just below the mezzanine level

Figure 23. A FINA service station under construction near Stivos. The fault zone is located between the tent, now occupied by the residents, and the building.

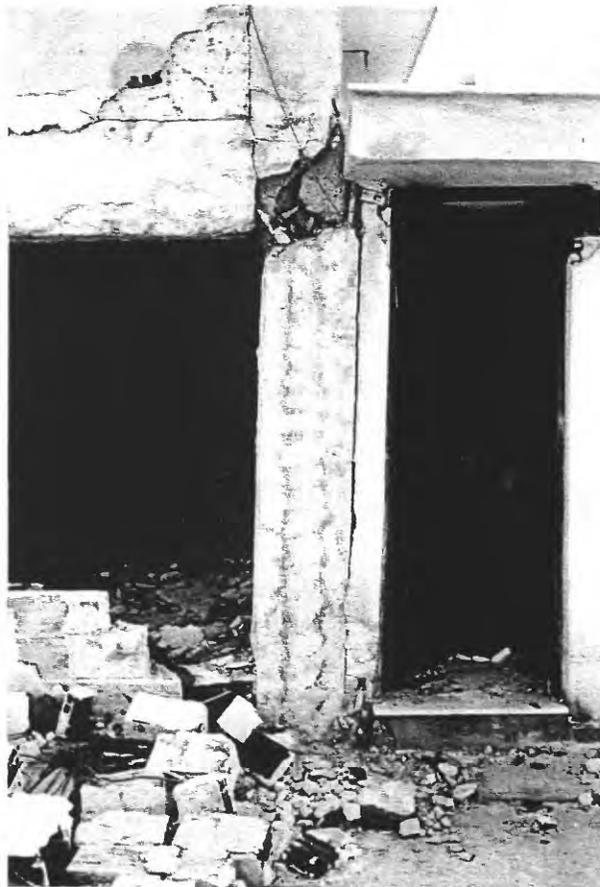
(Figure 24), and near the second floor; the latter were those that did not intercept the mezzanine extending across half the building area. The most heavily damaged west side of the structure had no wall up to the second floor (providing entrance to the vehicle servicing area), whereas the solid east wall of the building suffered no damage (Figure 25), except to the base of the corner column. The station operator reported the existence of faulting during the 1932 earthquake, but in a different location than that of the 1978 shock.

Figure 24. A damaged column at the FINA service station (Figure 23).

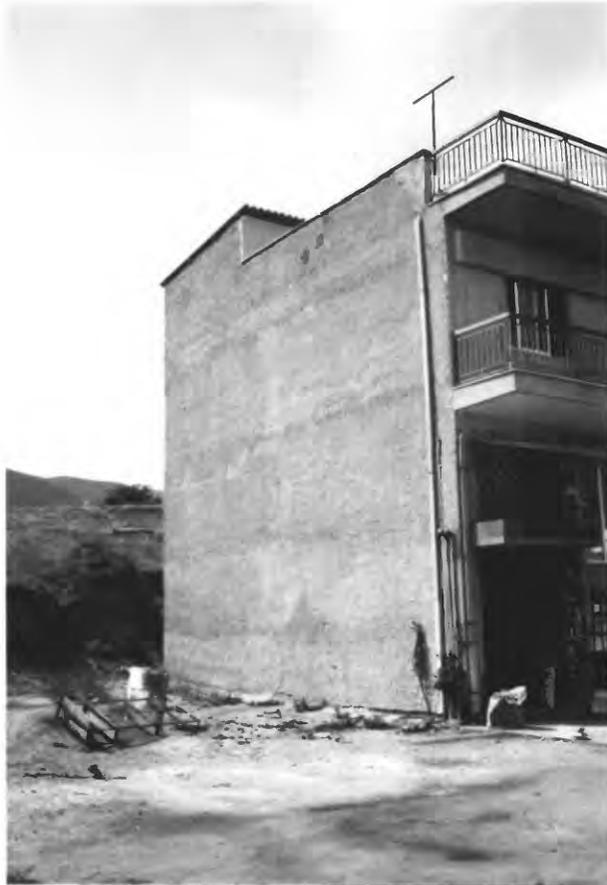
Figure 25. The undamaged rear wall at the FINA service station.

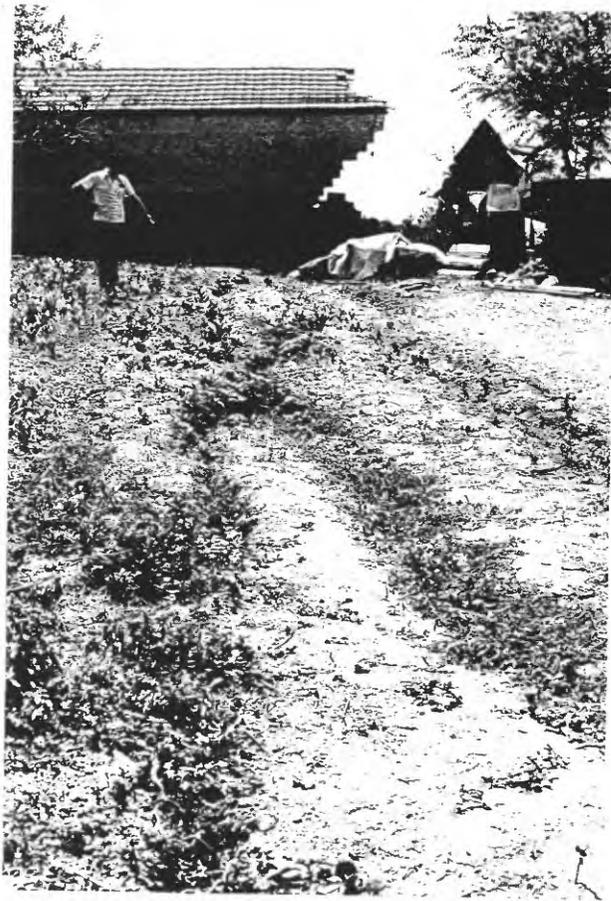
The fault zone passed through Stivos intercepted the main road and ran directly through at least one structure that partially collapsed (Figure 26). Several unreinforced concrete block, stone, and mud brick buildings were severely damaged or shaken down. A three-story reinforced-concrete frame building in central Stivos had ground floor damage consisting of damage to column bases and at the column-beam connections.

Figure 26. Faulting passed through a concrete block building in Stivos demolishing the down-slope section of the structure.

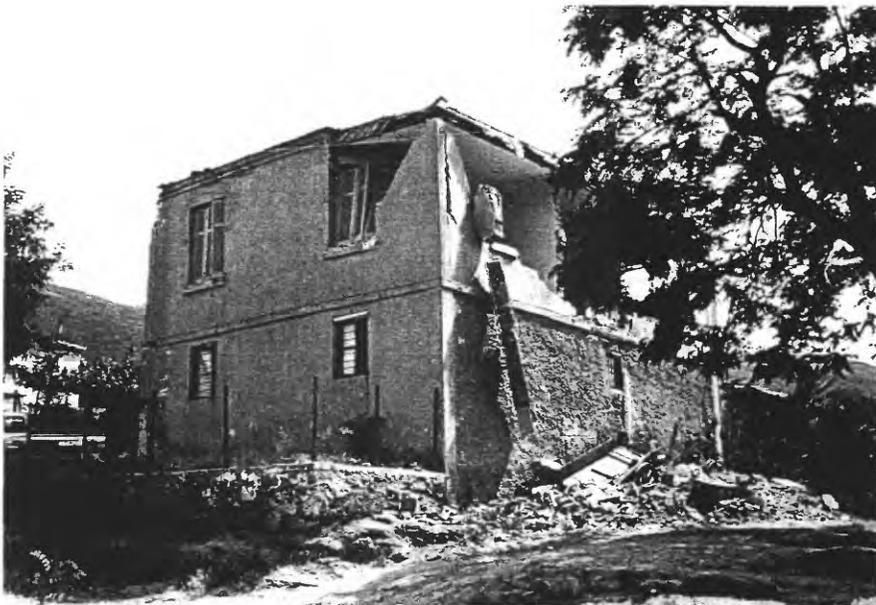
In contrast to other areas, the damage pattern in this village seems to bear no relationship to the location of the fracture zone since the structures in the upper reaches of Peristerona were essentially intact. But at the base of the hill, just above the intersection of the slope and highway, a number of houses and the entrance to the church were severely damaged (Figure 27). The church had a bell tower with a concrete cupola shaped dome supported by four narrow reinforced concrete columns standing over the walkway immediately in front of the main doors. The bell tower collapsed, although the remainder of the church was in good condition (Figure 28). Several unreinforced concrete block farm structures in the valley northwest of Peristerona were also flattened.

Figure 27. Typical damage at Peristerona near the base of the hill.

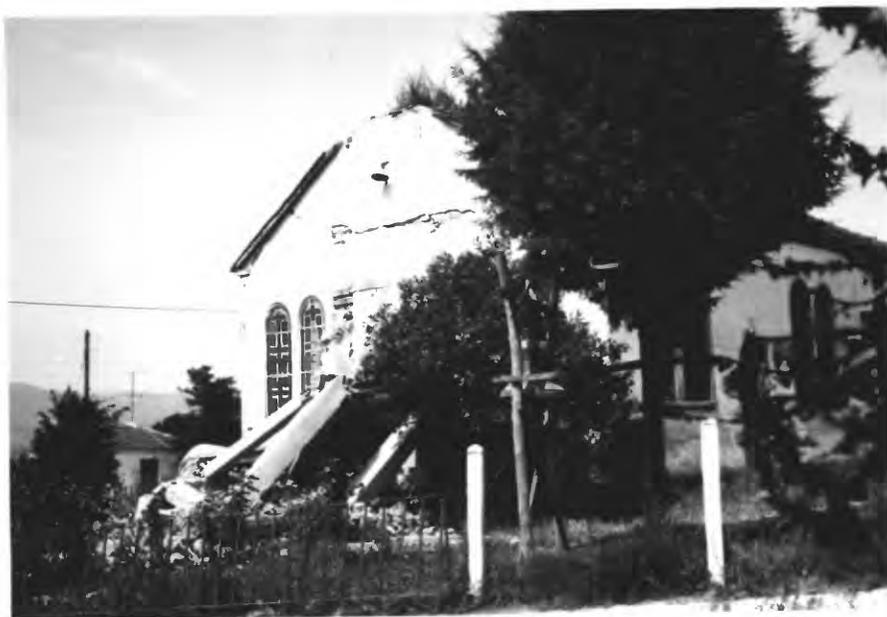
Figure 28. Collapsed entranceway columns at the church in Peristerona.
