United States Department of the Interior  
Geological Survey

The October 28, 1979, Landsliding On Tutuila,  
American Samoa

Jane M. Buchanan-Banks

Open-File Report  
81-81

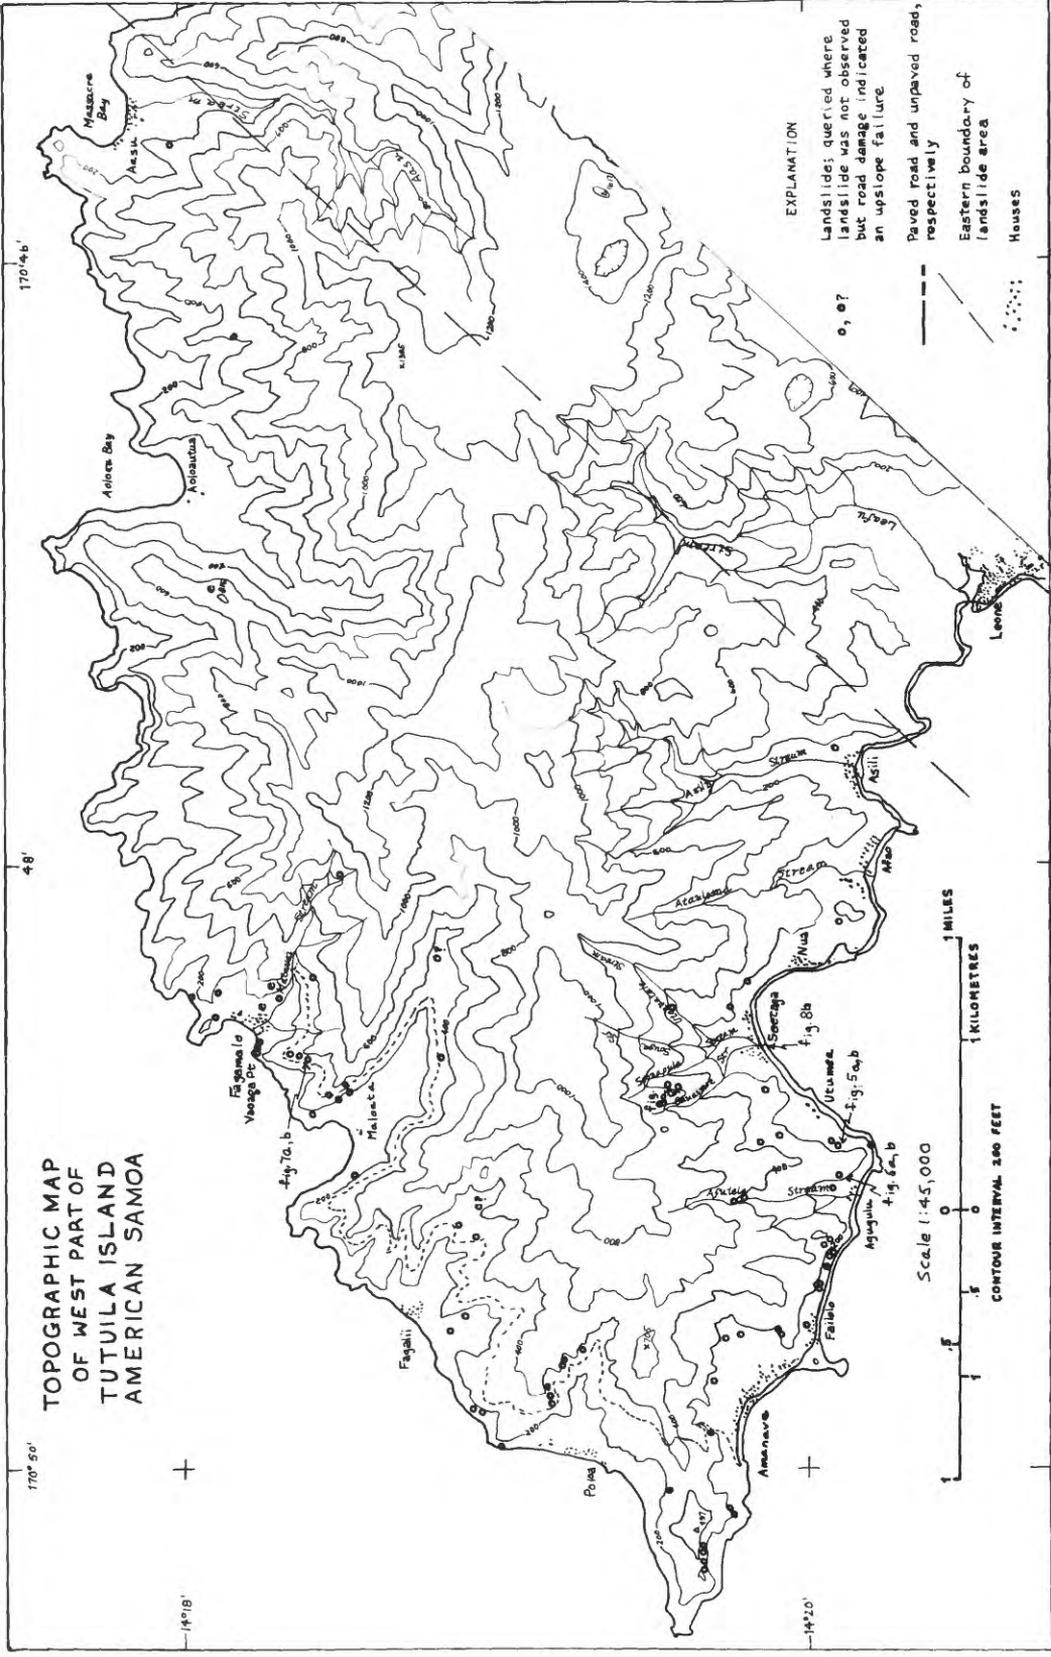
Figure 3

The latest episode of landsliding occurred during the early morning hours of Sunday, October 28, 1979 (Edvin G. Remund, oral comm.), when more than 70 landslides developed in an area west of a NE-SW line from Massacre Bay to Asili (fig. 3). It is estimated that more landslides occurred but were not observed due to the thick vegetative cover, poor light, and small amount of field time available. The exact times of the landsliding are not known but those in several of the villages were reported to have occurred between 0600 and 0700.

- Figure 3. Topographic map of west end of Tutuila Island showing general locations and estimated elevations of landslides.
- Figure 4. Schematic drawing of typical slump failure and resulting debris flow deposit (not to scale). Slump material from crown of slide erodes slope immediately downhill forming a chute. Due to the high fluid content of the slide material, it can flow for substantial distances beyond the base of the slope.

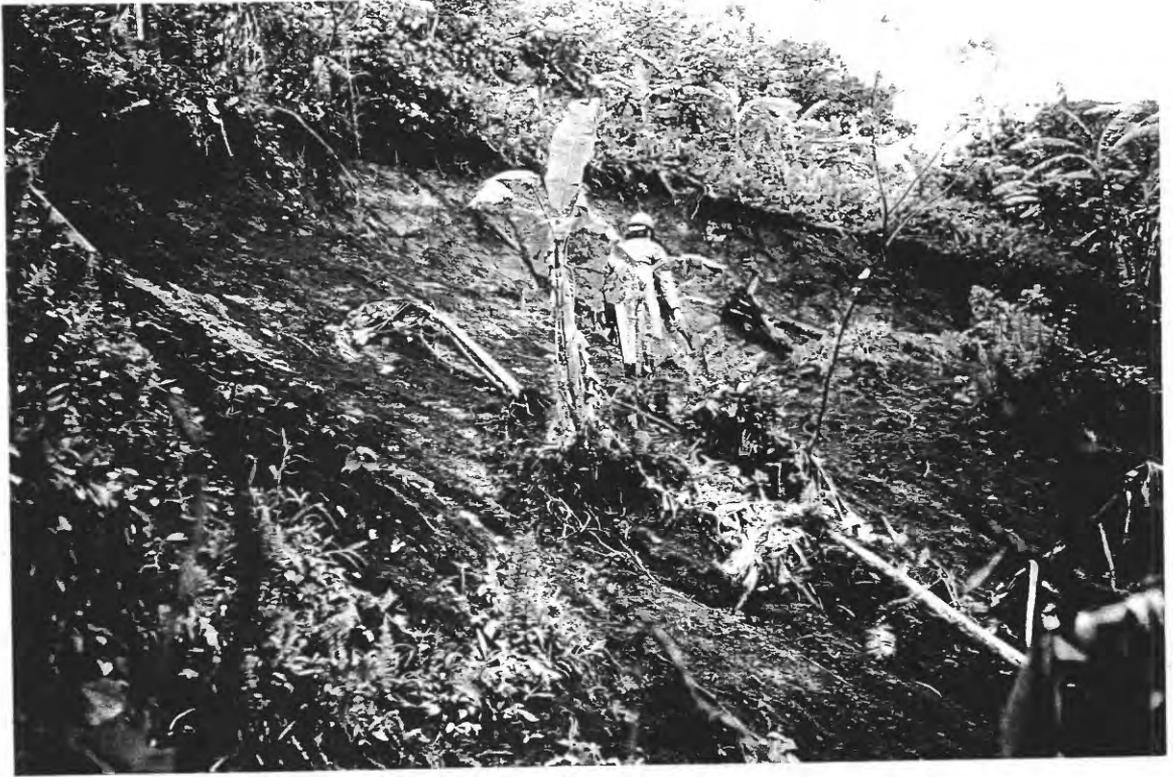
Fig 5a

- Figure 5a. Head scarp of slide at Utumea. Height of scarp approximately 5.5 m (18 ft). View towards northeast.
- 5b. Westward view taken from road of landslide shown in 5a.

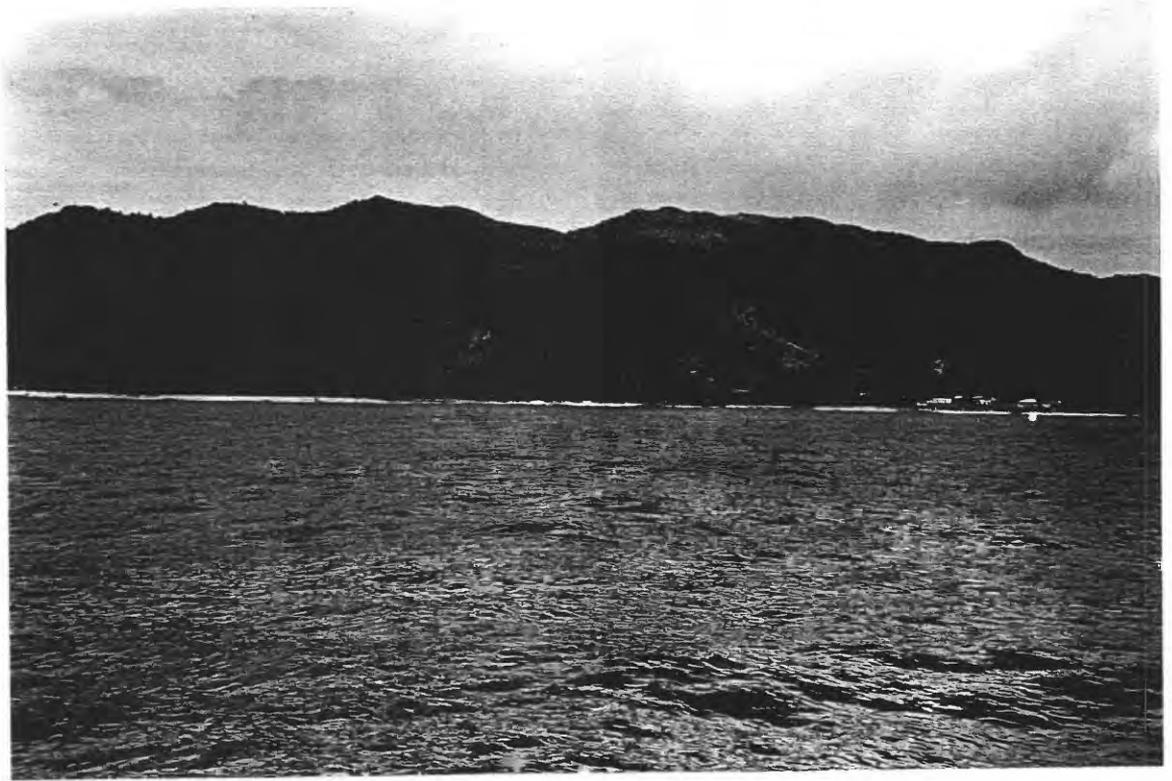
Fig. 6a

- Figure 6a. View towards north of landslides along a portion of the south coast. Slide to far right is in Agugula.
- 6b. Close up of landslide at Agugulu shown in 6a. View to northeast.

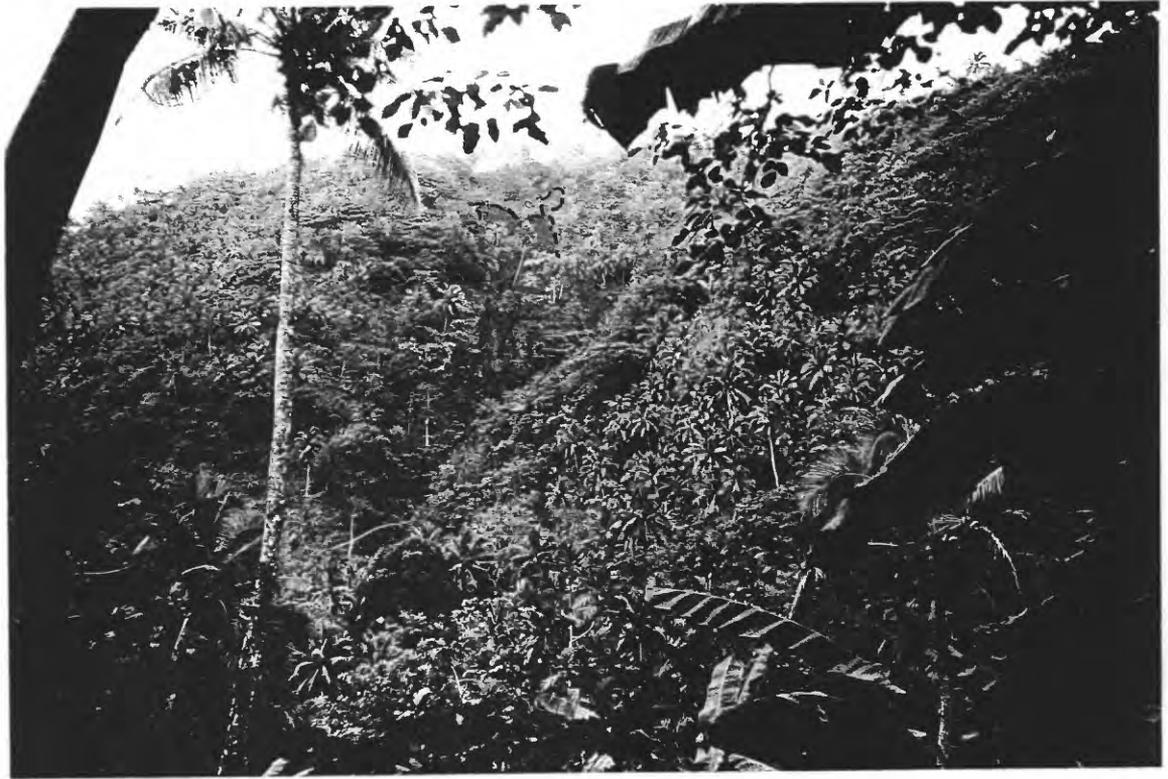
Fig. 8a

The severest consequences occurred at Seetaga where four people were killed. Eyewitness accounts from survivors at Seetaga indicated that the villagers were awake and moving about when they heard a loud boom. Within seconds, a debris flow entered their village, engulfed four people, and flowed to the sea (fig. 8a and 8b). They reported that the rain had not been unusually heavy the previous night nor that morning. The lateral force exerted by the flow apparently was not great. No houses were destroyed, although some were damaged, and coconut trees in the path of the debris flow were left standing (fig. 8b; field investigations took place nearly two months after the landsliding and the deposits within the villages had been modified by bulldozers). On two sets of vertical air photos, one taken in 1941 and another in 1961, a debris flow deposit can be seen at the confluence of the streams near Seetaga. On the 1941 photos, this deposit has a very fresh appearance and may have occurred during the hurricane of 1940. On the 1961 photos, the debris flow is still obvious although vegetation has been established on it.

- Figure 8a. Landslides in Soonapule Stream above Seetaga. View towards west.
- 8b. Debris flow material in Seetaga (modified by bulldozer) in part derived from landslides shown in 8a. View towards north
