AN ANALYSIS OF STRONG-MOTION DATA FROM A SEVERELY DAMAGED STRUCTURE,
THE IMPERIAL COUNTY SERVICES BUILDING, EL CENTRO, CALIFORNIA

Christopher Rojahn and P. N. Mork
U.S. Geological Survey
Menlo Park, California

U.S. Geological Survey
Open-File Report 81-194

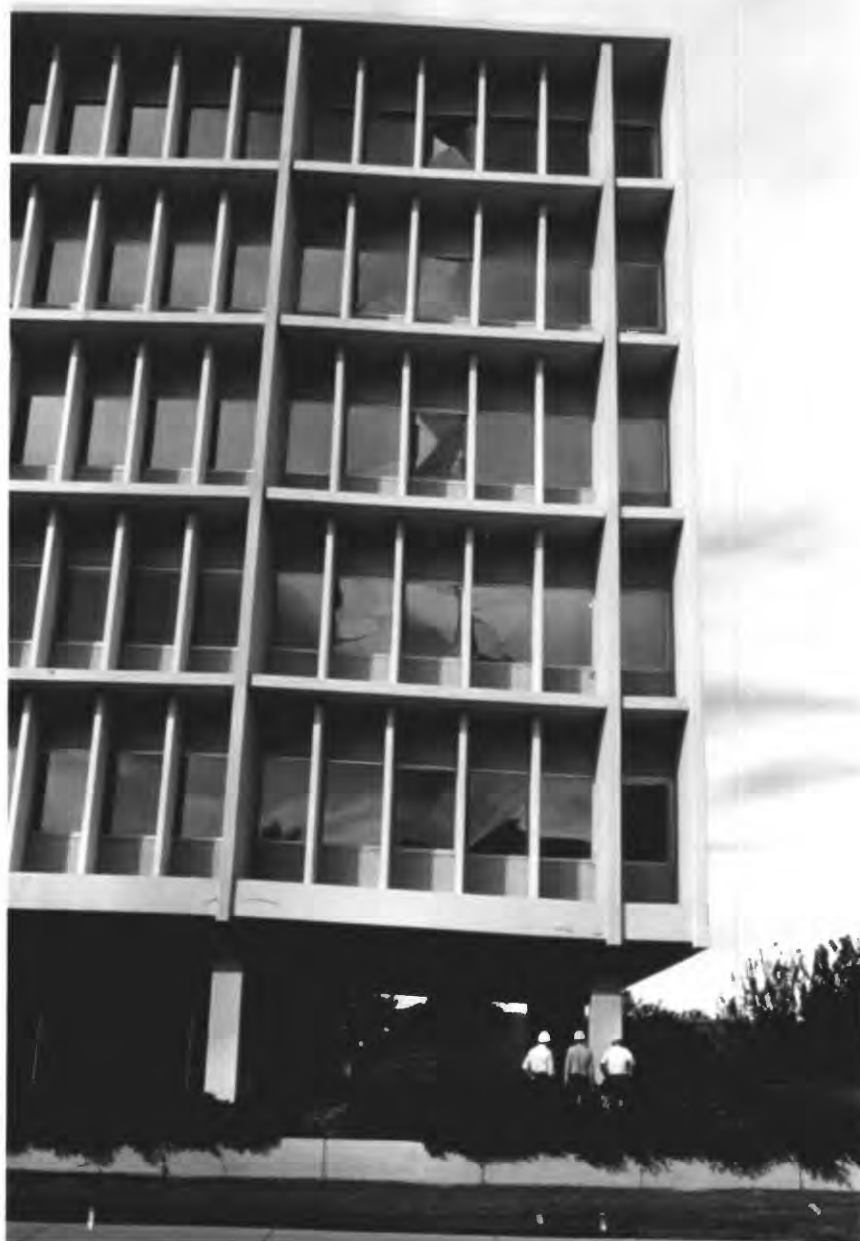
The most significant damage to the Imperial County Services Building was the partial collapse just above ground level of the four reinforced-concrete columns along the building's east end (figs. 3, 4). Concrete at the base of each column was badly shattered, vertical reinforcing bars were severely buckled, and horizontal tie bars were widely splayed. On the basis of measurements by the Imperial County Department of Buildings and Grounds, the columns were shortened by approximately 23 cm (9 in.) during the main shock and by approximately 7 1/2 cm (3 in.) more during the strongest aftershock (Randy Rister, oral commun., 1979). Less significant damage elsewhere in the building included minor cracking in all columns beneath the second floor (just beneath the beams), minor cracking or spalling at the base of most columns (just above ground level), and a north-south line of severe cracking (fig. 5) in all upper story floor slabs just to the east of the first interior row of columns (from the east end). The pattern of column damage suggests frame yielding in the longitudinal (east-west) direction and axial-force failure due to north-south overturning of the east-end shear wall; the floor-slab cracks were due to settlement of the structure at the east end.

Figure 3.--View northward of east end of Imperial County Services Building, showing row of columns (far right) that failed during October 15 main shock.

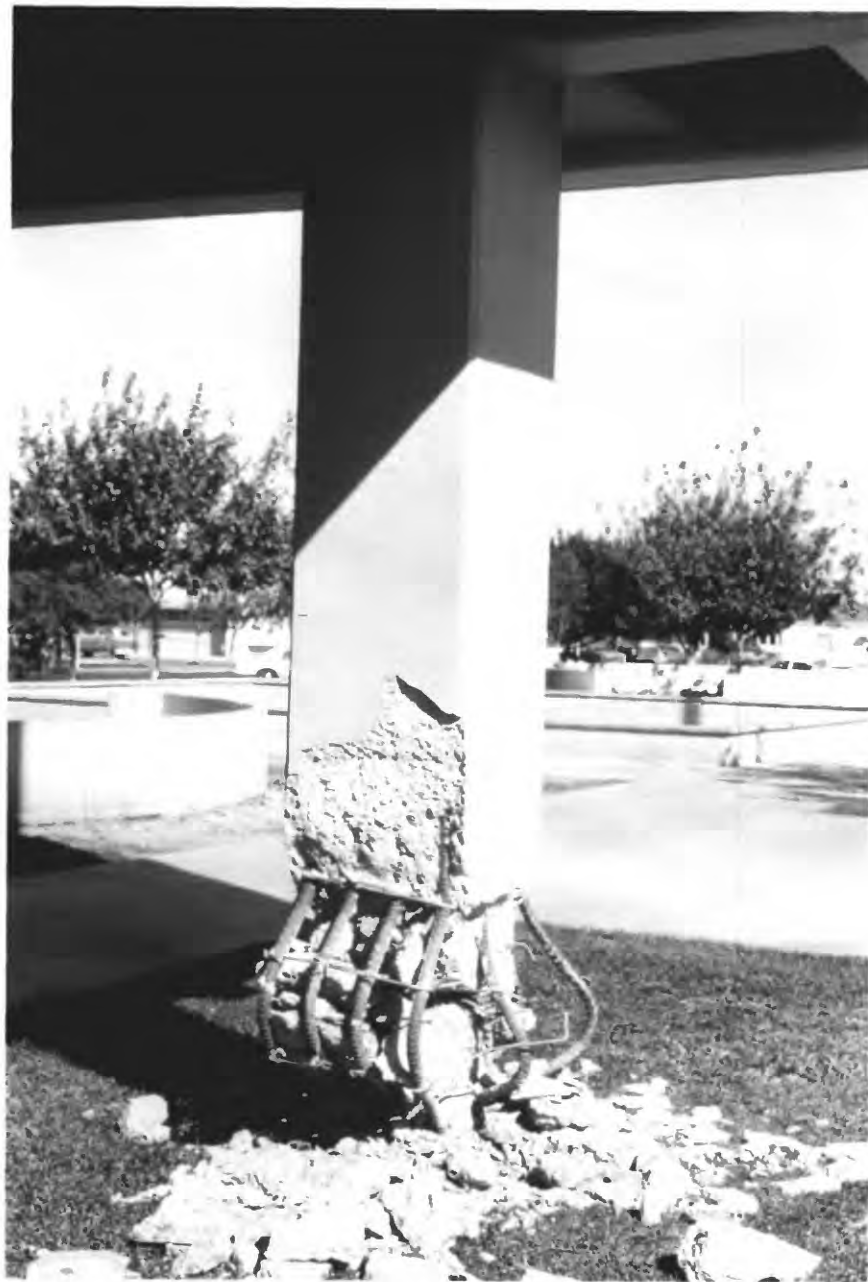
Figure 4.--One of four damaged reinforced-concrete columns along east end of Imperial County Services Building between ground and second floors. Damage to other three columns was similar.

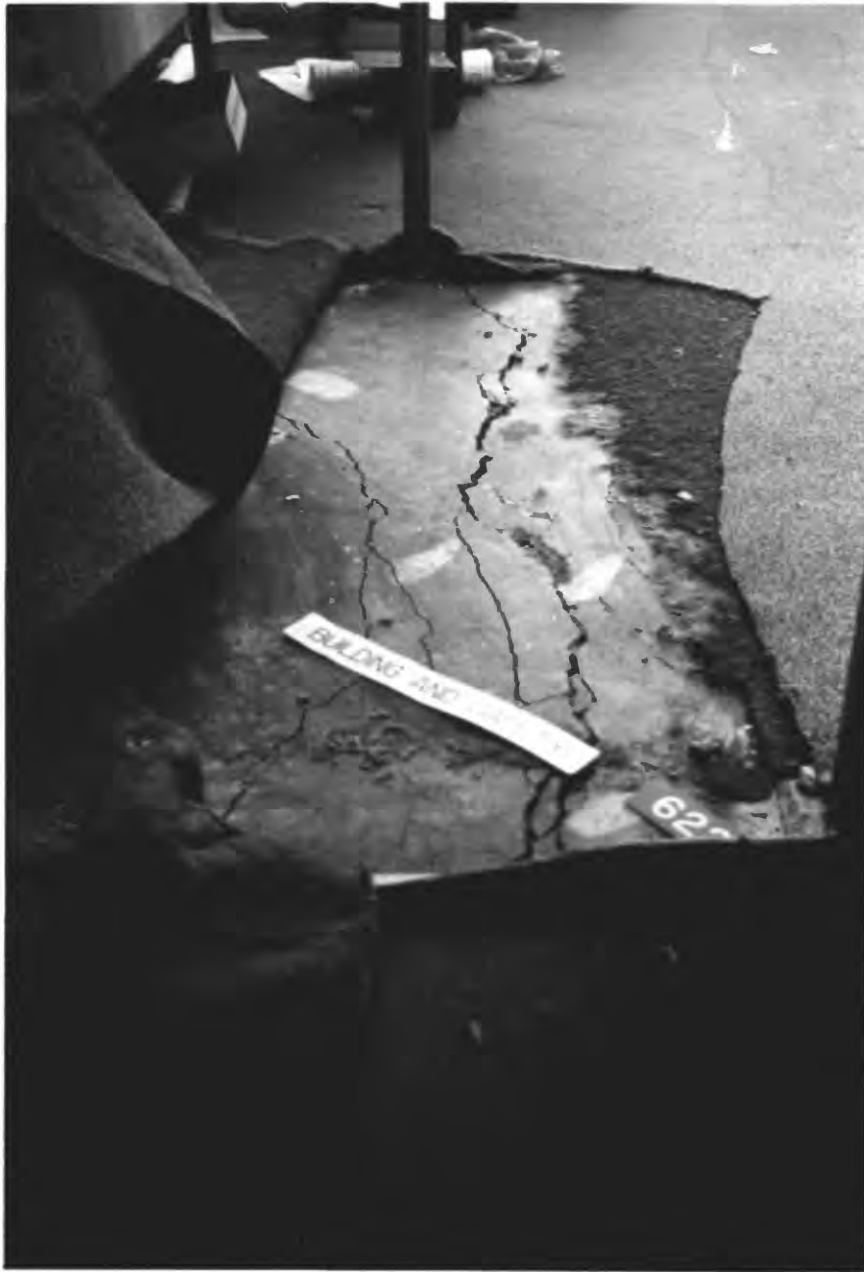
Figure 5.--North-south-trending crack in sixth floor just east of first interior row of columns (from east face).

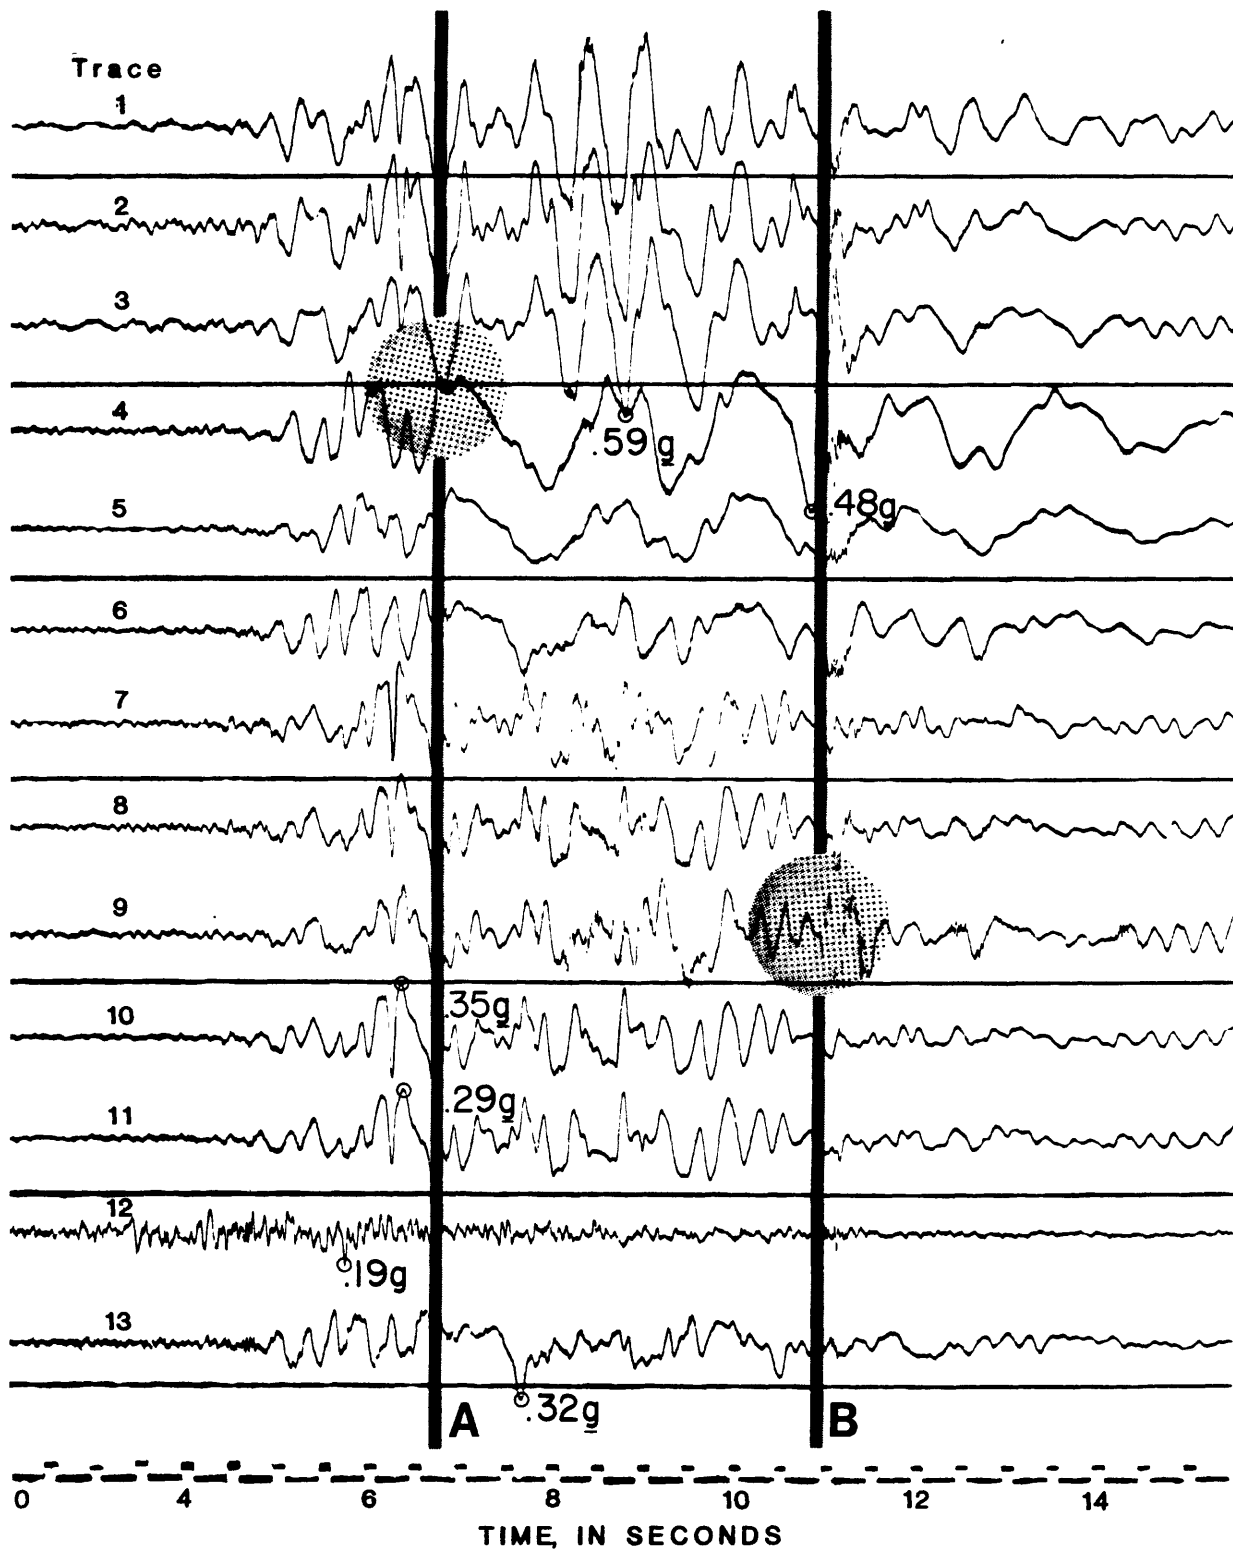
Various features of the main-shock accelerogram recovered from the building (fig. 8) provide important information on the mechanism of structural failure. These features are clearly evident in a twofold enlargement of the original record (fig. 11) but are not apparent in the plots of corrected digitized data (Porter, in press). The first major feature, an abrupt change in frequency content in the upper story east-west components, occurs at 6.8 s (traces 4 (shaded area A) -6, fig. 11). At that time the predominant period of vibration in all three components abruptly lengthens to approximately 1.6 s (average value for the first 2-1/2 cycles after 6.8 s). This period elongation, which occurs during the long-period acceleration pulse in the east-west component at ground level (max pulse acceleration, 0.24 g (uncorrected)), denotes a sudden decrease in the stiffness of the east-west reinforced-concrete frames. We therefore interpret this feature as the time at which damage begins. Immediately after 6.8 s, bursts of low-amplitude high-frequency motion begin to appear in all upper story components (especially traces 4, 6, 9, fig. 11). These bursts probably reflect the continuation of damage.

The second major feature, a 0.5-s-long burst of high-frequency (approximately 50 Hz) high-amplitude motion, occurs at 11.0 s in trace 9 (shaded circle B, fig. 11), which is the acceleration time history of the north-south component at the second floor directly above the columns that failed. We interpret this feature to denote the time at which the columns along the building's east face collapsed. At the same time, the frequency content of the north-south-component time histories recorded at both ends of the roof changed (traces 1, 3, fig. 11). Before 11.0 s the frequency of these two traces is roughly equivalent, that is, both ends of the roof are vibrating in phase; but after 11.5 s their frequencies are no longer the same. The predominant frequency at the west end of the roof after 11.5 s (trace 1, fig. 11) is approximately 1.7 Hz, whereas that at the east end of the roof (trace 3) is approximately 0.8 Hz. Corresponding predominant periods for the two components are 0.6 s (west end) and 1.2 s (east end). These data imply that the stiffness characteristics of the building in the north-south direction at the east and west ends were altered substantially between 11.0 and 11.5 s, and because the columns collapsed at the east end, this sudden difference in stiffness must denote that collapse.

Figure 11.--Enlargement of critical portion of October 15 accelerogram recorded in Imperial County Services Building. Shaded circles denote features discussed in text. Times at which damage initiation occurred and column collapse began are labeled A and B, respectively.

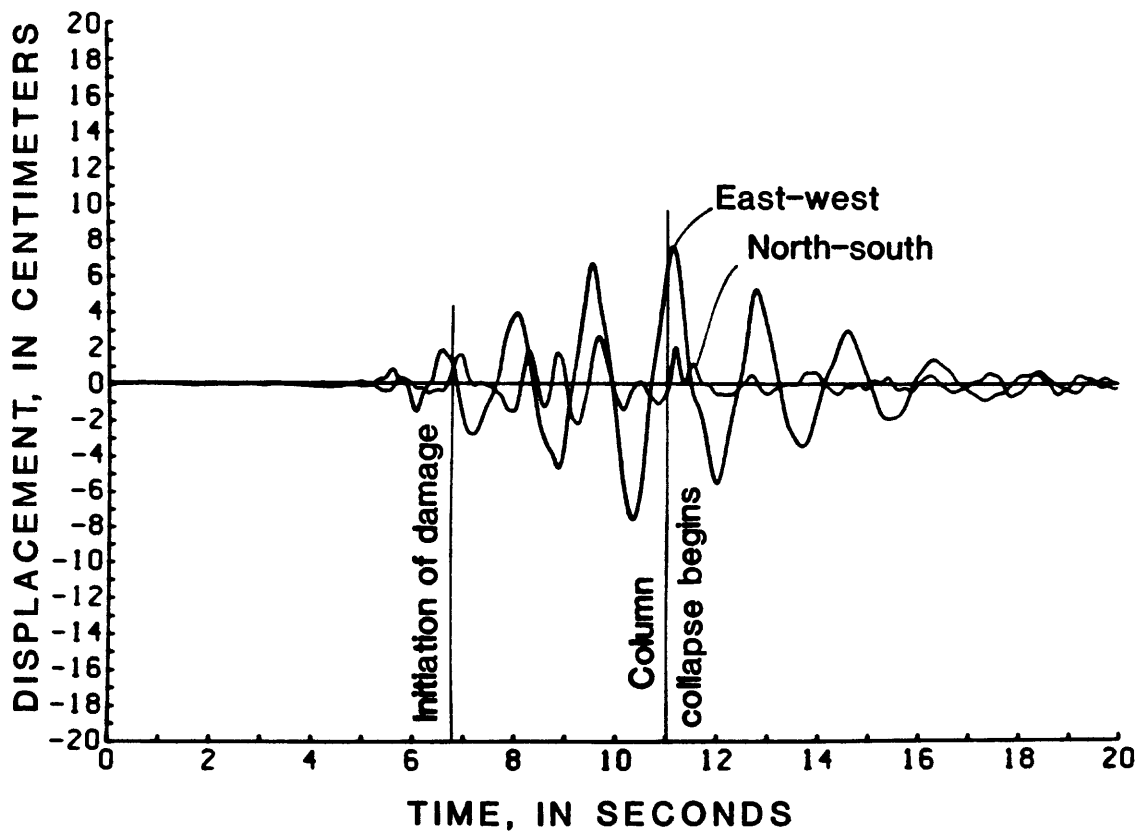
The superposition of north-south and east-west time histories of relative displacement at the east end between the second and ground floors (fig. 18) provides insight into the two-dimensional horizontal motion there before, during, and after the beginning of damage and the collapse of the columns. This plot indicates that: (1) at the time of damage initiation, the amplitudes of north-south and east-west relative displacement between the second and ground floors were approximately 0.9 and 1.1 cm, respectively; (2) the maximum north-south first-story relative displacement of approximately 2.7 cm occurred approximately 1.3 s before column collapse began; (3) column

collapse apparently began when the east-west relative displacement was approximately 6.2 cm, or 81% percent of the maximum (7.7 cm) that occurred approximately 0.1 s later; and (4) the north-south first-story relative displacement was relatively small (0.4 cm) when column collapse began. Also, the amplitude of north-south relative displacement between the roof and ground floor at the east end (fig. 16) when column collapse began was also small (0.8 cm); in other words, at the time of column collapse, the building was aligned nearly vertical in the north-south direction.

Figure 18.--Time history of east-west and north-south relative displacements between ground and second floor (difference of data from accelerometers 6 and 13, and 9 and 11), showing times of damage initiation and beginning of column collapse.
