OFF-ROAD VEHICULAR DESTABILIZATION OF HILLSLOPES  
THE MAJOR CONTRIBUTING FACTOR TO DESTRUCTIVE  
DEBRIS FLOWS IN OGDEN, UTAH, 1979

John K. Nakata

Open-File Report  
81-258

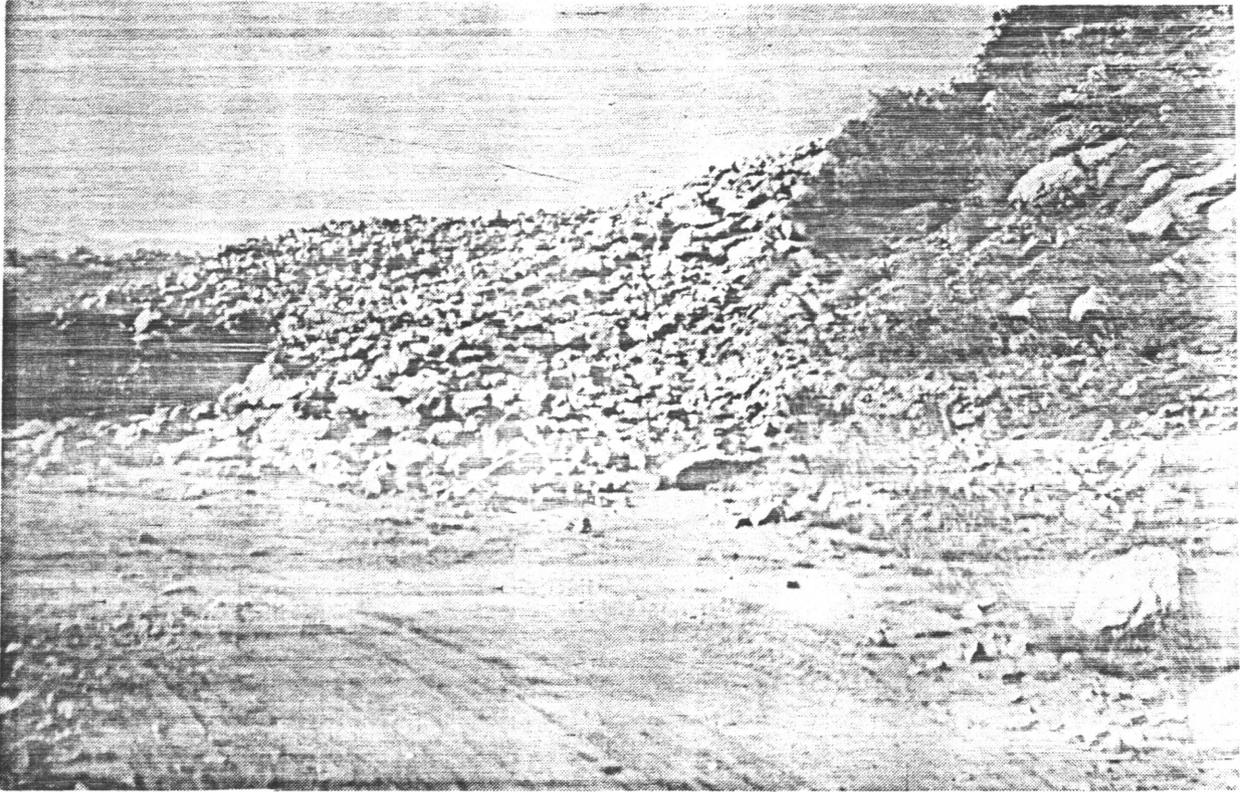
Fig. 2. Rocks as large as 1.5 meters in diameter were deposited on the covered segment of the canal east of Cook Street. The upstream drainage system is unmodified by man.

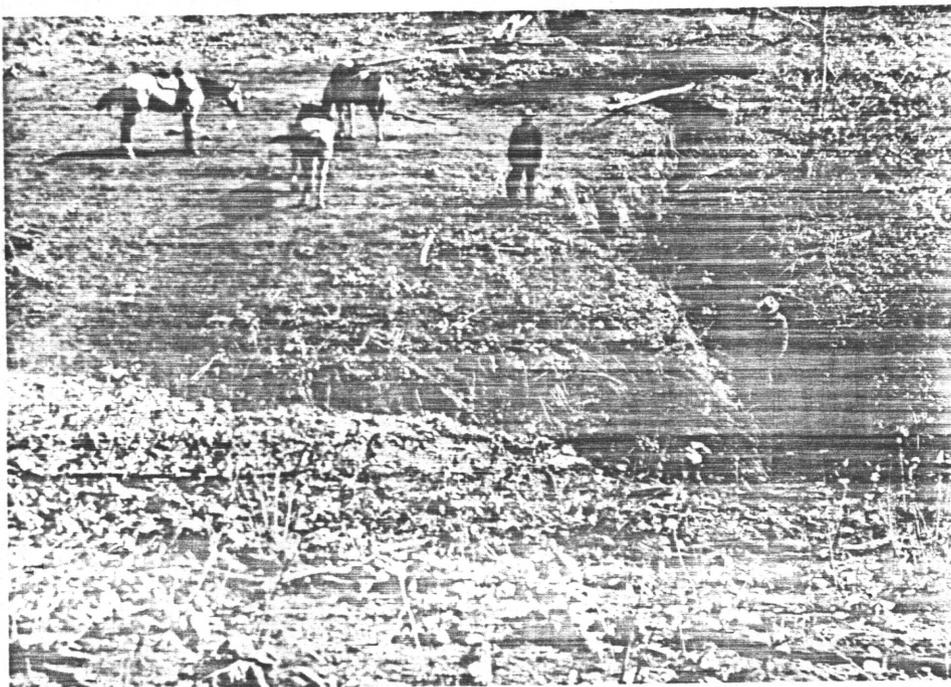
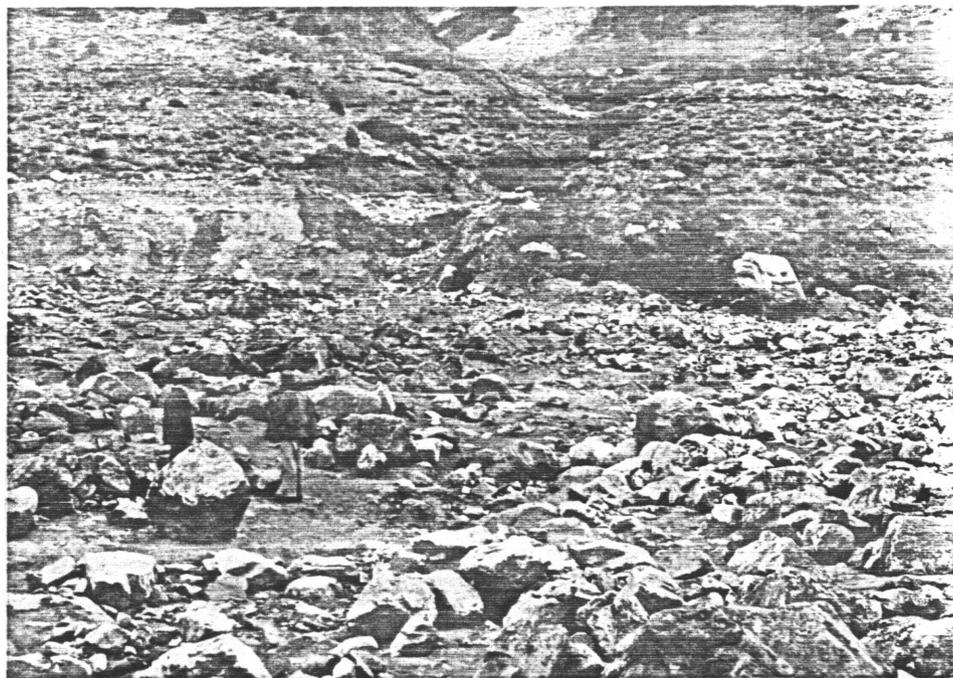
A man-induced debris flow occurred in August 1945 when a rock and mudflow covered farmland at the mouth of Jumpoff Canyon, 1.5 km north of the August 1979 mudflow (Fig. 3) (Robert Eldard, written commun., Oct. 29, 1979, Ogden City Planning Commission). Overgrazing during the spring and summer months had denuded the hillsides and left the land extremely vulnerable to erosion. Under similar circumstances, the southern San Joaquin Valley of California was devastated by wind and subsequent rains in December 1977 (Wilshire and others, in press). The loss of vegetative cover in both the Ogden and Bakersfield areas contributed to increased runoff sufficient to overload the drainage systems. Records from the Pioneer Weather Station in Ogden indicate that 3.58 cm (1.42 inches) of rain was sufficient to trigger the 1945 mudslide.

Fig. 3. A 1945 photograph shows overgrazed hillsides in Jumpoff Canyon (A), and the debris flow after August 1945 rains (B). Photographs courtesy of the Ogden City Planning Commission.

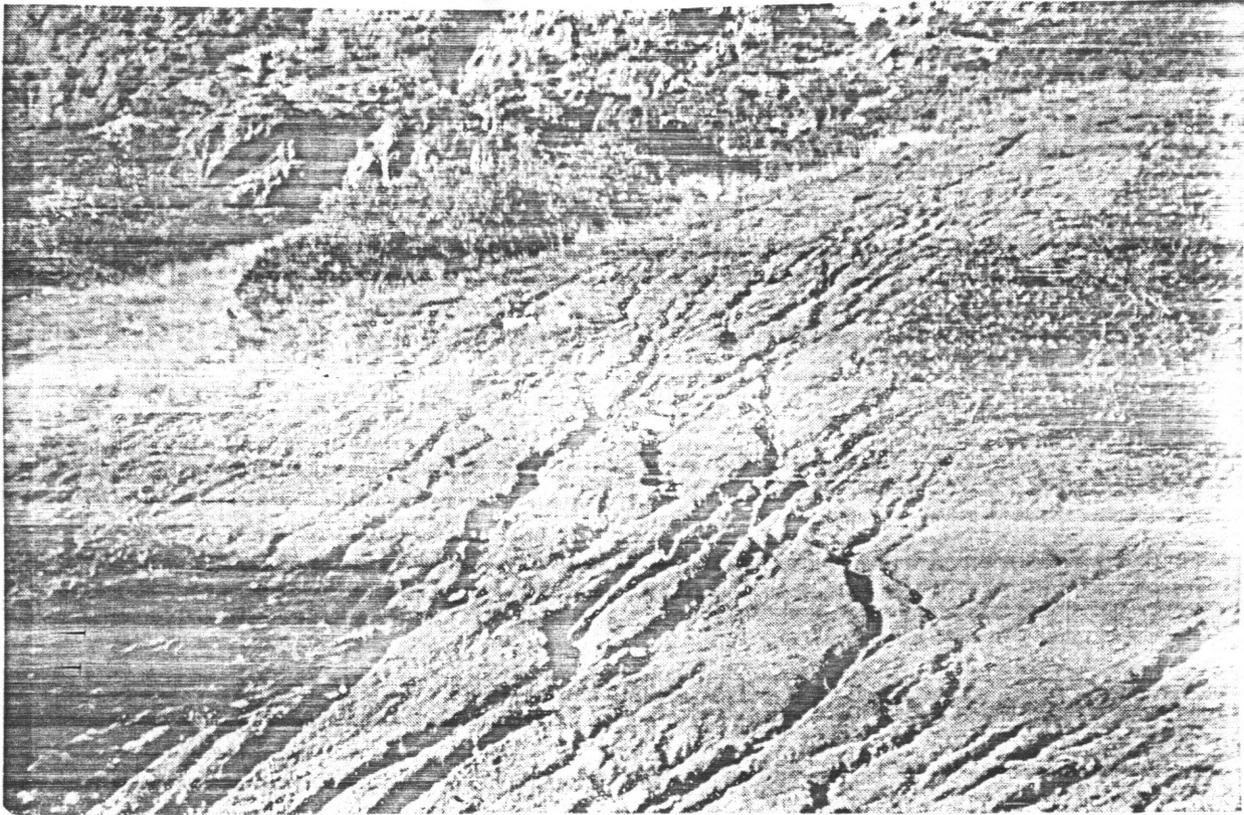
additional evidence that most of the gullies were the result of the August rainstorm. The length of the exposed roots indicates the amount of soil that had been eroded.

Fig. 4. Anastomosing gullies formed after August rains in all denuded areas. The string marks profile #7 (Fig. 5) along trail 1 and is approximately 11 meters long.

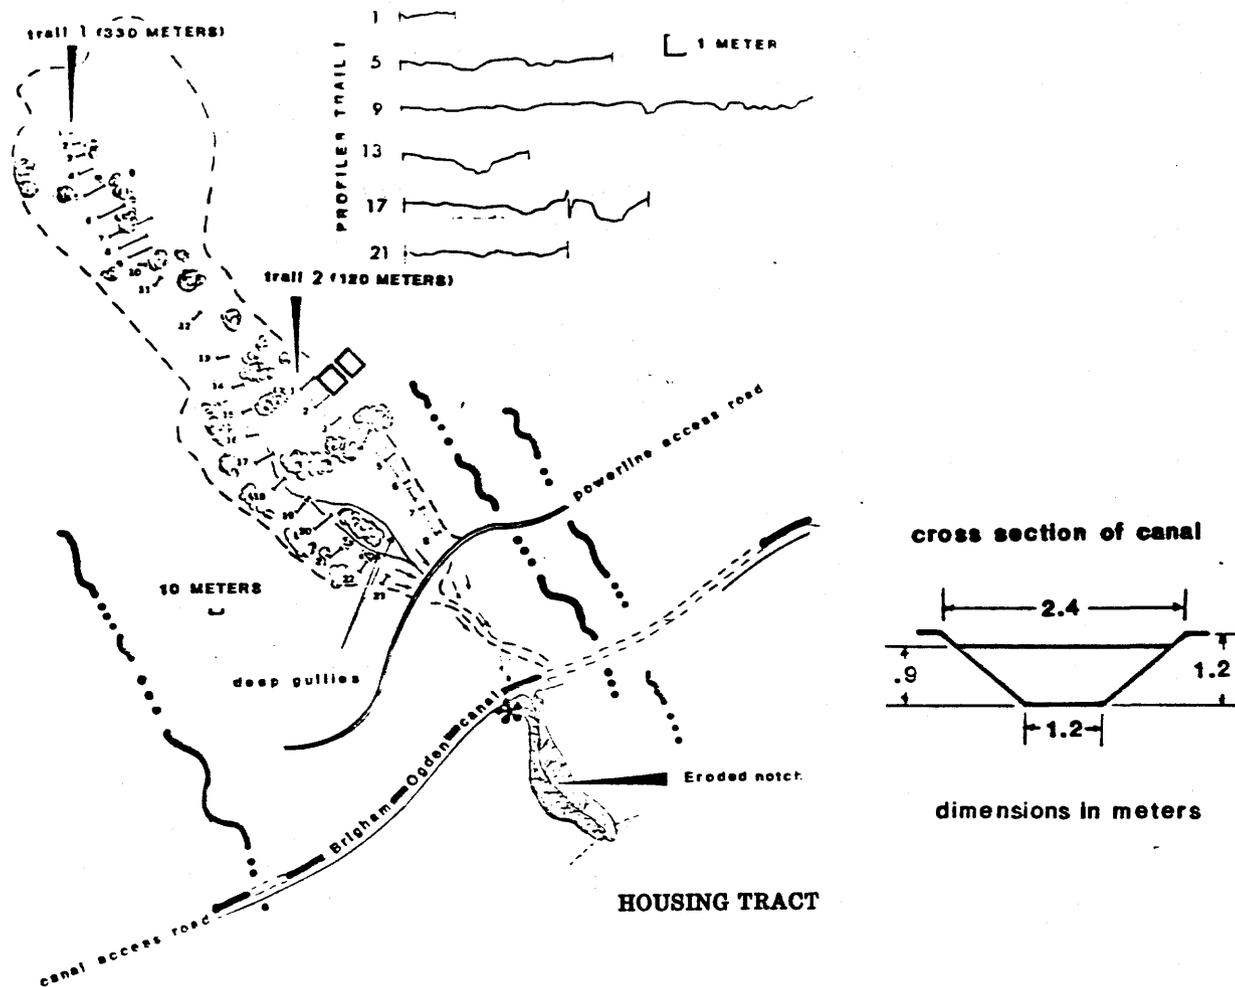
Profiles were made of two trails located above the canal to establish the order of magnitude of material eroded from the impacted hillside ( Fig. 5). A 330-meter section of a trail located on an interfluvium with a slope range of  $10^{\circ}$  to  $35^{\circ}$  was profiled to determine soil loss. The volume lost was  $187 \text{ m}^3$  with a mass loss of 325 or 359 metric tons, which corresponds to dry bulk density measurements of  $1.74 \text{ g/cm}^3$  and  $1.92 \text{ g/cm}^3$ . A second trail 120 meters long with a slope range of  $10^{\circ}$  to  $23^{\circ}$  lost  $72 \text{ m}^3$  of soil yielding values of 125 or 138 metric tons depending on which bulk density measurement is used.

The total minimum loss from the two trails is estimated as 450 metric tons of material. This figure does not apply to the entire destabilized area, nor does it account for natural erosion. Consequently, the volume loss reported represents only a partial estimate of the material eroded from the hills above the canal. However, the material displaced and channeled by ORV trails was sufficient to block the Brigham-Ogden canal which measures only  $2.8 \text{ m}^2$  in cross-sectional area (Fig. 5).

In the area above the canal (Fig. 5), two 75-m<sup>2</sup> plots, each with the same slope, slope aspect, and soil and both receiving excess runoff from denuded upslope terrain, were profiled to determine volume loss. The plot that was partially denuded by moderate ORV use lost 10 m<sup>3</sup> of soil, whereas the adjacent area subjected to light ORV use lost 4 m<sup>3</sup>. In areas not used by ORV's, the grass was matted by sheetflow, but the soil horizon was virtually intact.

Fig. 5. Sketch map of the off-road vehicle area in relation to the Brigham-Ogden Canal. Inset are typical profiles along trail #1, and a cross section of the canal at Third street.

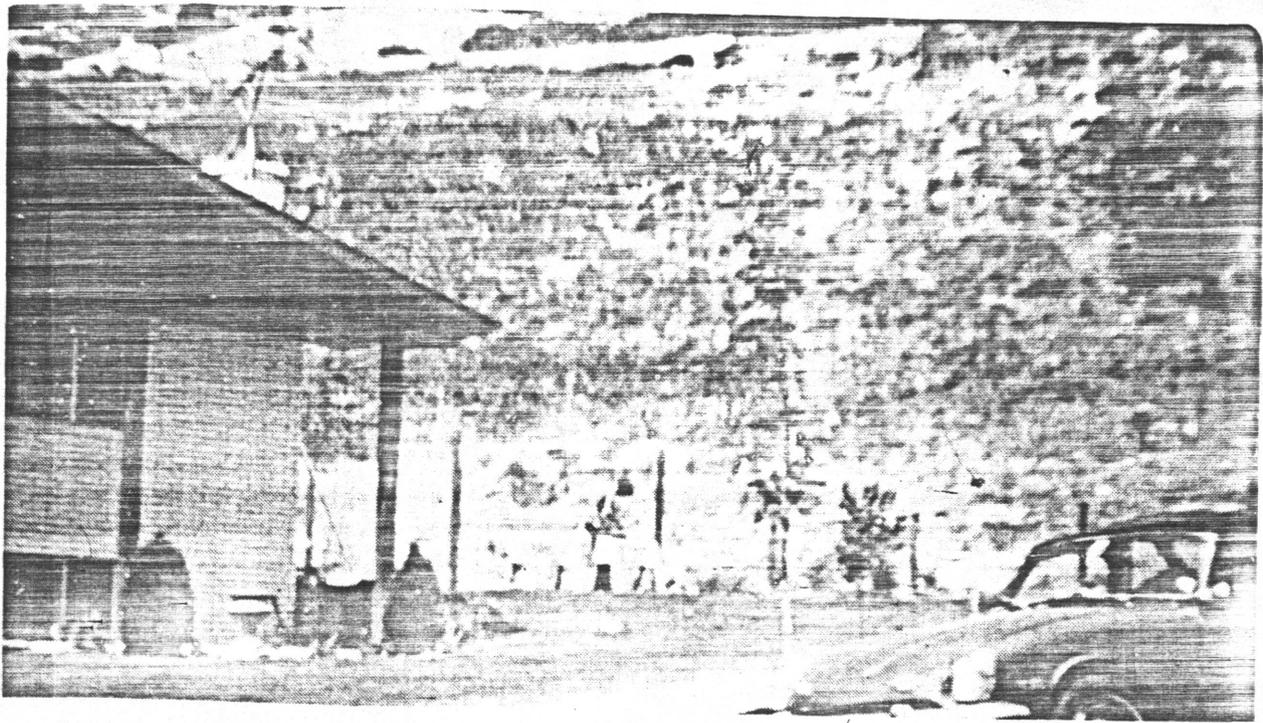
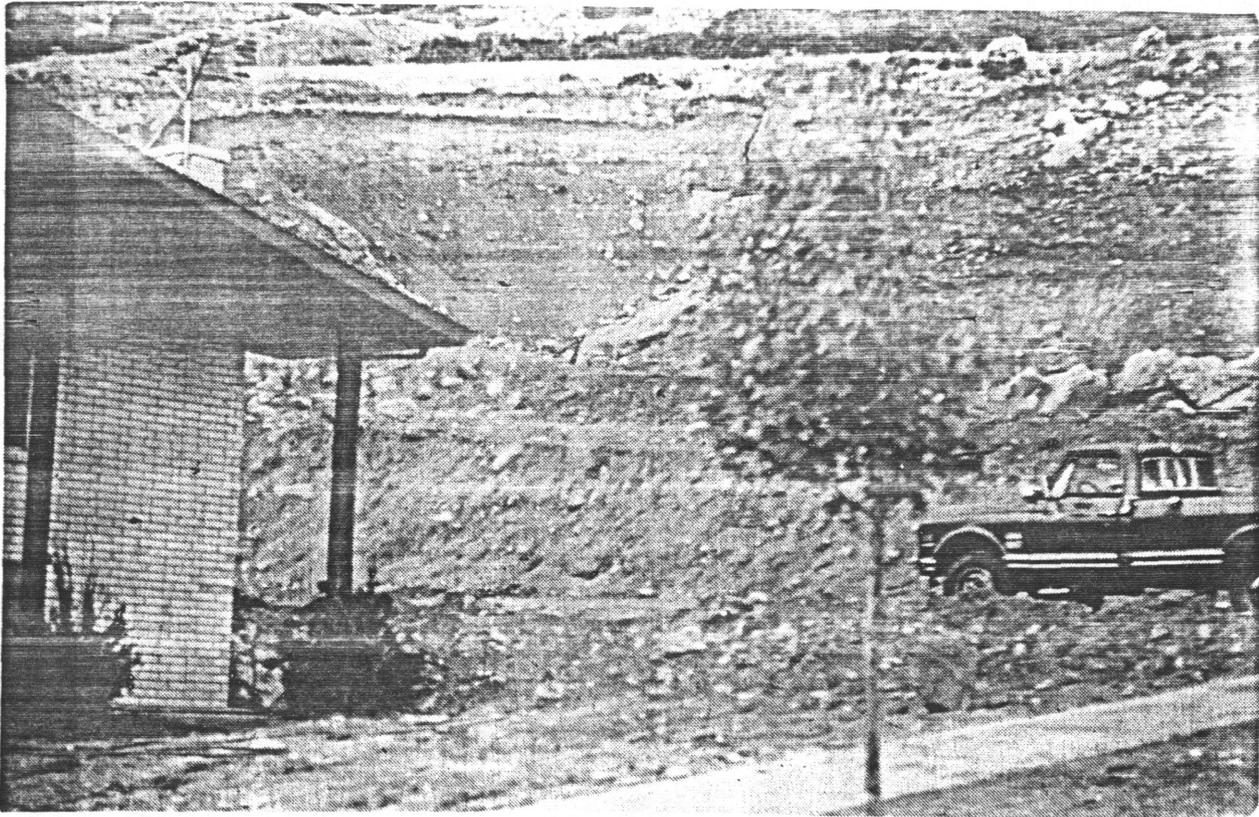
Grading done after the mudflow to protect houses from subsequent rains changed the configuration of the notch below the canal. Consequently, only crude measurements were made on this notch. A conservative estimate of the volume displaced is 12,000 m<sup>3</sup> or approximately 21,000 metric tons, on the basis of an average bulk density of 1.82 g/cm<sup>3</sup>. The erosion that occurred below the canal is dramatically illustrated in Fig. 6, which shows the hillside before and after the debris flow.

Fig. 6. Before and after photographs of the notch eroded by diverted canal water at the end of Third Street. Photograph (A) courtesy of Mr. and Mrs. L. Haun.
