INVESTIGATIONS OF THE 8 NOVEMBER 1980
EARTHQUAKE IN HUMBOLDT COUNTY, CALIFORNIA

U.S. Geological Survey

Open-File Report 81-397

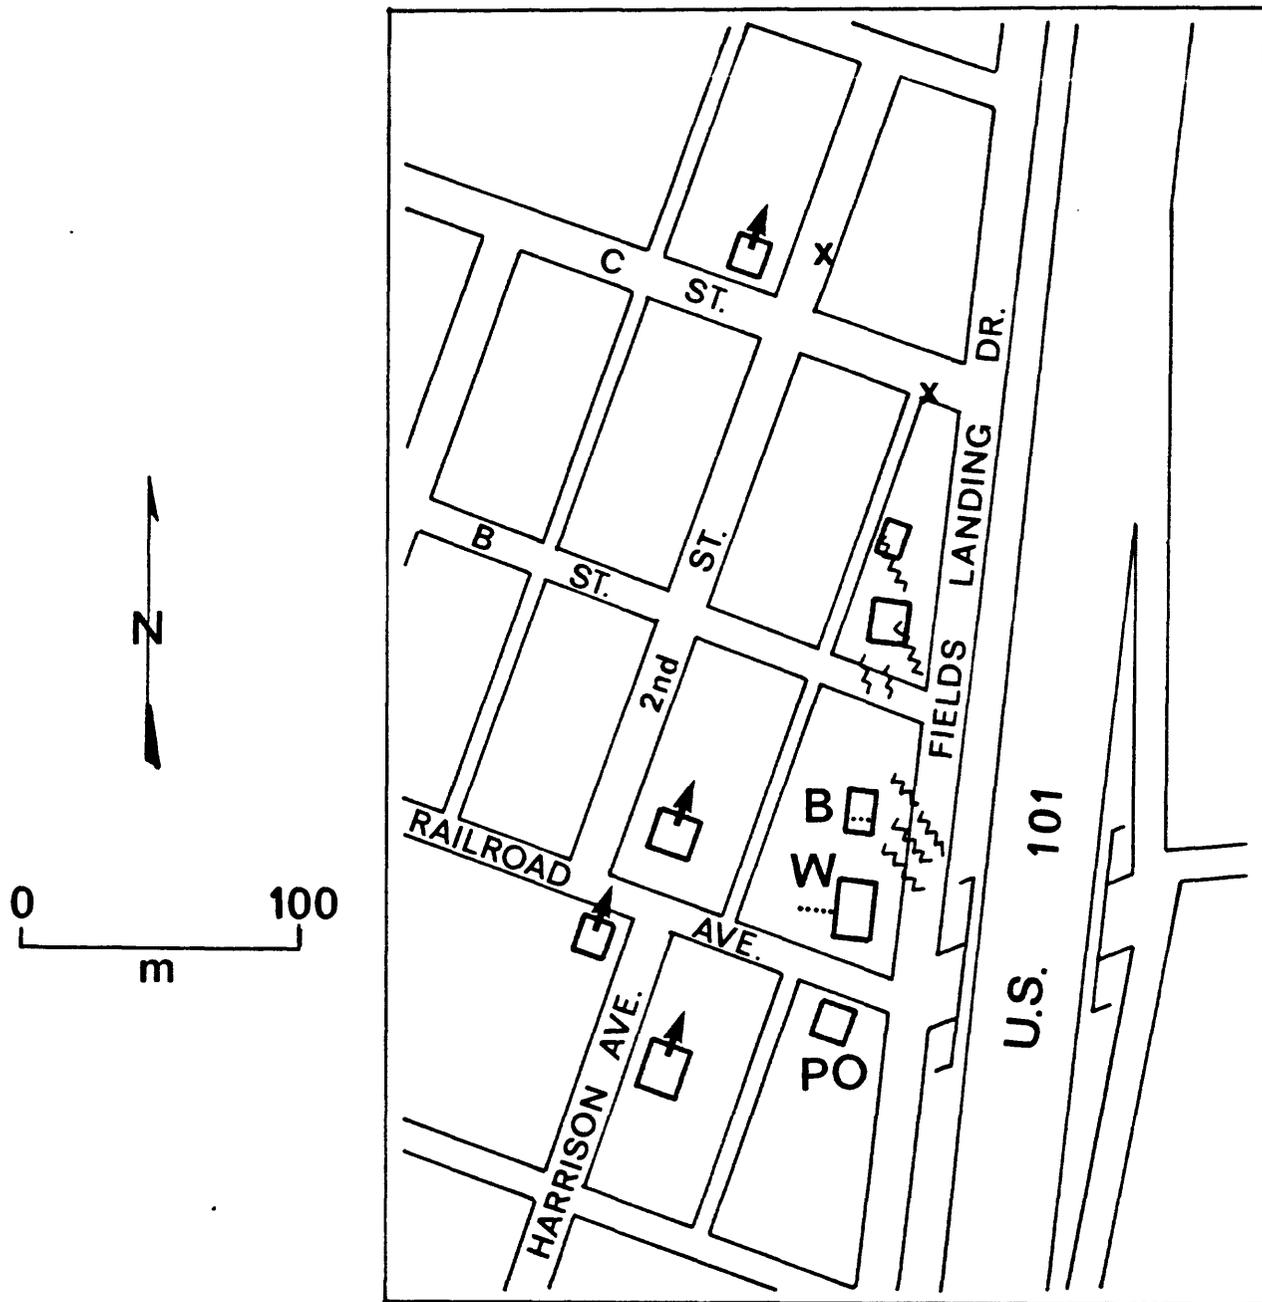
At least four wood-frame houses were shifted northward on their foundations and two of these fell partly to the ground (fig. 5). All were old and, though in good condition, had poor foundations consisting of vertical wooden supports on cement blocks with virtually no lateral bracing. None of these houses sustained severe damage to their superstructures. Nearby houses, some with similar foundations, were not damaged. Mobile homes sitting on cinder block supports did not shift during the earthquake.

At least two brick chimneys fell (fig. 5). The one at the back of the Whaler's Inn was old and had virtually no lateral support. The owner of Bochi's Crab Shack reported the chimney on the roof of his house fell and did slight damage to roof joists. A few other old brick chimneys with weak mortar were cracked.

Figure 5: Map of eastern part of Fields Landing showing damage caused by 8 November 1980 earthquake. (101) Highway 101; (B) Bochi's Crab Shack; (W) Whalers Inn; (PO) combination post office, store and service station; (X) broken pipe in the ground; heavy rectangles are damaged houses and buildings with arrows pointing the approximate direction of shift on the foundations; wavy lines are cracks in the ground; dotted lines are fallen brick chimneys. This is the locality 14 in the text and on figures 3B and 4.

The two large (1.5 m x 1.5 m) windows in the combination Post Office/gas station/grocery store were broken (Fig. 5). Window frames in the Whaler's Inn, an old two story wood-frame building, were distorted slightly and one small window above an exterior door was broken.

Old cracks in the street and sidewalk in front of Bochi's Crab Shack (just north of Whaler's Inn) opened or shifted slightly (fig. 5). Some new cracks less than a millimeter wide were formed. The general trend of the cracks was about N 45°W.

One block north of the Whaler's Inn cracks opened beneath one house, damaging the porch (fig. 5). This crack ran across the yard and through a detached garage that was slightly damaged. Some of the cracks showed vertical displacement (west side down) of up to 1 cm. These cracks were probably caused by settlement of sandy fill.

Gas (?) and sewer pipes beneath two streets were broken (fig. 5).

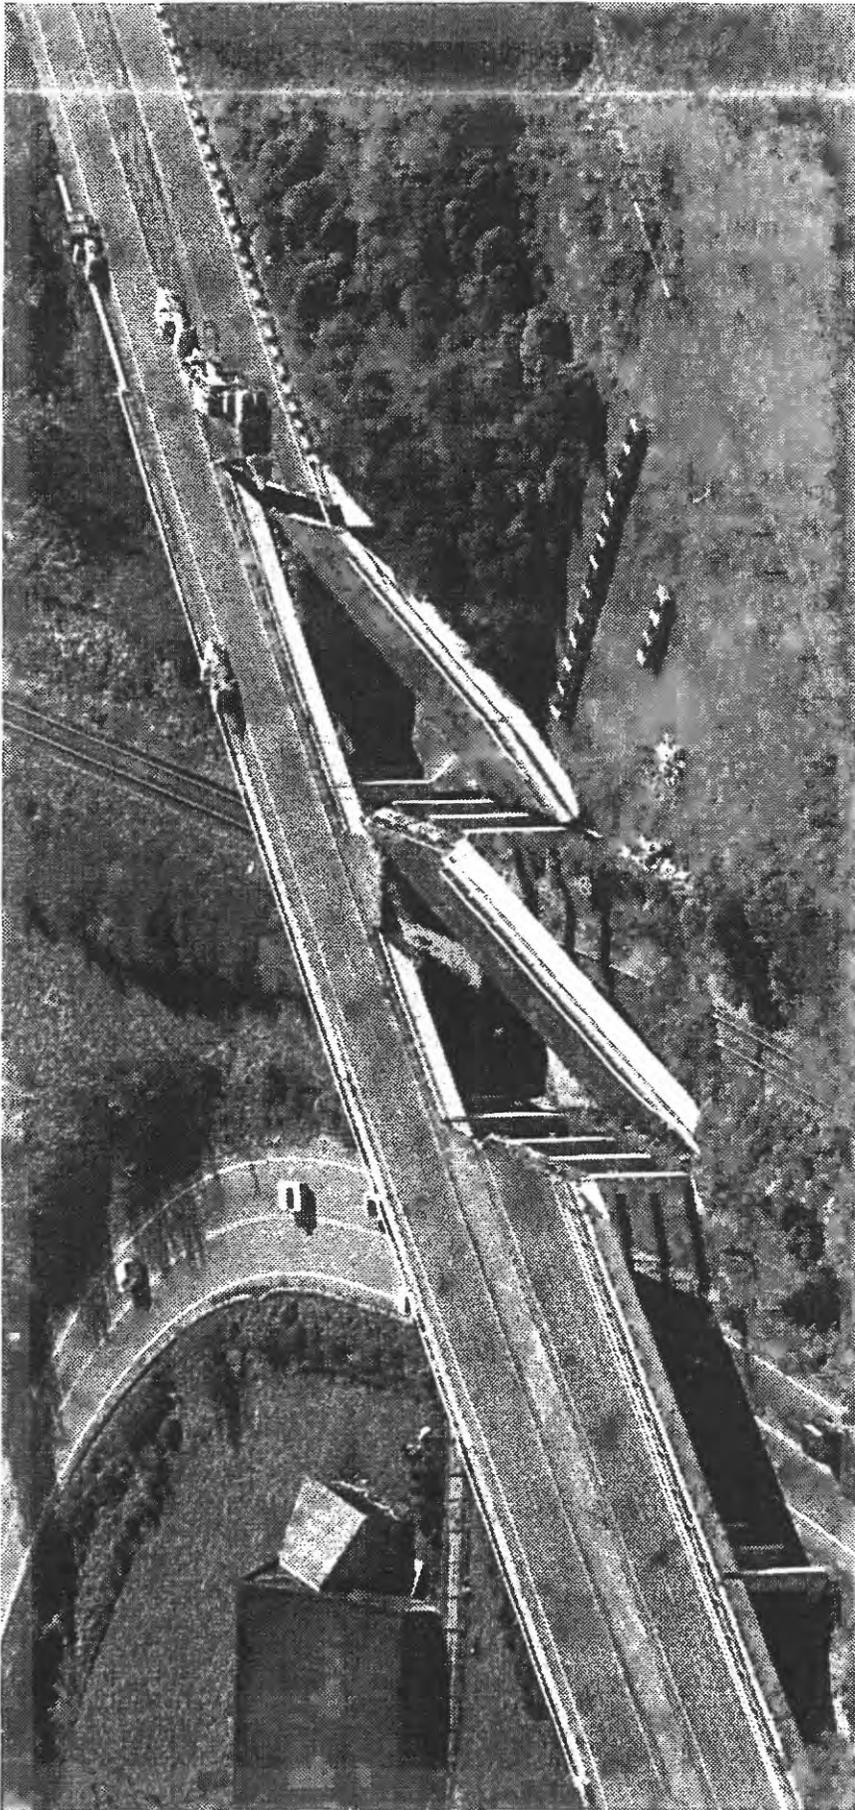
The north ends of the two southern spans in the southbound lanes came off their supports and dropped thirty feet to the ground during the earthquake (Photo 1). The only human injuries associated with the earthquake occurred when a car and pickup truck in the southbound lanes drove off the end of the span that remained in place and fell into the void created by one of the fallen spans. The south ends of the two fallen spans remained tilted against their supports. Pavement cracks opened along all joints between the spans that did not fall and along the joints at the abutments (Photo 3).

Photograph 1: Aerial view of the Tompkins Hill Road overpass of U.S. Highway 101 (locality 15, Figs. 3B and 4) showing the two collapsed bridge spans in the south-bound lanes. Photograph courtesy of the Times-Standard of Eureka, California.

The six spans that did not fall were all sinistrally rotated a slight amount. This rotation was possible because of the oblique angle of the unanchored joints at the ends of the spans. The northern ends of the two fallen spans rotated westward enough to clear their narrow supports. This rotation could have been caused by east-west shaking or north-south transitory compression caused by shaking.

According to a CALTRANS employee, this overpass, which was built in the late 1960's, was slightly damaged in the 1975 earthquake and was scheduled for structural reinforcement in 1981.

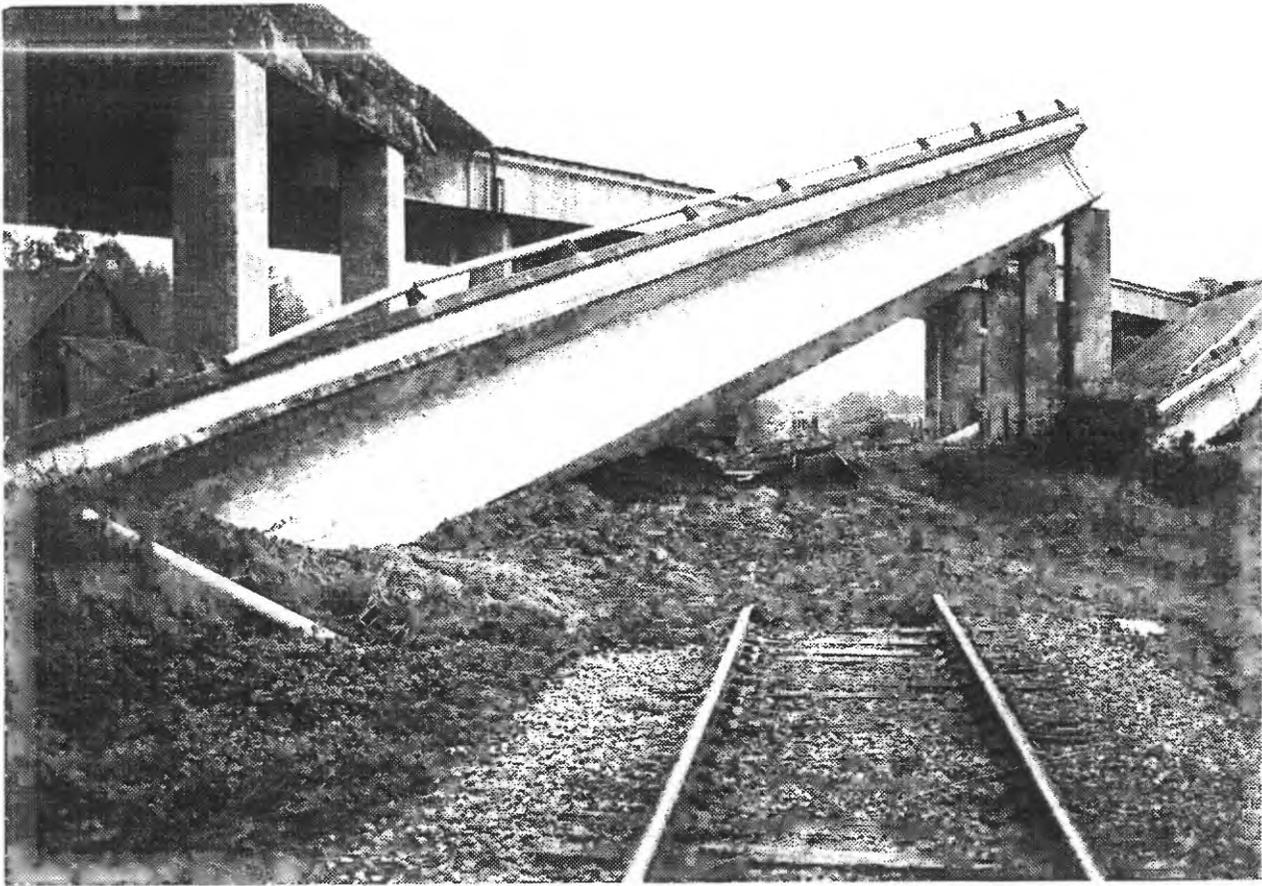
The cement columns and earth-filled abutments of this overpass structure were virtually undamaged except for hairline cracks near the base of one column, against which a fallen span was leaning (Photo 2). All columns remained vertical.

Photograph 2: Sand splashed across the railroad tracks where one of the spans of the Tompkins Hill Road overpass fell from its support, a ledge 15 cm wide (upper left). Note that all supporting columns are vertical and virtually undamaged. There was no evidence of ground failure in this area.

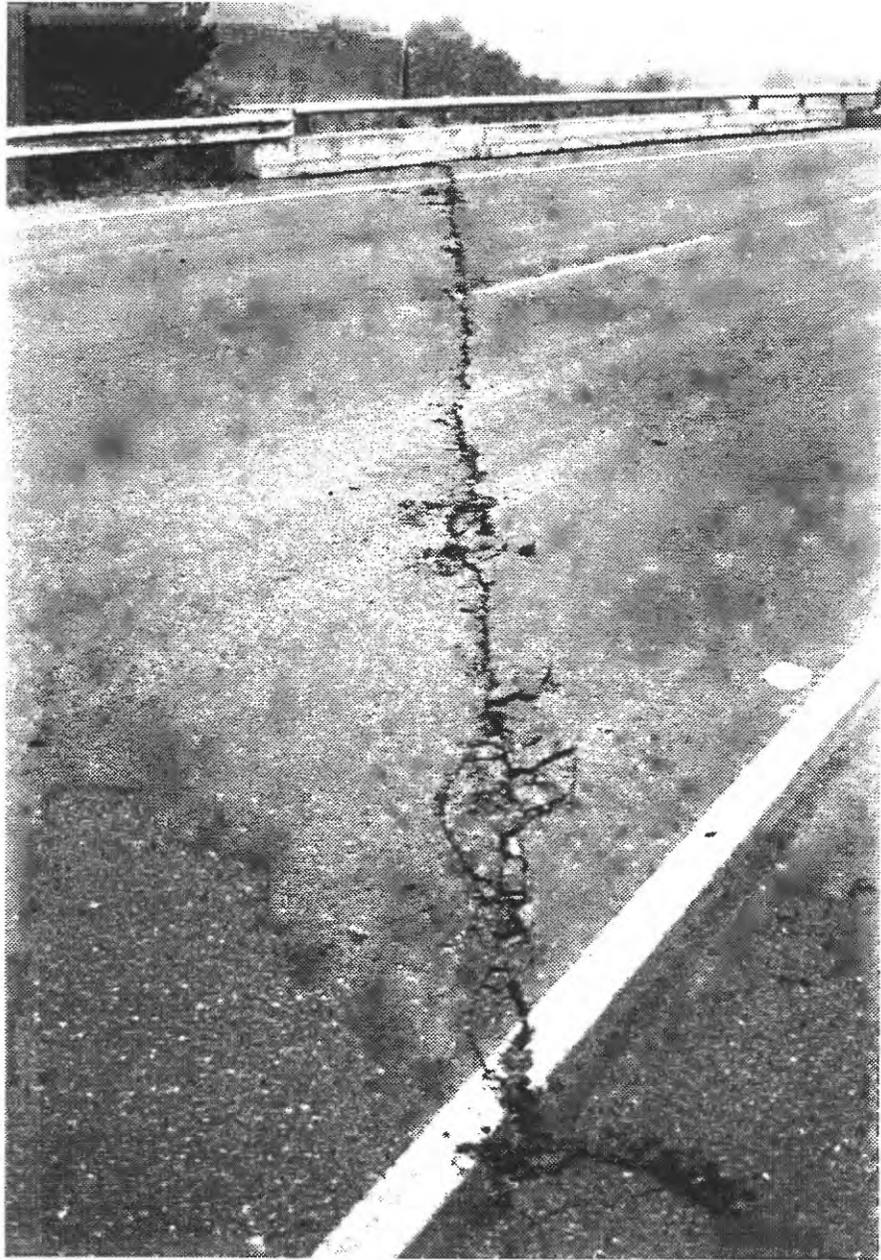
Photograph 3: Pavement cracks along a joint between a bridge span (right) and the north abutment (left) in the north-bound lanes of the Tompkins Hill Road overpass, U.S. Highway 101.

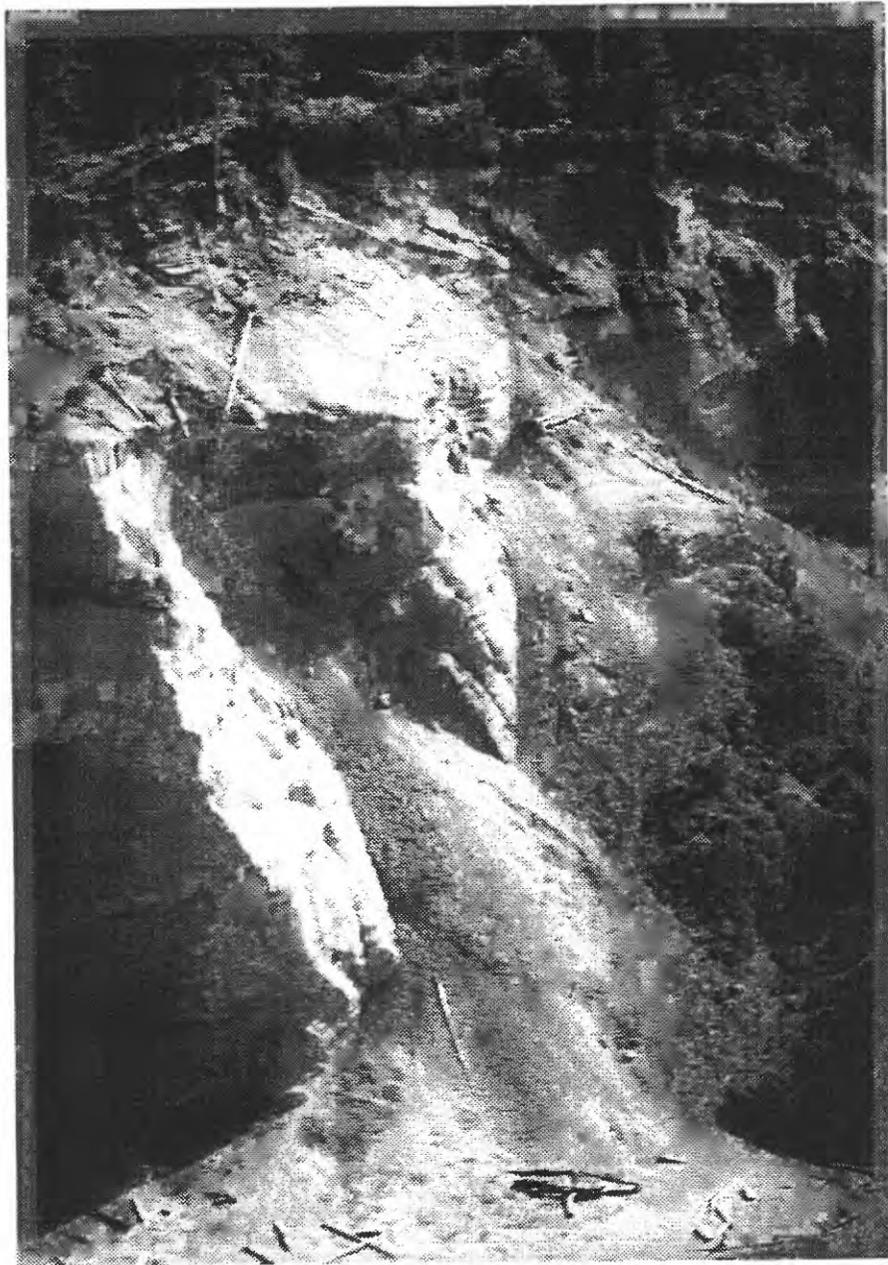
Viewed only from the air. A few small rock falls and debris slides attributable to the earthquake occurred along the steep coastal bluffs. The largest failure had a volume of less than about 100 m³ (Photo 4). Numerous older landslide scars and deposits along these bluffs showed no evidence of renewed movement. R. Kilbourne reported a wooden walkway along the sea cliff at Patricks Point State Park was damaged by a small landslide.

Photograph 4: Aerial view of a fresh debris slide on the coastal bluffs above Agate Beach (locality 6, Fig. 3A). The sediments exposed in the cliff face are semi-consolidated Pleistocene alluvial deposits unconformably overlain by marine sands.

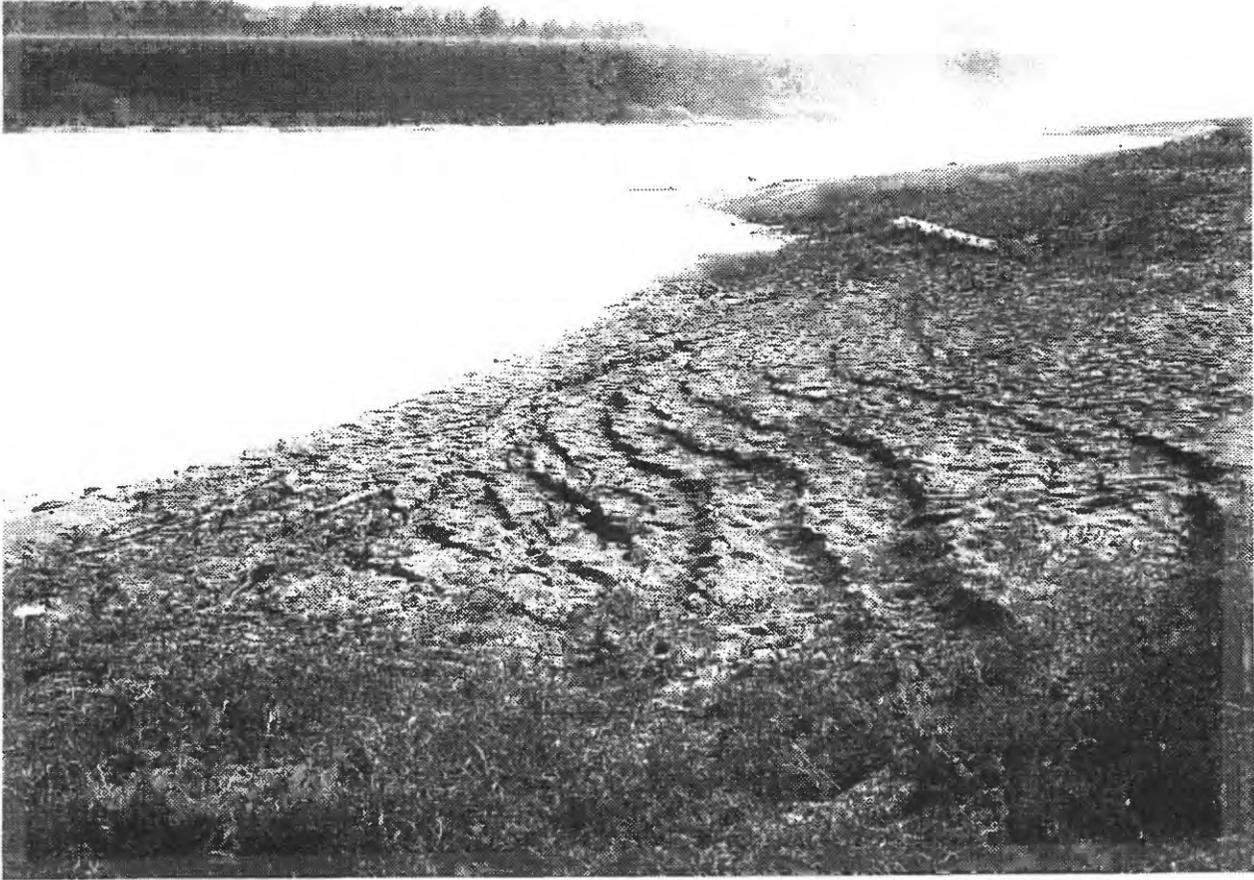
Photograph 5: A lateral spread on the east flank of Big Lagoon spit (locality 5, Fig. 3A). The lateral spread contains numerous internal scarps and cracks caused by differential displacement as the block moved toward the shoreline. The bounding scarp is about 10 m from the shoreline.

The lateral spreads consisted of blocks of displaced material several meters wide and tens of meters long that were broken by numerous internal cracks, scarps and grabens (photos 5 and 6). Maximum horizontal displacements of the blocks were about one meter; maximum vertical displacements on the scarps were about half a meter. Surface slopes on which lateral spreads occurred were between 2° and 10°.

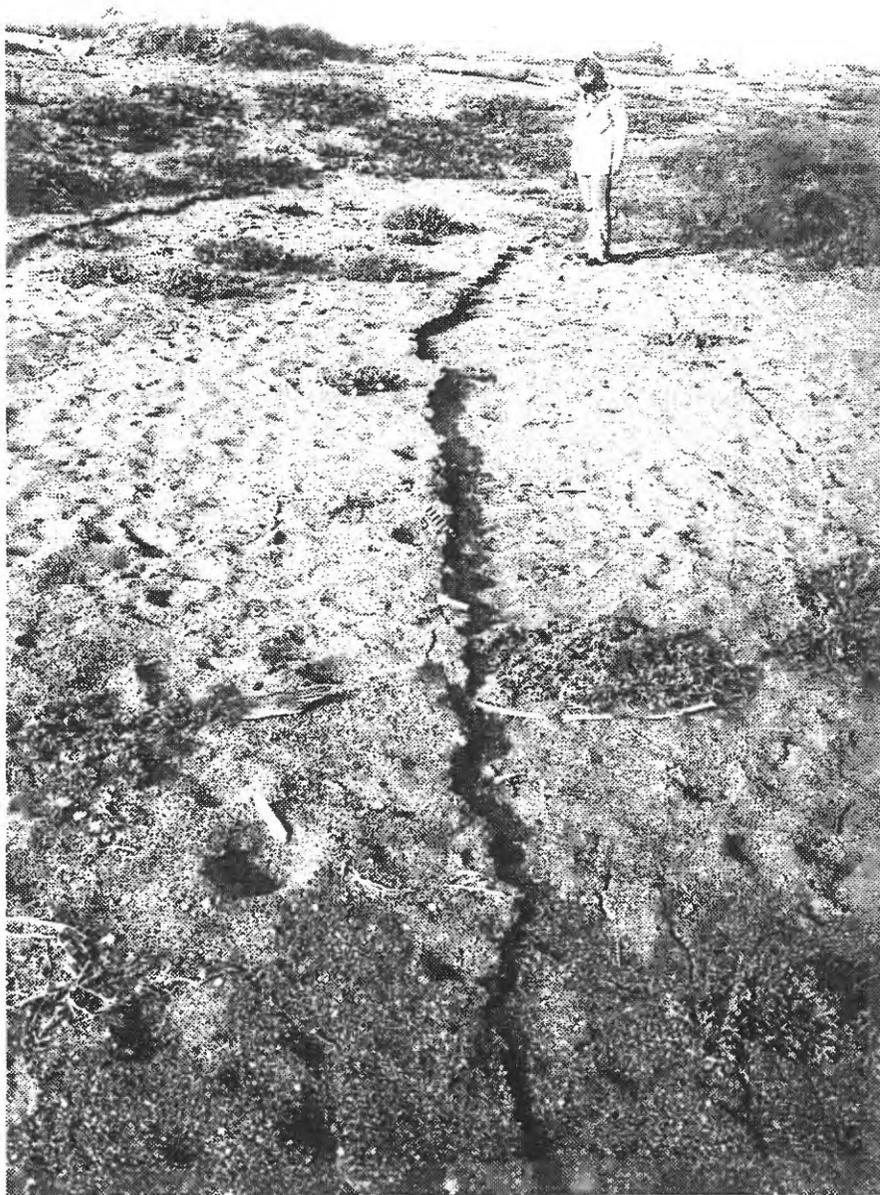
Lateral spreads and sand boils were confined to the reentrants. Cracks were concentrated in the reentrants also, but some cracks occurred on spurs separating the reentrants and between the reentrants and toward the crest of the spit. At one place cracks extended to the crest of the spit, a distance of 90 m from the shoreline. Some cracks also occurred in subsidiary sand bars that extend out into the lagoon from the spit. In all cases the cracks were approximately parallel to the local shoreline.

Photograph 6: Surface cracks associated with a lateral spreading on the east flank of Big Lagoon spit (locality 5, Fig. 3A).

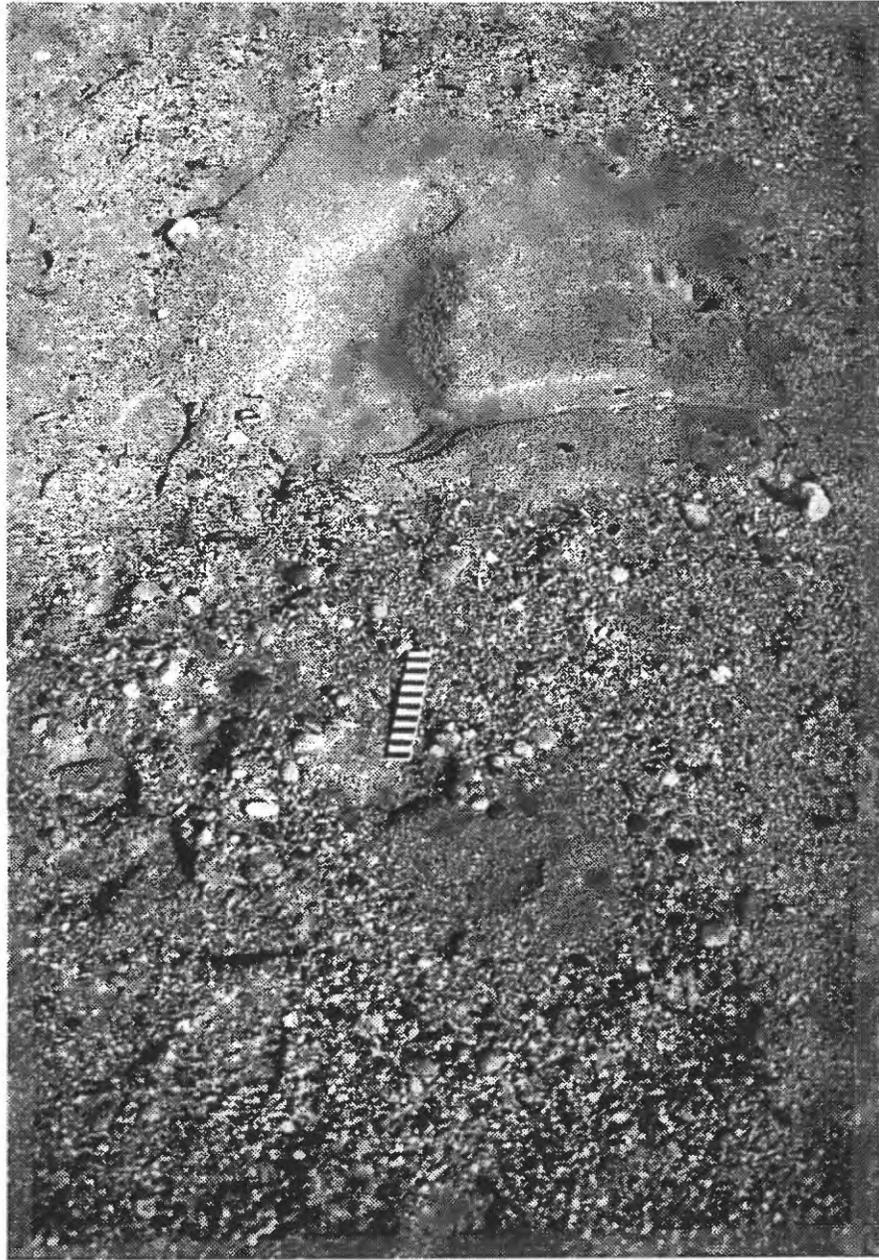
Photograph 7: Sand Boils on the east flank of Big Lagoon spit consist of aprons of sand around a central vent. Scale is marked in 1 cm divisions. See Figs. 6A and 6B for grain-size diagrams.

Sand boils, which formed where fountains of water and sand erupted from a subsurface layer of liquefied sand, consisted of vents surrounded by irregular aprons of fine- to medium-grained, well-sorted sand (photo 7). These aprons were a few centimeters to a few decimeters in diameter. A few vents had no sand aprons. The sand boils and vents occurred along cracks, some several tens of meters long.
