# GEOHYDROLOGIC DESCRIPTIONS OF SELECTED SOLID-WASTE DISPOSAL SITES IN PUERTO RICO

U.S. GEOLOGICAL SURVEY  
Open-file Report 81-490

By Arturo Torres-González and Fernando Gómez-Gómez

Prepared in cooperation with the  
Environmental Quality Board of Puerto Rico

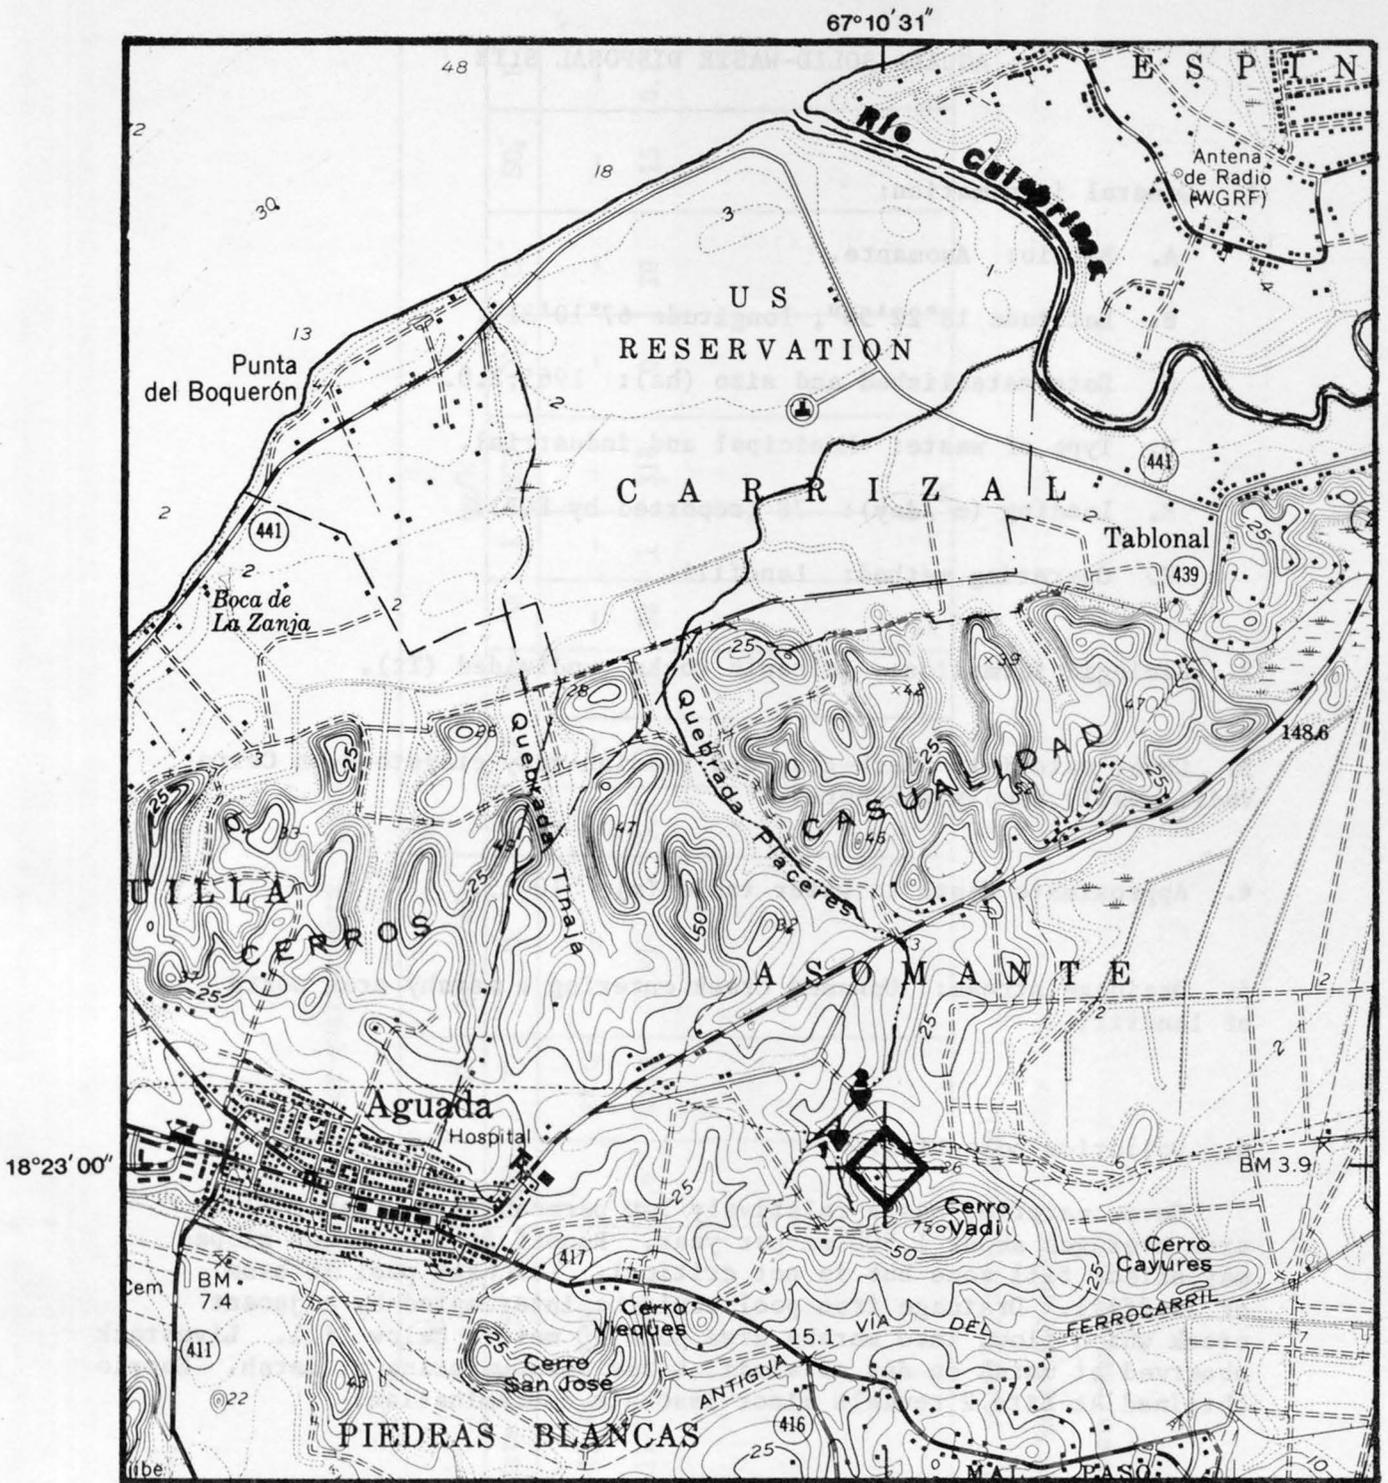
Figure 2.--Aguada solid-waste disposal site at Asomante.

Cover material has a relatively low permeability. Rainfall in area averages about 1,500 mm per year. Runoff from adjacent slopes may affect fill zone but is not critical. Leachate pool at base of landfill. Drainage from pool could be intercepted by adjacent creek which flows into marshy area some 40 meters below fill. Livestock observed at marsh on day of visit, horse seen watering at marsh. Sample obtained at site 2 reveals minor leachate contamination.

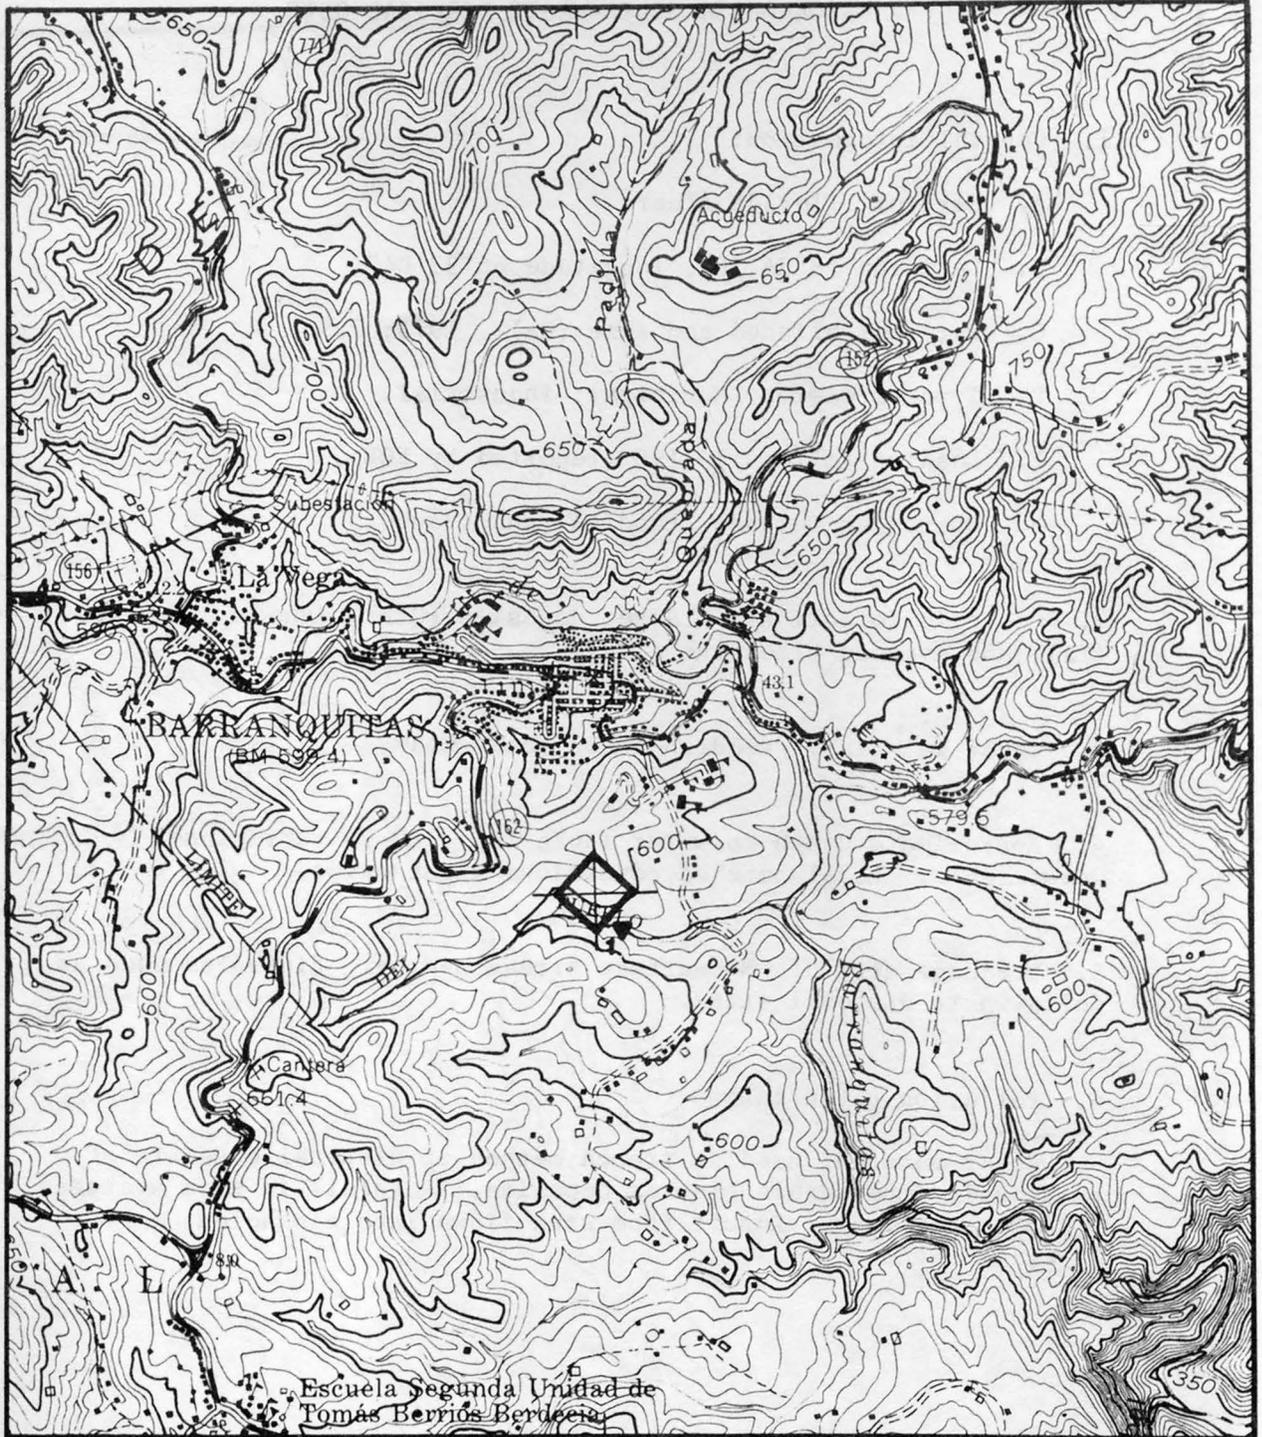
Figure 8.--Barranquitas solid-waste disposal site at Helechal.

Cover material used in trench method of disposal consists of relatively impermeable blanket deposits. Rainfall in area averages 1,780 mm per year. Runoff from area flows into sinkholes.

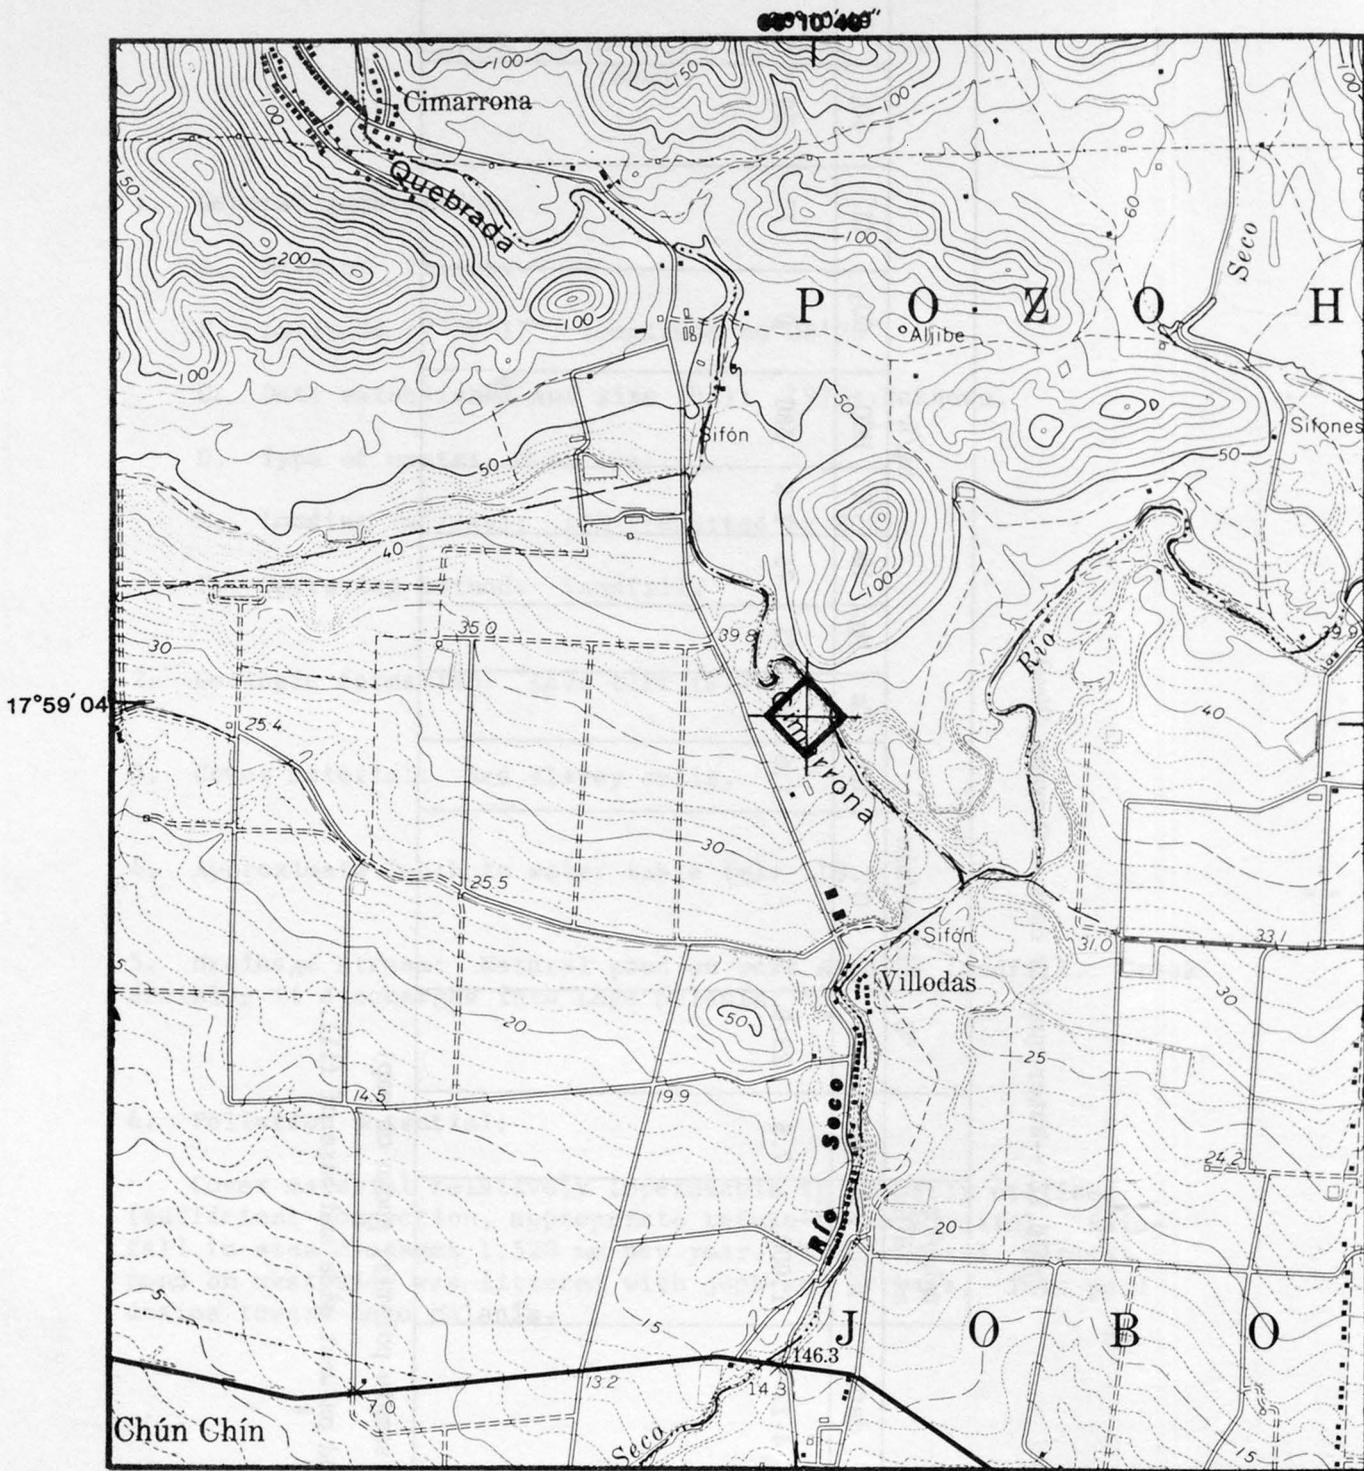
Figure 22.--Guayama solid-waste disposal site at Jobos, (old landfill).

No cover material, open dump. Closed in 1977. Rainfall in area averages 1,400 mm per year. When visited, intermittent Quebrada Cimarrona was littered with junk and garbage.

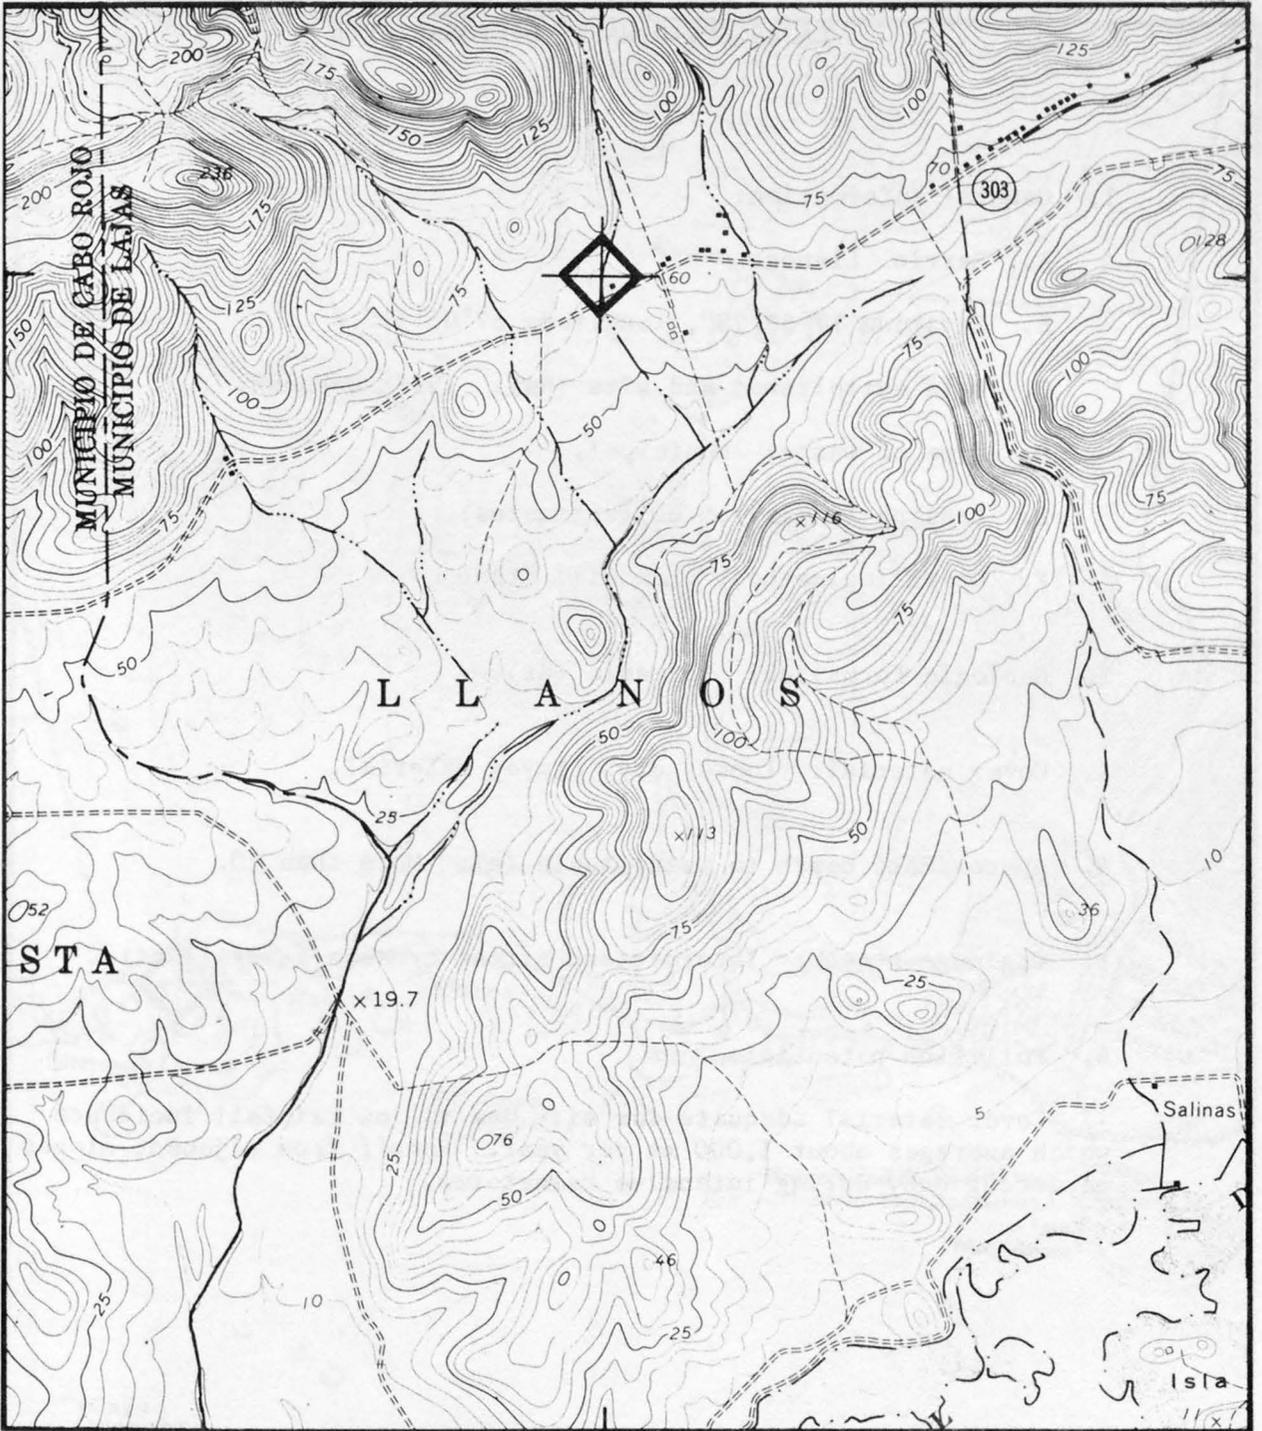
Figure 30.--Lajas solid-waste disposal site at Llanos, (new landfill).

Cover material adequate for site due to low rainfall incidence which averages about 1,000 mm per year. Runoff from adjacent slopes may occur only during intensive rainstorms.

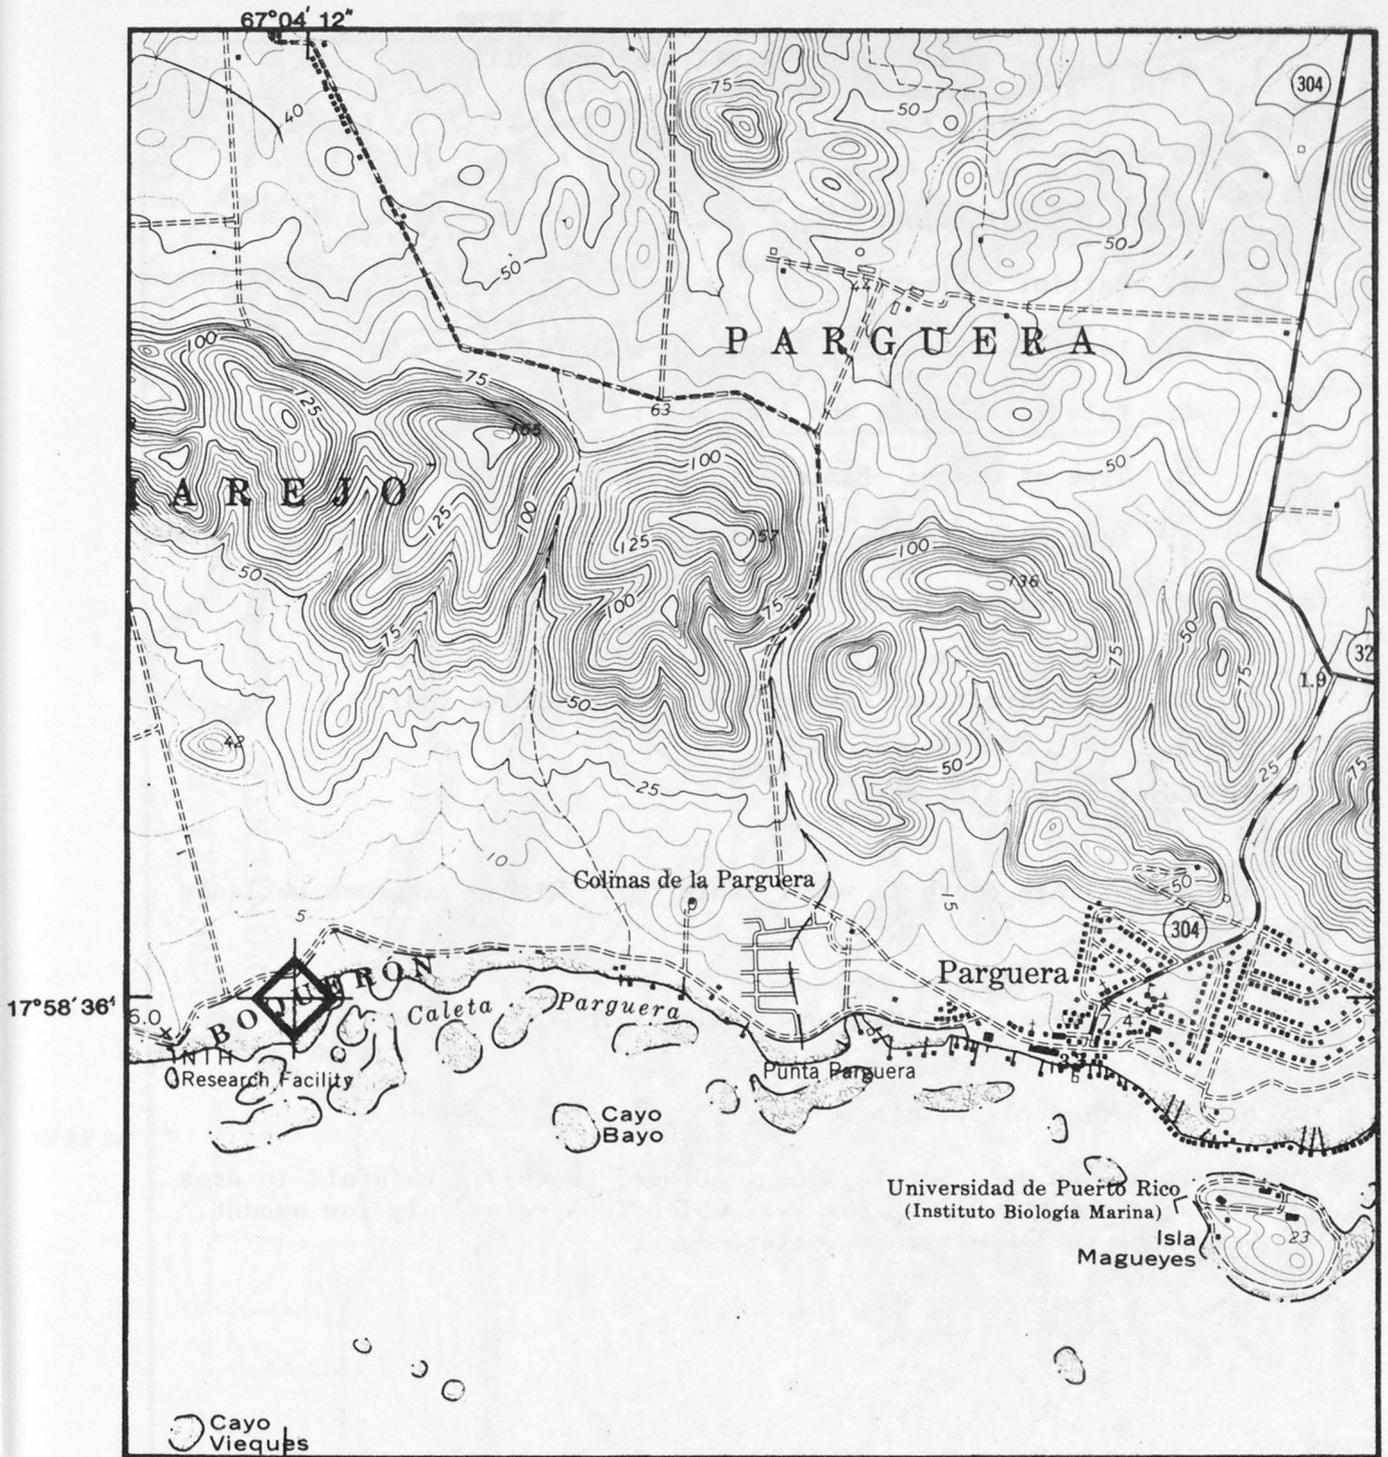
Figure 31.--Lajas solid-waste disposal site at Palmarejo, (old landfill).

It was an open burning dump. Closed in 1977. Rainfall in area averages about 1,000 mm per year which is a relatively low amount. Very near to the mangrove wetland zone.

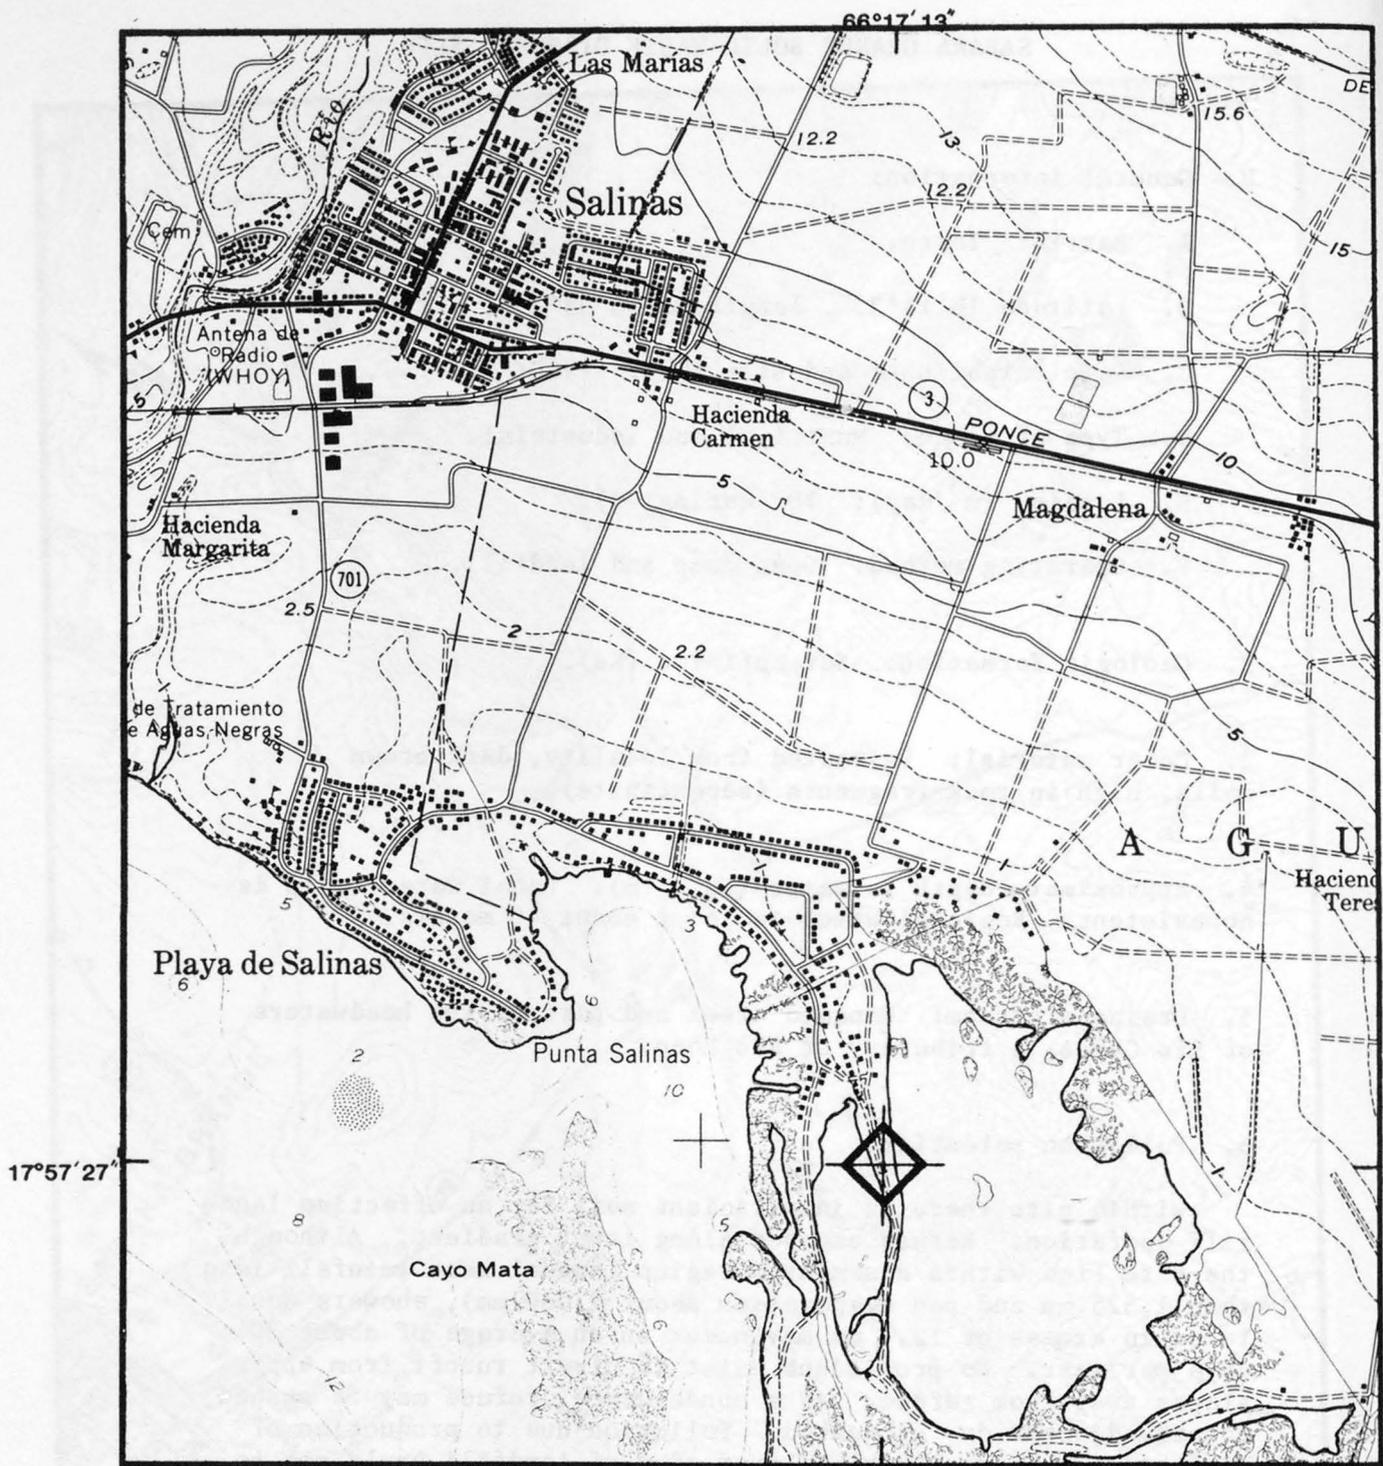
Figure 43.--Salinas solid-waste disposal site at Aguirre.

It was an open dump. Closed in 1977. Rainfall in area averages about 1,150 mm per year. Located within mangrove wetland zone.

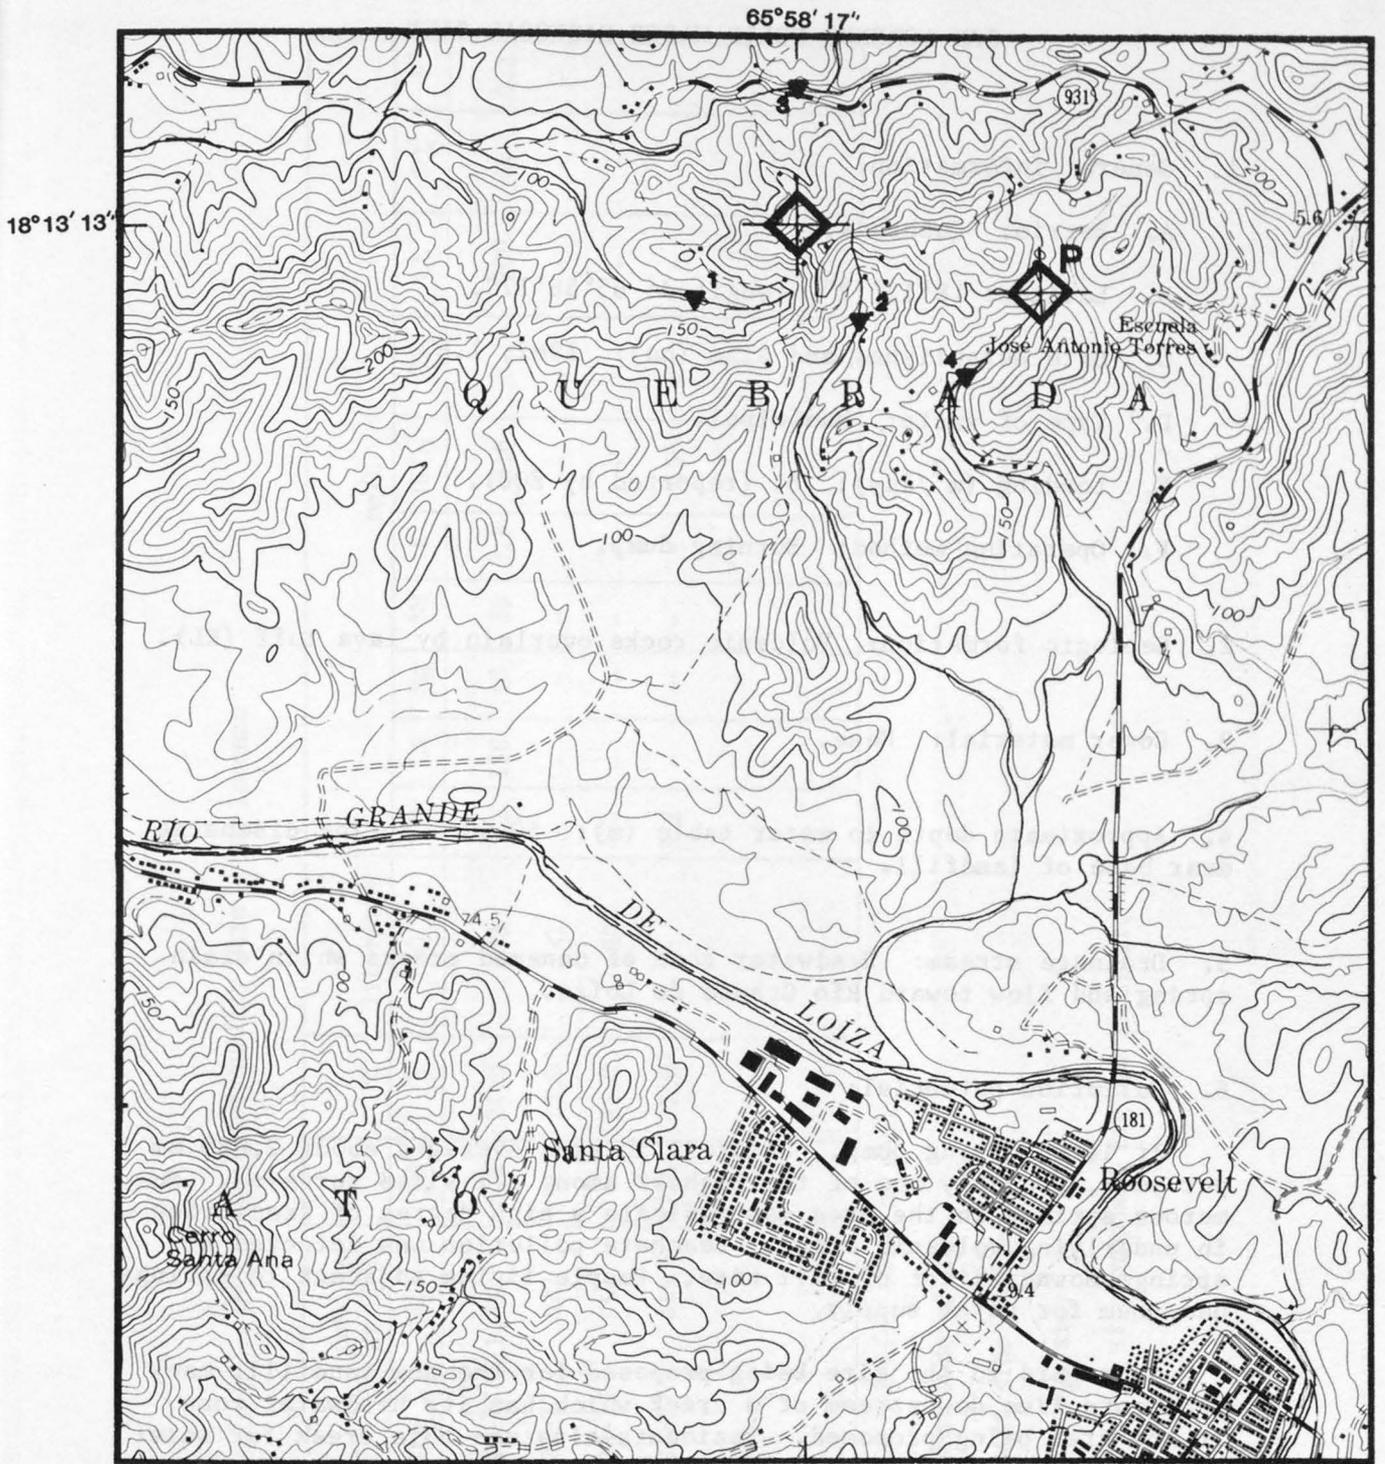
Figure 45.--San Lorenzo solid-waste disposal site at Quebrada.

It is a burning dump. Rainfall in area averages about 2,080 mm per year, probably one of the highest among all sites surveyed. Numerous springs in the area may indicate a high degree of fracturing in underlying volcanic rocks. Leachate pollution was detected at springs downgradient of fill site. People living adjacent to springs use them for water supply.

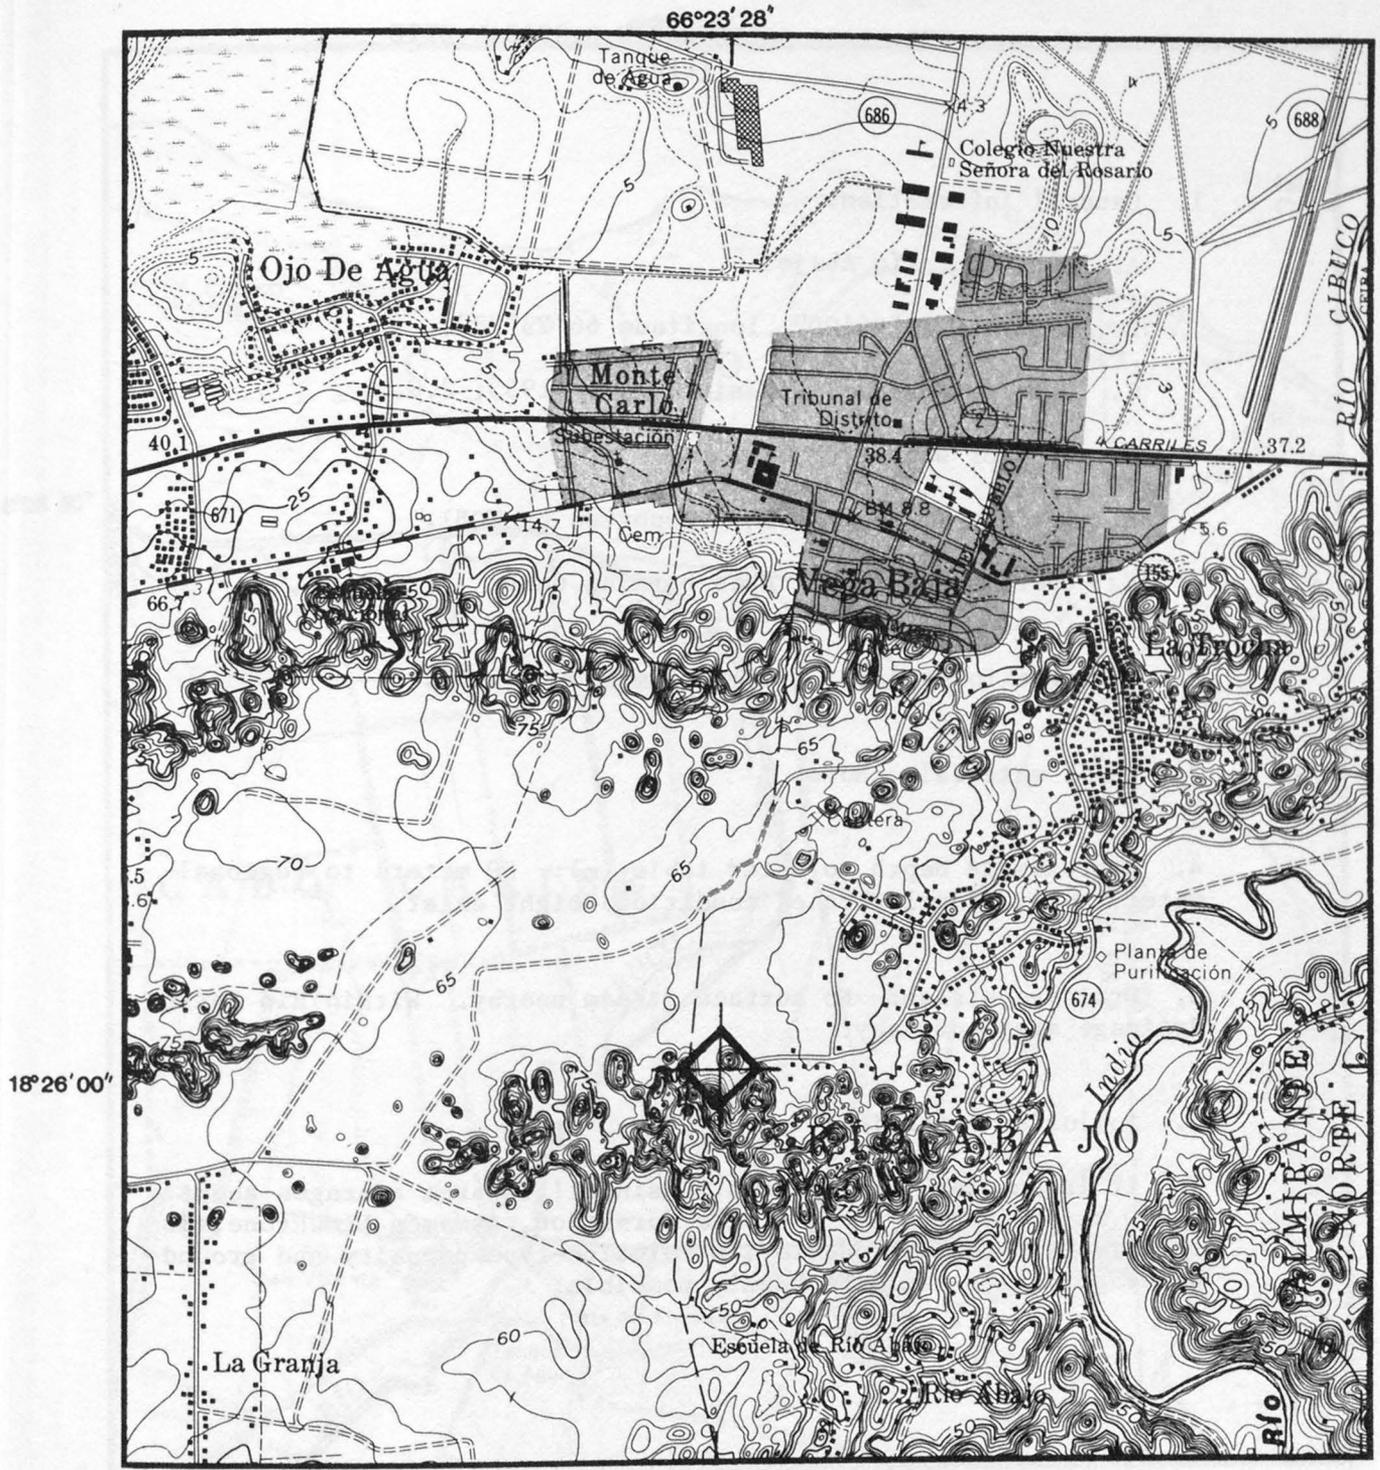
Figure 49.--Vega Baja solid-waste disposal site at Río Abajo, (old landfill).

It is an open burning dump. Rainfall in area averages about 1,900 mm per year. The geologic formation, Aymamón Limestone, is relatively permeable due to its solution-type porosity and ground-water pollution could be highly possible.

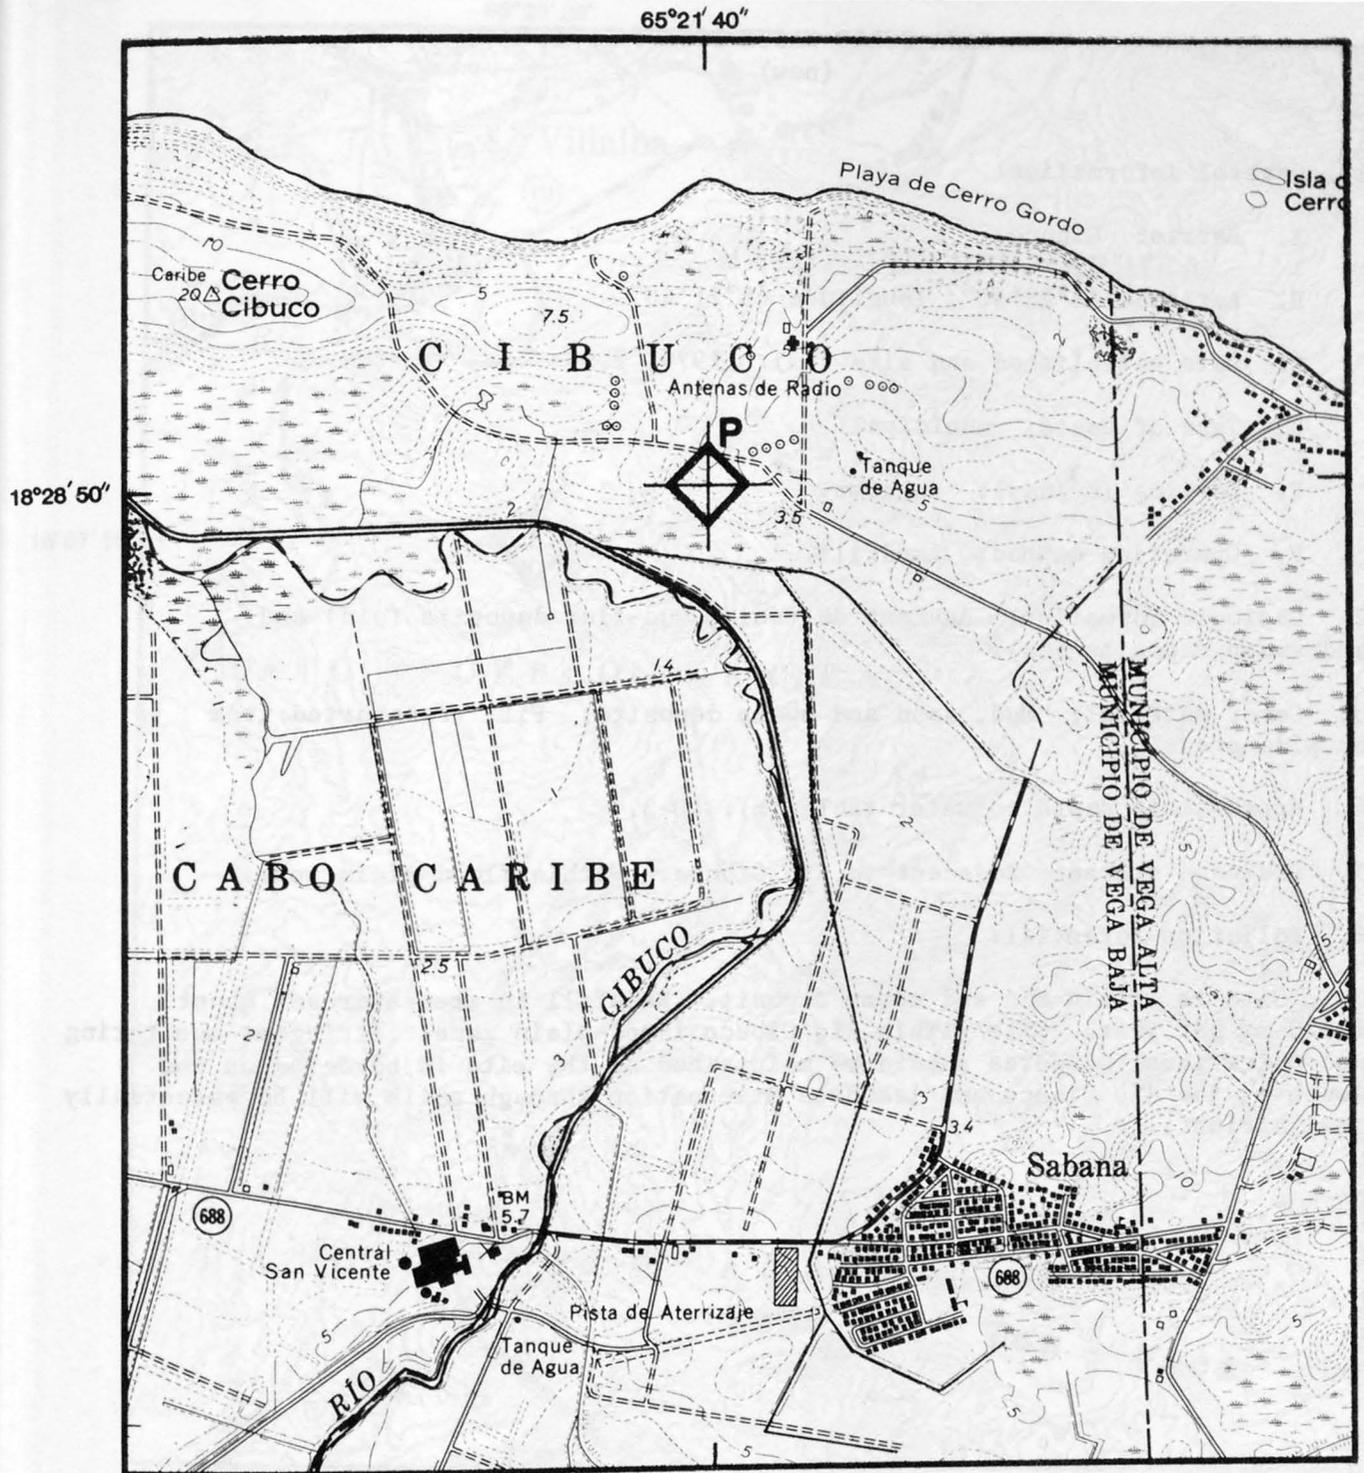
Figure 50.--Vega Baja solid-waste disposal site at Cibuco, (new landfill).

Cover material relatively permeable and offers insignificant attenuation to leached substances. Rainfall in area averages about 1,240 mm per year and this incidence maintains leachate production at a relatively low level. Nevertheless, leachate ponds were observed during the visit. Runoff from fill zone enters headwater zone of the unnamed creek. Anomalous water-quality values at sample site 2 seems to indicate possible effects by leachate pollution.
