INVESTIGATION OF AUGUST 1980
BLOWOUT AND FIRE, LEASE OCS-G 4065
MATAGORDA ISLAND BLOCK 669, GULF OF MEXICO
OFF THE TEXAS COAST

U.S. Geological Survey
Open File Report 81-706

Open File Report 81-706

September 1981

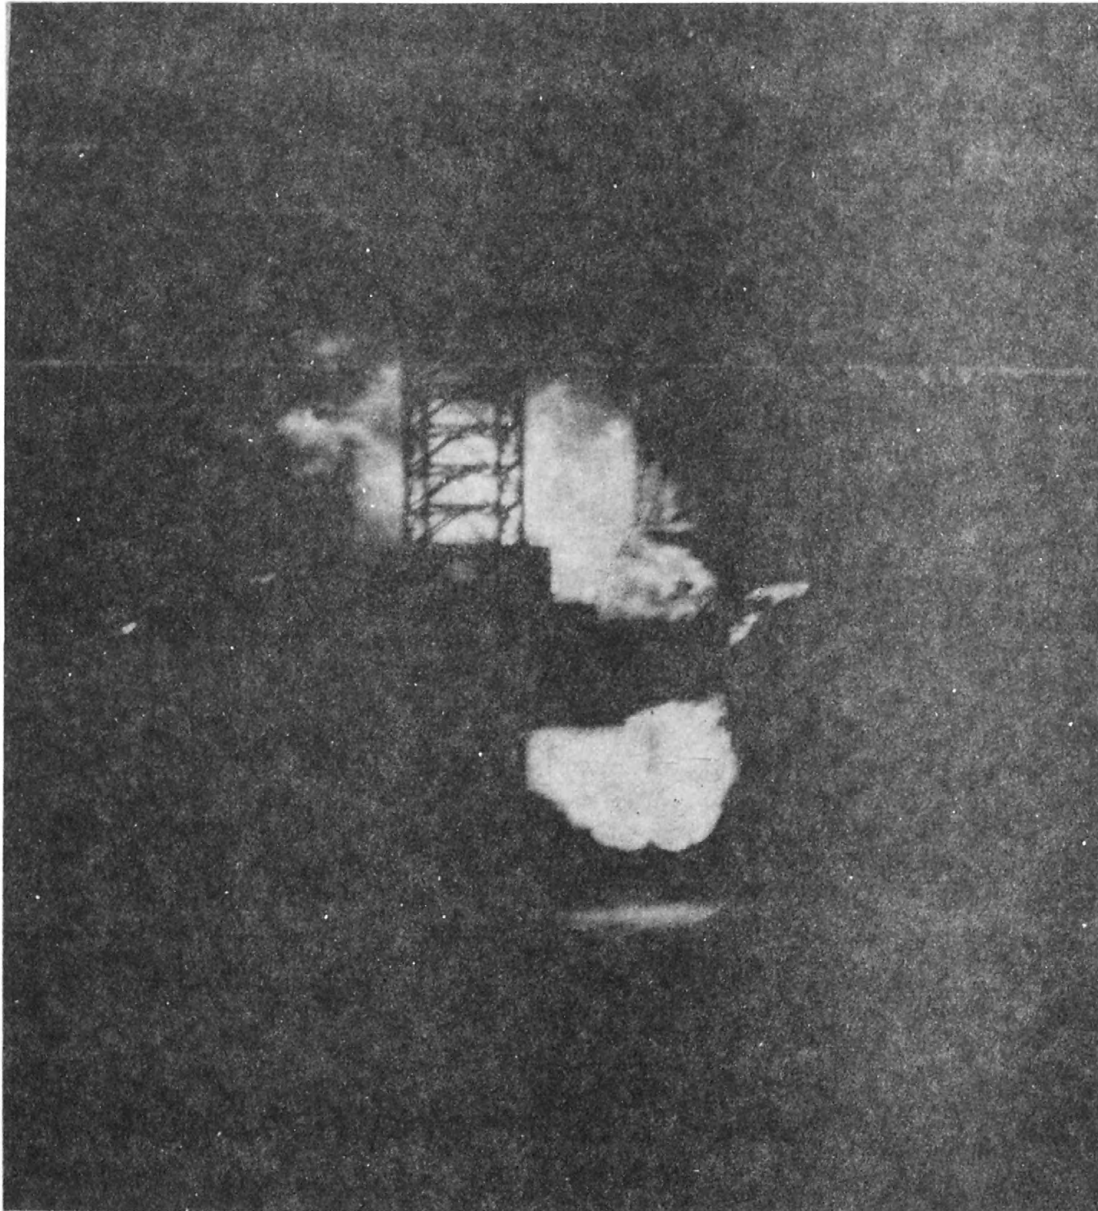
Photo No. 1
Date: August 30, 1980, 6:30 a.m.
Location: Matagorda Island Block 669
Gulf of Mexico, off Texas coast
DESC: View of fire on rig, Ocean King
from MV Gulf Fleet 32

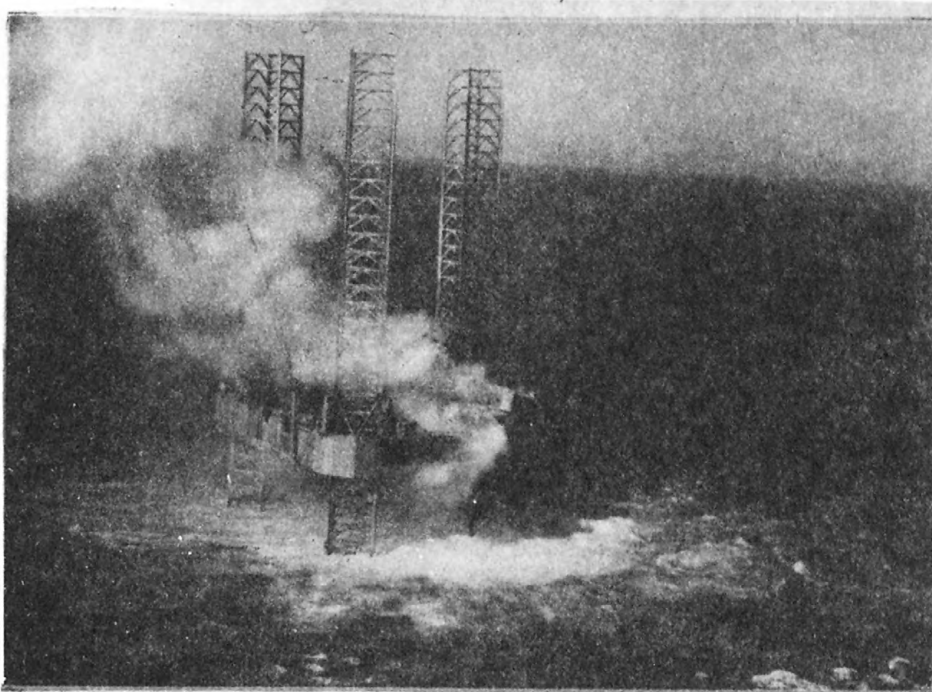
Date: August 30, 1980, a.m. Location: Matagorda Island
Block 669, Gulf of Mexico
off Texas coast

DESC: View of fire on rig, Ocean King, from helicopter

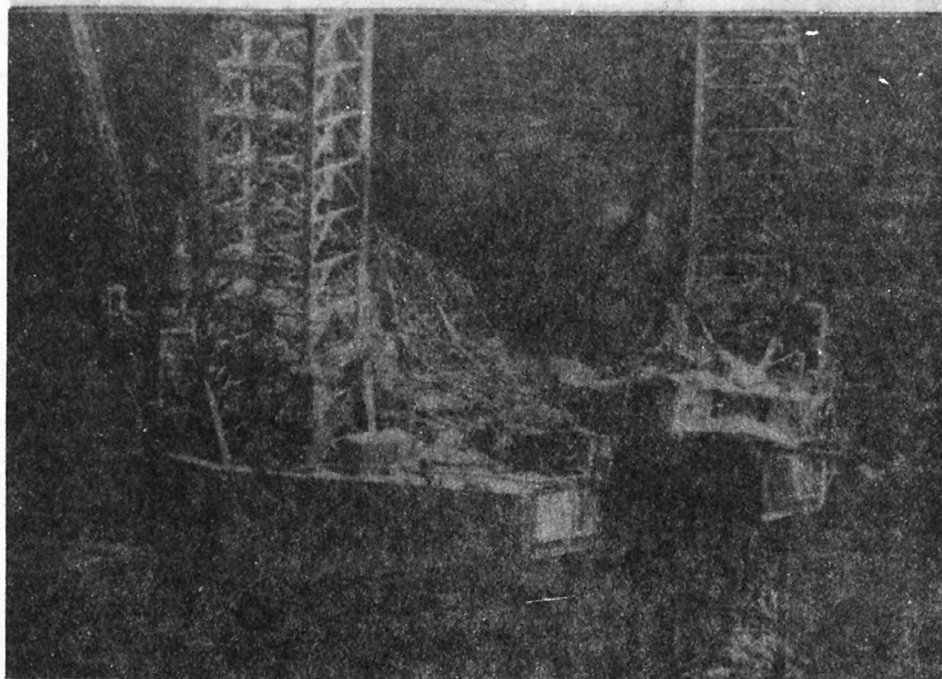
Photo No. 3

The fire burned until extinguished at 5:00 p.m. on September 1, 1980. The well had bridged at 12:00 noon. The rig was heavily damaged on the main and machinery decks with the loss estimated at \$30,000,000 (see Photo No. 3).

The rig, Ocean King, was extensively damaged, including three bent legs, a number of structural cross members severed, and numerous holes in the barge. The living quarters, drill floor, and machinery room were heavily damaged by the fire (see Photo No. 3).

Date: September 1, 1980, p.m. Location: Matagorda Island
Block 669, Gulf of Mexico

DESC: View of damage to rig, Ocean King, from helicopter

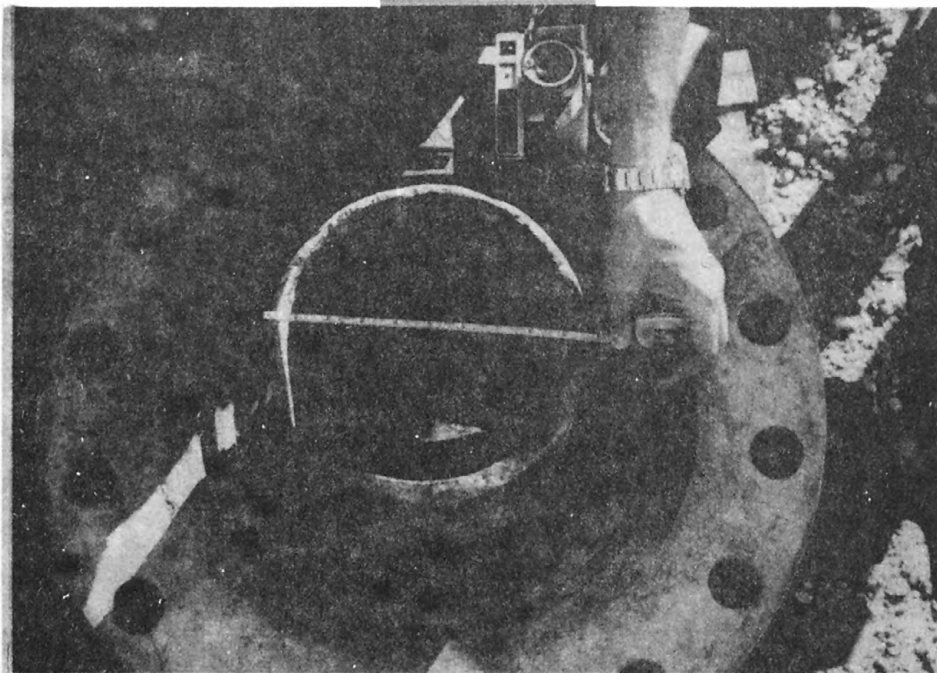
Photo No. 4

to protect the casing from undue wear by drill pipe action in the upper portion of the hole. When the packoff was eventually retrieved, Cities Service Company personnel noted that it was well worn. Further examination of a piece of the 9 5/8" casing removed from just below the casinghead indicated that one side was worn to a 1/8" (0.125 inch) thickness (see Photo No. 4). In comparison, manufacturer's specifications on the same 9 5/8", 47#/ft., S-95 grade casing, which was used in Well No. 1, indicate a new pipe wall thickness of 0.472 inch and a corresponding internal yield pressure rating of 8150 psi.

- a. Directional drilling operations in the 9 5/8" casing had been conducted over some 41 days, a sufficient time for the casing wall to be worn, thereby reducing casing integrity (see Photo No. 4). Apparently, when high pressures were encountered, no particular consideration was given to determining a lesser internal yield pressure as a result of the probable wear.
- b. Failure to investigate possible communication between the 9 5/8" and 13 3/8" casings on the part of Ocean Drilling and Exploration Company and Cities Service Company personnel when the pressure on the 9 5/8" casing dropped from 7,300 psi to 4,900 psi approximately 5 hours prior to the explosion and fire. If a check had been made on the existence of flow in the 13 3/8" casing, decisions on venting the well and evacuating all personnel may have been different.

Date: September 10, 1980 Location: Cities Service Co.
Pelican Island Yard, Galveston, Texas
DESC: View of piece of 9 5/8" casing retrieved from
Well No. 1 OCS-G 4065

4. The installation of a wear bushing or casing packoff for drill pipe operations below surface casing.
 5. A statement in the Application for Permit to Drill (Form 9-331c) where mudline casing hangars are planned to be used, giving information as to type and depth of installation.

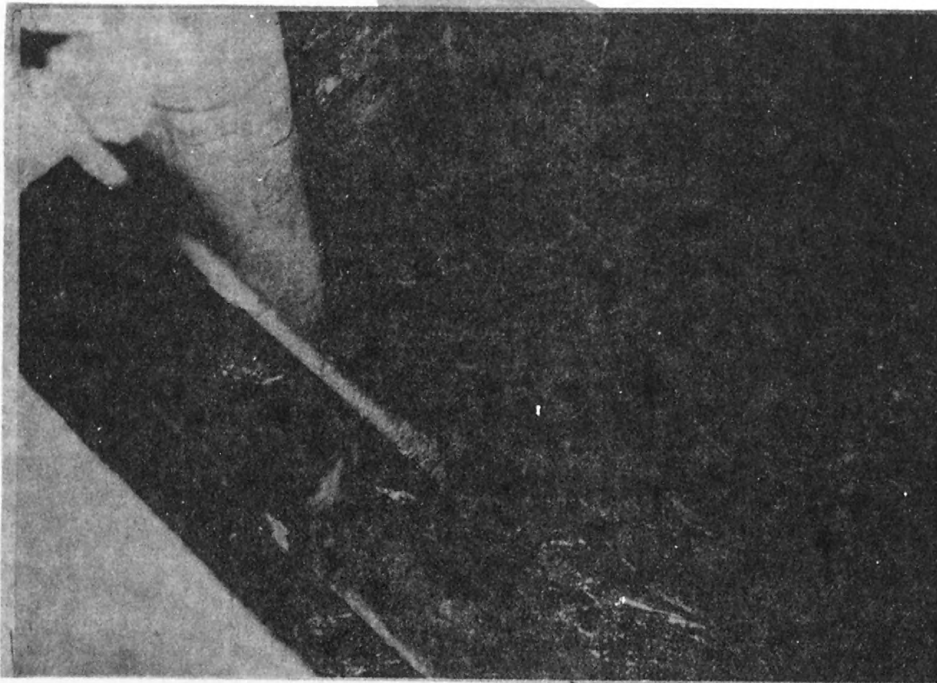
Photo No. 5

During these operations, the mud monitoring system was not working correctly. The pit level indicator could not operate properly because the mud level in the pits was so high that the alarm could not be actuated if a mud gain occurred. The arms and floats in the active pits were jammed against pit beams such that the alarm for the mud pit level at the drill floor was inoperable (see Photo No. 5).

- a. The excessive mud level in the mud tanks prior to the incident was sufficient to render the mud pit level monitor and warning alarm inoperative.
- b. With the existence of the condition described in (a.) above, procedures were not established to assure that any pit level rise, while circulating out the formation fluids intrusion, would be promptly noted.

Date: September 3, 1980 Location: Matagorda Island
Block 669, Gulf of Mexico
DESC: View of float control in mud pit aboard rig, Ocean King

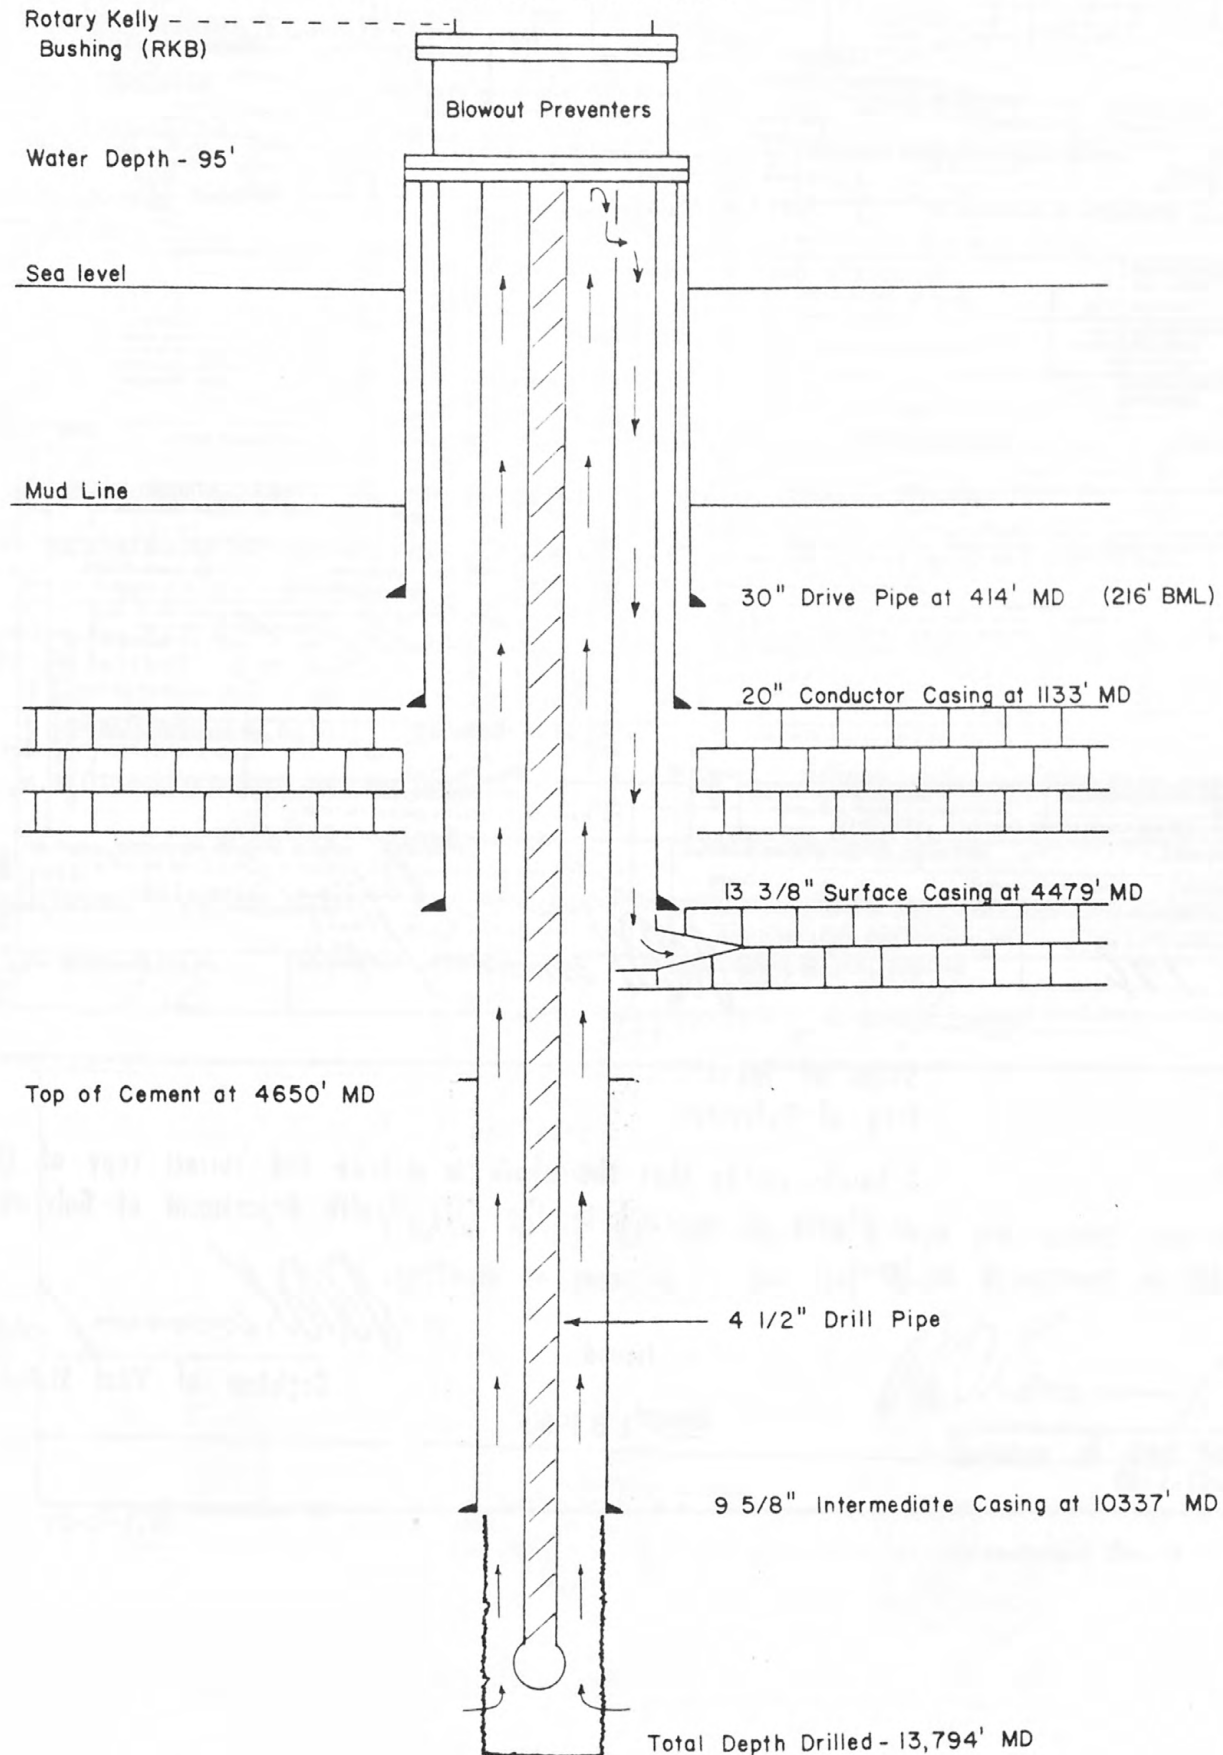
Attachment No. 3

At about 12:45 a.m., August 30, 1980, the casing pressure reached 7300 psi. Rig personnel heard a dull explosion, felt the rig vibrate, and noted a sudden drop in the casing pressure to 4900 psi. Six additional crewmen climbed down the escape net or stairway to the standby boat at this time, leaving 11 personnel aboard the rig. Apparently, the 9 5/8" casing had ruptured just below the blowout preventers and casingheads (see attachments No. 2 and 3).

The proximate cause of the explosion and fire was the failure of the 9 5/8" casing under pressure just below the blowout-preventer stack and casinghead. This failure resulted in the release of drilling mud and formation gas under high pressure into the 13 3/8" surface casing. With release of the well flow into the 13 3/8" casing, the casing shoe broke down and the surface pressure dropped considerably. Several hours later, the 13 3/8" surface casing ruptured, resulting in (1) the release of well fluids into the 20" conductor casing at a pressure in excess of the 20" casing and the 30" drive pipe internal yield pressure; (2) the failure of both the 20" and 30" casings shortly thereafter; and (3) the release of well fluids into the atmosphere. In a matter of seconds, ignition of the gaseous hydrocarbons by an unknown source occurred resulting in:

Sometime after ignition, the 13 3/8", 20", and 30" casings burst below the mud line allowing total release of the well. These holes were located by divers soon after the incident.

Rupture of 9 5/8" Casing
and
Breakdown of 13 3/8" Casing Shoe
OCS G 4065 Well No. 1
