Investigation of August 1980
Blowout and Fire, Lease OCS-G 2271
Vermilion Block 348, Gulf of Mexico
Off the Louisiana Coast

U. S. Geological Survey
Open File Report 81-712

April 1981

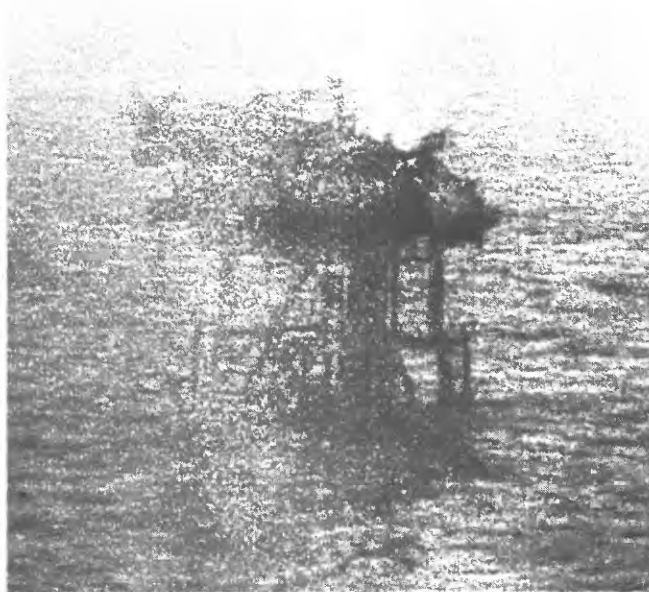
The gas did not ignite until the following morning at approximately 4:30 a.m. on August 25, 1980, (see Attachment 2). The source of ignition has not been determined.

The upper deck of the platform, the drilling rig, SEE Rig 8, and the living quarters were essentially destroyed in the fire (see Attachment 2). All wellheads were damaged and will have to be replaced. Wells on the platform were temporarily abandoned in accordance with OCS Order 3 and were not completed. No pollution resulted, due to the fact that the flow was dry gas.

Date: Prior to Commencement of Spraying By
Jet Barge Jirafa on 8/28/80
Location: Vermilion Block 348, Platform "A"
Photographer: Supplied by Mesa Petroleum Co.

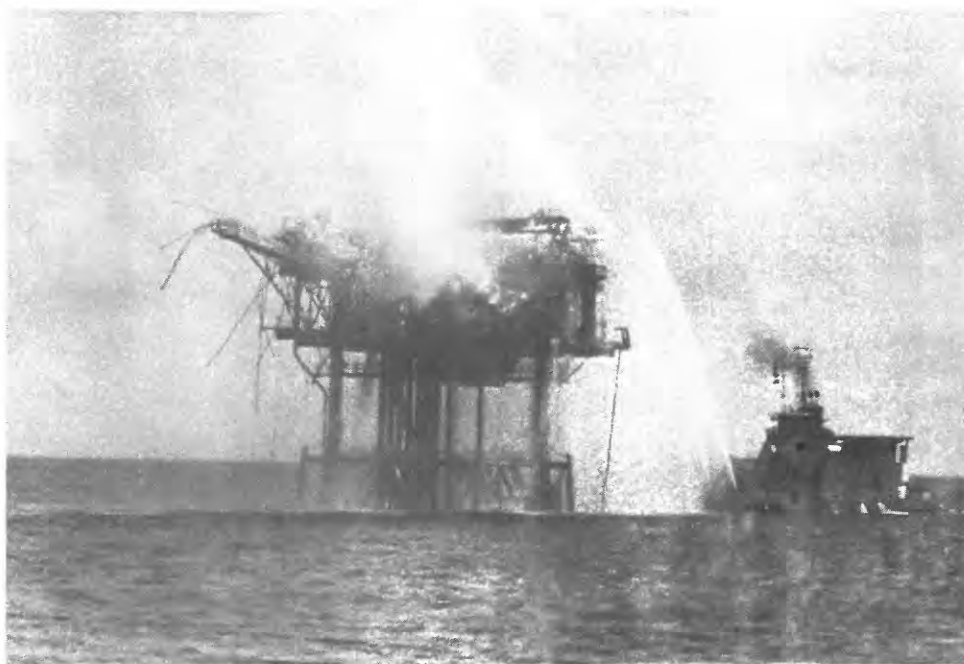
Date: After Commencement of Spraying by Jet
Barge Jirafa on 8/28/80
Location: Vermilion Block 348, Platform "A"
Photographer: Supplied by Mesa Petroleum Co.
