UNITED STATES  
DEPARTMENT OF THE INTERIOR  
GEOLOGICAL SURVEY

GEOLOGIC, GEOPHYSICAL, AND IN SITU STRESS INVESTIGATIONS  
IN THE VICINITY OF THE DINING CAR CHIMNEY,  
DINING CAR/HYBLA GOLD DRIFTS,  
NEVADA TEST SITE

By  
U.S. GEOLOGICAL SURVEY

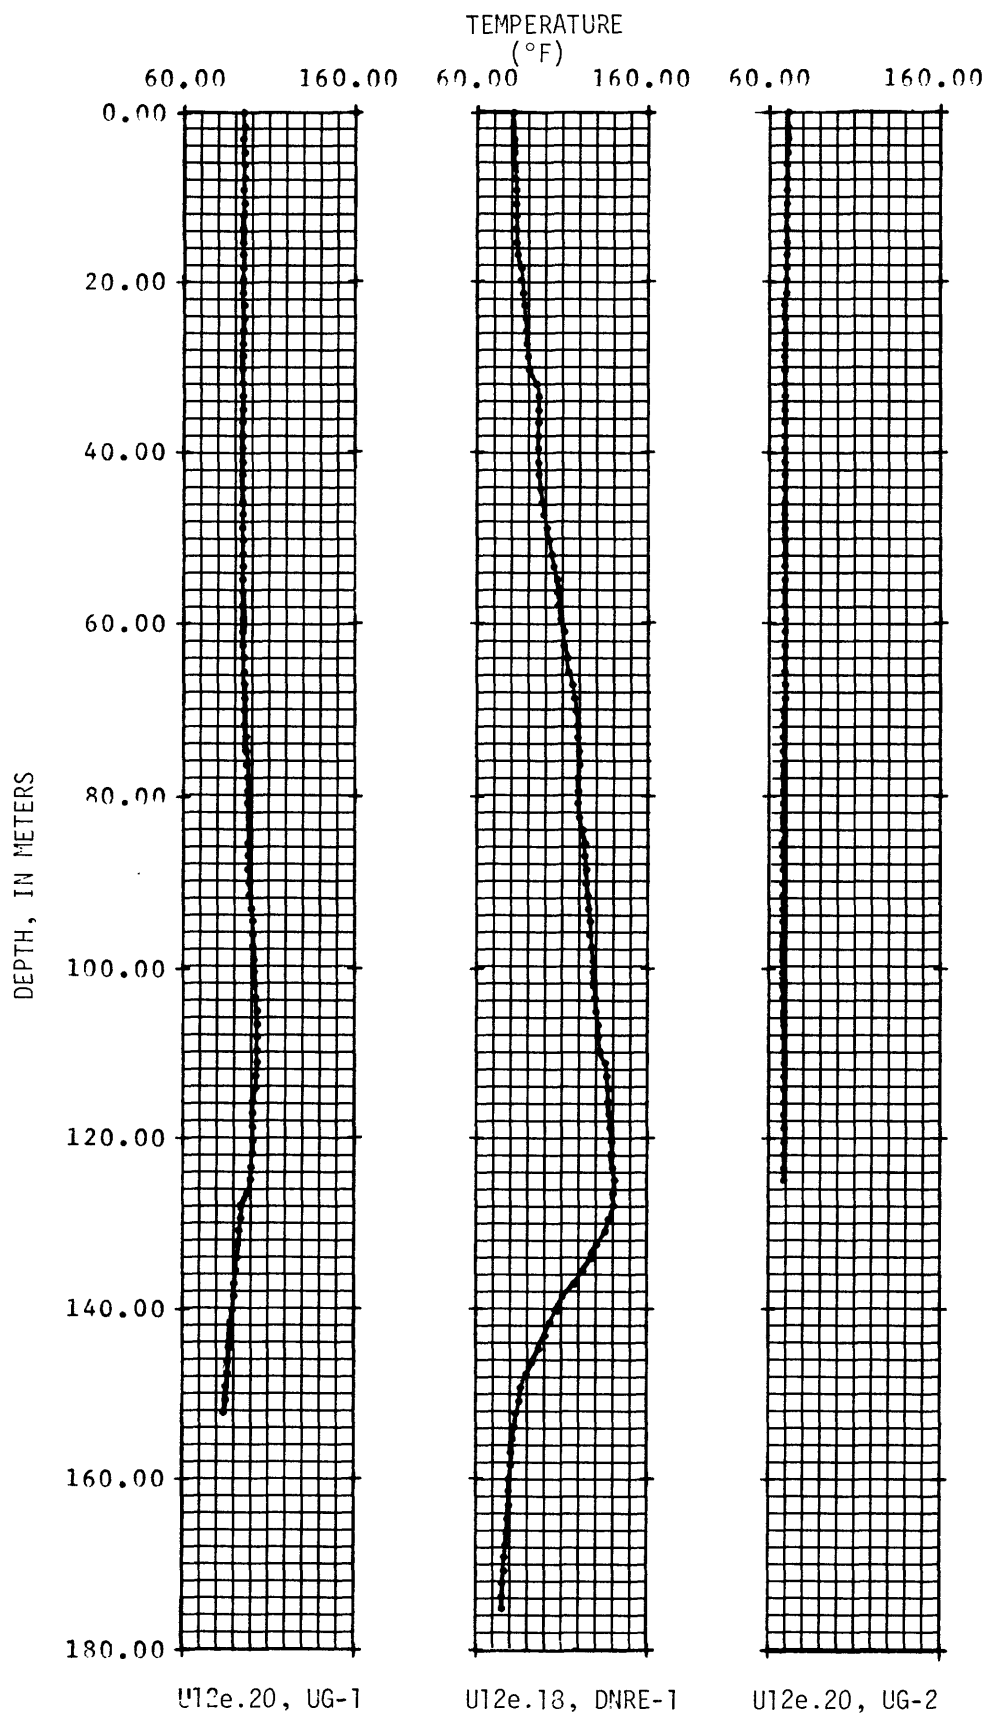
The temperature logs from the three drill holes in and near the chimney are reproduced on figure 14. The maximum reading in the chimney was about 60°C (141°F). Normal rock temperature in the tunnel beds as determined by the author by monitoring thermistors anchored 12.2 m (40 ft) in the wall in the

Figure 14.--Temperature logs obtained in three horizontal holes in the Dining Car chimney area.

U12n.07 tunnel is 20°C (68°F). It is apparent that the rock in the UG-2 drill hole is essentially at normal temperature. The maximum temperature recorded in the UG-1 hole is about 39°C (103°F). The water flowing into the holes at the time of logging makes the significance of highs and lows difficult to assess. The maximum temperature in the UG-1 hole is located beyond the preshot location of the side pipe drift. The absence of anomalous temperatures in the UG-2 hole indicates asymmetry in the isotherms produced by the Dining Car event with respect to the WP, a condition which might be expected given the preshot geometry of the experimental drifts near the device.

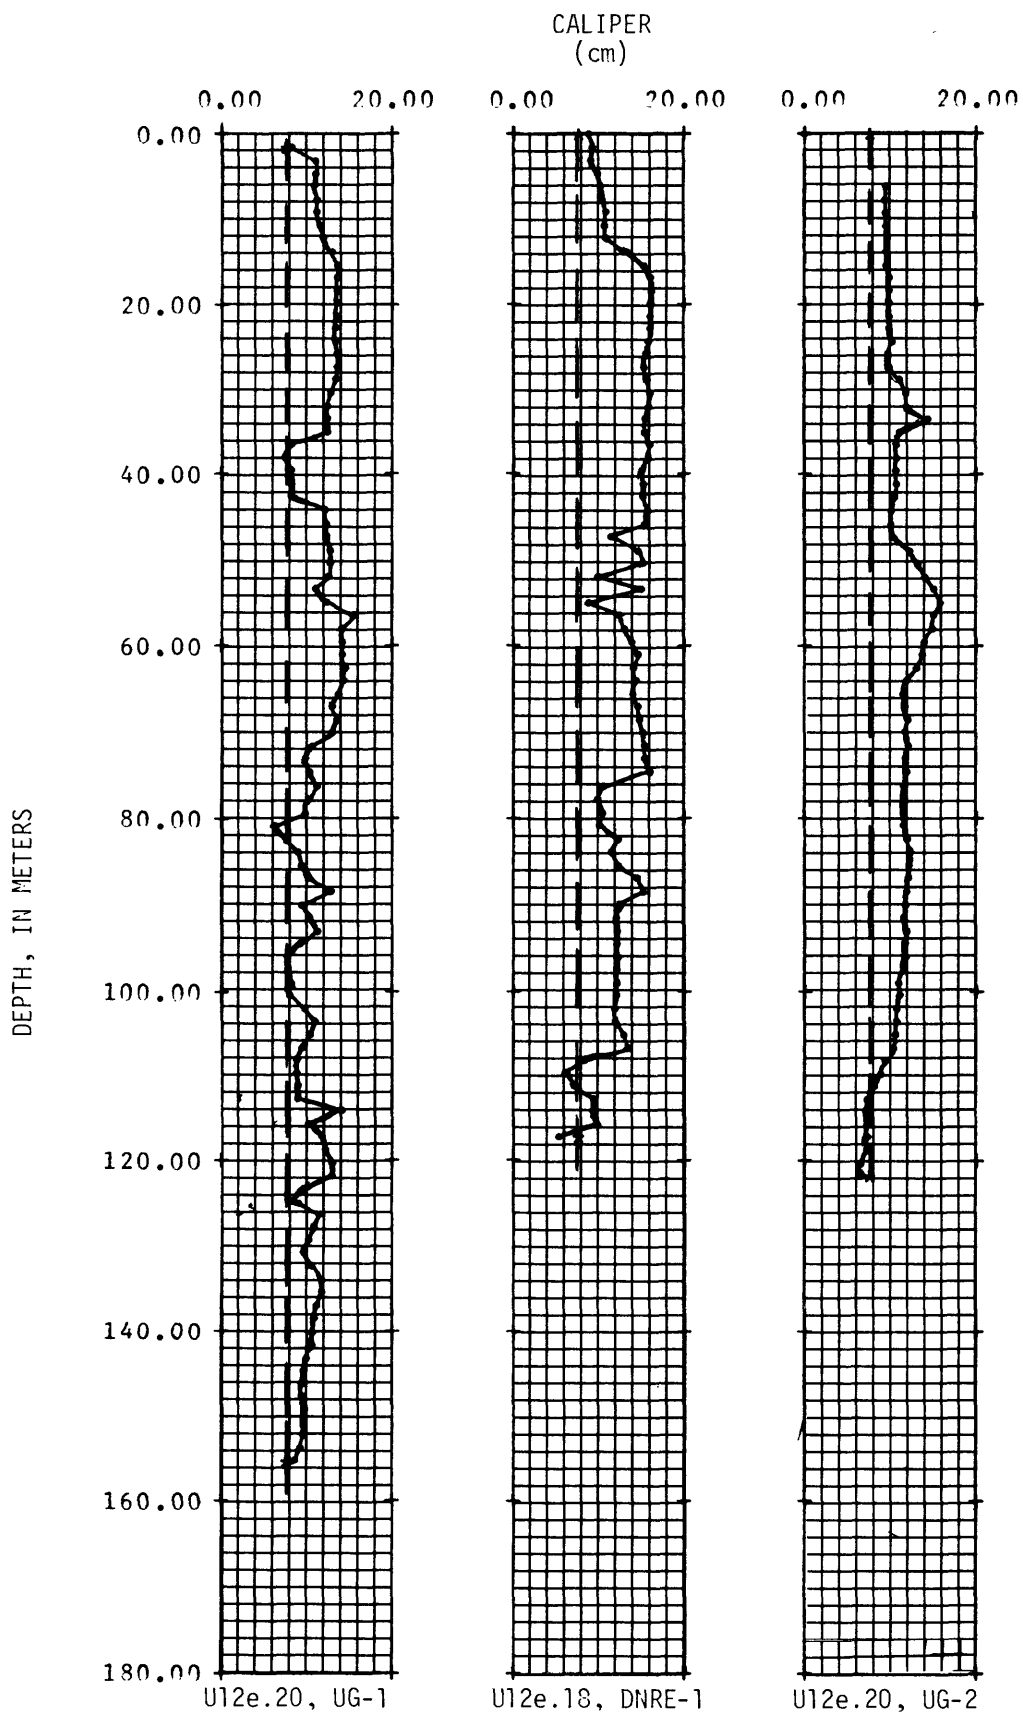
The caliper logs obtained in the three holes in the chimney region are shown on figure 15. The logs all show deterioration of the holes. This does not appear to be a function of proximity to the chimney.

Figure 15.--Caliper logs obtained in three horizontal holes in the Dining Car chimney area.

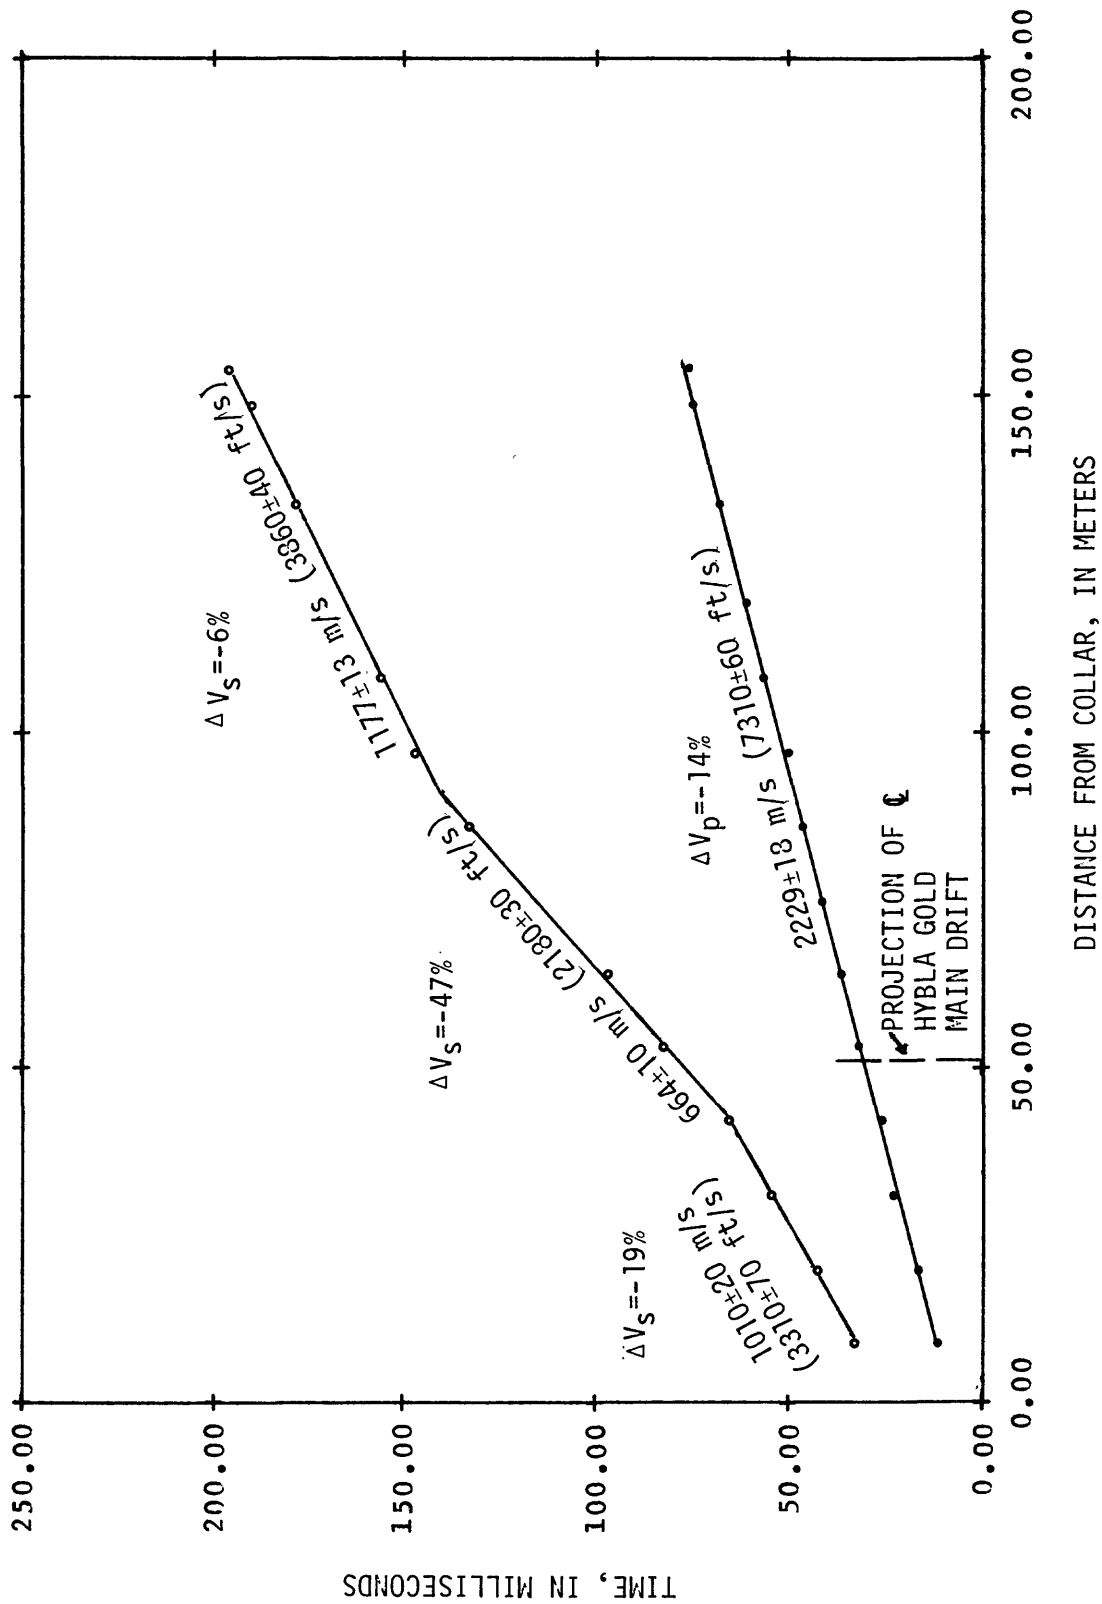
Figure 21.--Results of geophone survey in U12e.20 UG-1 drill hole.  $\Delta V_p$ ,  $\Delta V_s$  refer to changes in velocity referenced to preshot velocities obtained in Dining Car area.

The low velocities observed closest to the chimney in the UG-1 and UG-2 holes (figs. 21, 22) are postulated to delineate zones where the tuff has pervasively failed under the influence of the transit of the shock wave and growth of the cavity. It is noteworthy that the velocity changes are most noticeable in the shear-wave velocity, the compressional-wave velocity being somewhat insensitive in these zones. As will be subsequently observed in the seismic velocities obtained in the Hybla Gold drifts, this insensitivity of the compressional velocity is a consistent effect.

The changes listed on the figures quantify what is visually apparent on the traveltime plots, i.e., that the Dining Car explosion has been considerably more effective in lowering the in situ shear-wave velocity than the compressional-wave velocity, particularly for the pervasively failed material outside the chimney (figs. 20, 21). The shear velocity in the tuff immediately outside the chimney is down nearly 50 percent in the UG-1 hole.

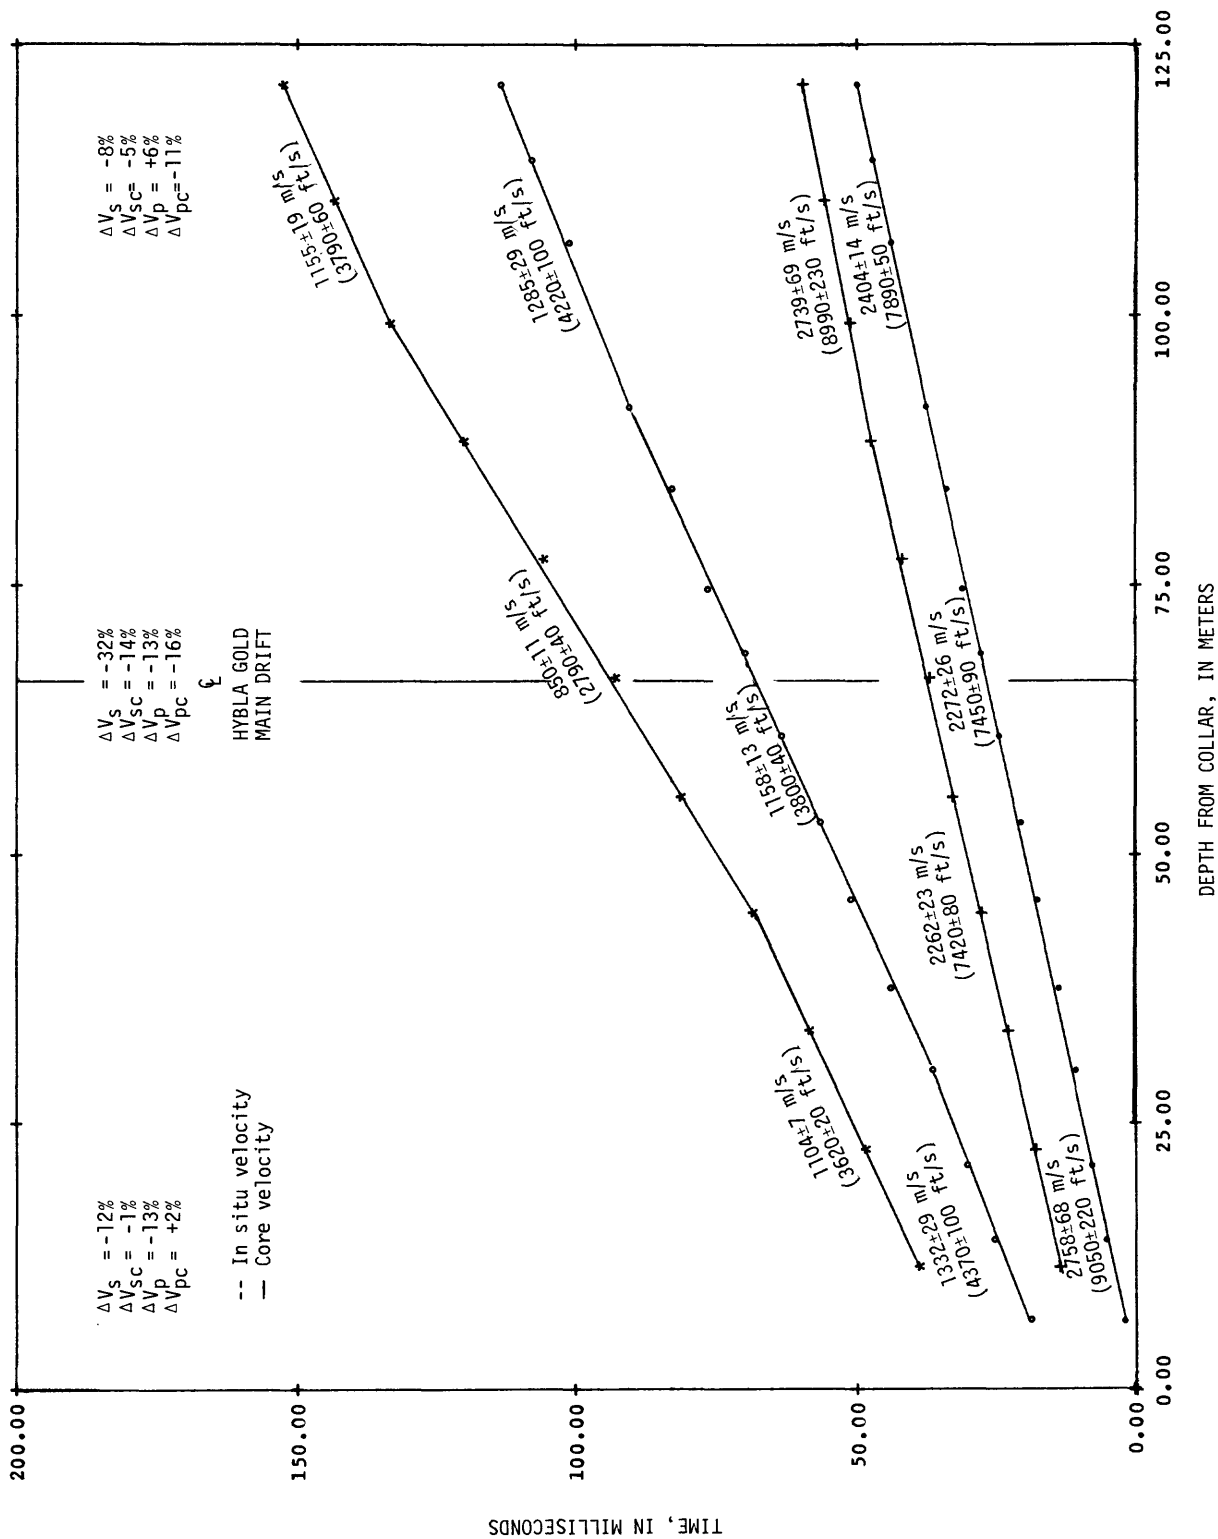
Figure 22.--Results of geophone survey in U12e.20 UG-2 drill hole compared with time-distance plots derived from core data.  $\Delta V_p$ ,  $\Delta V_s$  refer to changes in velocity referenced to average preshot velocities obtained in Dining Car area.  $\Delta V_{sc}$ ,  $\Delta V_{pc}$  refer to changes in average preshot core velocities.

The velocity traveltime plots derived from the core data in the UG-2 hole (fig. 22) also distinctly show the zone of pervasive failure. They differ from the in situ data as follows:

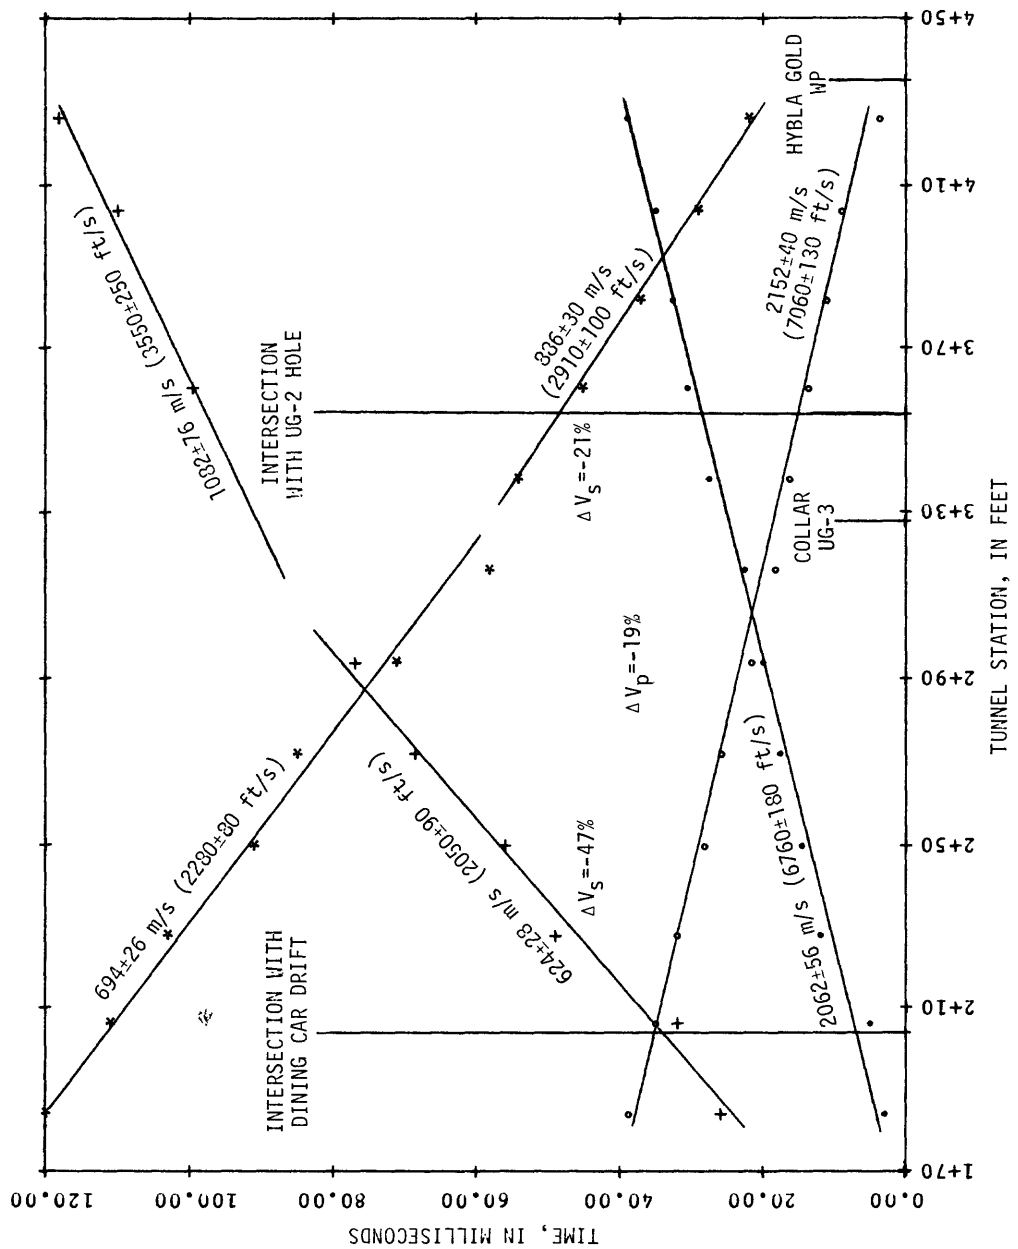
Figure 23.--Results of seismic survey in U12e.20 tunnel, main drift. Moduli were derived using averages of velocities of equivalent segments and assuming a density of 1.9 Mg/m<sup>3</sup>.

The absence of distinct breaks in the slope of the compressional-wave time-distance plot in the main drift (fig. 23) at the same locations as the shear-wave plot is an interesting phenomenon and one for which there is no ready explanation. This is a consistent result as may be noted in the results in the UG-1 and UG-2 drill holes (figs. 21, 22). Assuming that the arrivals are travelling over equivalent paths, the implication is that the explosion-induced effects on the tuff are such that the compressional velocity is relatively insensitive to these effects. This does not mean that the compressional velocity is not reduced. We are unaware of any previous work which demonstrates such dramatic changes in shear velocity unaccompanied by similar changes in compressional velocity. "Inconsistencies" of this dramatic nature have not been observed in any preshot seismic survey in Rainier Mesa tunnels.

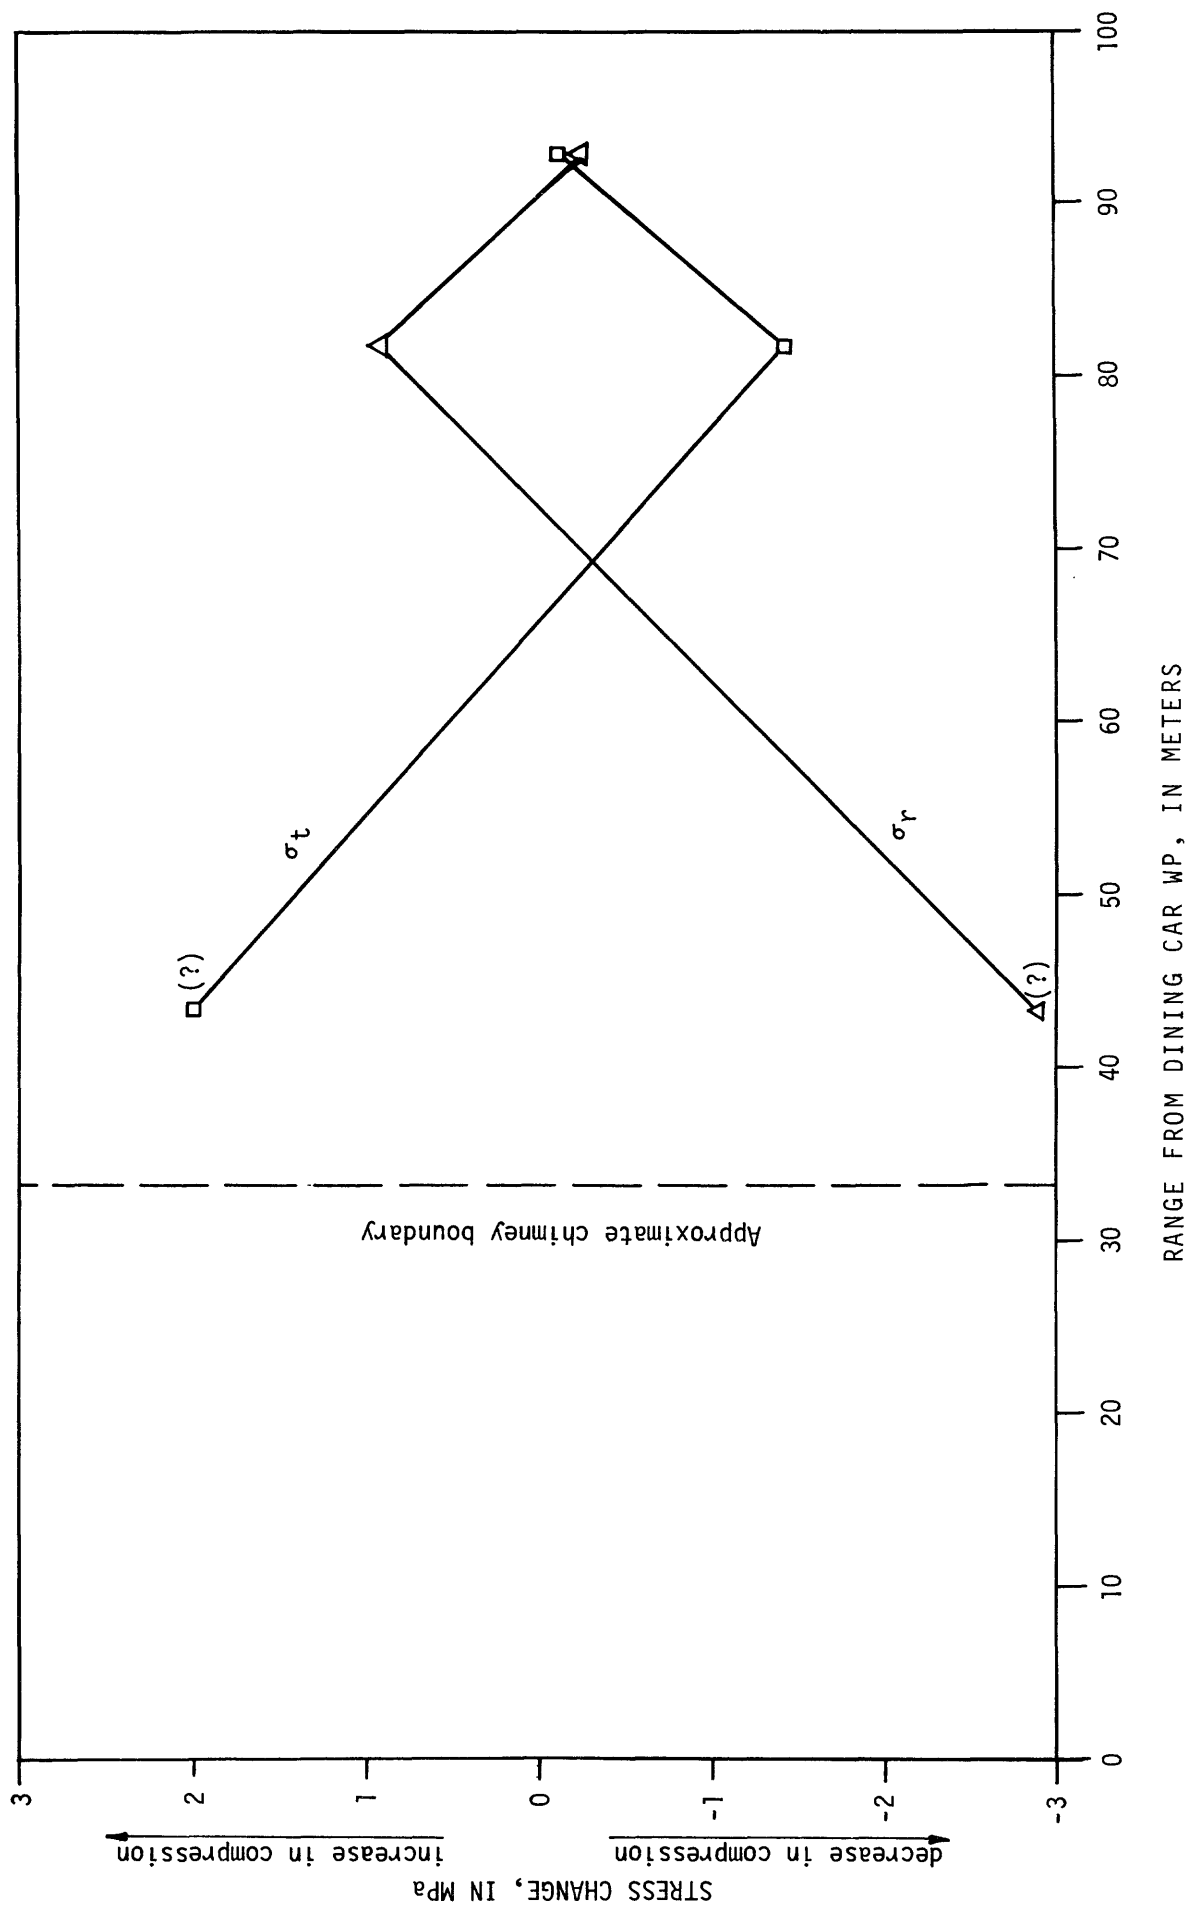
Ignoring the stress change magnitudes on figure 45, the following can be said about the pattern of stress change. Near the Dining Car chimney at the ISS-9 location (44-m (144.4-ft) range from Dining Car WP), the tangential component of stress change is relatively more compressive, while at the Hybla Gold WP site (83-m (272.3-ft) range from Dining Car) the radial component of stress change is relatively more compressive. At the ISS-7A location (93-m (305.1-ft) range from Dining Car) the change in both radial and tangential components is approximately equal and insignificant. The pattern of stress change therefore indicates a "crossover" of the radial and tangential components of stress change somewhere between 44- and 83-m (144.4- and 272.3-ft) range from the Dining Car WP, most probably between about 60- and

Figure 45.--Radial ( $\sigma_r$ ) and tangential ( $\sigma_t$ ) components of remnant horizontal stress change versus range from Dining Car WP.

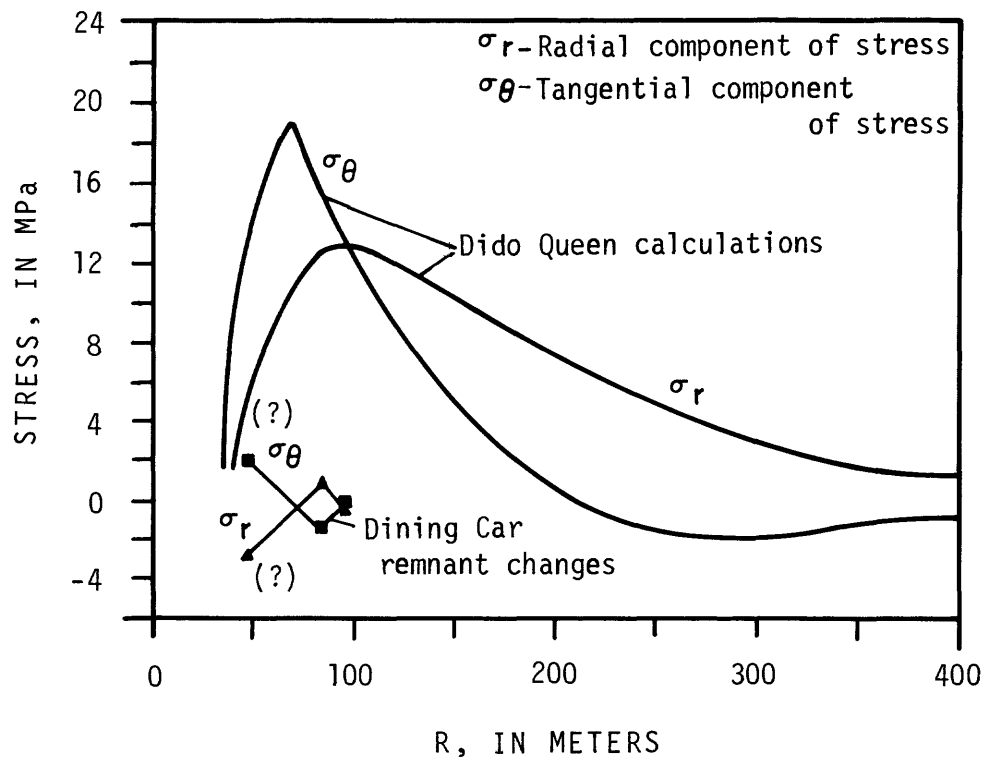
It is obvious from figure 46 that the magnitude of the measured components of remnant stress change do not approximate the stress increase predicted by the calculational model. This does not imply that the results of the model are invalid, because the effects of creep and other time-dependent phenomena on the explosion-induced stress distribution are largely unknown. It is apparent from this comparison, however, that if the calculational models provide a reasonable estimate of explosion-induced "residual" stresses, then these stresses do not persist for long periods of time in the low modulus rocks of Rainier Mesa. If it is accepted that the orientation and relative magnitudes of the measured horizontal stress changes are an artifact of the original induced stresses, then it is noteworthy that the pattern of change is qualitatively similar to that predicted by the model. That is, near the chimney the tangential component of stress change is most compressive, but at greater range the radial component of stress change becomes most compressive. It is therefore suggested that the pattern of remnant stress change in the vicinity of Dining Car provides a qualitative indication based on field measurements that a "stress cage" once existed around the Dining Car cavity, and that the geometric characteristics of this "stress cage" were similar to those predicted by numerical modeling. Unfortunately, the data provides no indication as to what the probable magnitudes or lateral dimensions of the induced stresses were shortly after execution of the Dining Car event.

Figure 46.--Comparison of calculated "residual" stress cage for Dido Queen event to remnant stress changes determined in vicinity of Dining Car event.
