UNITED STATES DEPARTMENT OF THE INTERIOR  
GEOLOGICAL SURVEY

Distribution of Intensity for the Westmorland, California  
Earthquake of April 26, 1981

Open-File Report 82-485

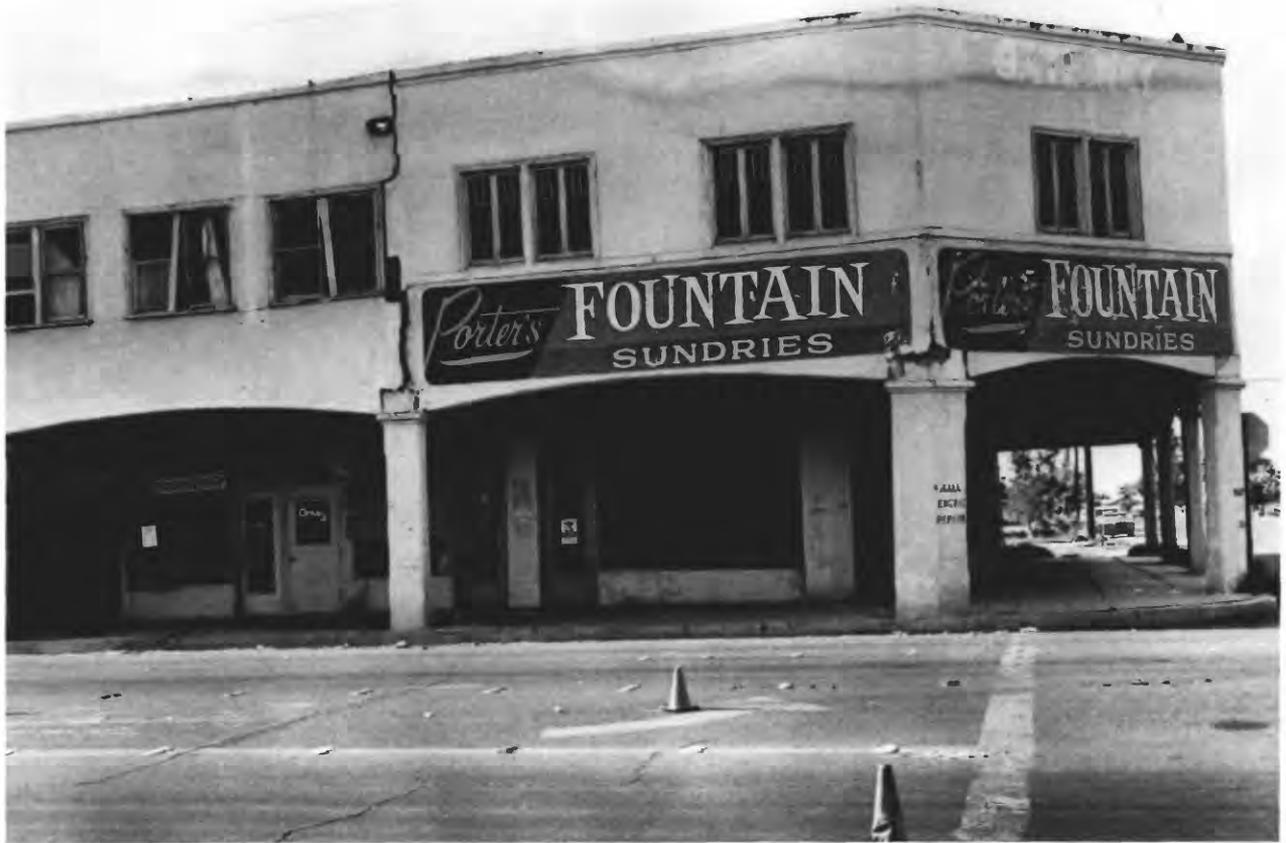
5. Porter's Fountain (fig. 3a and 3b). Porter's Fountain was badly damaged. The concrete columns at the corner of the building tilted out towards the street. Apparently these columns were not tied to the overhead portion of the building. The rebar in the columns simply extended into the framework and were not secured by any means. The building has been torn down by demolition crews. This building was constructed in a style typical of the area—two-story, wood frame, covered by stucco with a front portico extending the length of the building.

Figure 3A--Porter's Fountain. (This Westmorland building is located at site number five in Figure 2. See text for damage description). Minutes after this photo was taken, a portion of the front of the building was torn down by demolition crews. (Photo courtesy of Paul Noden, Imperial Valley Press).

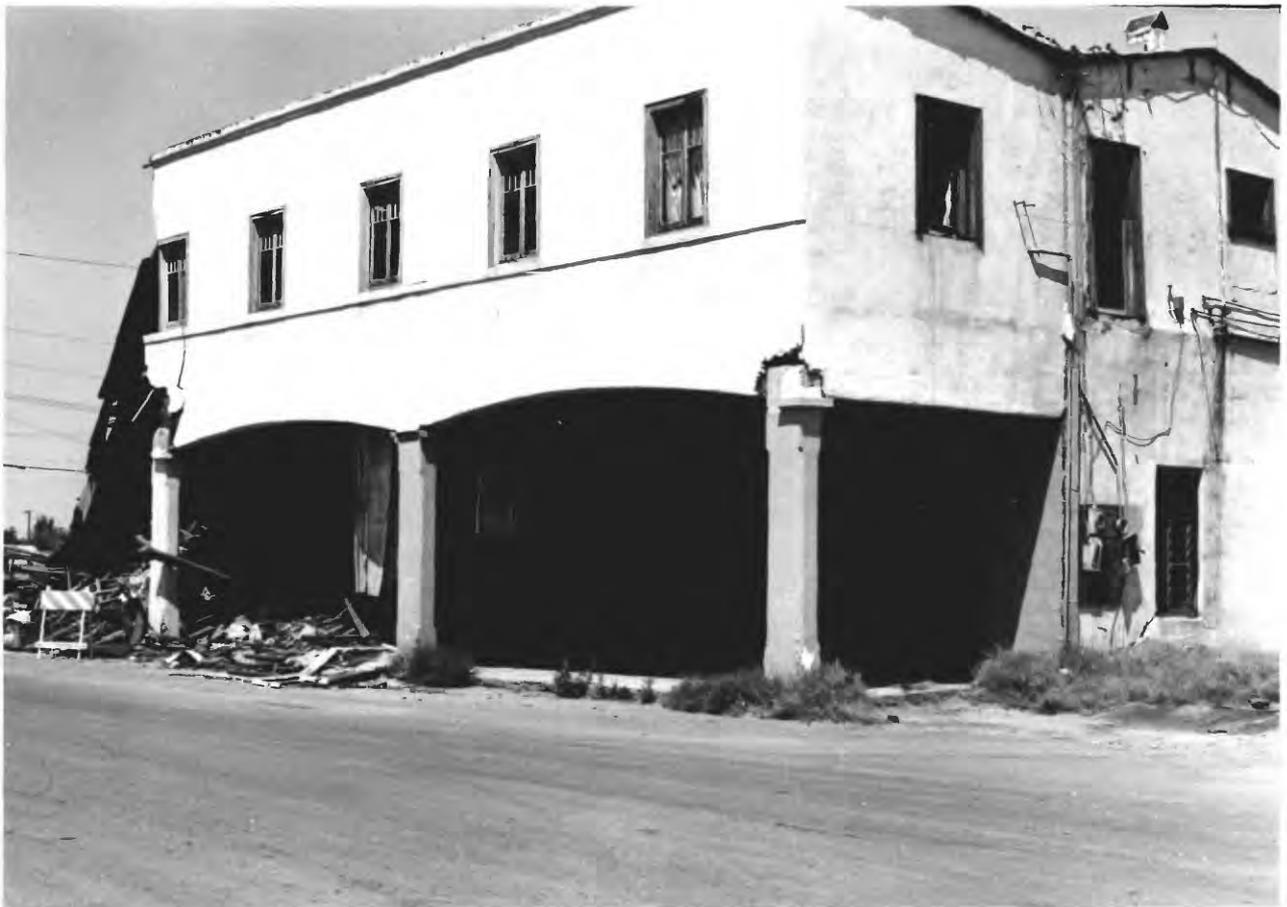
Figure 3B--Porter's Fountain (rear view). Photo shows major structural damage at junction of the portico and the building. This photo was taken after demolition crews had torn down the front section of the building. (Photo by S. T. Algermissen, U.S. Geological Survey).

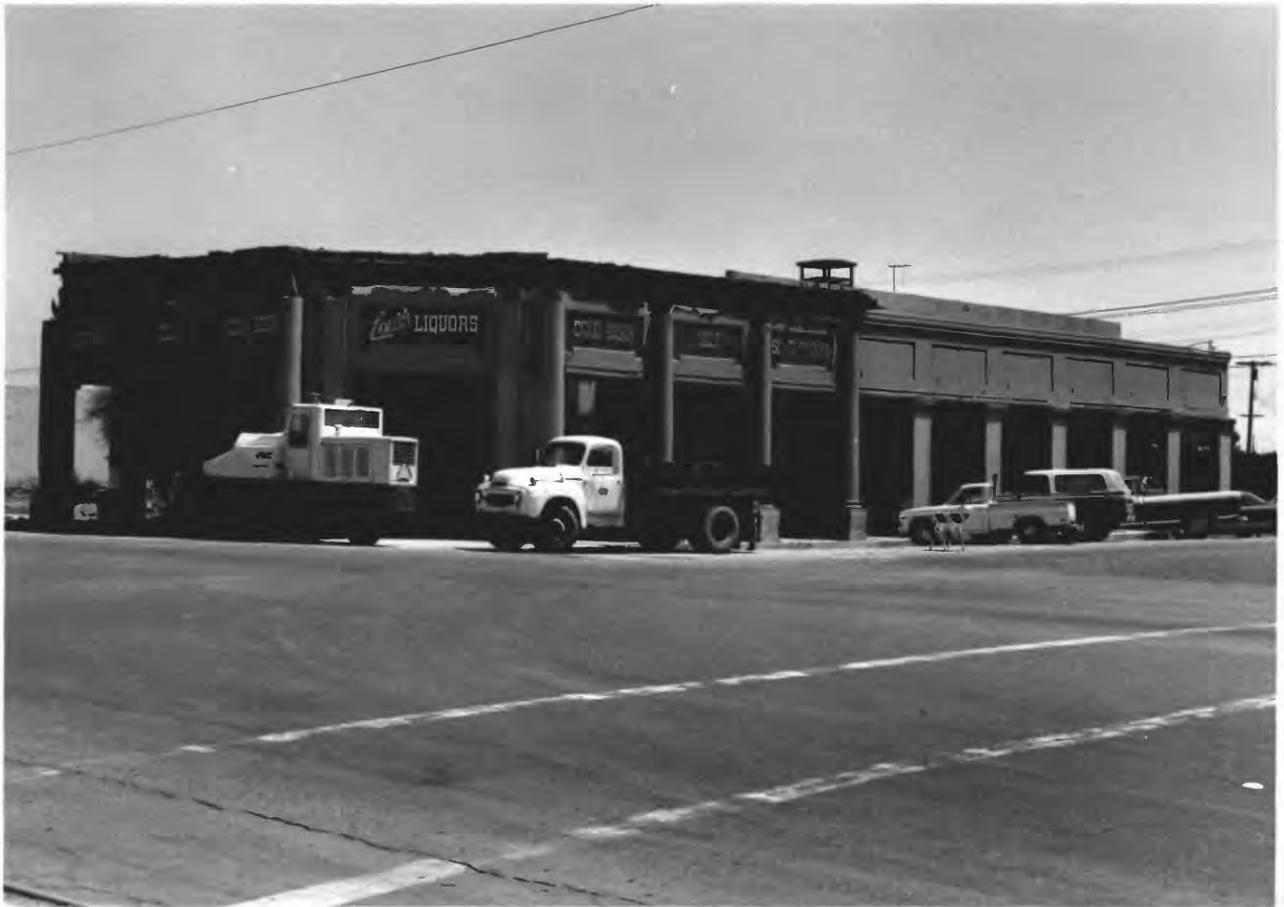
9. The building located at the southeast corner of Center Street and Main Street sustained damage to the parapet wall at the arcade (fig. 4). The building is primarily of frame and plaster construction with metal "ornamentation" along the Center Street side. Some weakness was apparently caused by a leaking roof that allowed water to rot the wooden members. The balance of the building appeared undamaged.

Figure 4.--Westmorland, southeast corner of Center and Main Streets. This building is located at site number 9 in Figure 2. See text for damage description. (Photo by S. T. Algermissen, U.S. Geological Survey).

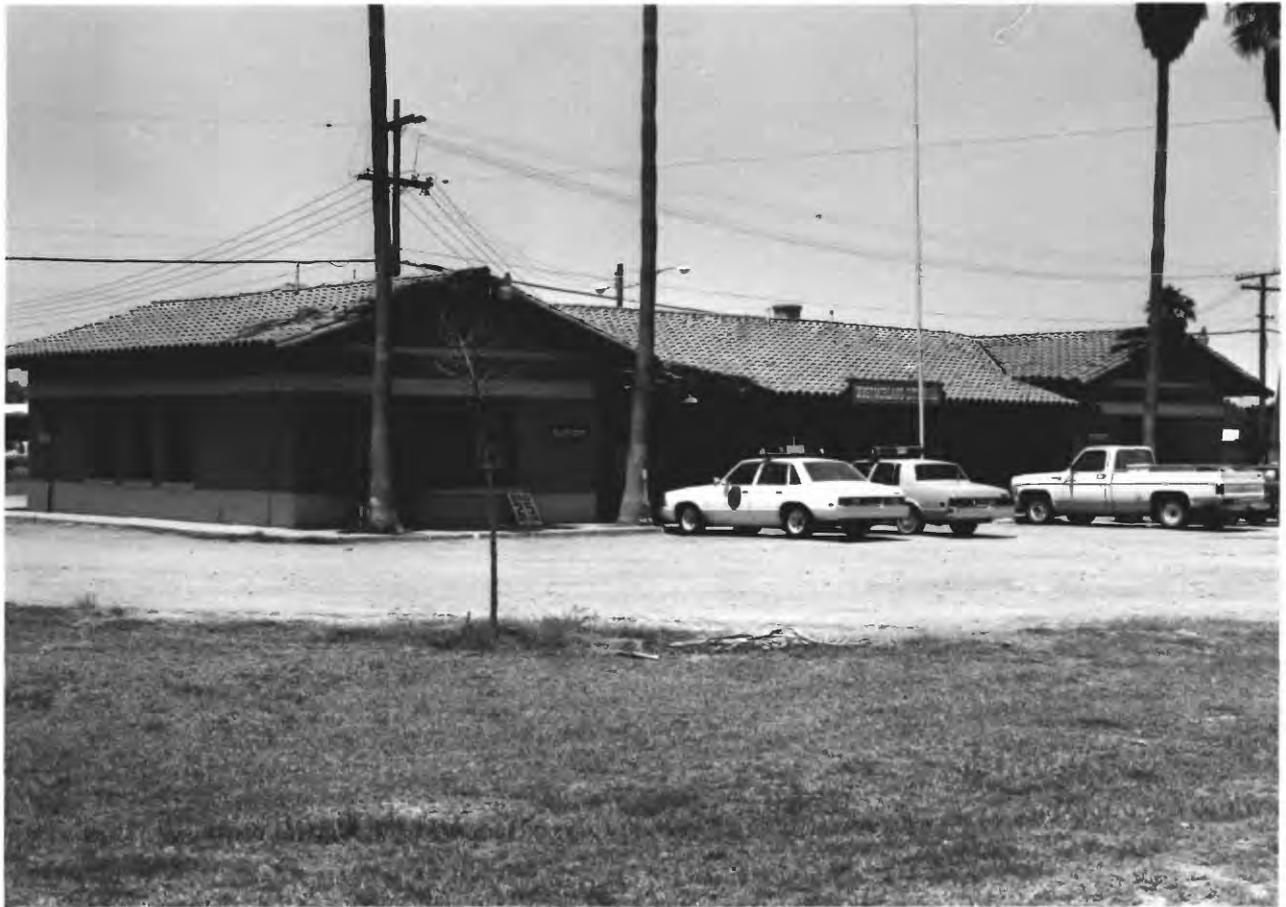
14. Built in 1934 as a WPA project, Westmorland City Hall is a one-story adobe brick structure with massive 24-inch thick walls. The structure sustained relatively minor exterior damage in the form of tile loss on the roof and a cracked chimney (fig. 5a). Interior damage was restricted to minor cracks opening diagonally above the corner of a door lintel in the south chambers entrance and along the bottom of the east-facing wall of the chambers (fig. 5b).

Figure 5A--Westmorland City Hall. Damage occurred in the form of cracking of interior walls (Figure 5B) and tiles shaken from the roof. This building is located at site number 14 in Figure 2. See text for further damage description). (Photo by S. T. Algermissen, U.S. Geological Survey).

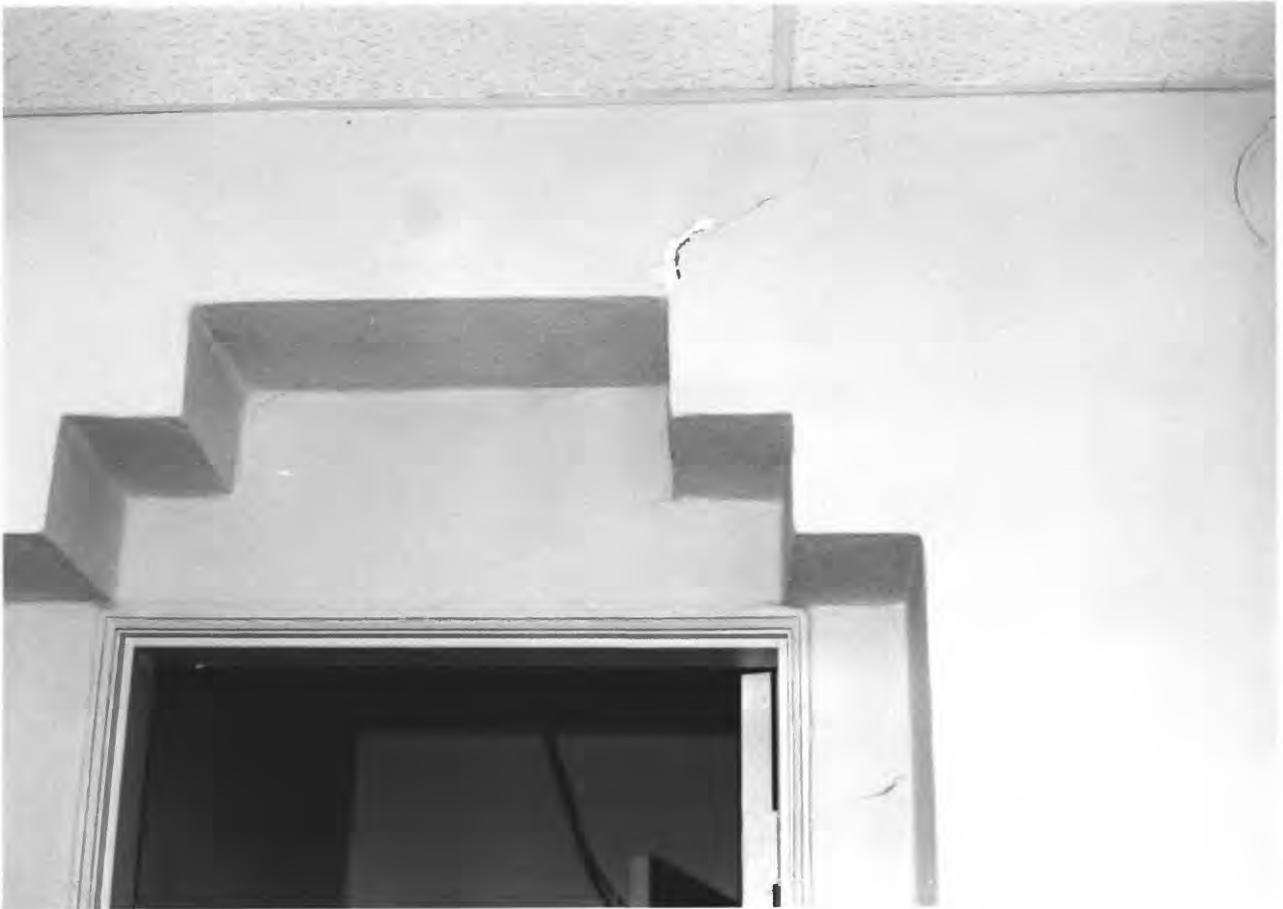
Figure 5B.--Interior wall damage in Westmorland City Hall. (Photo by S. T. Algermissen, U.S. Geological Survey).

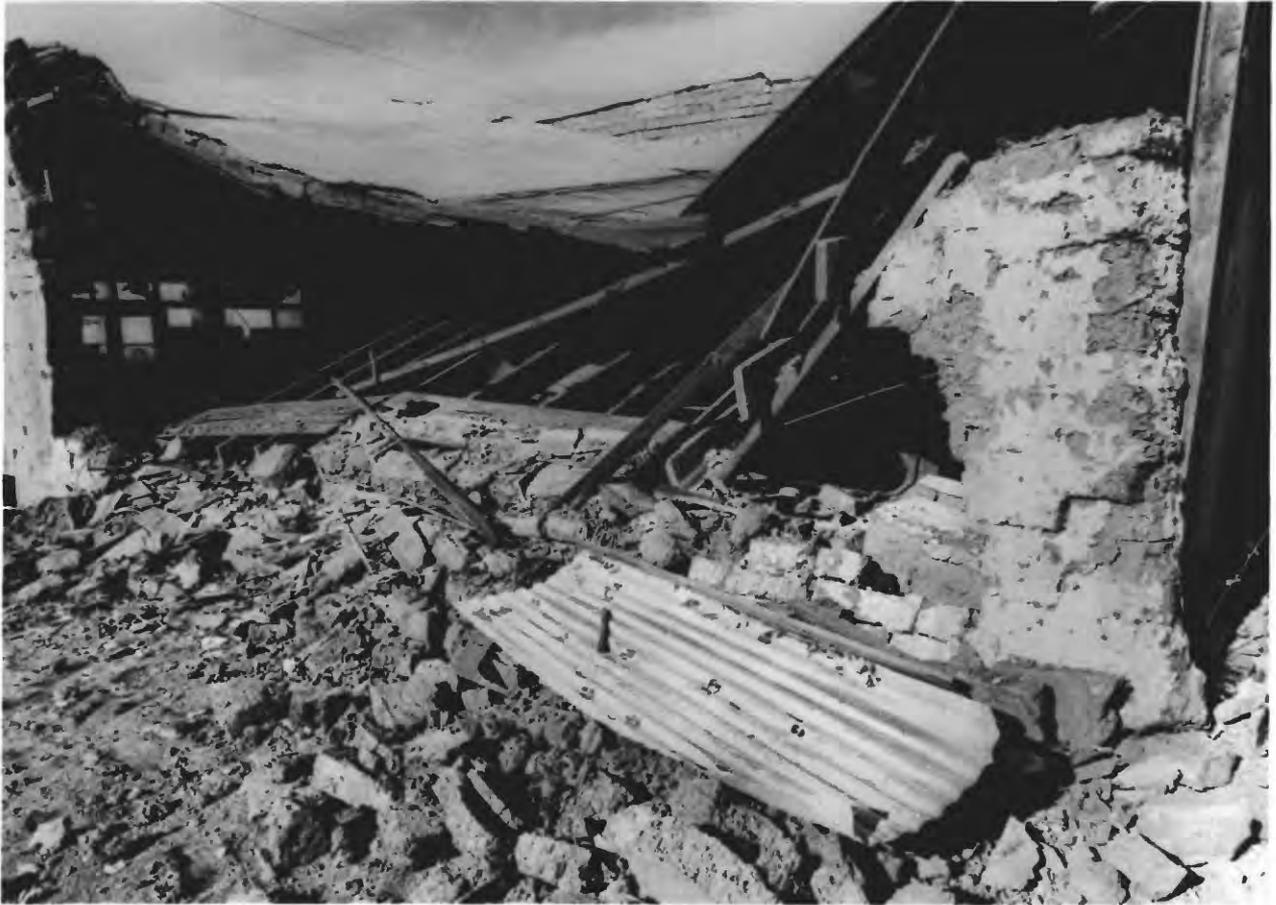
22. 230 Seventh Street. This house trailer shifted about 18 inches and fell off of its metal jack supports (fig. 6).
23. 152 West Sixth Street. The west wall and wood-frame roof of this adobe storage shed collapsed. The structure has been condemned (fig. 7).

Figure 7.--The west wall and wood frame roof of this adobe storage shed collapsed. This structure in Westmorland is located at site number 23 in Figure 2. See text for damage description. (Photo courtesy of Paul Noden, Imperial Valley Press).

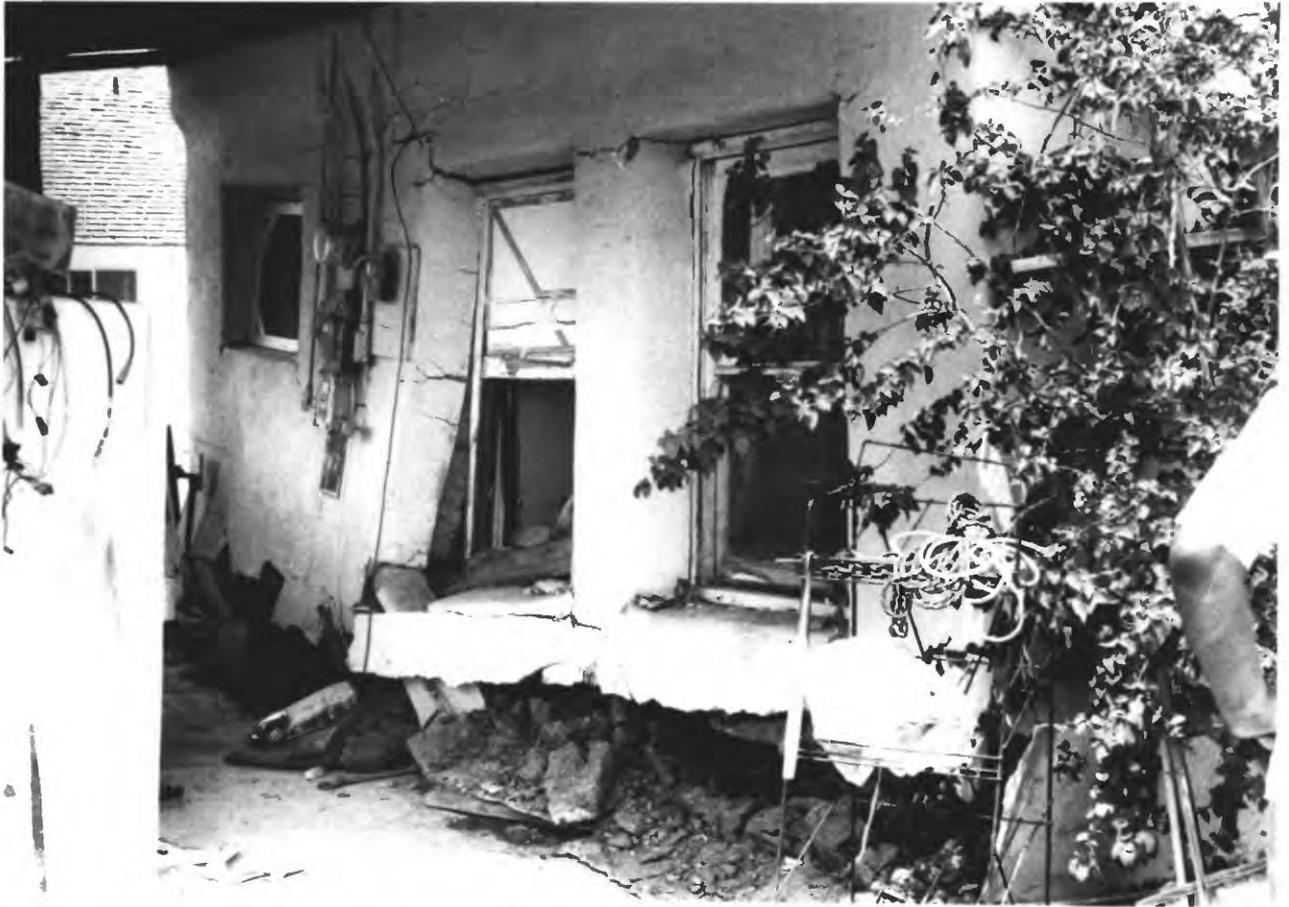
37. 162 East Third Street. The rear part of the foundation of this adobe dwelling collapsed (figs. 8a and 8b). The east wall also collapsed. Severe cracking occurred in all of the walls, and the dwelling was condemned by the Brawley Building Inspector.

Figure 8A.--Collapsed foundation of stucco-over-adobe-brick residence. This dwelling was condemned by the Brawley Building Inspector. This Westmorland home is located at site number 37 in Figure 2. See text for further damage description. (photo courtesy of Paul Noden, Imperial Valley Press).

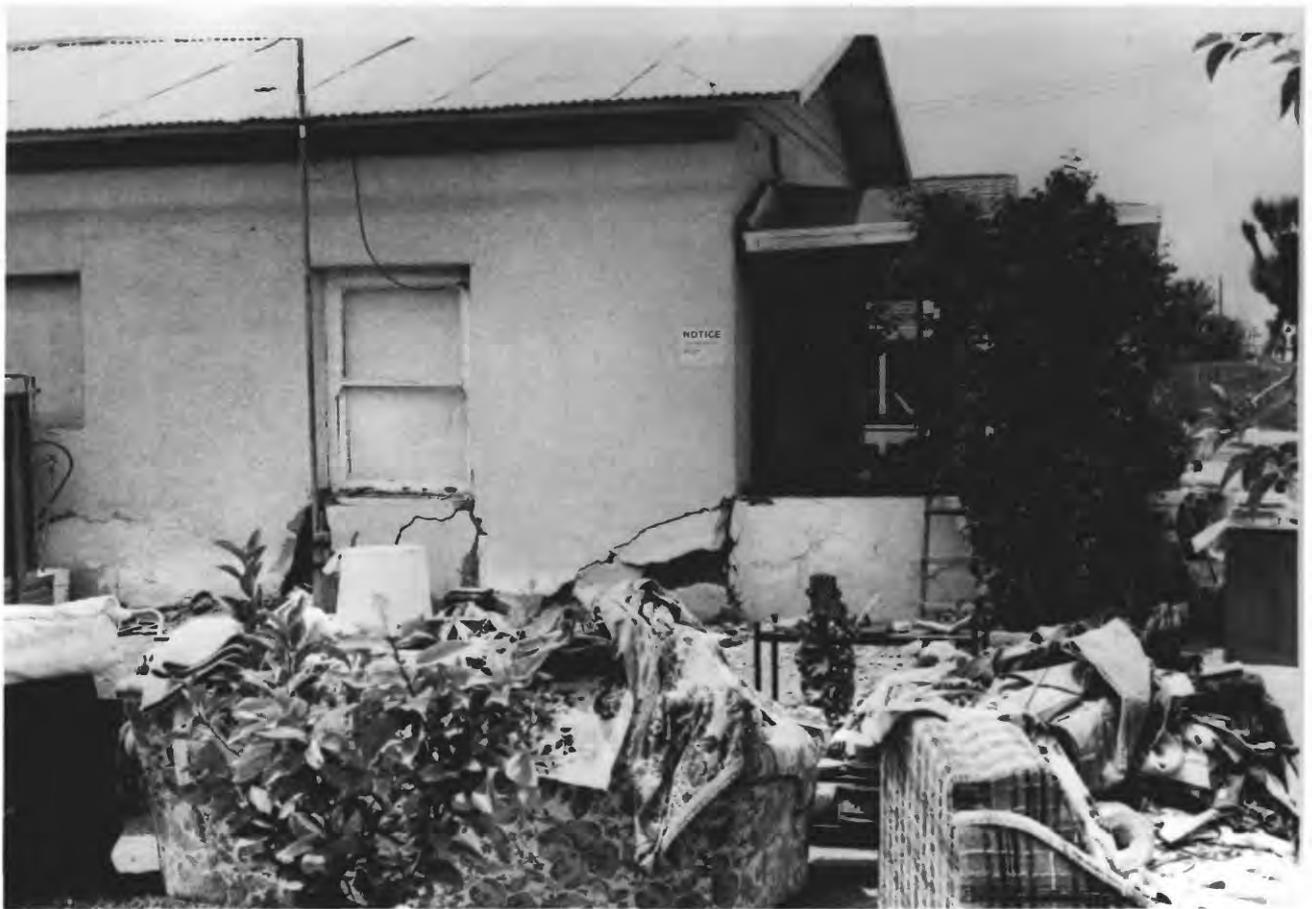
Figure 8B.--Side view of residence described in Figure 8A. (Photo courtesy of Paul Noden, Imperial Valley Press).

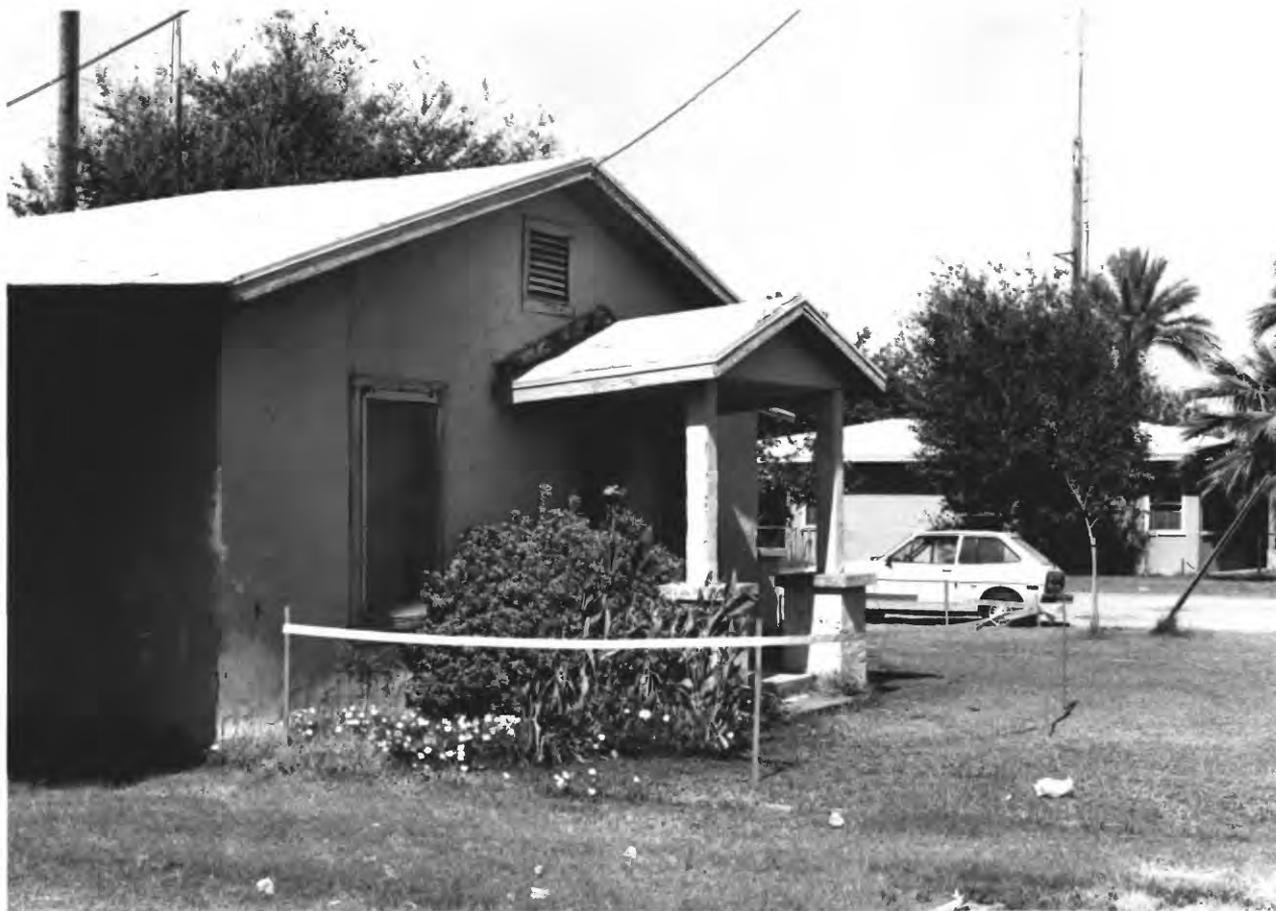
41. The dwelling at this location had an inflection in the foundation.
42. The front porch of this dwelling separated from the remainder of the house. Supporting columns buckled, tilting the porch roof towards the structure (fig. 9).
43. A small amount of stucco had fallen from the exterior walls of this dwelling.
44. Cracking was apparent in the adobe walls. Large pieces of plaster fell.
45. The house trailer at this location shifted off of its supports. The floor of the trailer broke loose from the frame and was hanging out of the trailer.
46. Westmorland Water Treatment Plant. The water filtering system was damaged, rendering the plant inoperable. The water tower at the plant now tilts south.

Figure 9.--Westmorland residence--the front portch separated from the rest of the house. The house is located at site number 42 in Figure 2. See text for damage description. (Photo by S. T. Algermissen, U.S. Geological Survey).

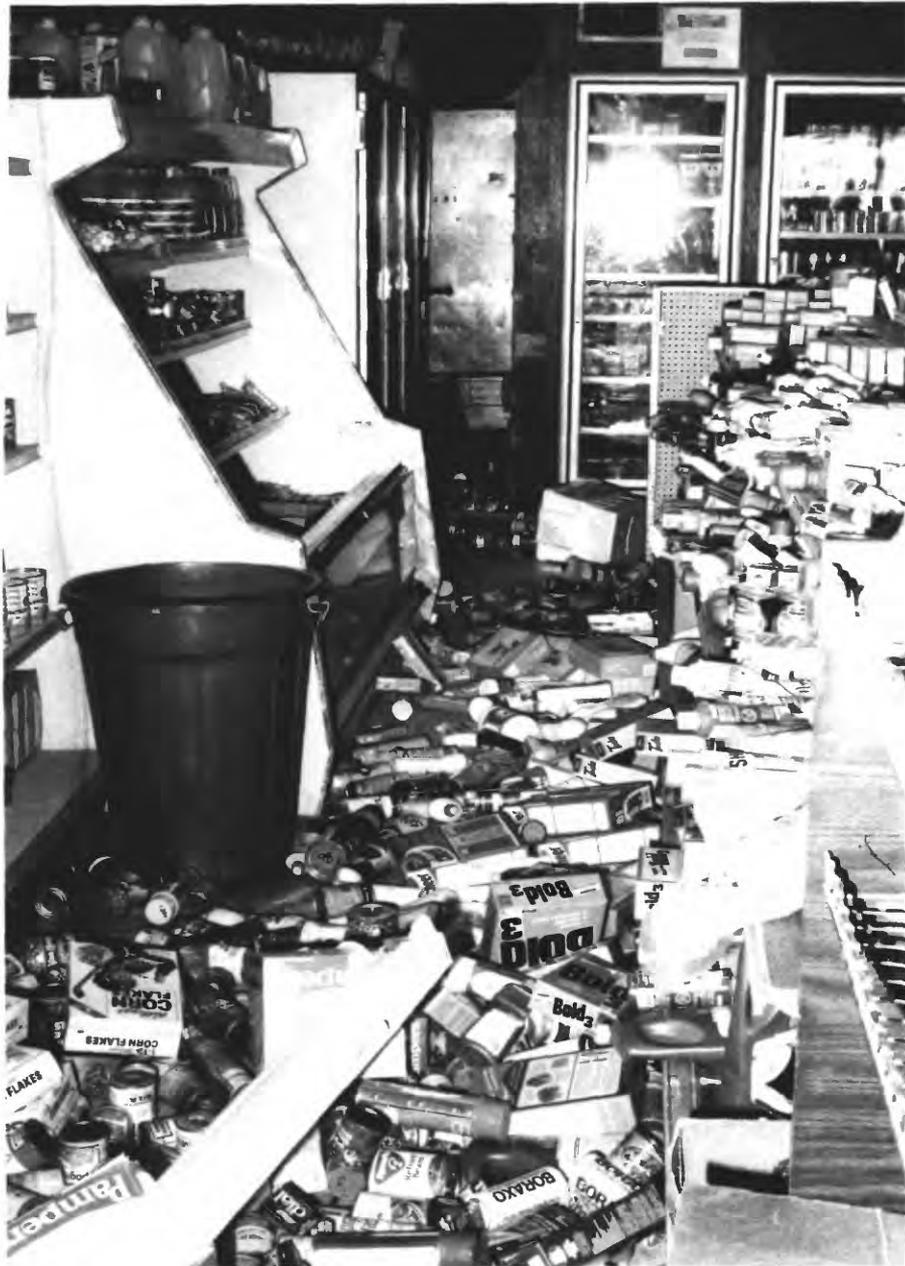
Figure 11.--Merchandise off of shelves in Westmorland grocery store. This type of damage also occurred at grocery stores in Calipatria. (Photo courtesy of Paul Noden, Imperial Valley Press).

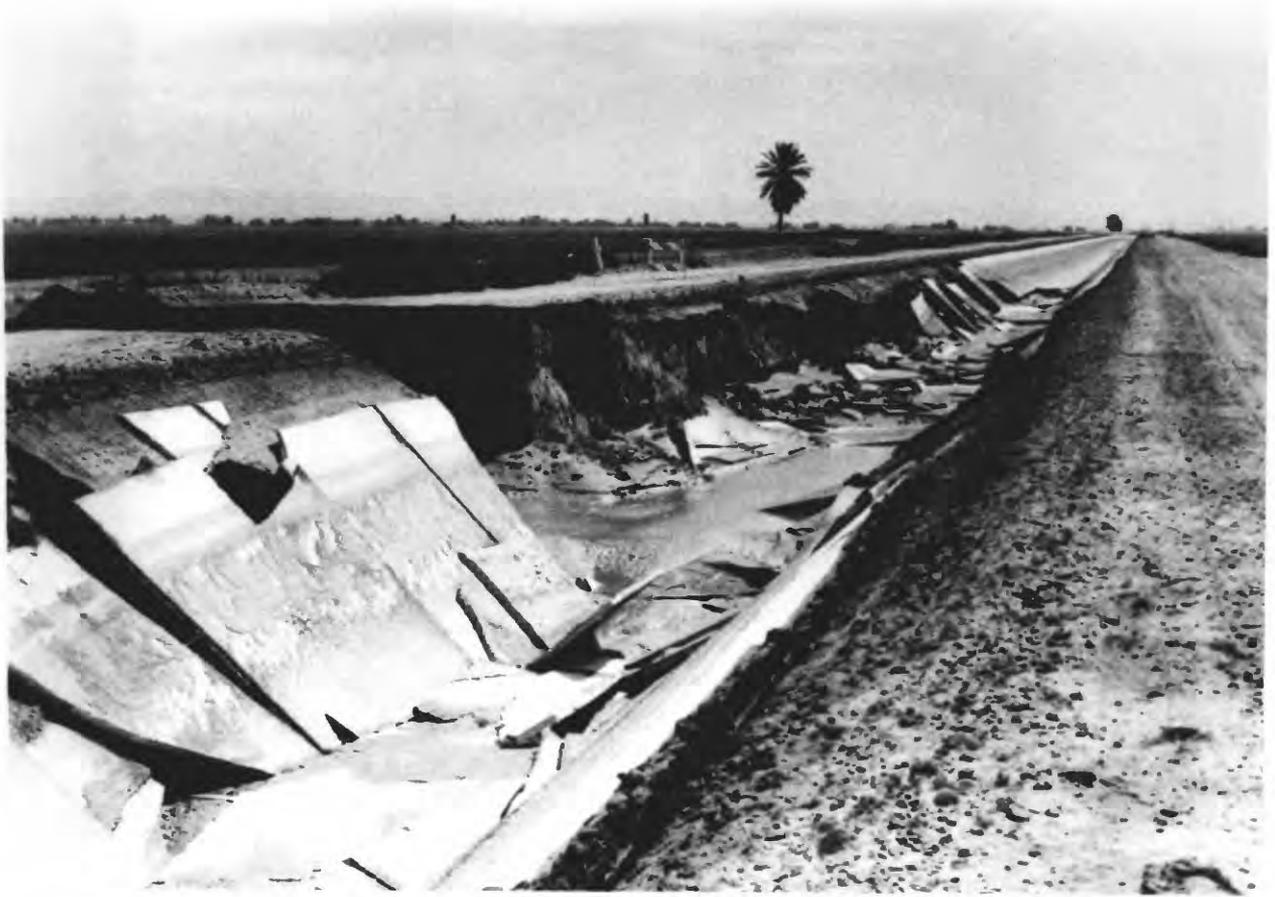
Figure 12.--Damage to the Vail Canal in the epicentral area. The damage is thought to be due to ground slumping. (Photo by Ronnie Valles, Imperial Valley Press).

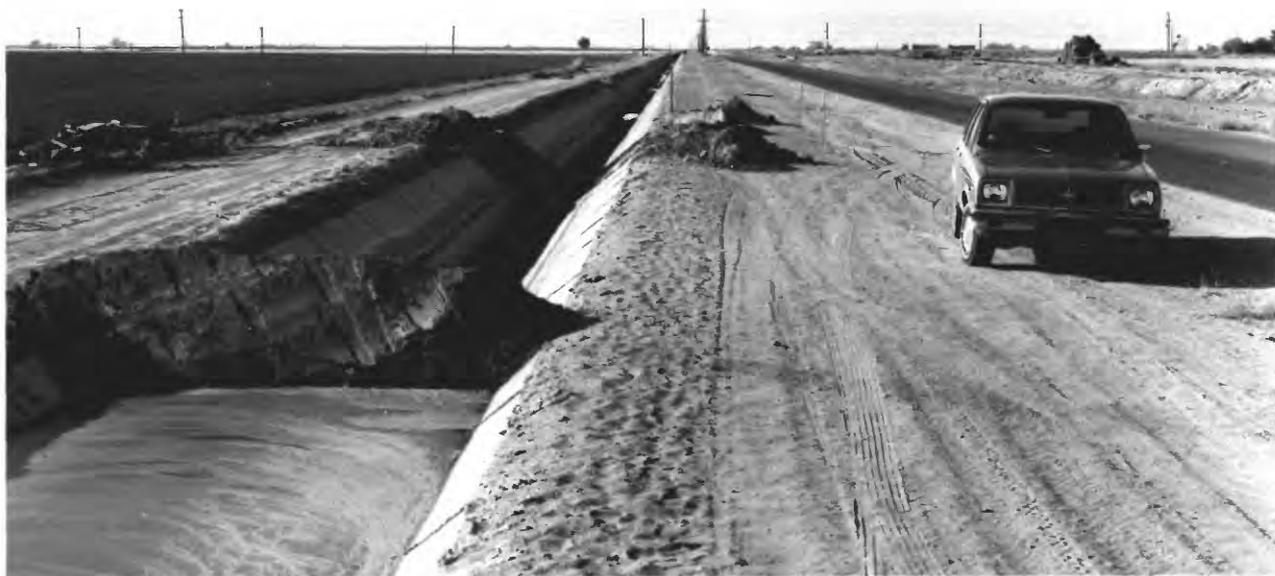
Figure 13.--Slumping which occurred in many earthen canals. Canal has been dammed to stop water flow for repairs. (Photo by S. T. Algermissen, U.S. Geological Survey).

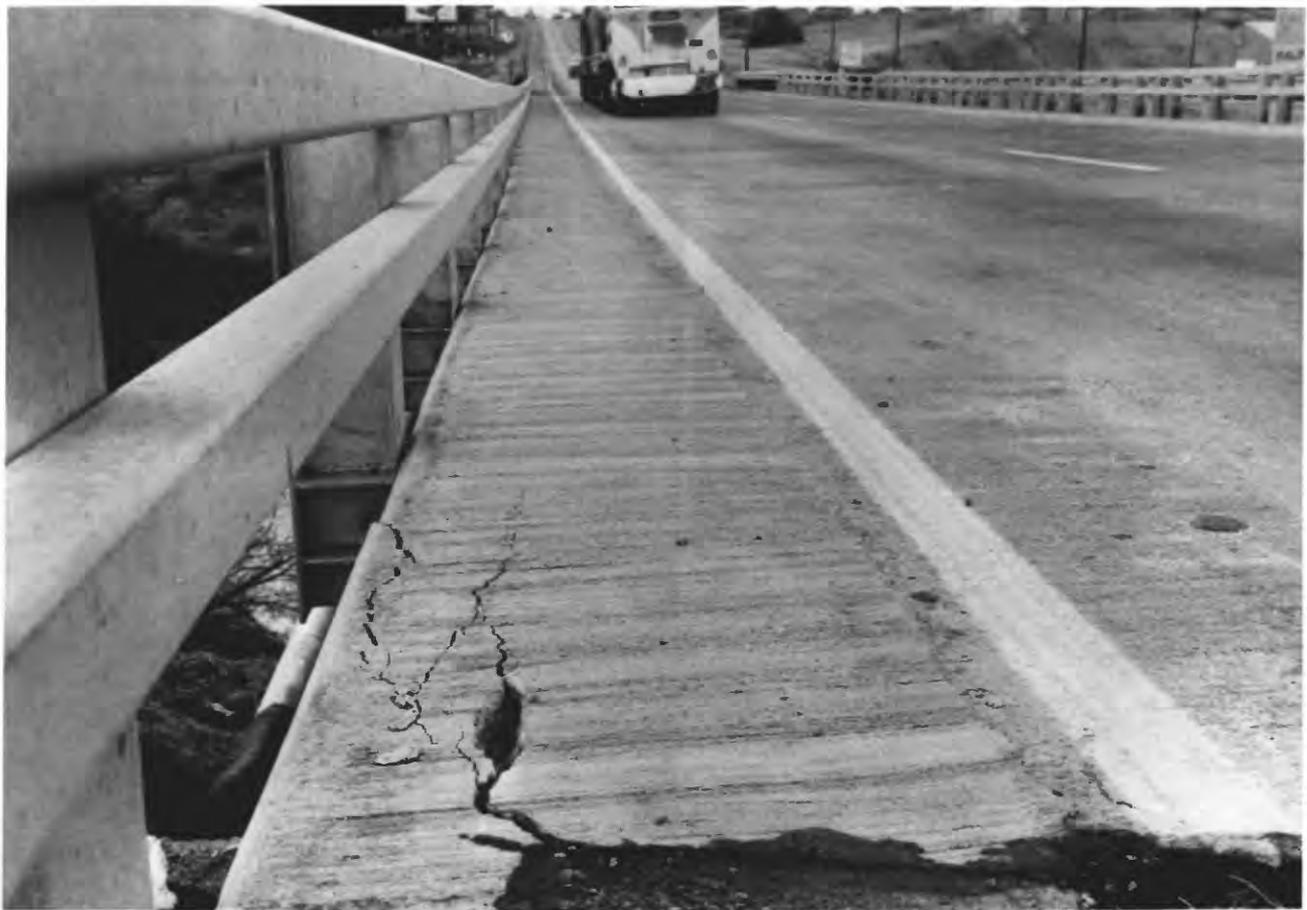
Several bridges in the epicentral area sustained cracking and chipping of concrete. This was most noticeable on a bridge just west of Brawley which crosses the New River. At this site, the bridge deck shifted noticeably at each end, causing the highway pavement to become cracked and uneven (fig. 14). This bridge experienced damage in the 1979 El Centro earthquake, principally to the abutments at each end of the bridge which were cracked and chipped to the extent that the reinforcement bars were exposed at bridge level. Also, many of the support pillars were cracked at the bridge deck connection, and the asphalt road had settled about 13 cm relative to the bridge (Reagor and others, 1980). A bridge on State Highway 111 over the Alamo River, closer to the epicenter, had hairline cracks around the supporting piers, about 20 cm below the road deck. In cases of minor damage such as this, in such a seismically active region, it is often difficult to determine unequivocally that the damage occurred during the latest episode of shaking. Lacking any prior record of damage to the structures, such judgements are made according to the fresh appearance of the damage. Small, loose flakes of concrete were apparent in an anastomosing network of fine hairline cracks on one of the piers. There was much slumping around the bridge abutments and sand boils were found in close proximity to the bridge.

Figure 14.--New River Bridge located on Highway 86 just outside the western city limits of Brawley. This bridge sustained major damage in the 1979 El Centro earthquake. (Photo courtesy of Paul Noden, Imperial Valley Press).

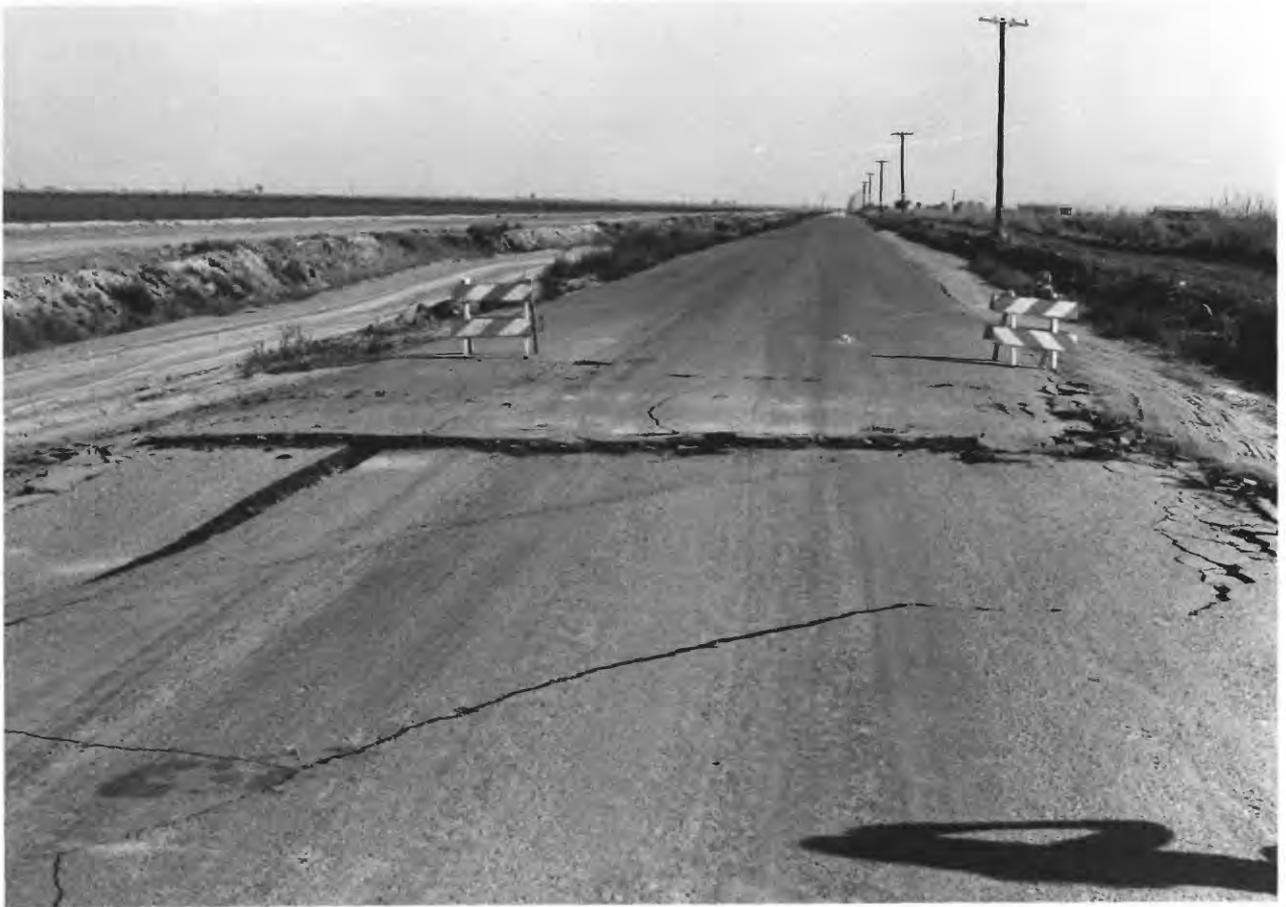
Ground and road pavement cracks were widespread in the epicentral region, especially near major canals and rivers where one would expect a somewhat higher water table. Figures 15a and 15b show pavement cracking on an area of Lack Road about 2 1/2 km northwest of Westmorland. No building damage resulting from liquefaction was observed.

Figure 15A.--Road pavement cracking occurred throughout the epicentral area. This photograph was taken on Lack Road, west of Westmorland. (Photo by S. T. Algermissen, U.S. Geological Survey).

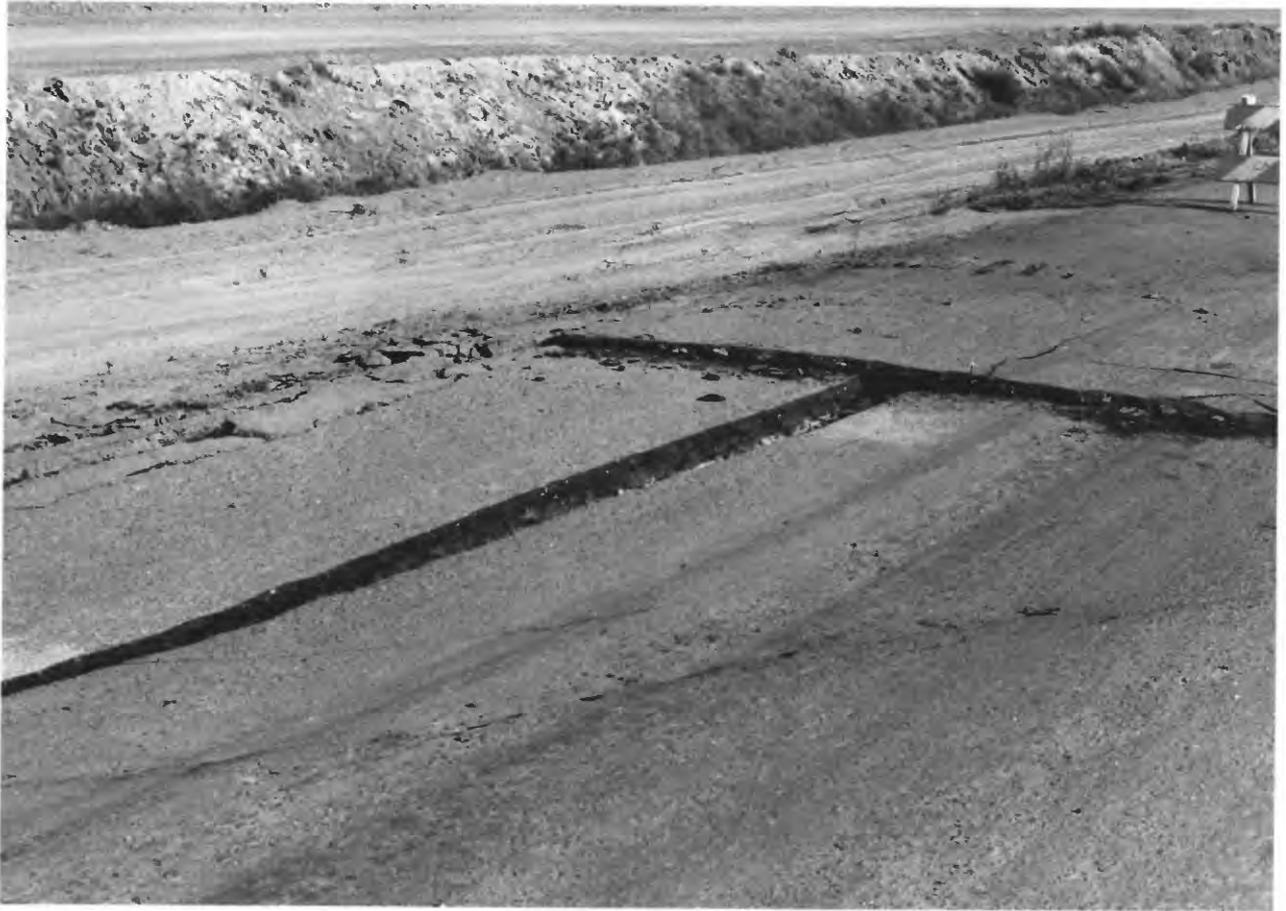
Figure 15B.--Closer view of road cracking. (Photo by S. T. Algermissen, U.S. Geological Survey).

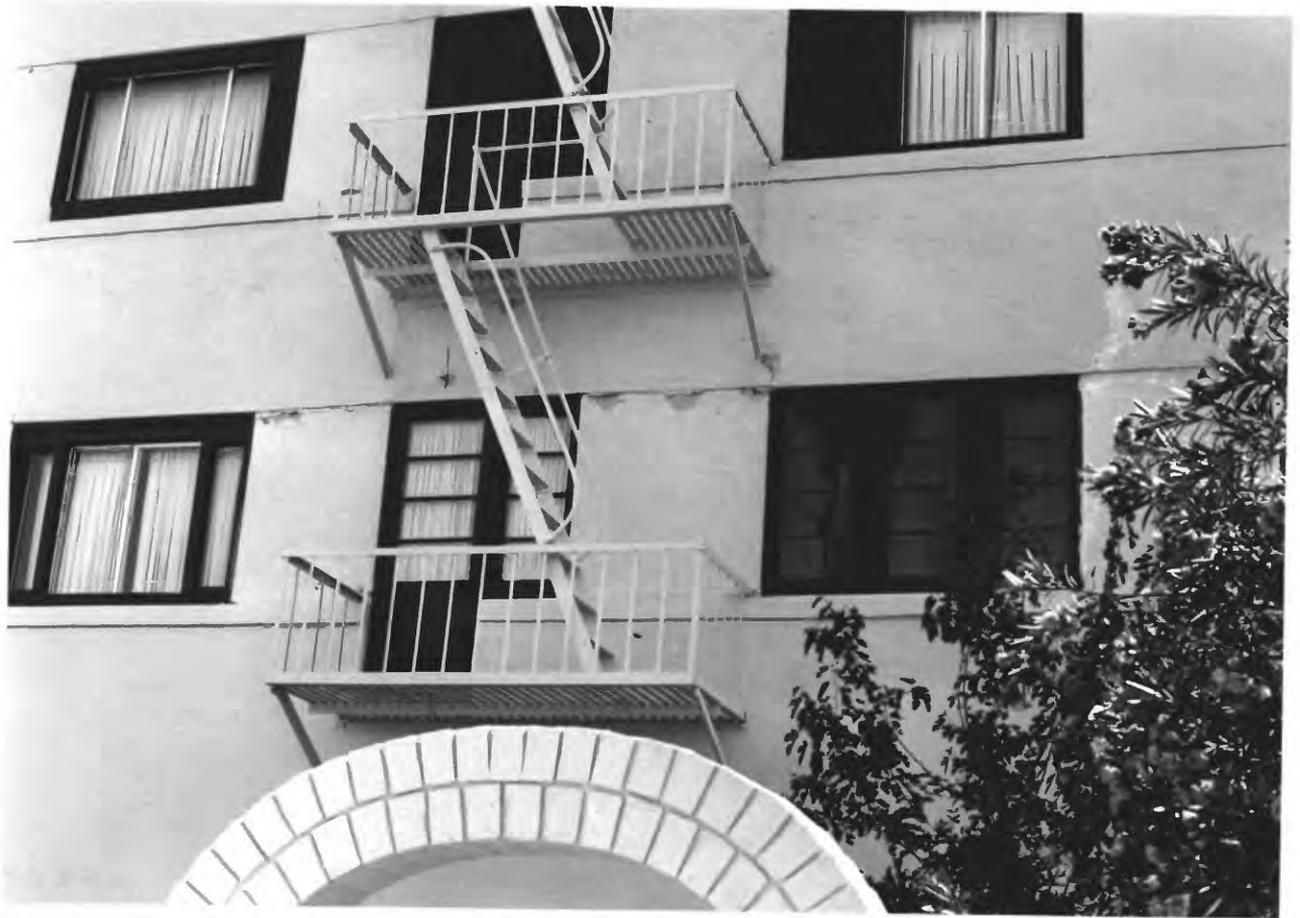
At Brawley, located 14 km southeast of the epicenter, the four-story Planter's Hotel sustained damage in the form of cracking and falling of exterior stucco. This damage occurred mainly around windows and at the junctions of the Hotel's story levels. Figures 16a and 16b show character-

Figure 16A.--West side of Planter's Hotel in Brawley. Cracking is noticeable in mid-area of picture. (Photo by S. T. Algermissen, U.S. Geological Survey).

istic cracking and fall of plaster at this site. The Planter's Hotel has experienced exterior cracking in prior earthquakes and shows evidence of much patching and repair. As indicated in figure 1, Brawley was assigned Intensity VI.

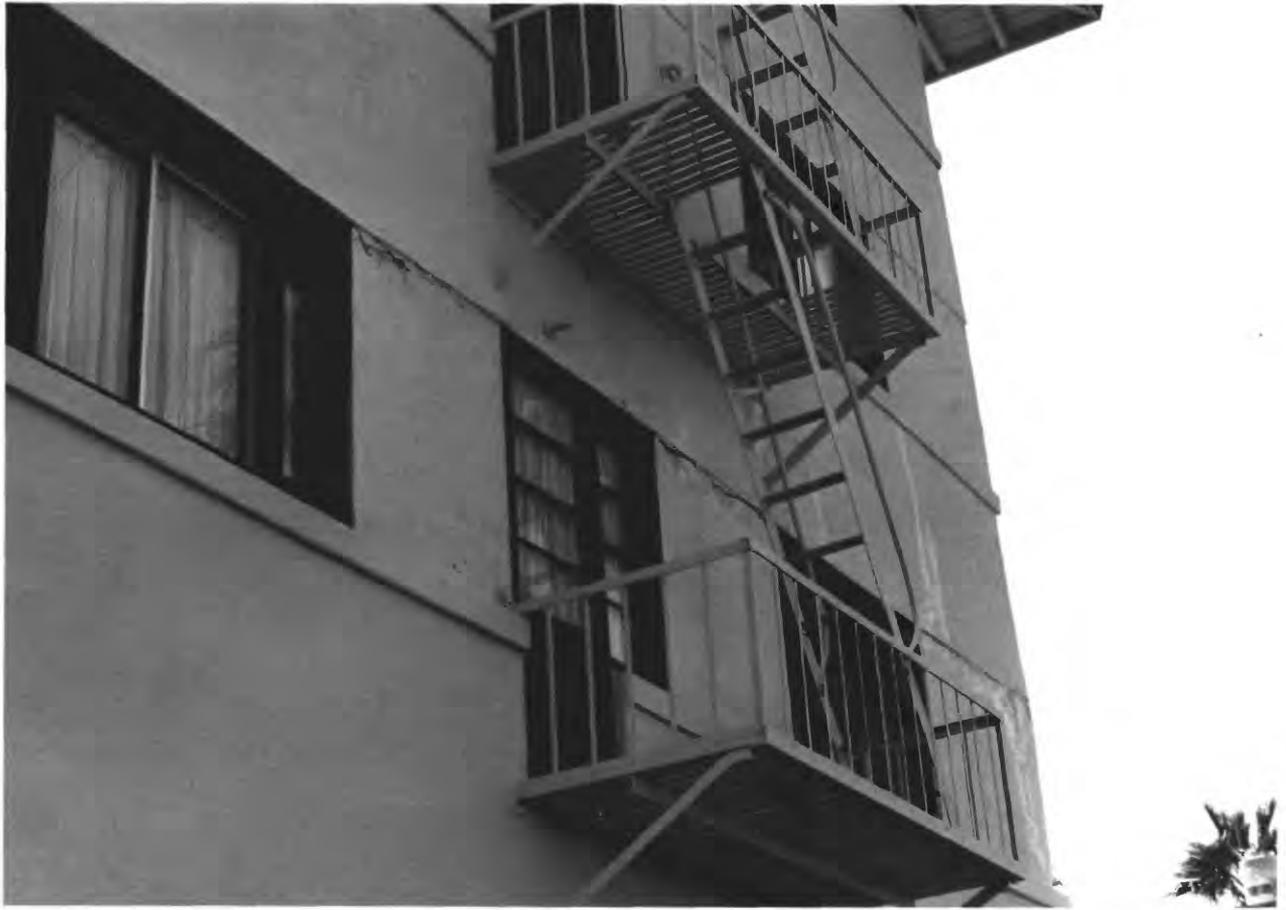
Figure 16B.--Angular view of west side of Planter's Hotel showing extent of cracking. (Photo by S. T. Algermissen, U.S. Geological Survey).
