# **LANDSAT 3 RETURN BEAM VIDICON RESPONSE ARTIFACTS:**

**A Report on RBV Photographic Product Characteristics and  
Quality Coding System**

EROS Data Center  
U.S. Geological Survey  
Sioux Falls, South Dakota 57198

August 1981

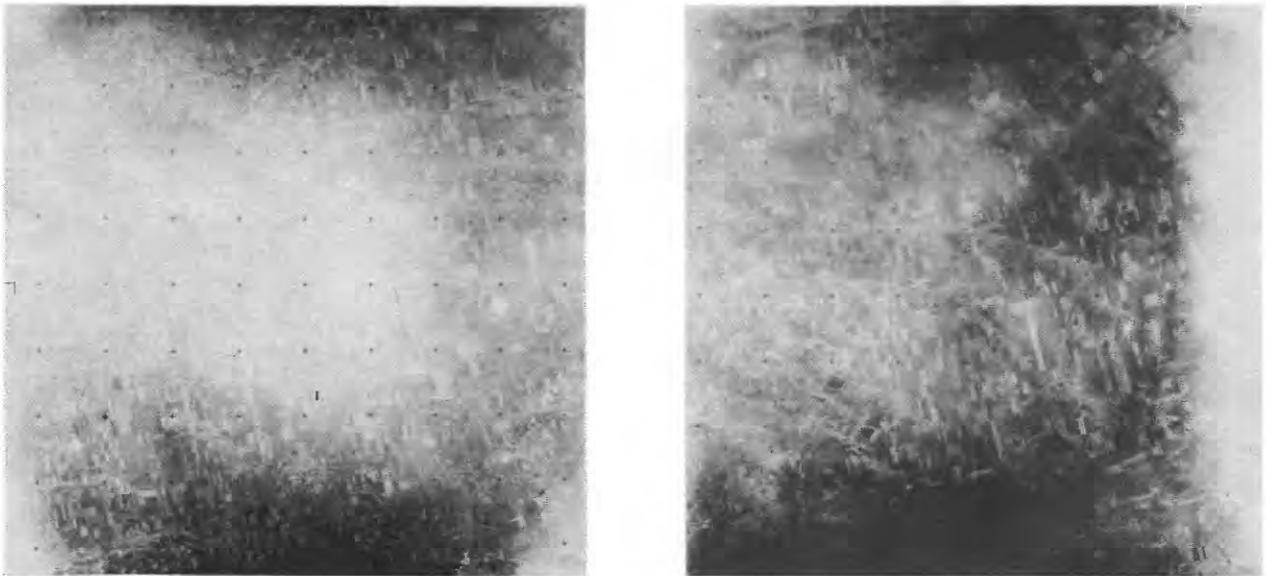
Figure 3. Examples of Shading in Two Adjacent Subscenes

Shading is most obvious when the data acquired lie within a relatively narrow range of gray levels. Differences from camera to camera can be seen in Figure 3 where overall scene density varies considerably between two adjacent subscenes. The left-hand image in Figure 3 also shows how variations in camera response from point to point across the camera faceplate can produce camera-unique shading patterns. Some shading is evident in the right-hand image, as well.

The prelaunch tests were performed in order to collect enough information to minimize these differences during ground processing after launch. Although minimization has been accomplished, it has been impossible to remove these effects totally. The result is a residual, spatially-varying, gray-level-dependent shading in most RBV images. Shading is unique to each subscene, and it affects some images more than others.

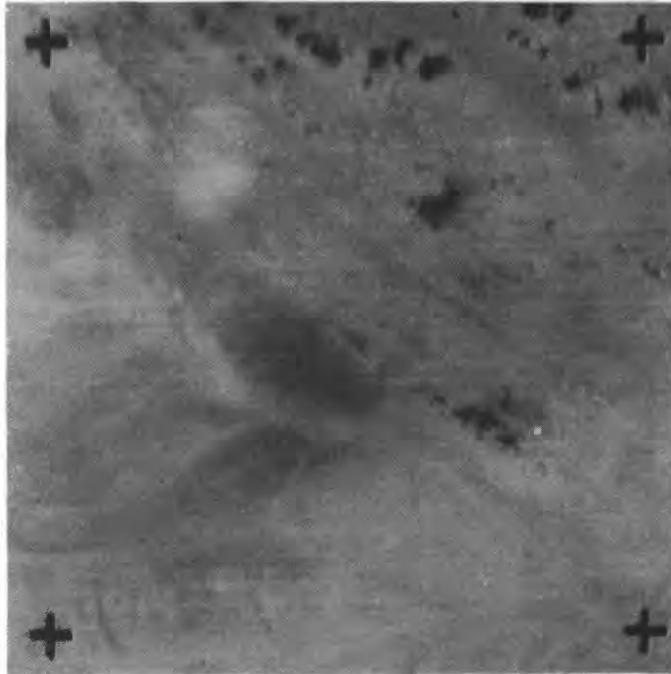
Figure 5. Enlarged Corner Area Illustrating Poor Focus

For some RBV data, it is obvious that the corners of the image are out of focus when compared to the more central parts of the image. This is a vidicon tube characteristic and can be seen in the raw data. While the optics system could be at fault, the cause is much more likely to be thermal perturbations or a phenomenon known as "beam-landing" error. The effect is aggravated by imperfect deshading and the presence of high-frequency noise (causing spatial distortions) when either of these occur. Figure 5 is a good example of a poorly focused corner. Note the blurred reseau mark.

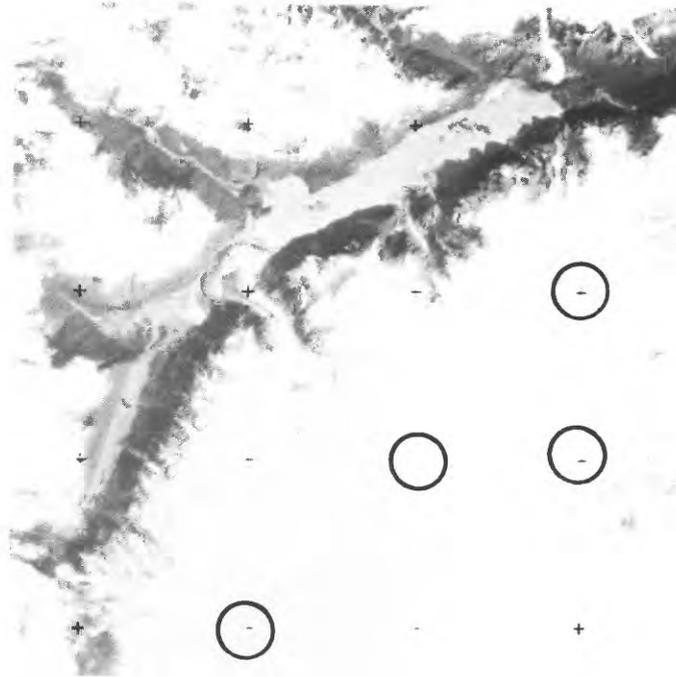
Figure 6. Examples of Incomplete or Missing Reseau Marks

The reseau marks that have been inscribed on the faceplate of each camera can appear to be lost in an image when they occur among data that lie at either radiance extreme. For low-radiance data, the reseaus merge into the background and are obscured. For high-radiance data, the reseaus can be washed out or lost due to a vidicon characteristic called "blooming." The latter effect is probably a result of the gain setting on the RBV sensor and cannot be corrected by ground processing. Figure 6 is an enlargement of an image where high-radiance image data have caused reseau marks to be missing.

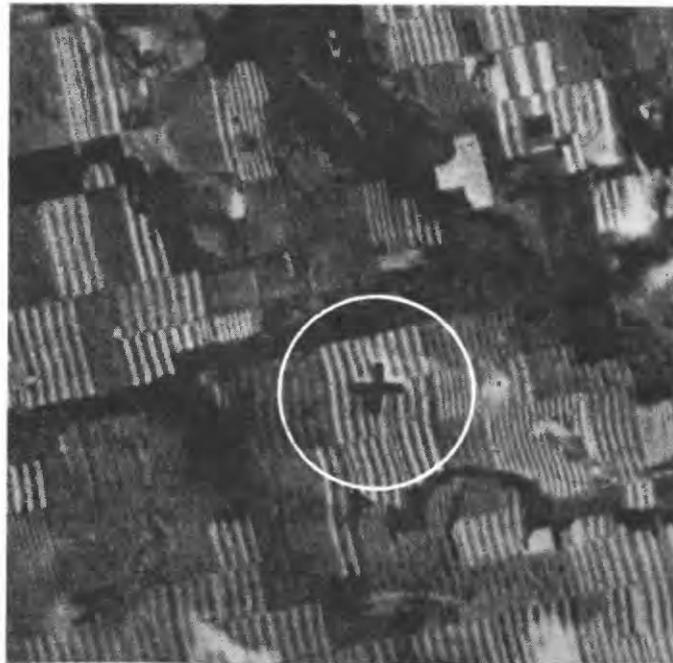
Figure 7. Examples of Data Distortion

Distortion in reseau marks and image data can occur when the raw data contain time-code-induced anomalies. The enlargement in Figure 7 contains some reseau marks that are badly curved, and the image data near them, as well as elsewhere, are similarly distorted. Minor data losses in the time-code signal are thought to cause this horizontal shifting of data. Although this effect is not restricted to any area in an image, it is usually most pronounced in the corners of the image.

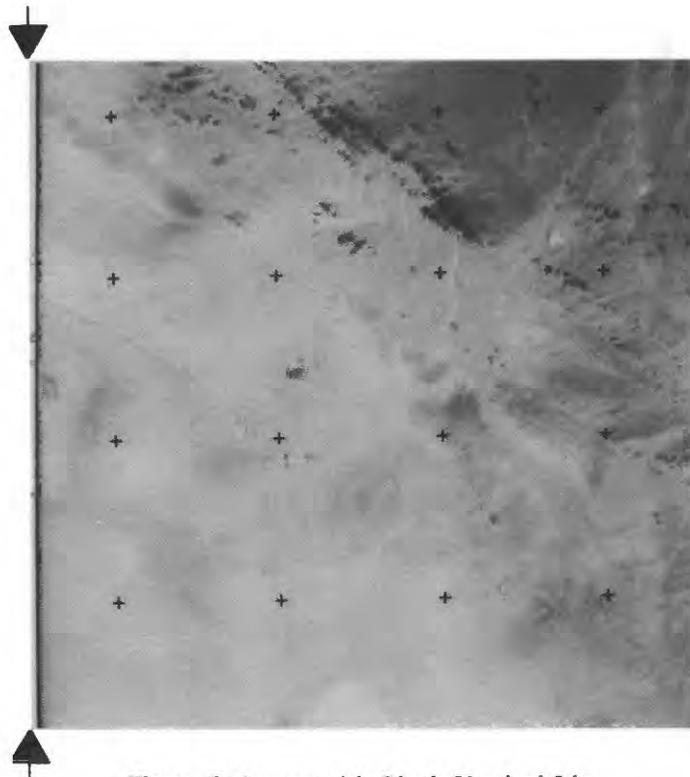
Figure 8. Image with Black Vertical Line

Image data acquired by camera no. 2 (which acquires subscenes B and D) contain a thin black line along the left vertical edge of the image. This is evident when the left edge of the image contains high-radiance data. Figure 8 is one example. This artifact occurs as a result of both hardware and software problems in the ground processing system. Its impact on image quality is strictly cosmetic, and it is shown here more for completeness than for any other reason.

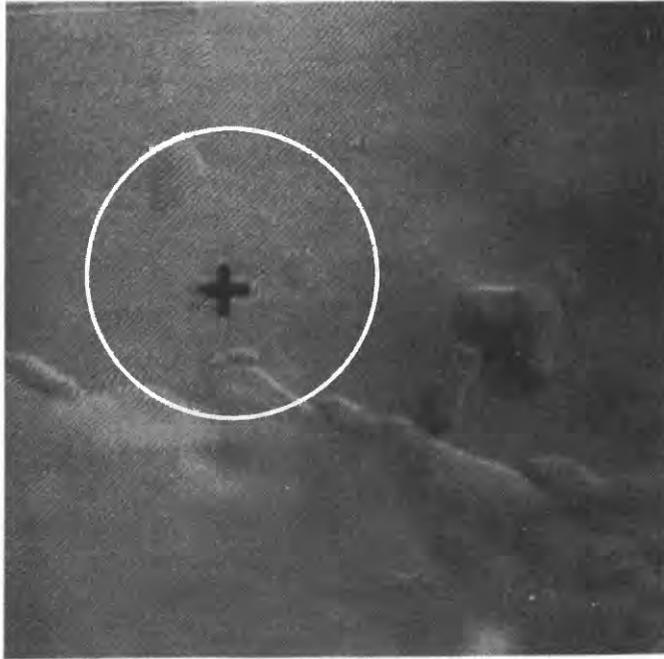
Figure 9. Example of Graining

Production of a large volume of RBV data has resulted in the identification of specific images that contain a "graining" or a fabric-type appearance. The enlargement in Figure 9 shows an example of bad graining in the upper left corner. The grain effect has been found to exist in almost all of the data processed to date. Probably attributable to some form of noise, the grain effect is currently under analysis at GSFC where attempts are being made to properly characterize it.

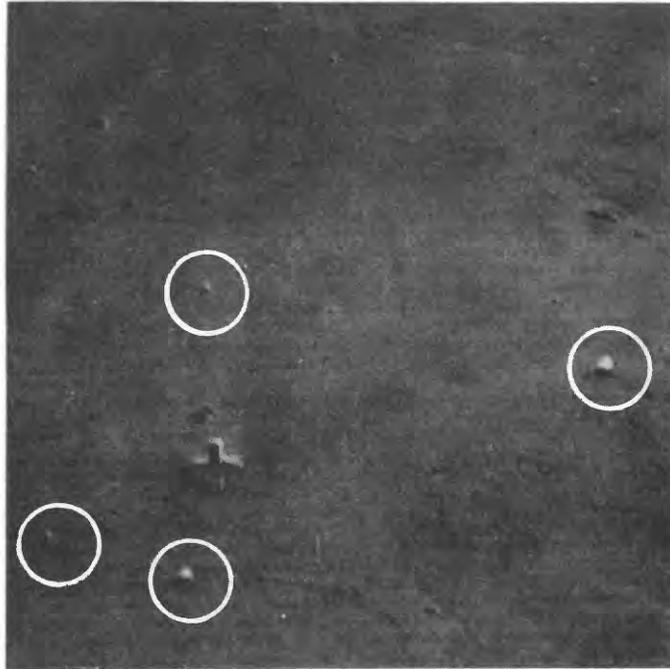
Figure 11. Examples of Tears

The second type of faceplate contamination cannot be seen clearly unless the proper combination of sun angle and scene radiance exists. When these conditions exist, one can detect bright white pinhole-size spots that are each accompanied by a black "shadow" of unknown origin. These are termed tears. The enlargement in Figure 11 has examples of tears; at this scale the tear shadows actually seem to be the dominant feature. Tears can be attributed to two causes. In some cases, they are a manifestation of minor flaws in the photoconductive layer of the vidicon. In other cases they represent localized areas of condensate on the camera faceplate. They always occur in the same place, and their detection is dependent upon the gray level of the image data written over them. They appear to be permanent.

Both types of faceplate contamination, hot spots and tears, are uncorrectable by ground processing.

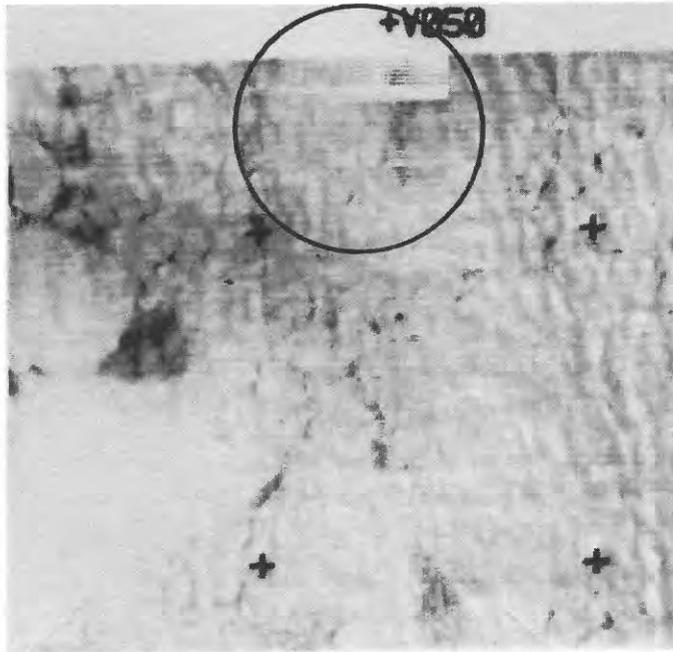
Figure 12. Example of RBV Geometric Anomaly

A small fraction of RBV data has been found to contain a local geometric distortion. Image data in this category can be recognized by the presence of parallel lines restricted to the left one-third of the image. Such an area is highlighted in Figure 12. These lines always occur near the top and on the left-hand side of the subscene. They do not extend into any other one-third segment of the image data, and they are abruptly terminated at the boundary between the left one-third of the data and the center one-third.

This artifact is introduced by ground processing and should be capable of being removed by the same means. A study is under way at GSFC to determine how this might best be done.
