GEOLOGICAL SURVEY

Intensity survey of the Borah Peak,  
Idaho, earthquake of October 28, 1983

Open-File Report 84-166

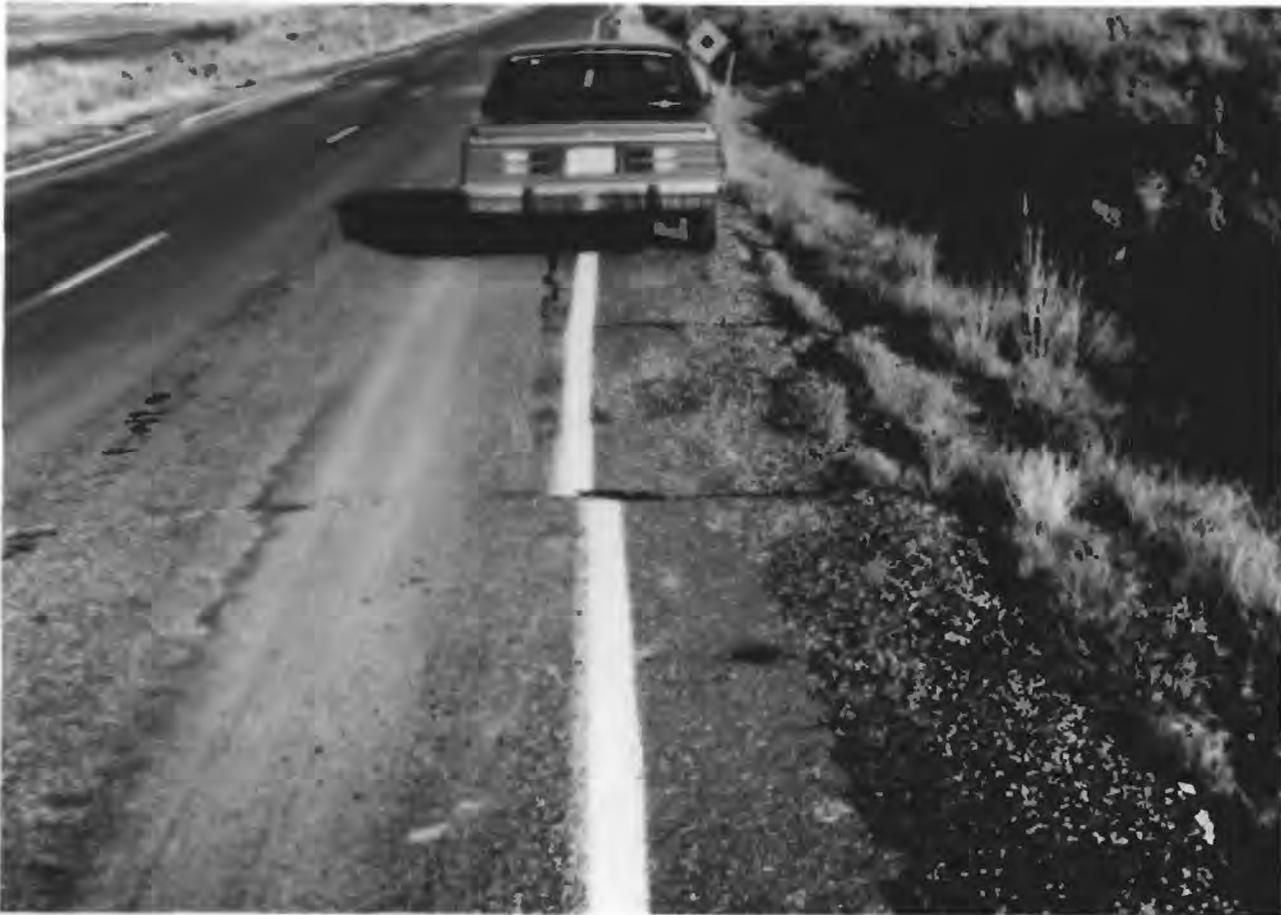
Moderate cracking, coupled with slumping, was observed on U.S. Alt. 93 a mile north and a mile southeast of the Trail Creek Road intersection. The asphalt road surface was cracked longitudinally with transverse cracks and patched areas cutting across the road (fig. 6). As we continued to cross these areas for several days, we noted that the roadway was becoming very wavy.

Figure 6.--Asphalt road cracks on U.S. Alt. 93 which is the main north-south highway through the valley. The white line at the edge of the roadway was offset 4 1/2 inches to the left. The location is a mile north of the Trail Creek Road intersection. Asphalt road cracks at other locations were similar in appearance.

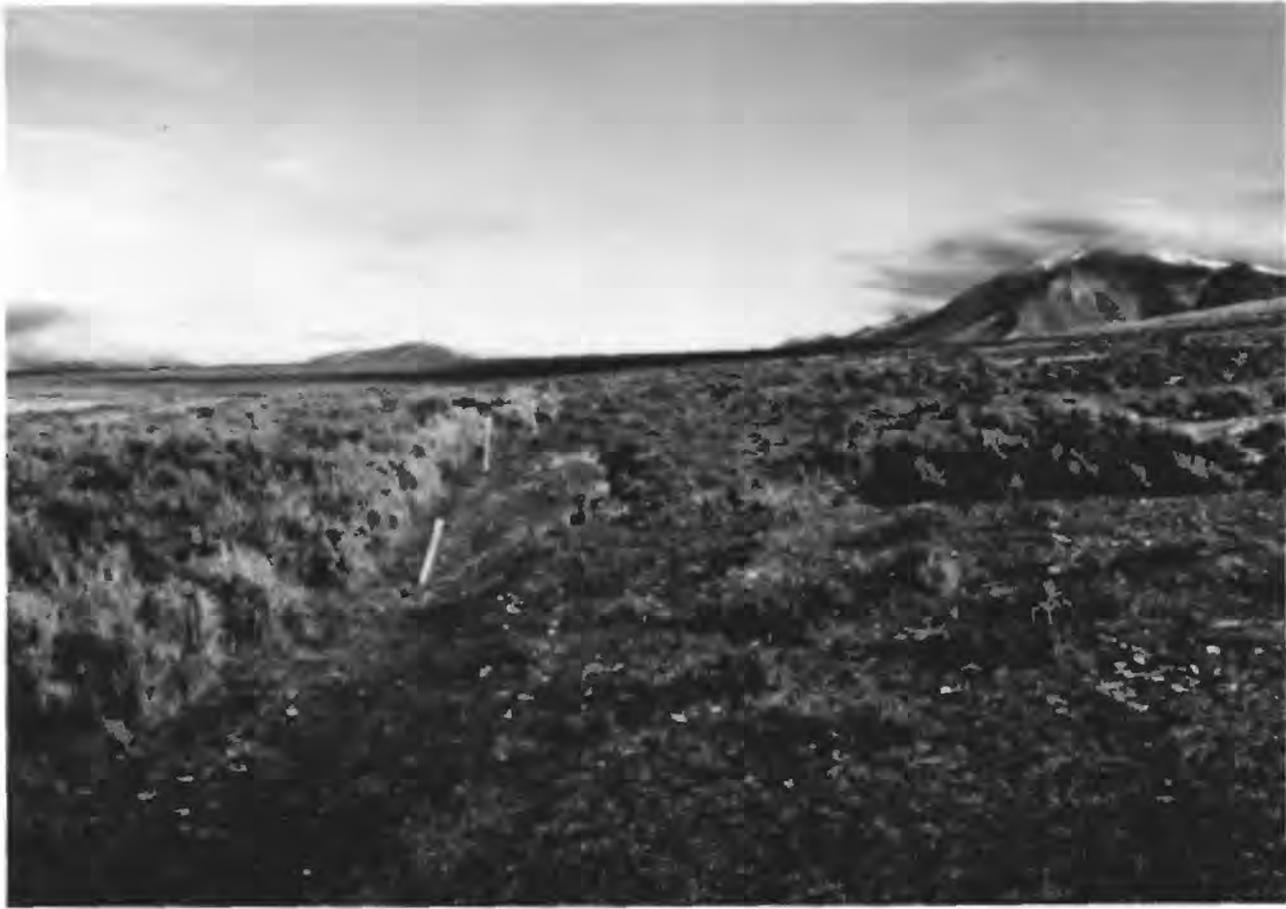
Large ground cracks occurred in an open field at a mile north of the Trail Creek Road intersection on U.S. Alt. 93 (fig. 7 and fig. 8). The ground cracks, which varied in length, width, and depth, trended northeast toward the Lost River Mountain Range. The dry cracks were located 20 yards east of the highway. The Thousand Springs Valley marsh area was adjacent to the west side of the highway (fig. 9).

Figure 7.--Open ground cracks on the east side of U.S. Alt. 93. The location is a mile north of the Trail Creek Road intersection. Lost River Mountain Range appears in the background.

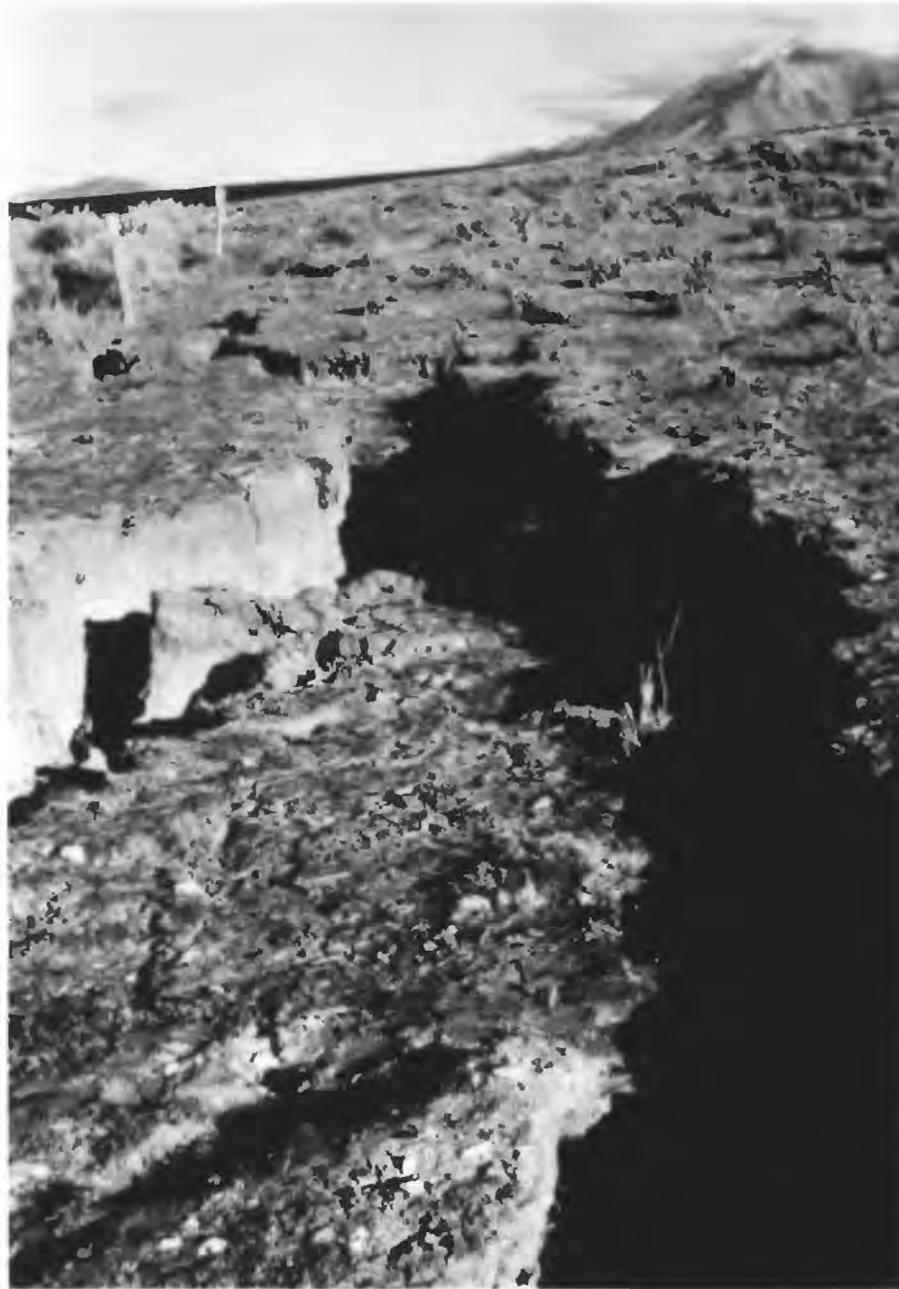
Figure 8.--A close-up view of one of the larger ground cracks shown in Figure 7. The crack was estimated to have a depth of 15-18 feet and 6-8 feet in width.

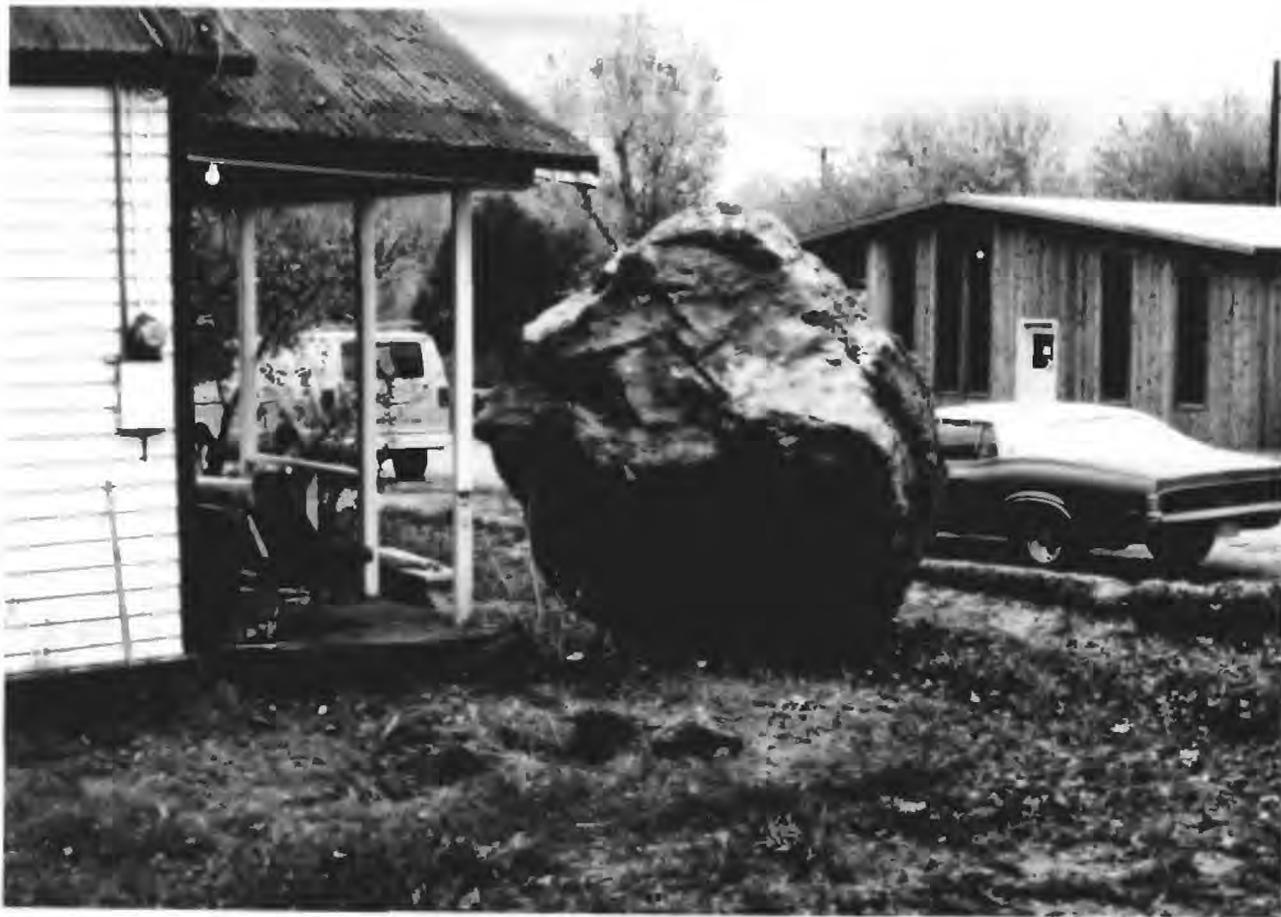
Huge boulders, which rolled down the slopes of the mountains in the northwest section of Challis, were spectacular (fig. 16 and fig. 17). Some of the homes adjacent to the slopes were damaged by the fallen boulders. A huge boulder narrowly missed the residence of Georgia Smith. The house was located one block away from the mountain slope. The boulder rolled between two houses at the base of the slope, down the road, across a wooden bridge, and came to rest in the Smith's front yard. The side of the front porch was slightly damaged on their wood-frame house (fig. 18).

Figure 18.--The large boulder, which fell down the slope shown in Figure 17, came to rest in the front yard of Georgia Smith's residence. Challis, Idaho.

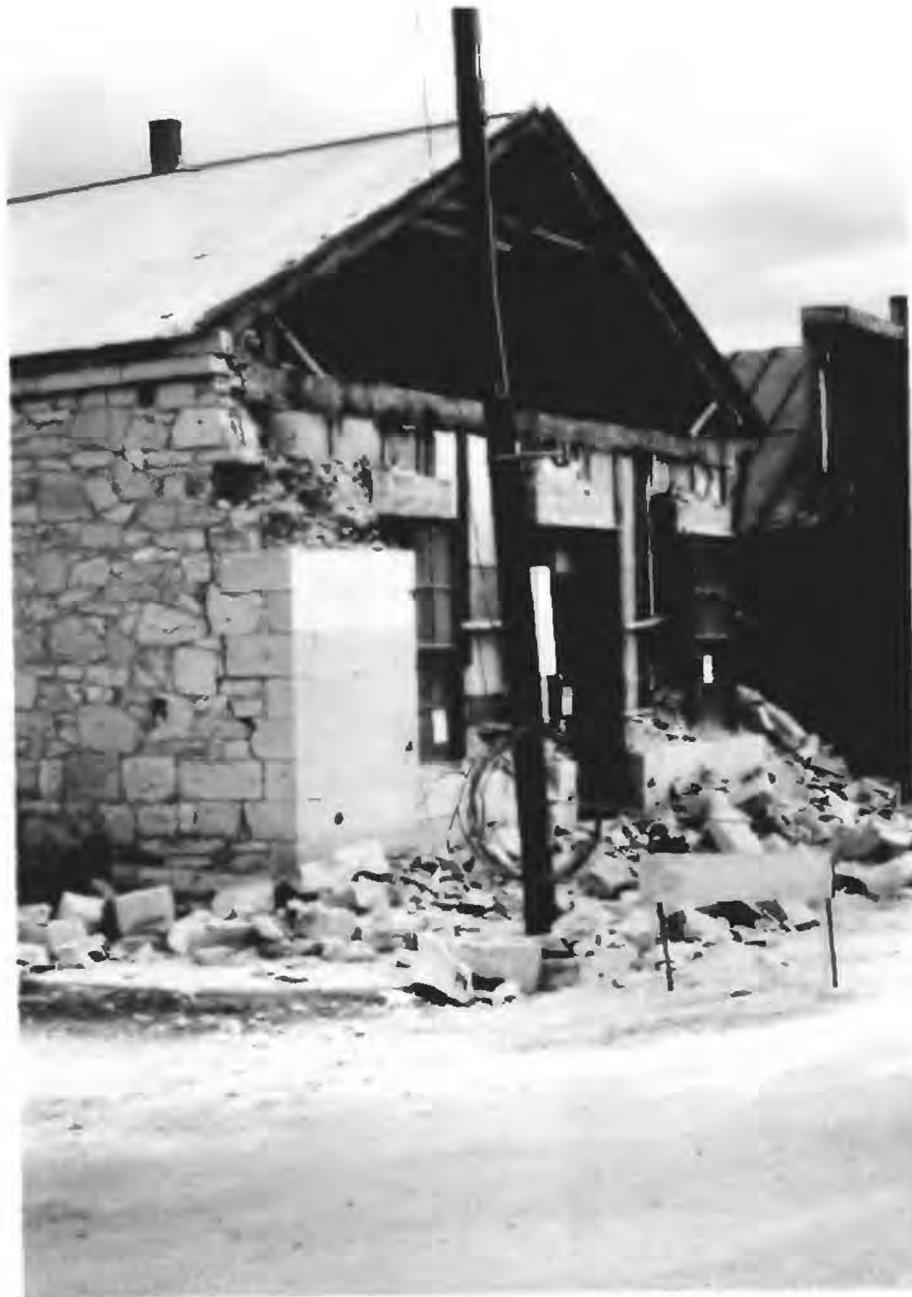
Second-hand Store on Main Street: The building was constructed of concrete block in the early 1900s. At the time we were there, workers had pulled down much of the rubble from the building's concrete block store front. The original damage, as it could be determined from newspaper photographs, was the partial collapse of the concrete block store front about midway from the top (fig. 19). This vacant building was one of the older buildings in Challis.

Figure 19.--The partial collapse of the concrete block store front. The vacant second-hand store, which was one of the older buildings in Challis, was located at the western edge of the business district on Main Street. The original earthquake damage was masked by the removal of additional portions of the front wall before this photograph was taken.

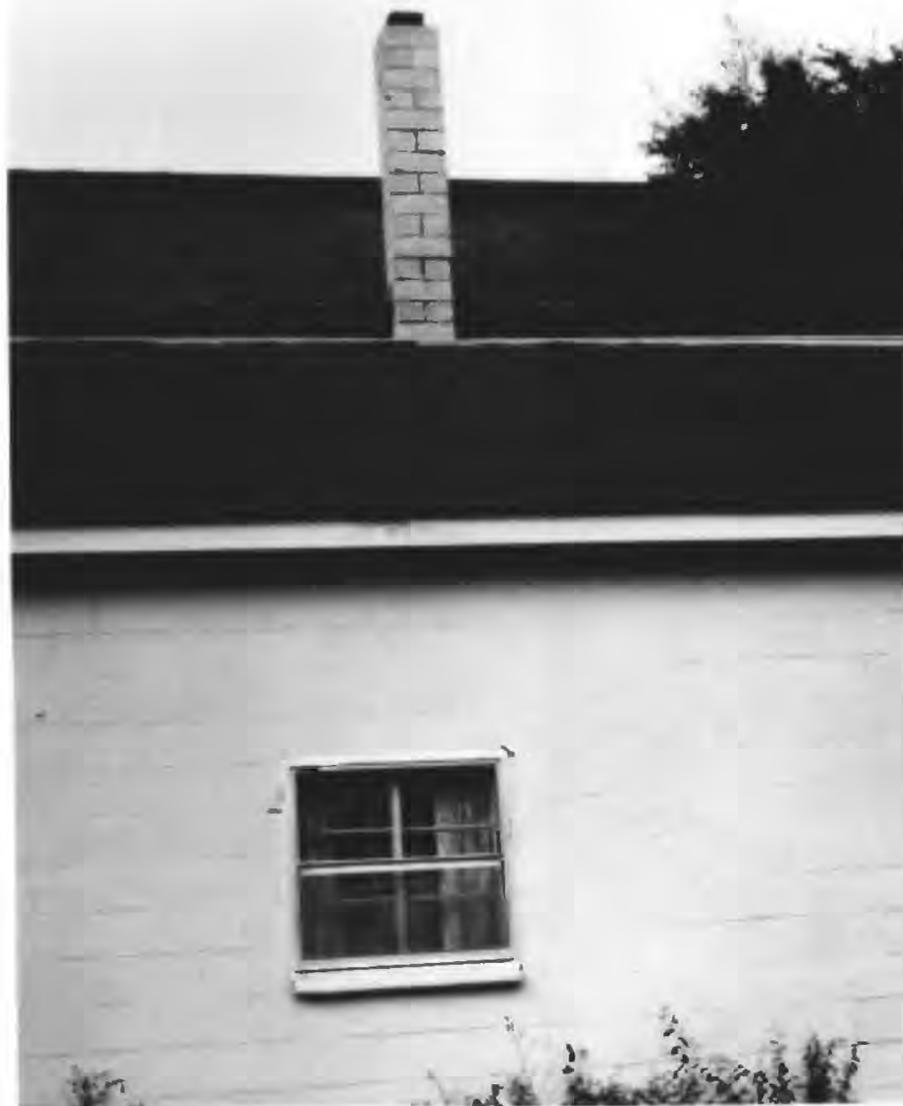
Sew and Save Thrift Shop on Main Street: The structure was a one-story, cinder block building. The cinder block chimney, on top of the building, was cracked along the mortar seams. No other damage to the building was observed (fig. 20).

Figure 20.--The Sew and Save Thrift Shop on Main Street in Challis, Idaho. The exterior walls of the building were not damaged. Enlarged mortar-seam cracks in the cinder block chimney.

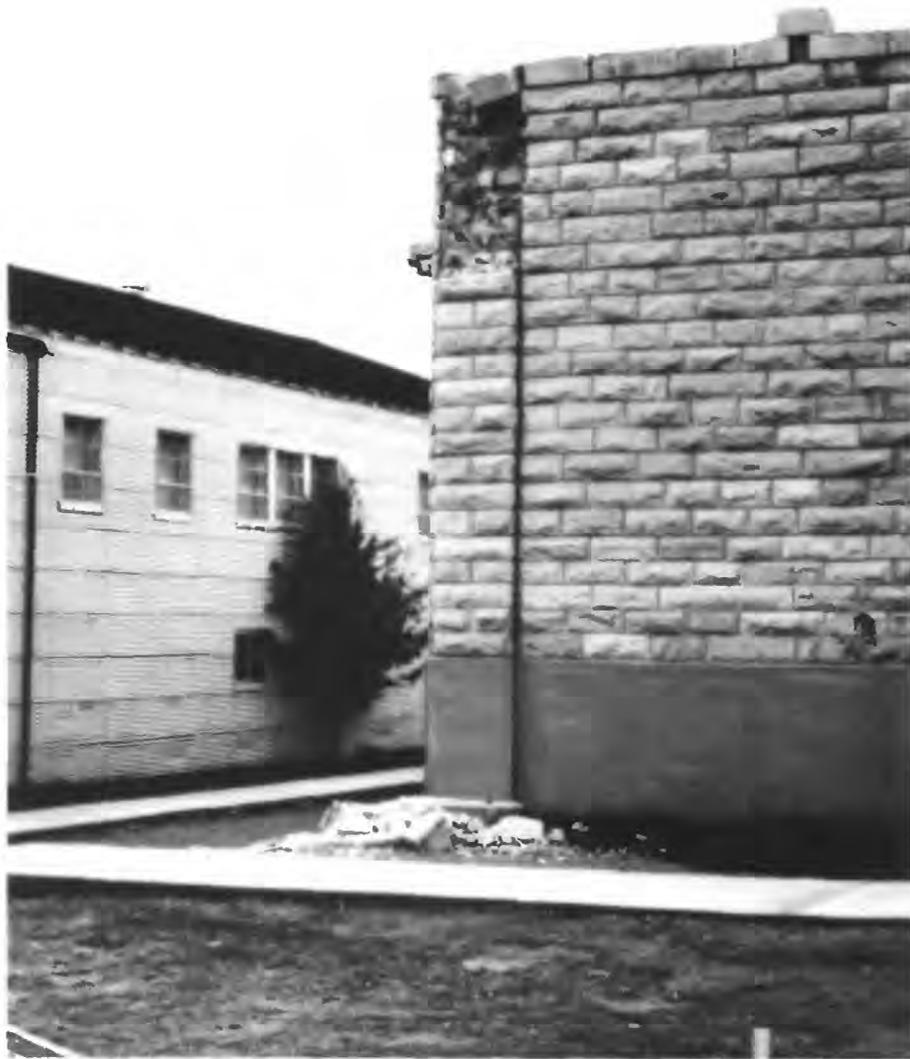
The stone front entrance, which was pulled away from the building, was the significant structural damage to the High School. Some of the stone facing at the northeast corner of the front entrance fell (fig. 21). At the rear of the building, numerous cracks were observed along the mortar seams in the 10-foot tall chimney. Similar cracks occurred in the exterior walls (fig. 22). This building was another one of the older structures in Challis which was built in 1922. The building was closed. The new High School was reported to be undamaged.

Figure 21.--The northeast corner of the stone front entrance of the old Challis High School which is located on Main Street. Some fall of the stone facing was evident. The major structural damage to the school was that the stone front entrance was pulled away from the building.

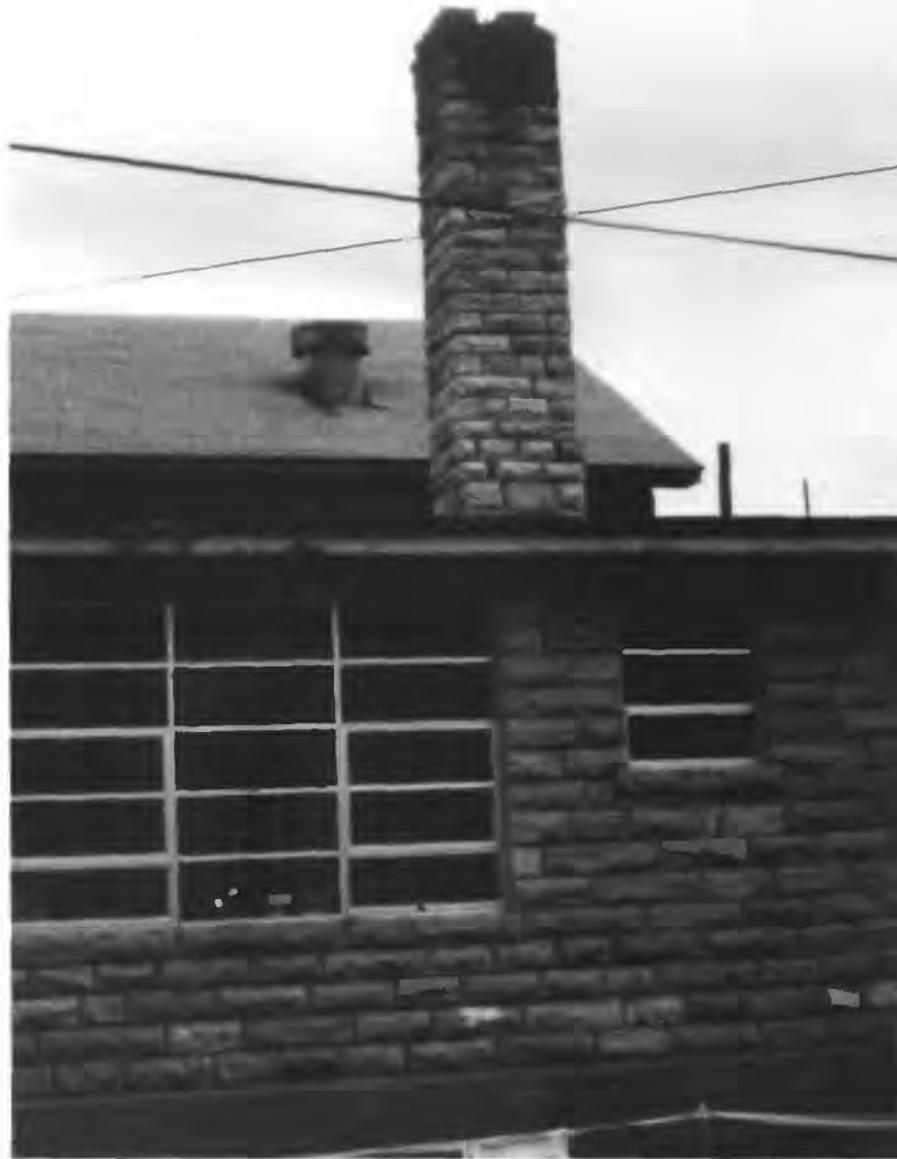
Figure 22.--Enlarged mortar-seam cracks in the chimney at the rear of the old Challis High School. Similar mortar-seam cracks occurred in the west exterior wall.

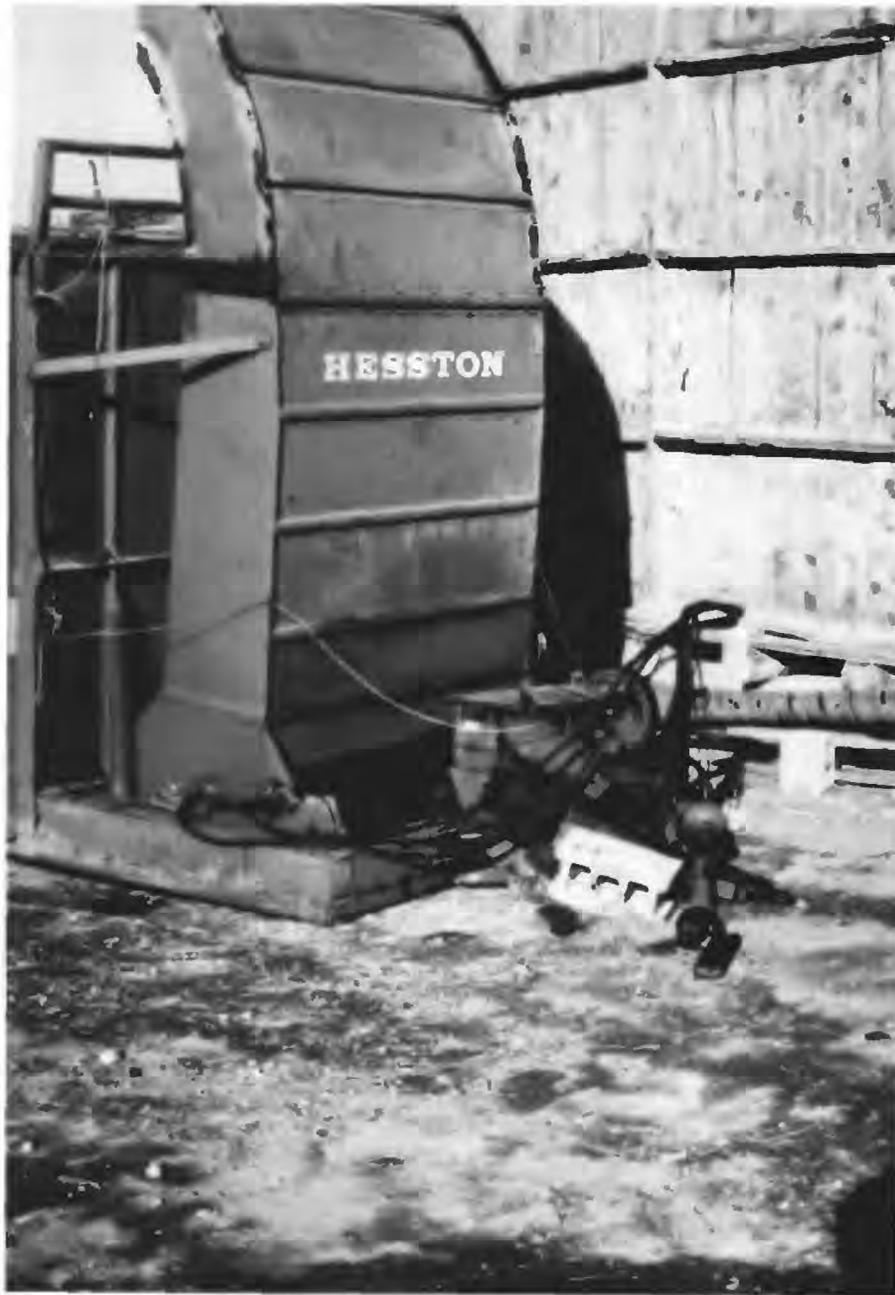
Behind the Fulton residence, the trailer hitch of a piece of heavy farm equipment was shaken off the cinder block support (fig. 25). A tractor's transmission, which was suspended from a chain hoist, was flung westward over the tractor's fender. A portion of the chain was broken (fig. 26). Gordon Fulton reported that the fender was not touched by the transmission.

Figure 25.--The trailer hitch of the farm equipment was shaken off the cinder block support. Fulton residence.

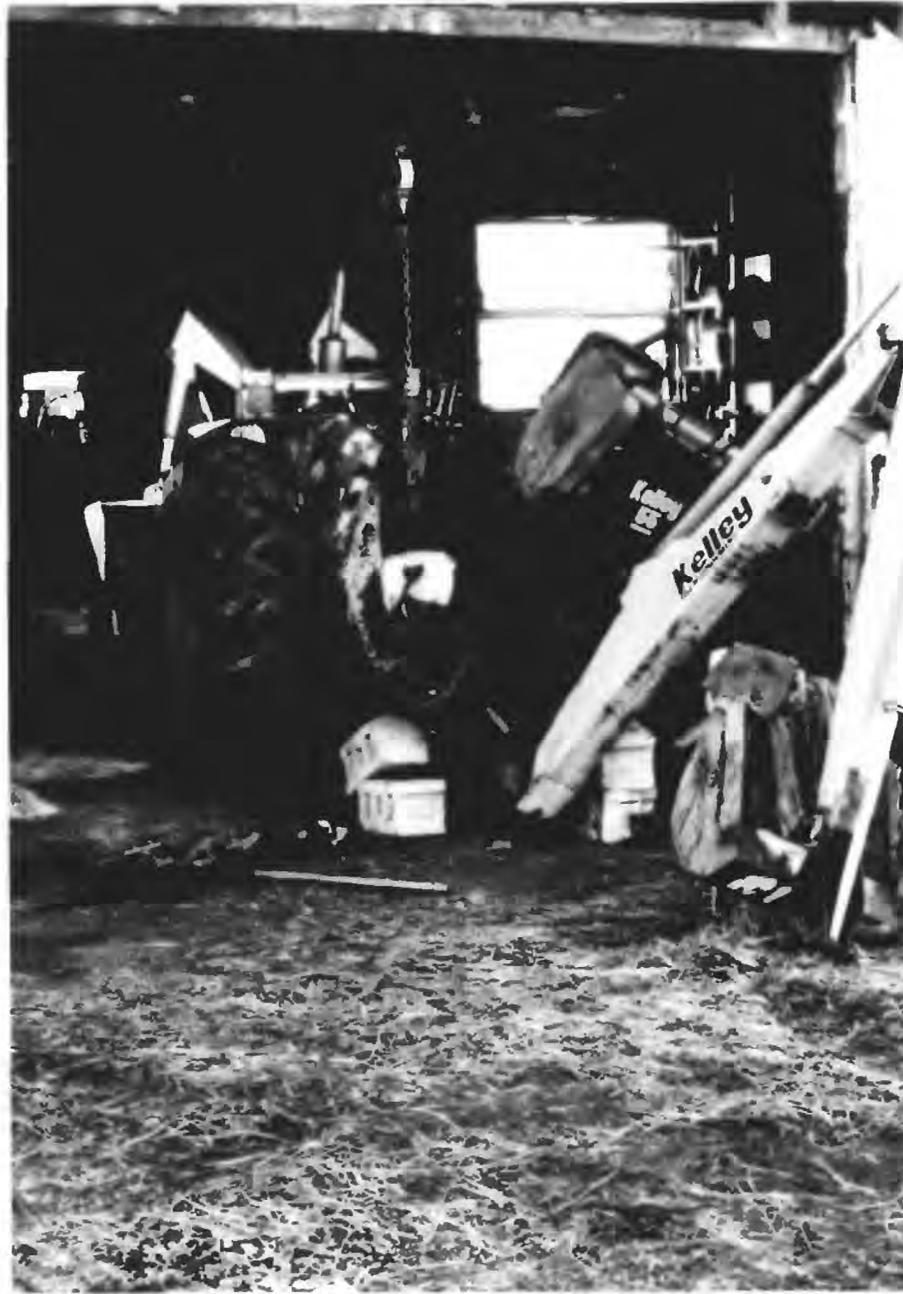
Figure 26.--The transmission of this tractor was suspended by the chain hoist. The transmission was flung westward (to the right) over the tractor's fender. The chain snapped and deposited the transmission on the floor of the building. The back hoe portion of the tractor was shaken off the cinder block support. Tools and cans of oil were shaken from the shelves and work tables in this building. Fulton residence.

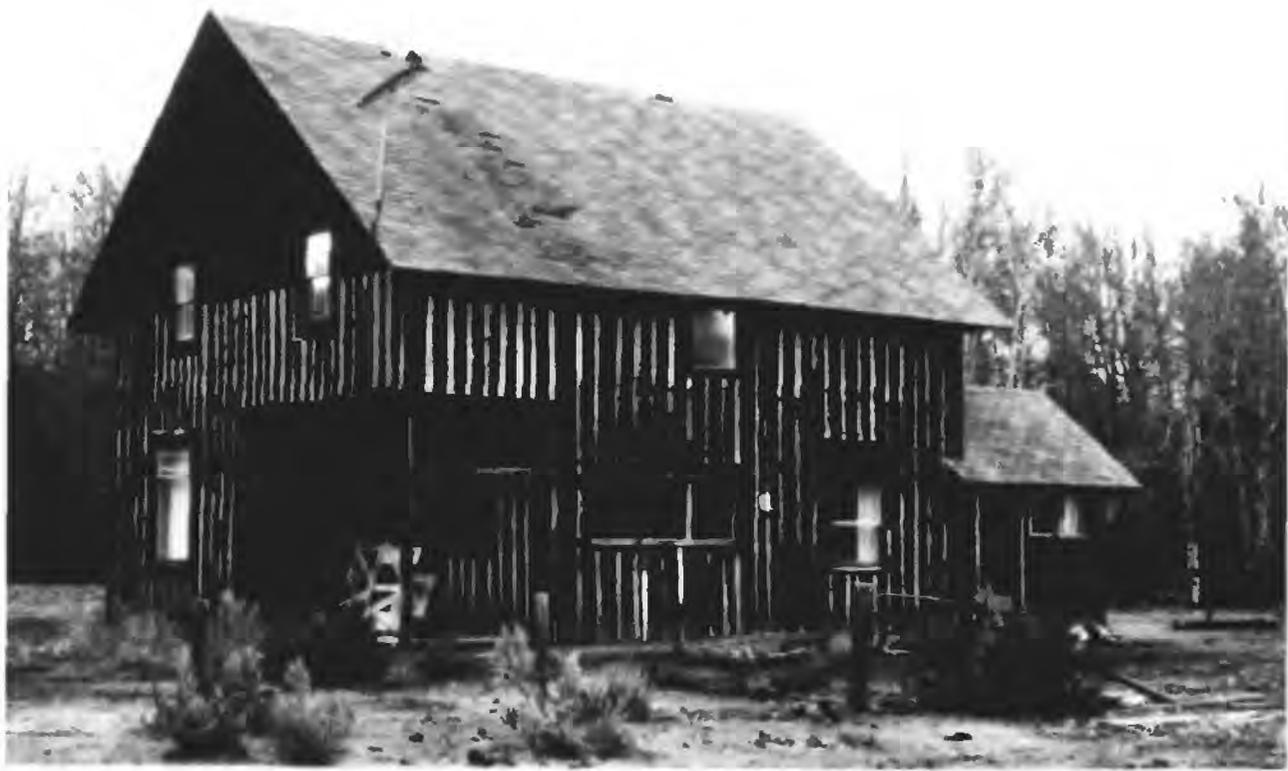
Johnson Stockade House: The two-story, log-stockade, A-frame house was located about 100 yards away from the main house (fig. 27). The house was set on a concrete foundation. A stockade house differs from a log cabin in that the logs are vertical rather than horizontal. Mr. Johnson reported it was "damn well constructed". The two well-mortared brick chimneys, without flue-liners, fell from the roof, through the attic, and into the second-story rooms. The rooms were cluttered with bricks. It was difficult to tell if furniture damage in these rooms was a result of the earthquake or due to the fallen bricks. Downstairs, there were a few cracks in the plaster ceiling and walls. In the kitchen, a few glasses and dishes were shaken to the floor from the cabinet top by the sink. In the utility room, which joined the kitchen and served as the rear entrance to the house, many of the items on the walls

Figure 27.--The log stockade house at the Johnson residence. The two brick chimneys fell from the roof, through the attic, and into the second-story rooms.

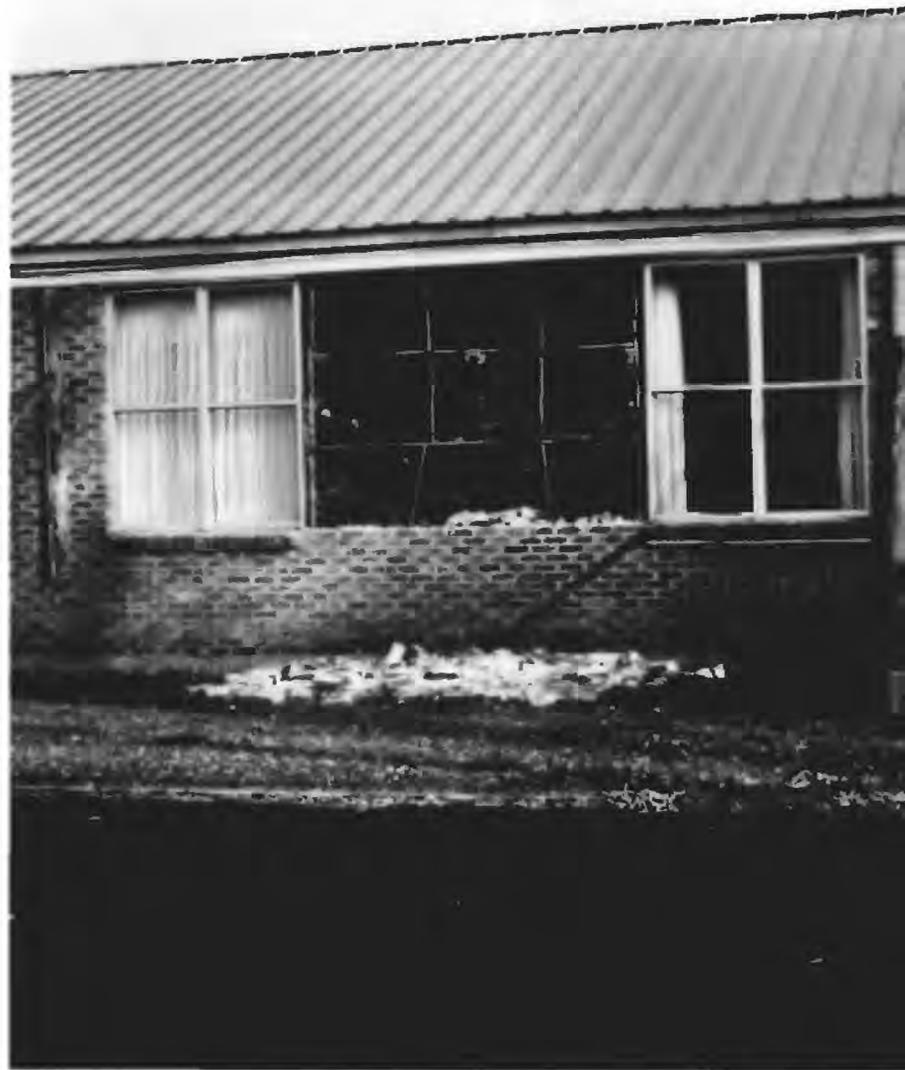
Figure 28.--The north wall of the Church of Jesus Christ of Latter Day Saints, Leslie Ward at Leslie, Idaho. One section of the brick-veneer facing fell to the ground. Note the log poles which were placed against the exterior north wall to prevent further damage.

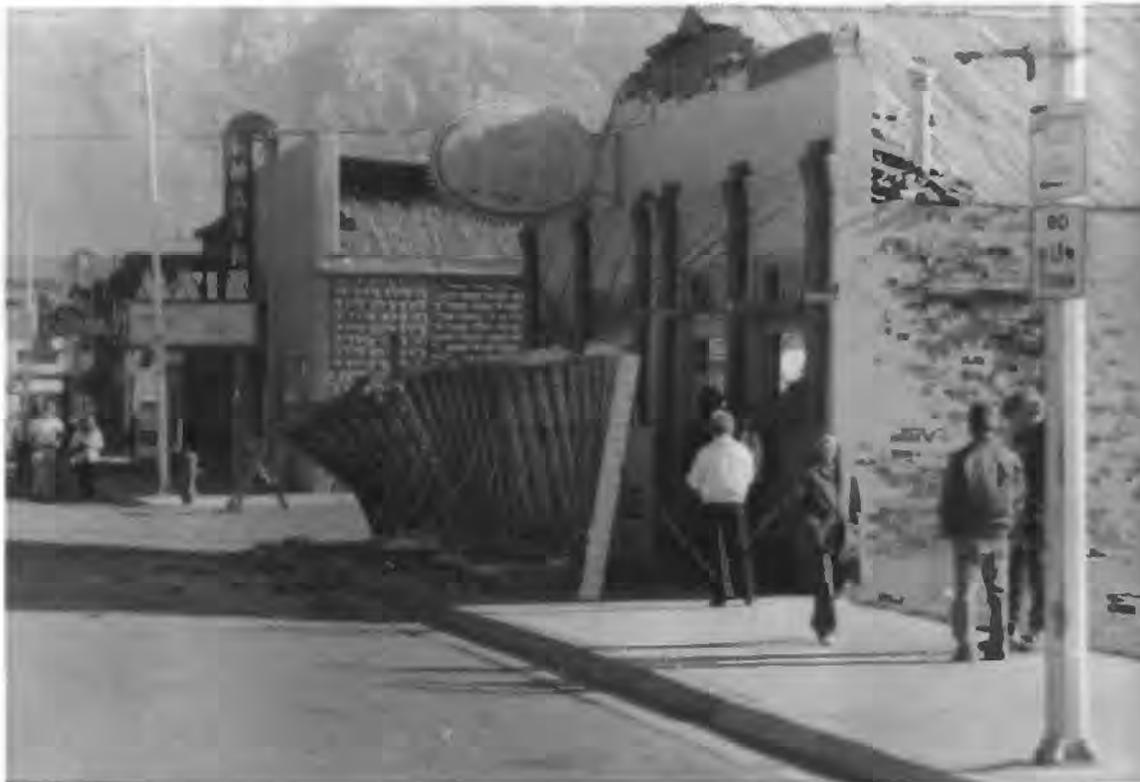
Figure 30.--Ivie's IGA Grocery in Mackay, Idaho. The bricks and the awning were shaken down from the store front. The theater marquee was apparently not damaged. Looking east along the south side of Main Street. Photograph by Robert Bower of the Post-Register Newspaper, Idaho Falls, Idaho.

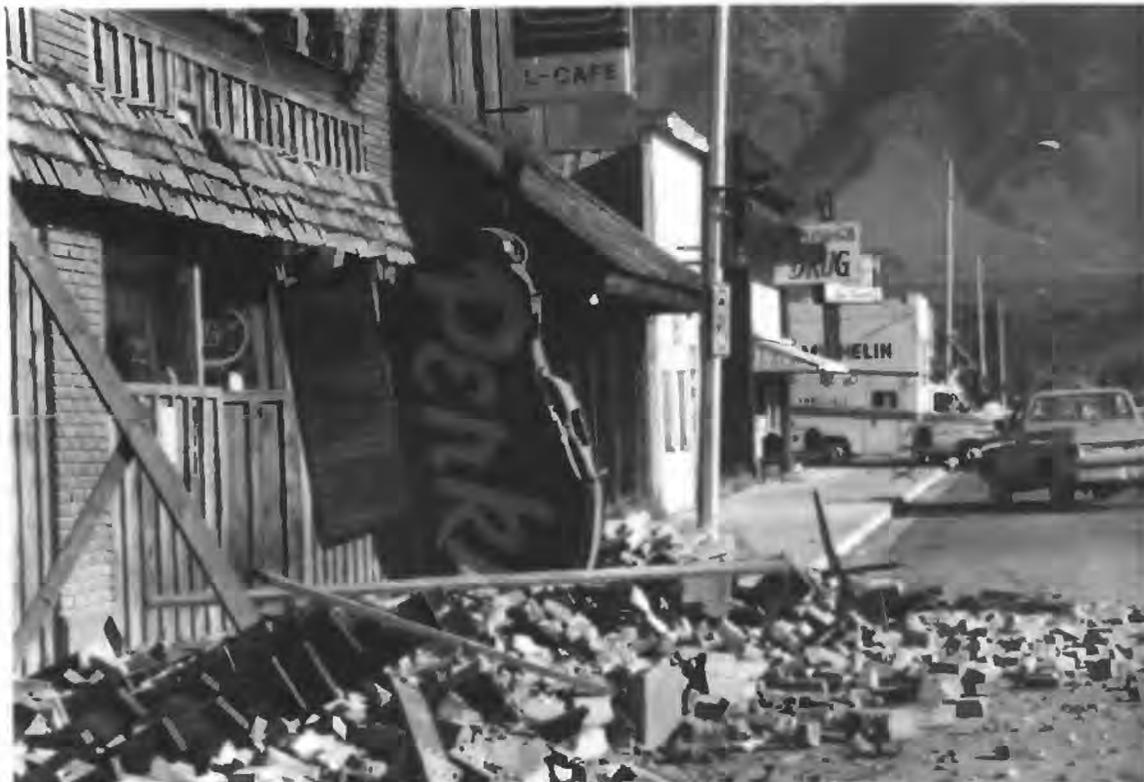
Figure 32.--Looking east along the north side of Main Street in Mackay, Idaho. On the sidewalk, the bricks are from the partially collapsed wall of Perks Bar. The building west of the parked ambulance is Mackay Drug. Photograph by Robert Bower of the Post-Register Newspaper, Idaho Falls, Idaho.

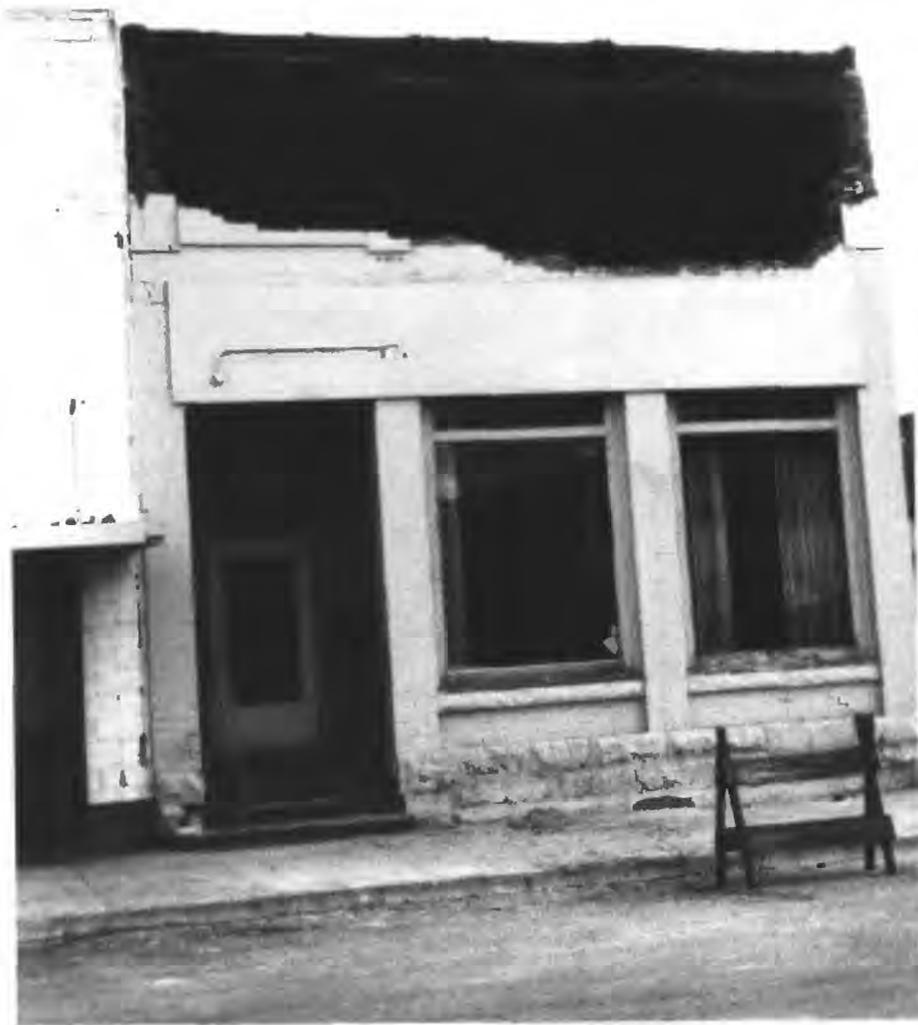
Figure 36.--Mackay City Hall which is located on the south side of Main Street. The original earthquake damage and additional portions of the wall have been removed prior to the time this photograph was taken (see Figure 31).

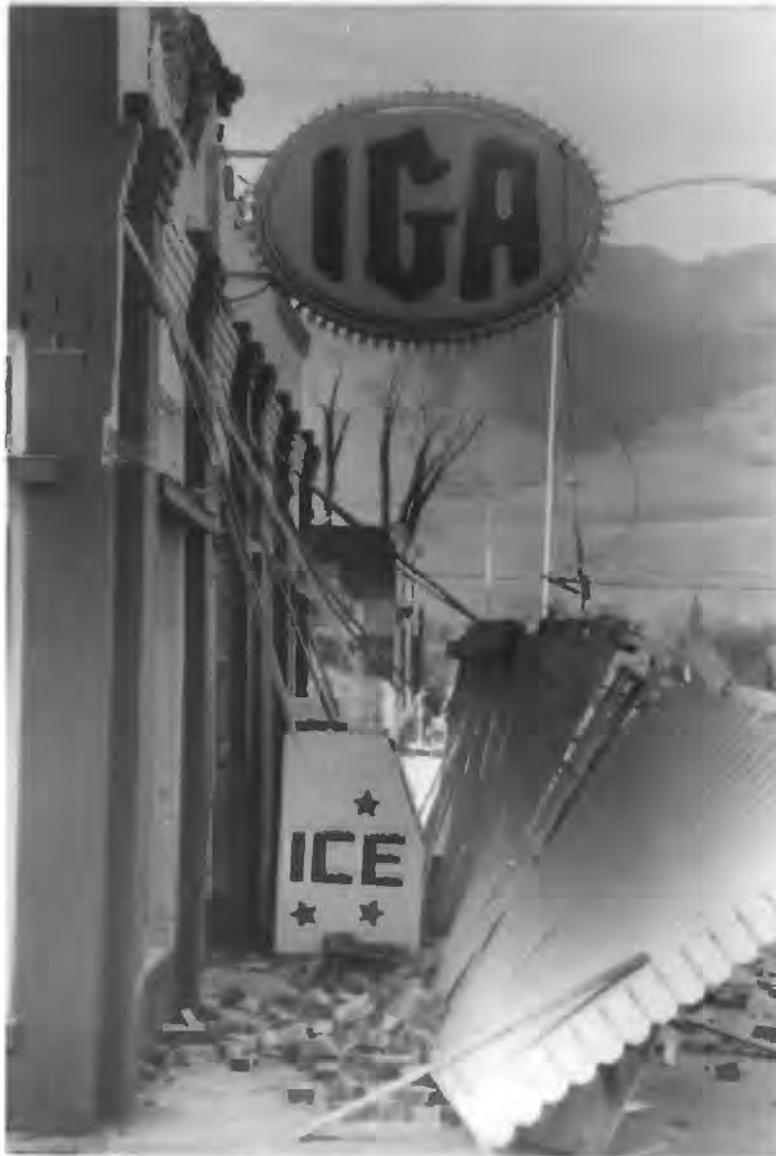
Figure 40.--Ivie's Grocery Store which is located on the south side of Main Street. Mackay, Idaho. The aluminium awning and support rods were shaken down. Photograph by Robert Bower of the Post-Register Newspaper, Idaho Falls, Idaho.

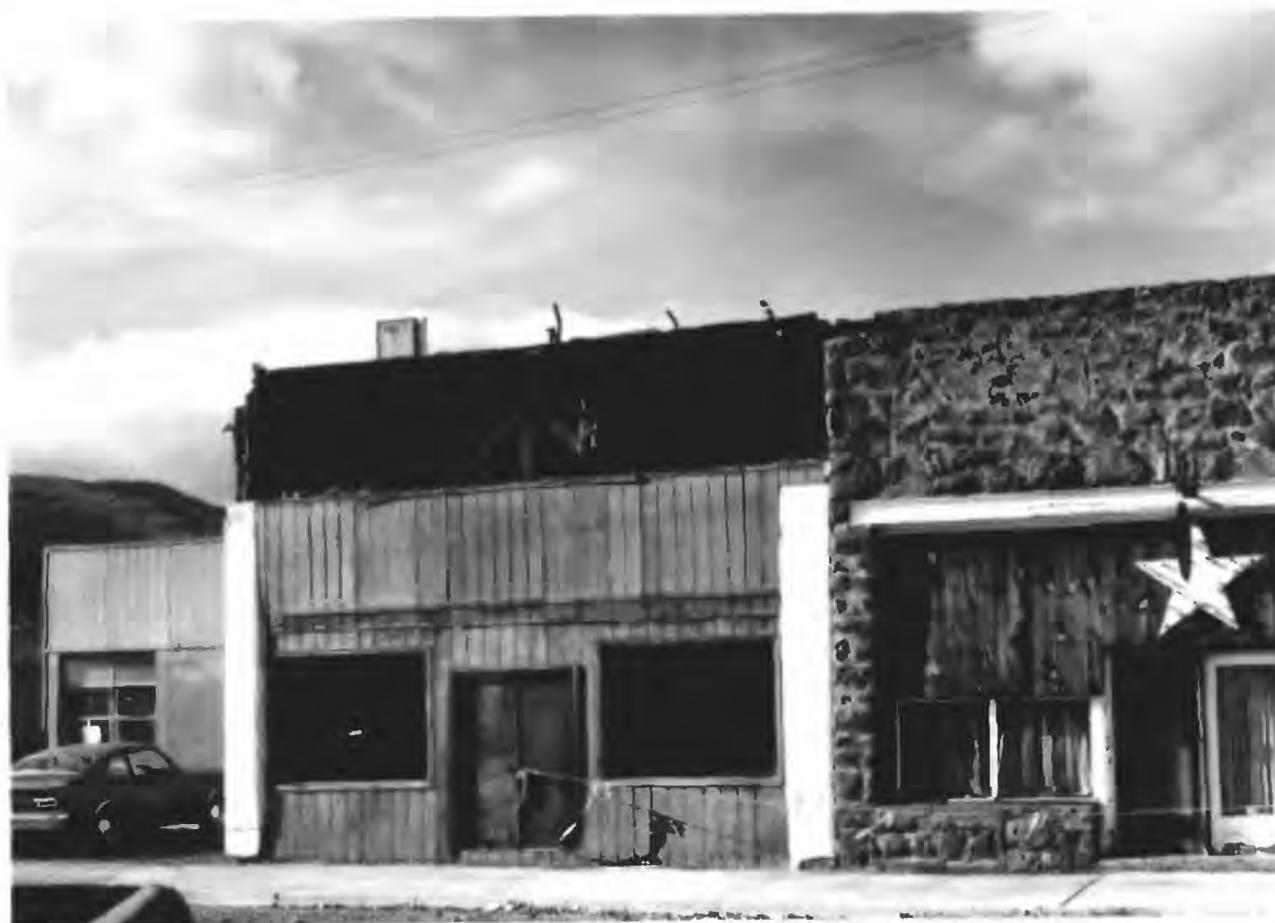
The building to the west and adjacent to the lodge hall was a storage building. The building front was a combination of wood and masonry. The upper masonry half of the front fell. The west cinder block wall of the building, which was painted white with an advertisement for Michelin Tires,

Figure 43.--The Lions Lodge Hall (building with the star) and the adjacent storage building which is located on the north side of Main Street in Mackay, Idaho. The south wall of the Lodge Hall was pushed slightly outward. The masonry half of the storage building's store front fell.

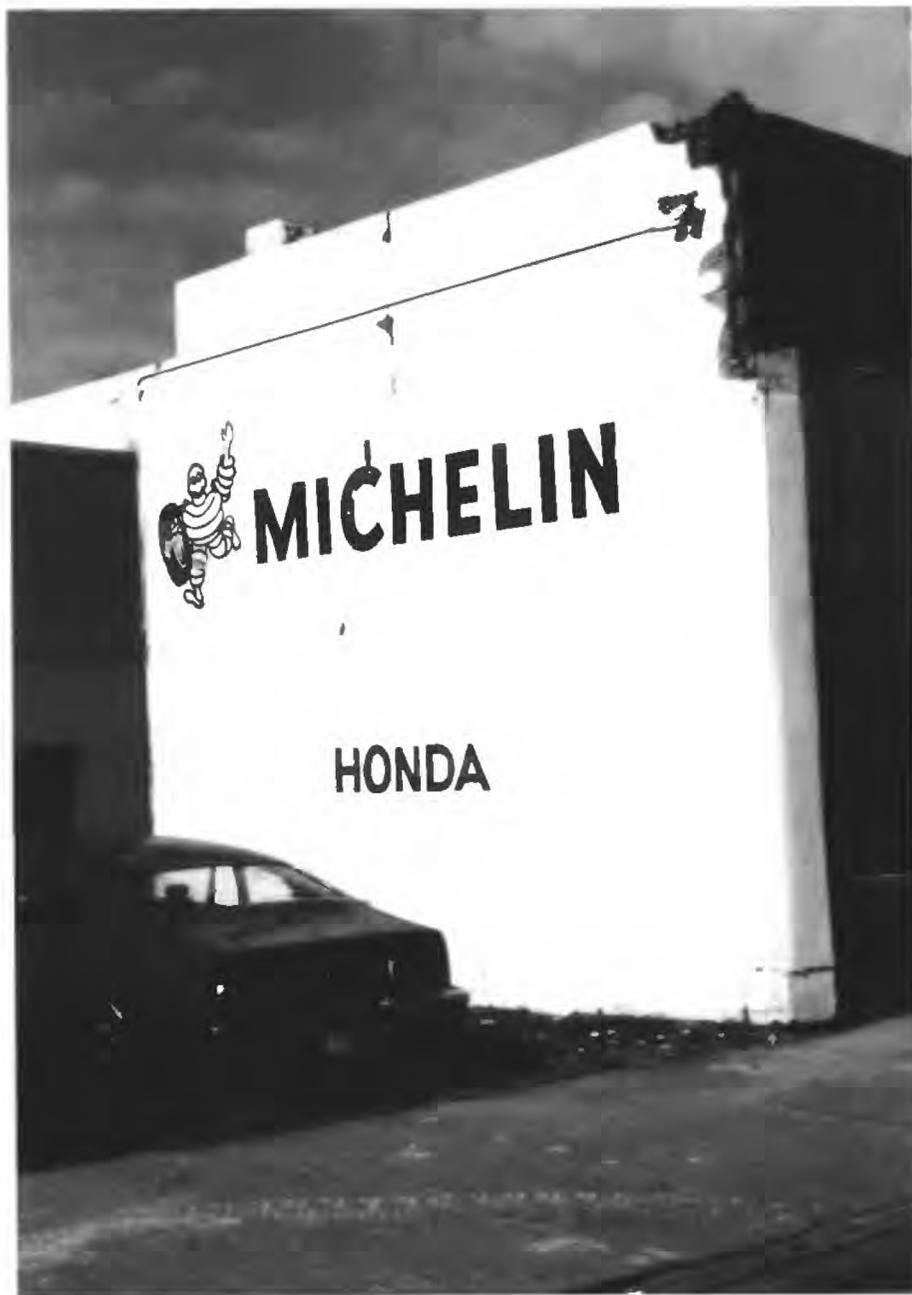
Figure 44.--The west wall of the storage building shown in Figure 43. The wall was cracked from top to bottom. Some collapse of the wall where it connects to the store front. Mackay, Idaho.

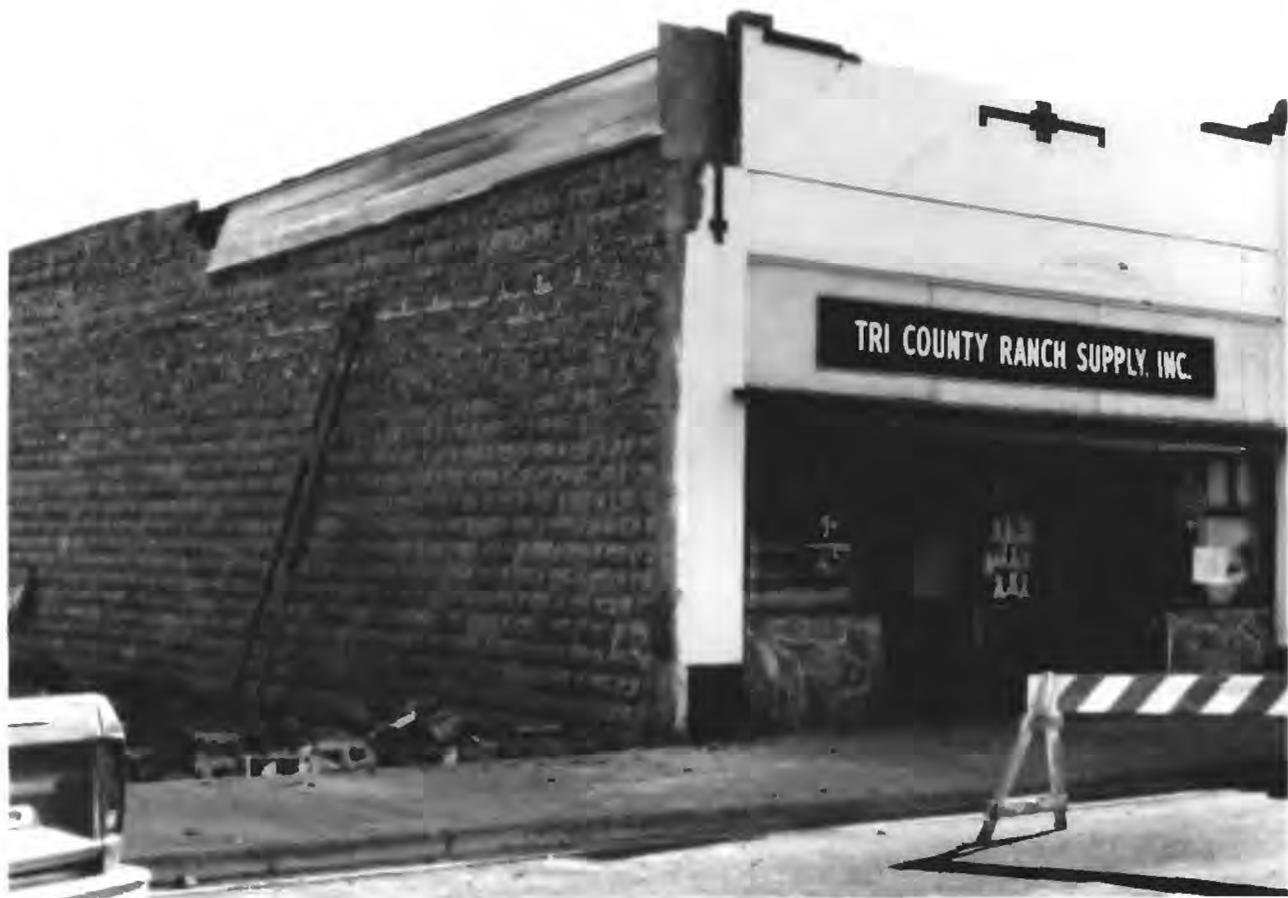
Figure 45.--A view of the partially collapsed east wall of the Tri County Ranch Supply, Inc. Some bricks are missing from the cracked store front. South side of Main Street in Mackay, Idaho.
