GEOLOGICAL SURVEY

Intensity survey of the Borah Peak,  
Idaho, earthquake of October 28, 1983

Open-File Report 84-166

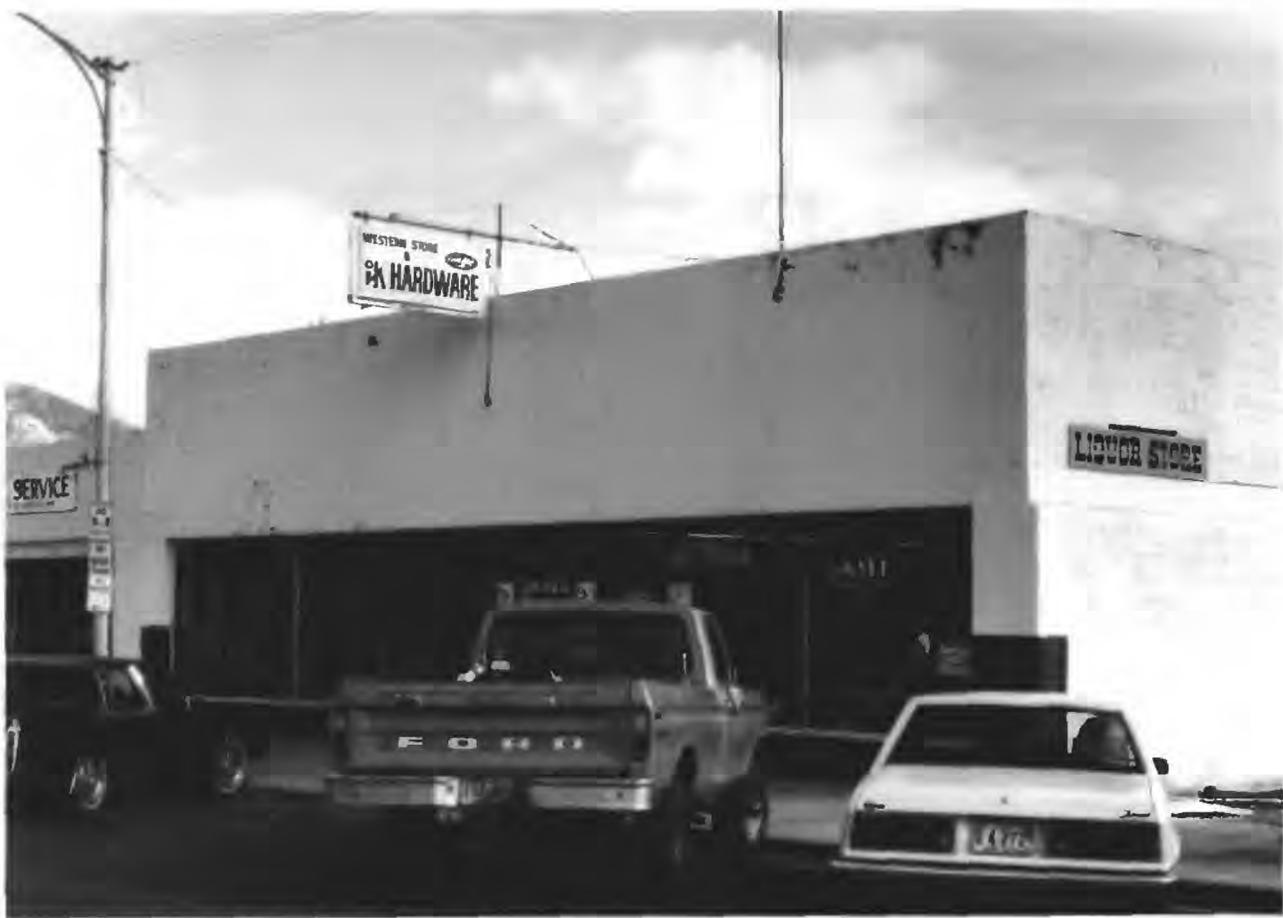
Figure 46.--The cracked, plaster-covered, cinder block store front of the Western Store and OK Hardware. South side of Main Street in Mackay, Idaho.

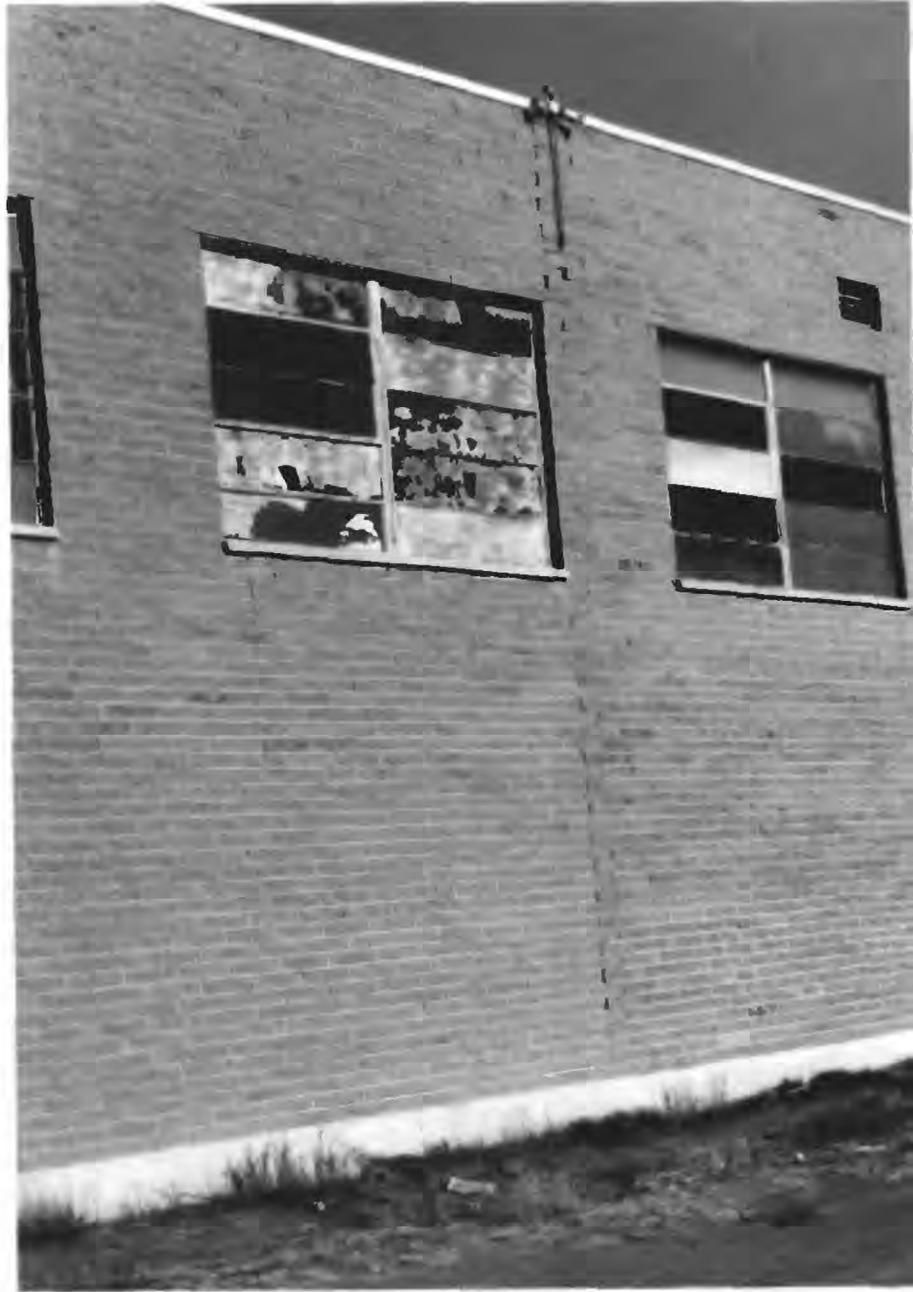
Figure 48.--A photograph showing the displacement of bricks in the exterior west wall of the Mackay High School gymnasium.

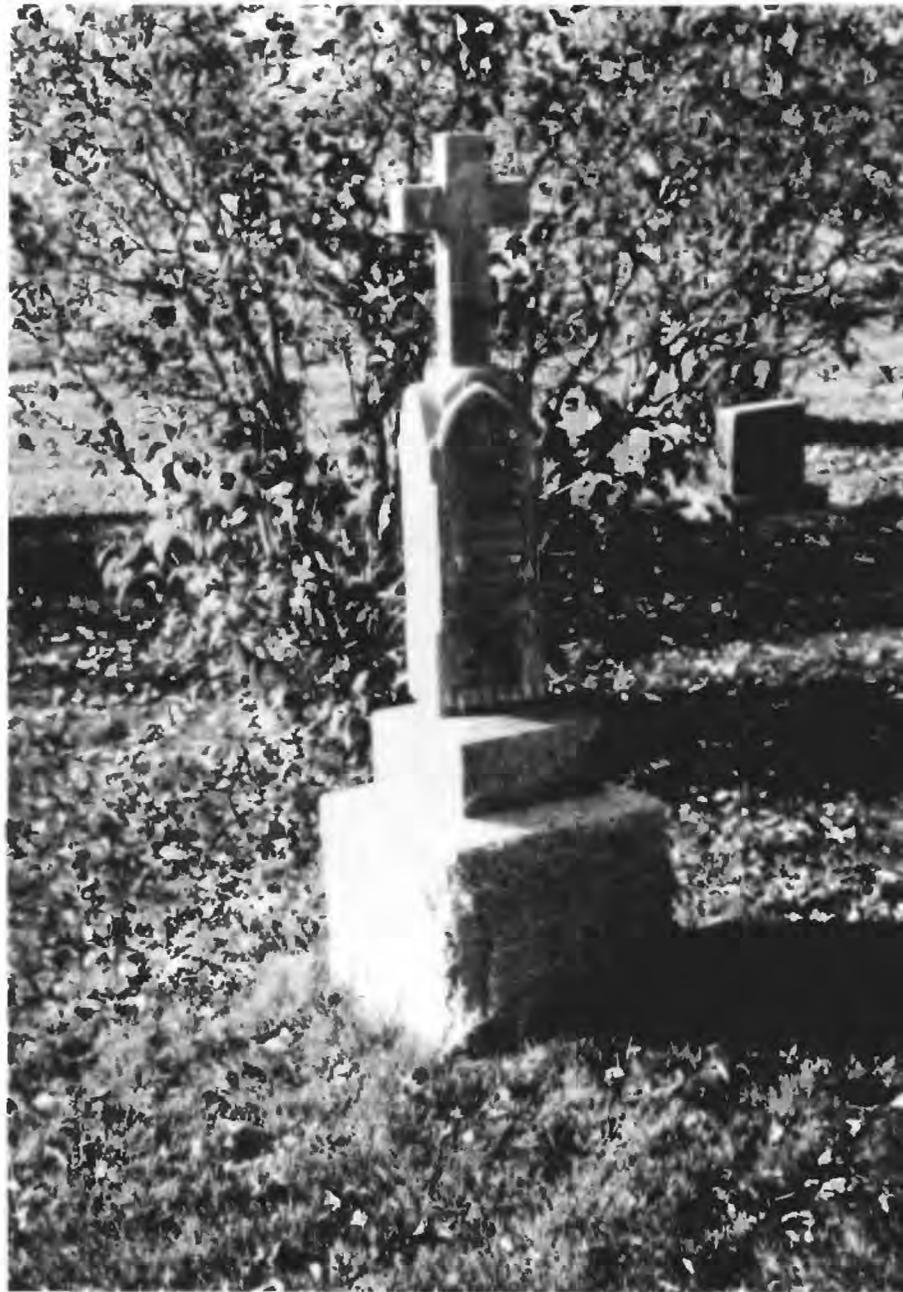
Figure 50.--Mackay Cemetery. The top stone was twisted clockwise and offset 1 and 1/2 inches to the northwest. The mortar beneath the twisted stone was absent.

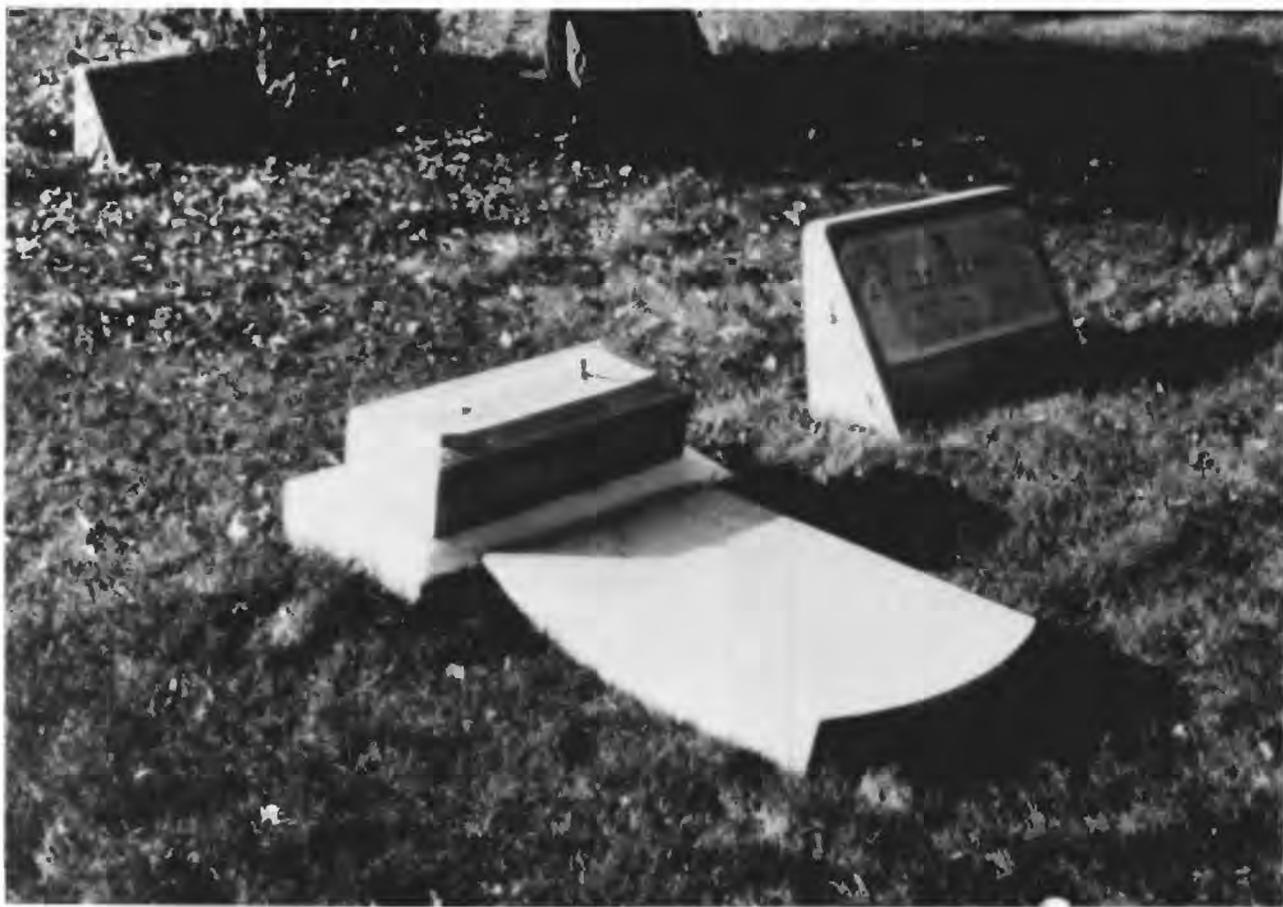
Figure 51.--Mackay Cemetery. The top stone overturned and fell toward the south. Note the two wooden pegs which held the fallen stone in place. One peg was broken.

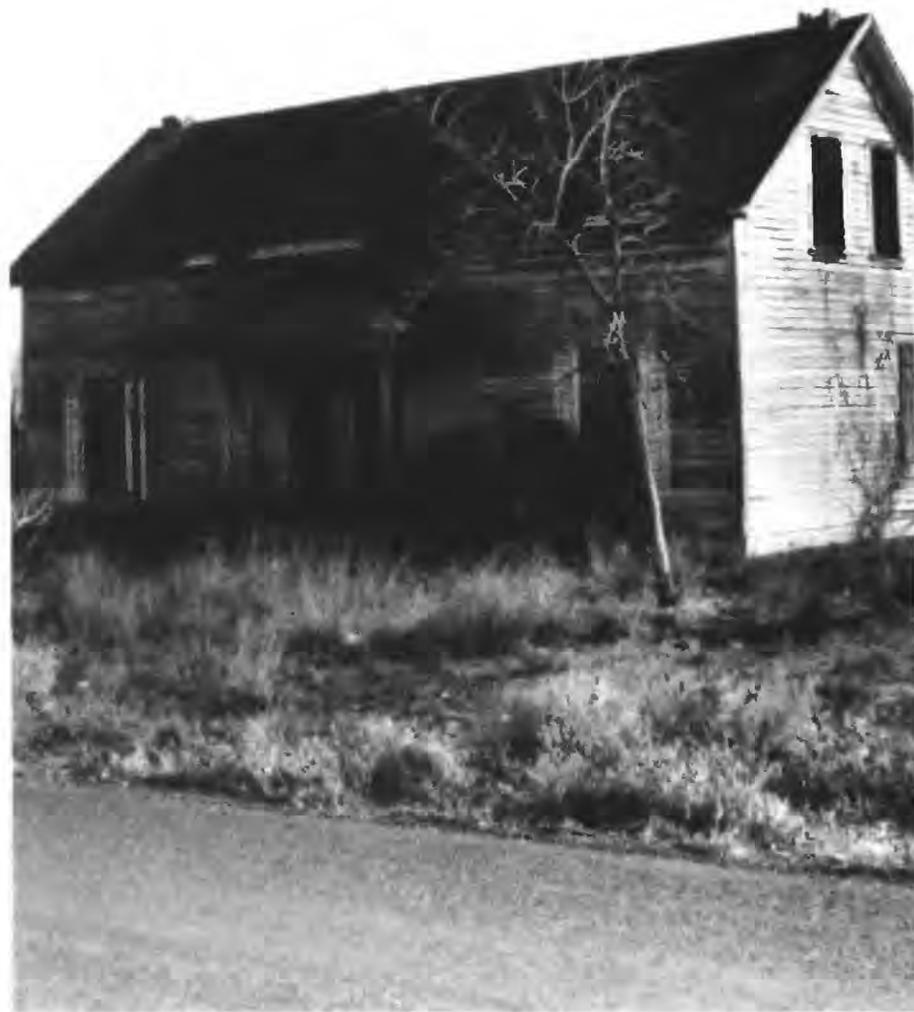
Figure 52.--An older wood-frame residence in Mackay, Idaho showing damage to chimneys without flue-liners.

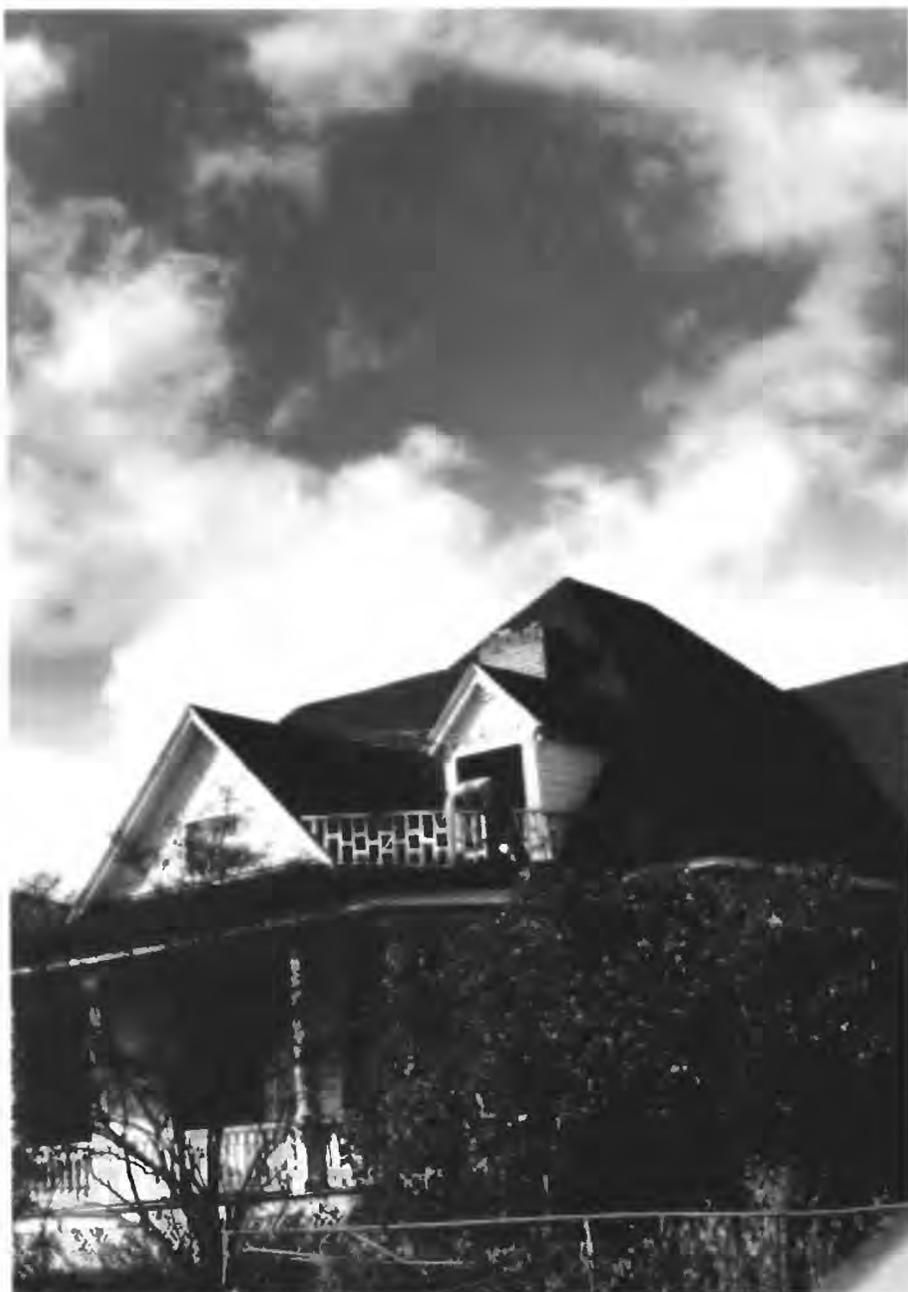
Figure 53.--The chimney bricks were shaken down to near roof line. The man on the roof is picking up the fallen bricks. Mackay, Idaho.

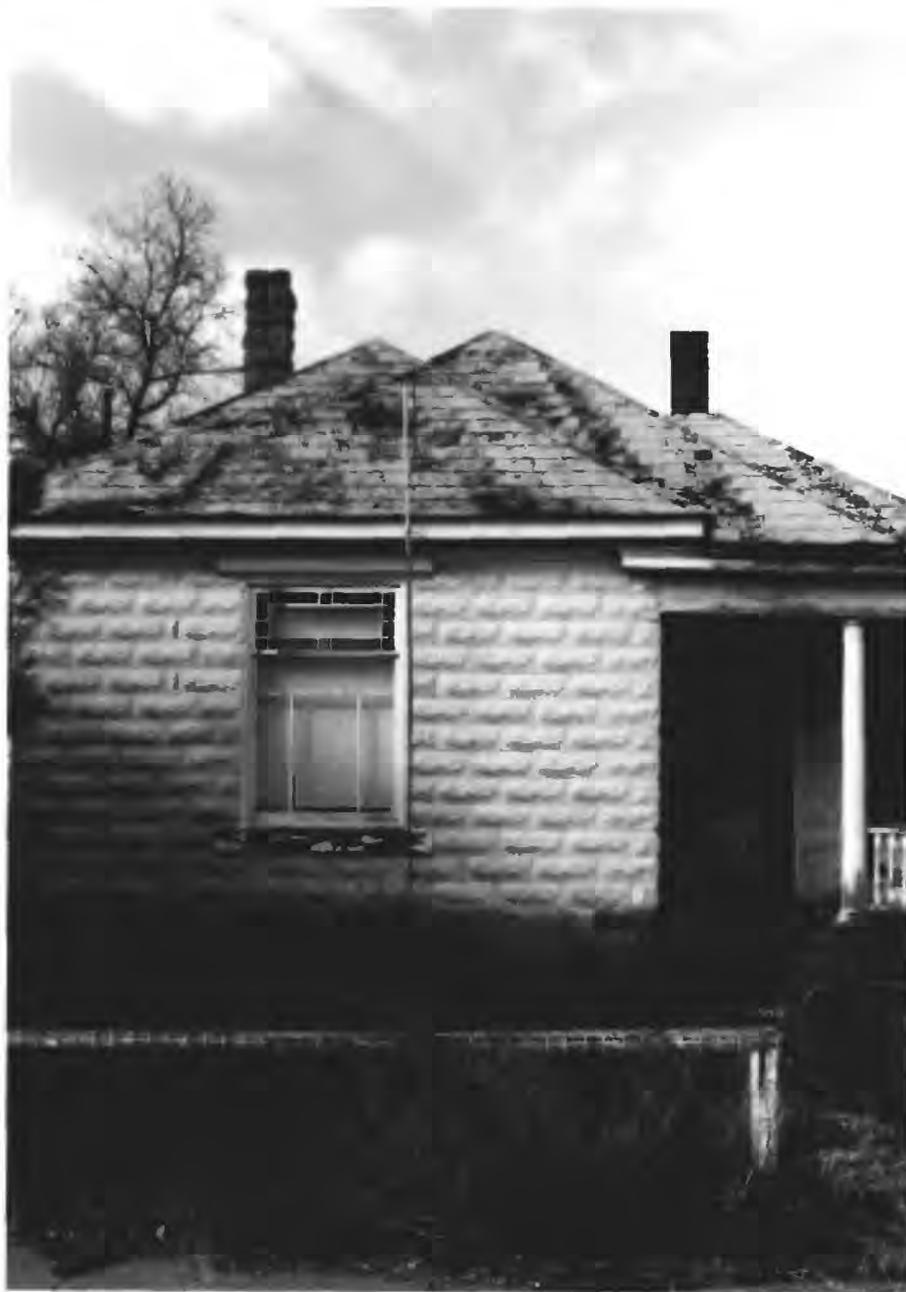
Figure 54.--A few bricks in the front chimney were slightly displaced (spread apart). The rear chimney did not appear to be damaged. Mackay, Idaho.

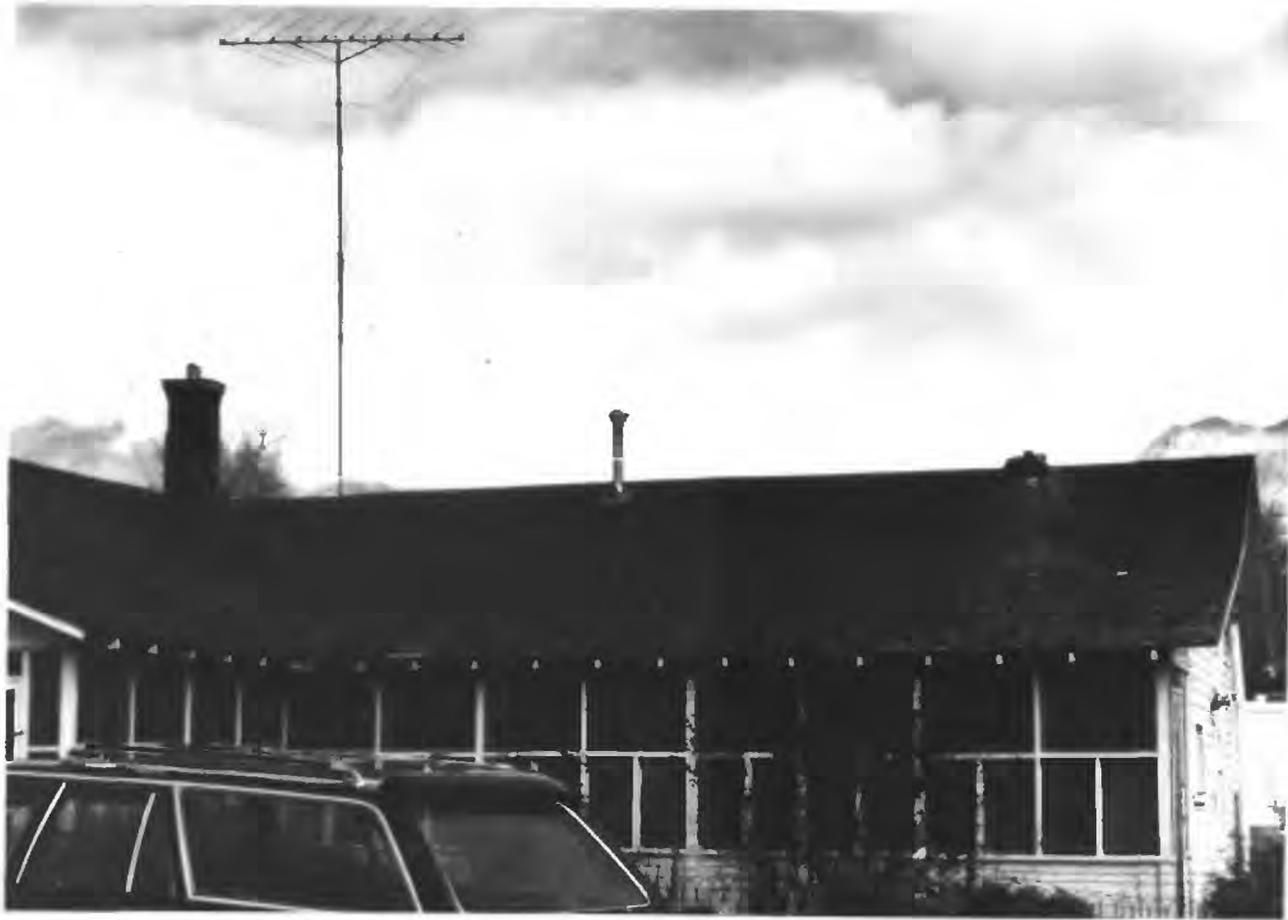
Figure 55.--The chimney to the right was shaken down. The left chimney was slightly twisted with the bricks displaced at the connection of the chimney base and the roof line. Mackay, Idaho.

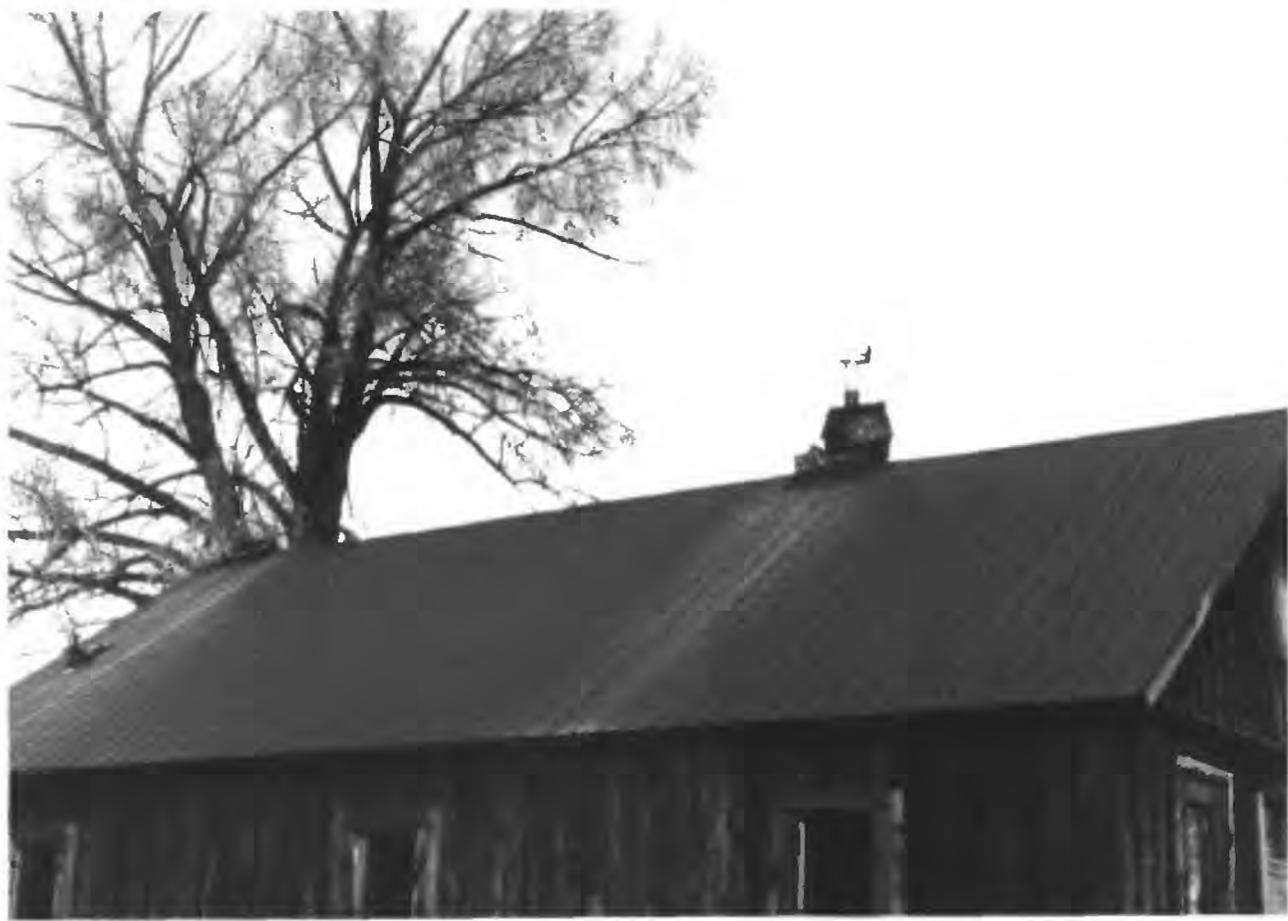
Figure 56.--A view of an offset chimney with a metal flue-liner. The chimney without a flue-liner on the left side of the house is missing. Mackay, Idaho.

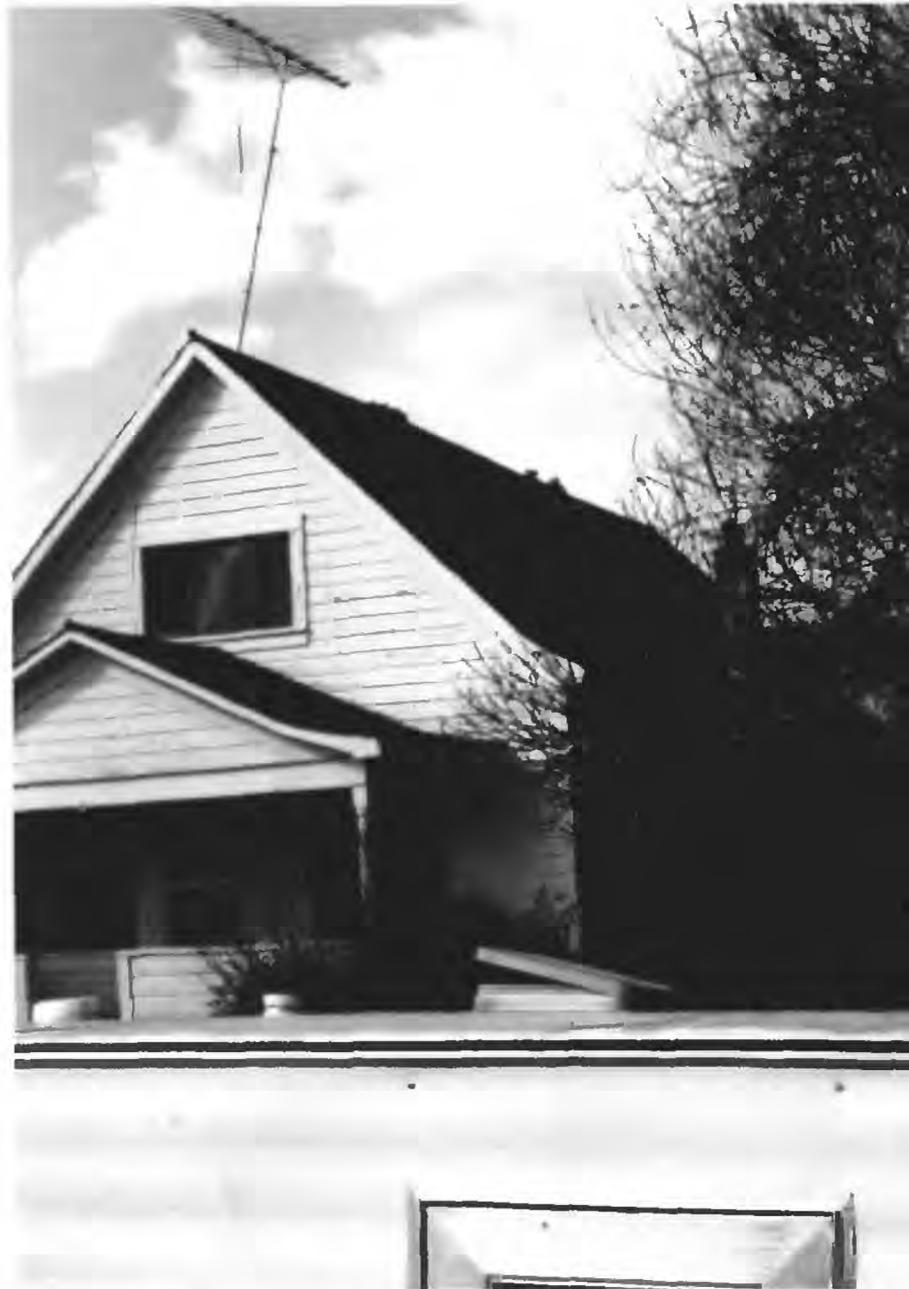
Figure 57.--The cinder block chimney beside the house was separated slightly from the house. Note the damage to the two brick chimneys on the roof. Mackay, Idaho.

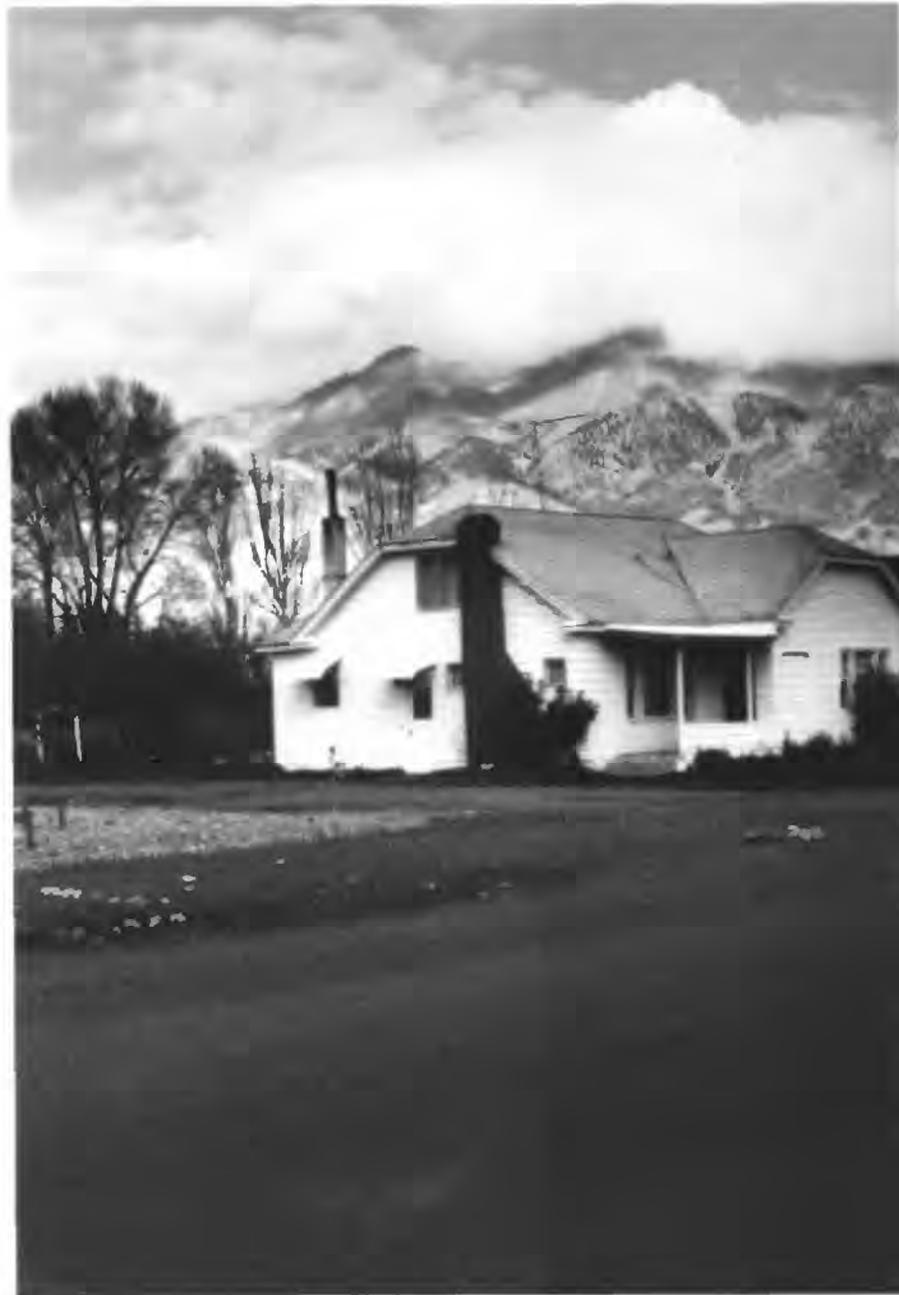
Figure 58.--A cinder block chimney with a metal retaining strap. The brick chimney, beside the house, lost several tiers of bricks down to the roof line. Mackay, Idaho.
