UNITED STATES DEPARTMENT OF THE INTERIOR
GEOLOGICAL SURVEY

THE MORGAN HILL, CALIFORNIA
EARTHQUAKE OF APRIL 24, 1984
(A PRELIMINARY REPORT)

Open-File Report 84-498 A

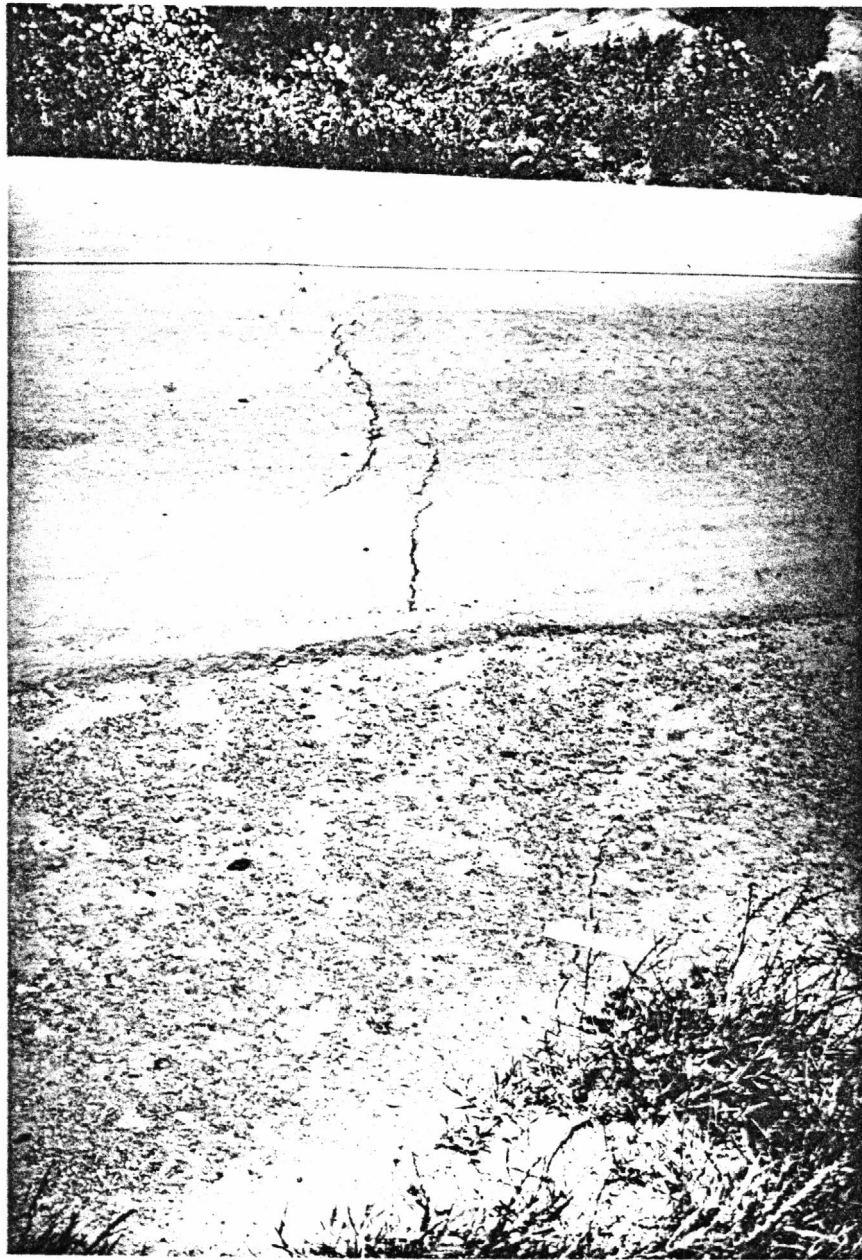
Figure 3. View northeast along trace of Calaveras fault at Shore Road 10 km northeast of Hollister. SHR1 lies in road shoulder off right side of photo, crossing the trace at an angle of 45° . Cracks in road began after repaving in 1982. Fifteen-cm white scale in lower right-hand corner indicates location of fresh crack in road shoulder apparently caused by afterslip following April 24 earthquake (see Figure 4).

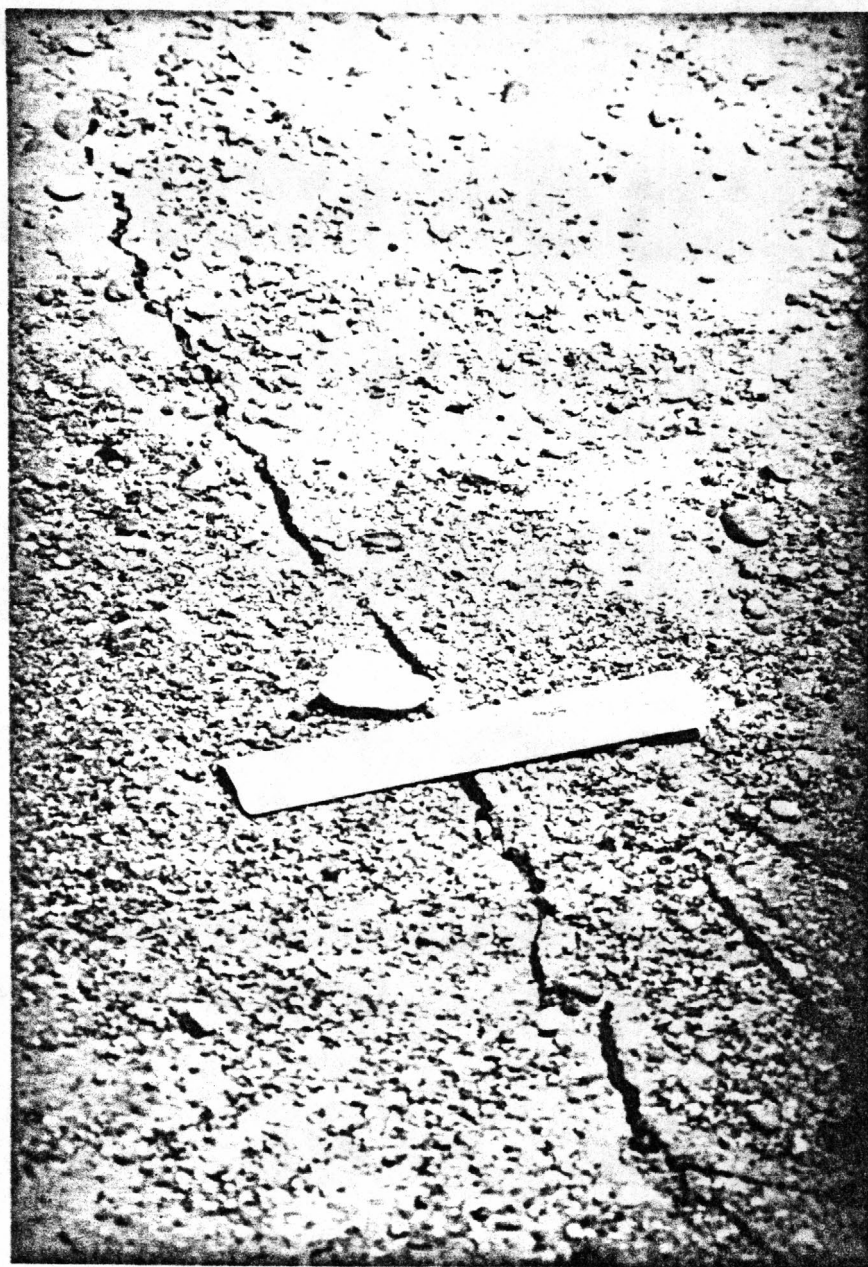
Figure 4. Close-up of fresh crack 1 m long and 0.5 cm at widest opening, beside Shore Road. Scale is 15 cm long.

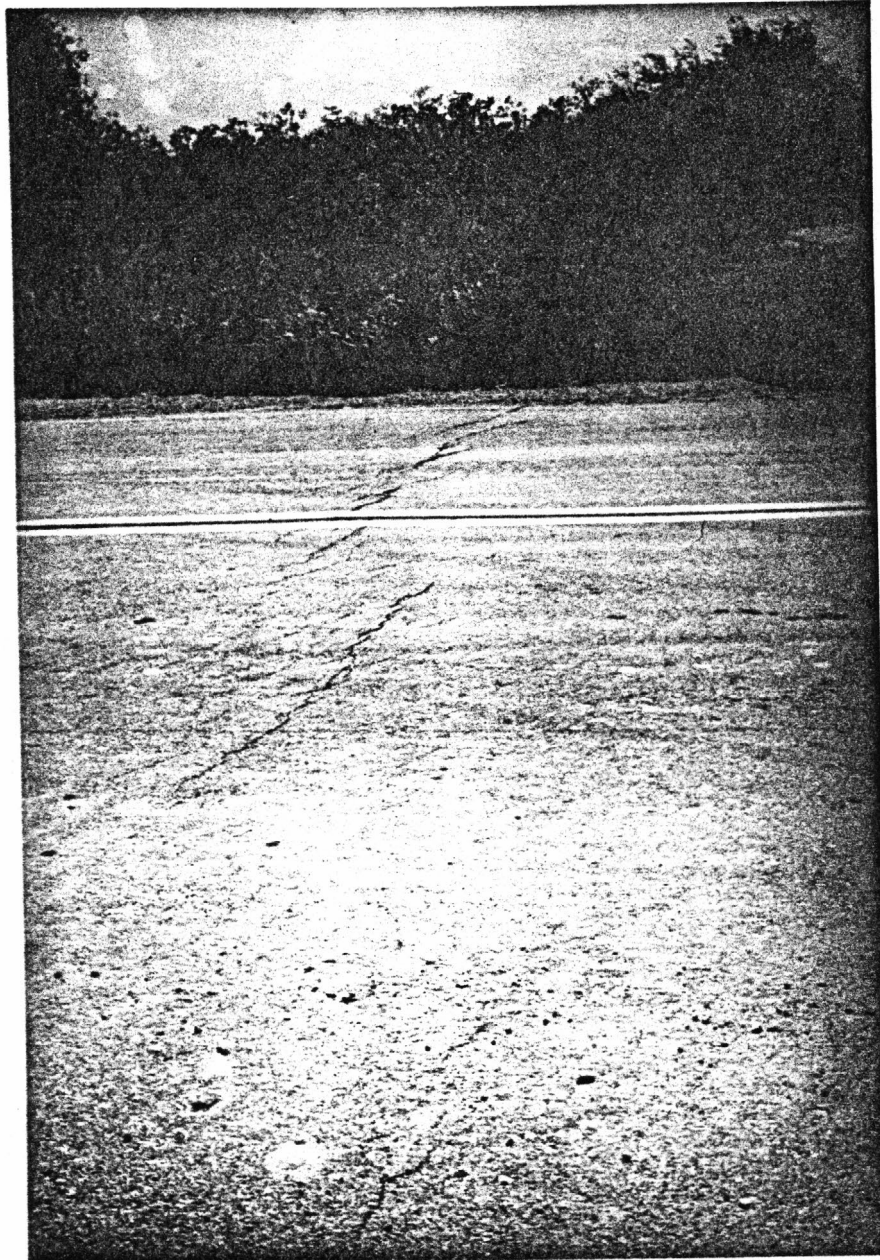
Figure 5. View southeast along Calaveras fault trace at Shore Road. SHR1 is in shoulder in left upper center of picture. Arrow indicates hairline crack extending from dirt shoulder into roadway.

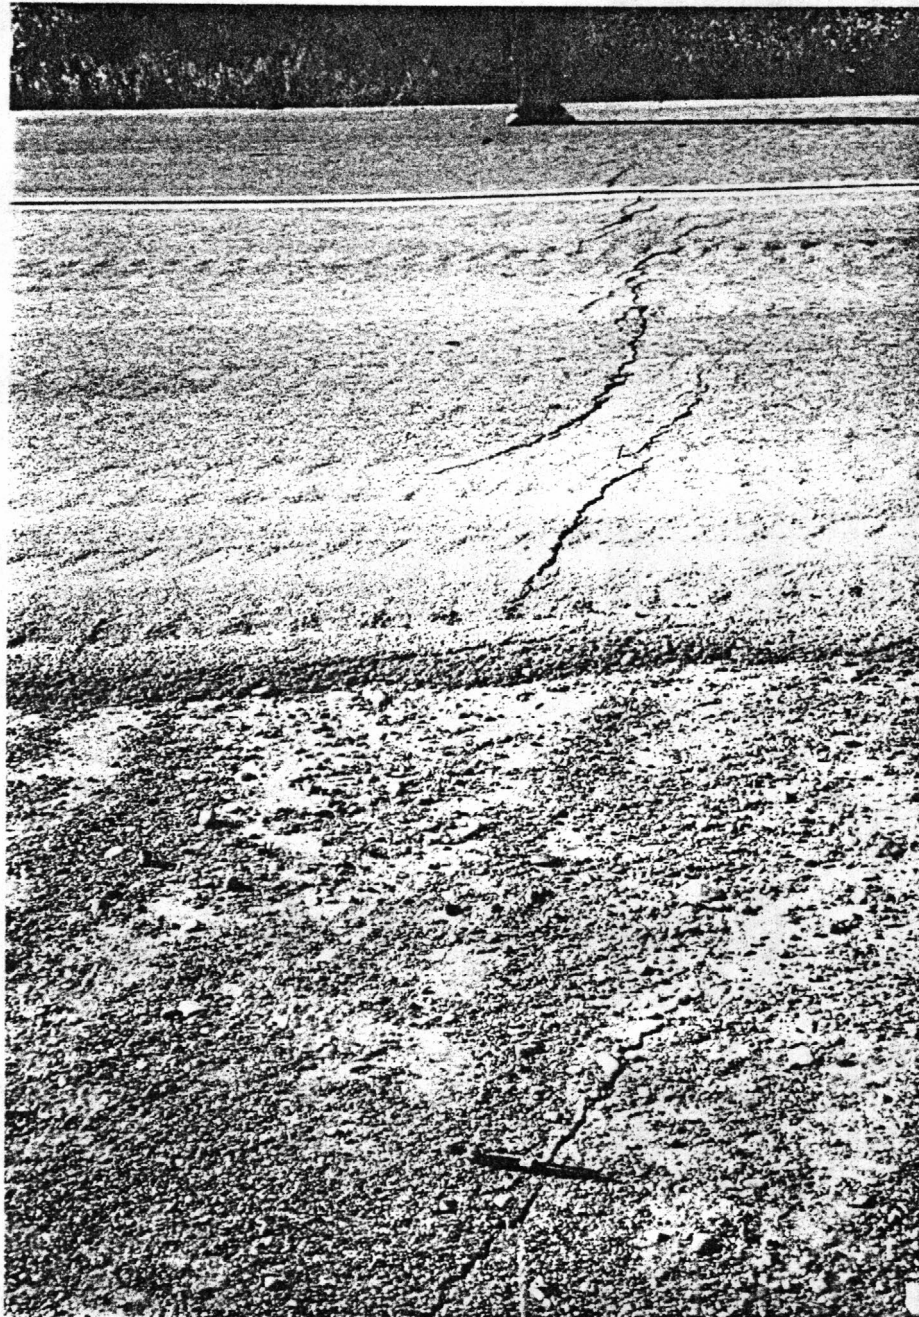
Figure 2. Calaveras fault at Shore Road on 25 April 1984. The left-stepping en echelon cracks appear in the asphalt and also in the dirt (pen for scale).

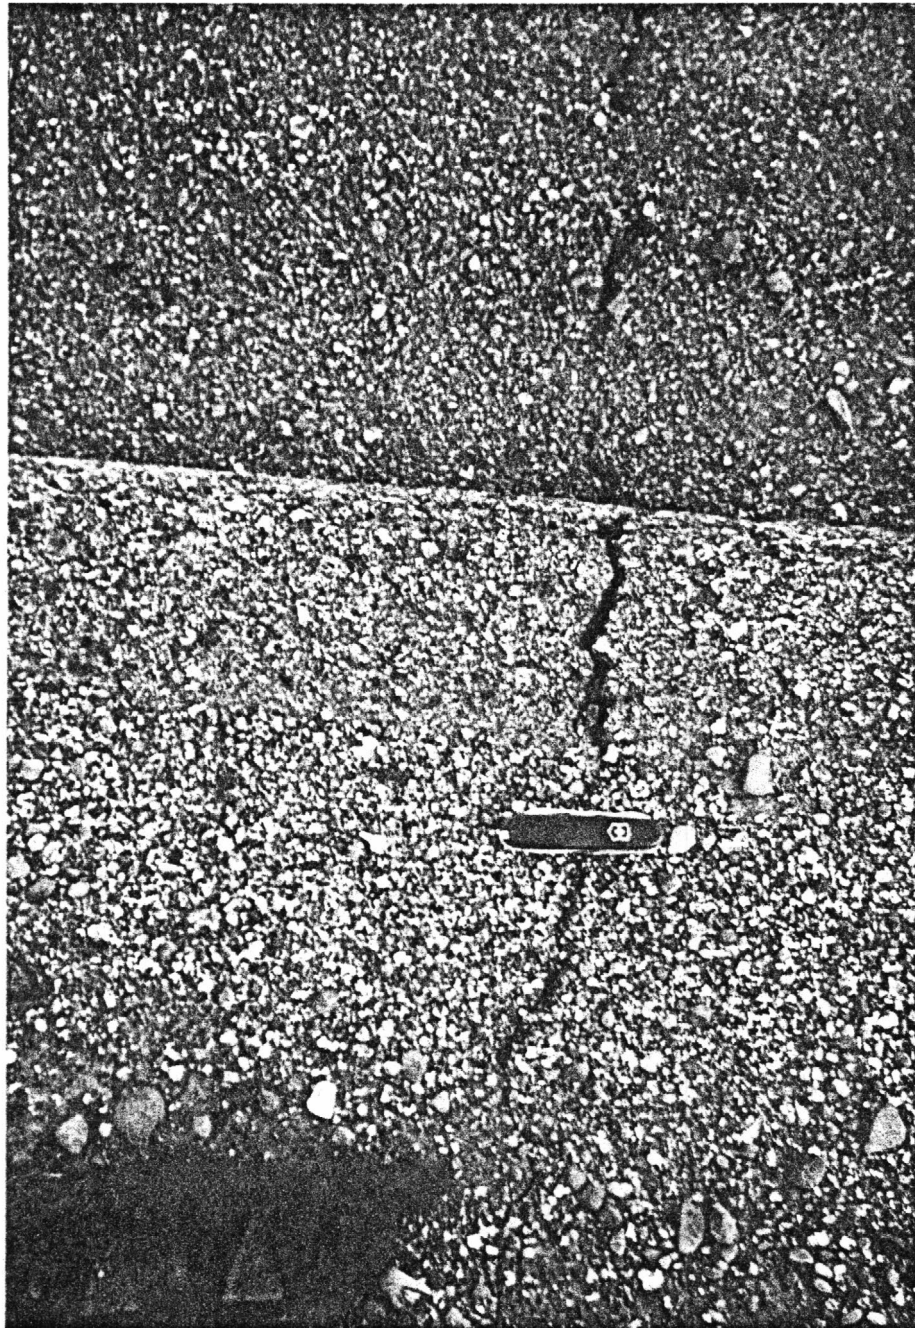
Figure 3. Calaveras fault at Highway 152 (Pacheco Pass Road) on 25 April 1984. Crack in darker upper part of photo is in asphalt of the road. Crack in lighter middle part of photo above the knife is in road curb which is offset about one centimeter in a right-lateral sense. Crack beneath knife and in lower part of photo is in dirt alongside the road and also shows right-lateral offset.

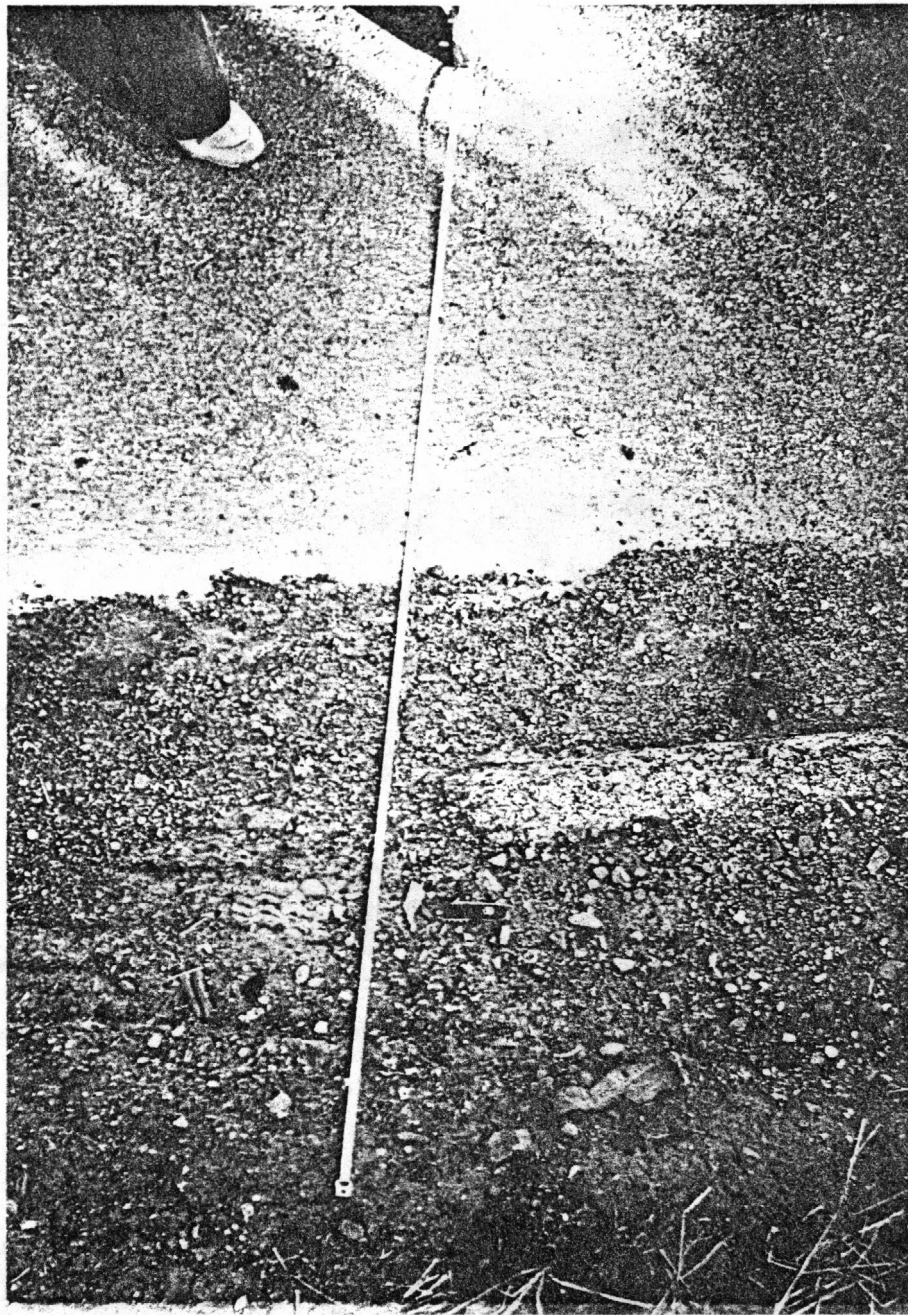
Figure 4. Calaveras fault at Highway 152 (Pacheco Pass Road) on 25 April 1984. This crack is northeast of the one shown in Figure 3. Crack in lighter upper part of the photo to the right of the tape is in asphalt. Crack in darker lower part of the photo is in dirt and runs from underneath the knife downward and underneath the tape about 1.5 knife lengths from the end of the tape.

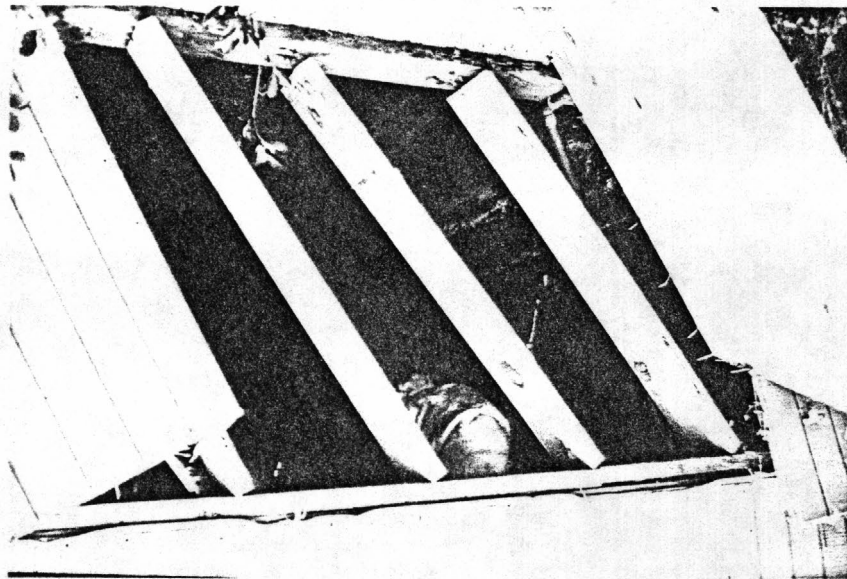
Figure 2. A house reported as "off its foundation" in Morgan Hill. The perimeter and interior footings of the house are intact and undamaged by the earthquake. The lateral displacement of the house and consequent damage was due to shear deformation within the wall immediately above the foundation. a) View of house from a distance showing damage and distortion to the structure. b) Close-up view skewed studs and siding that pulled off from the wall as the structure deformed.

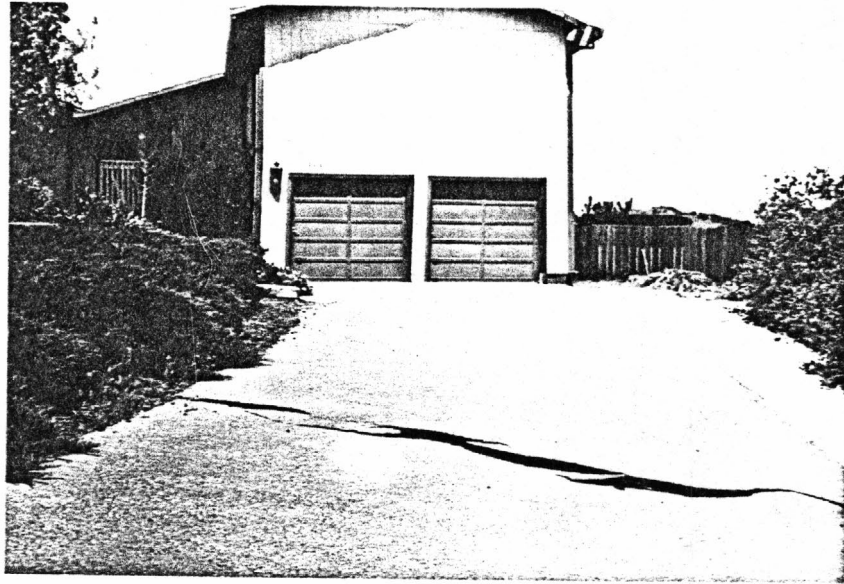
Figure 3. Prominent fissure in a driveway near the crest of the hill above the house shown in Fig. 1. The fissure was caused by local ground displacement, probably an incipient slope failure, but had no significant influence on damage to the houses in the area.

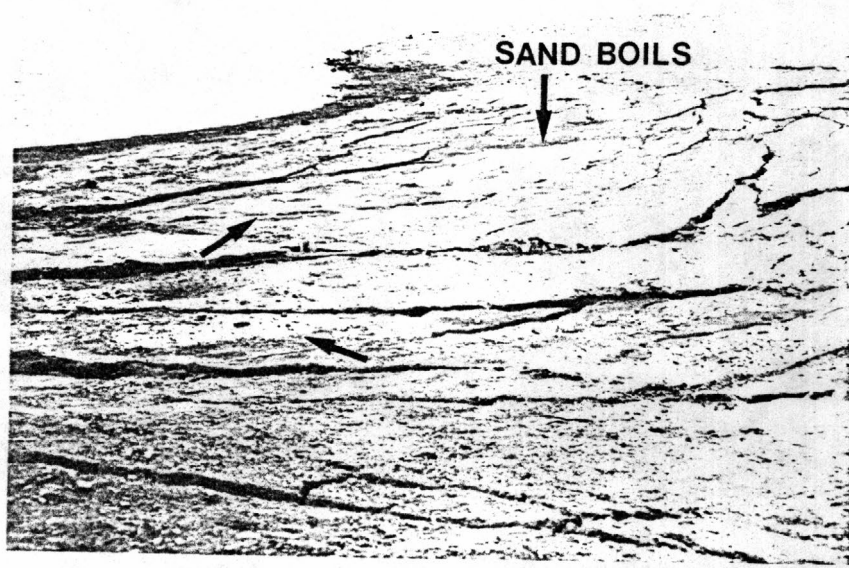
Figure 5. Sand boils and fissures near the shoreline on the east side of Anderson reservoir. Liquefaction and minor lateral spreading caused these features.

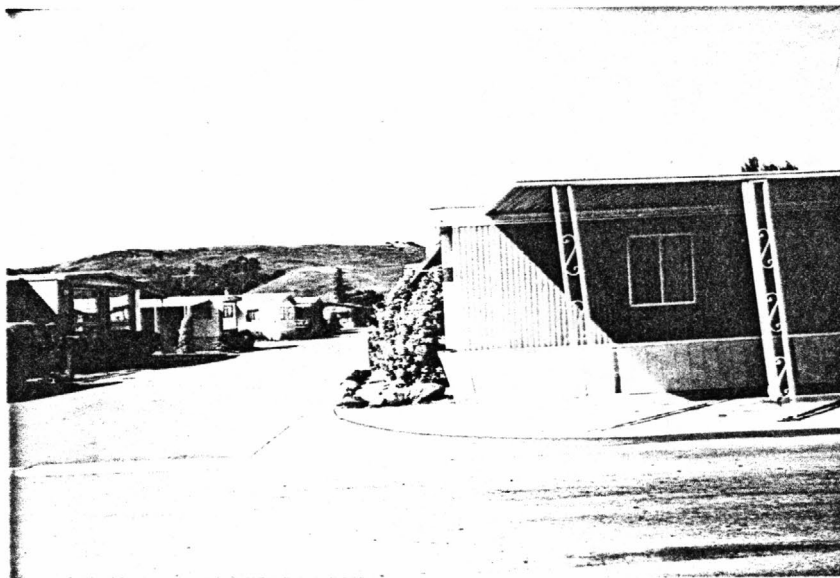
Figure 5. Partially collapsed mobile home at location 1 in Madrone Mobile Home Estates. North is to the right.

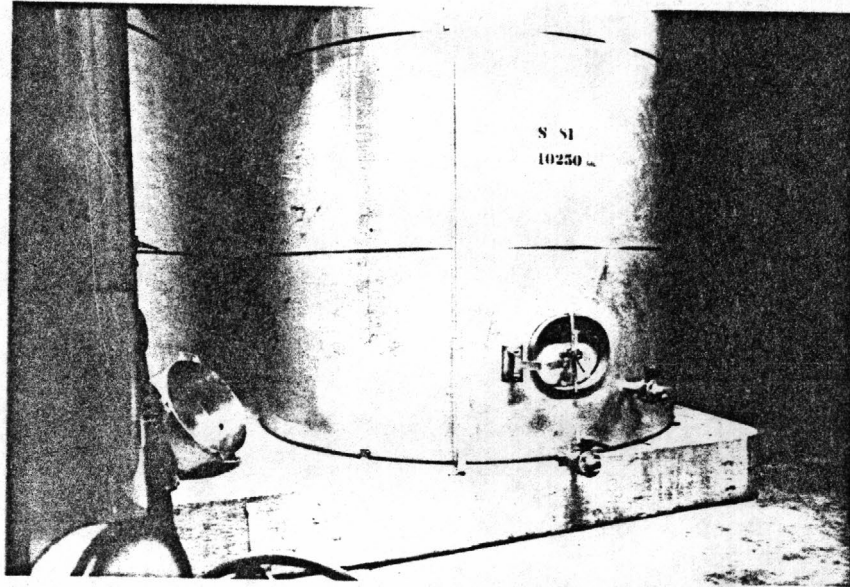
Figure 10. Photograph inside the Emilio Guglielmo Winery, 1480 Main Street (location 18). Photograph shows 10,250 gallon storage tank that was welded to catwalk support which in turn was bolted into the concrete pad. This stainless steel tank rotated 2.5 cm (1 inch) counterclockwise (to the right), the catwalk was mildly wrenched. This tank was empty. Other tanks that were filled to capacity and developed elephant toe bulges over consistent azimuthal arcs while shifting on the same concrete pad.

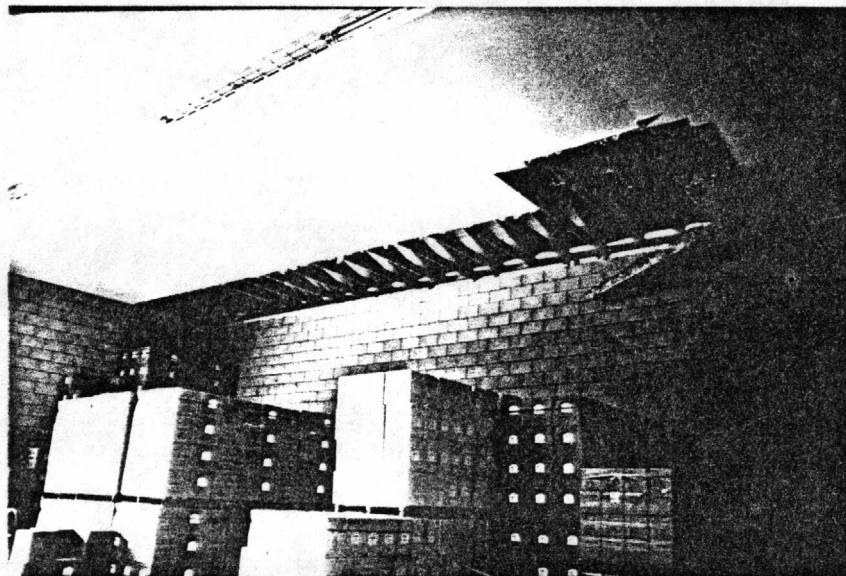
Figure 11. Sheetrock that fell from ceiling adjacent to western-most cinder block wall at the Emilio Guglielmo Winery (location 18).

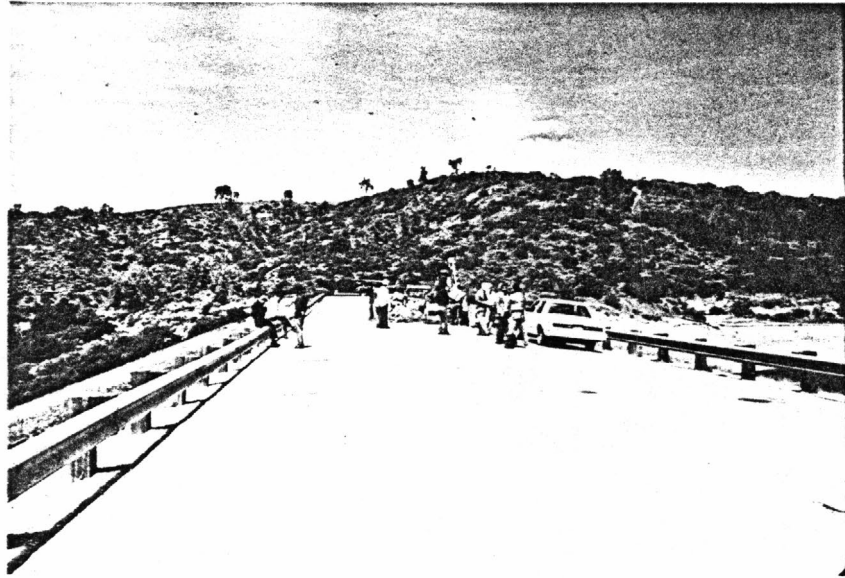
Figure 12. Longitudinal cracks that developed along the crest of the Anderson Dam (location (51)). The location of trench parallel to the longitudinal upstream crack is in the right center.

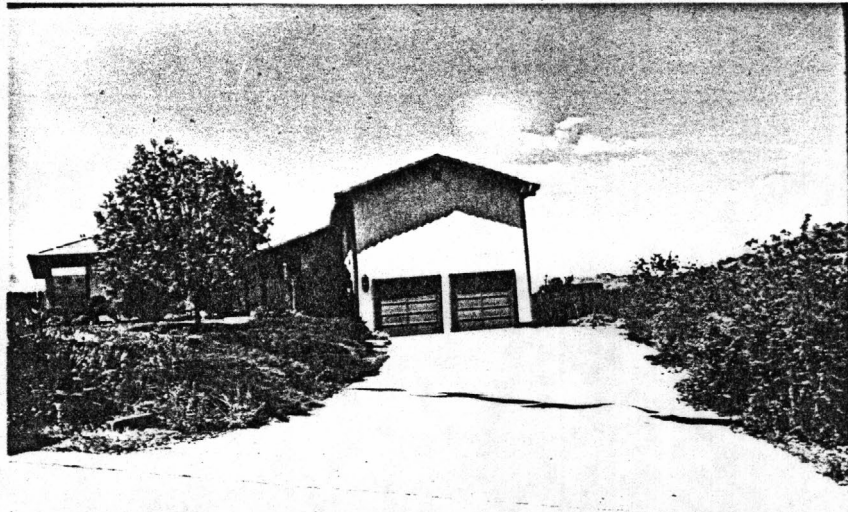
Figure 14. Racked house (house #3, in Figure 3) along Oak Ridge Court in Jackson Oaks tract (location (69)) with crack propagating east-west through its driveway. Crack has both extensional and vertical components (down on the south). View is to the north.

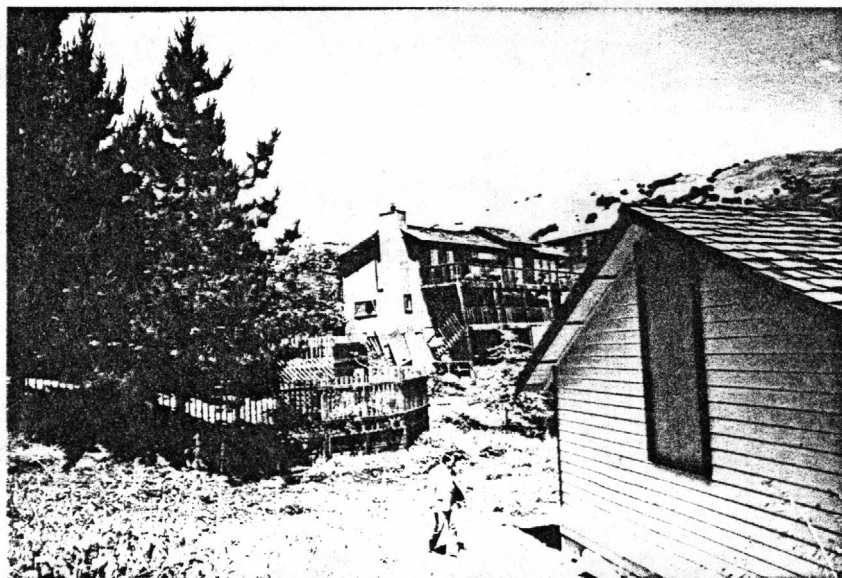
Figure 15. Jackson Oaks housing tract (location (69)). House #1 from next to house #2 (house numbers from Figure 3). Note unshattered and rotated shear panels on house #1 which appear to have provided little shear protection.

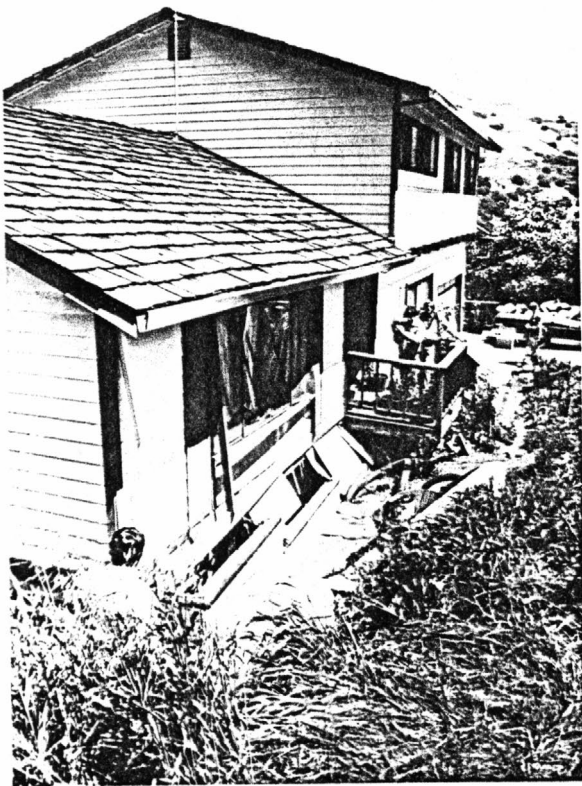
Figure 16. House #2 along Oak Ridge Lane (location (69)). Note sill plate still secured to the concrete perimeter foundation. This instance of a house ripped from its foundation suggests high lateral ground accelerations.

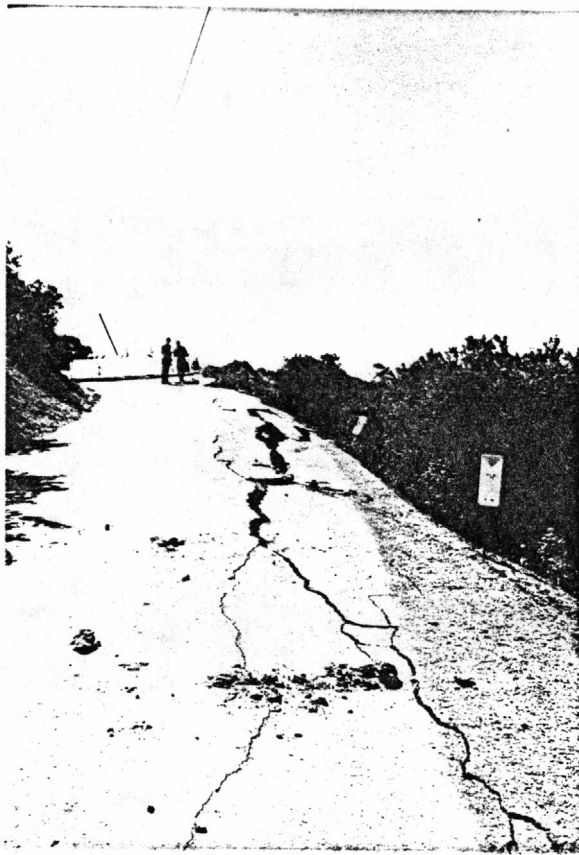
Figure 18. One of many fill failures along East Dunne Avenue within 0.8 km (0.5 miles) of the Cochrane Bridge. These failures were typically down toward the reservoir which is to the right of the photo.

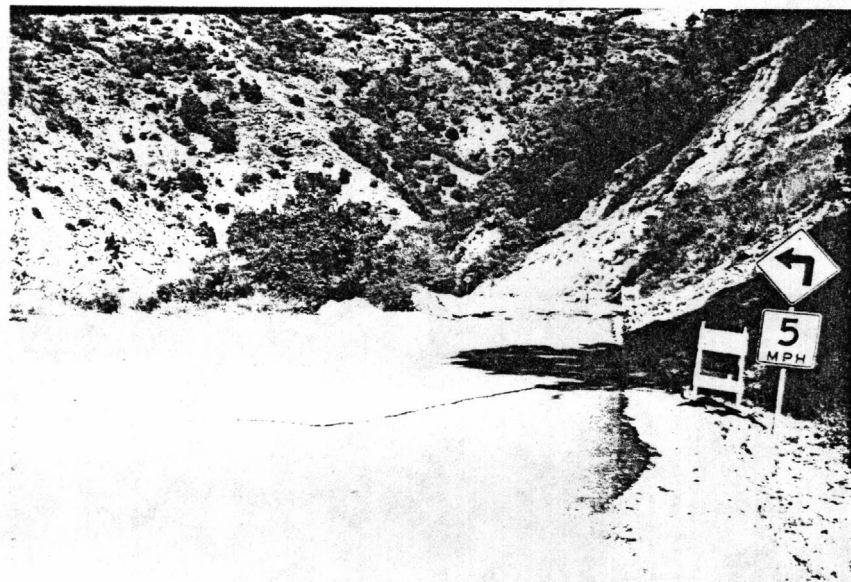
Figure 19. Large complex landslide within 0.2 km (1/8 mile) of the Cochrane Bridge disrupts the East Dunne Avenue right-of-way (near location (69)). This landslide obscures the trace of the Calaveras Fault. Note repeated patching of pavement along this stretch of the road.

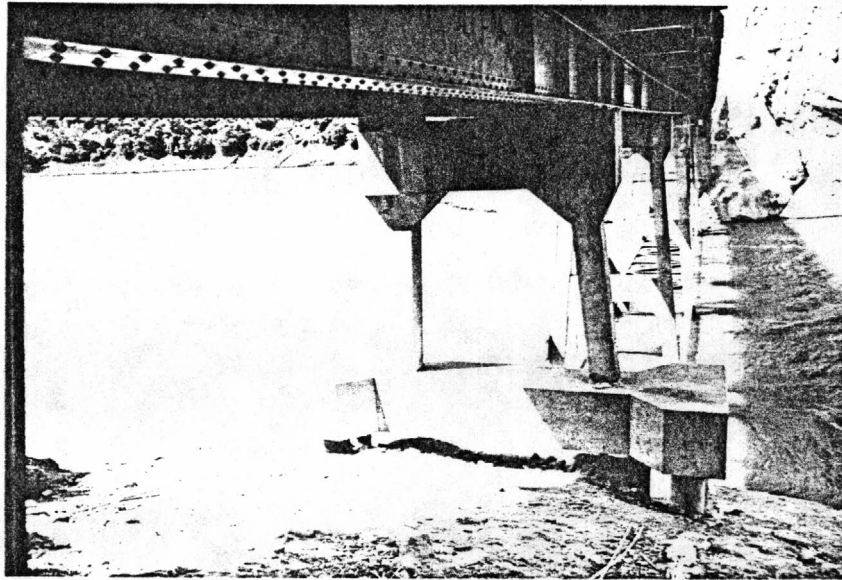
Figure 22. Spalled post added to strengthen the Cochrane Bridge (near location (69)) after a creeping segment of the Calaveras was discovered to be twisting the bridge.

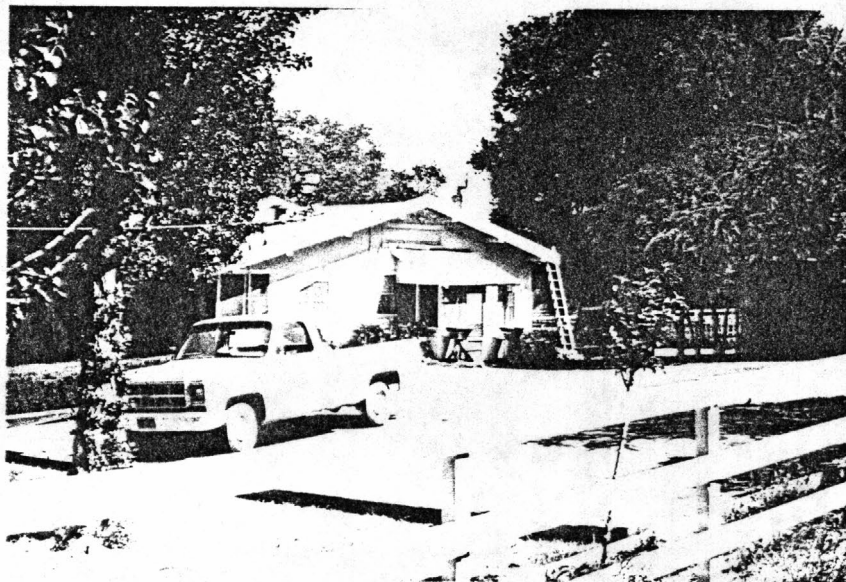
Figure 23. Circa 1914 wood frame house in San Felipe Valley at location (33) with fallen chimney and stem wall cracks in its perimeter foundation. View to the ESE.

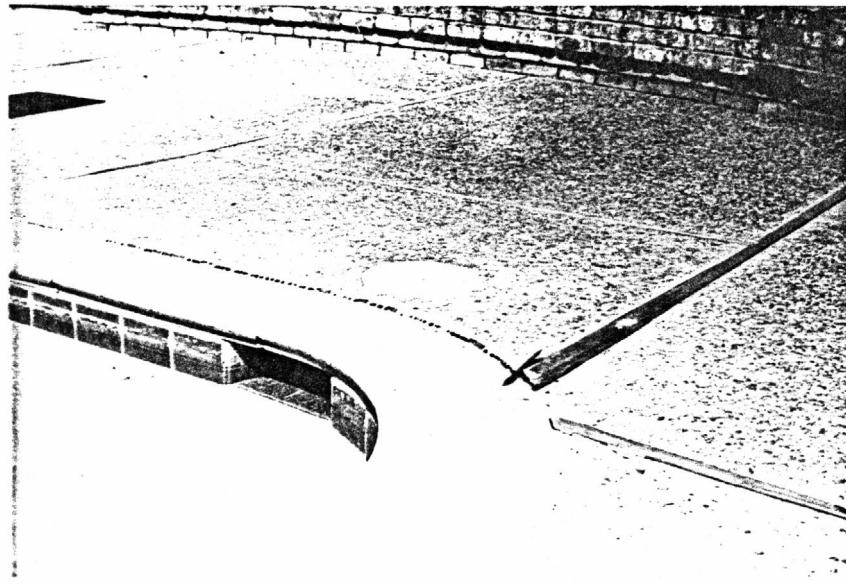
Figure 24. Concrete pool apron in the San Felipe Valley at location (33) that has settled differentially due to minor lateral spreading of Holocene and Late Pleistocene stream deposits.
