# HYDROLOGY, GEOMORPHOLOGY, AND DAM-BREAK MODELING OF THE JULY 15, 1982, LAWN LAKE DAM AND CASCADE LAKE DAM FAILURES, LARIMER COUNTY, COLORADO

U.S. GEOLOGICAL SURVEY

Open-File Report 84-612

By Robert D. Jarrett and John E. Costa

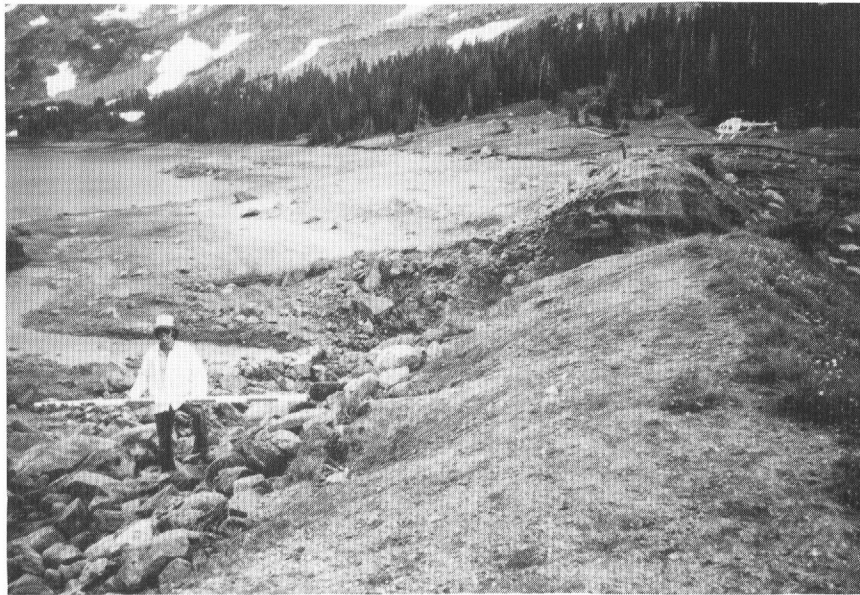
Figure 4B.--The top of Lawn Lake dam after failure (July 1982). Man is holding rod at elevation of water at time of failure.

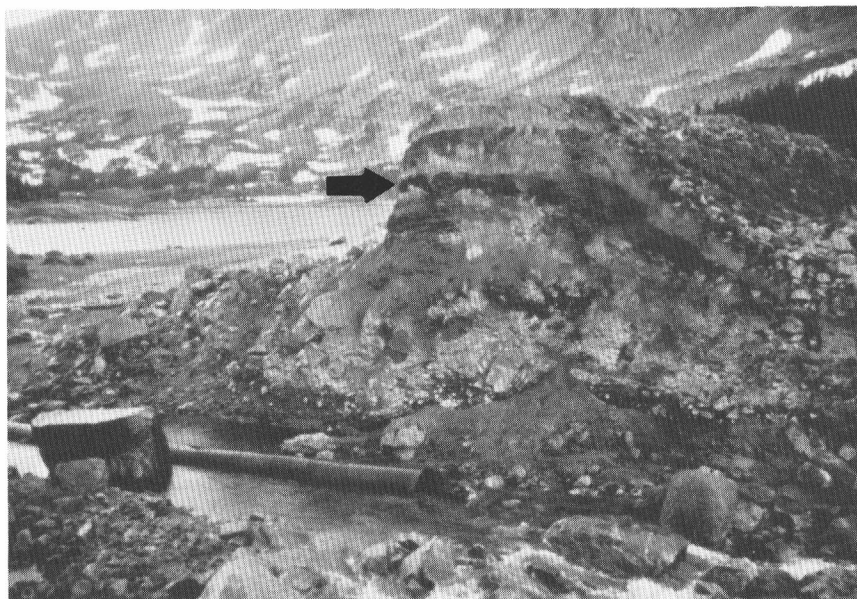
Figure 5.--The cross section of Lawn Lake dam following failure.  
Arrow indicates dark organic layer 4 to 5 ft below top of dam.

Earthfill in the dam was sufficiently fine-grained to be frost-susceptible. Soil-property changes induced by numerous freeze-thaw cycles could have been a possible cause of failure. However, no ice lenses nor frozen ground were found during investigations at the damsite in July 1983; any changed soil characteristics would be reflected in the geotechnical investigations of the fill material.

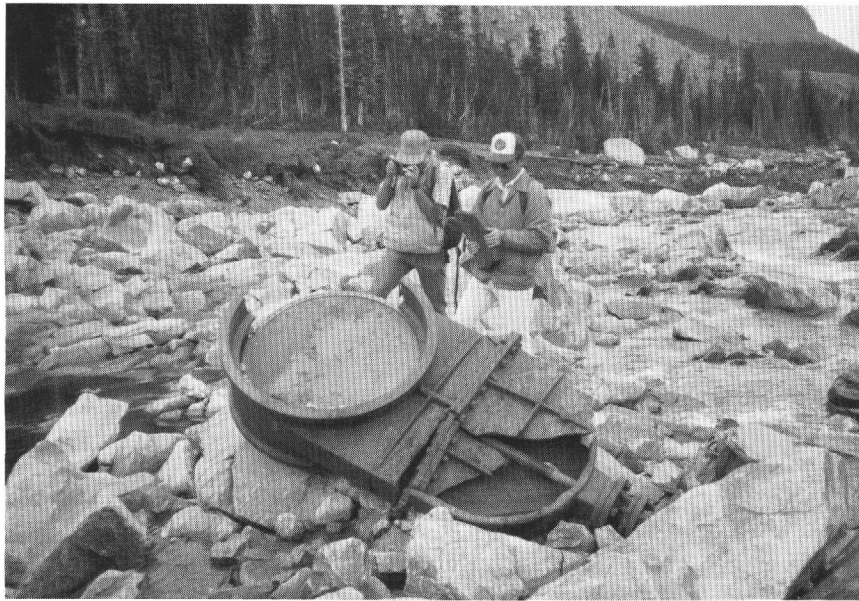
During investigations at the damsite, numerous pieces of lead caulking that was used to form the seal between the outlet pipe and the gate valve (fig. 6) were found. This lead caulking was corroded and deteriorated to the point that it would be unlikely to form a water-tight seal. The use of lead caulking to secure the pipe and valve was not in compliance with original plans and specifications approved by the Colorado State Engineer in 1902, which indicated that the valve would be encased in concrete.

Figure 6.--The remains of the outlet valve from Lawn Lake dam. Investigations of this valve led to the conclusion that lead caulking had severely deteriorated.

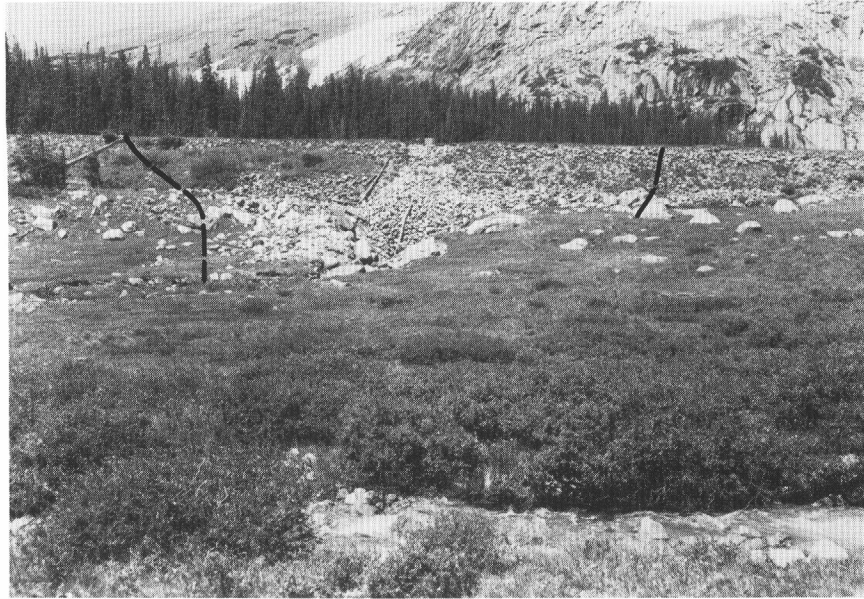
Figure 7A.--The downstream face of Lawn Lake dam prior to failure, showing the location of the outlet well and pipe (July 11, 1958). Dashed lines on dam face show location of eroded breach. Photo courtesy of the National Park Service.

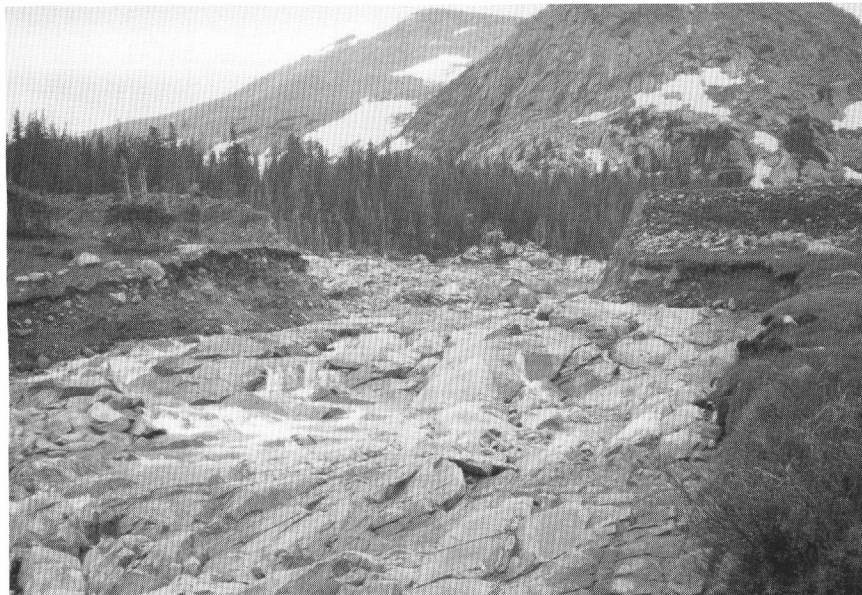
Surveyed breach dimensions are: Depth of 28 ft, top width of 97 ft, and bottom width of 55 ft. Following the complete failure of the dam embankment at about 0530 MDT, the resulting outflow of water reached its peak discharge very quickly (estimated to be within 10 min). The resulting flood peak of 18,000 ft<sup>3</sup>/s (see "dam-Break Modeling") then proceeded down the Roaring River toward Horseshoe Park and the Cascade Lake dam.

Figure 7B.--The front of Lawn Lake dam following failure showing the breach width.

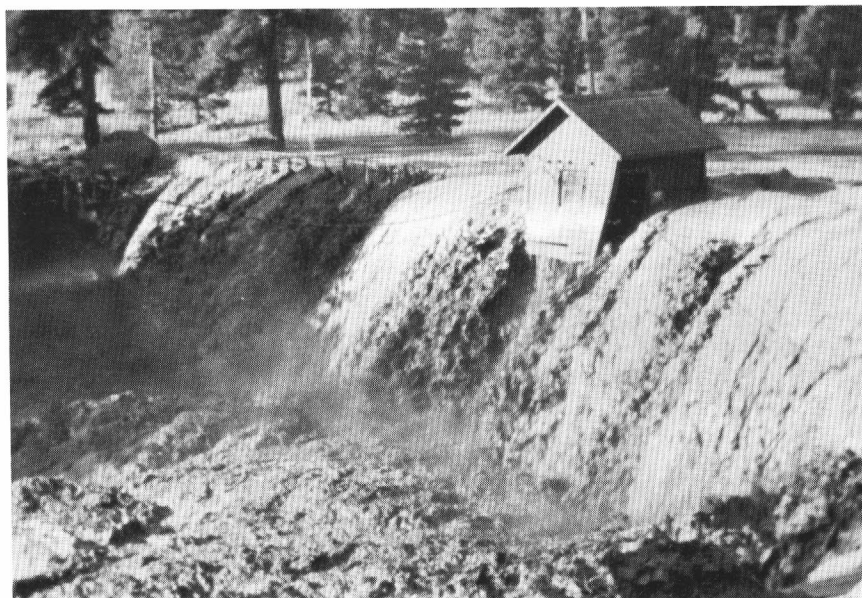
Figure 9A.--Water overtopping Cascade Lake dam.

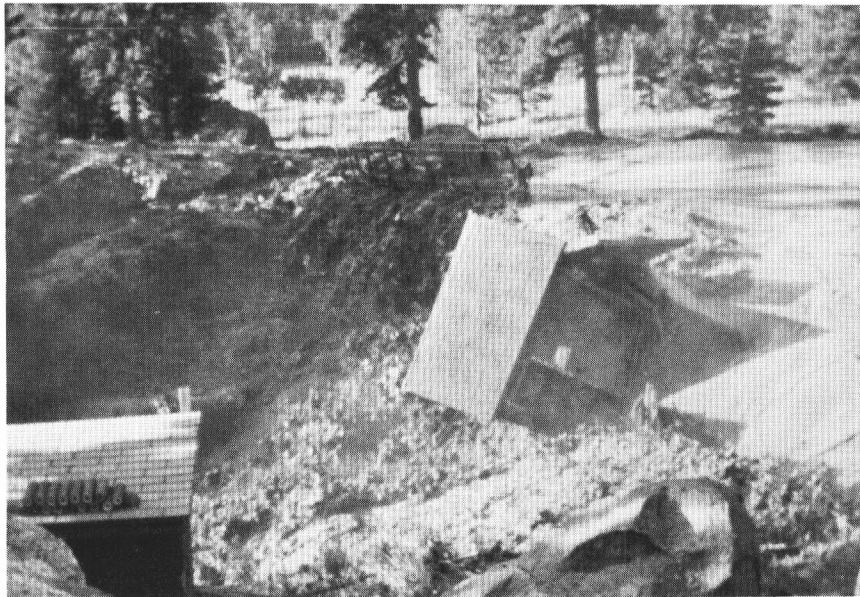
Figure 9B.--Cascade Lake dam in the initial stages of failure.

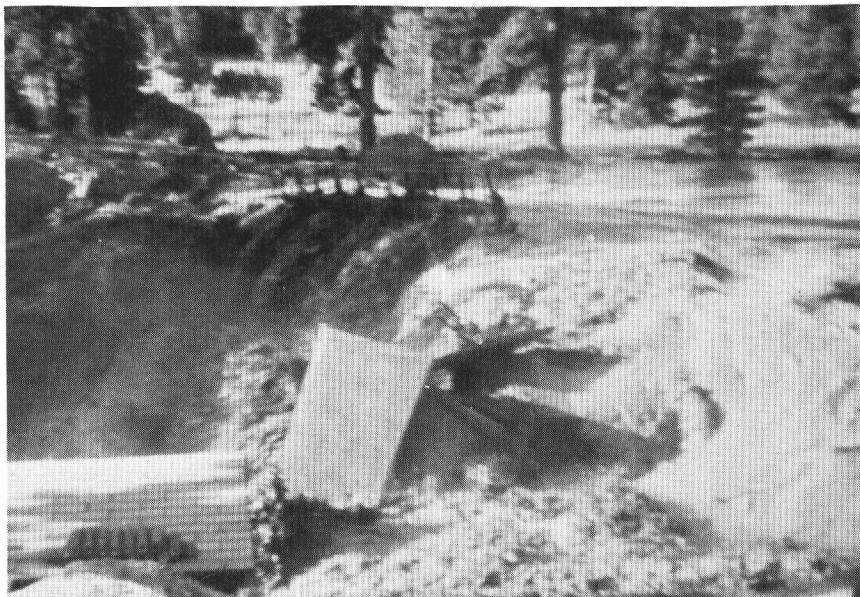
Figure 9C.--Cascade Lake dam taken a few seconds after photograph 9B.

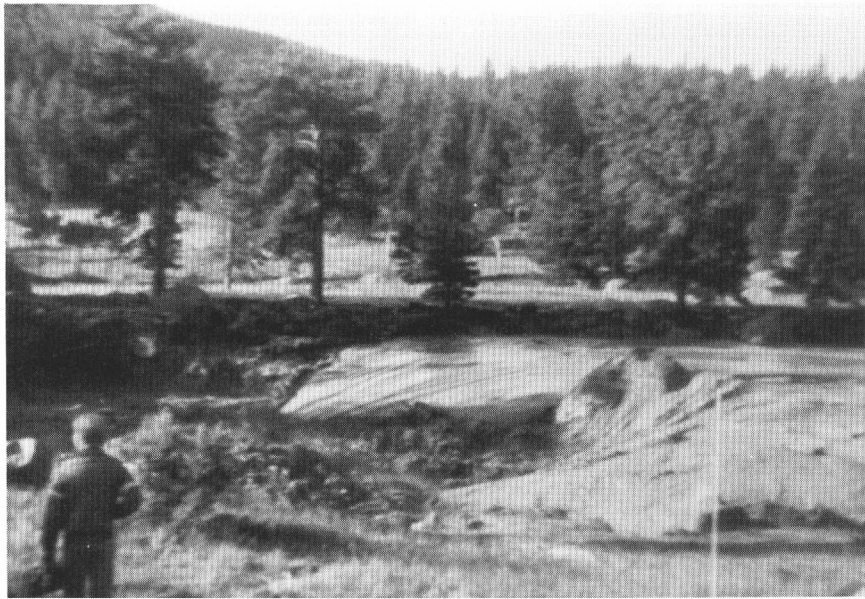
Figure 9D.--The location of Cascade Lake dam immediately after total failure. Photos A-D courtesy of Grace George Davis and Jennifer D. George.

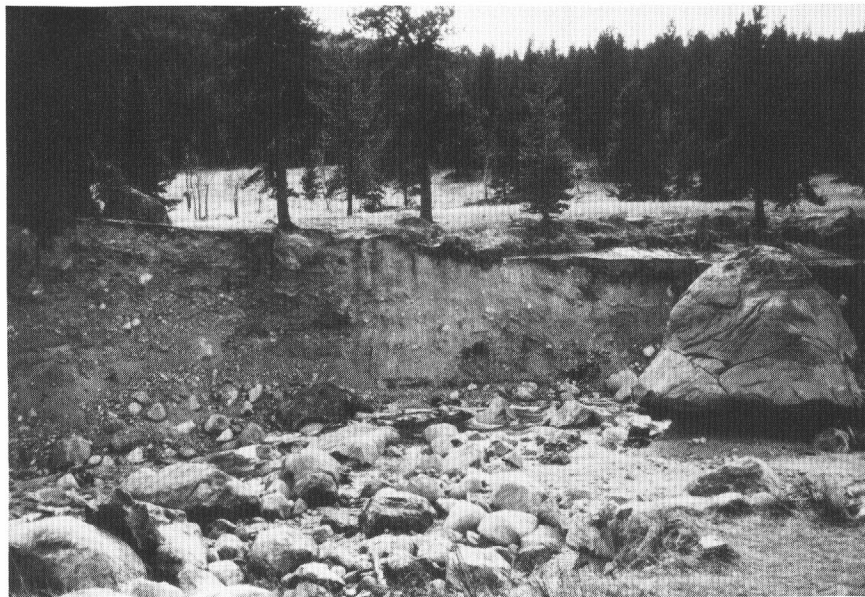
Figure 9E.--The location of Cascade Lake dam following the failure and draining of Cascade Lake. Top of the large boulder on the reservoir floor is shown in figure 9D and in figure 8.

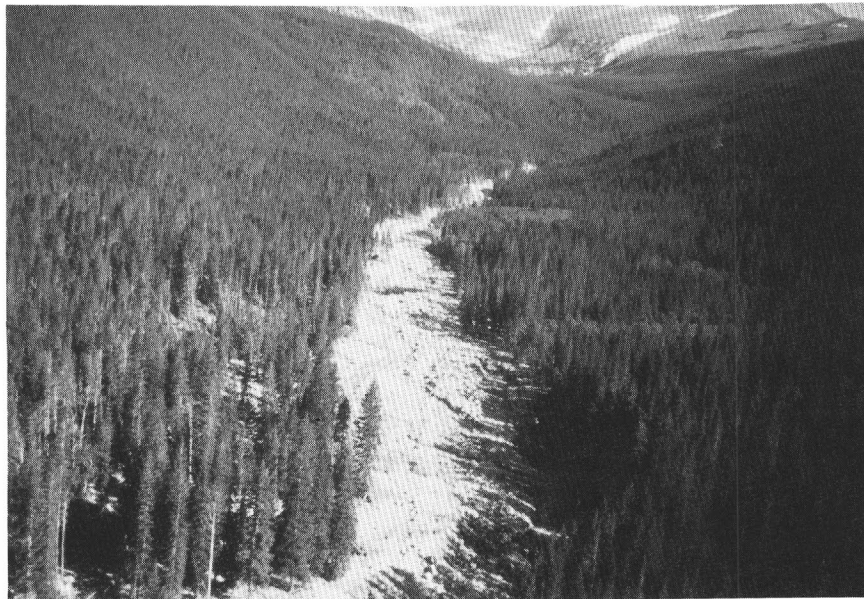
Figure 10.--The middle reach (river mile 2.1) of the Roaring River showing the extensive areas of scour and fill along the channel.

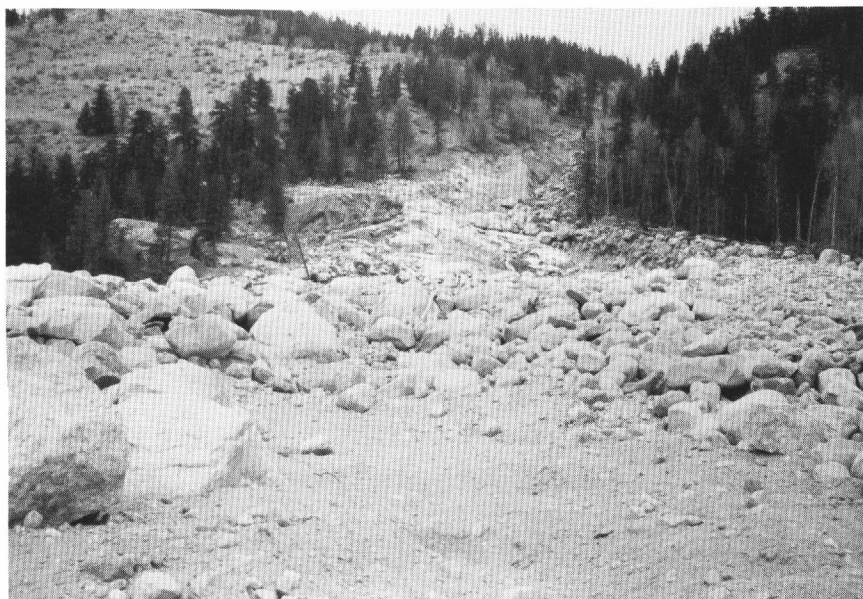
Figure 16B.--The Roaring River in 1982, after the flood, from approximately the same location as in figure 16A.

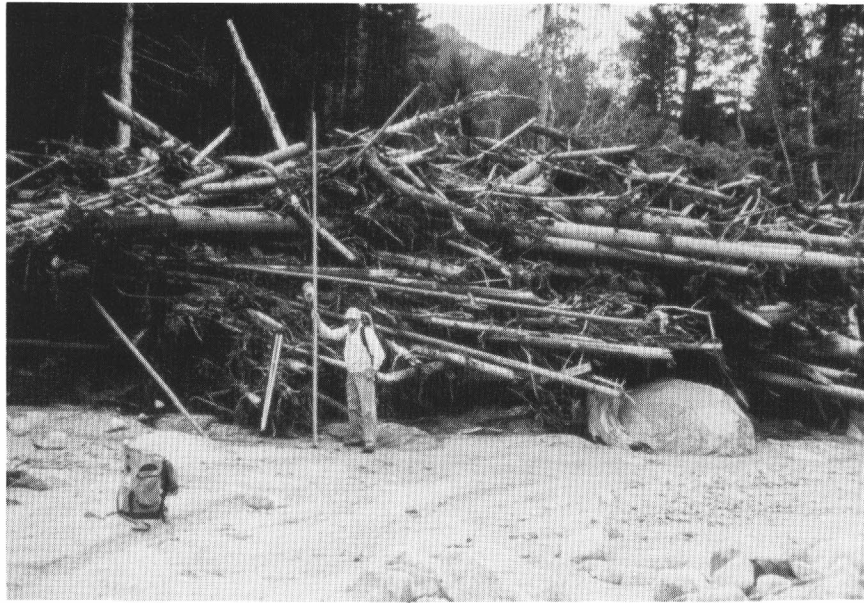
Figure 17.--The remains of a large debris dam in the Roaring River valley near river mile 3.21.

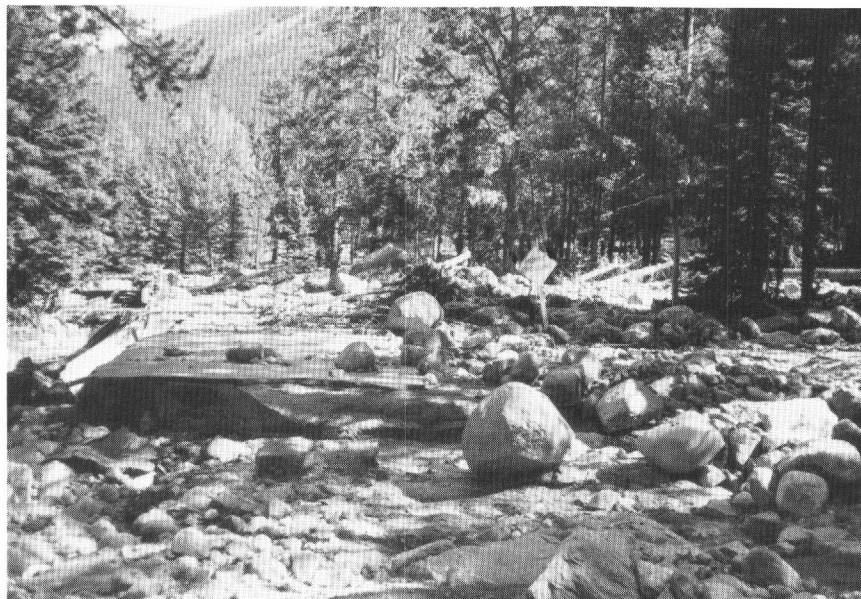
Figure 20.--The entrance to Aspenglen Campground downstream from Cascade Lake dam through the campground area at river mile 7.01. Boulders moved by the relatively wide, shallow flow of water (resembling overland flow).

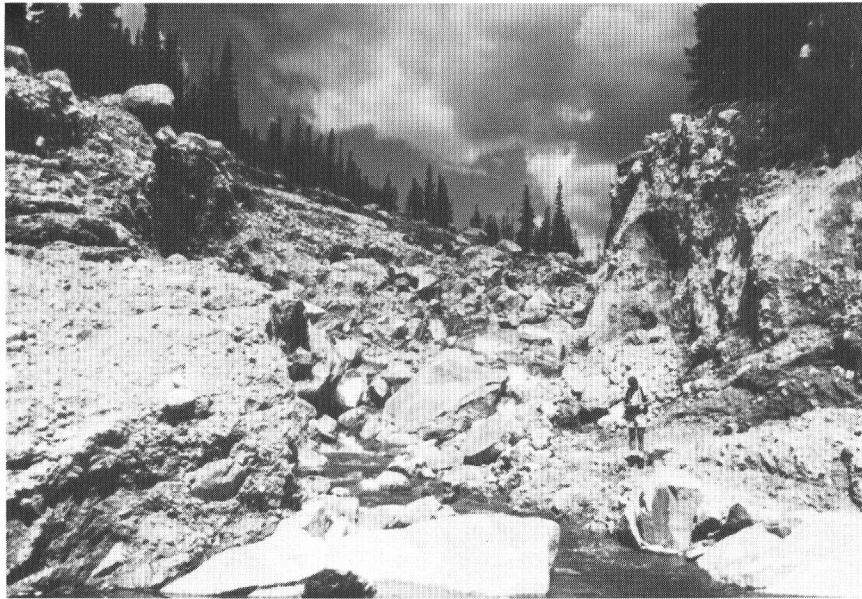
Figure 26.--Deeply scoured reach in the Roaring River valley below Lawn Lake dam at river mile 0.28. Ground moraine was scoured 35 feet to bedrock. Man (for scale) in right center of photo.

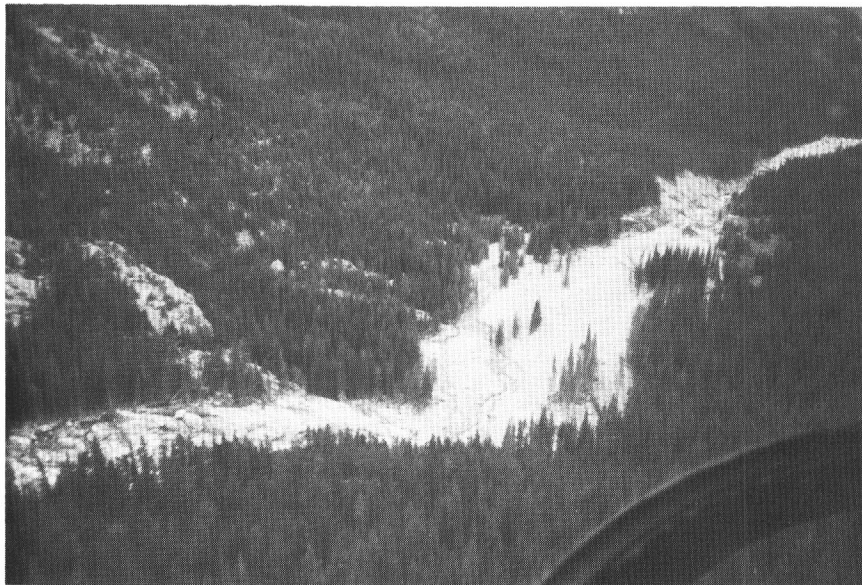
Figure 27.--The Roaring River valley at river mile 1.14 (aerial); down-valley is to the right. From the left edge of the photo, the channel is scoured to bedrock and very steep; a wide depositional reach is at a mountain meadow; a short, steep-scoured reach is defined by the slope failures on the left bank; and, finally, a flatter depositional reach extends off the right edge of photo.

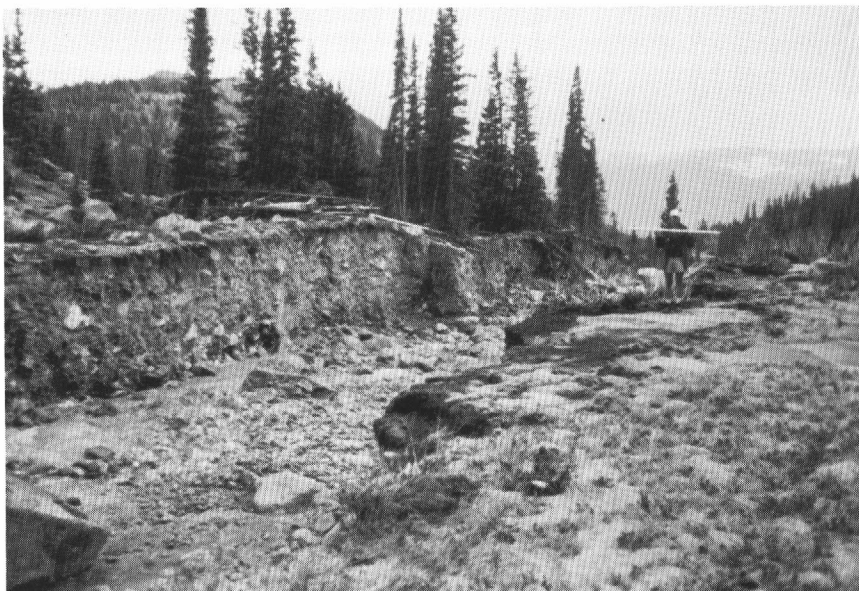
Figure 28.--View downstream at river mile 0.55 on the Roaring River valley in a scoured reach. Depth of scour is 25 feet; man is holding rod at the level of high-water marks.

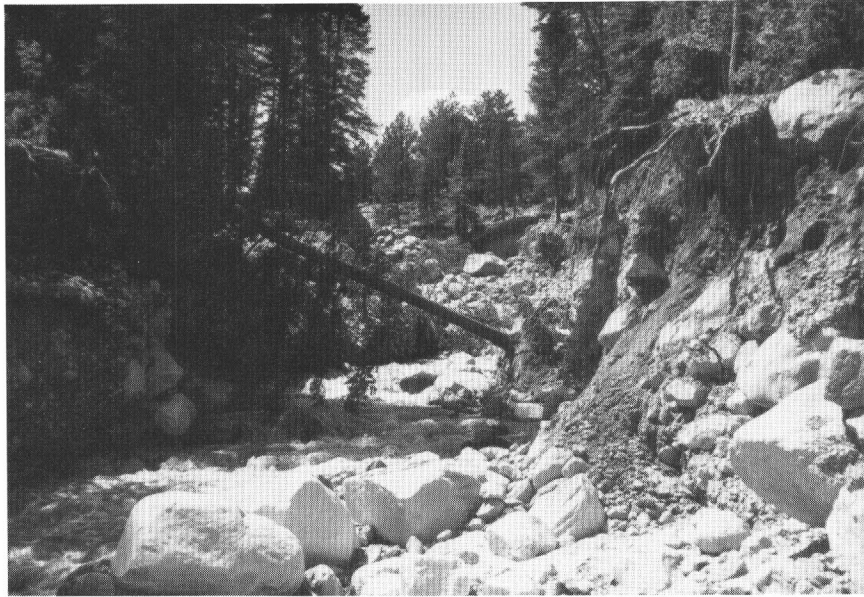
Figure 42.--The Fall River channel about 0.3 mile below Cascade Lake dam, showing extensive channel scour. View is upstream.

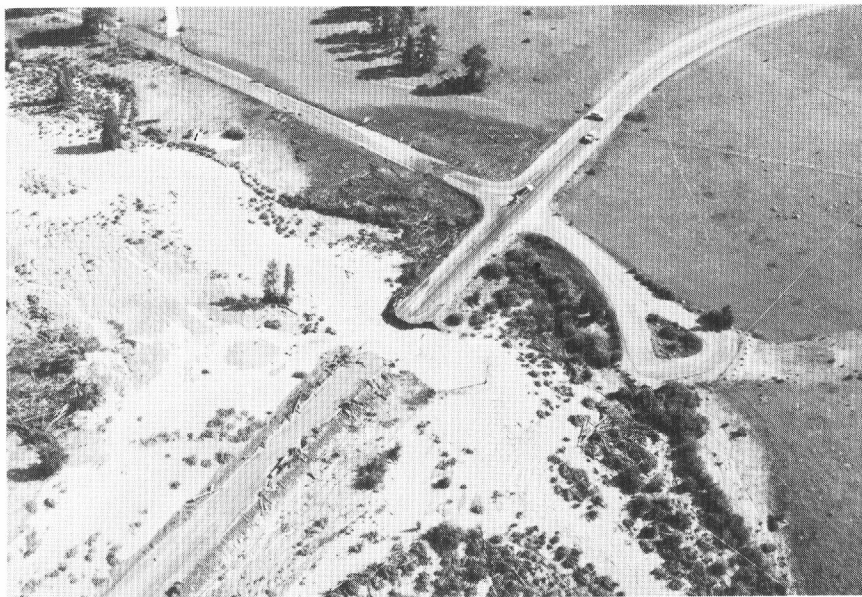
Figure 50.--About 0900 MDT on July 15, 1982, looking upstream at washed-out U.S. Highway 34 bridge in Rocky Mountain National Park at river mile 5.3. Photo courtesy of Zenas Blevins, U.S. Bureau of Reclamation.

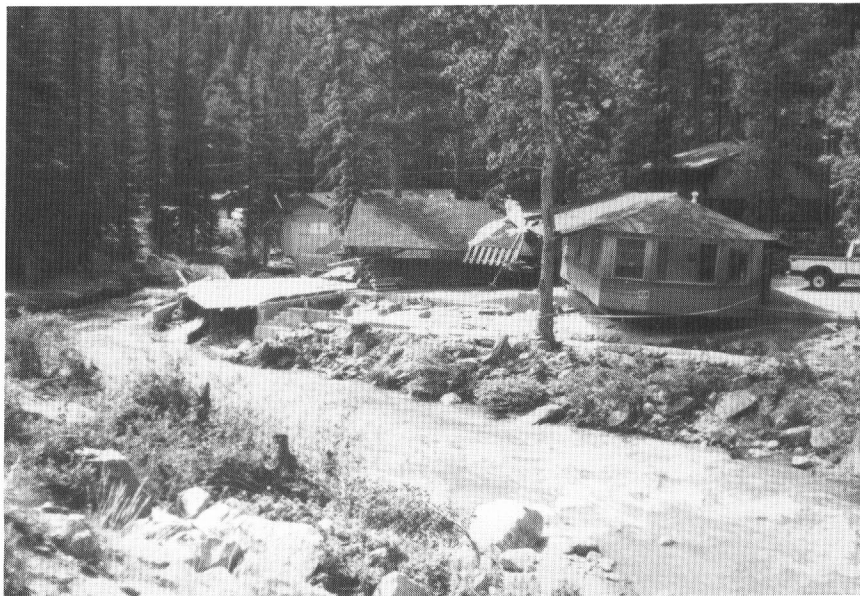
Figure 51A--The Ponderosa Lodge, which was destroyed by the flood, at river mile 9.9 on the Fall River. Note the structure was rotated almost 90° off its foundation.
