Stability of Slopes Below the Sherwood Uranium Mine, Spokane Indian
Reservation, Northeastern Washington

Alan F. Chleborad and Robert L. Schuster

Open File Report 84-627

1984

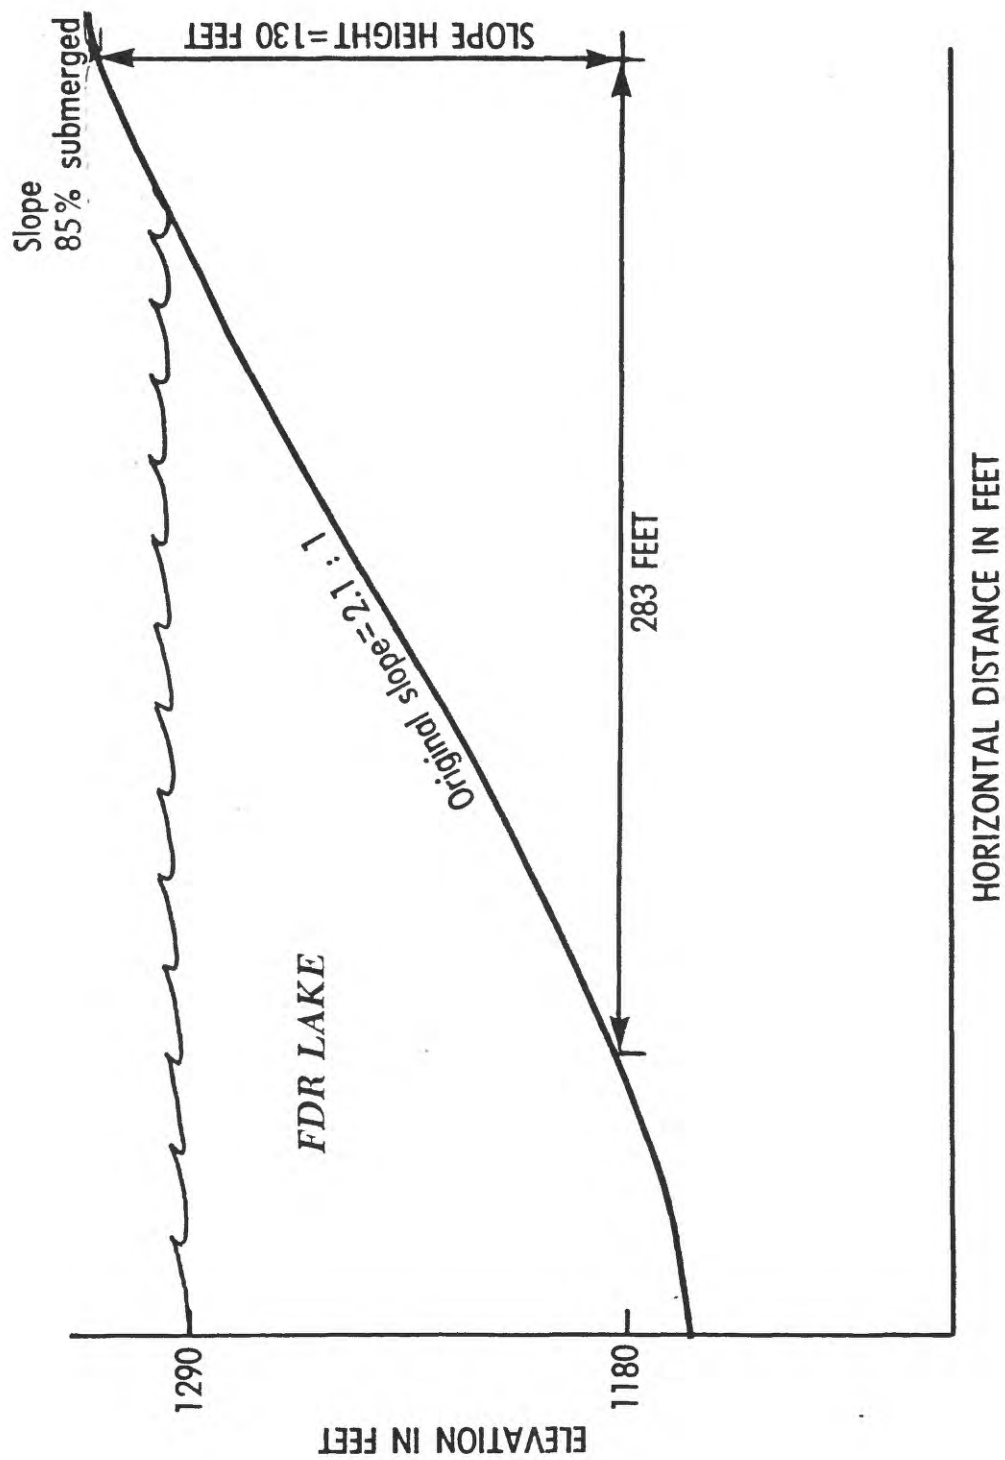
Figure 4.--Cross section of lake bank below the Sherwood Mine, drawn from data provided by Jones and others (1961, table 8, slope 92), whose analysis suggested likelihood of landsliding.

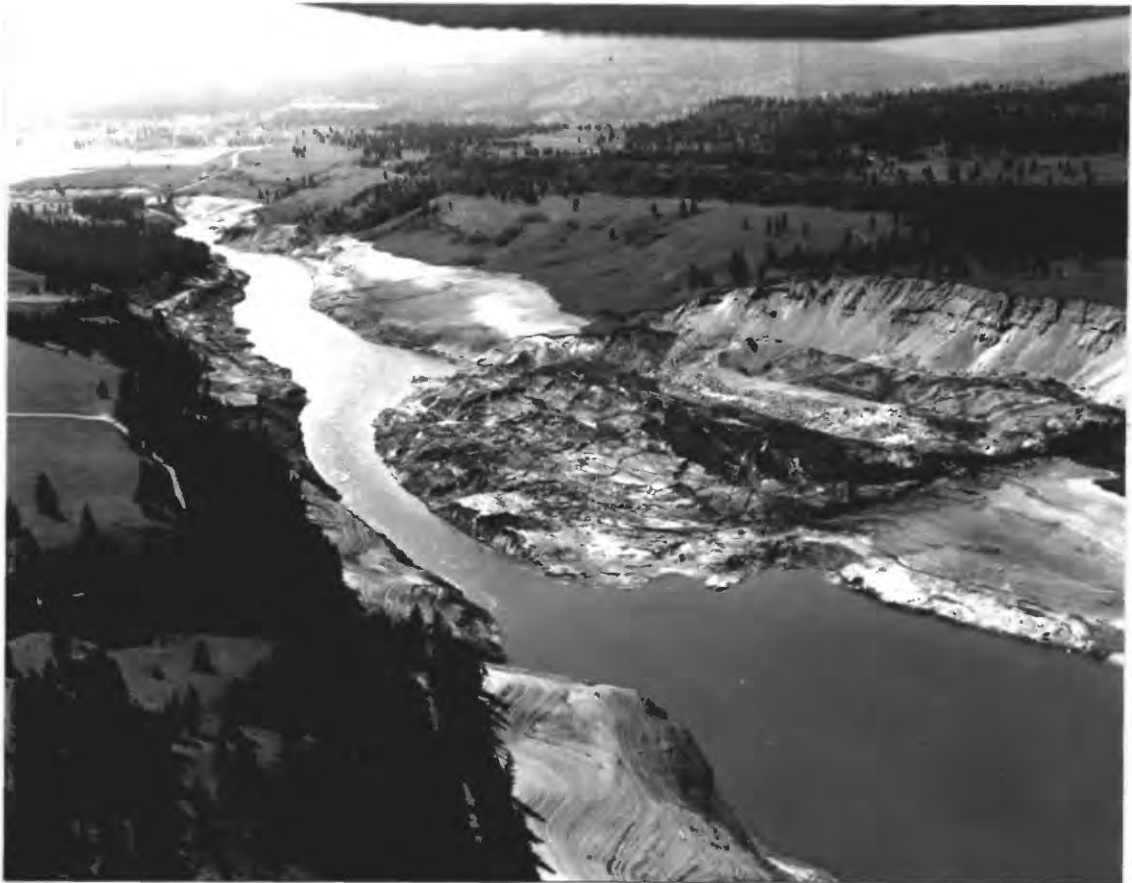
Figure 5.--Jackson Springs slide on the Spokane River Arm of Franklin D. Roosevelt Lake. This earth slump, which had a volume estimated at over 14×10^6 yd³, occurred on March 26, 1969, on a terrace consisting of alternating beds of lacustrine clay, silt, and sand. The slump occurred during a period of extreme drawdown necessitated by excavation for a forebay preliminary to construction of the Third Powerplant at Grand Coulee Dam (U. S. Bureau of Reclamation, 1969). (Photograph courtesy of U. S. Bureau of Reclamation.)

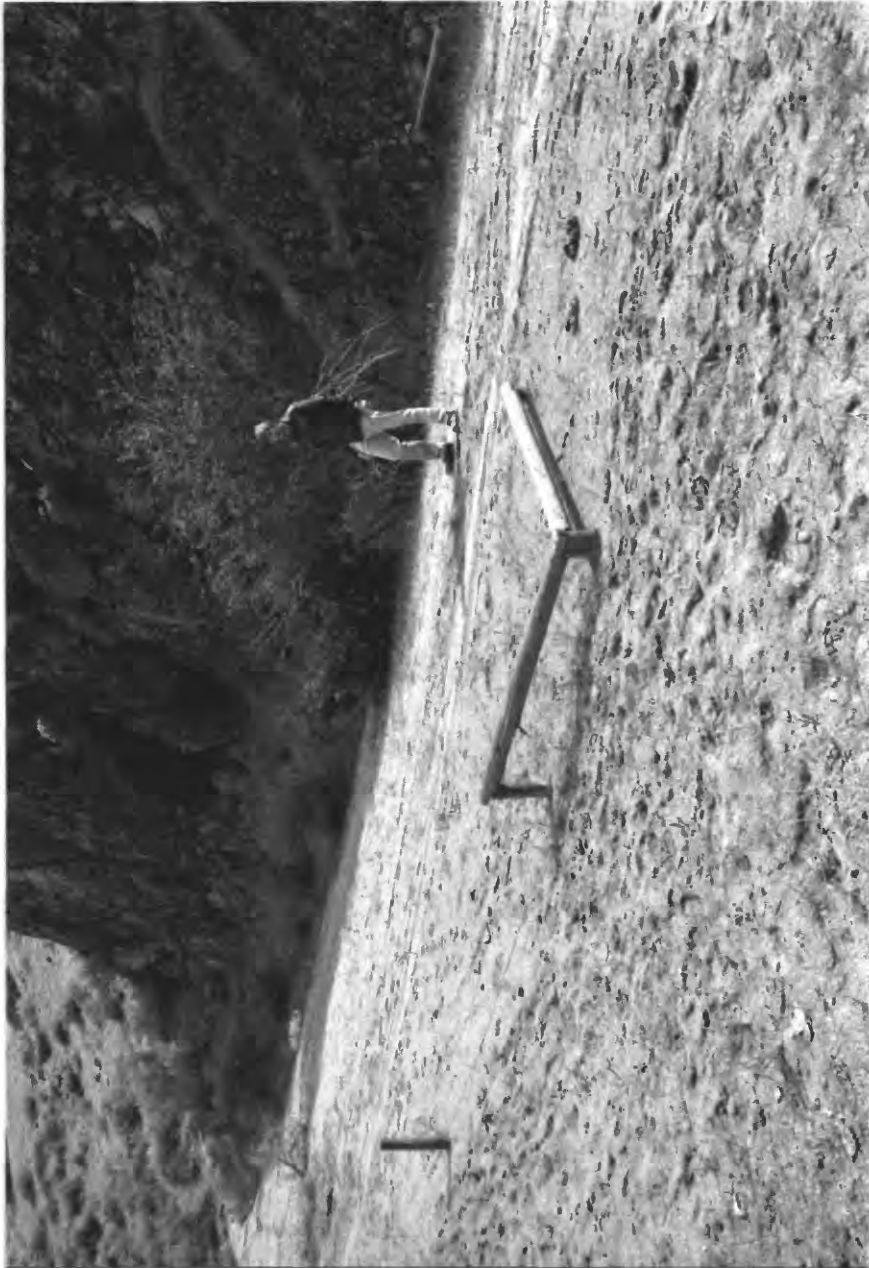
The formation of alluvial fans on the slopes below the mine is an ongoing process attributable to the loose, easily eroded nature of the sand, silt, and gravel deposits, and to the concentration of surface run-off due to natural topographic features and the effects of the mining operation. The alluvial fans appear to be old deposits unrelated to the mining, with the exception of three in slope areas II and III that are so indicated on plate 1. Those recent deposits, which are several tens of feet thick, have formed within the last few years as a result of the concentration of surface run-off in the mine area and the breaching of berms designed to control erosion (fig. 9).

Figure 9.--Recently formed alluvial fan at the bottom of slope area III. The fan is the result of rapid gully erosion of loose sand, silt, and gravel deposits, the breaching of sand berms, and associated wet sand flows originating in upper slope areas. Top rail of partially buried fence was originally about 5 ft above ground surface.

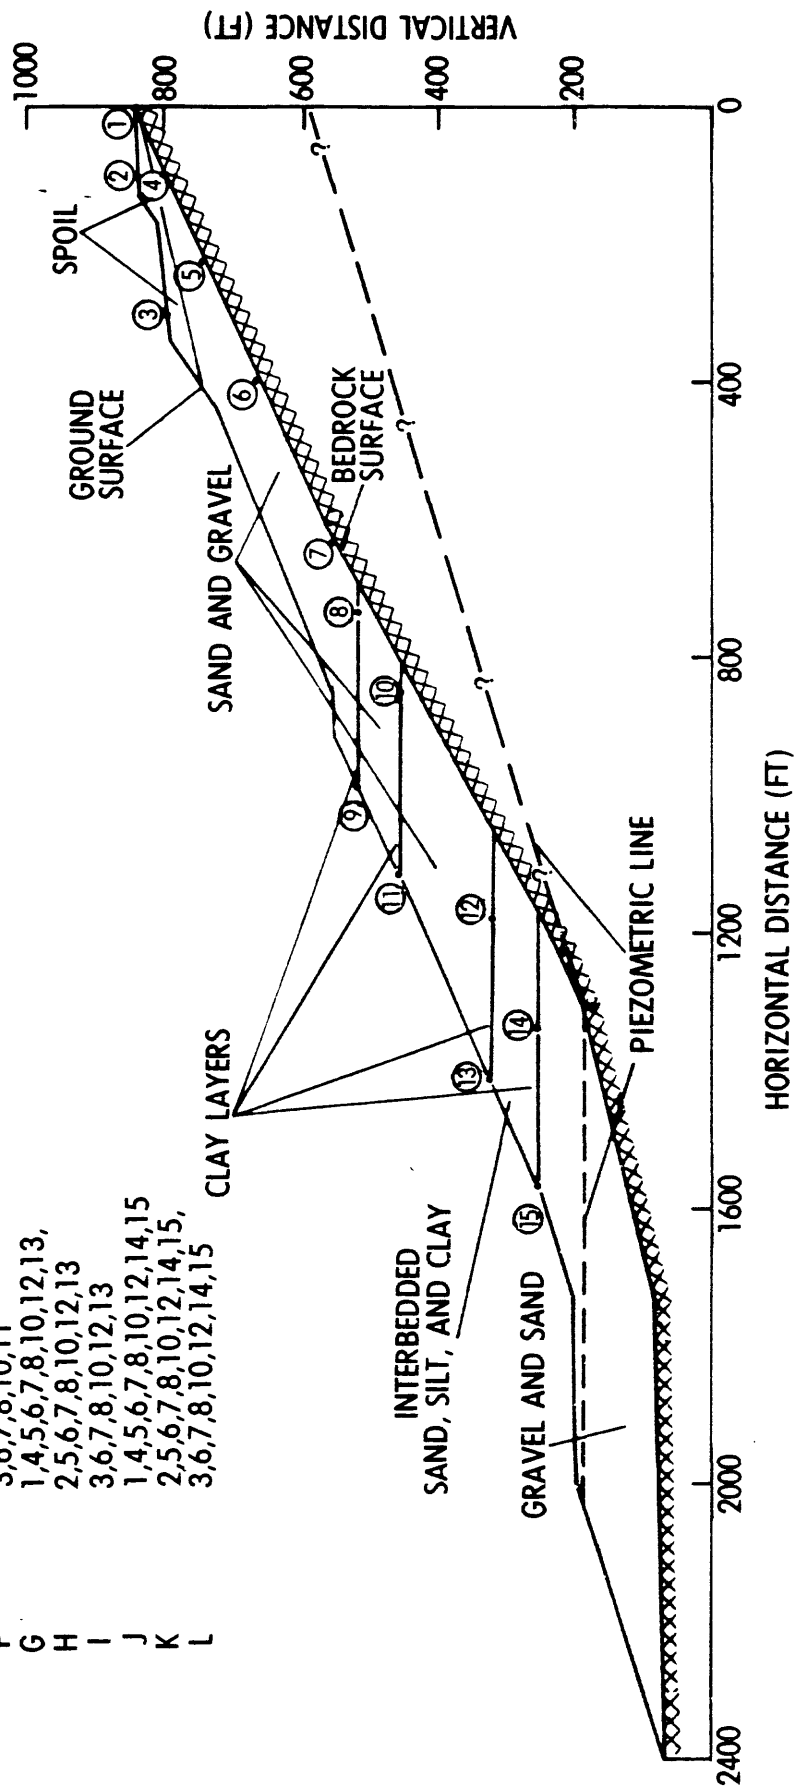
Figure 20.--Idealized cross section A-A' (plate 1, slope area II) showing the location of trial failure surfaces.

All of the trial failure surfaces in slope area II (fig. 20) are above the "filled" reservoir level of 1290 ft above sea level, and all extend to the top of the slope, involving varying amounts of existing spoil. Calculated factors of safety (table 5) range from 1.62 to 2.01 using peak strength parameters, and from 1.55 to 1.86 using residual values. A check on results for trial failure surface 'C' using the sliding wedge analysis shows good agreement with the Morgenstern-Price results. Incipient slope failure is not indicated for any of the trial failure surfaces under existing conditions.

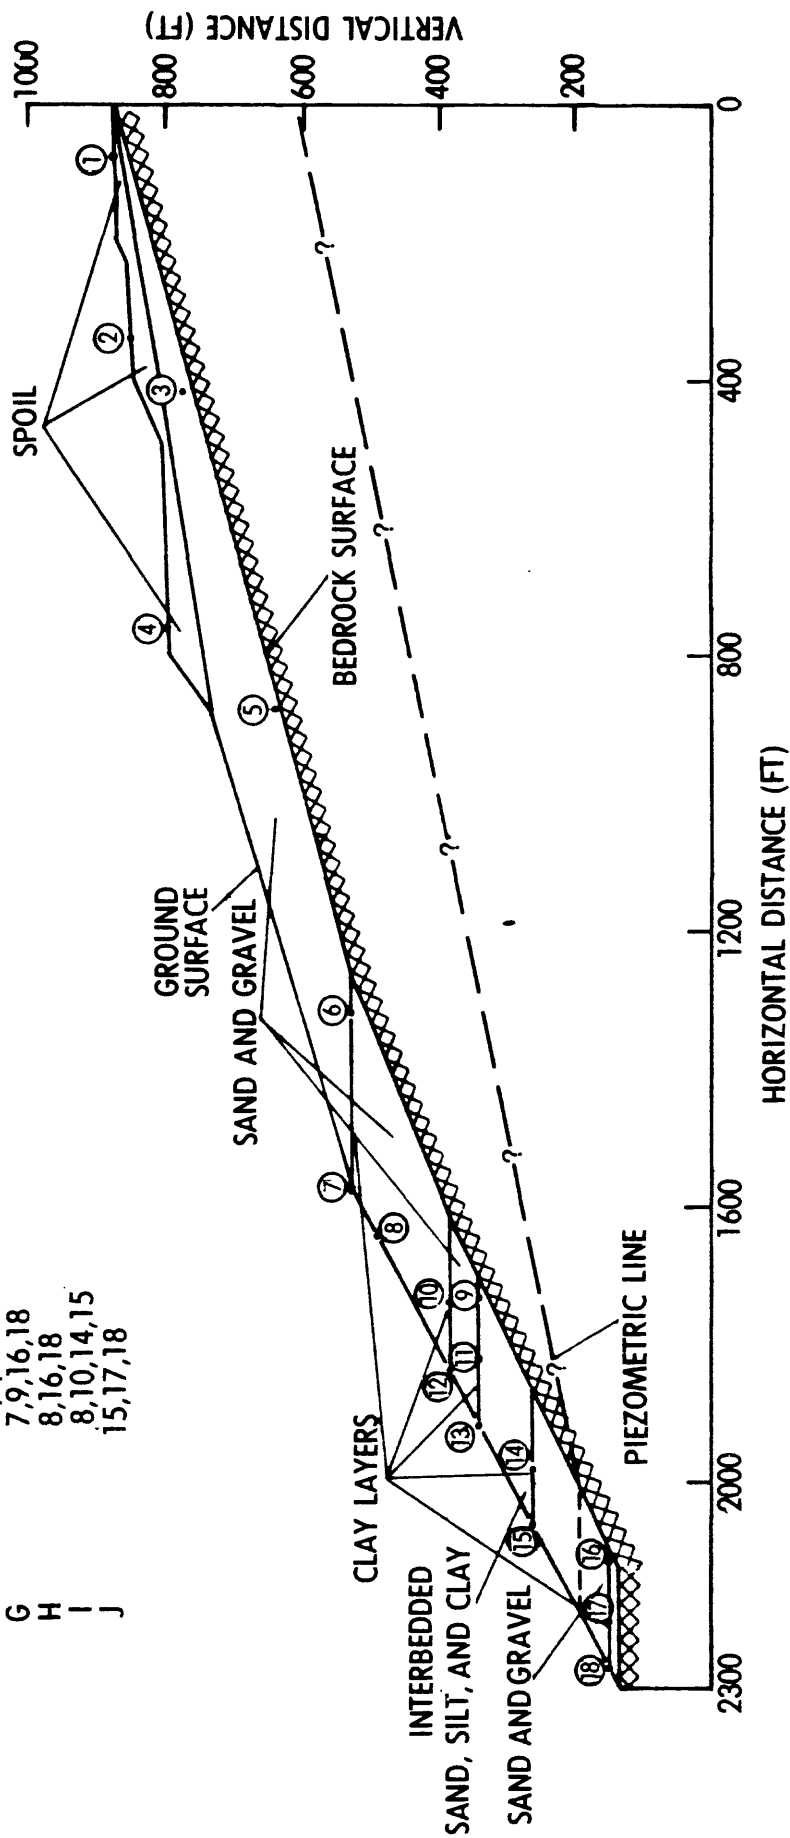
Figure 21.--Idealized cross section B-B' (plate 1, slope area IV) showing the location of trial failure surfaces.

The lower parts of three of the trial failure surfaces in slope area IV (G, H, and J, in fig. 21) are submerged during the "filled" reservoir condition, and thus are subject to drawdown effects. All of the other surfaces lie above that level. Several acceptable solutions were obtained using the Morgenstern-Price analysis, but none involving the drawdown condition. The sliding-wedge analysis was used successfully in those cases. As shown in table 6, factors of safety range from 1.41 to 2.93 using peak strengths and from 1.03 to 2.82 using the residual values. Lower factors of safety are associated with the shorter, steeper surfaces in the lower part of the slope, some of which were subjected to the drawdown condition. These surfaces, which do not involve spoil material, were selected and analyzed

Trial failure surface	Locus of failure-surface points (see fig. 21 for location)	Conditions		Factor of safety		Stability analysis used
		Reservoir level	Spoil-pile involvement	Based on peak shear strength	Based on residual shear strength	
						1 - Morgenstern-Price 2 - Sliding wedge
A	1, 3, 5, 6, 7	Trial failure surface above filled reservoir level	Involves existing spoil	2.93	2.82	1
B	2, 3, 5, 6, 7	----do-----	----do-----	2.81	2.69	1
C	4, 5, 6, 7	----do-----	----do-----	2.39	2.21	1
C	4, 5, 6, 7	----do-----	----do-----	2.61	2.34	2
D	4, 5, 6, 10, 12	----do-----	----do-----	2.18	2.15	1
E	7, 10, 12	----do-----	None	1.53	1.08	1
E	7, 10, 12	----do-----	----do-----	1.41	1.07	2
F	7, 9, 13	----do-----	----do-----	1.69	1.03	1
F	7, 9, 13	----do-----	----do-----	1.47	1.05	2
G	7, 9, 16, 18	Drawdown condition (reservoir level 1190 ft above sea level)	----do-----	1.41	1.33	2
H	8, 16, 18	----do-----	----do-----	1.42	1.28	2

I	8, 10, 14, 15	Trial failure surface above filled reservoir	----do-----	1.38	1.27	2
J	15, 17, 18	Filled (reservoir level at 1290 ft above sea level)	----do-----	1.58	*	1
J	15, 17, 18	Drawdown condition (reservoir level at 1190 ft above sea level)	----do-----	1.43	1.12	2
